# Kowloon-Canton Railway Corporation

## West Rail

## Pre-operation Environmental Audit Report

### December 2003

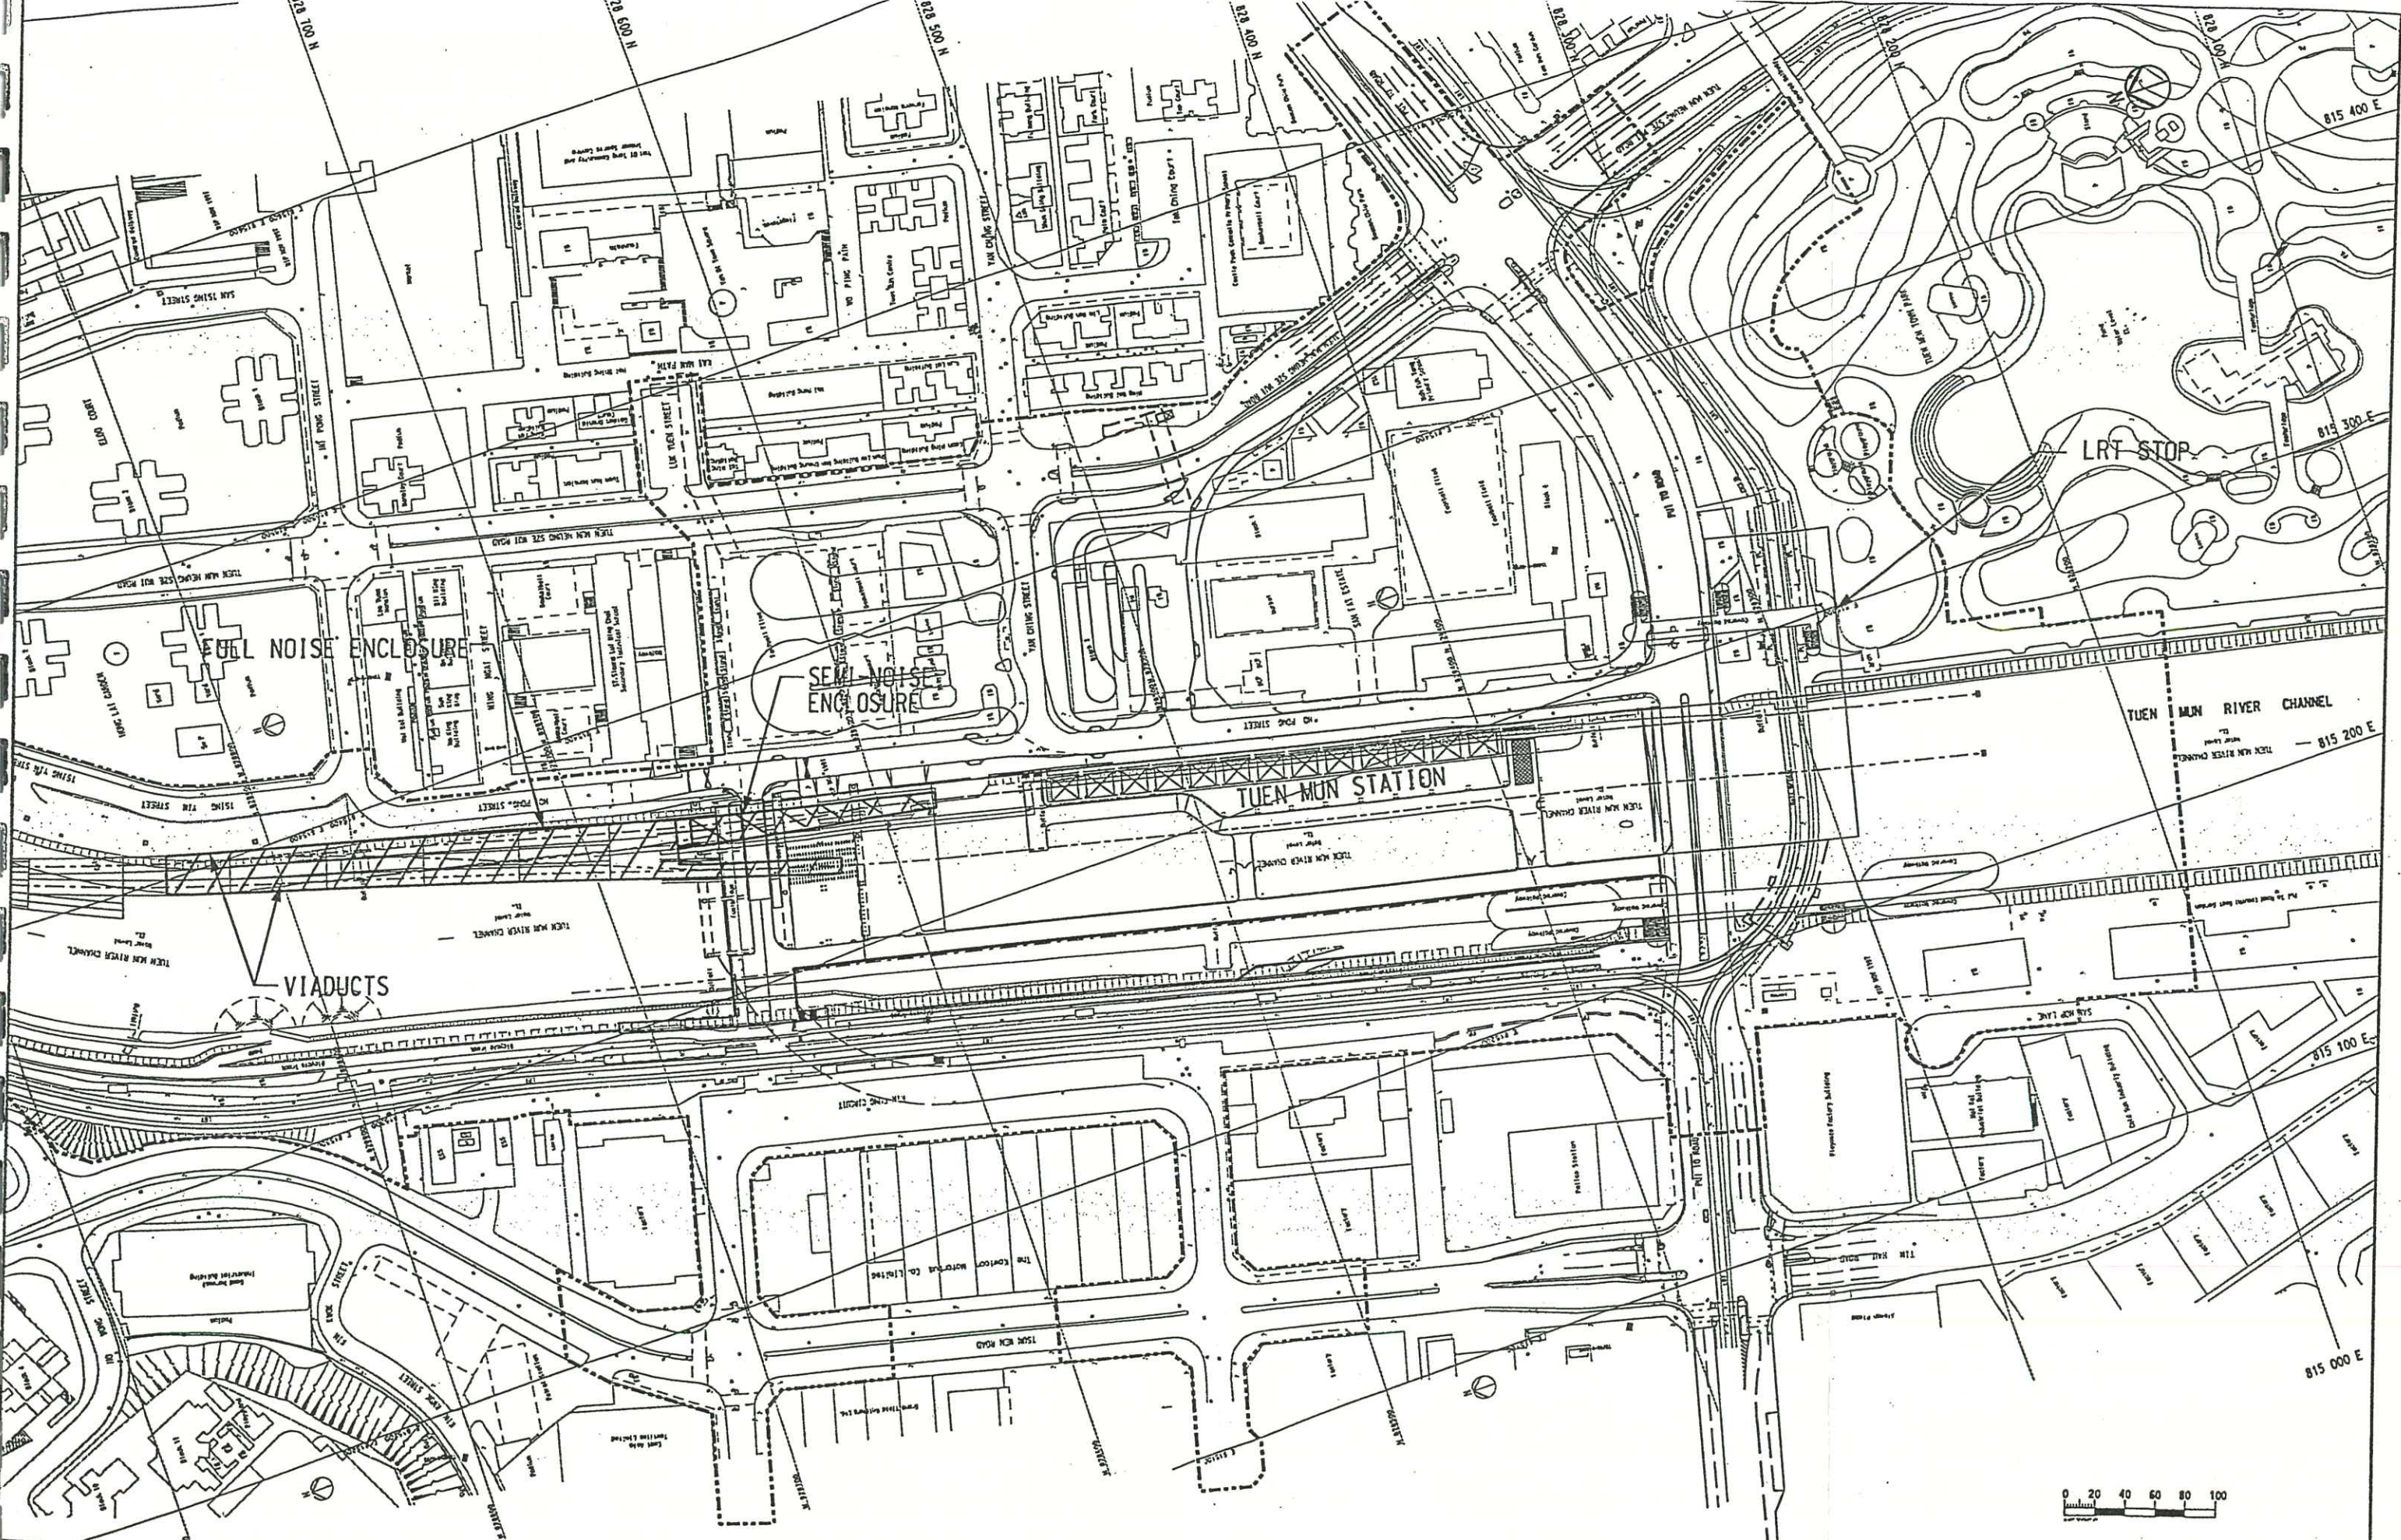
FIGURE 7  
LOCATION OF NOISE ENCLOSURE -  
TUEN MUN

In addition to the change in operational parameter, the design of the noise enclosure at Tuen Mun has also been changed in order to fulfil the Fire Services Department's requirement on fire safety. A section of the noise enclosure is changed to semi-noise enclosure where the openings are facing industrial area without noise sensitive receivers. A VEP application was submitted to EPD regarding this change and was approved on 8 July 2002. The layout drawing of the revised noise enclosure was submitted to EPD on 14 August 2002. For ease of reference, the location of the noise enclosure is also shown on Figure 7 annexed to this report.
