CONTRACT HY/2009/15

CENTRAL – WAN CHAI BYPASS TUNNEL (CAUSEWAY BAY TYPHOON SHELTER SECTION)

Landscape Plan

Submission Status: For Approval

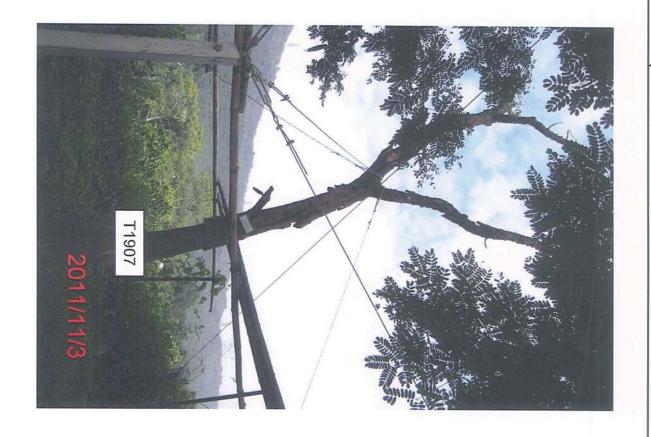
Central-Wan Chai Bypass - Shelter Section) Tree Mark: Tunnel (Causeway Bay Typhoon HY/2009/15 T1906 and T1907

- The trees grew near the seaside of the rocky embankment of the East Breakwater concrete and rock breaking around their root balls could not be avoided. holding nursery, they intended to grow unhealthily and became week gradually and process, we also found that the root balls were not intact attached with soil and before they were transplanted. died as a consequence hence no pruning works were done for the transplanting. After transplanted to the During the transplanting works in early 2011, During the
- 2 Referring to the specialist had already highlighted the following: Submission ref CCW/CSF/LDS/000037B dated 23 December 2010, our landscape Tree Survey Report submitted under cover of Contractor's
- (a) between rock. For tree No. T1906, the root system distorted due to confined growing space Preparation of root ball was unfeasible
- **b** transplanting.

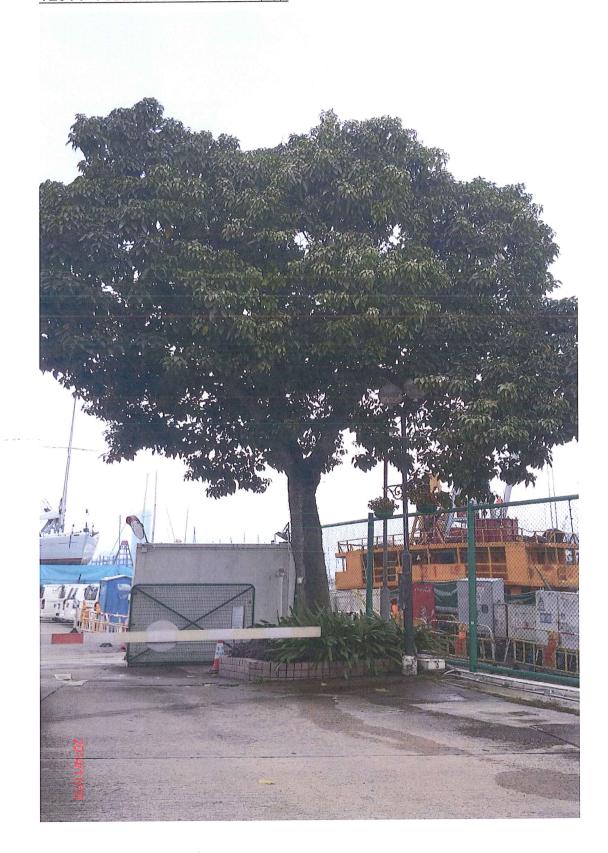
T2014 - Aleurites moluccana 石栗

T2014	Aleurites moluccana	石栗	Police Officer's Club	8	4.5	481	5.48	G	G	No significant defect observed 未有察覺明顯缺陷	Cabling / other support (to be done by POC 安裝鑽索或支撐物(由警察員工會所負責) Reminded POC of the tree condition 已通知警察員工會所有關樹木情況
T009	Liquidamber Formosana	楓香	Works Area W1 at Siu Ho Wan	4	3	100	6.17	F	F	No significant defect observed 未有察覺明顯缺陷	Nil
T010	Acacia Confusa	臺灣相思	Works Area W1 at Siu Ho Wan	5	5	115	6.14	F	F	No significant defect observed 未有察覺明顯缺陷	Nil
T011	Liquidamber Formosana	楓香	Works Area W1 at Siu Ho Wan	4	3	95	6.12	F	F	No significant defect observed 未有察覺明顯缺陷	Nil
T012	Acacia Confusa	臺灣相思	Works Area W1 at Siu Ho Wan	9	7	302	6.21	F	F	No significant defect observed 未有察覺明顯缺陷	Nil
T013	Acacia Confusa	臺灣相思	Works Area W1 at Siu Ho Wan	8	5	153	6.21	F	F	No significant defect observed 未有察覺明顯缺陷	Nil
