**Re: Contract No. HY/2009/15  
Central – Wan Chai Bypass – Tunnel (Causeway Bay Typhoon Shelter  
Section)  
Landscape Plan (Rev. 7)**

**Landscape Plan (Revision 7) under FEP-06/364/2009/A for Contract No. HY/2009/15**

**Contract No. HY/2009/15**  
**Central-Wan Chai Bypass – Tunnel (Causeway Bay Typhoon Shelter Section)****Submission of Tree Survey Report - Review of**  
**Existing Trees Proposed to be Felled at Portions IV and XXII**

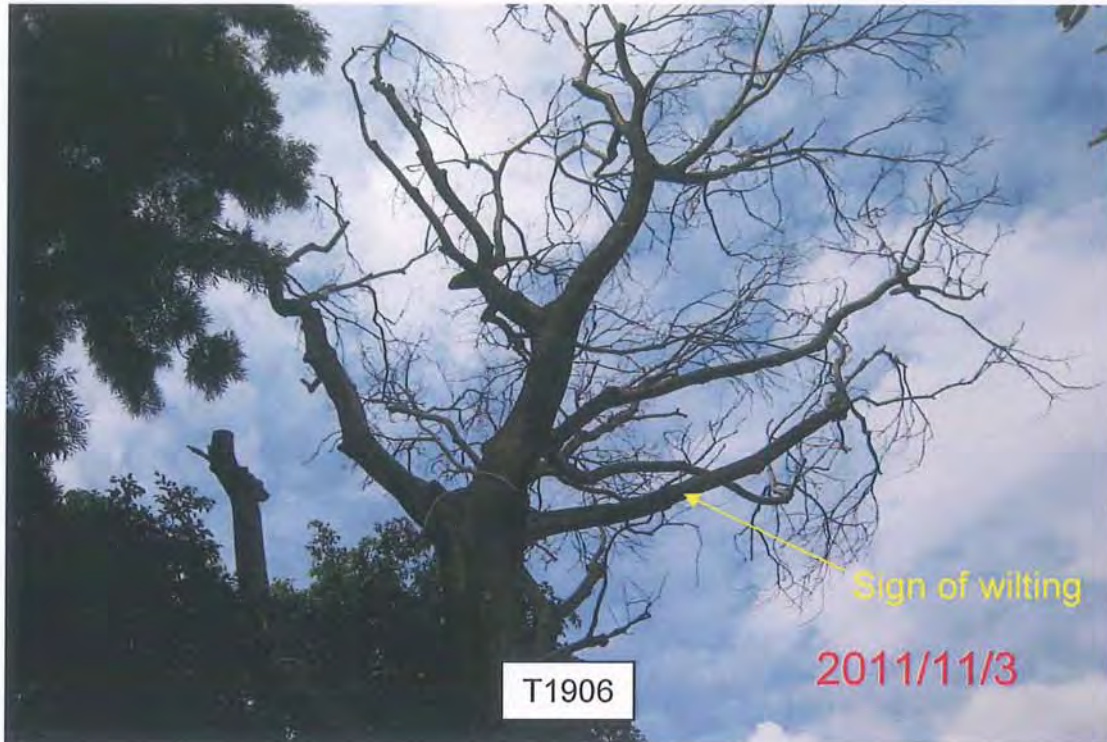
1. The trees grew near the seaside of the rocky embankment of the East Breakwater before they were transplanted. During the transplanting works in early 2011, concrete and rock breaking around their root balls could not be avoided. During the process, we also found that the root balls were not intact attached with soil and hence no pruning works were done for the transplanting. After transplanted to the holding nursery, they intended to grow unhealthily and became weak gradually and died as a consequence.

There were pre-existed conditions that the trees T1906 and T1907 were not suitable for being transplanted that we had pointed out before the execution of such works. Nevertheless, we have made our best endeavors to maintain the trees in healthy conditions during the whole process of the transplanting and in the holding nursery as required under the Contract. Therefore, under such circumstances, it is considered that we are not responsible for remedial works or replacement for the dead trees.

Sign of wilting

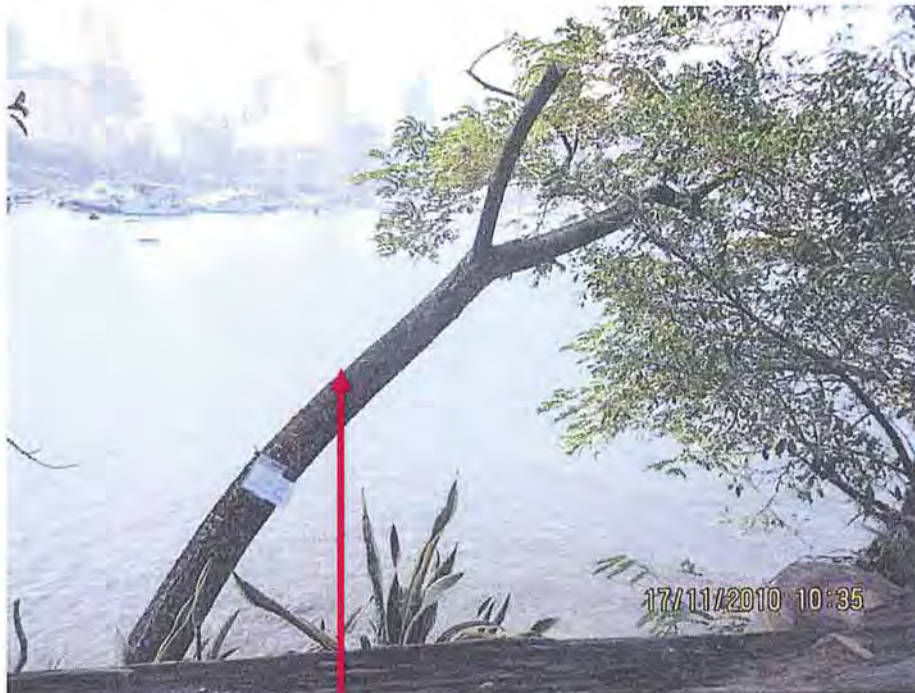
(l) Tree no. T1911 - Albizia lebbeck 大葉合歡

Leaning severely within existing rock slope

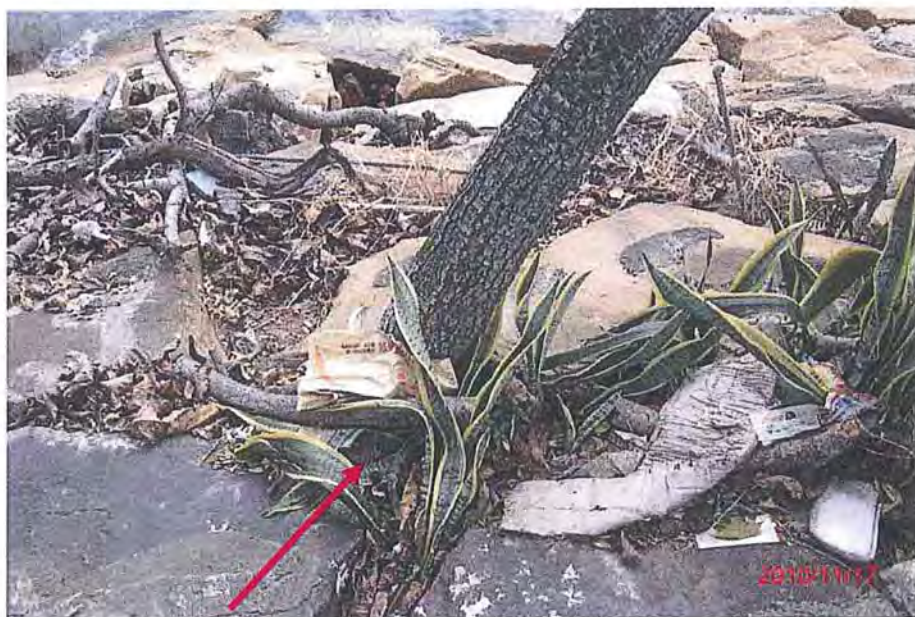
Rootball distorted due to growth in rock slope gradient

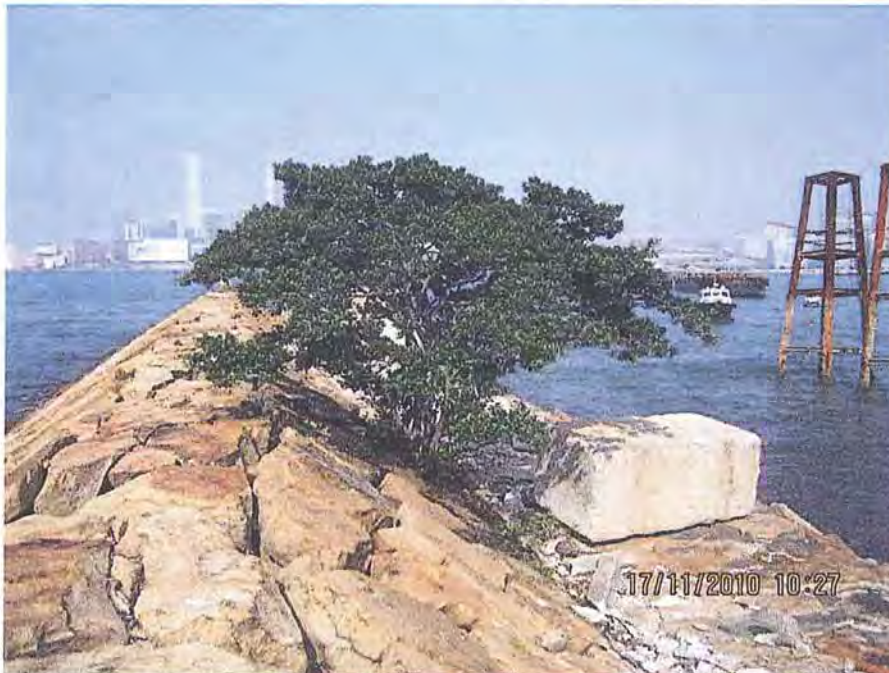
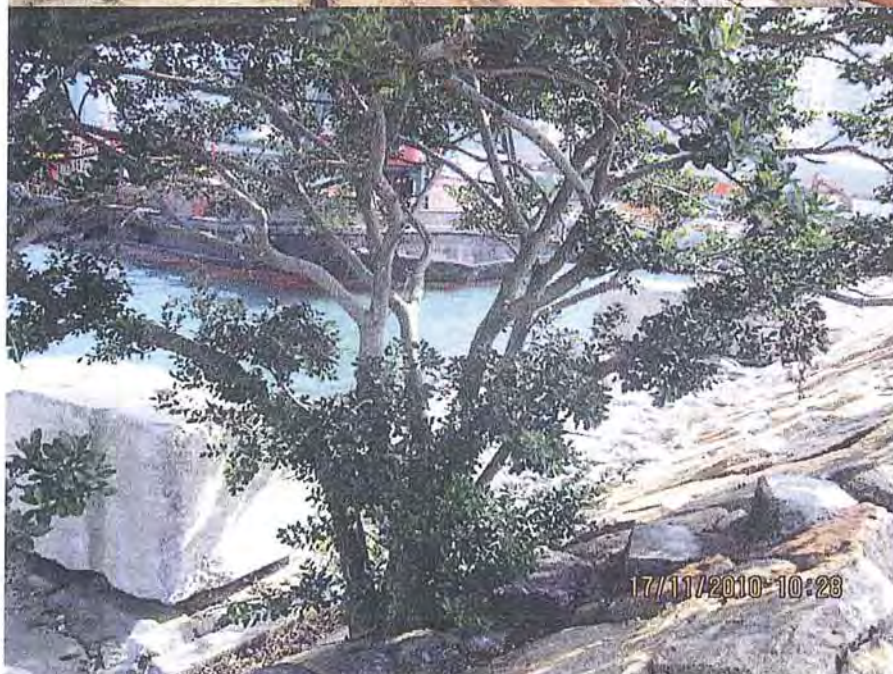
(n) Tree no. T2015 - *Ficus microcarpa* 榕樹, 細葉榕

Root system has developed at a 45 degree slope elevation in rocks.  
Root system distorted due to confined growing space between rocks.

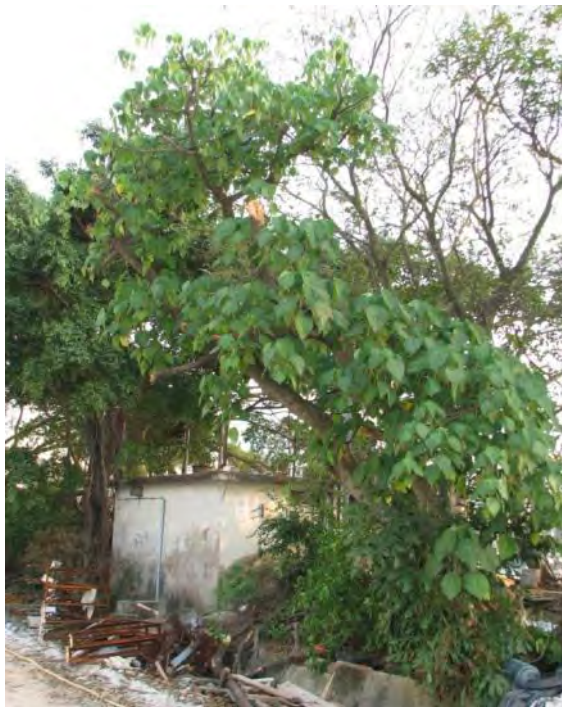
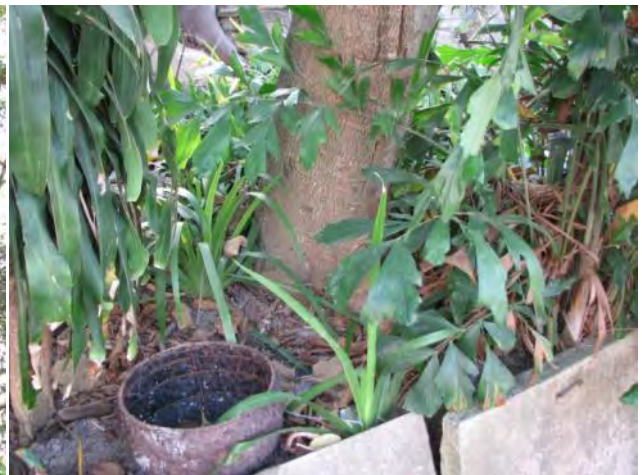
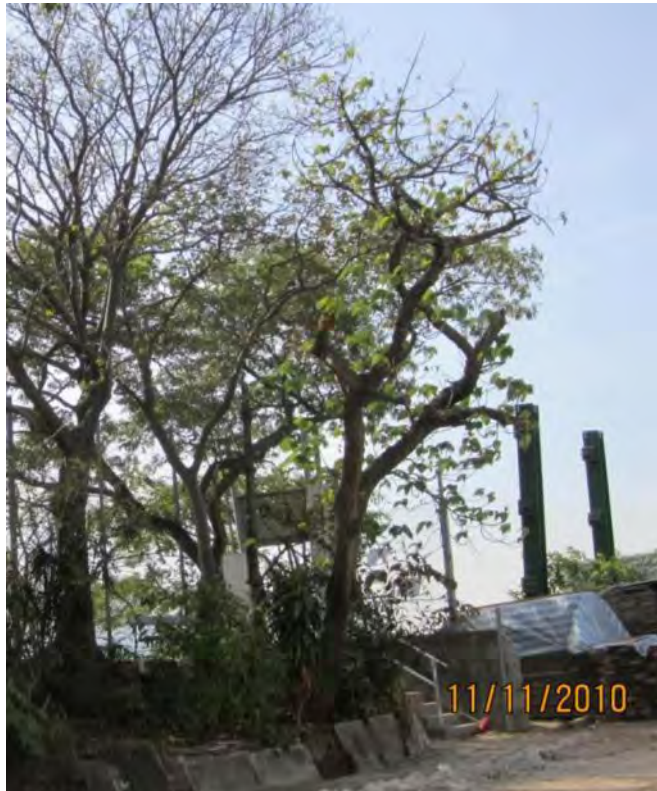
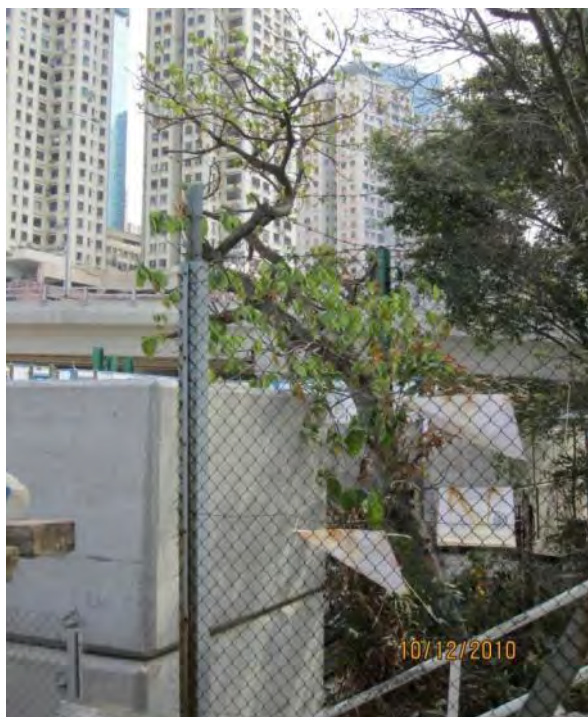
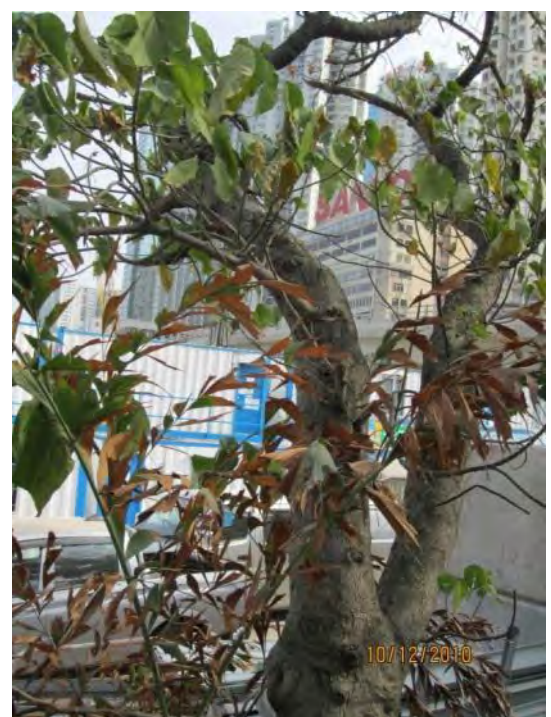
1. Location of the Incident: At Portion 22
2. Tree No.: T1905
3. Species of Trees: *Macaranga tanarius* 血桐
4. Size of Trees: Height 7m, Crown Spread 5m, DBH 330mm
5. Status: Transplant
6. Date and Time (incident occurred): 24/1/2011, 15:00
7. Nature and Brief Account of the Incident:
  - i. Termite attack
  - ii. Less than 20% of sound wood (xylem) remains. (Refer to appendix A)
8. Follow-up Actions being taken:
  - i. Removed the infected tree
  - ii. Used the registered pesticide to prevent further infection to other trees. (Refer to appendix B)
  - iii. Inspection the other trees to check whether the invasion of termites.
9. Relevant Background Information: recently photos for T1905

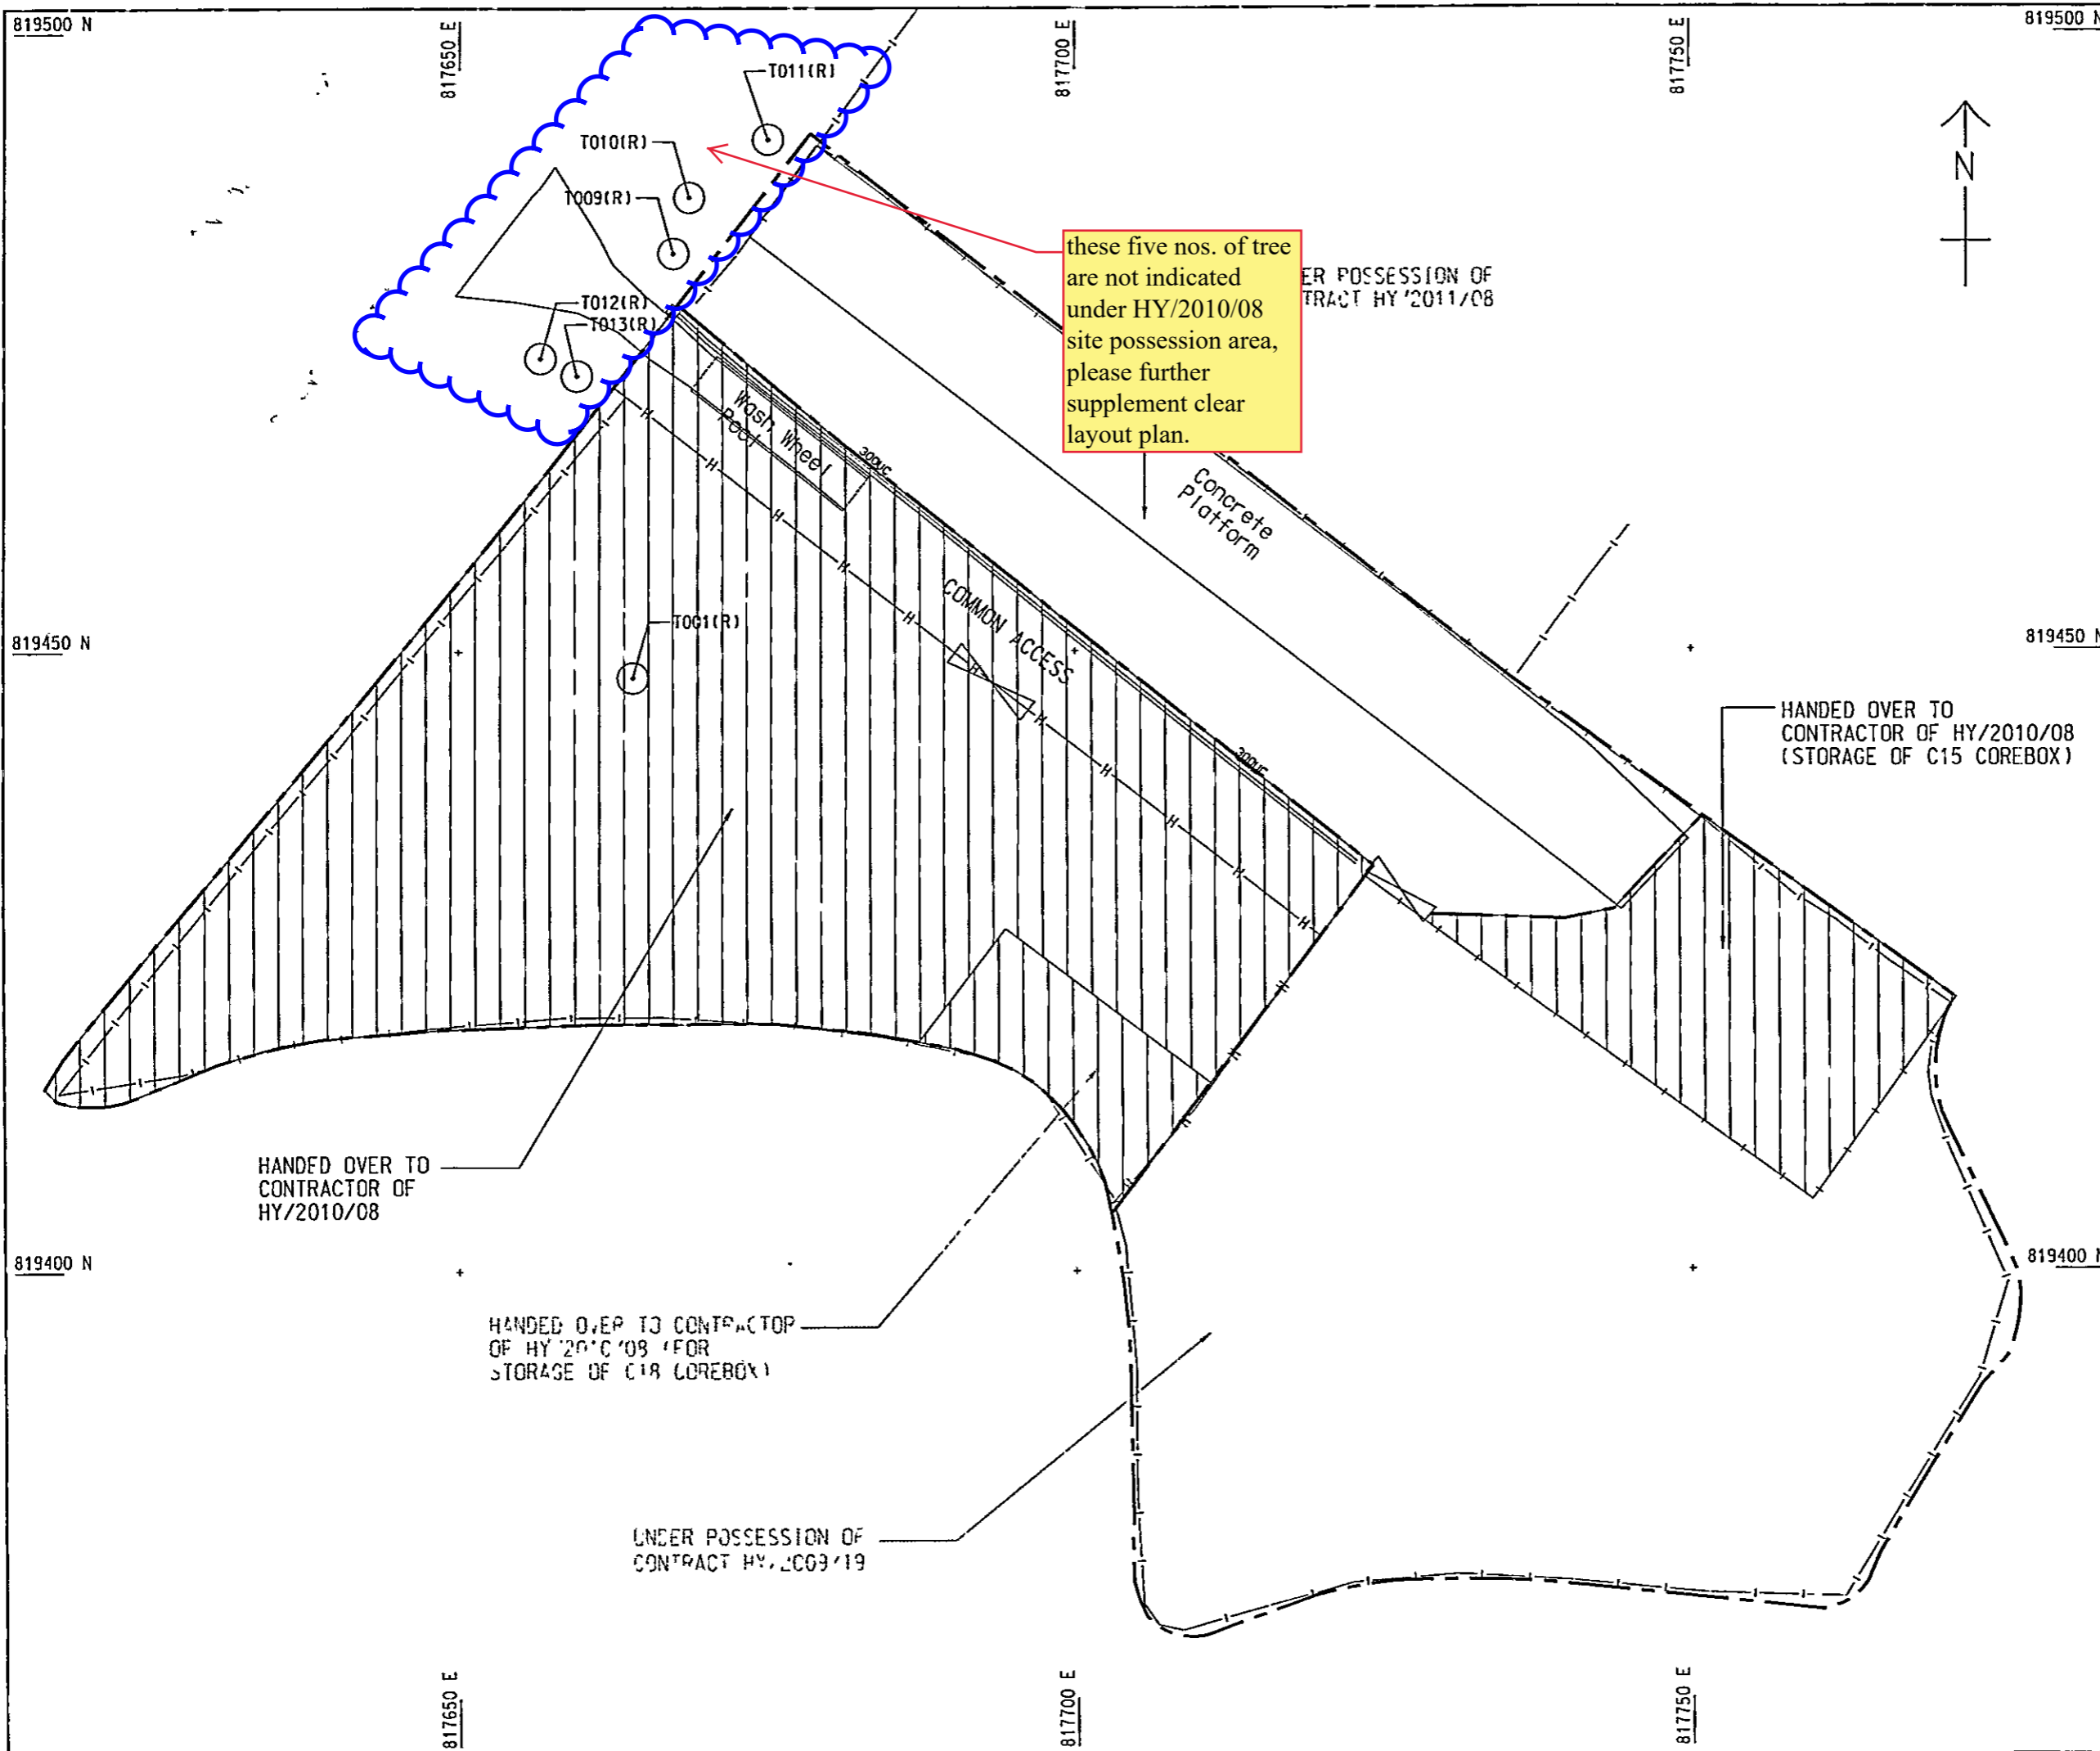
these five nos. of tree are not indicated under HY/2010/08 site possession area, please further supplement clear layout plan.

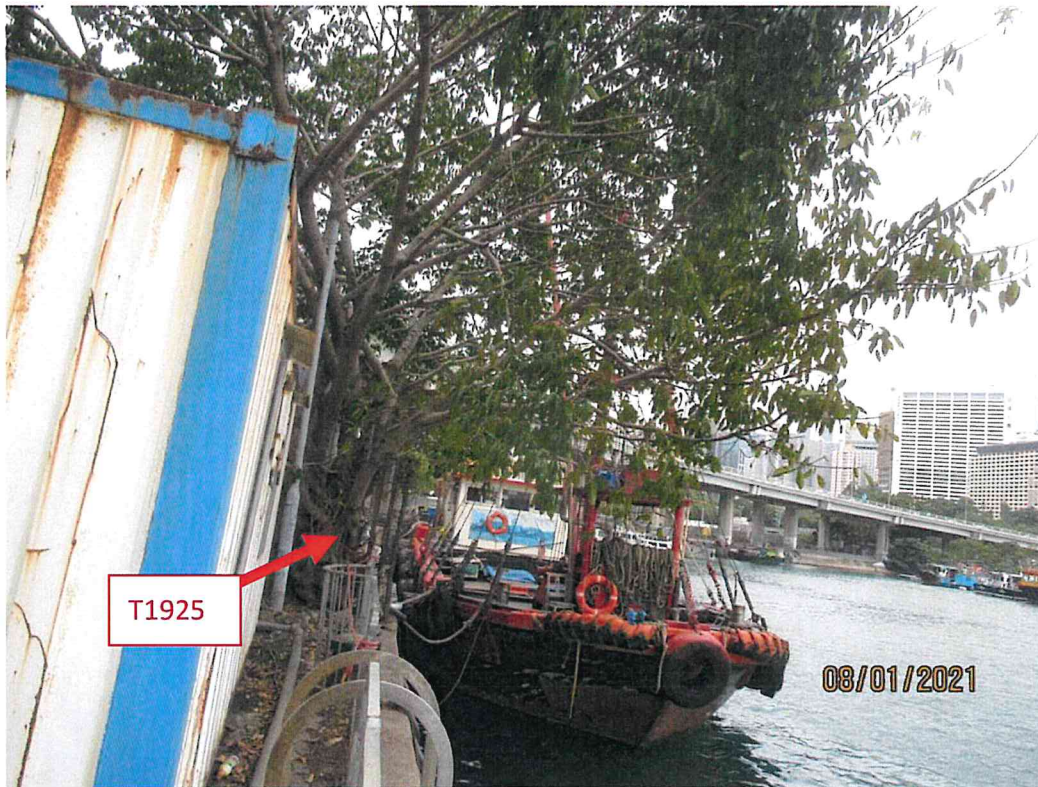
The pier may be open to public after the site office removed this year. Follow-up action on T1925 will be considered to be taken.

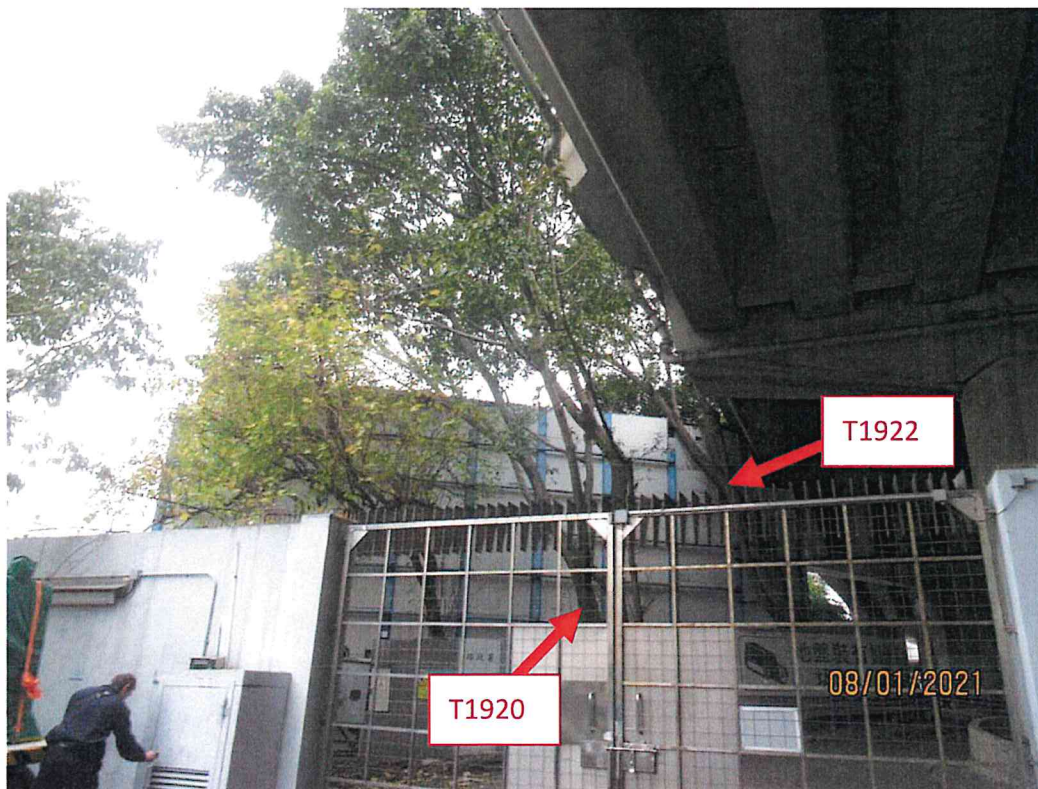
T1920 and T1922 were pruned on the bridge in 2020. Follow-up action on the office side of T1920 and T1922 will be considered to be taken after the site office removed.

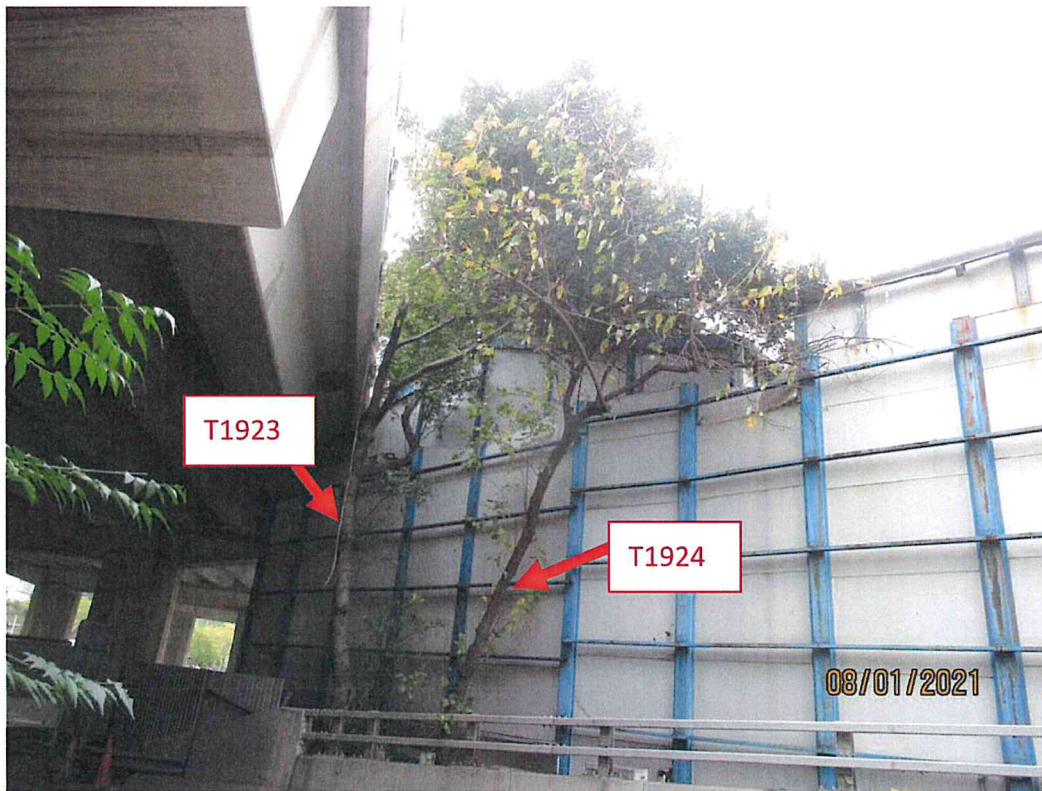
T1923 and T1924 were pruned on the bridge in 2020. Follow-up action on the office side of T1923 and T1924 will be considered to be taken after the site office removed.

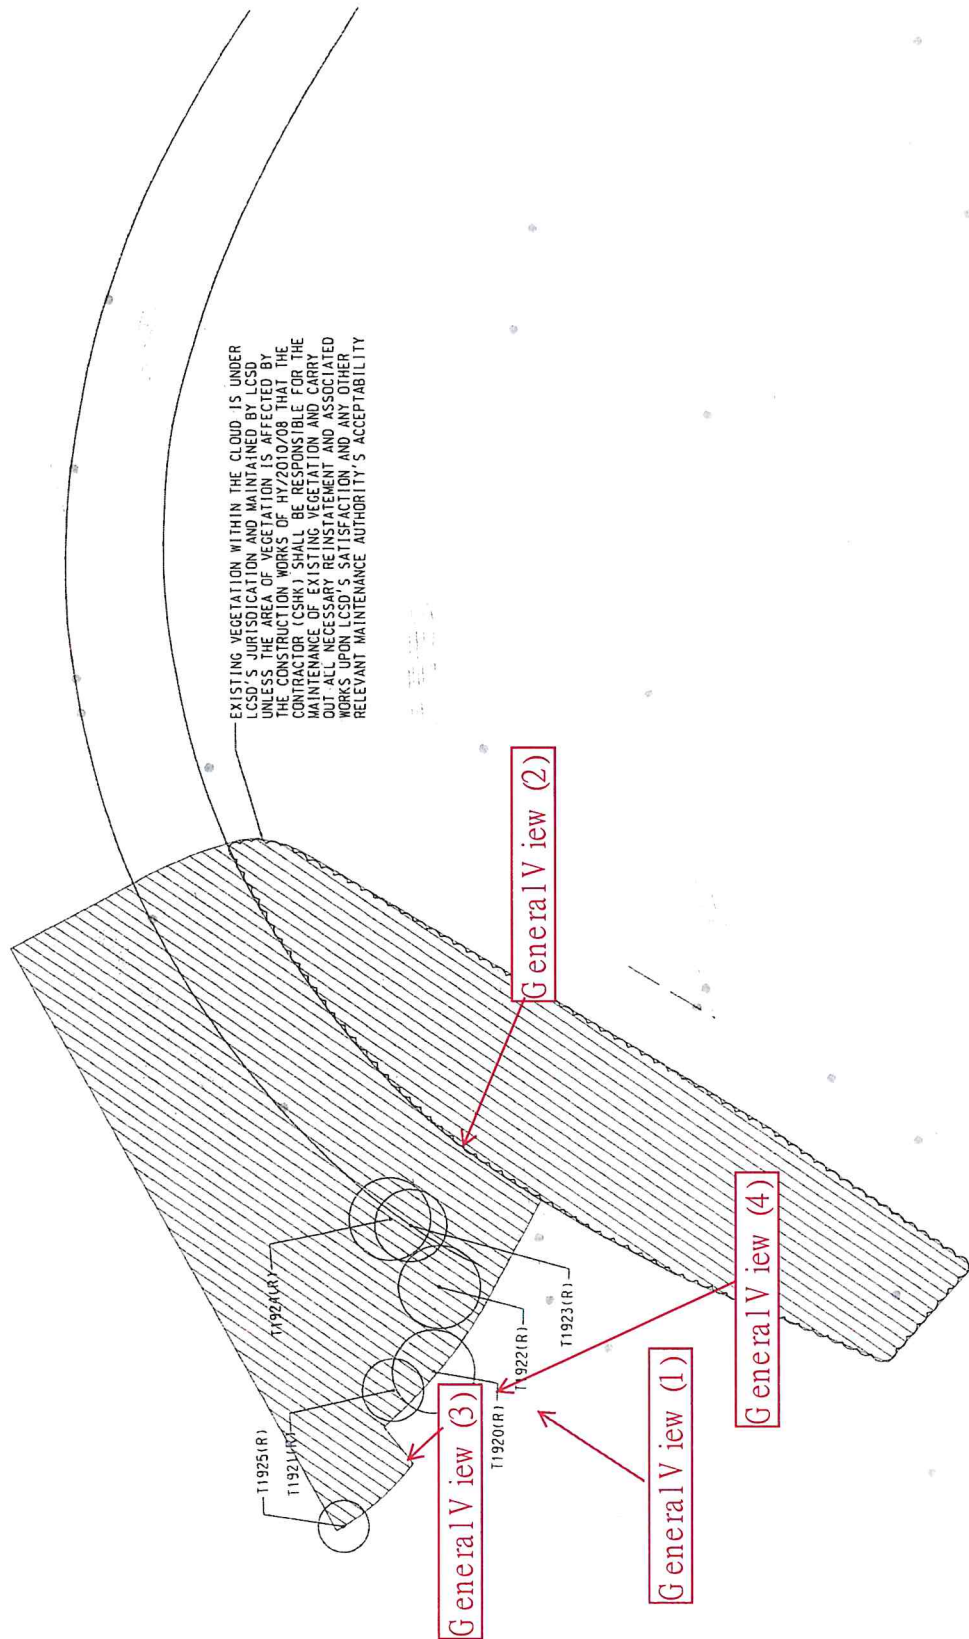
TITLE  
TREE PRESERVATION PLAN OF REMAINING AREA BY HY/2010/08 CONTRACTOR

EXISTING VEGETATION WITHIN THE CLOUD IS UNDER LCSD'S JURISDICTION AND MAINTAINED BY LCSD. UNLESS THE AREA OF VEGETATION IS AFFECTED BY THE CONSTRUCTION WORKS OF HY/2010/08 THAT THE CONTRACTOR (CSHR) SHALL BE RESPONSIBLE FOR THE MAINTENANCE OF EXISTING VEGETATION AND CARRY OUT ALL NECESSARY REINSTATEMENT AND ASSOCIATED WORKS UPON LCSD'S SATISFACTION AND ANY OTHER RELEVANT MAINTENANCE AUTHORITY'S ACCEPTABILITY
