**CONTRACT NO. DC/2006/15 BUILDING AND
CIVIL MAINTENANCE AND MINOR WORKS OF
DSD PLANTS AND FACILITIES (2007-2009)**

**GROUNDWATER MONITORING AT
NGONG PING STW AND EFFLUENT EXPORT
PIPE**

MONTHLY EM&A REPORT

(OCTOBER 2007)

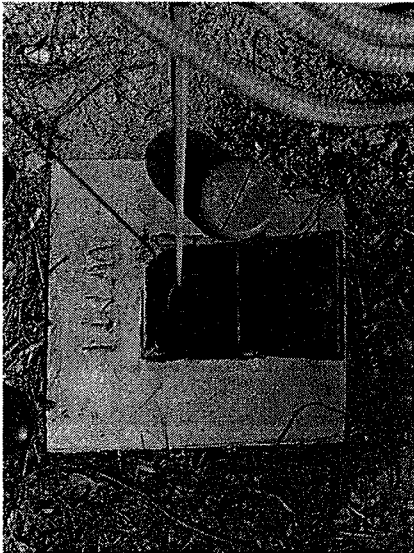
WM1

Remark (if any) : The tests marked with "*" indicated the tests were sub-contract to ALS Technichem (HK) Pty Ltd and HOKLAS accredited. Ground water monitoring was only carried out at Borehole WM3 only since other boreholes were observed to be dry during the monitoring.
