**Landslide Preventive Works at Po Shan Road,  
Mid-Levels – Design and Construction  
(Natural Terrain Risk Mitigation Works)**

**Monthly Operation Phase Landscape and  
Visual Audit Report No. 12**

December 2010

**Monthly Inspection Report No. 12**

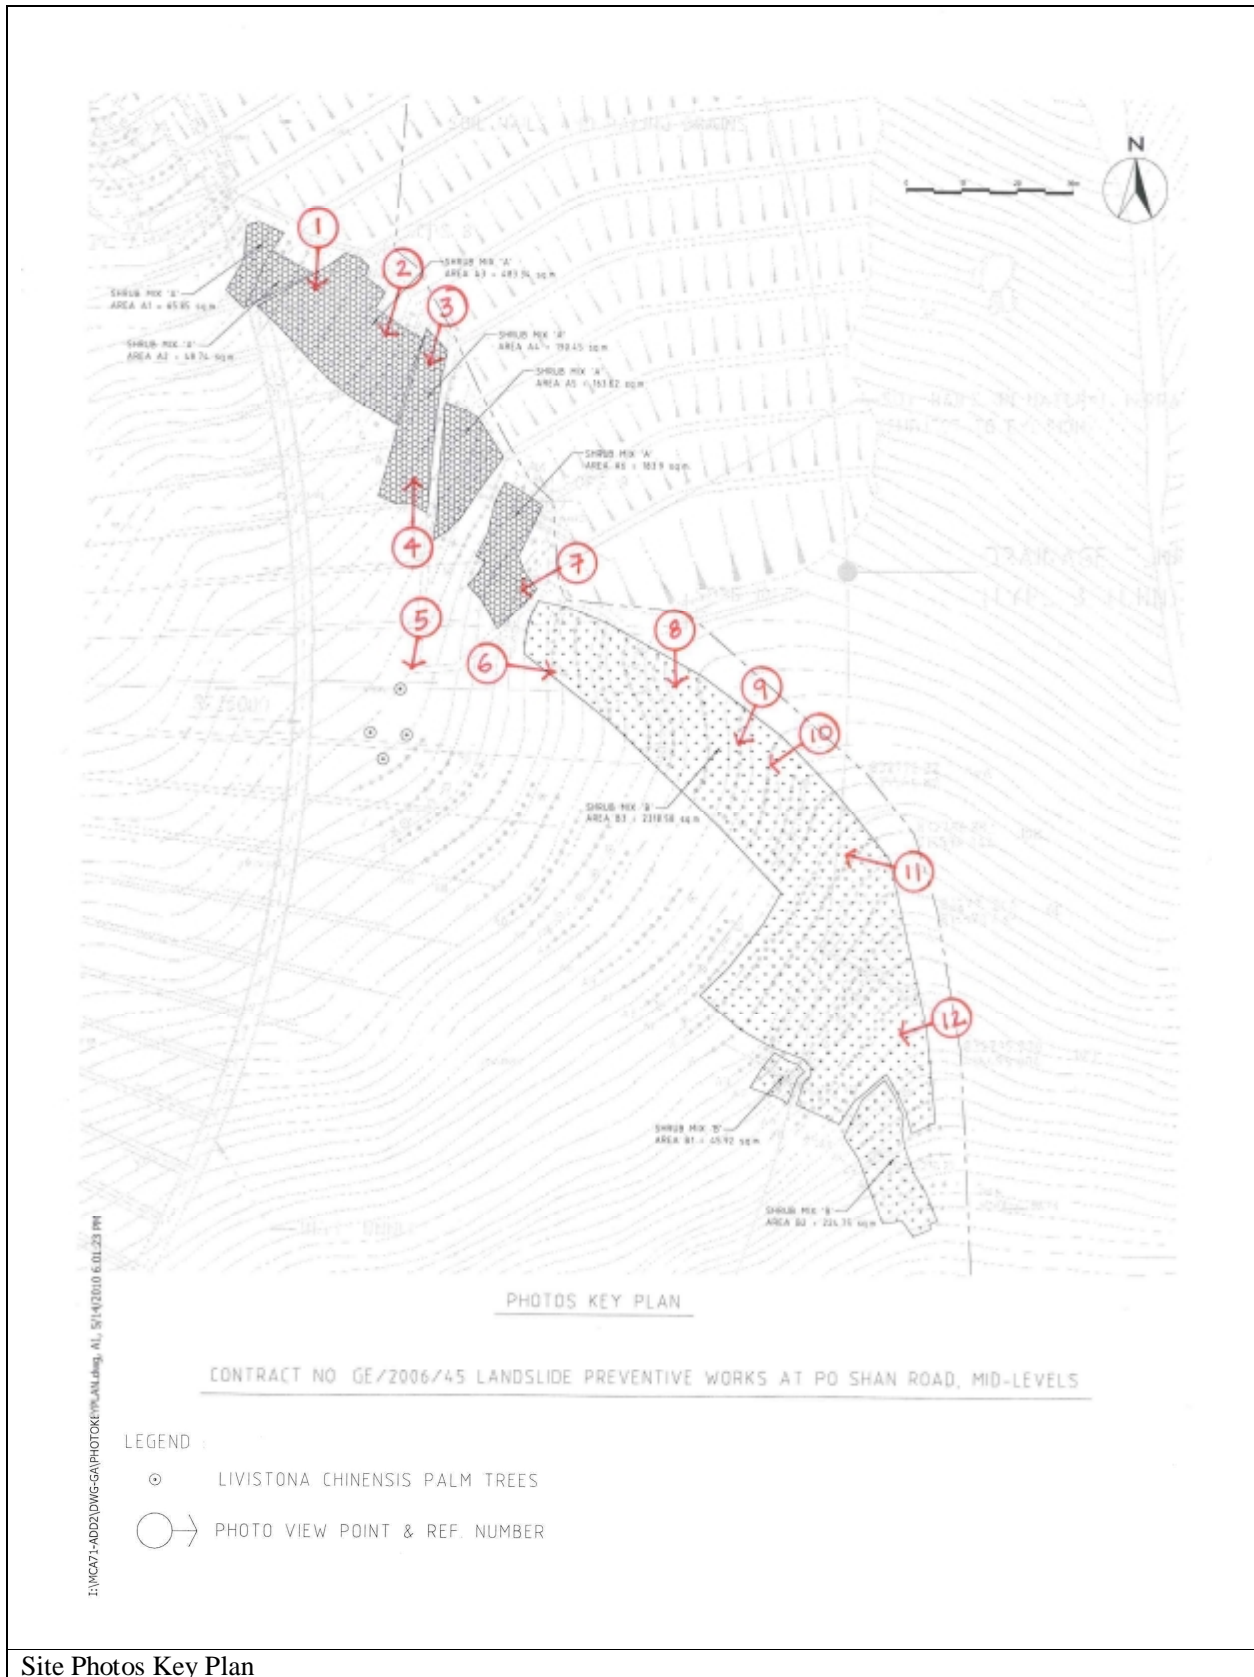
Site Photos Key Plan

- It was generally observed that the shrubs and palm trees under establishment were in healthy condition and well established. Please refer to typical site inspection photos 1 to 12 enclosed under Appendix-B.
- The inspection was the last monthly inspection of the 12-month Establishment Period and no outstanding works was found.
