MONTHLY ENVIRONMENTAL MONITORING & AUDIT REPORT

Highways Department

Route 8
Between Tsing Yi and Cheung Sha Wan
Phase 2b East Tsing Yi Viaduct

*Monthly Environmental
Monitoring & Audit Report
(29th November 2008 - 28th December 2008)*

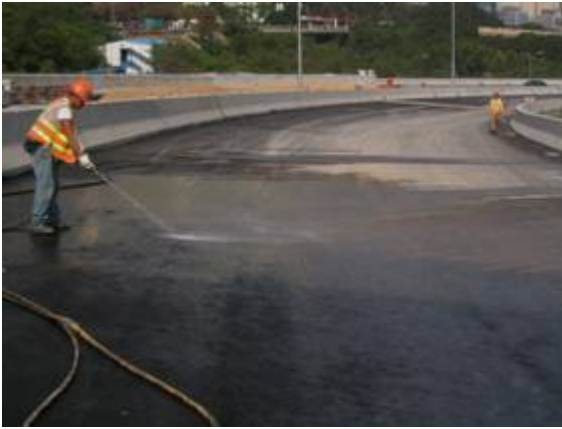
Photo 01 (area P2-SA6B (Bridge D1))

Item	Findings	DCBJV's Corrective and Preventive measures	Effectiveness of measures
1.	DCBJV was reminded that all haul roads (P2-SA6B, Bridge D1) should be kept clear of dusty materials or to be sprayed with sufficient water to maintain the entire road surface wet.	Water sprinklers and hose have been deployed on site for water spraying at area P2-SA6B (Bridge D1). DCBJV replied that the frequency of water spraying should be increased to minimize the dust impact generated from vehicular movement.	Completed and closed. (Please refer to Appendix Q Photo 01).

Corrective and Preventive Actions – Water sprinklers and hose have been deployed on site for water spraying at area P2-SA6B (Bridge D1). DCBJV replied that the frequency of water spraying should be increased to minimize the dust impact generated from vehicular movement. Completed and closed (Please refer to *Appendix Q* Photo 01).
