CONSTRUCTION OF YUEN LONG SOUTH BRANCH SEWERS AND EXPANSION OF HA TSUEN SEWAGE PUMPING STATION

THE NINTH RESULTS OF LANDSCAPE AND VISUAL IMPACT MONITORING FOR OCTOBER 2010 (NO.9)

Site Inspection Cl	hecklist	t			
Co	ntract No.:	DC/2009/08					
Co	ontract title:	Construction of Yuen Long South Sewer and Expansion	n of Ha Ta	suen Sew	age Pum	ping Station	
Co	ontractor:	China State Construction Engrg. (HK) Ltd.					
Lo	cation:	Ha Tsuen Sewage Pumping Station					
Ins	spection Date:	15-Oct-2010

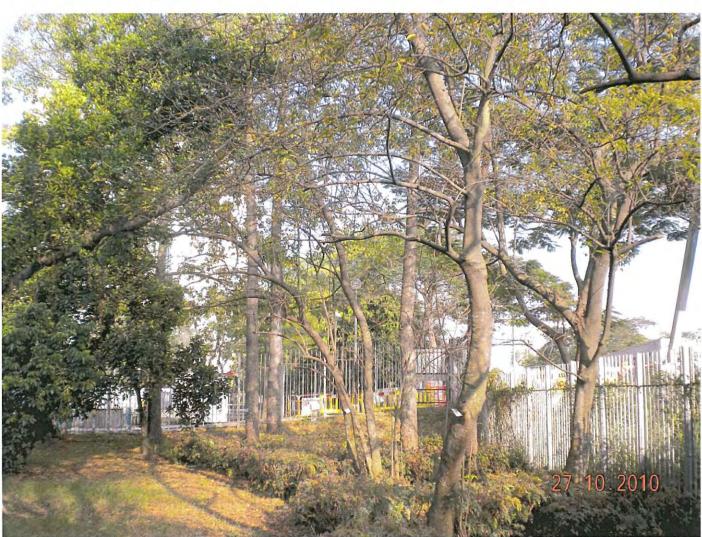
HA260

conditions of some transplanted trees should be reviewed in the regular inspection as per attached. We are found out the trees was dead

Generally, the overall conditions are normal in the transplanting and visual impact at Ha Tsuen Sewage Pumping Station. The cond of hoarding was satisfactory. The protection works maintained for the transplanted and the preserved trees. The health conditions of the transplanted trees should be reviewed in the regular inspection in the establishment period. Some of the die branch need to remove and frequency watering is required
