Document Details					
Client Drainage Services Department					
Project Contract No. DC/2007/24 Harbour Area Treatment Scheme Stage 2A Construction of Sewage Conveyance System from Aberdeen to Sai Ying Pun					
Document Title Monthly Environmental Monitoring and Audit Report No. 22 Covering the Period from 1 October 2011 to 31 October 2011					
Document No. EMA/027					
Distribution					
Copy No.	Issued To	Copy No.	Issued To		
01-02	Leighton-LNS JV	10	Metcalf & Eddy-AECOM JV		
03	Mott MacDonald Hong Kong Ltd	11	ACL (Project Office)		
04-08	EPD	12	ACL (Head Office)		
09	DSD				
Submission Ref			Controlled Copy No.		
SUBM Ref.	DC/2007/24/31.20/OG3180/EC/SH/EY				
Atkins Ref.(s)					
Revision History					
B	17 November 2011	Submission to IEC and ER for Further Review	Various	Susana Halliday	Eric Chui
A	14 November 2011	Submission to IEC and ER for Review	Various	Susana Halliday	Eric Chui
Rev.	Date	Description	Prepared	Checked & Reviewed	Approved

Contract No. DC/2007/24
Harbour Area Treatment Scheme Stage 2A
Construction of Sewage Conveyance System from Aberdeen to Sai Ying Pun

Contract No. DC/2007/24
Construction of Sewage Conveyance System from Aberdeen to Sai Ying Pun
Condition 4.4

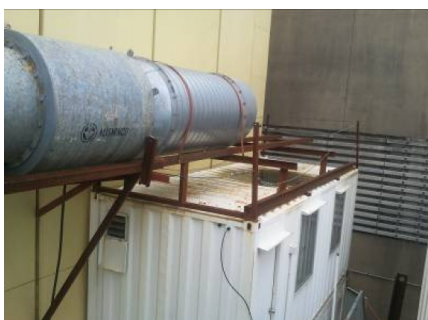
Photo 3 Unused chemical materials were removed on roof of workers rest area.

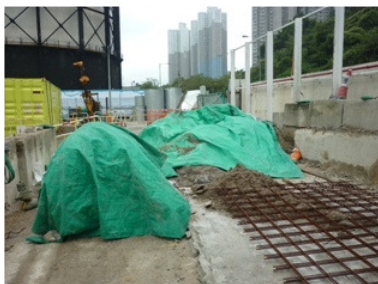
Photo 3 The cement mixer had been removed

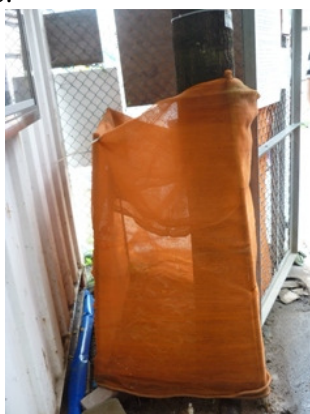
Photo 3 The protective fencing had been provided to the tree.

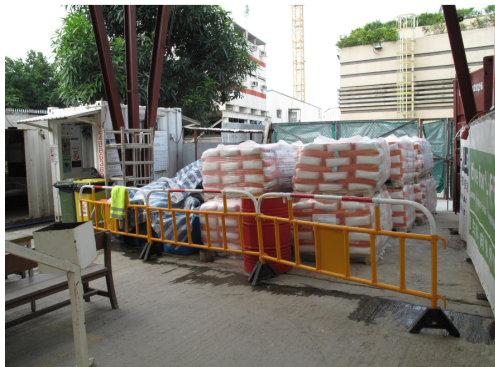
Photo 3 Stocking of chemicals in the worker resting area near the entrance shall be avoided

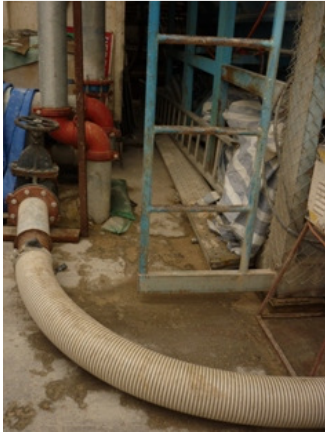
Photo 1 Mud was found underneath the treatment tank was cleared
