Document Details					
Client <b>Drainage Services Department</b>					
Project <b>Contract No. DC/2007/24 Harbour Area Treatment Scheme Stage 2A Construction of Sewage Conveyance System from Aberdeen to Sai Ying Pun</b>					
Document Title <b>Monthly Environmental Monitoring and Audit Report No. 26 Covering the Period from 1 February 2012 to 29 February 2012</b>					
Document No. <b>EMA/032</b>					
Distribution					
Copy No.	Issued To	Copy No.	Issued To		
01-02	Leighton-LNS JV	10	Metcalf & Eddy-AECOM JV		
03	Mott MacDonald Hong Kong Ltd	11	ACL (Project Office)		
04-08	EPD	12	ACL (Head Office)		
09	DSD				
Submission Ref				Controlled Copy No.	
SUBM Ref.					
Atkins Ref.(s)		DC/2007/24/31.20/OG3513/EC/SH/EY			
Revision History					
B	14 March 2012	Submission to IEC and ER for Further Review	Various	Susana Halliday

Contract No. DC/2007/24  
Harbour Area Treatment Scheme Stage 2A  
Construction of Sewage Conveyance System from Aberdeen to Sai Ying Pun

## Environmental Certification Sheet – 36

**Contract No. DC/2007/24  
Construction of Sewage Conveyance System from Aberdeen to Sai Ying Pun  
Condition 4.4 – Submission of Monthly EM&A Report for February 2012 (no. 26)**

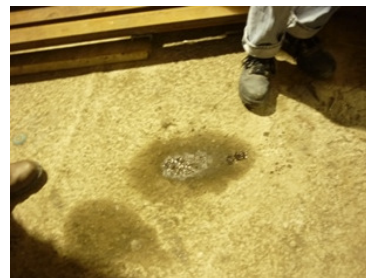
1. The accumulated water was found on the floor under the air compressor inside the noise enclosure. (Photo 3)

Photo 3 The accumulated water was found on the floor under the air compressor inside the noise enclosure.

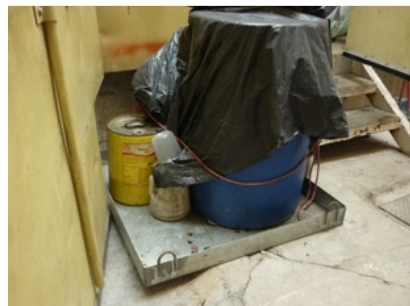
Photo 4 The accumulated water was cleared in the drip tray near the noise enclosure.

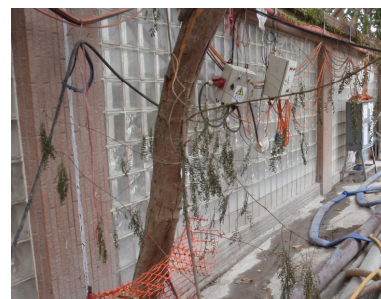
Photo 2 The wastes near the hoarding were removed.

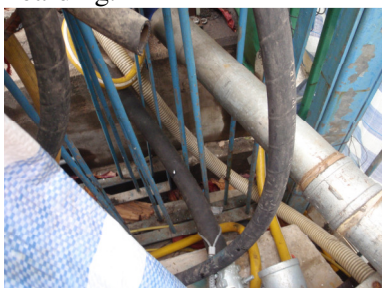
1. Some general refuses were found in the U-channel near the site hoarding.(Photo 1)

Photo 1 Some general refuses were found in the U-channel near the site hoarding.

1. The contractor was reminded to remove the general refuses and keep the site tidiness.

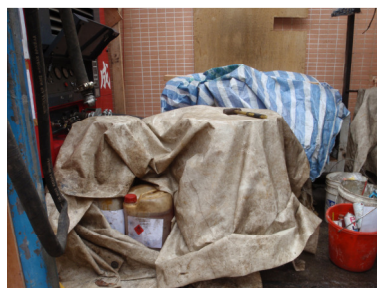
Photo 2 The unknown oil was removed properly.

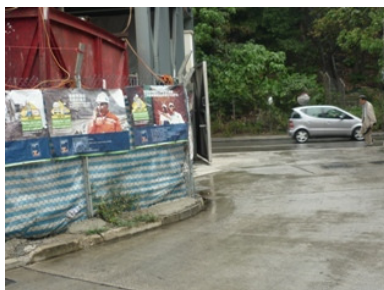
Photo 5 The muddy water near the boundary behind the sedimentation tank was cleared

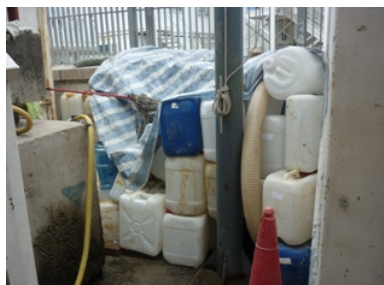
Photo 1 Empty drums were accumulated near the sedimentation tank.

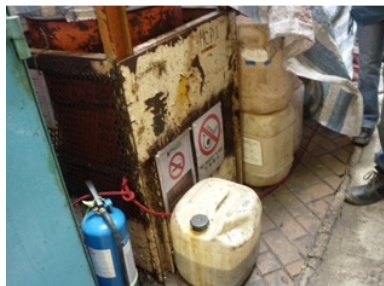
1. Oil drums were found without drip trays near noise enclosure. (Photo 3)

Photo 3 Oil drums were found without drip trays near noise enclosure.

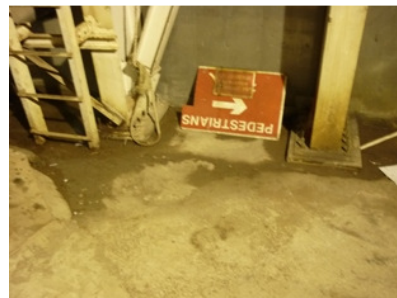
Photo 4 The accumulated water was cleared on the floor under the air compressor inside the noise enclosure.

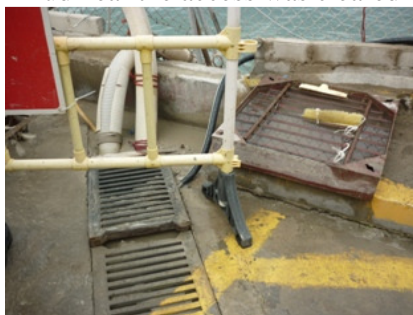
Photo 5 Mud near the access was cleared

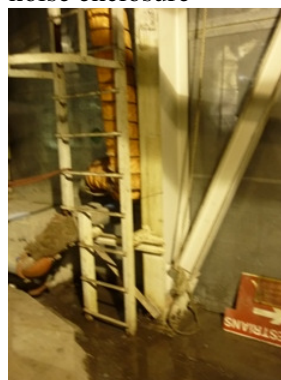
1. Accumulated water was found on the floor under the air compressor inside the noise enclosure.(Photo 4 )

Photo 4 Accumulated water was found on the floor under the air compressor inside the noise enclosure

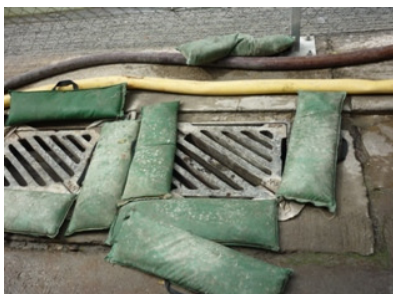
Photo 1 No oil water was found discharging into gully

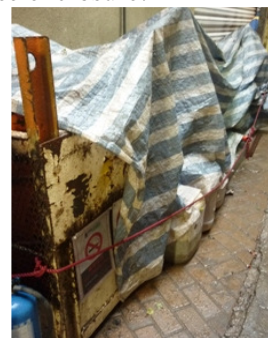
Photo 2 Oil drums were found without drip trays near noise enclosure.

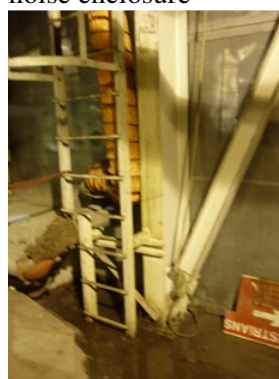
Photo 4 Accumulated water was found on the floor under the air compressor inside the noise enclosure

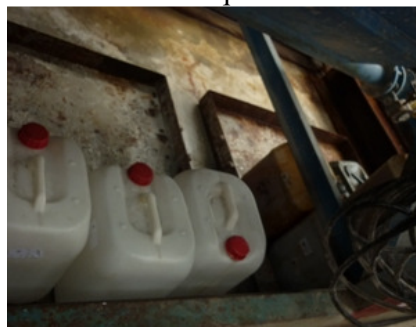
Photo 2 The drip tray had been provide to chemical under Aqua.Sed
