Contract No. DC/2007/24
Harbour Area Treatment Scheme Stage 2A
Construction of Sewage Conveyance System from Aberdeen to Sai Ying Pun

Environmental Certification Sheet – 42

Document/ Plan/Changes/Information to be Certified/ Verified:	Quarterly Environmental Monitoring and Audit Report No.10 (EMA/038, Rev B)
Date of Report:	24 July 2012
Date of correspondence to IEC:	25 July 2012
Date received:	25 July 2012

**Contract no. DC/2007/24
Construction of Sewage Conveyance System from Aberdeen to Sai Ying Pun
Submission of 10th Quarterly EM&A Report for April to June 2012 (Rev. B)**

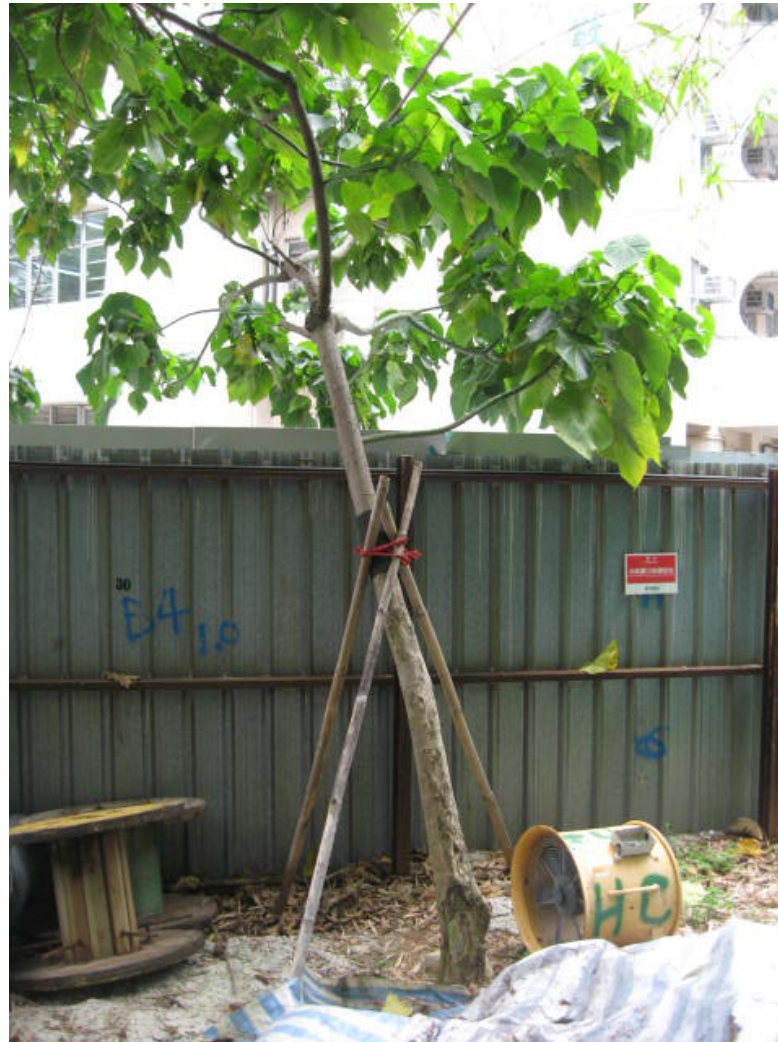
Sandy Bay site --- Photo 8
Untagged trees spotted by ERM during this month site audit.

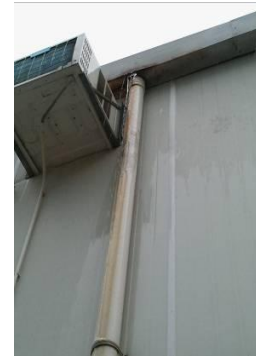
Photo 2 The water leakage was found at the roof of site office

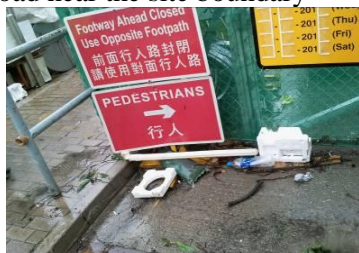
Photo 1 The trashes were found on the public access road near the site boundary

1. The contractor was reminded to remove the trashes and keep the site tidiness.

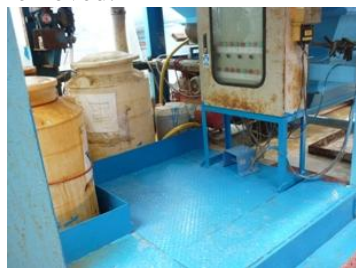
Photo 2 The chemicals near the Aqua Sep have been removed.

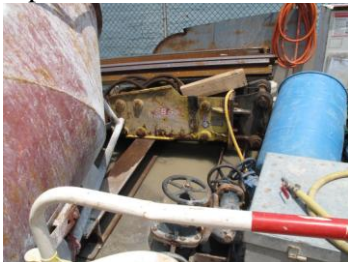
Notes / Issues Recorded On Site: General Housekeeping: 1. Accumulated water was found at the corner near the stockpiles since last inspection. (Photo 1)
Previous Environmental Site Inspection Checklist – Report No. 120424 General Housekeeping: Accumulated water found at the corner near the stockpiles has shown no improvement since last inspection. (Photo 1) Current Environmental Site Inspection Checklist – Report No. 120502 1. The contractor was reminded to clear stagnant water pool.

Photo 1 Accumulated water was found at the corner near the stockpiles since last inspection

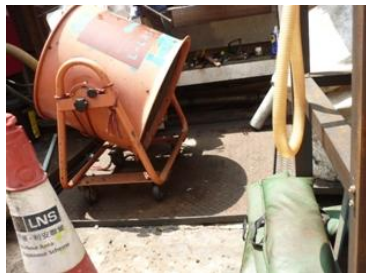
Photo 3 The accumulation waste was cleared

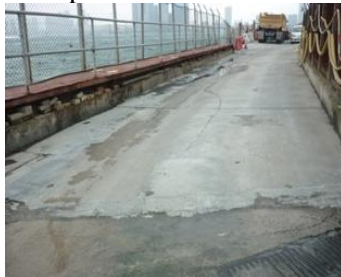
Photo 1 Some stagnant water was found near the access path

1. The contractor was reminded to avoid water accumulation.

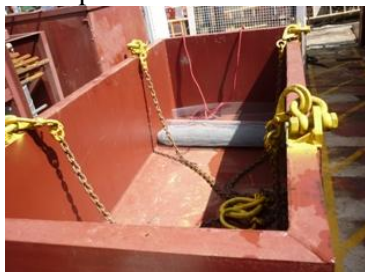
Notes / Issues Recorded On Site: Nil.
Corrective Actions – Mitigation Measures Implemented or Proposed (if any): Previous Environmental Site Inspection Checklist – Report No. 120529 General Housekeeping 1. Water accumulation in skip on the noise platform was cleared. (Photo 1) Current Environmental Site Inspection Checklist – Report No. 120605 Nil.

Photo 1 Water accumulation in skip on the noise platform was cleared
