Central Police Station Conservation
and Revitalisation Project:
Thirty-third Monthly EM&A Report
(1 July to 31 July 2014)

Issue Date: August 2014

Environmental Resources Management

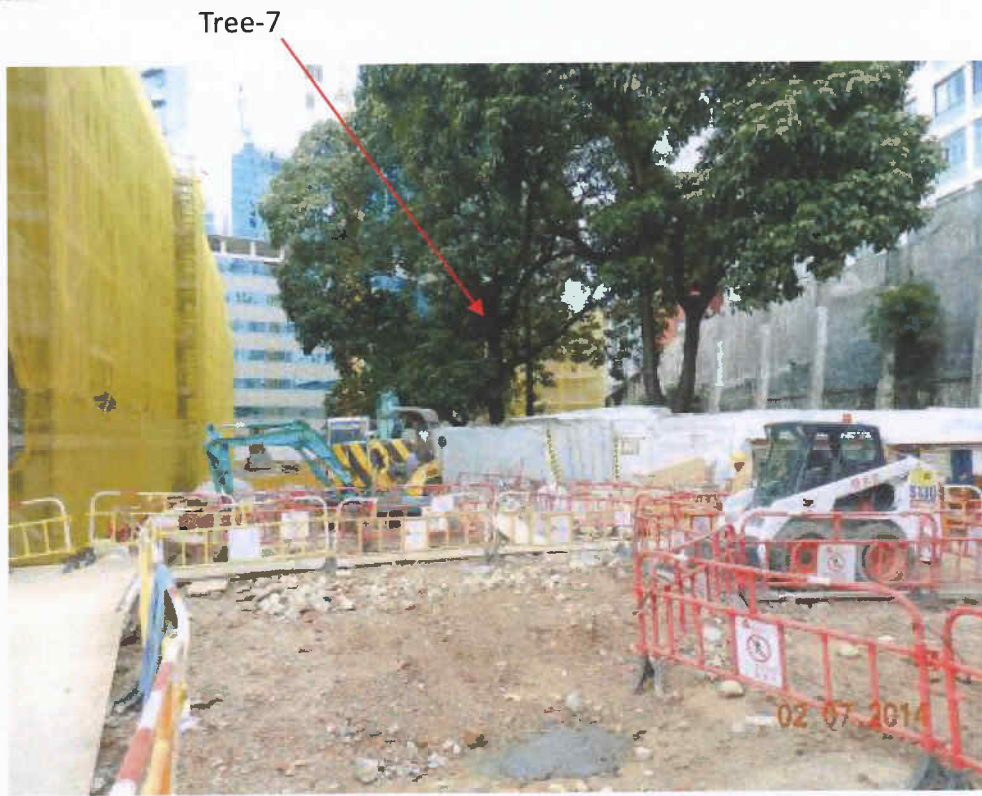
Fig. 9 The access near Tree-7 is clean and tidy.

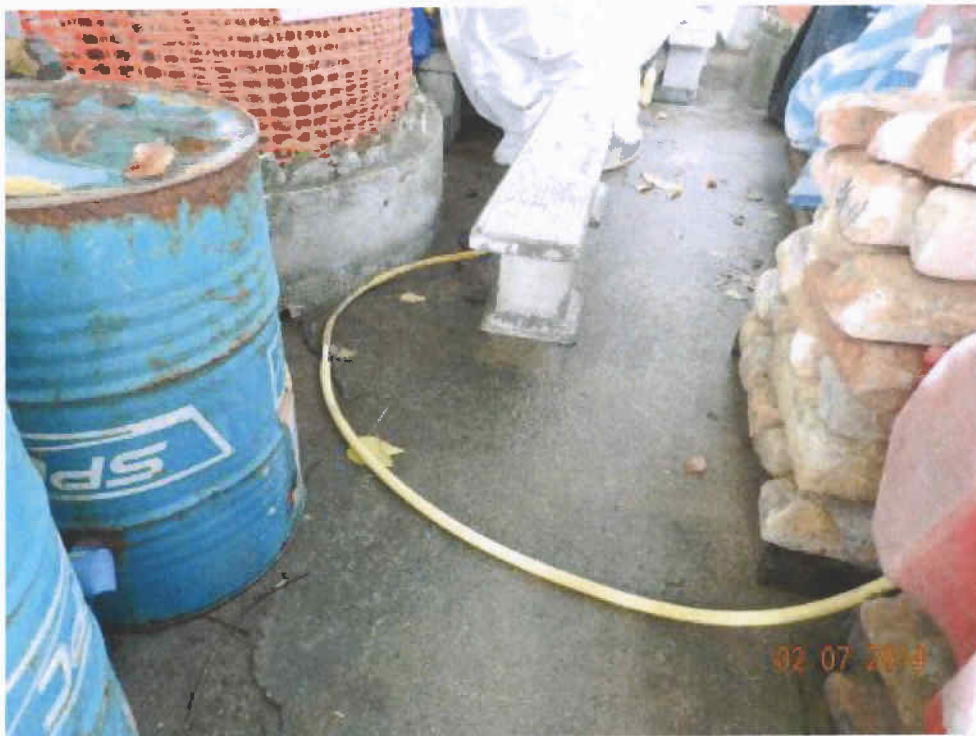
Fig. 8 The access near Tree-8 is clean and tidy.

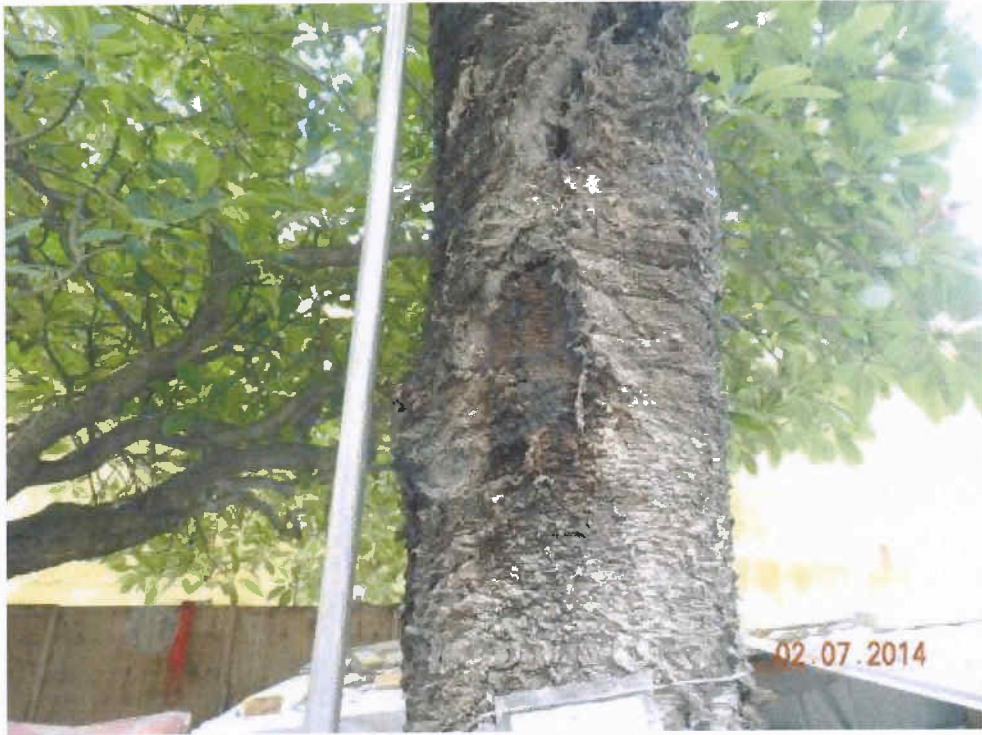
Fig. 5 Vigorous branches/leaves appear on the tree.

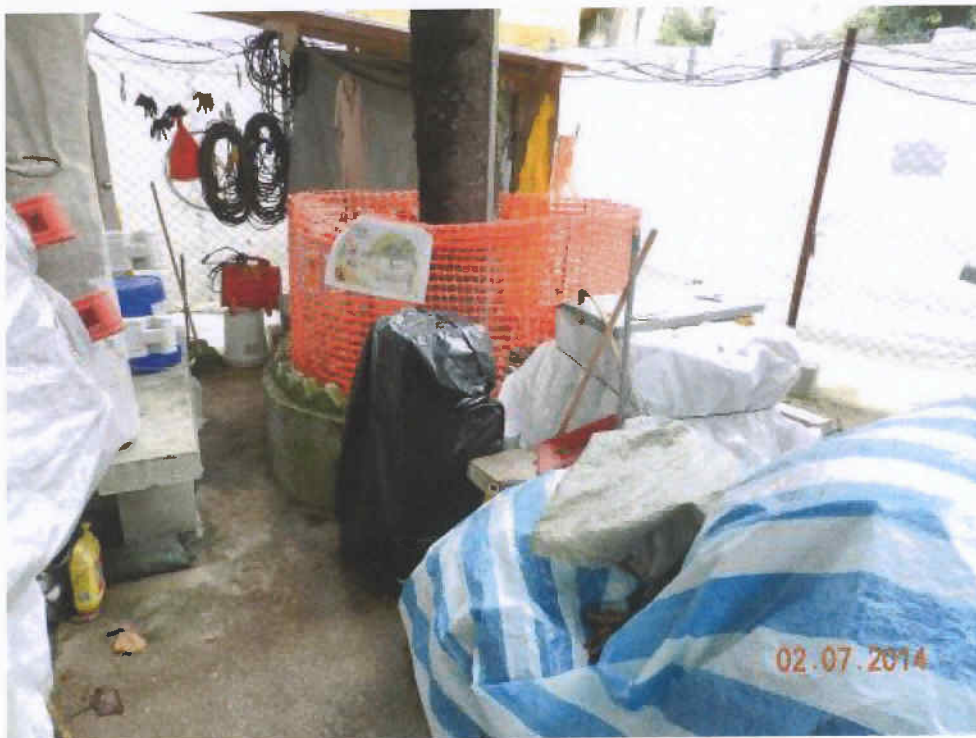
Fig. 8 Construction works are in progress outside the cordon zone.

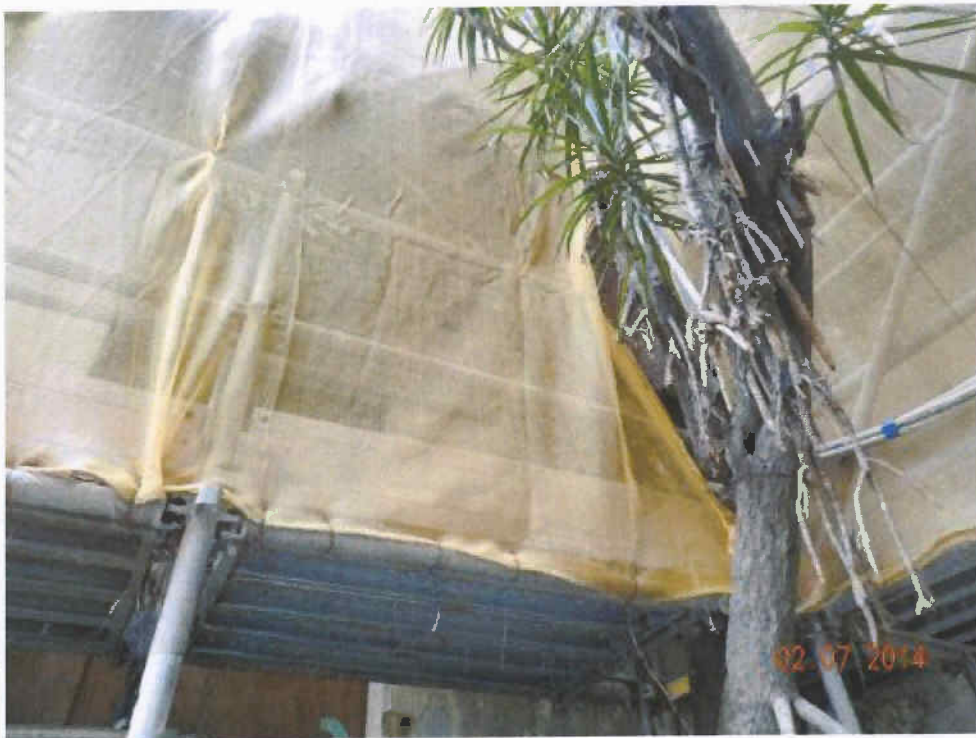
Fig. 8 Vigorous and green leaves appear on the tree.
