Central Police Station Conservation  
and Revitalisation Project:  
*Thirty-sixth Monthly EM&A Report*  
*(1 October to 31 October 2014)*

Issue Date: November 2014

The Jockey Club CPS Limited

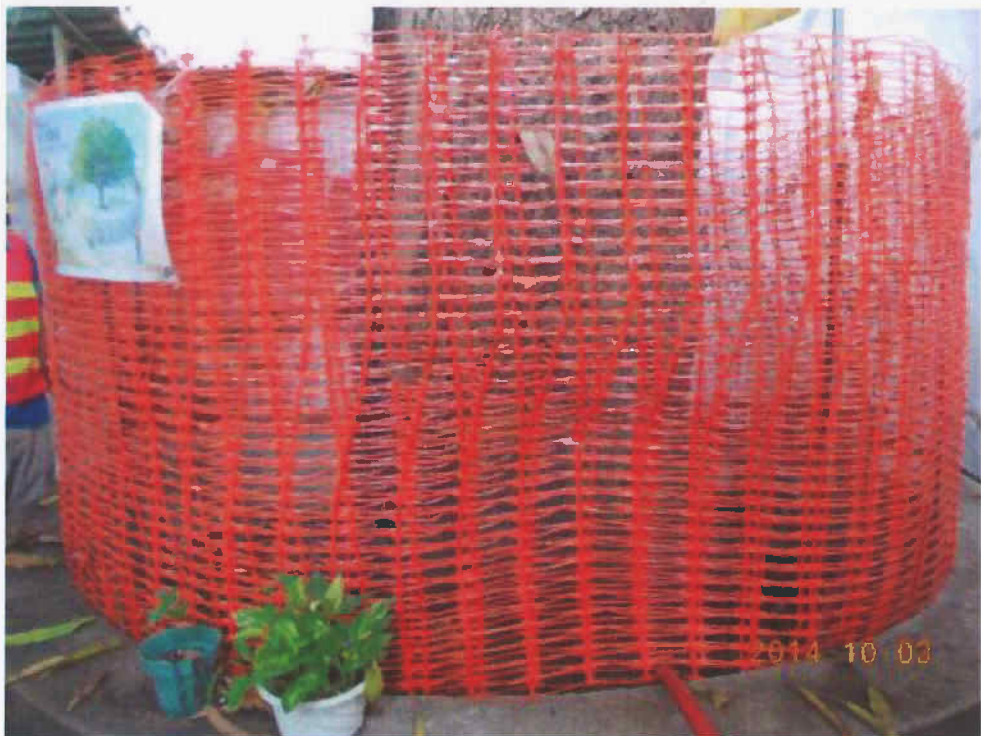
Fig. 4 Health condition of the mid trunk is fair.

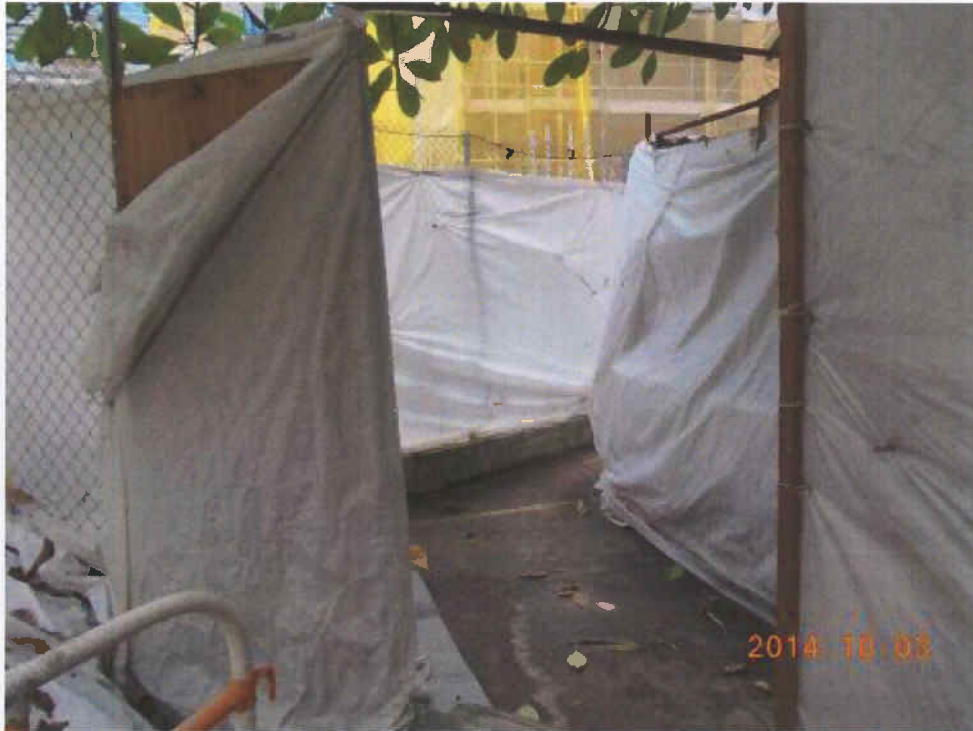
Fig. 9 Construction works are in progress outside the cordon zone.

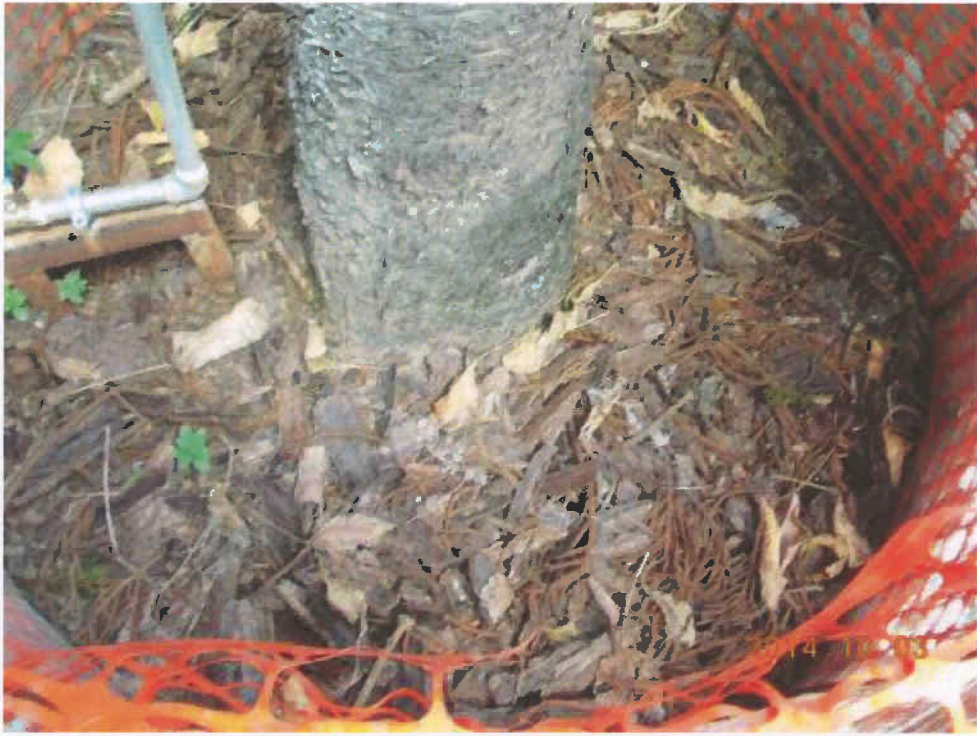
Fig. 3 Health condition of the mid trunk is fair

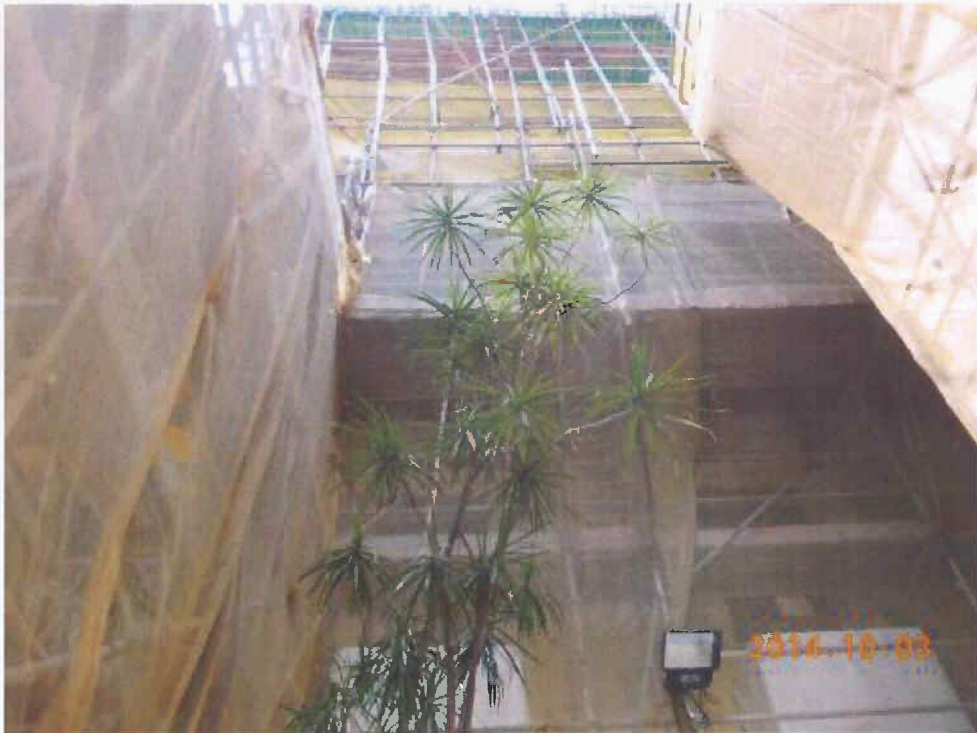
Fig. 8 Many metal tubes are placed near the planter.
