Central Police Station Conservation and Revitalisation Project: 23rd Quarterly EM&A Report (1 May 2017 to 31 July 2017)

Issue Date: October 2017

The Jockey Club CPS Limited

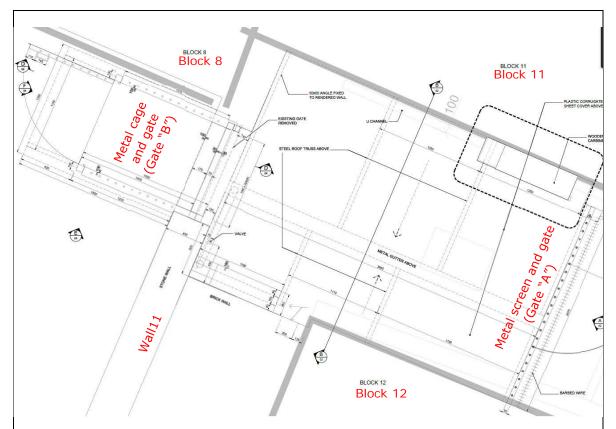
Above, photo taken on 30th July 2009, dotted line showing the Transfer Gate "A" within A Hall Yard.

Above, cartographic drawing produced in 2012 showing the location of gates A within A Hall Yard.
