# **Construction Waste Management Plan**

## **Central Police Station Conservation and Revitalisation Project (Rev.5)**

| | Central Police Station Conservation and<br>Revitalisation Project Management<br>Contract | Rev. No. : 5 |

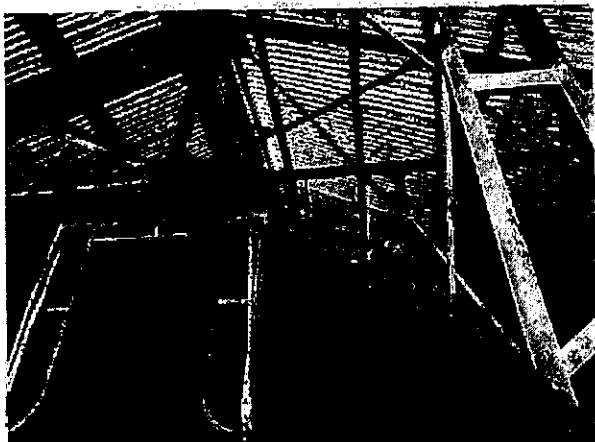
Photo 13. General view of Block 18

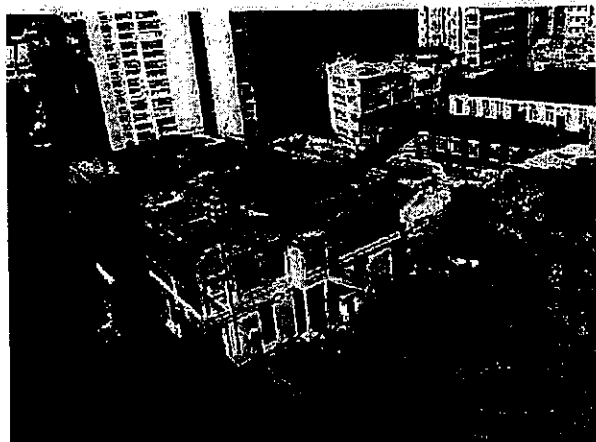
Photo 3. General view of the Block 17 Concrete Roof

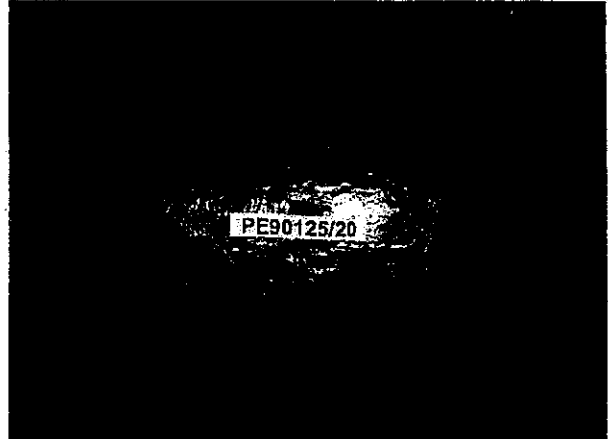
Photo 14. Chimney Lagging at Generator Room, Room 124, 1/F of Block 1 was confirmed as ACM (Sample No. PE90125/20, ACM Item No. ED/0011-5, photo taken on 03 Mar 2009).

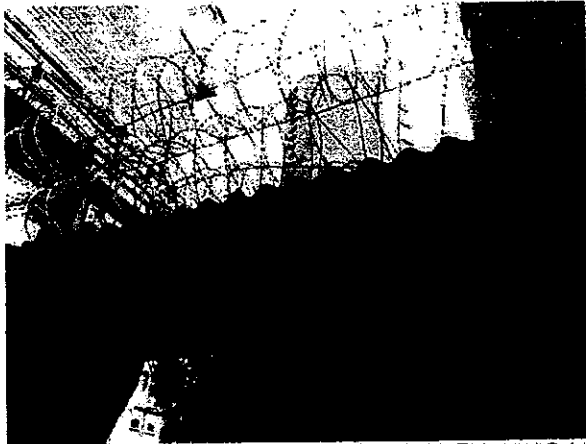
Photo 21. ACM Corrugated Sheet (Type 2) at the Entrance Gate, G/F of Block 17 (Photo taken on 20 Oct 2011).

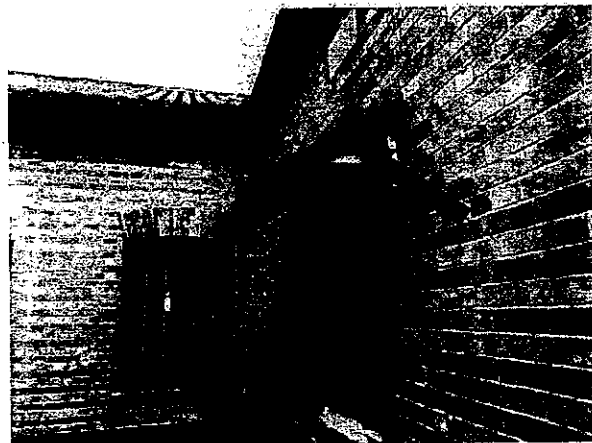
Photo 23. ACM Corrugated Sheet (Type 1). Photo taken at Light Well, 2/F of Block 9 (Photo taken on 20 Oct 2011).

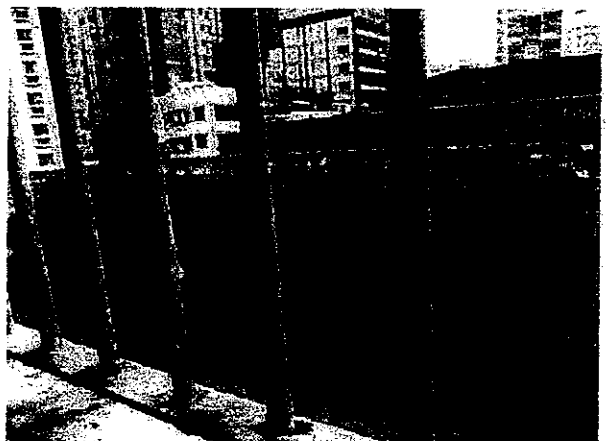
Photo 28. Asbestos-containing Corrugated Sheet (Type 1) at the Roof of Block 18 (ACM Item No. ED/0011-2, photo taken on 23 Feb 2009).

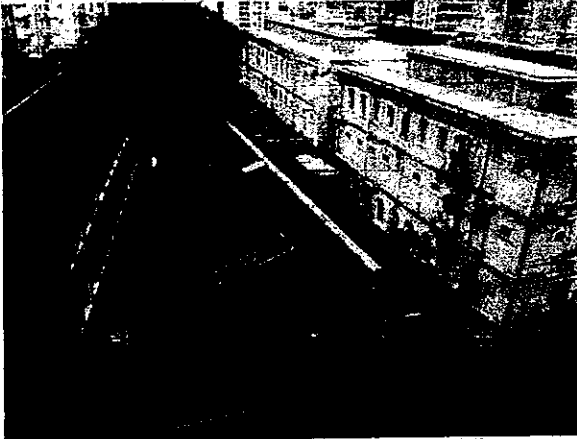
Photo 31. Asbestos-containing Corrugated Sheet (Type 1) at the Roof of Block 16 (Photo taken on 18 Nov 2011).
