Contract No. DC/2007/24
Harbour Area Treatment Scheme Stage 2A
Construction of Sewage Conveyance System from Aberdeen to Sai Ying Pun

Environmental Certification Sheet – 47

Contract No. DC/2007/24
Construction of Sewage Conveyance System from Aberdeen to Sai Ying Pun
Condition 4.4 – Submission of Monthly EM&A Report for October 2012 (no. 34)

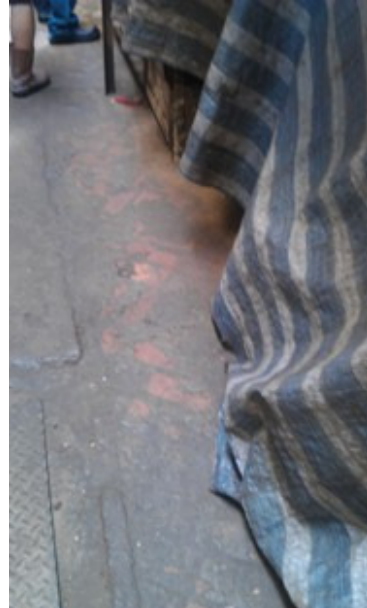
Photo 4 Waste oil near the noise enclosure of the inner entrance was cleared

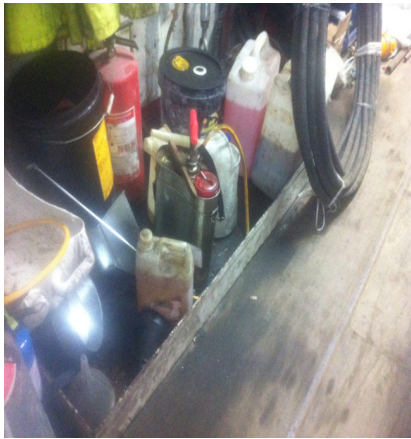
Photo 3 The issue of Waste oil near the welding area will be follow in next inspection.
