Contract No. DC/2007/24  
Harbour Area Treatment Scheme Stage 2A  
Construction of Sewage Conveyance System from Aberdeen to Sai Ying Pun

## Environmental Certification Sheet – 67

**Contract No. DC/2007/24  
Construction of Sewage Conveyance System from Aberdeen to Sai Ying Pun  
Condition 4.4 – Submission of Monthly EM&A Report for January 2014 (no. 49)**

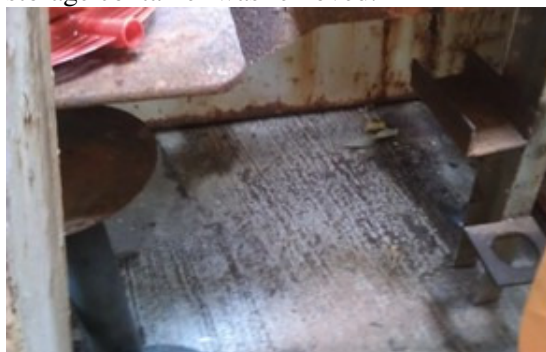
PhotoF\_1 An empty chemical drum near the chemical storage container was removed.

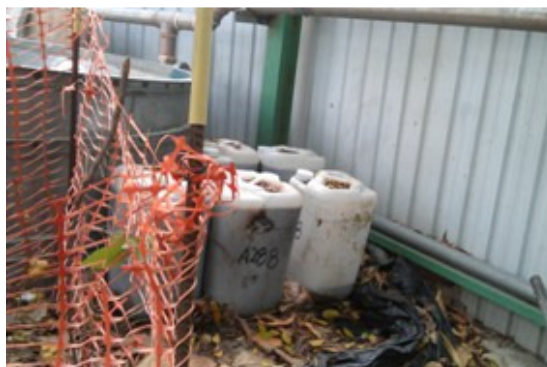
Photo 1 Some chemical drums were found without drip trays and chemical labels near the RE's car park.

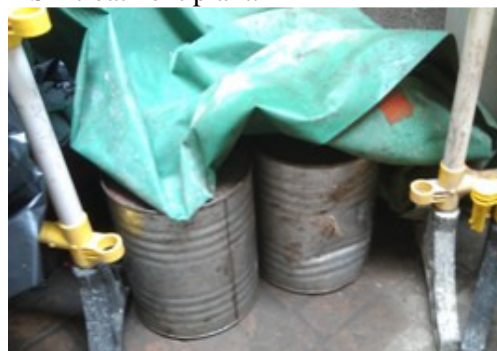
Photo 2 Some chemical drums were found without drip trays and chemical labels in access between noise enclosure and DSD treatment plant.

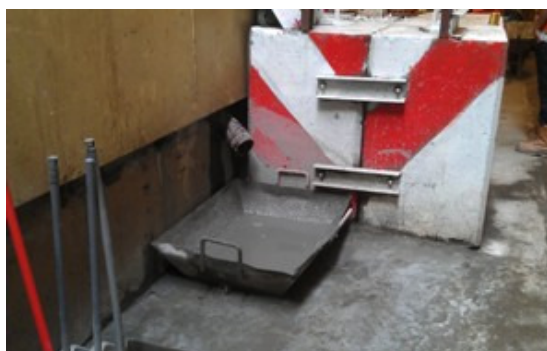
Photo 3 Wastewater from concrete sampling was stored in an unsuitable container. The waste water may overflow during the concrete sampling

2. The Contractor was reminded to treat the wastewater generated from concrete sampling before discharge.
3. The Contractor was recommended to clear the concrete wastewater and prevent wastewater to leak to nearby gully.

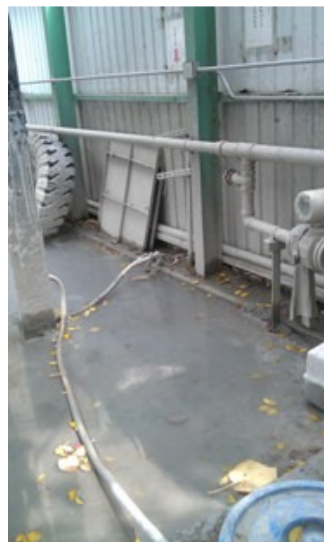
Photo 4 The concrete wastewater was accumulated near the RE's car park

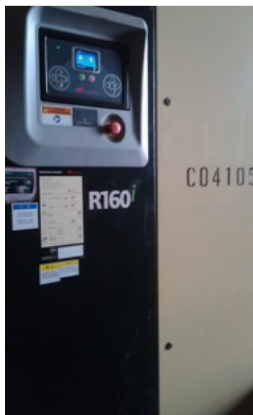
<p><b>Follow up actions for previous site audit:</b>  <b>Previous Environmental Site Inspection Checklist – Report No. 131231</b>                  Nil.</p>
<p><b>Notes / Issues Recorded On Site:</b>  <b>Noise:</b>                  1. No noise label was provided for an air compressor inside the noise enclosure.</p>
<p><b>Corrective Actions – Mitigation Measures Implemented or Proposed (if any):</b>  <b>Current Environmental Site Inspection Checklist – Report No. 140107</b>  <b>Noise:</b>                  1. According to the Contractor's information, the new air compressor was under testing and safety checking. The Contractor was reminded to provide a noise level for the air compressor.</p>

Photo 1 No noise label was provided for an air ompressor inside the noise enclosure.

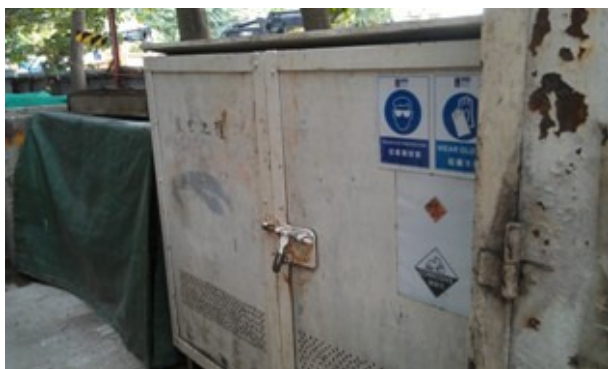
Photo 1 The storage area for rechargeable battery was not locked.

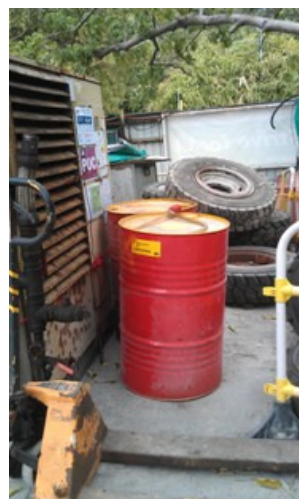
Photo 2 The chemical drums near site entrance were observed without drip trays.

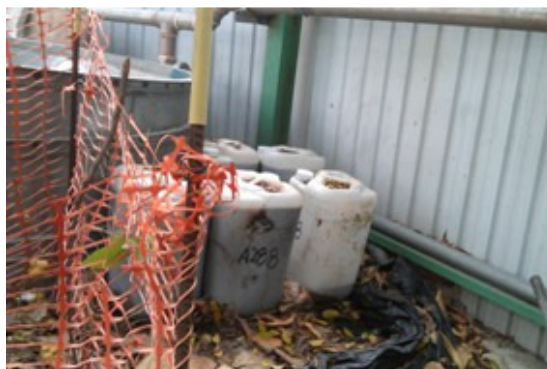
Photo 1 Some chemical drums were found without drip trays and chemical labels near the RE's car park.

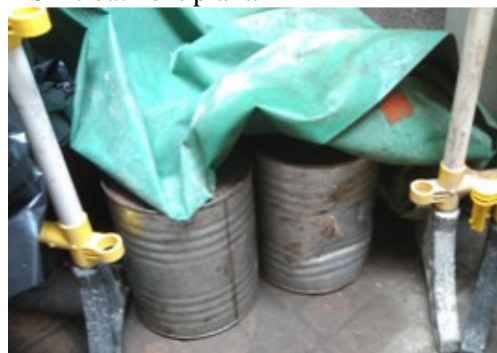
Photo 2 Some chemical drums were found without drip trays and chemical labels in the access between noise enclosure and DSD treatment plant.

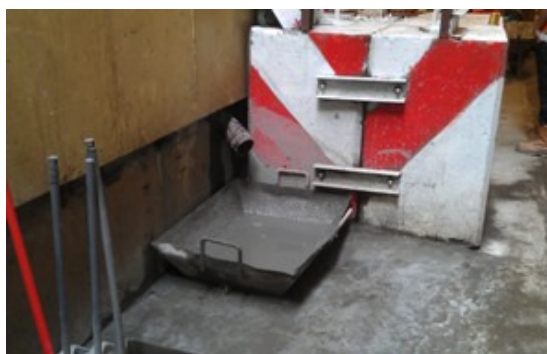
Photo 3 Wastewater from concrete sampling was stored in an unsuitable container. The waste water may overflow during the concrete sampling

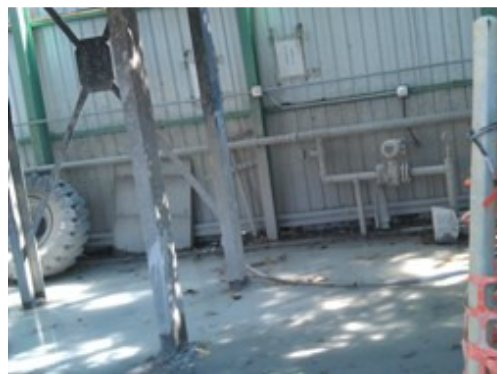
4. Concrete bags were found without cover. (Photo 5)

Photo 5 Concrete bags were found without cover

4. The Contractor was recommended to provide cover for the cement bags.

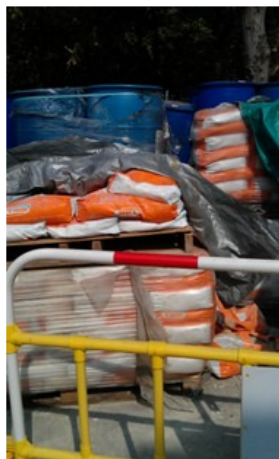
2. Unknown chemical was found inside the metal stockpiles.(photo 2)

Photo 2 Unknown chemical was found near the stockpiles

1. The Contractor was reminded to cover the dusty materials properly.
2. The Contractor was reminded to label the chemical drum and store it properly.
3. The Contractor was reminded to clear waste oil and prevent oil split out.

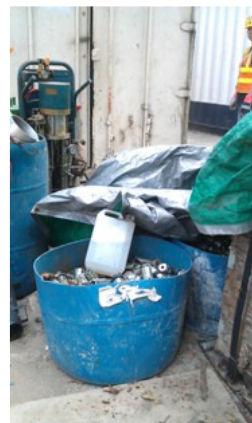
Photo 3 The access was blocked during the site inspection.

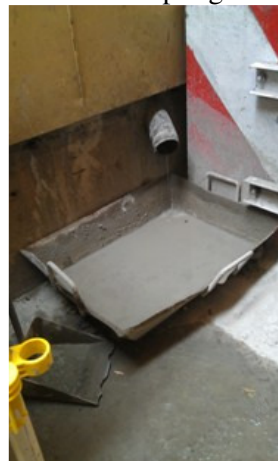
Photo 3 The concrete wastewater was accumulated near the RE's car park.

2. The Contractor was reminded to treat the wastewater generated from concrete sampling prior to discharge.
3. The Contractor was recommended to clear the concrete wastewater and prevent wastewater to leak to nearby gullies.

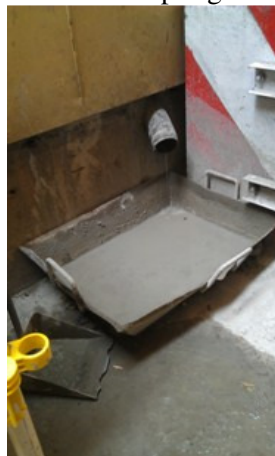
Photo 3 The concrete wastewater was accumulated near the RE's car park.

2. The Contractor was reminded to treat the wastewater generated from concrete sampling prior to discharge.
3. The Contractor was recommended to clear the concrete wastewater and prevent wastewater to leak to nearby gullies.

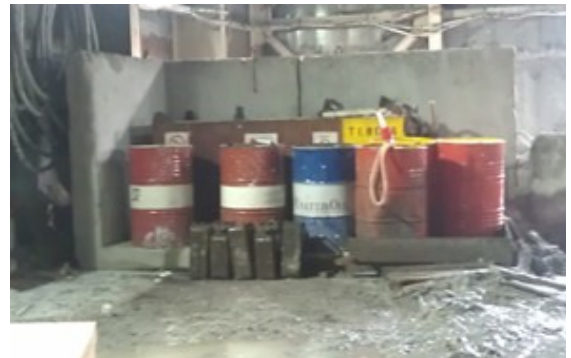
Photo  
3 Oil stains were found next to bund near the  
entrance
