Contract No. DC/2007/24
Harbour Area Treatment Scheme Stage 2A
Construction of Sewage Conveyance System from Aberdeen to Sai Ying Pun

Document/ Plan/Changes/Information to be Certified/ Verified:	Quarterly Environmental Monitoring and Audit Report No.11 (EMA/042, Rev B)
Date of Report:	31 October 2012
Date of correspondence to IEC:	31 October 2012
Date received:	31 October 2012

Contract no. DC/2007/24
Construction of Sewage Conveyance System from Aberdeen to Sai Ying Pun
Submission of 11th Quarterly EM&A Report for July to September 2012 (Rev. B)

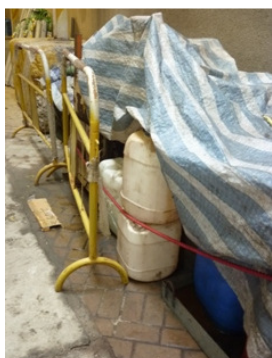
Photo 1 Chemicals without drip tray were found on the access near the noise enclosure

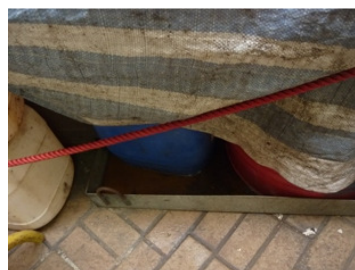
Photo 2 Some soil droplets were found near stockpiles in the noise enclosure.

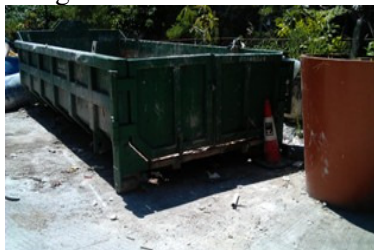
Photos 1 and 2 Trashes were found next to the skip near the gate

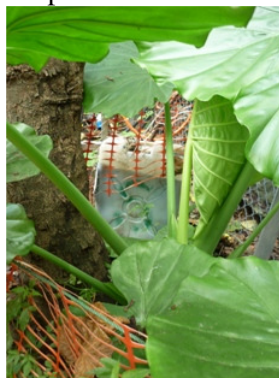
1. Some chemical drums were found without suitable labels and drip tray next to air compressor near the mobile crane (Photo 1) and near the retained tree near plants stockpiles in workshop.(Photo 2)

Photo 2 Some chemical drums were found near the retained tree near plants stockpiles in workshop.

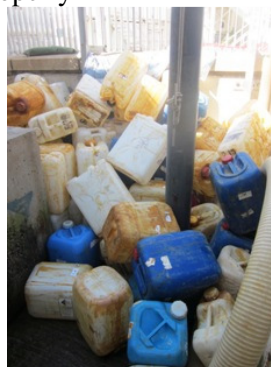
Photo 2 Empty chemical containers were stored improperly

3. The contractor is reminded to provide drip tray to chemical containers on the access near the noise enclosure.
4. The contractor is recommended that empty chemical containers shall be stored or disposed properly.
5. The contractor is reminded to cleared chemical properly avoid chemical leaking.

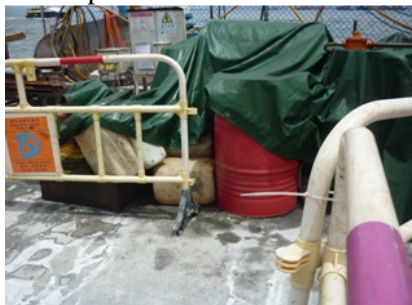
1. Some chemical containers were found without labels and drip tray near stockpiles. (Photo 1)

Photo 1 Some chemical containers were found without labels and drip tray near stockpiles

1. The contactor was reminded to provide suitable labels and drip tray to chemical containers near stockpiles.

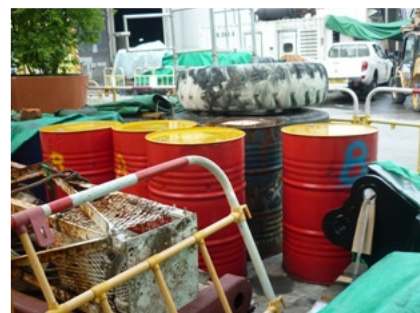
Photo 2 Oil barrels were found without drip trays

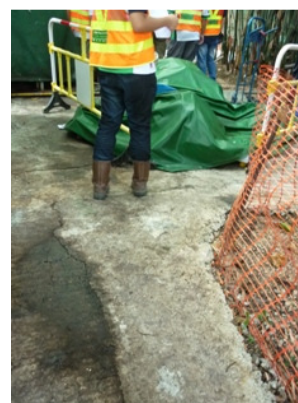
2. Oil remaining was found near the chemical storage (Photo 9) and near the plant next to noise enclosure.(Photos 10 and 11)

Photo 9 Oil remaining was found near the chemical storage

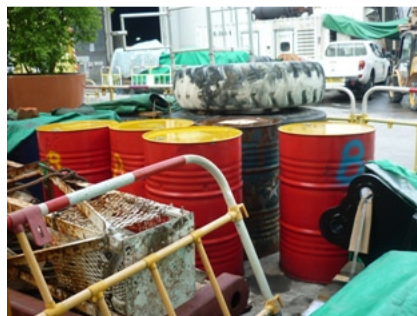
Photo 2 Oil barrels were found without drip trays

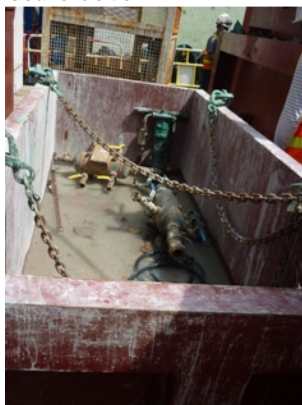
2. Stagnant water was found in skip on noise enclosure cover (Photo 1)

Photo 1 Stagnant water was found in skip on noise enclosure cover

2. The contractor was reminded to clean the accumulated water in skip on noise enclosure cover to prevent mosquito breeding.

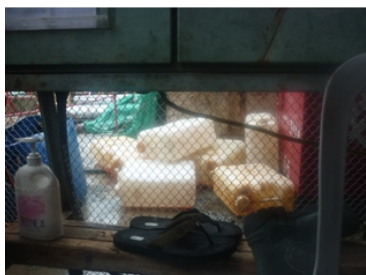
3. Some chemical drums were found without suitable labels and drip tray next to air compressor near the mobile crane (Photo 1) and near the retained tree near plants stockpiles in workshop (Photo 2) since last inspection. (27 July 2012)

Photo 1 Some chemical drums were found without suitable labels and drip tray next to air compressor near the mobile crane.

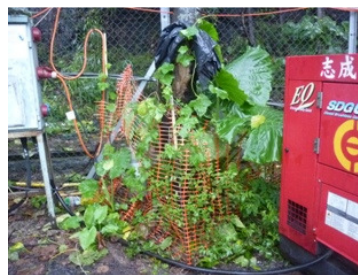
Photo 2 Some chemical drums were found near the retained tree near plants stockpiles in workshop.

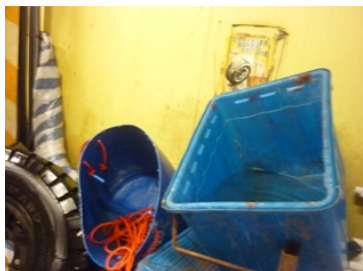
- 3. Water accumulation was found in drip tray since last inspection (Photo 2) and in the plastic containers near noise enclosure. (Photo 3)

Photo 3 Water accumulation was found in the plastic containers near noise enclosure

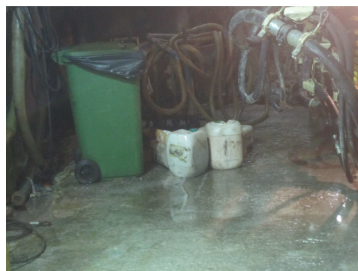
- 6. Chemicals without drip tray were found in the tunnel adit. (Photo 4)

Photo 4 Chemicals without drip tray were found in the tunnel adit.

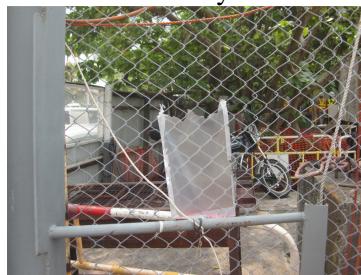
6. Copies of Environmental Permit were wet / loosened after heavy rain. (Photo 2).

Photo 2 Copies of Environmental Permit were wet / loosened after heavy rain.

1. The contractor was reminded to replace the copies of Environmental permit.

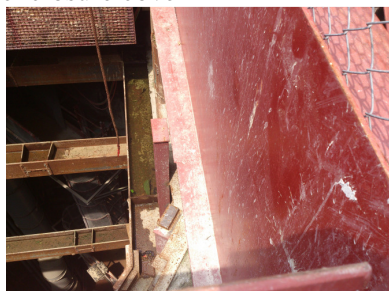
3. Stagnant water was found in the I-beam (Photo 1)

Photo 1 Stagnant water was found in skip on noise enclosure cover

3. The contractor was reminded to clean the accumulated water in the I-beam to prevent mosquito breeding.

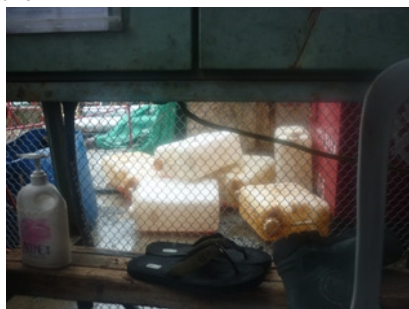
2. Some chemical drums were found without suitable labels and drip tray next to air compressor near the mobile crane (Photo 1) since site inspection on 27 July 2012.
3. Some chemical barrels were found in workshop without suitable labels and drip tray (Photos 2, 3 and 4)

Photo 1 Some chemical drums were found without suitable labels and drip tray next to air compressor near the mobile crane

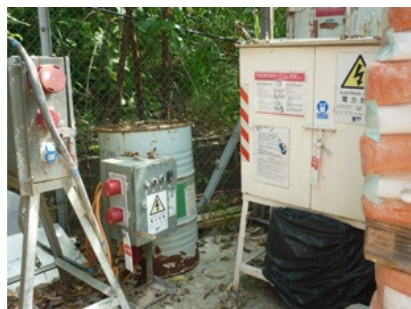
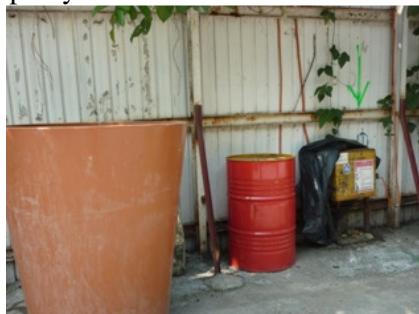
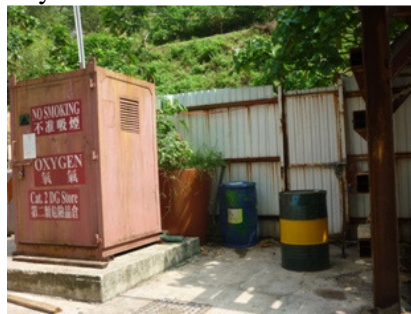
Photo 2 Some chemical barrels were found in workshop without suitable labels and drip tray

Photo 3 Some chemical barrels were found in workshop without suitable labels and drip tray

Photo 4 Some chemical barrels were found in workshop without suitable labels and drip tray

3. The contractor was reminded to provide suitable labels and drip tray to chemical barrels in workshop.

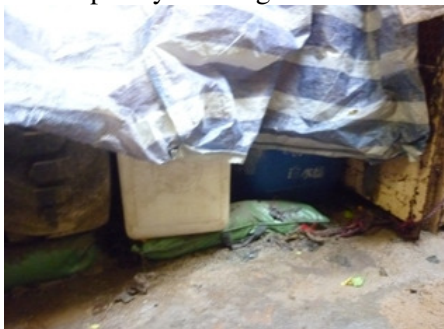
Photo 3 The contractor provided some sand bags for temporary bunding

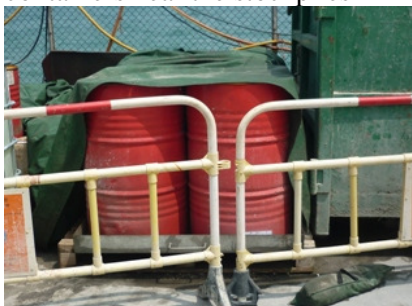
Photo 1 Drip tray was provided to the chemical containers near the stockpiles

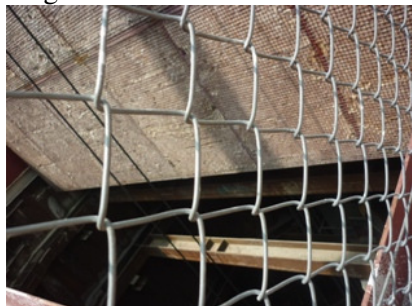
Photo 3 Stagnant water l-beam was cleared

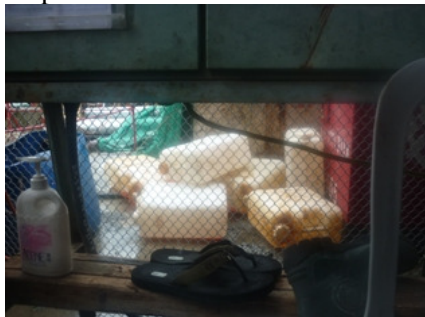
1. Some chemical drums were found without suitable labels and drip tray next to the air compressor near the mobile crane (Photo 1) since site inspection on 27 July 2012.
2. Some chemical barrels were found in workshop without suitable labels and drip tray (Photos 2, 3 and 4).

Photo 1 Come chemical drums were found without suitable labels and drip tray next to the air compressor near the mobile crane

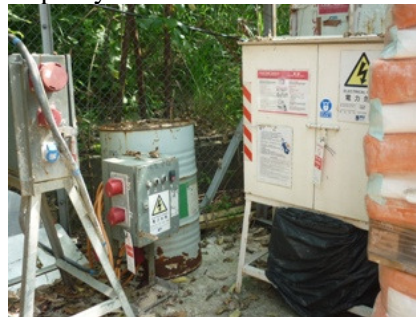
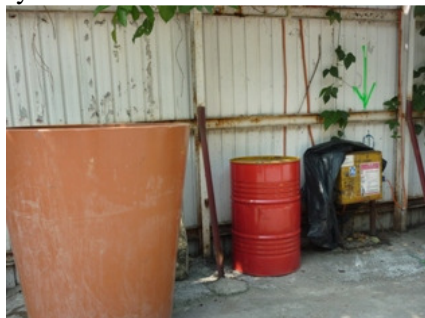
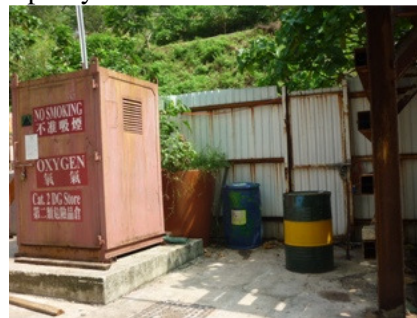
Photo 2 Some chemical barrels were found in the workshop without suitable labels and drip tray

Photo 3 Some chemical barrels were found in the workshop without suitable labels and drip tray

Photo 4 Some chemical barrels were found in the workshop without suitable labels and drip tray

1. The contractor was reminded to provide suitable label and drip tray to chemical barrels in the workshop.

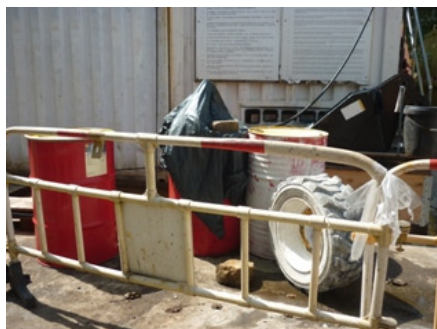
Photo 1 Chemicals were found outside the chemical storage area

Photo 2 Chemicals were found outside the chemical storage area

1. The contractor was reminded to place chemical properly, and sand bags should be provided for temporary storage.
2. The contractor was reminded to provide suitable labels to chemicals.

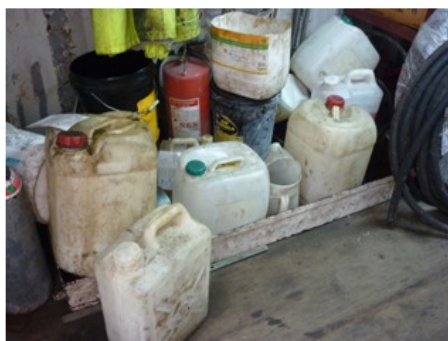
Photo 3 Chemicals without labels were found in plant container

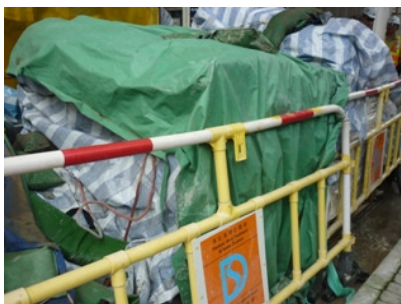
Photo 1 Cement bags were covered properly

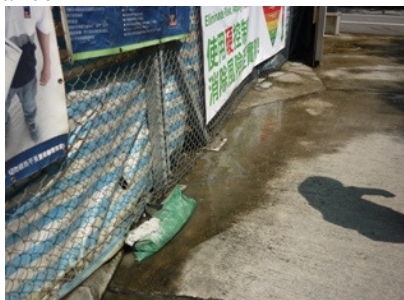
1. Water ponding was found near the site entrance (Photo 1).

Photo 1 Water ponding was found near the site entrance

1. The contractor was reminded to clear the accumulated water and ensure the drainage system is in good condition.

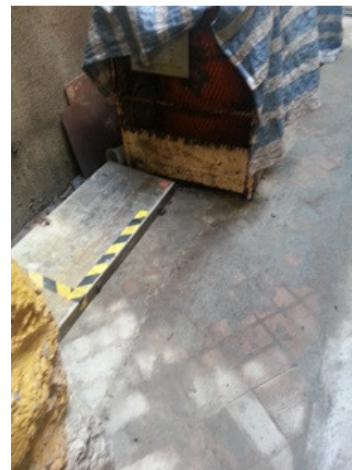
Photo 5 Contaminated soil near drip tray was cleared

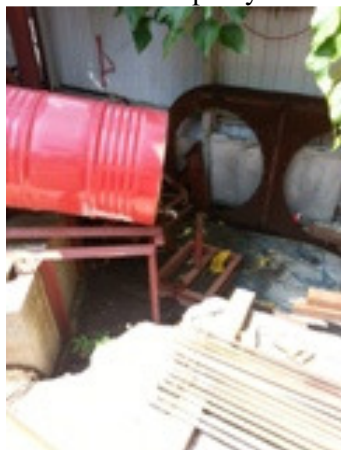
1. Chemical near welding zone was found without drip tray (Photo 1).

Photo 1 Chemical near the welding zone was found without drip tray

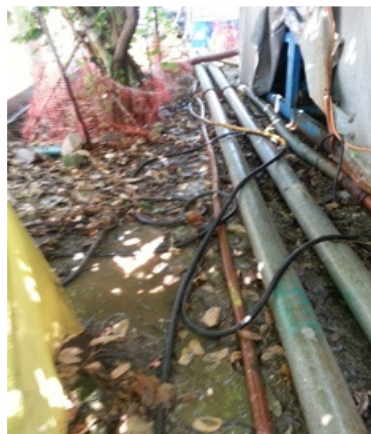
7. Water accumulation was found behind the sedimentation tank (Photos 2 and 3).

Photo 2 Water accumulation was found behind the sedimentation tank

Photo 3 Water accumulation was found behind the sedimentation tank

4. The contractor was recommended to clear the water accumulation behind the sedimentation tank and prevent mosquito breeding.

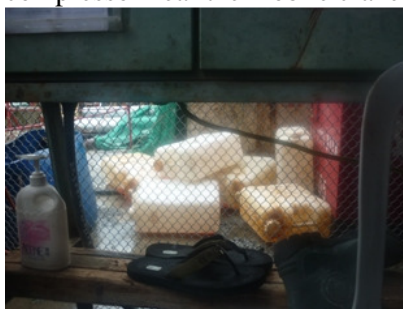
Photo 2 Some chemical drums were found without suitable labels and drip tray next to air compressor near the mobile crane

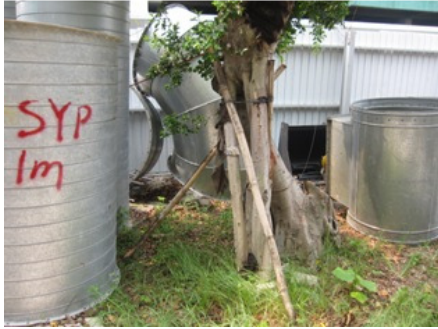
1. The transplanted tree T003 was found without protective fence since last inspection (Photo 7).

Photo 7 The transplanted tree T003 was found without protective fence since last inspection

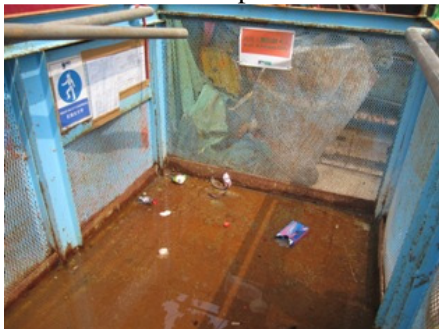
1. Stagnant pool and leaves accumulation were found around the workshop (Photos 8 and 9).

Photo 9 Stagnant pool and leaves were found around the workshop

1. The contractor was reminded to clear water accumulation in PTW and to ensure the drainage system is in good condition.
2. The contractor was reminded to clear the stagnant pool in the man cage where had been found in workshop and keep the site tidiness.

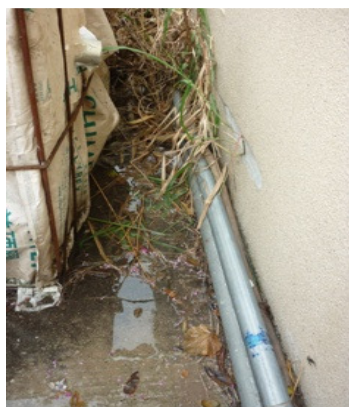
4. Water leaking and accumulated were found opposite the adjacent contractor's site office (Photos 1 and 2).

Photo 1 Water leaking and accumulated were found around the adjacent contractor's site office

2. The contractor was recommended to clear the water accumulation and fix the pipe if the pipe is leaking.

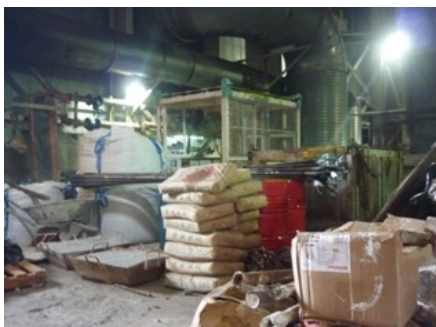
Photo 3 Cement bags without properly cover

1. The contractor was recommended to provide cover to storage cement bags.

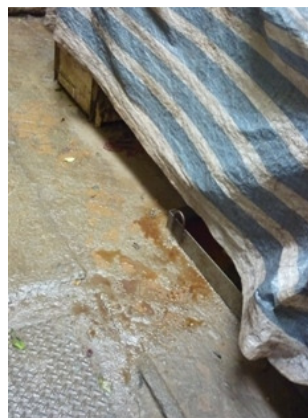
1. Oil droplets were found near the noise enclosure (Photo 4).

Photo 4 Oil droplets was found near the noise enclosure

1. The contractor was reminded to clear oil droplets near the noise enclosure with oil dispenser.

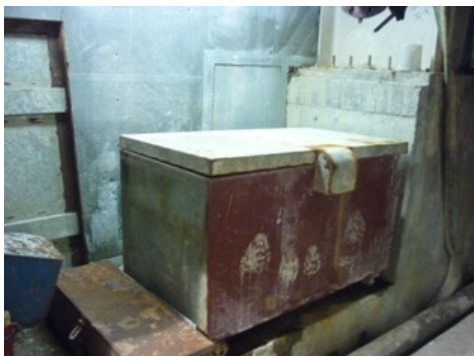
Photo 5 Water accumulated and trashes were found in the skip in the noise enclosure

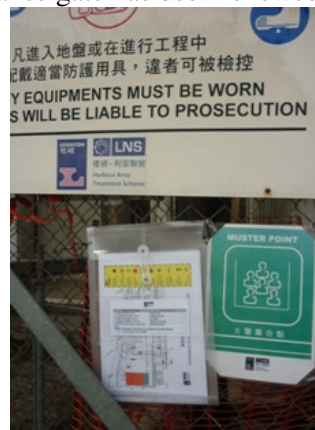
Photo 6 The folder for permits storage where near the entrance gate has been renewed

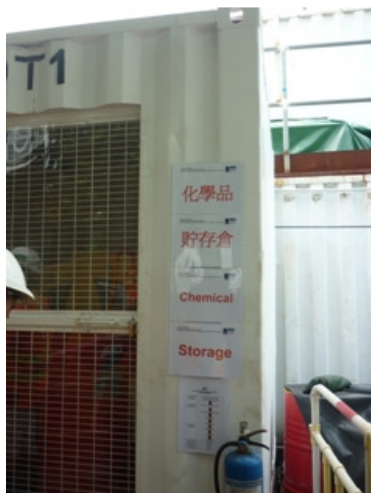
Photo 5 The label had been provided to the new chemical storage cargo

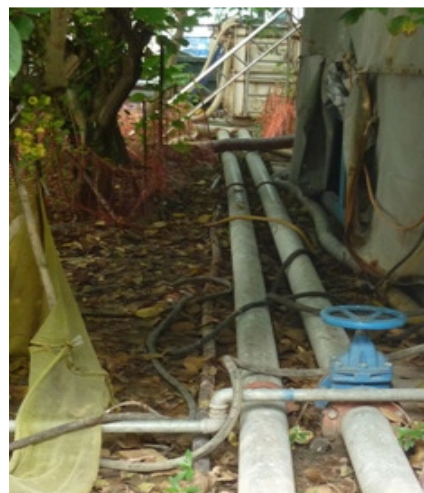
Photo 6 No potential stagnant pools were found behind the sedimentation tank

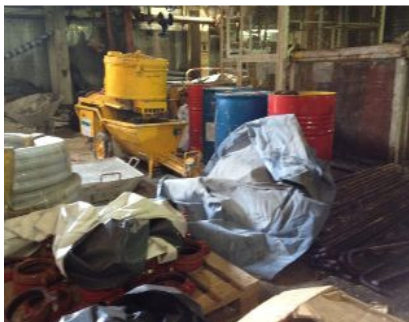
Photo 3 Cement bags had been covered by tarpaulin

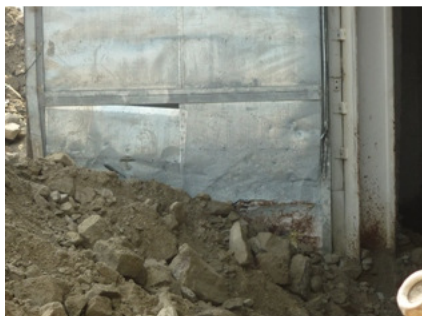
1. The door of noise enclosure was found broken since last inspection. (Photos 1 and 2)

Photo 1 The door of noise enclosure was found broken.

Photo 2 The door of noise enclosure was found broken. (Taken on 14th August 2012)

1. According to contractor, acoustic mat will be provided to cover broken part for temporary treatment.

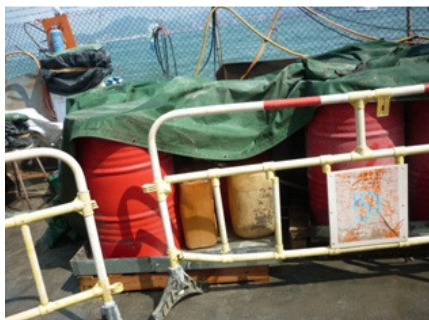
1. Chemical without suitable labels were found. (Photo 3)

Photo 3 Chemical without suitable labels were found

1. The contractor is recommended to provide the suitable label to unknown chemical.

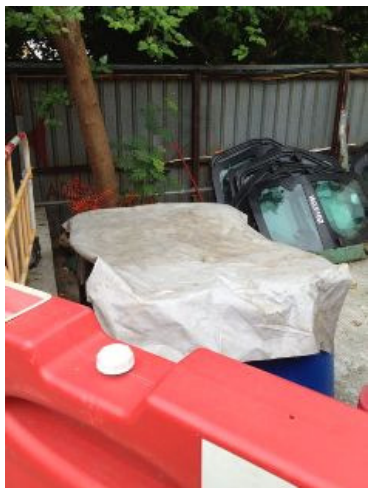
Photo 3 Tarpaulin had been provided to barrels near the DG Storage to prevent water accumulation

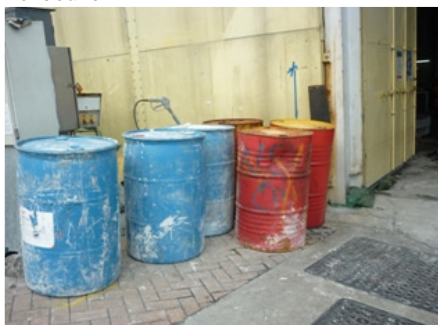
1. Some chemical barrels were found without drip tray near the door of noise enclosure. (Photo 1)

Photo 1 Some chemical barrels were found without drip tray near the door of noise enclosure

4. The contractor is recommended to provide drip tray to chemical barrels near the door of noise enclosure.

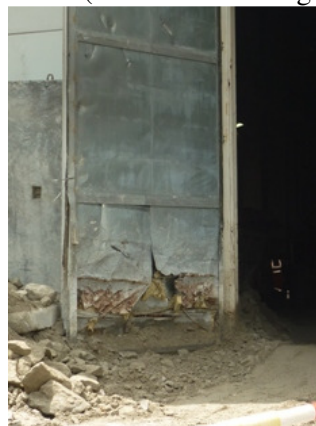
- 2. The door of noise enclosure was broken since last inspection. (Photos 1 and 2)

Photo 1 The door of noise enclosure was found broken.

Photo 2 The door of noise enclosure was found broken.(Taken on 14th August 2012)

- 2. According to contractor, acoustic mat will be provided to cover broken part for temporary treatment.

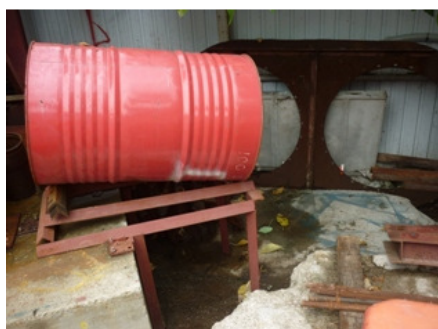
14. Chemical near welding zone was found without drip tray since last inspection.(Photo 1)
15. The chemicals without labels were found in Plant container since last inspection.(Photo 2)

Photo 1 Chemical near welding zone was found without drip tray

4. The Contractor is reminded to provide drip tray to chemical near the welding zone and provide suitable labels to chemicals stored in material container.

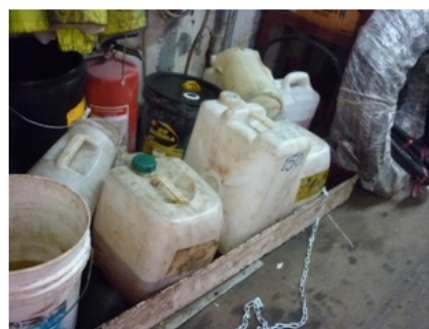
Photo 2 The chemicals without labels were found in Plant container

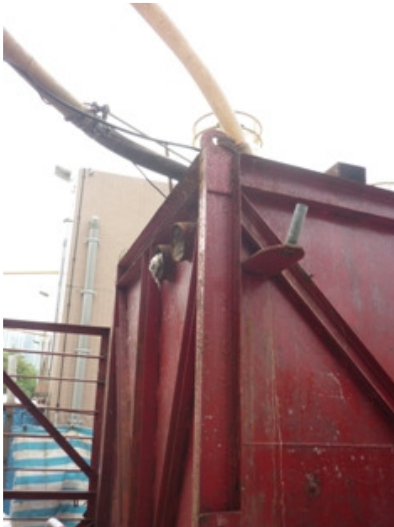
1. No more leaking was found near the sedimentation tank. (Photo 3)

Photo 3 No more leaking was found near the sedimentation tank

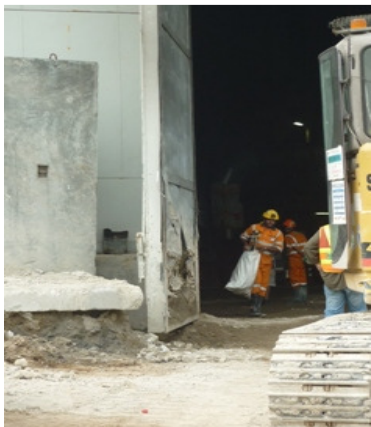
Photo 1 The door of noise enclosure was found broken.

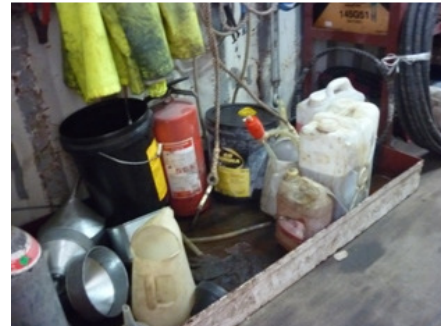
Photo 2 The chemicals without labels were found in Plant container

1. The Contractor is reminded to provide drip tray to chemical near the welding zone and provide suitable labels to chemicals stored in material container.

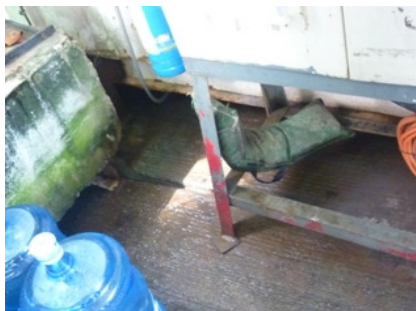
1. The issue of dripping from air conditioner (Photos 1 and 2) will be follow next inspection due to no inspection had been undertaken in the resting zone.

Photos 1 and 2 Dripping from air conditioner was found near material container
