Document Details					
Client Drainage Services Department					
Project Contract No. DC/2007/24 Harbour Area Treatment Scheme Stage 2A Construction of Sewage Conveyance System from Aberdeen to Sai Ying Pun					
Document Title Quarterly Environmental Monitoring and Audit Report No. 12 Covering the Period from 1 October 2012 to 31 December 2012					
Document No. EMA/046					
Distribution					
Copy No.	Issued To		Copy No.	Issued To	
01-02	Leighton-LNS JV		10	Metcalf & Eddy-AECOM JV	
03	Mott MacDonald Hong Kong Ltd		11	ACL (Project Office)	
04-08	EPD		12	ACL (Head Office)	
09	DSD				
Submission Ref				Controlled Copy No.	
SUBM Ref.					
Atkins Ref.(s)	DC/2007/24/31.20/OG4004/EC/SH/SO				
Revision History					
A	28 January 2013	Submission to IEC and ER for Review	Various

Contract No. DC/2007/24
Harbour Area Treatment Scheme Stage 2A
Construction of Sewage Conveyance System from Aberdeen to Sai Ying Pun

Document/Plan/Changes/Information to be Certified/ Verified:	Quarterly Environmental Monitoring and Audit Report No.12 (EMA/046, Rev A)
Date of Report:	1 February 2013
Date of correspondence to IEC:	1 February 2013
Date received:	1 February 2013

**Contract no. DC/2007/24
Construction of

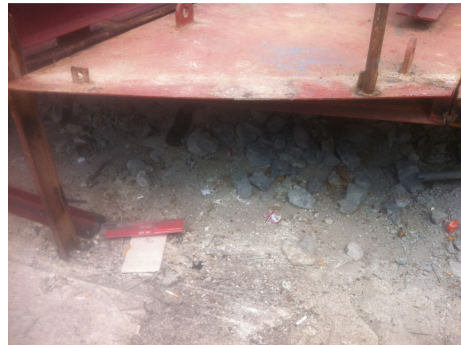
Photo 3 The contractor has removed the chemical container

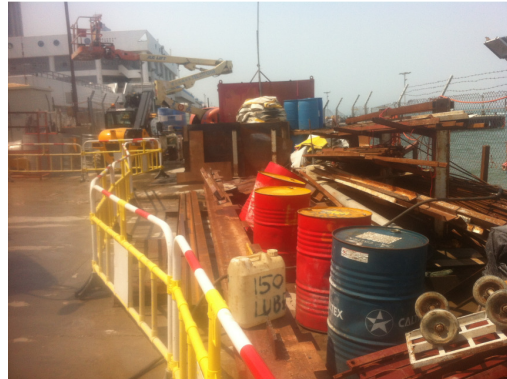
Photo 2 Chemical barrels were found to be without drip trays outside the noise enclosure area

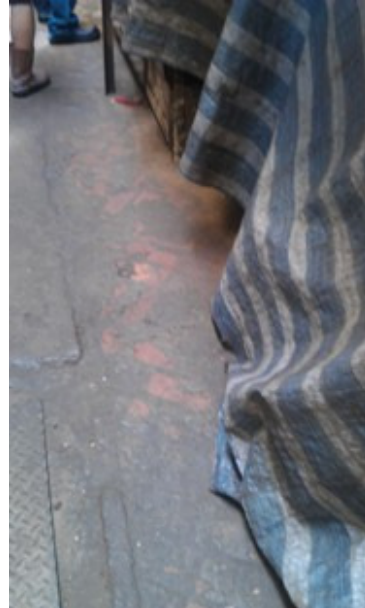
Photo 4 Waste oil near the noise enclosure of the inner entrance was cleared

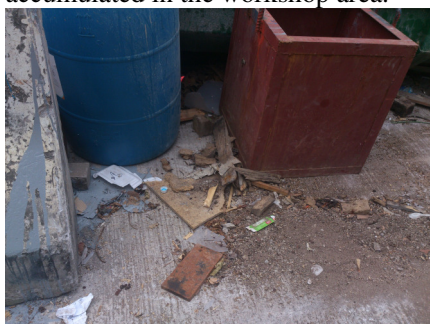
1. The general waste was found accumulated in the workshop area. (Photo 1)

Photo 1 The general waste was found accumulated in the workshop area.

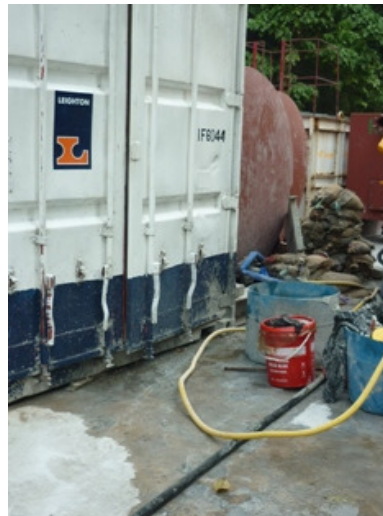
Photo 4 Some known chemical drums next to the white container had been removed.

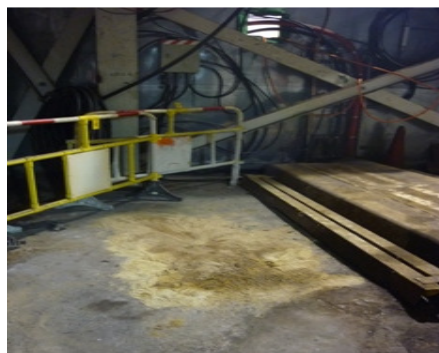
Photo 2 The waste oil was cleared with oil absorbents.

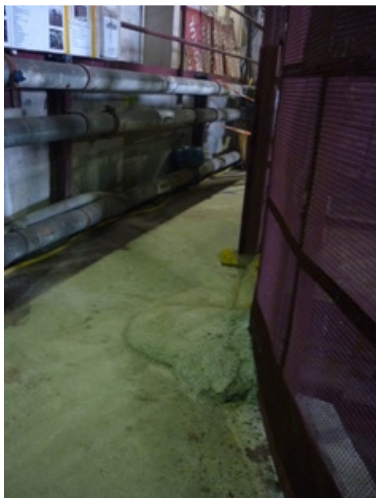
Photo 3 Water accumulation next to air compressor in noise enclosure was cleared.

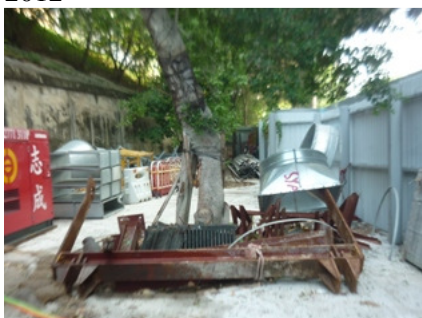
Photo 1 Construction materials were stored too close to the tree (T003 (T)) in Storage area since inspection on 24 October 2012

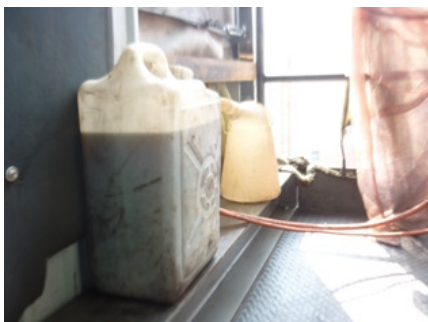
Photos 3 A chemical container was found near the generator at 1st platform without label

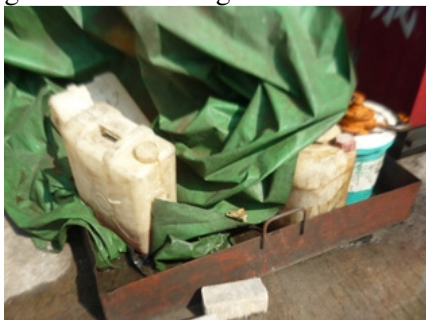
Photo 7 Waste oil was accumulated in drip tray of generator at storage area

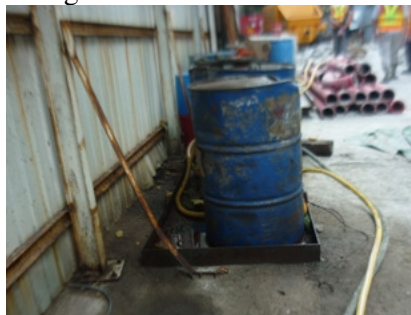
1. Some trashes were found next to the stairs in PTW and near the rubbish skip in storage area.(photos 8 and 9)
2. Accumulated of water was found in drip tray of oil barrels near the stockpiles in storage area. (Photo 10)

Photo 10 Accumulated of water was found in drip tray of oil barrels near the stockpiles in storage area

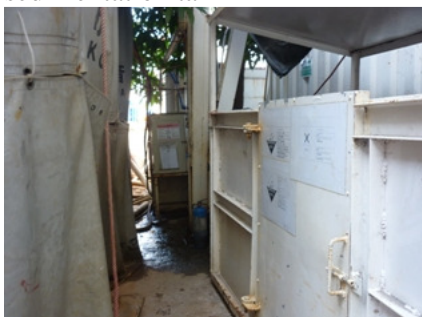
Photo 1 Some water accumulated next to sedimentation tank

1. The Contractor is recommended to avoid water accumulation next to sedimentation tank.

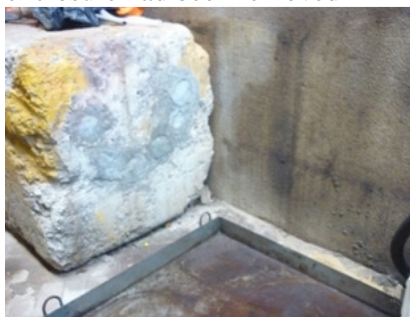
Photo 2 The unknown chemical near the noise enclosure had been removed

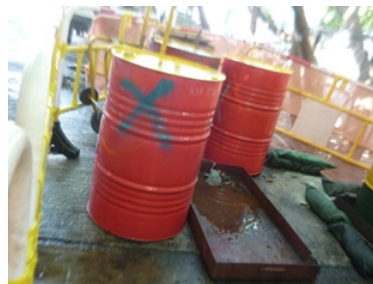
Photo 2 Some chemical barrels were found without drip tray next to chemical storage since last inspection

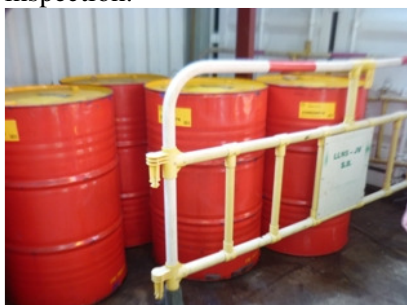
Photo 3 Some chemical barrels were found without drip tray next to chemical storage since last inspection.

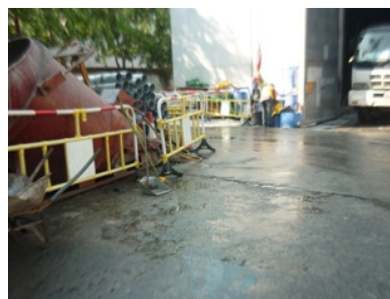
Photo 4 Some oil stains were found next to the stockpiles

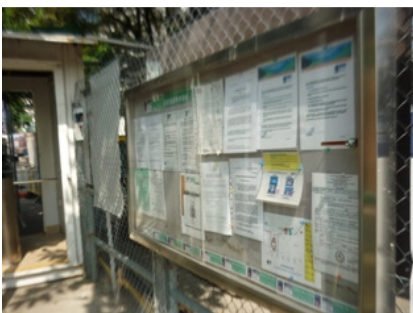
Photo 1 Invalid EP was found at main entrance..

1. The Contractor is reminded to display the valid EP at main entrance.

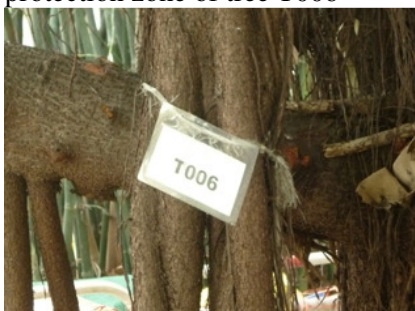
1. Non-use water plastic pipe hang from the branch of Tree 038. (Photo 5)
2. A metal bar was found inside the tree protection zone of tree T006.(Photos 6 and 7)

Photo 7 A metal bar was found inside the tree protection zone of tree T006

1. The Contractor is suggested to remove all construction materials from the Tree 038 and Tree T006.

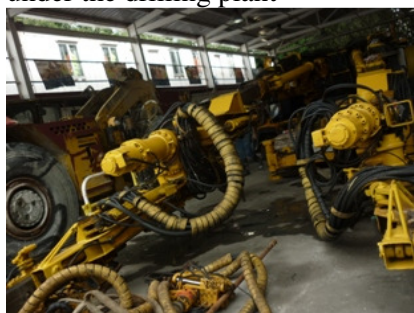
1. Some chemical with green colour was found under the drilling plant.(Photo 8)

Photo 8 Some chemical with green colour was found under the drilling plant

1. The Contractor is reminded to clear chemical stain under the drilling plant as chemical treatment.

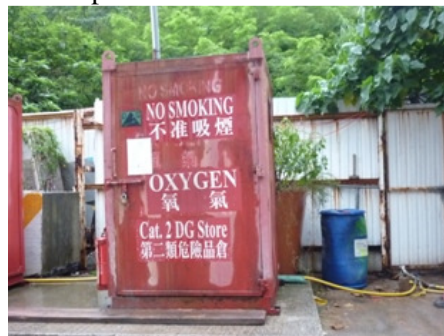
1. A waste oil barrel was found near the Oxygen Container in storage area since inspection on 13th November 2012. (Photo 6)

Photo 6 A waste oil barrel was found near the Oxygen Container in storage area since last inspection

1. The Contractor is reminded to remove the waste oil barrel near the Oxygen container in storage area
2. The Contractor is recommended to clear accumulated oil in drip tray of generator at 1st platform and drip tray of generator in storage area.

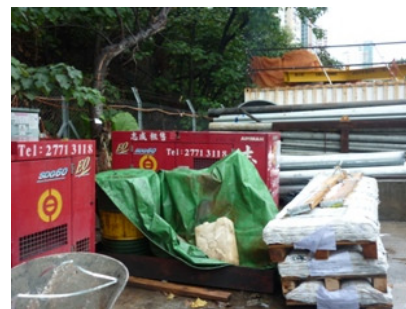
1. Some white smoke was observe from generator in storage zone.(Photo 8)

Photo 8 Some white smoke was observe from generator in storage zone

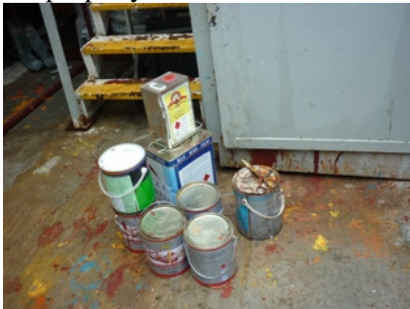
1. The chemical storage container was found without lock since last inspection. (Photo 3)
2. Some dusty material were found without properly cover since last inspection. (Photo 4)
3. Some chemicals were found without place properly. (Photo 5)

Photo 5 Some chemicals were found without place properly

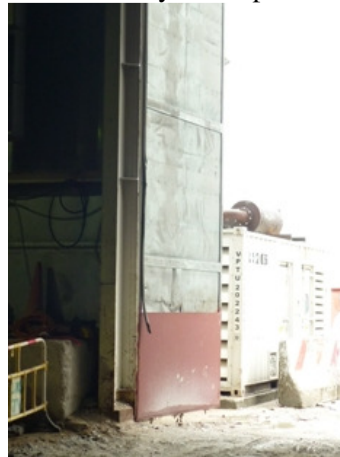
Photo 6 The door of the noise enclosure had been cover by metal plate

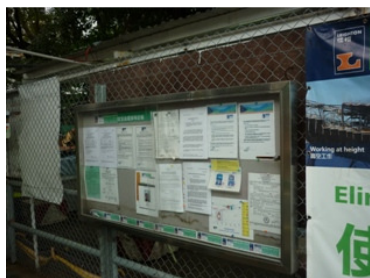
1. No valid EP was found at entrance. (Photo 1)

Photo 1 No valid EP was found at entrance.

1. The Contractor is reminded to display the valid EP at main entrance.

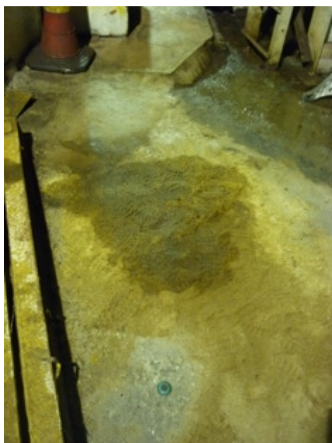
Photo 3 Some sand mix with oil was found inside noise enclosure

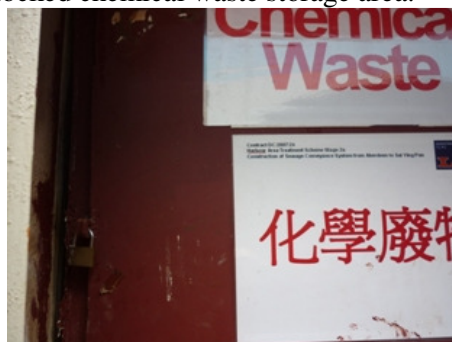
Photo_F 2 The chemical waste was stored in a locked chemical waste storage area.

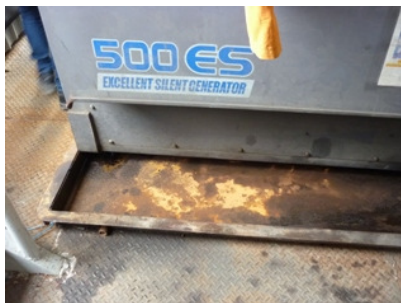
Photo_F
1 Waste oil accumulated in drip tray of generator at the first platform was cleared.

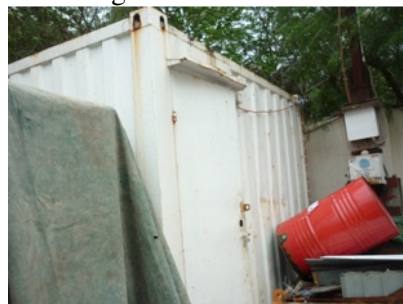
1. A chemical container was found near the generator at the first platform without label. (Photo 1)
2. An unknown chemical drum was found in container next to entrance gate. (Photo 2)

Photo 2 An unknown chemical drum was found in container next to entrance gate

1. The Contractor was recommended to display chemical storage list of the chemical storage.
2. The Contractor was reminded to provide suitable labels to the chemicals near the generator at 1st platform and in storage area.
3. The Contractor was reminded to provide labels to chemical drums next to entrance gate

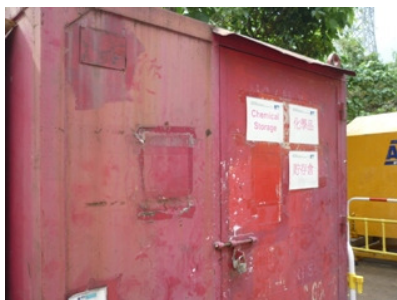
3. The chemical storage was found without chemical storage list since the site inspection undertaken on 30th October 2012. (Photo 3)

Photo 3 The chemical storage was found without chemical storage list since the site inspection undertaken on 30th October 2012

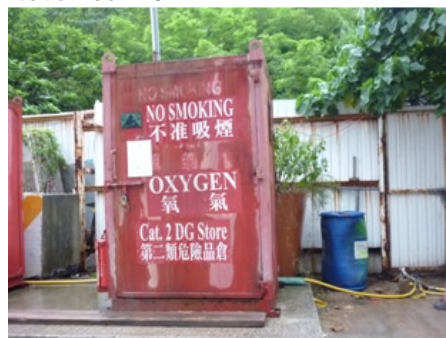
4. A waste oil barrel was found near the Oxygen Container in storage area since the site inspection undertaken on 13th November 2012. (Photo 4)

Photo 4 A waste oil barrel was found near the Oxygen Container in storage area since the site inspection undertaken on 13th November 2012

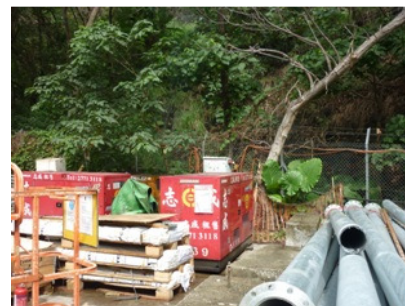
6. Some white smoke was observed from generator in storage zone since the site inspection undertaken on 4 December 2012.(Photo 6)

Photo 6 Some white smoke was observed from generator in storage zone.

6. The Contractor was recommended to fix the generator in storage zone.

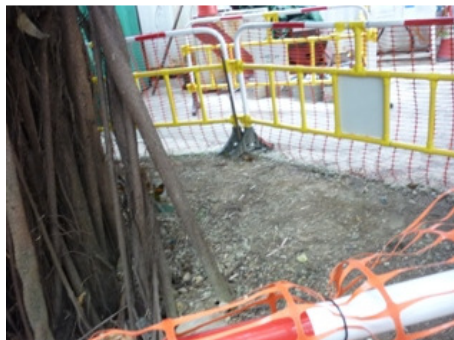
Photo_ F 1 The metal bar inside the tree protection zone of tree T006 was removed

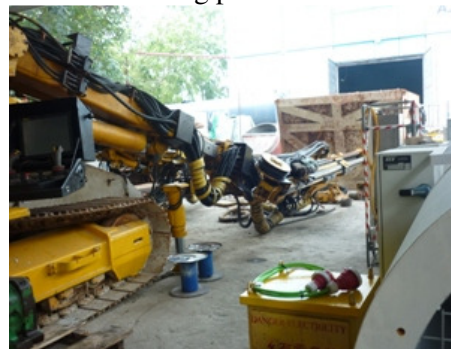
Photo_F 2 The chemical with green colour under the drilling plant was cleared

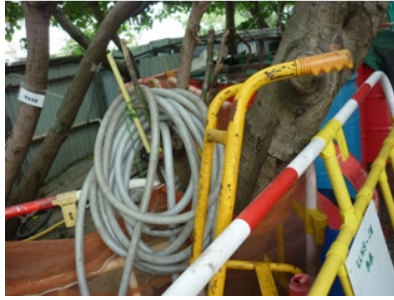
Photo 2 Non-use water plastic pipe was hung on the branch of Tree 038

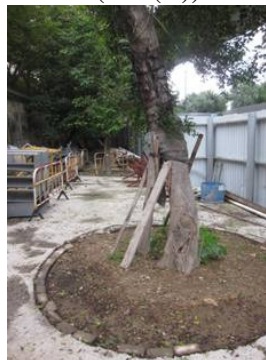
Photo_F
2 The construction materials were moved away from the tree (T005 (T)) and tree (T84(R)) in storage area.

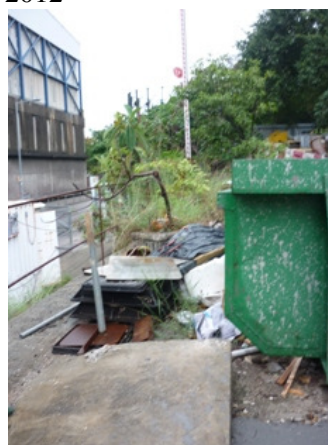
4. Some trashes were found near the rubbish skip in storage area since the site inspection undertaken on 13th November 2012. (photo 4)

Photo 4 Some trashes were found near the rubbish skip in storage area since the site inspection undertaken on 13th November 2012

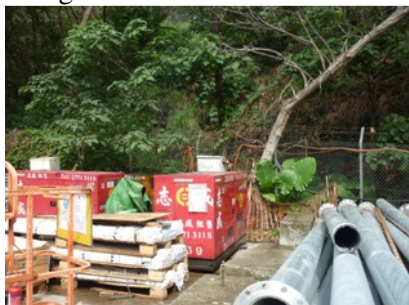
5. Some white smoke was observed from generator in storage zone since the site inspection undertaken on 4 December 2012.(Photo 5)

Photo 5 Some white smoke was observed from generator in storage zone.

5. The Contractor was recommended to provide maintenance for the generator in storage zone.

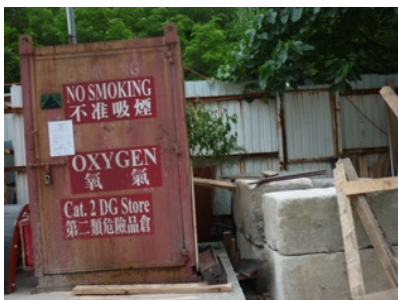
Photo_F
1 The waste oil barrel near the Oxygen
Container in storage area was removed.

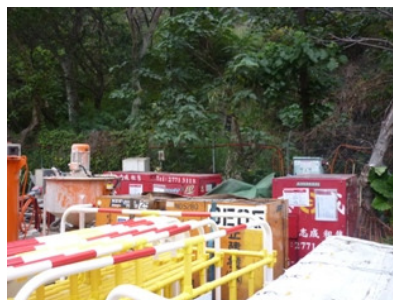
7. The generator was observed no more white smoke exhausted.(Photo F_2)

Photo_F
2 No white smoke was exhausted from
the generator.

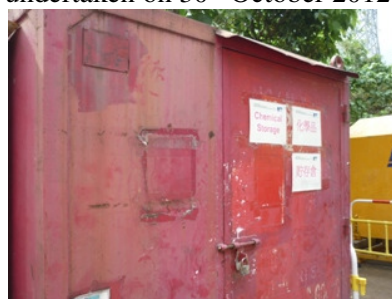
Photo 2 The chemical storage was found
without chemical storage list
since the site inspection
undertaken on 30th October 2012

1. The Contractor was reminded to provide labels to chemical drums next to entrance gate.
2. The Contractor was recommended to display chemical storage list of the chemical storage.
3. The Contractor is reminded to provide drip tray and suitable label to chemical drum near the tree T005 (T).

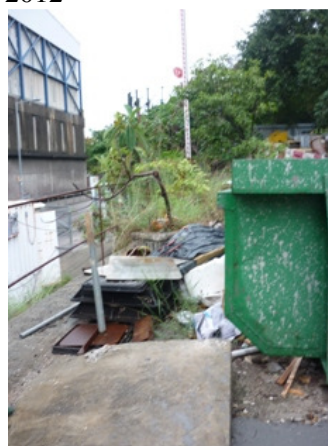
9. Some trashes were found near the rubbish skip in storage area since the site inspection undertaken on 13th November 2012. (photo 4)

Photo 4 Some trashes were found near the
rubbish skip in storage area since the site
inspection undertaken on 13th November
2012

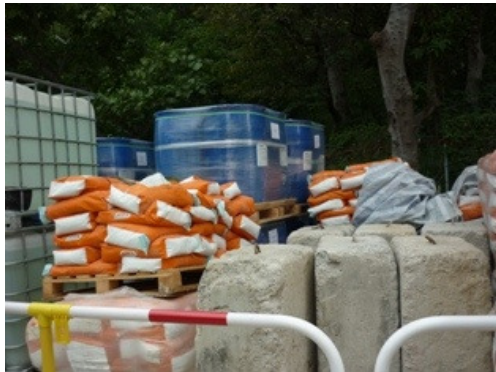
10. Dusty material were found without cover properly.(Photo 5)

Photo 5 Dusty materials were not covered properly.

5. The Contractor was recommended to cover dusty material within works area.

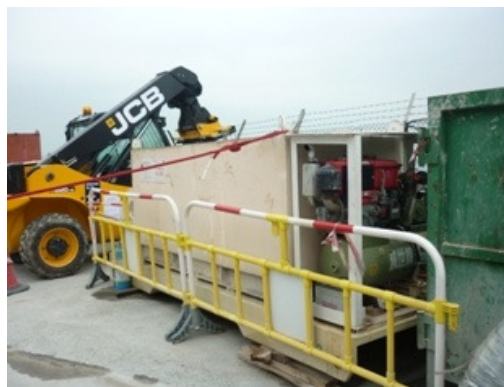
The chemical drum was behind the fuel tank.

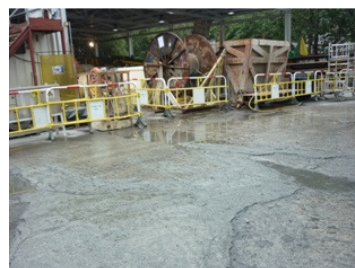
Photo F_2 The oil stains and unknown chemical stains near the noise enclosure and entrance gate were cleared
