**Shatin to Central Link –  
Tai Wai to Hung Hom Section**

Conservation Plan  
for the Old Pillbox  
at the former Tai Hom Village site

# Shatin to Central Link Consultancy Agreement No. C1103 Detailed Design for Diamond Hill Station and Stabling Sidings

Further Structural Survey for the Old Pillbox

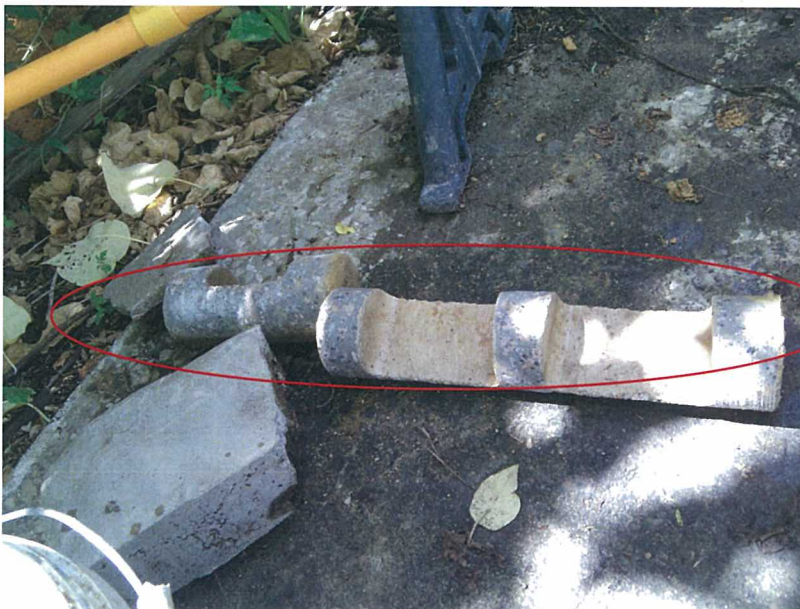
Extracted core samples, mark W1-1 and W1-2, revealed the wing wall of pillbox was constructed by two rows of concrete hollow blocks

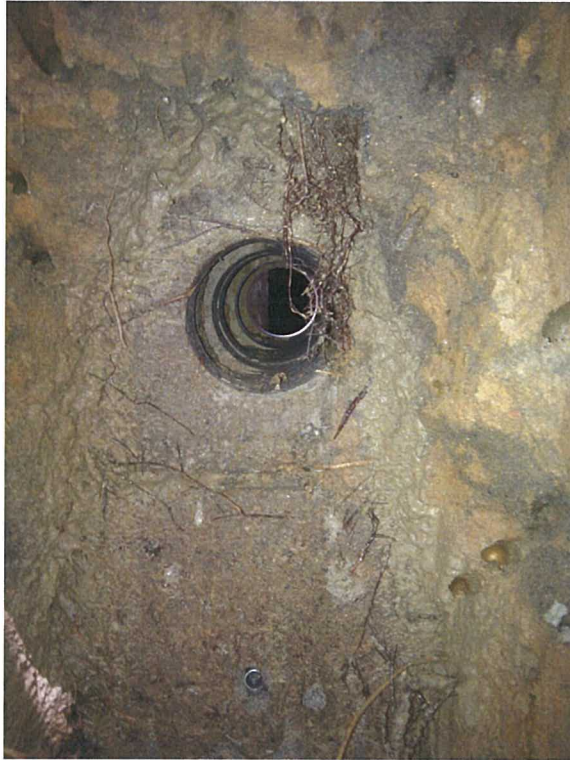
Thickness of wing wall measured through the core-hole is 665mm

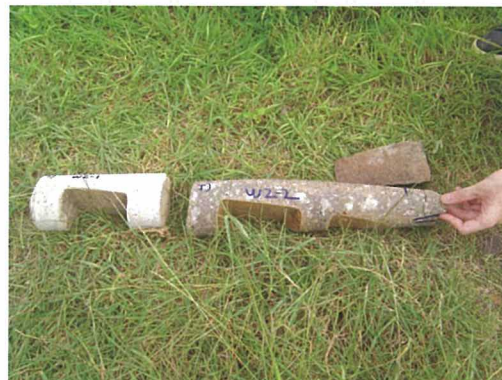
Extracted core samples, mark W2-1 and W2-2, revealed the wall of pillbox was constructed by two rows of concrete hollow blocks

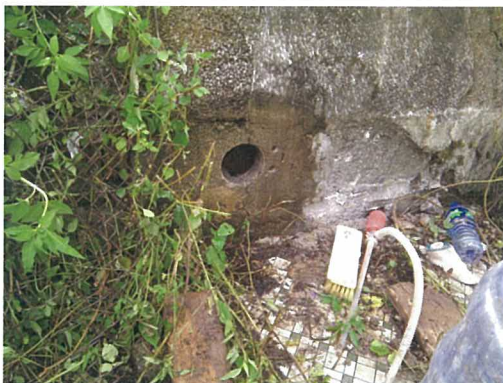
Thickness of wing wall measured through the core-hole is 730mm

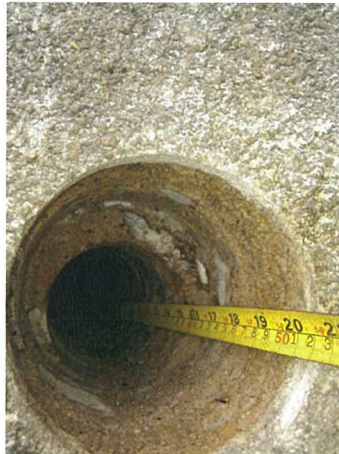
Thickness of roof dome is 515mm

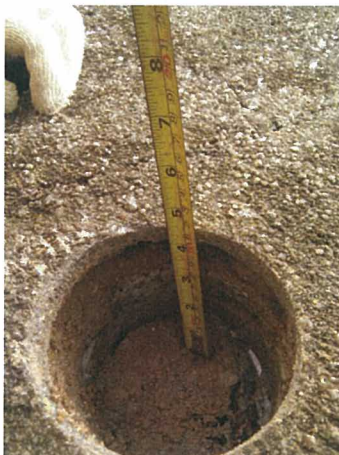
Rebar was encountered at 110mm
