West Island Line Project

Archaeological Watching Brief Report (Rev A)

December 2013

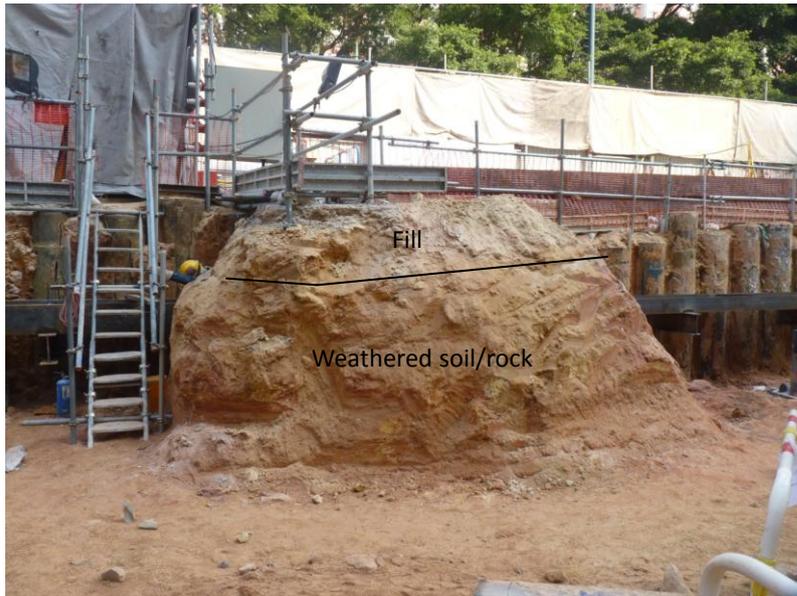
Plate 11.B.1 Photograph taken of the south/centre part of the site, showing the stratigraphy of the site, i.e. shallow artificial fill over weathered soils and rock.

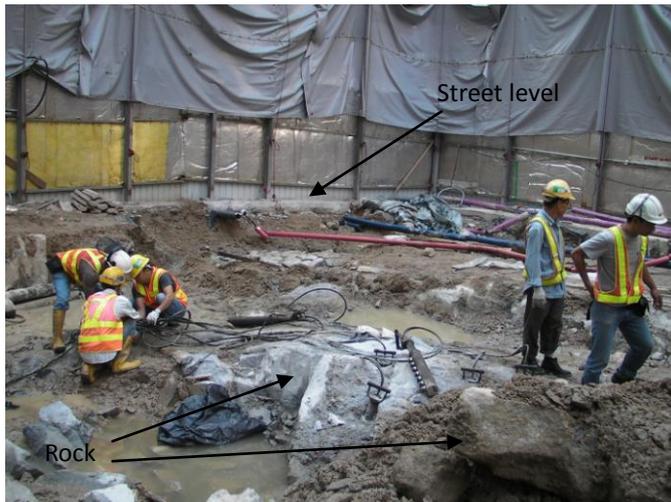
Plate 11.B. 5 Photograph showing large boulders and rockhead at shallow depths; notice the rock in the front right corner and the drilling of rockhead in the centre; the street level is visible in the back of the photo

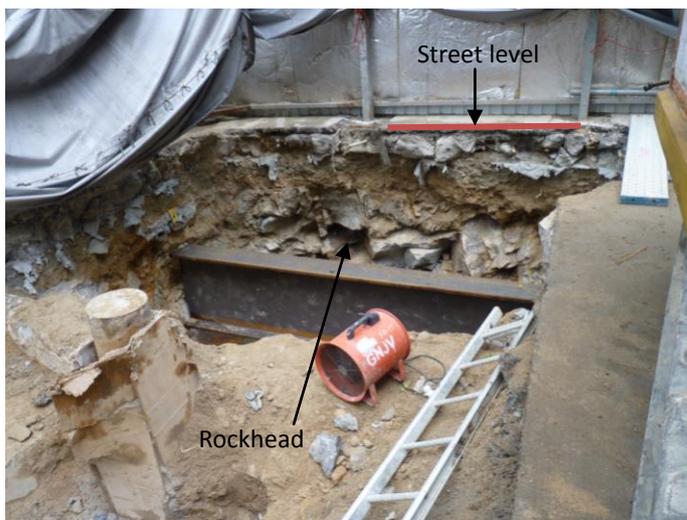
Plate 11.B.6 Photograph showing the proximity of the current surface and rockhead and boulders; notice the cut rock beneath the surface in the centre of the photo. The rock was cut to place the I-beam which carries the working deck

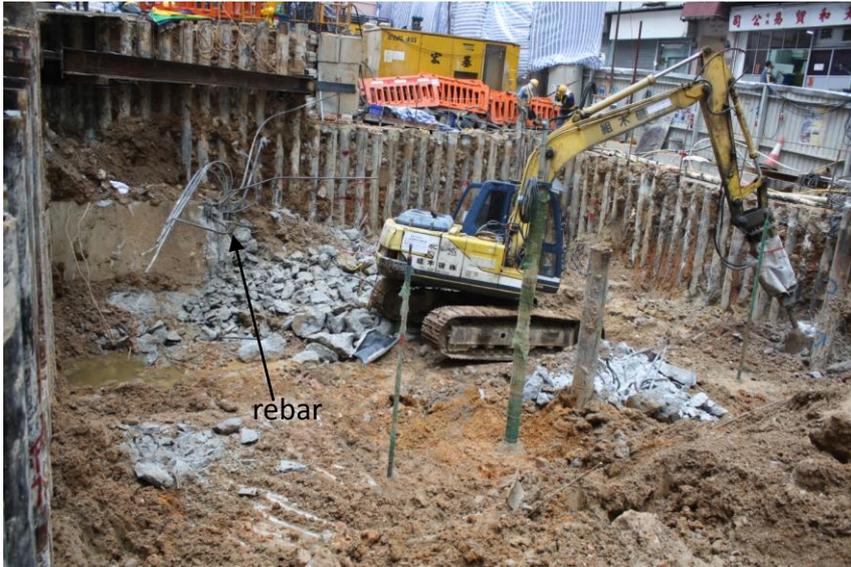
Plate 11.B.11 Photograph showing the western portion of the site looking to the south; notice the deep disturbance by the rebar centre-left of the photo

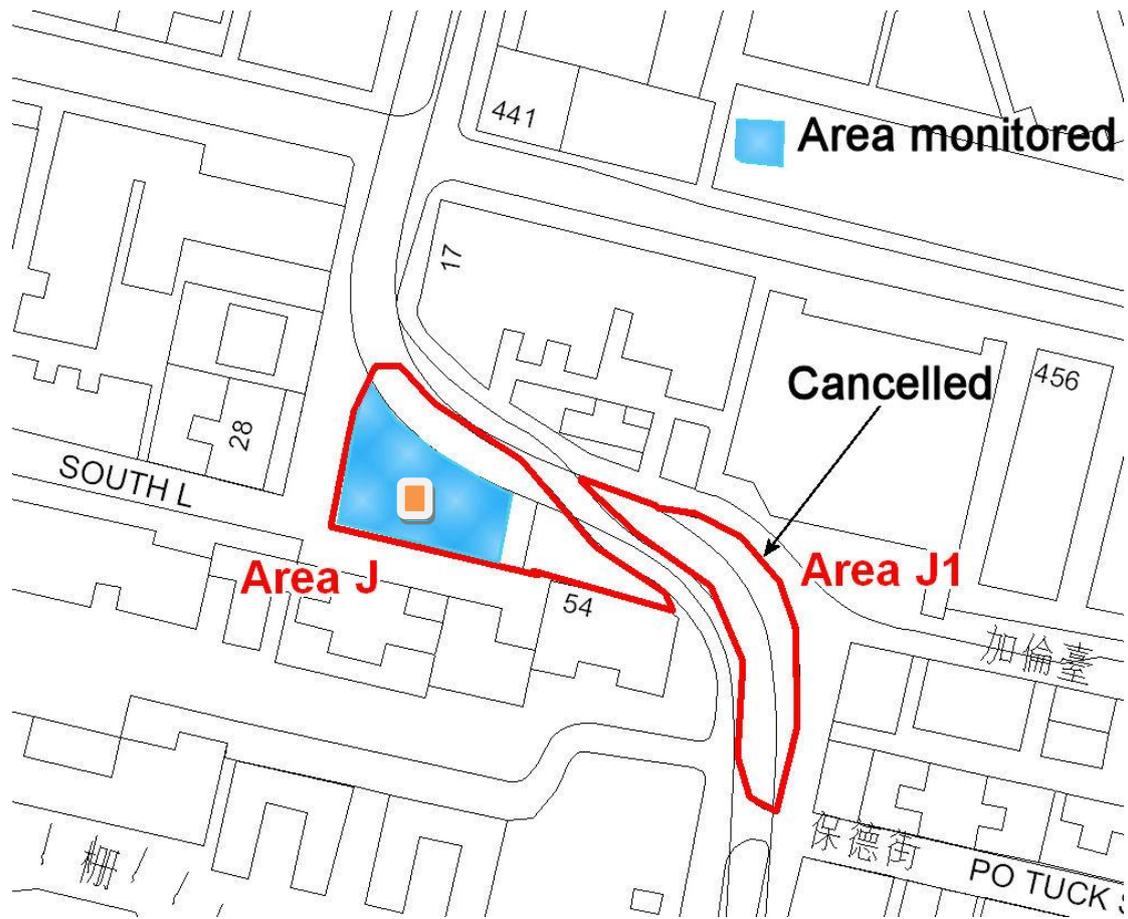
Figure 11.B.4 Map showing the extent monitored at Site J, Hill Road in blue and the cancelled area J1;

Marks the location of modern deep rebar foundation

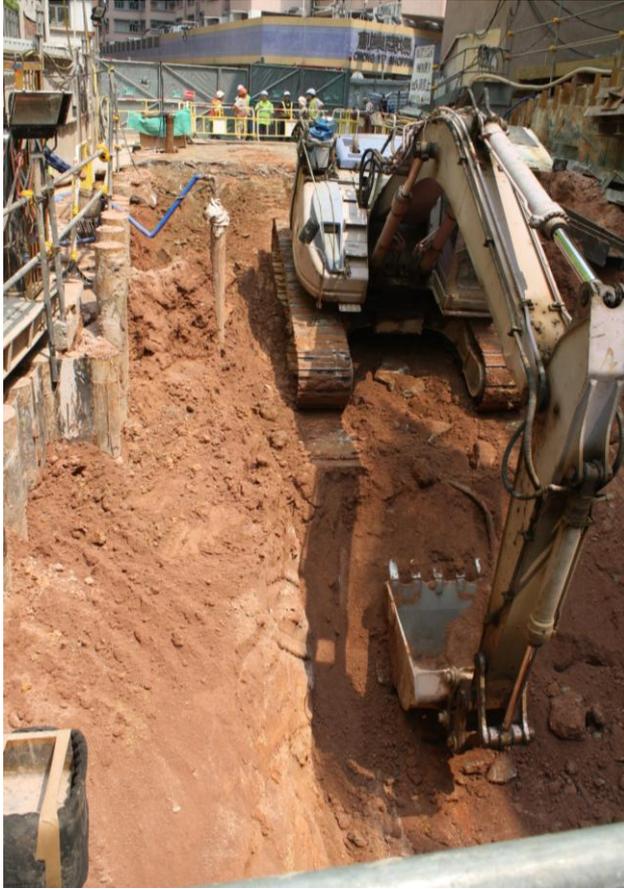
Plate 11.B.15 Photograph showing the area excavated and the deeply weathered red hill slope soils

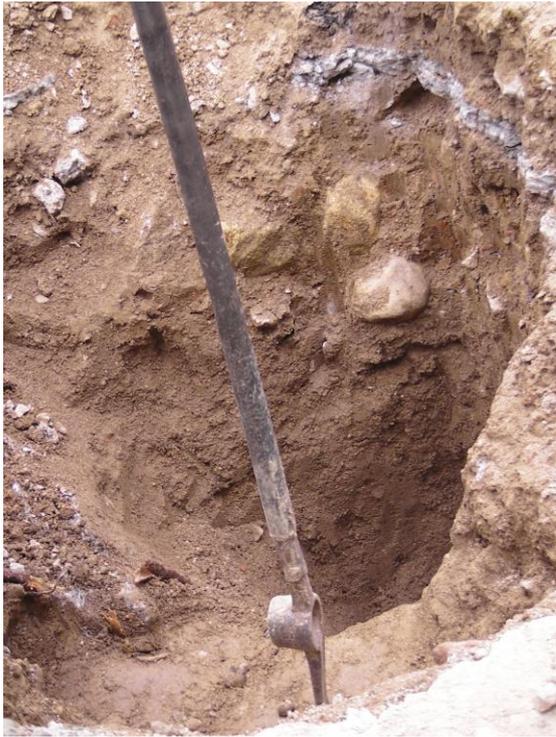
Plate 11.B.17 Small utility test pit excavation viewed at site inspection stage suggesting sterile soils at shallow depths.

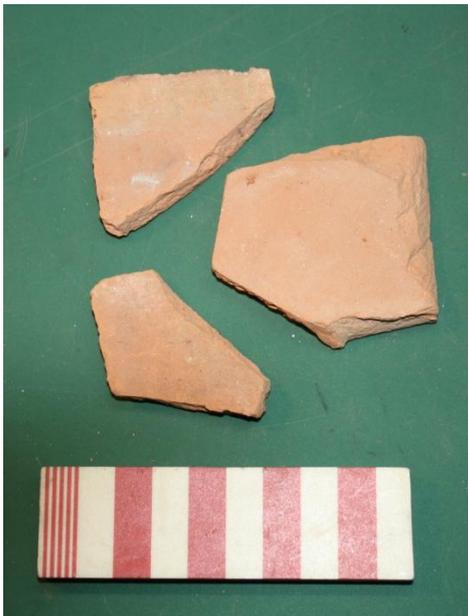
Plate 11.B.21 Photograph showing 3 tile fragments, undiagnostic in date, found within the foundation cut (104) for wall foundation 103.

The foundation trench for the wall [104] cut into pre-existing CDG fill [105] and had an east-west orientation. Apart from three undiagnostic red tile fragments (probably 20th-century in date) (Plate 11.B.21) within the foundation cut no other dateable material was noticed.

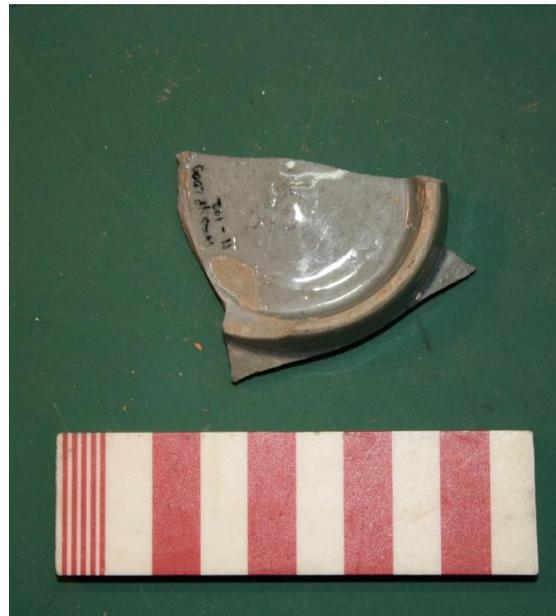
Plate 11.B.22 Photograph showing a provincial porcelain base sherd dated late 19th-century to 20th-century

The continuation of wall foundation **[WF103]** was noted in the Northwest corner of Site M (703) and it extended for some 11m west of where it was first discovered. During removal of hardcore layer **[102]**, which sealed the wall foundation **[WF103]**, a base sherd of late 19th-century to 20th-century provincial porcelain (Plate 11.B.22) was recovered.

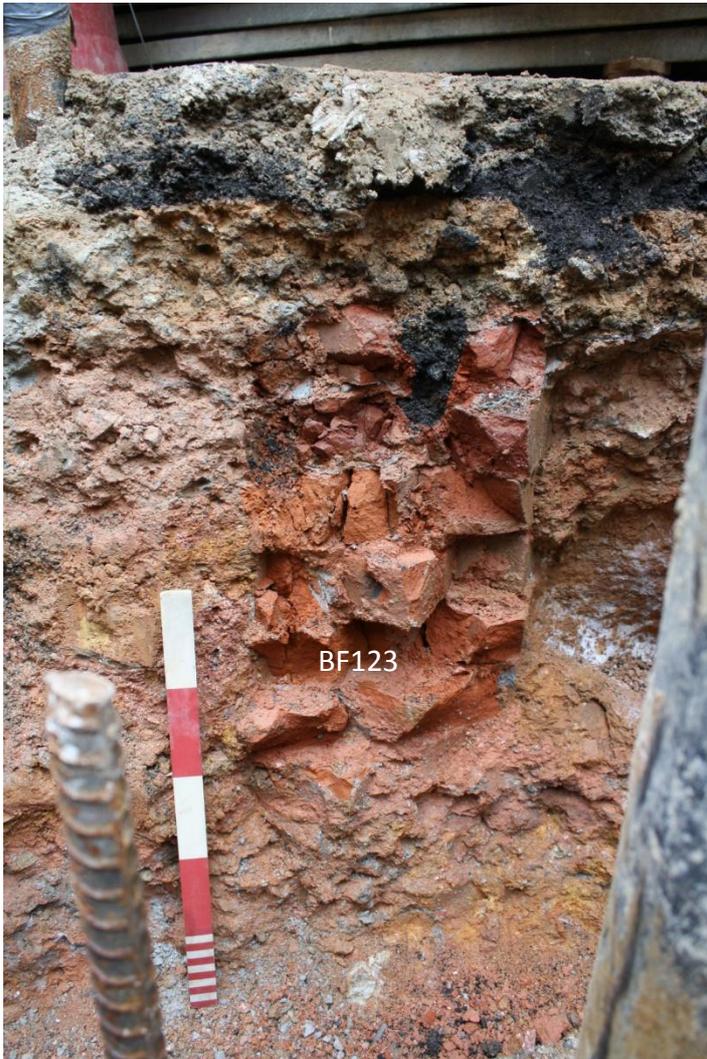
Plate 11.B.32 Photograph showing BF123; view of west facing section

Eastern side of shaft ring-beam groundworks, three sets of structural remains were noted: an E-W orientated red brick foundation (**BF123**), an E-W orientated grey brick foundation (**BF124**), and an N-S orientated granite wall foundation (**WF125**). **BF123** consisted of a patch of red bricks. **BF124** consisted of 4 courses of grey bricks, of which the first one was laid on edge and 3 following ones laid flat. **WF125** had a gravel/mortar layer below the granite blocks (**130**), but within the same cut (**126**).

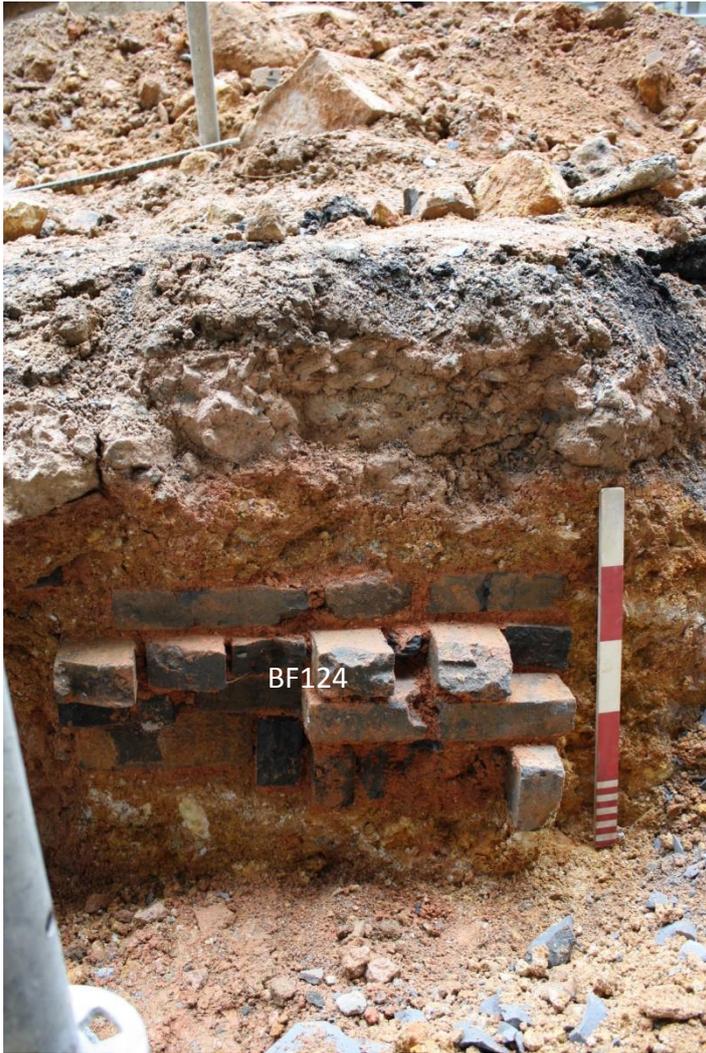
Plate 11.B.33 Photograph showing BF124; view of east facing section

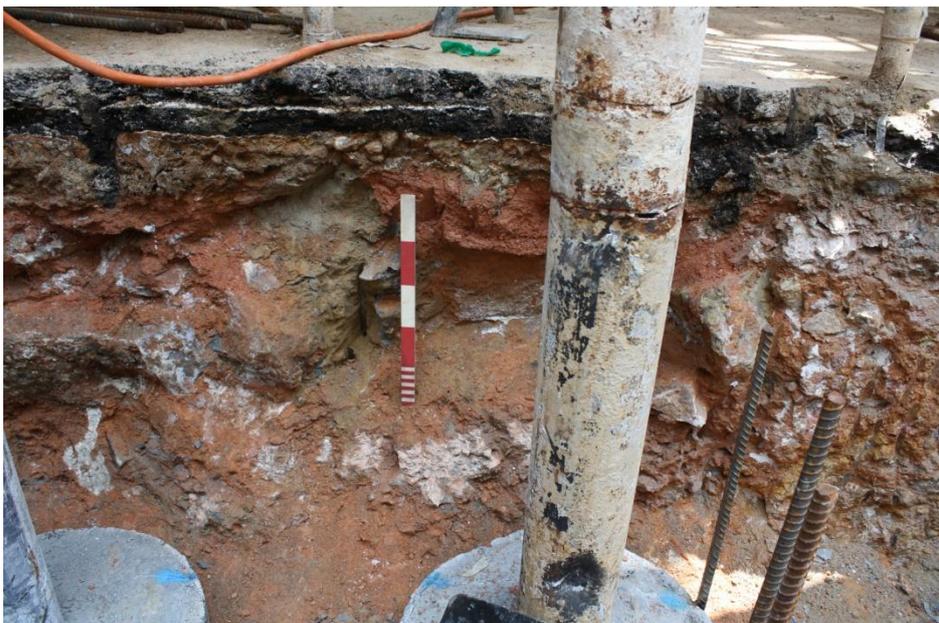
Plate 11.B.34 Photograph showing WF125; view of west facing elevation

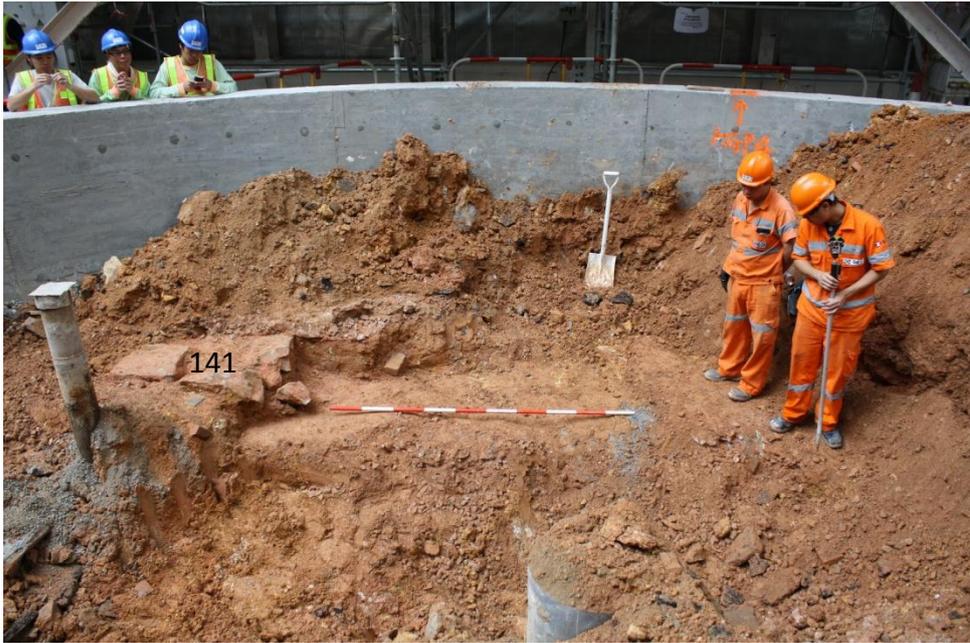
During the first AWB visit, only the north facing elevation of the 5m-long wall foundation [**WF141**] was visible in the southern edge of the ring-beam trench, but it had not yet been fully exposed.

Plate 11.B.35 Photograph of WF 141; view looking east

The remains of a granite wall foundation and brick manhole [**WF141** and **MH142**] were first unearthed in the *Northwest corner* of the spoil basin area. The two lengths of granite wall foundation [**WF141**] were uncovered – one E-W orientated foundation at the western edge of the spoil basin and another 5m-long E-W orientated example, appeared to be the continuation of the one found the previous day. Few artefacts were found in the CDG fill (**140**) surrounding the structures (Plate 12.A.1); the finds consist of Qing to early modern materials. **MH142** is a more recent manhole structure.

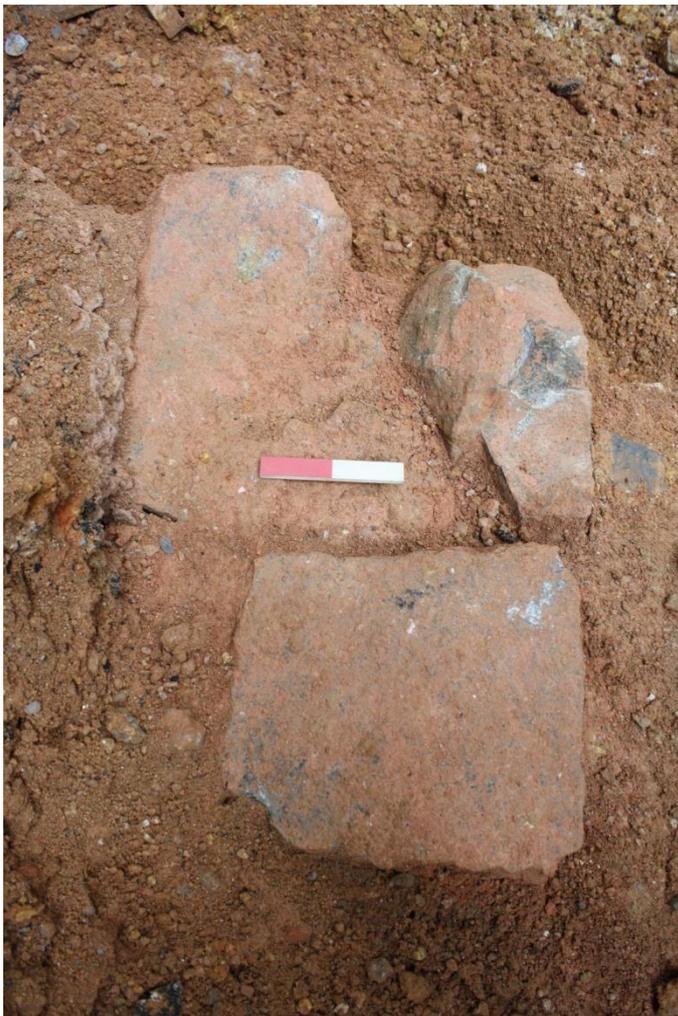
Plate 11.B.36 Photograph of WF 134 in detail; view of plan looking south

A further fragmentary wall foundation (**WF134**) was identified in the NE quadrant of the shaft footprint. The remains of **WF134** had an upper surface level of 37.98m PD – approximately 0.15m below the modern basketball court (BBC) surface, whilst the base level of the foundation trench cut was at 37.30m PD. **WF134** was constructed in a manner similar to previous granite foundations on site, having a mortar/gravel hardcore bed upon which the granite block foundation had then been built. The blocks ranged between 43 by 45 by 18cm and 29 by 30 by 18cm filled in between with smaller stones.

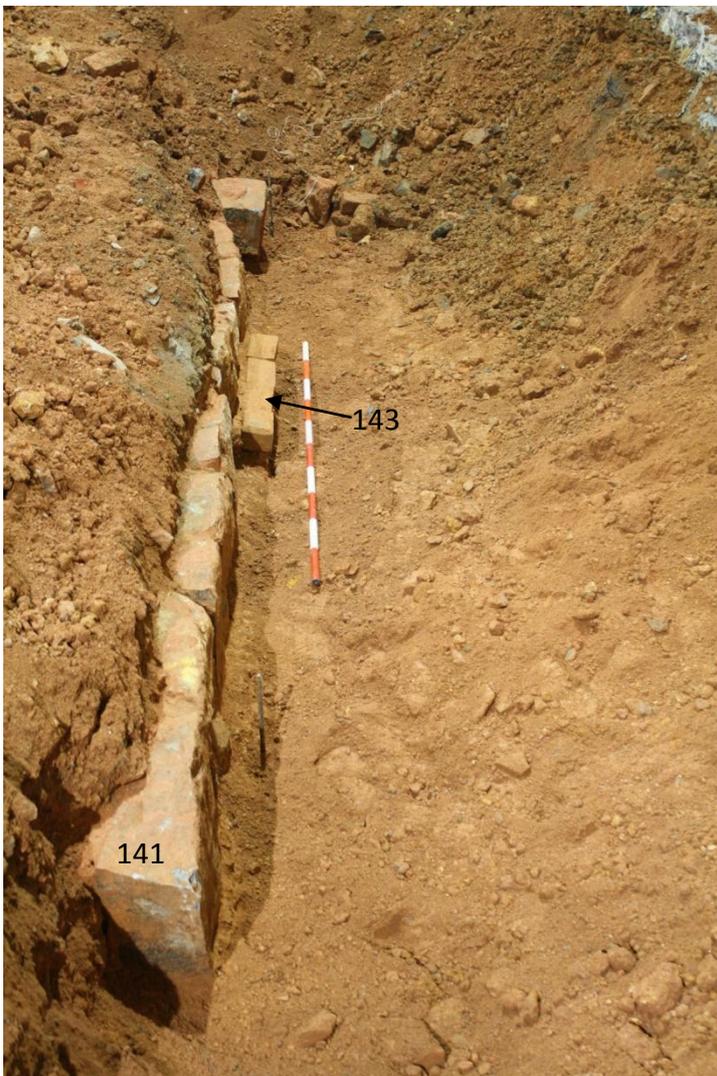
Plate 11.B.40 Photograph of granite wall foundation 141 and the brick foundation 143 along side; view to the west

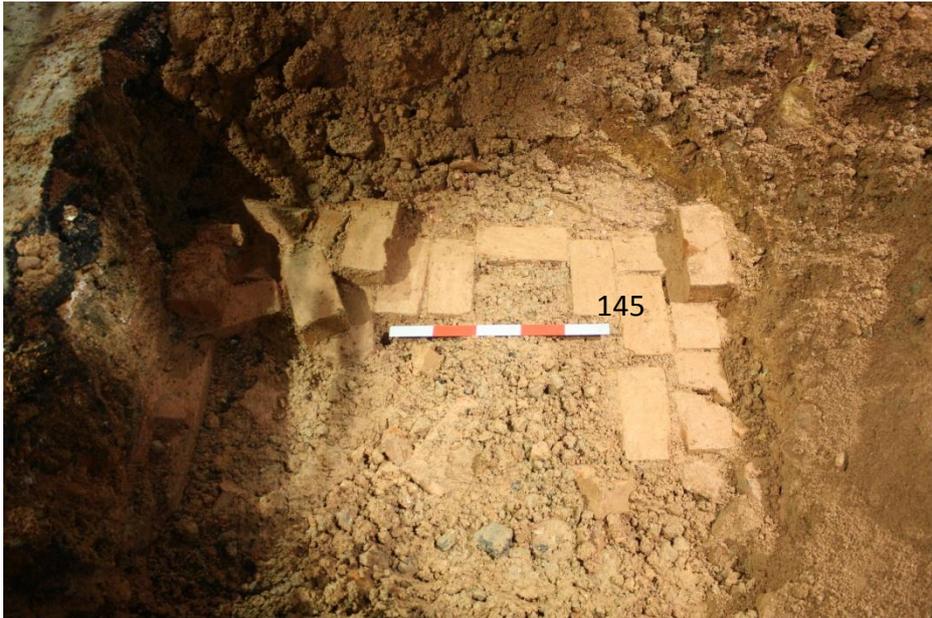
Plate 11.B.41 Photograph of brick foundation 145

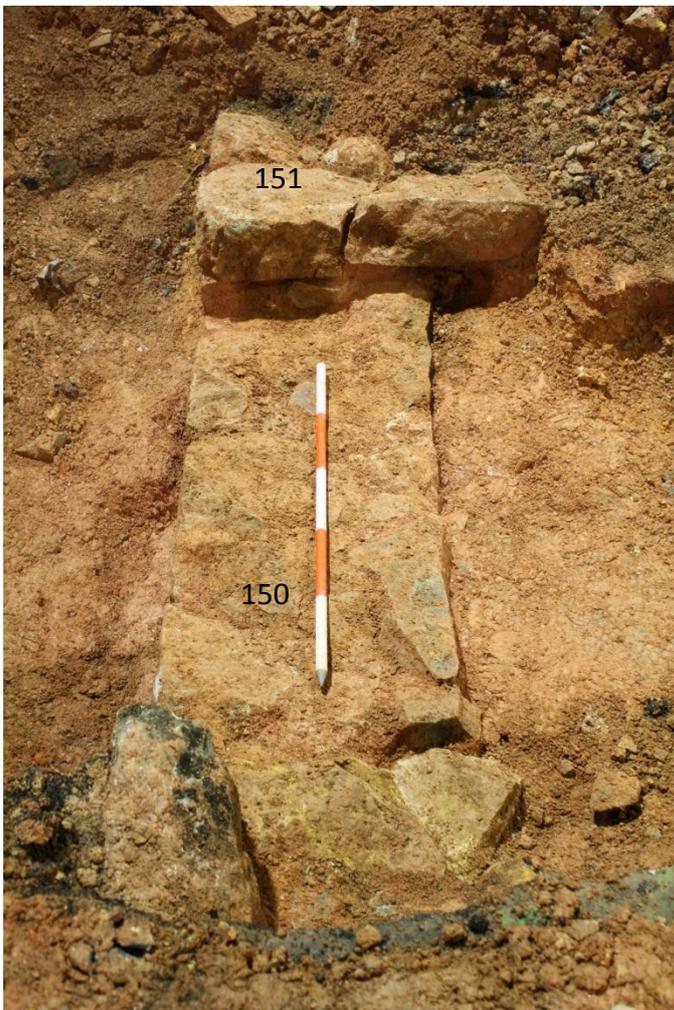
Plate 11.B.42 Photograph shows granite foundation 150 and the upper courses 151

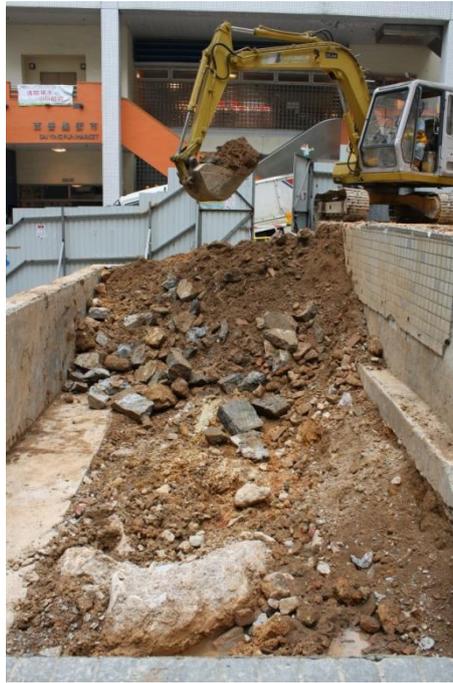
The subsequent AWB works showed that the groundworks for the present development did not extend deeper than the area previously disturbed by the construction of the sitting out area (Plate 11.B.44). The site at formation level thus comprised the remains of the sitting out area's concrete foundations with rubble backfill in-between. No archaeological findings were therefore made.

Plate 11.B.44 Photograph showing the deep sequence of disturbance at Site M2; view looking east

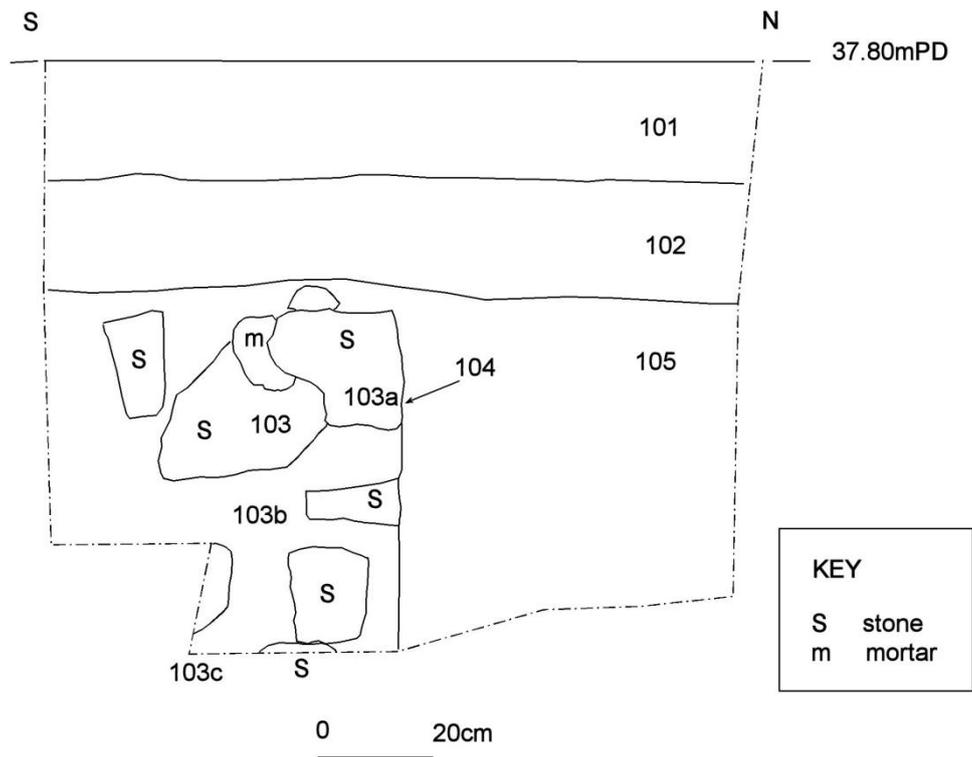
Drawing 1 East facing section of wall foundation 103 and its associated cut 104

In the ***Northeast corner*** of the noise enclosure monitoring indicated below modern surface and a sequence of CDG fill, a wall foundation [WF103] constructed with granite blocks (Drawing 1 and 2). The red bricks measured ca. 0.18 by 0.23 by 0.27m and 0.08 by 0.10 by 0.10m in size. White mortar was noticed in patches but there was no evidence that the foundation had been fully mortared.

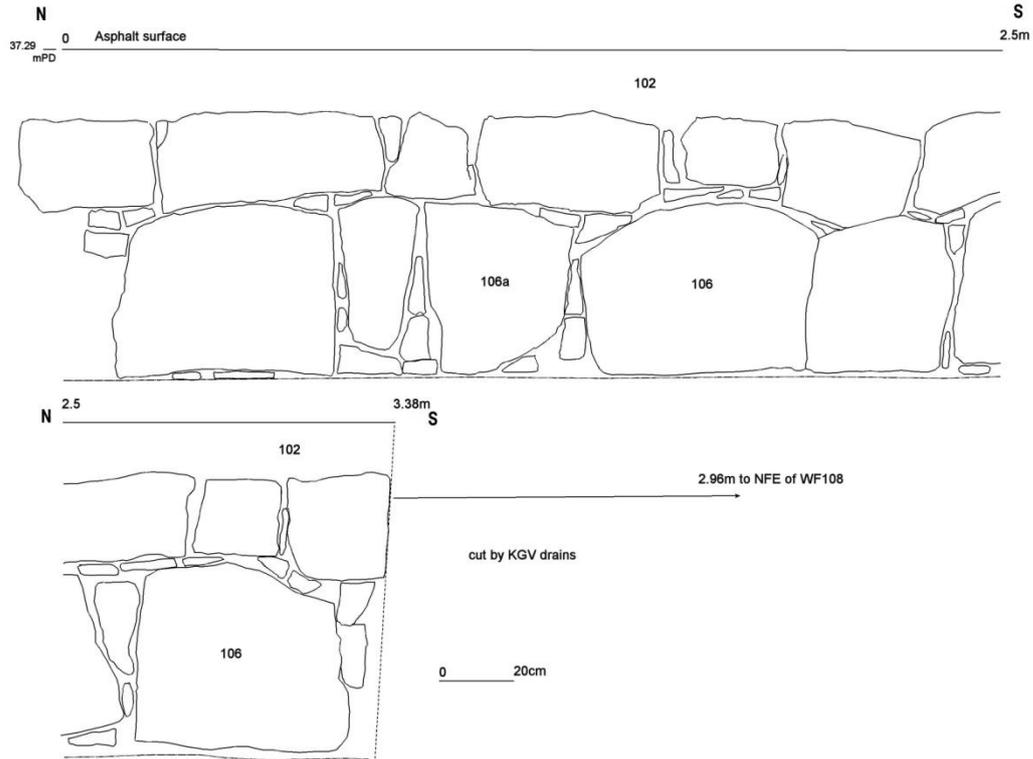
Drawing 3 Drawing shows 3 metres section of granite wall foundation 106 and which continued for approximately another 3m metres

WF106 extended some 6.5m N-S and was 0.65m high at the limit of excavation by 0.63m thick. In **CAP 3** the wall foundation had been cut by a substantial E-W orientated modern drain, but the remains of a further length of wall were visible 2.96m south of **WF106**, in the north facing section of the trench (**WF108**).
