Appendix A

L&V Checklist

Landscape and Visual Impact Assessment Checklist for Site Audit – North Point PTW

Inspection Date: 18 May, 2022
Time: 10:30 am

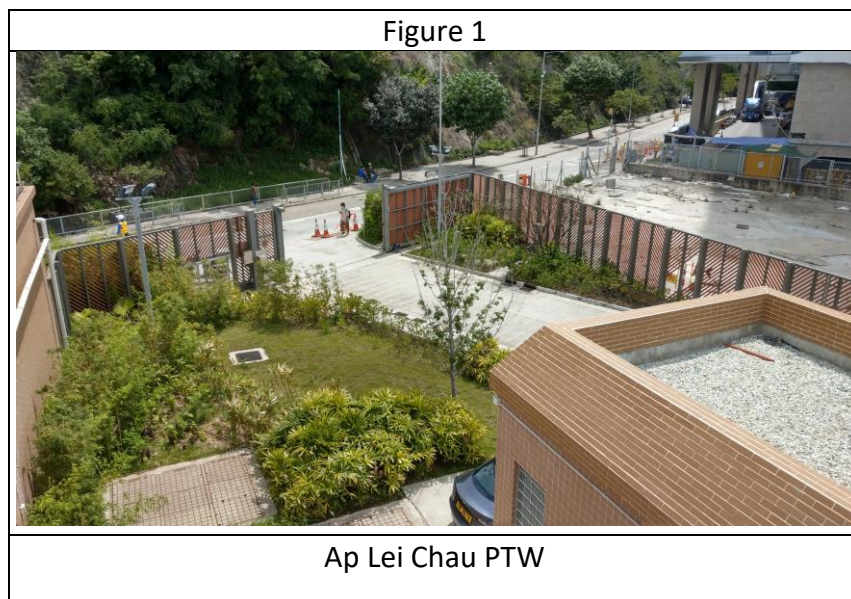
- No visible irregularities were found

- Contractor was reminded to carry out proper maintenance to plantings and recommended to increase the frequency of watering.

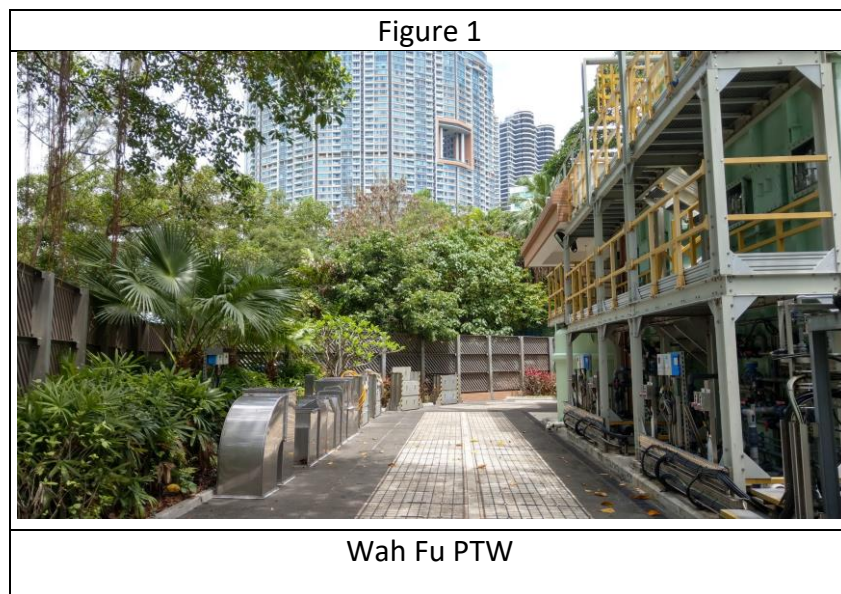
- No visible irregularities were found

- Contractor was reminded to carry out proper maintenance to plantings and recommended to increase the frequency of watering.

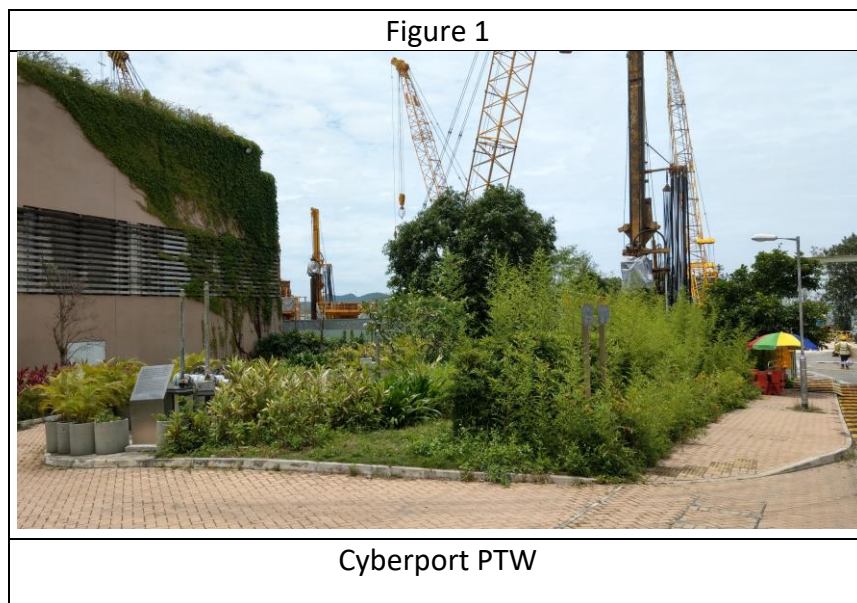
- No visible irregularities were found

- Contractor was reminded to carry out proper maintenance to plantings and increase the frequency of watering. It is also recommended to increase the maintenance of pot plants.

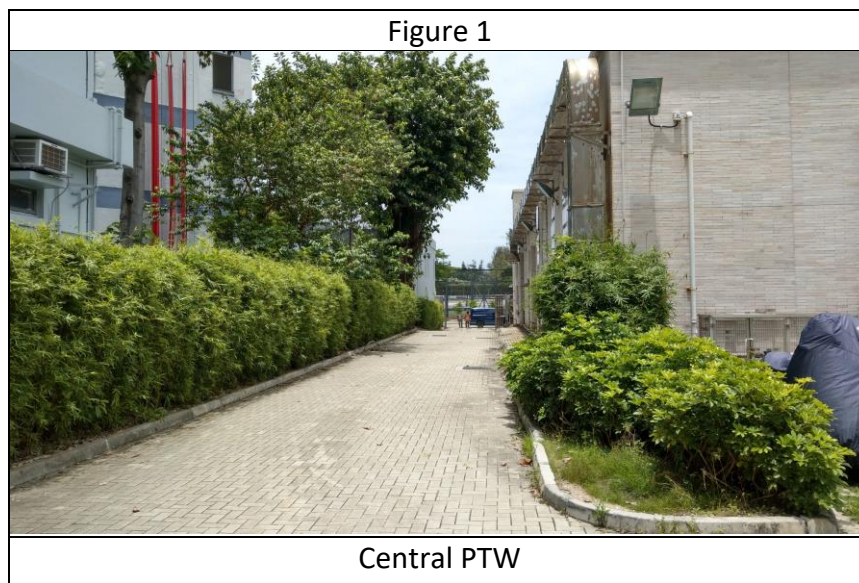
- No visible irregularities were found

- Contractor was reminded to carry out proper maintenance to plantings.

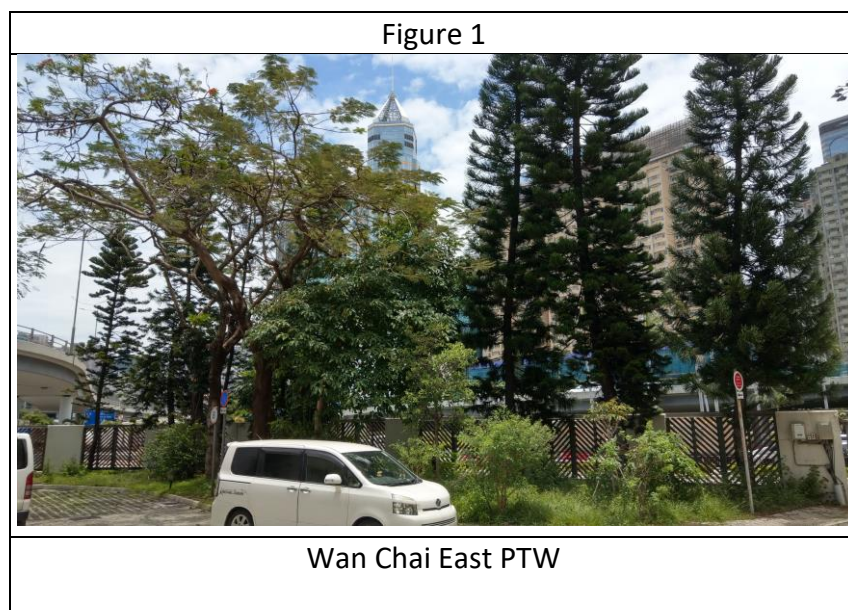
- No visible irregularities were found

- Contractor was reminded to carry out proper maintenance to plantings and recommended to provide adequate protection to trees adjacent to works area.
