Appendix A

L&V Checklist

Landscape and Visual Impact Assessment Checklist for Site Audit – North Point PTW

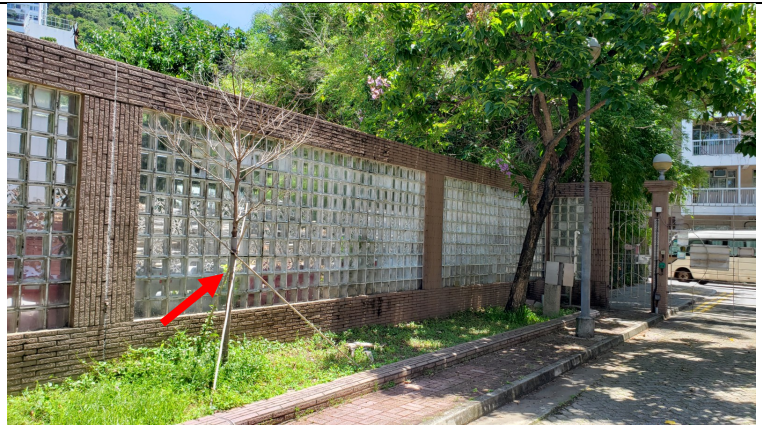
Figure 1	Figure 2

1. The health condition of marked tree (shown in Figure 2) is poor. The Contractor is recommended to carry out remedial action or tree replacement.
