**Landscape and Visual (L&V) Monitoring Report for
Harbour Area Treatment Scheme Stage 2A
(Operational Phase) (July 2022)**

Report No.: OT_2022009

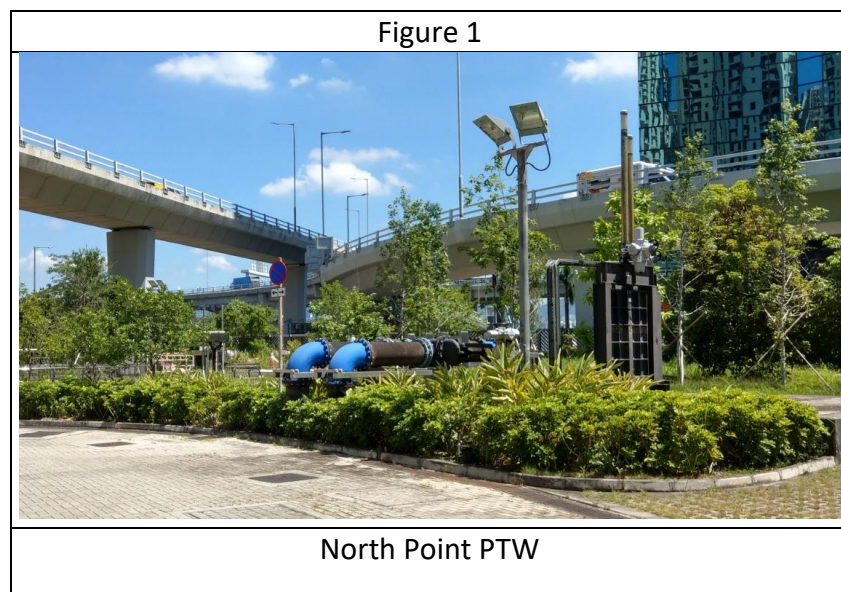
- No visible irregularities were found

- Contractor was reminded to carry out proper maintenance to plantings and was recommended to further increase the frequency of watering in the period of extreme hot weather.

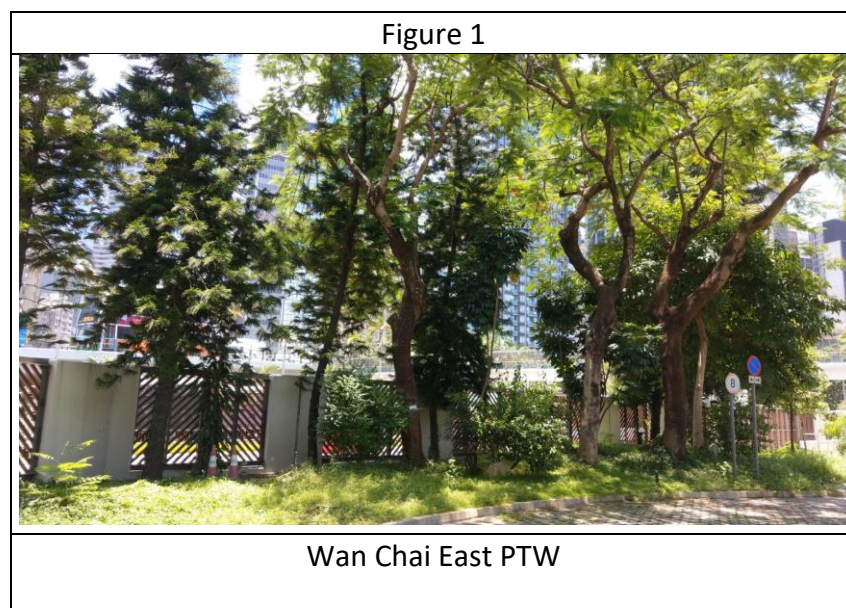
- No visible irregularities were found

- Contractor was reminded to carry out proper maintenance to plantings and recommended to further increase the frequency of watering in the period of extreme hot weather.

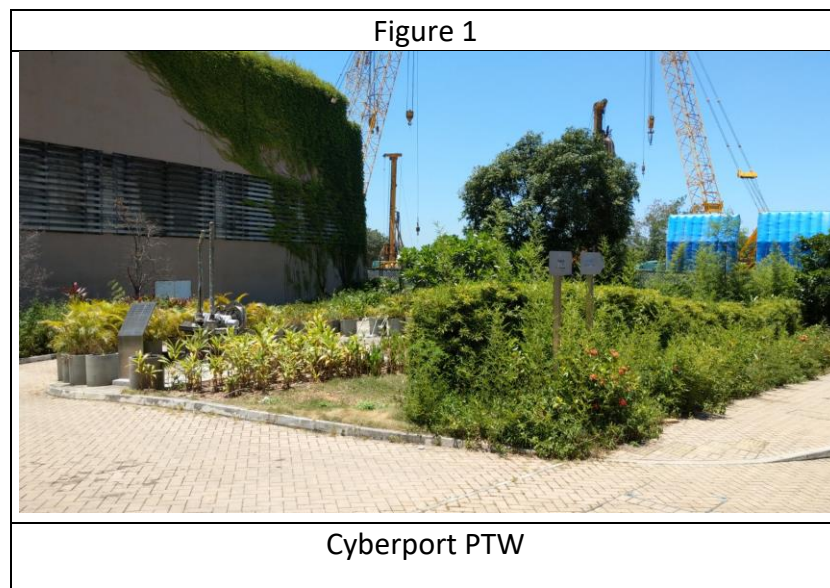
- No visible irregularities were found

- Contractor was recommended further increase the frequency of watering in the period of extreme hot weather.
- It is recommended to increase the maintenance of pot plants.
