Landscape and Visual (L&V) Monitoring Report for Harbour Area Treatment Scheme Stage 2A (Operational Phase) (December 2022)

Report No.: OT_2022016

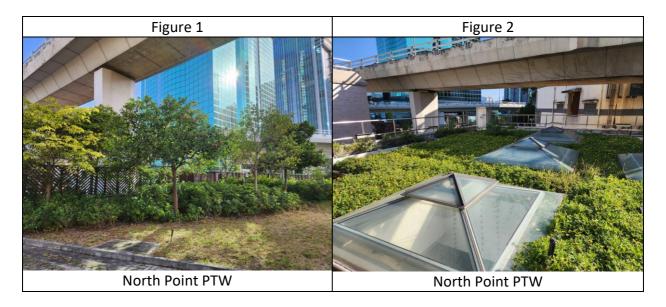
Photo Record:

1. Contractor was reminded to carry out proper maintenance to plantings and recommended to further increase the frequency of watering in the period of dry weather.

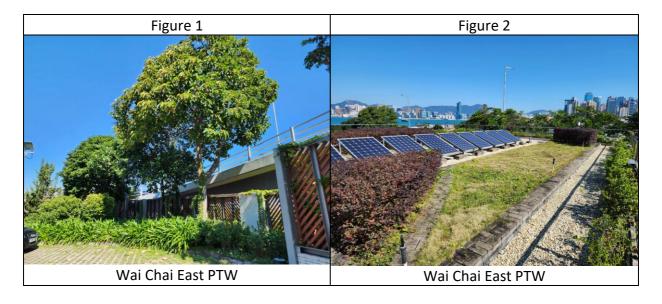
Photo Record:

1. Contractor was reminded to carry out proper maintenance to plantings and recommended to further increase the frequency of watering in the period of dry weather.

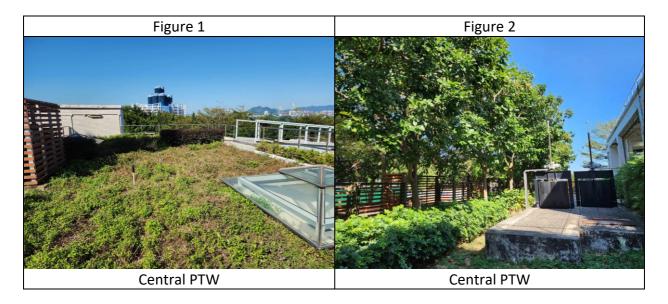
Photo Record:

1. Contractor was reminded to keep maintenance and recommended to further increase the frequency of watering in the period of dry weather.

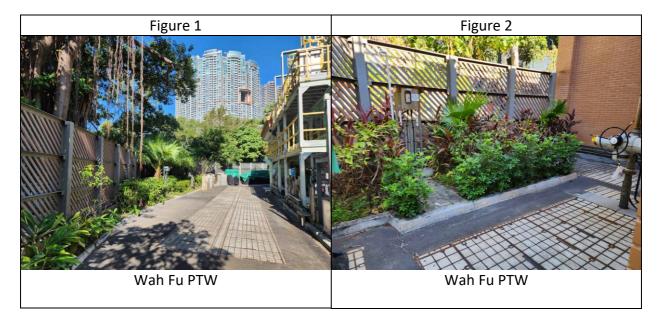
Photo Record:

1. Contractor was reminded to carry out proper maintenance to plantings and recommended to further increase the frequency of watering in the period of dry weather.

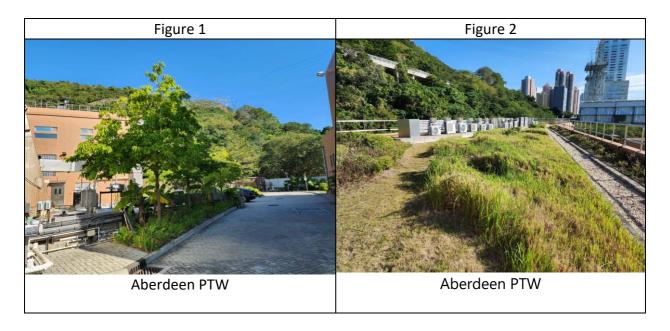
Photo Record:

1. Contractor was reminded to carry out proper maintenance to plantings and recommended to further increase the frequency of watering in the period of dry weather.
