Contract No. HY/2011/03

**Hong Kong-Zhuhai-Macao Bridge Hong Kong Link Road
Section between Scenic Hill and Hong Kong Boundary Crossing
Facilities**

Monthly EM&A Report No.111 (December 2021)

14 January 2022

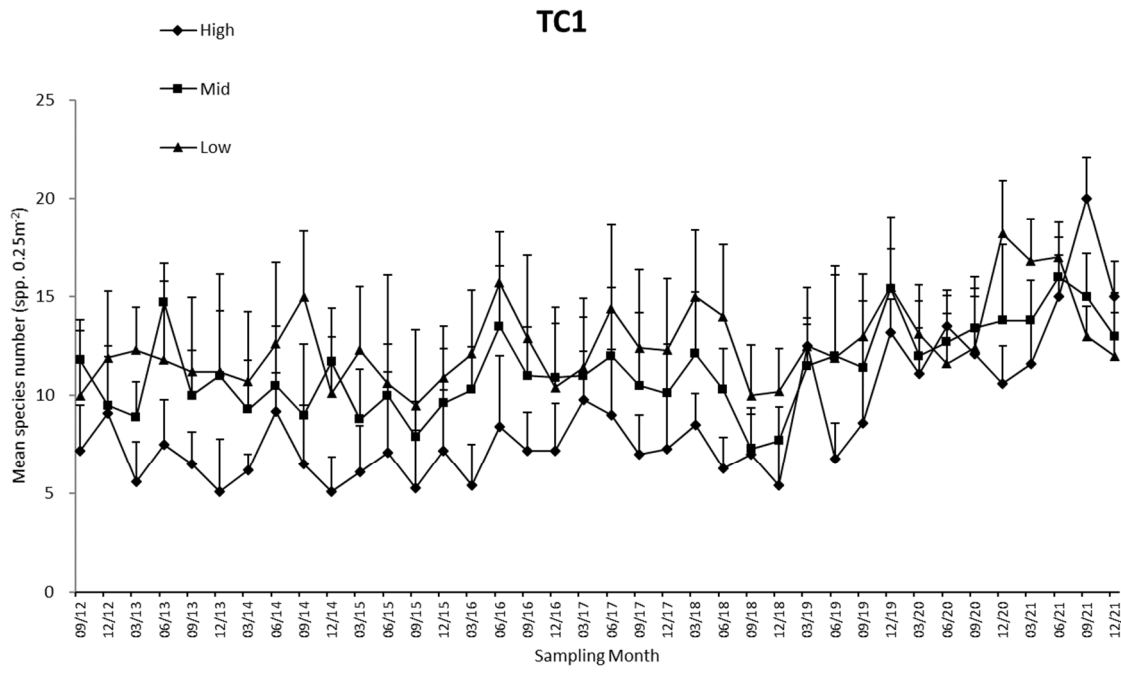
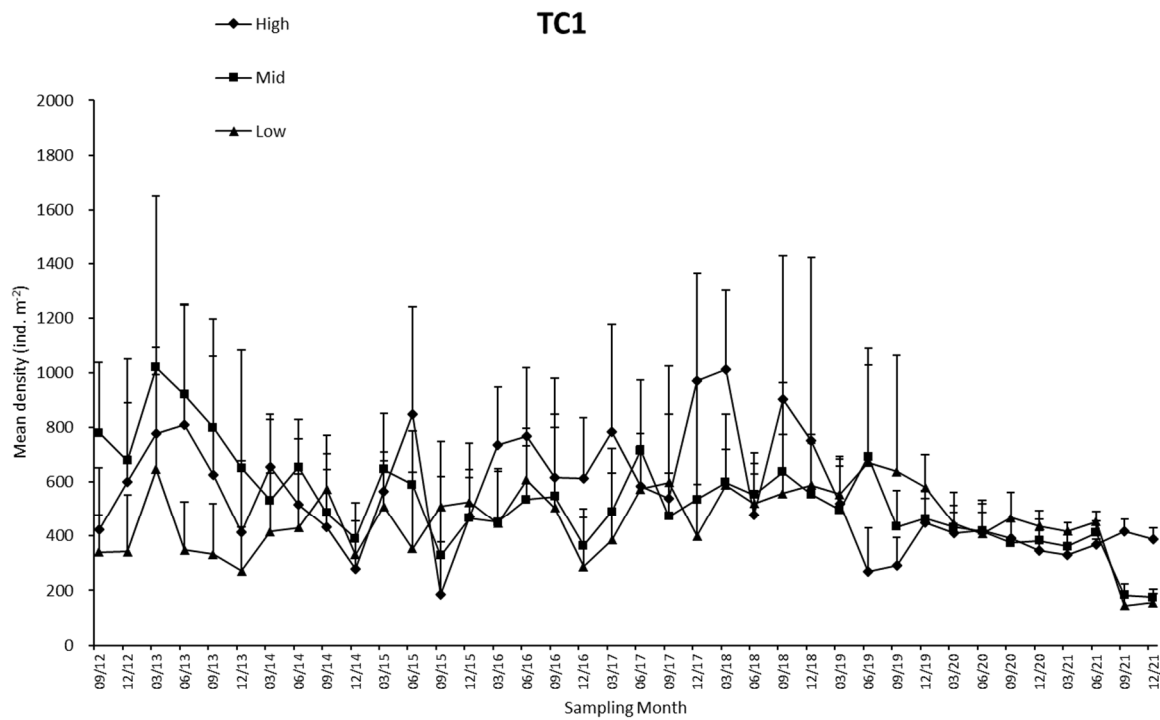
Figure 3.14 Temporal changes of mean number of species, mean density, Shannon-Weaver Diversity Index (H') and Pielou's Species Evenness (J) (mean + SD) at every tidal level in sampling zone TC1

- 6.5.56 In the present survey, no clear trend of mean species number, mean density, H' and J observed among the tidal level.
- 6.5.57 **Figures 3.14 to 3.17 of Appendix I** show the temporal changes of mean species number, mean density, H' and J at every tidal level and in every sampling zone along the sampling months. In general, all the biological parameters fluctuated seasonally throughout the monitoring period. Lower mean species number and density were recorded in dry season (December) but the mean H' and J fluctuated within a limited range.

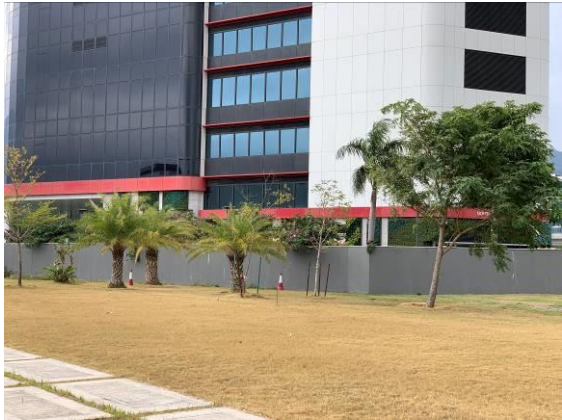
<p data-bbox="365 746 819 778">Photo F1 – Proper maintenance was provided.</p>

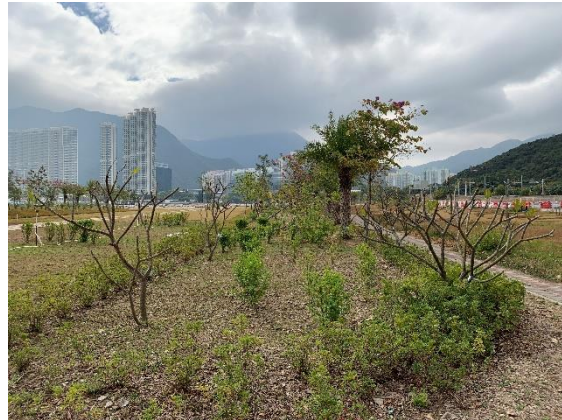
<p data-bbox="947 746 1402 778">Photo F2 – Proper maintenance was provided.</p>	
TD / Others – Next to HMA Admiration Building

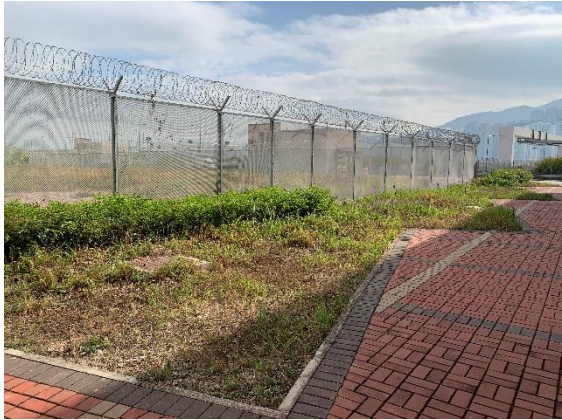
<p data-bbox="365 1225 925 1279">Photo F3 - The weeds were removed and maintenance is in progress.</p>
