Contract No. HY/2013/01
Hong Kong – Zhuhai – Macao Bridge
Hong Kong Boundary Crossing Facilities – Passenger Clearance Building
Certification of Quarterly EM&A Report No. 16

**Contract No. HY/2013/01
HZMB HKBCF – Passenger Clearance Building
Quarterly EM&A Report No. 16 for June 2018 to August 2018**

Contract No. HY/2013/01

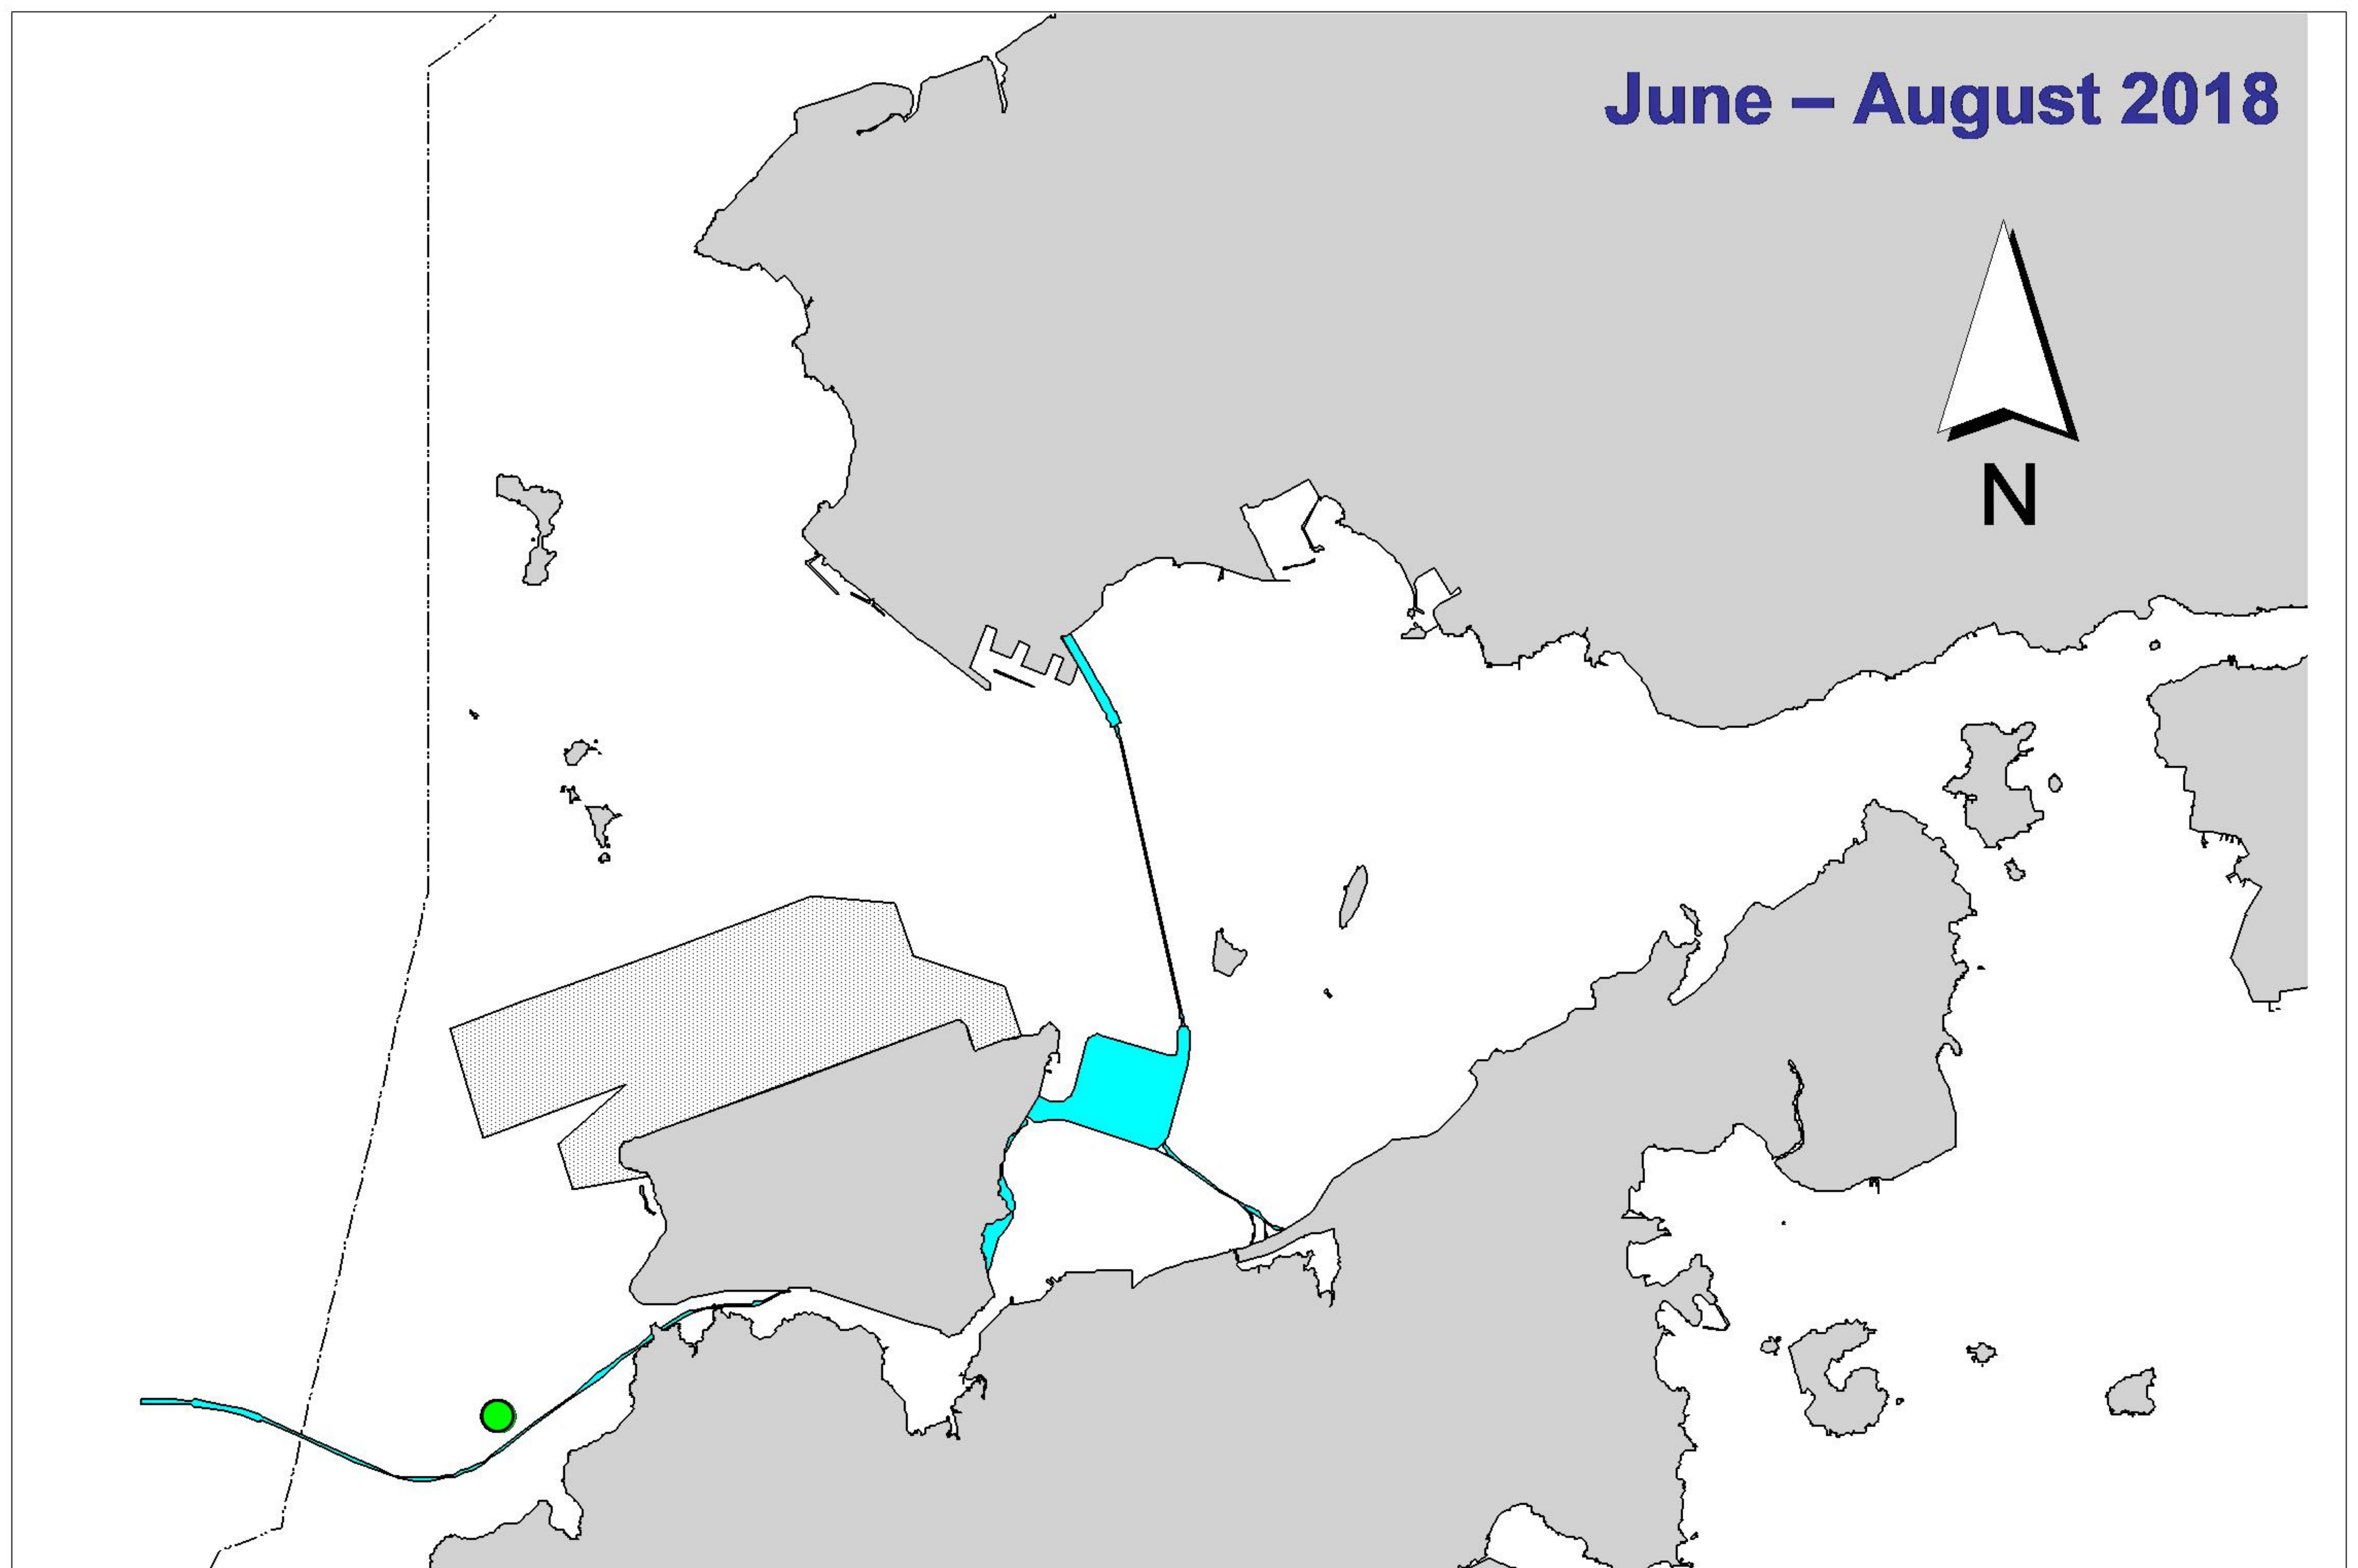
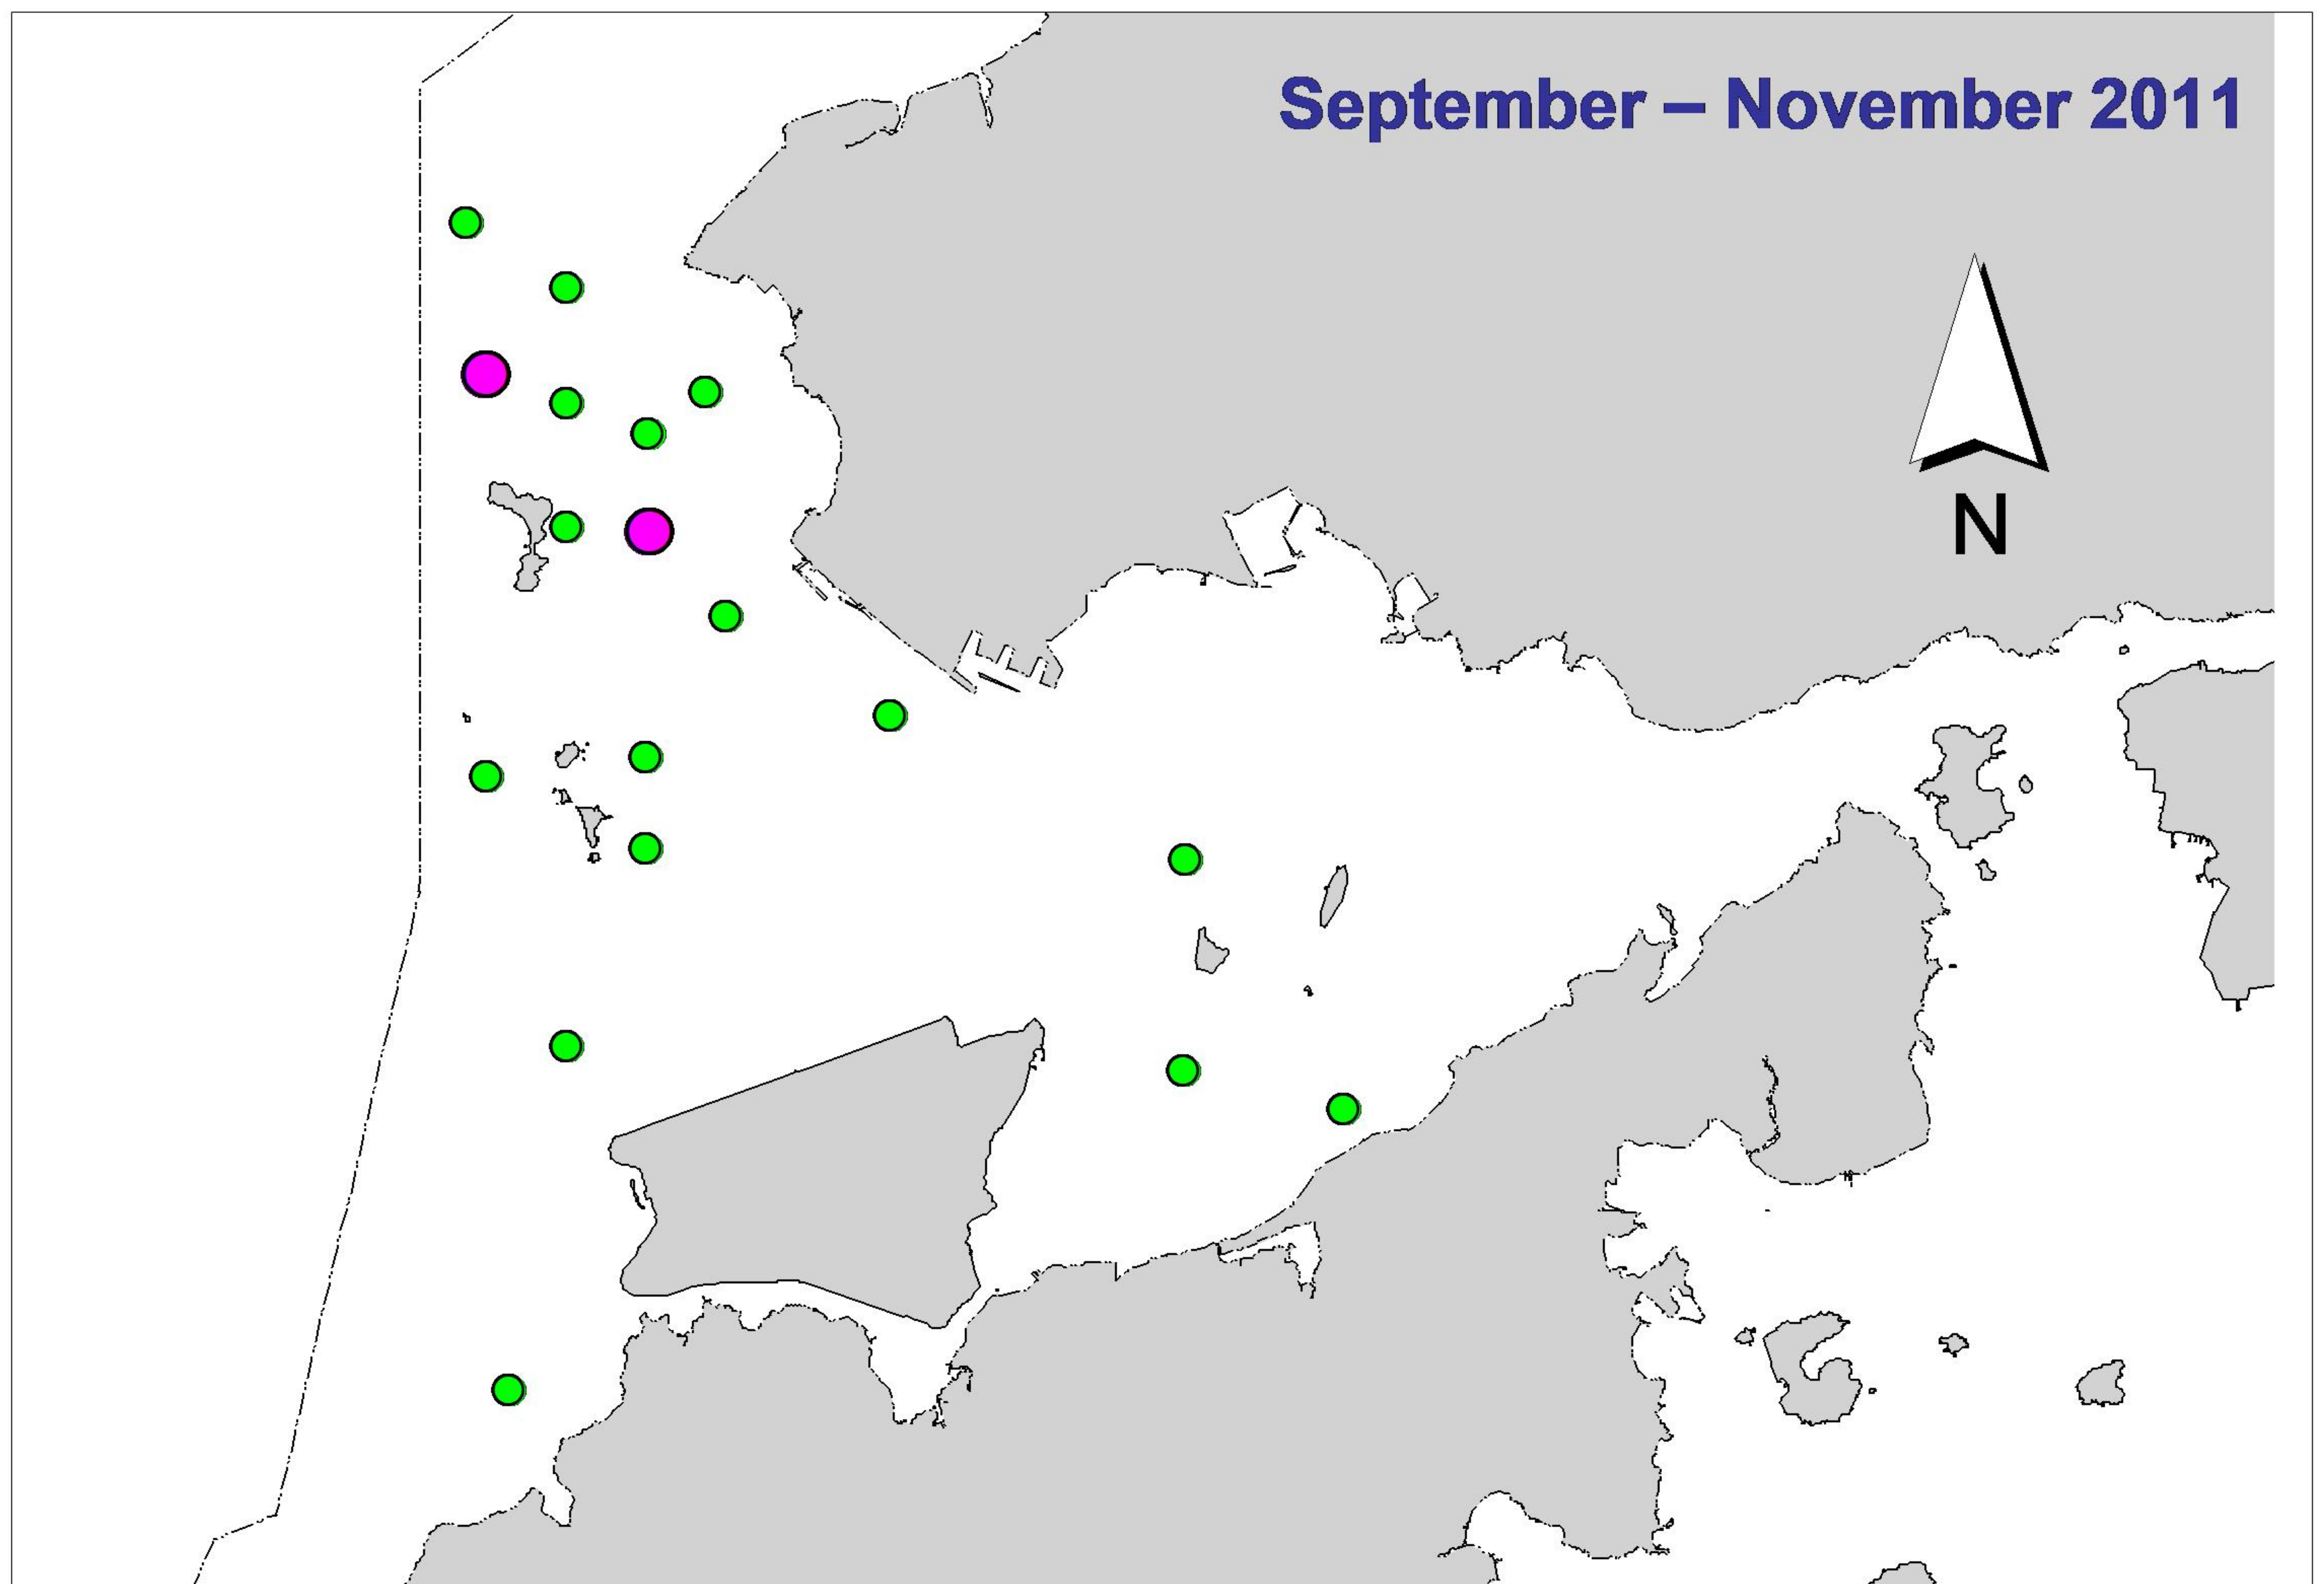
Figure 2. Distribution of Chinese white dolphins with larger group sizes during HKBCF impact phase (top) and baseline monitoring surveys (bottom) (green dots: group sizes of 5 or more; purple dots: group sizes of 10 or more)

3.4.4. This larger group with five animals was sighted near the HKLR09 alignment at the southwest corner of NWL survey area (Figure 2). This is in contrary to the baseline period, when the larger dolphin groups (5 animals or more per group) were frequently sighted and evenly distributed in NWL waters, with a few also sighted in NEL waters.

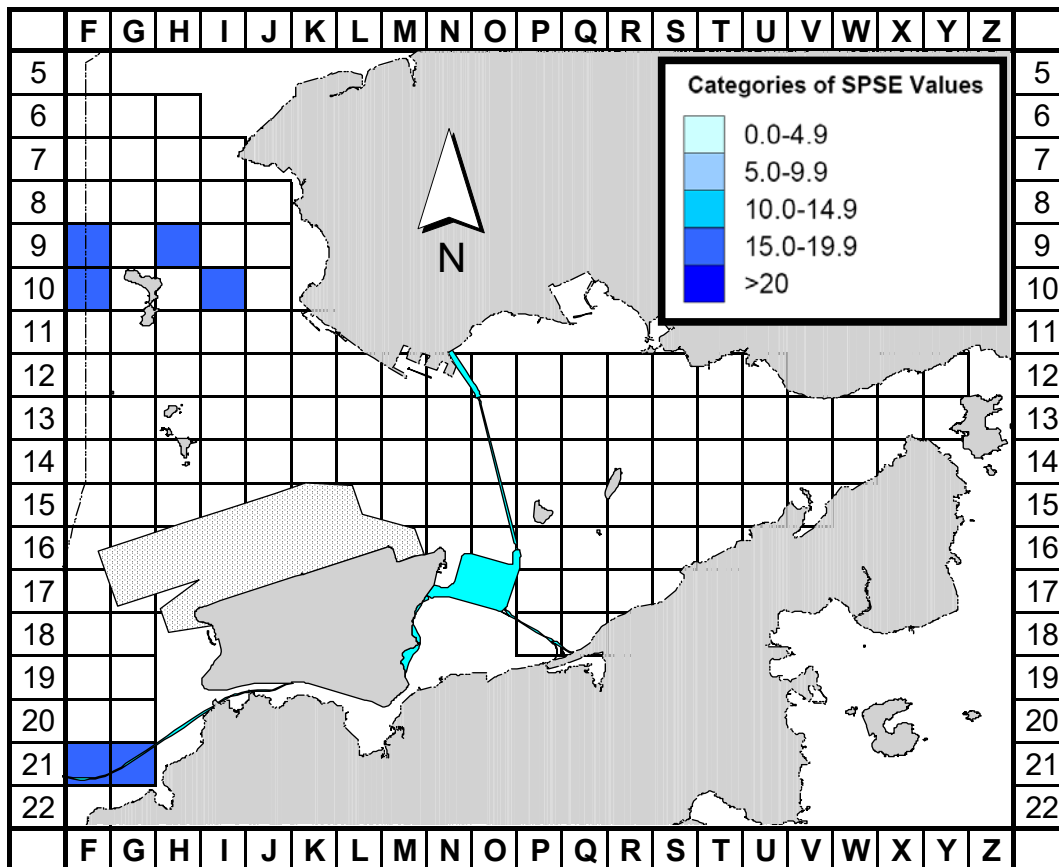
Figure 3a. Sighting density of Chinese white dolphins with corrected survey effort per km² in Northeast and Northwest Lantau survey areas, using data collected during HKBCF impact monitoring period (June-August 18) (SPSE = no. of on-effort sightings per 100 units of survey effort)

3.4.31 From June to August 2018, only six grids recorded dolphin presence during on-effort search in North Lantau waters. Moreover, just two of the six grids recorded moderate to moderately high dolphin densities, and both grids overlapped with the HKLR09 alignment at the southwest corner of NWL waters (**Figures 3a and 3b of Appendix L**).

3.5.1. From June to August 2018, only six grids recorded dolphin presence during on-effort search in North Lantau waters. Moreover, just two of the six grids recorded moderate to moderately high dolphin densities, and both grids overlapped with the HKLR09 alignment at the southwest corner of NWL waters (Figures 3a and 3b). The four grids near Lung Kwu Chau only recorded low to very low dolphin densities.

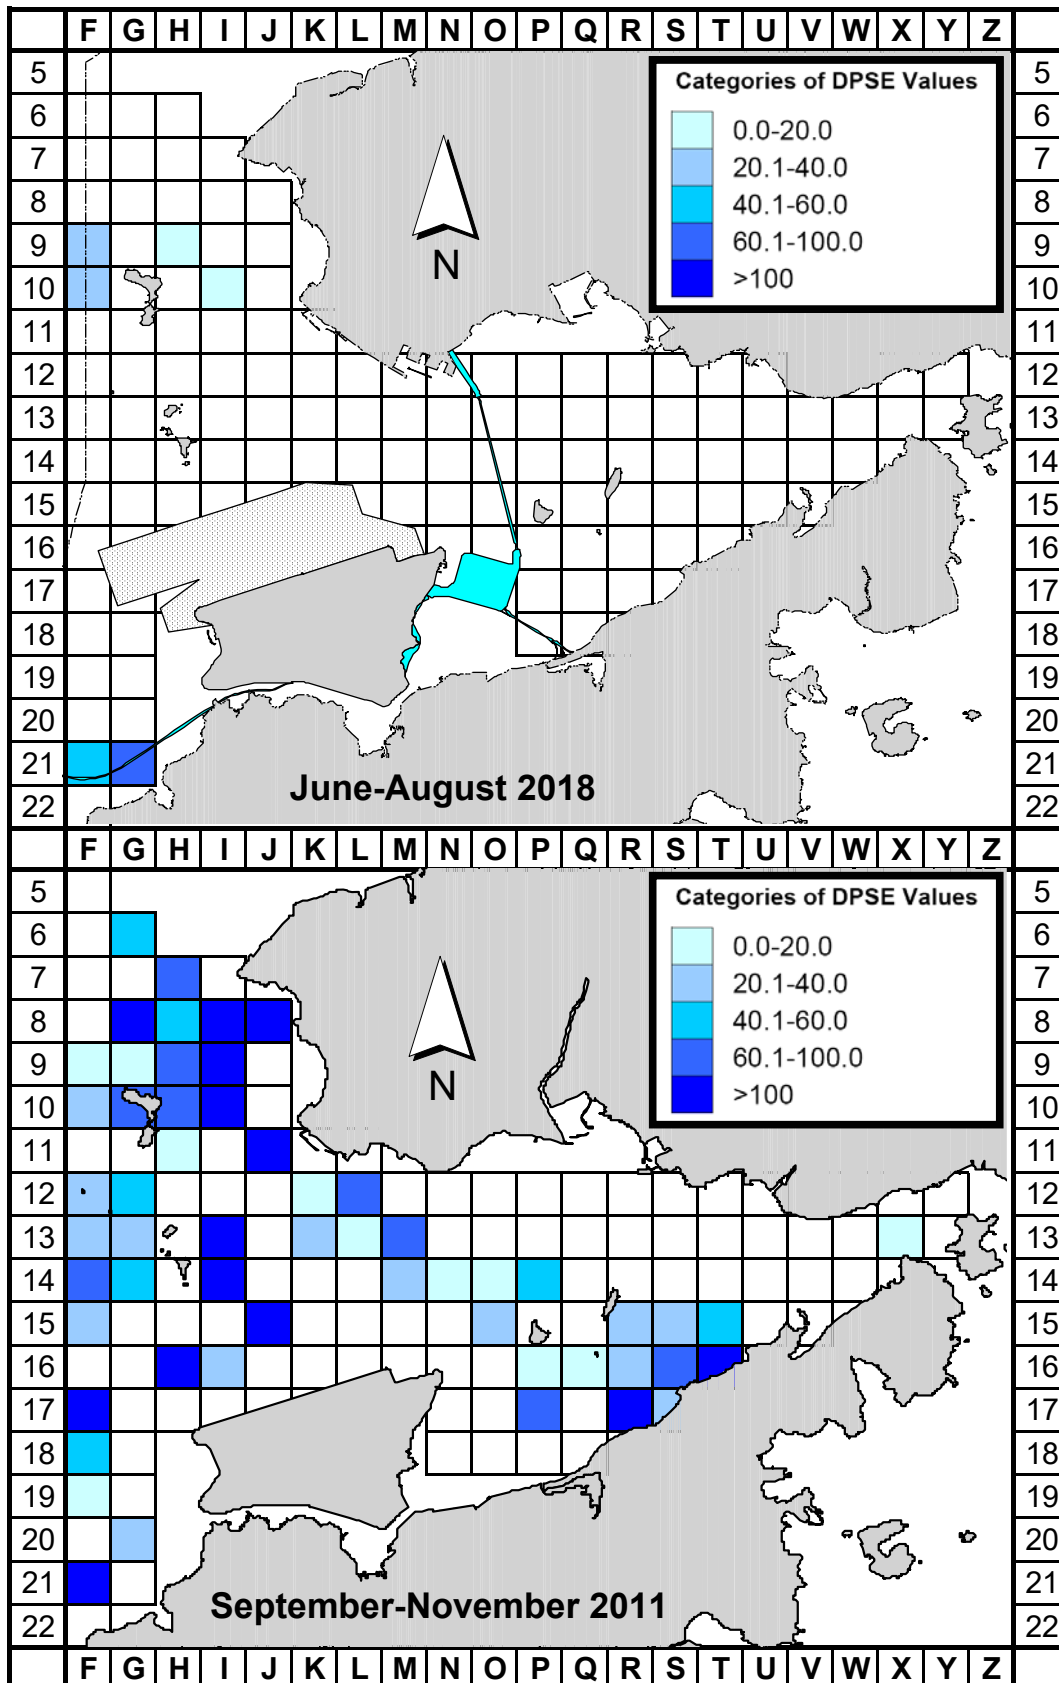
- 3.5.3. When compared with the habitat use patterns during the baseline period, dolphin usage in NEL and NWL has drastically diminished in both areas during the present impact monitoring period (Figure 4). During the baseline period, many grids between Siu Mo To and Shum Shui Kok in NEL recorded moderately high to high dolphin densities, which was in stark contrast to the complete absence of dolphins there during the present impact phase period (Figure 4).

- 3.5.4. The density patterns were also very different in NWL between the baseline and impact phase monitoring periods, with high dolphin usage throughout the area during the baseline period. In contrast, only two grids with moderate to moderately high dolphin densities were located at the southwest corner of NWL waters near Shum Wat during the present impact phase period (Figure 4).
