Central Police Station Conservation
and Revitalisation Project:
5th Annual EM&A Review Report
(1 November 2015 to 31 October
2016)

Issue Date: May 2017

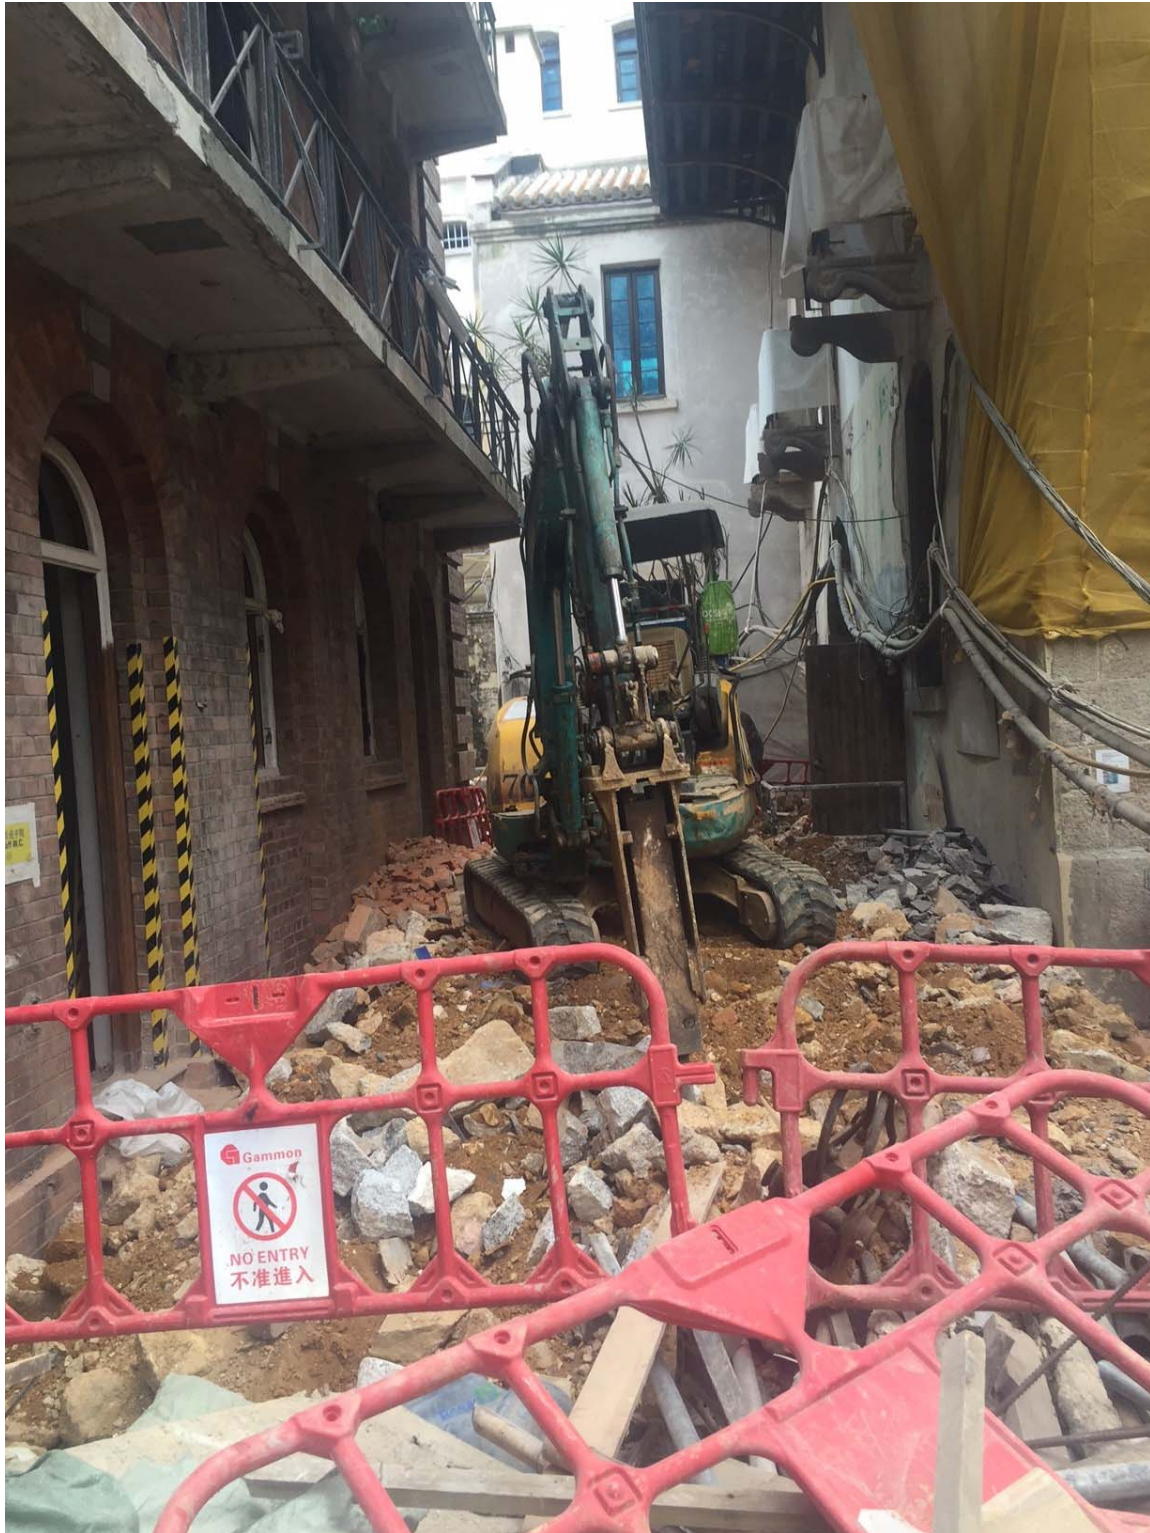
Above, photo taken on 5th November 2015, showing site works on the Magistracy Terrace (West). No protection was provided to the granite steps nor the masonry walls.

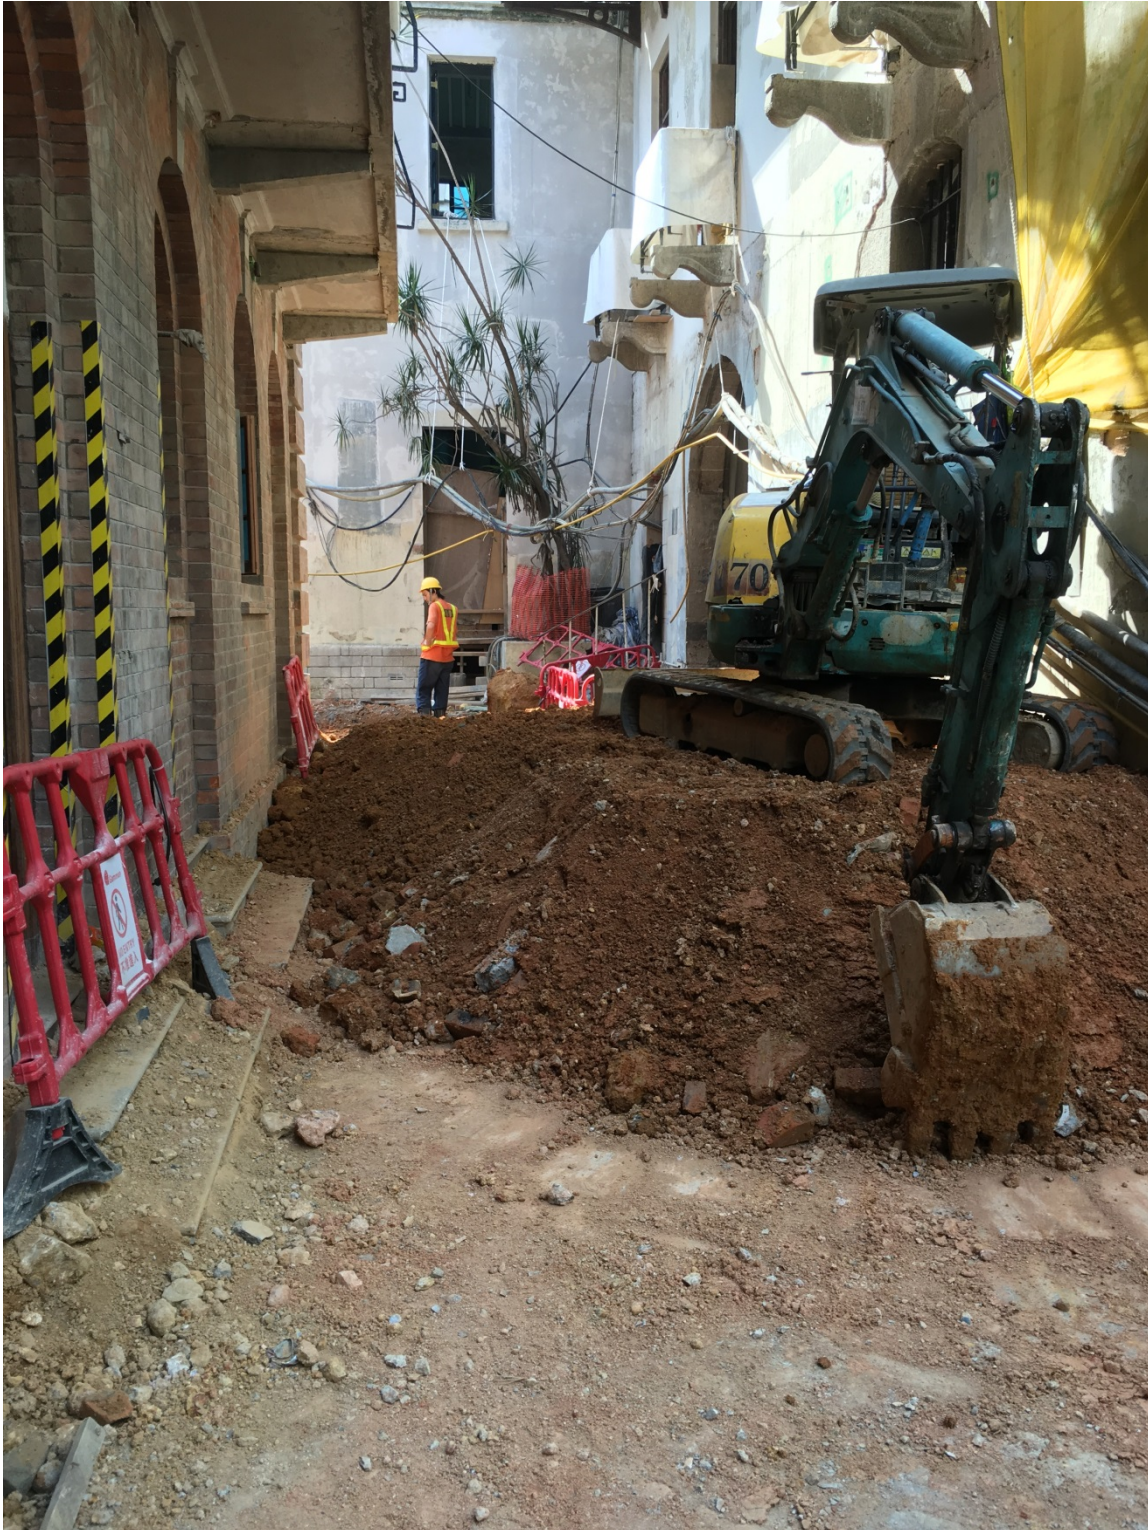
Above, photo taken on 23rd November 2015, no improvement had been made to protect the surrounded building fabric.

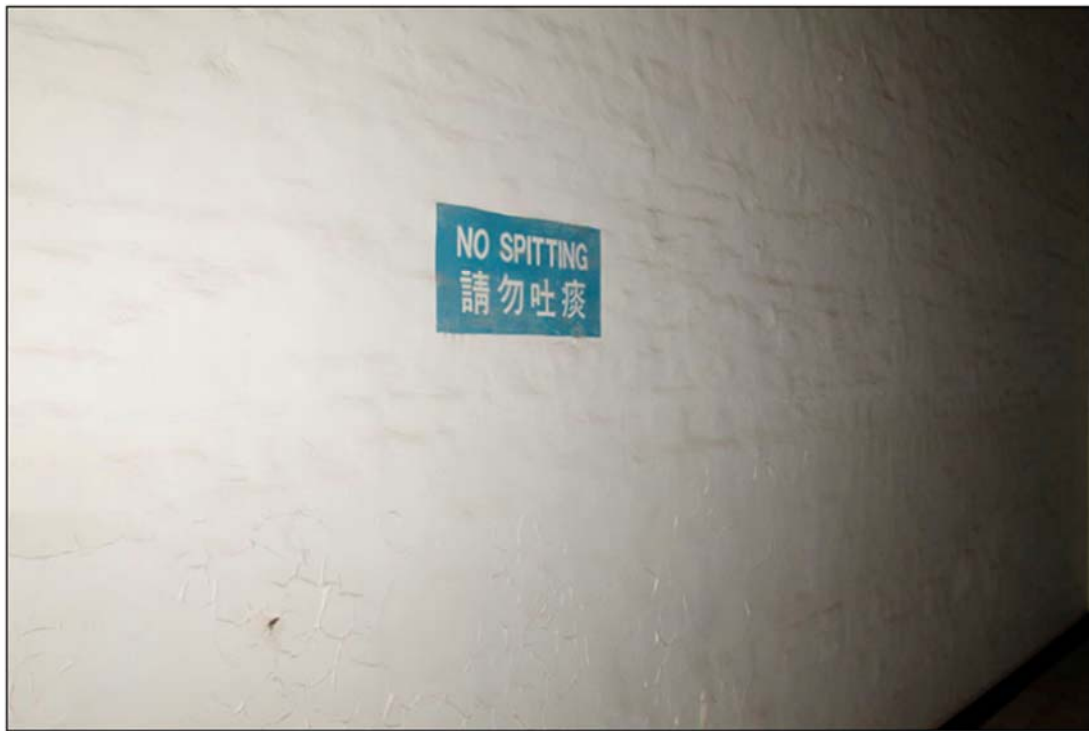
Photo 03-2F-230 General view of the wall (21-3-2012)

Above, photograph dated 21st March 2012, showing the “NO SPITTING 請勿吐痰” painted sign.

- a) Thorough check had been carried out for the protection to other existing painted signs;
- b) Briefing to Works Contractors' workers and the Management Contractor's frontline staff was conducted on 3-Feb
- c) The revised setting out of the sockets to be agreed with Purcell and JRP
- d) Relocate the conduits according to the revised setting out
- e) Repair to the damaged painted sign (method statement to be submitted separately)

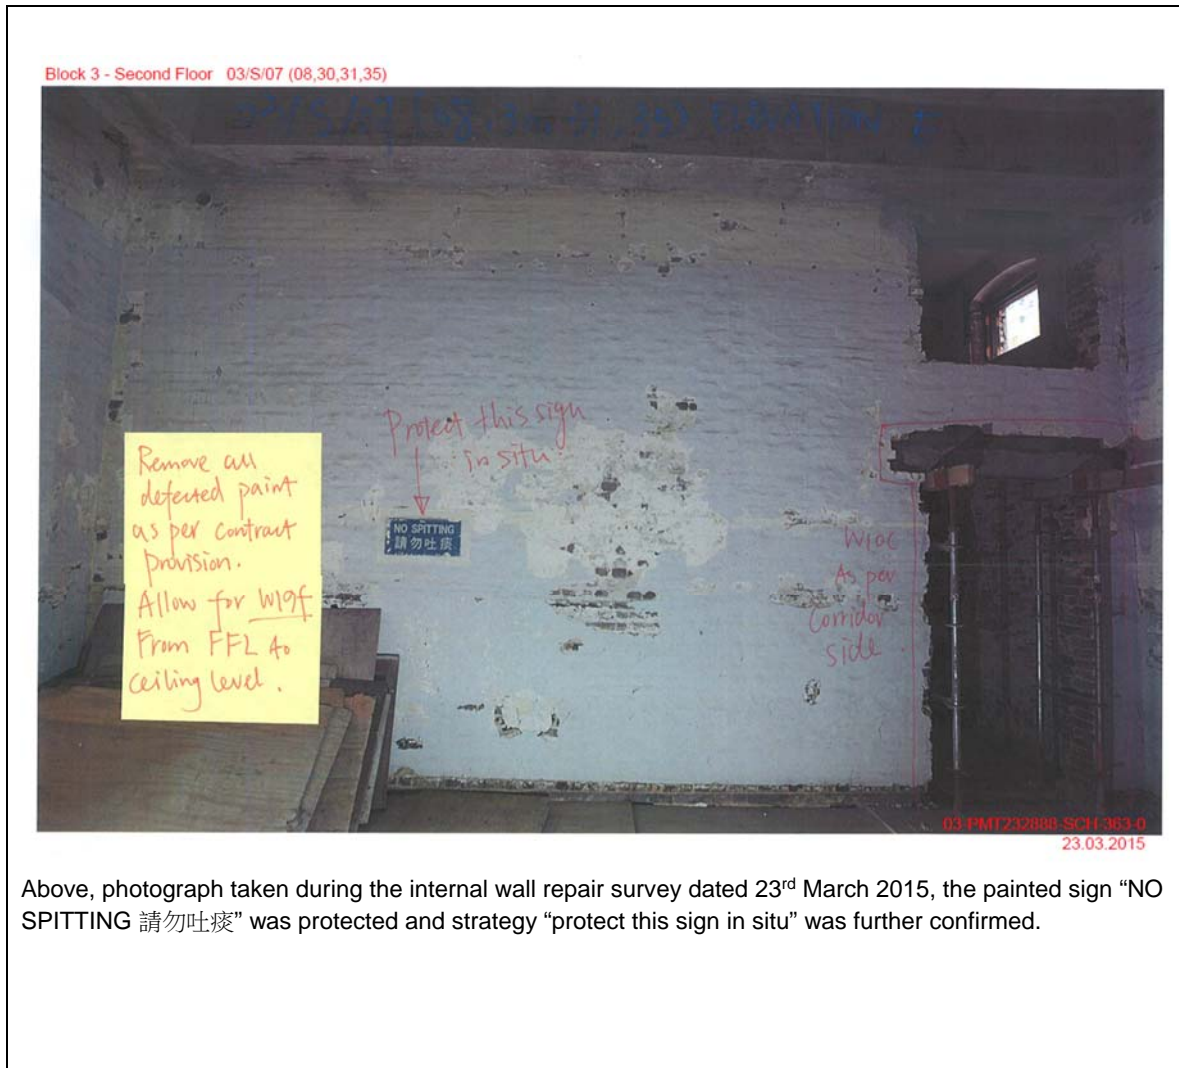
Above, photograph taken during the internal wall repair survey dated 23rd March 2015, the painted sign “NO SPITTING 請勿吐痰” was protected and strategy “protect this sign in situ” was further confirmed.

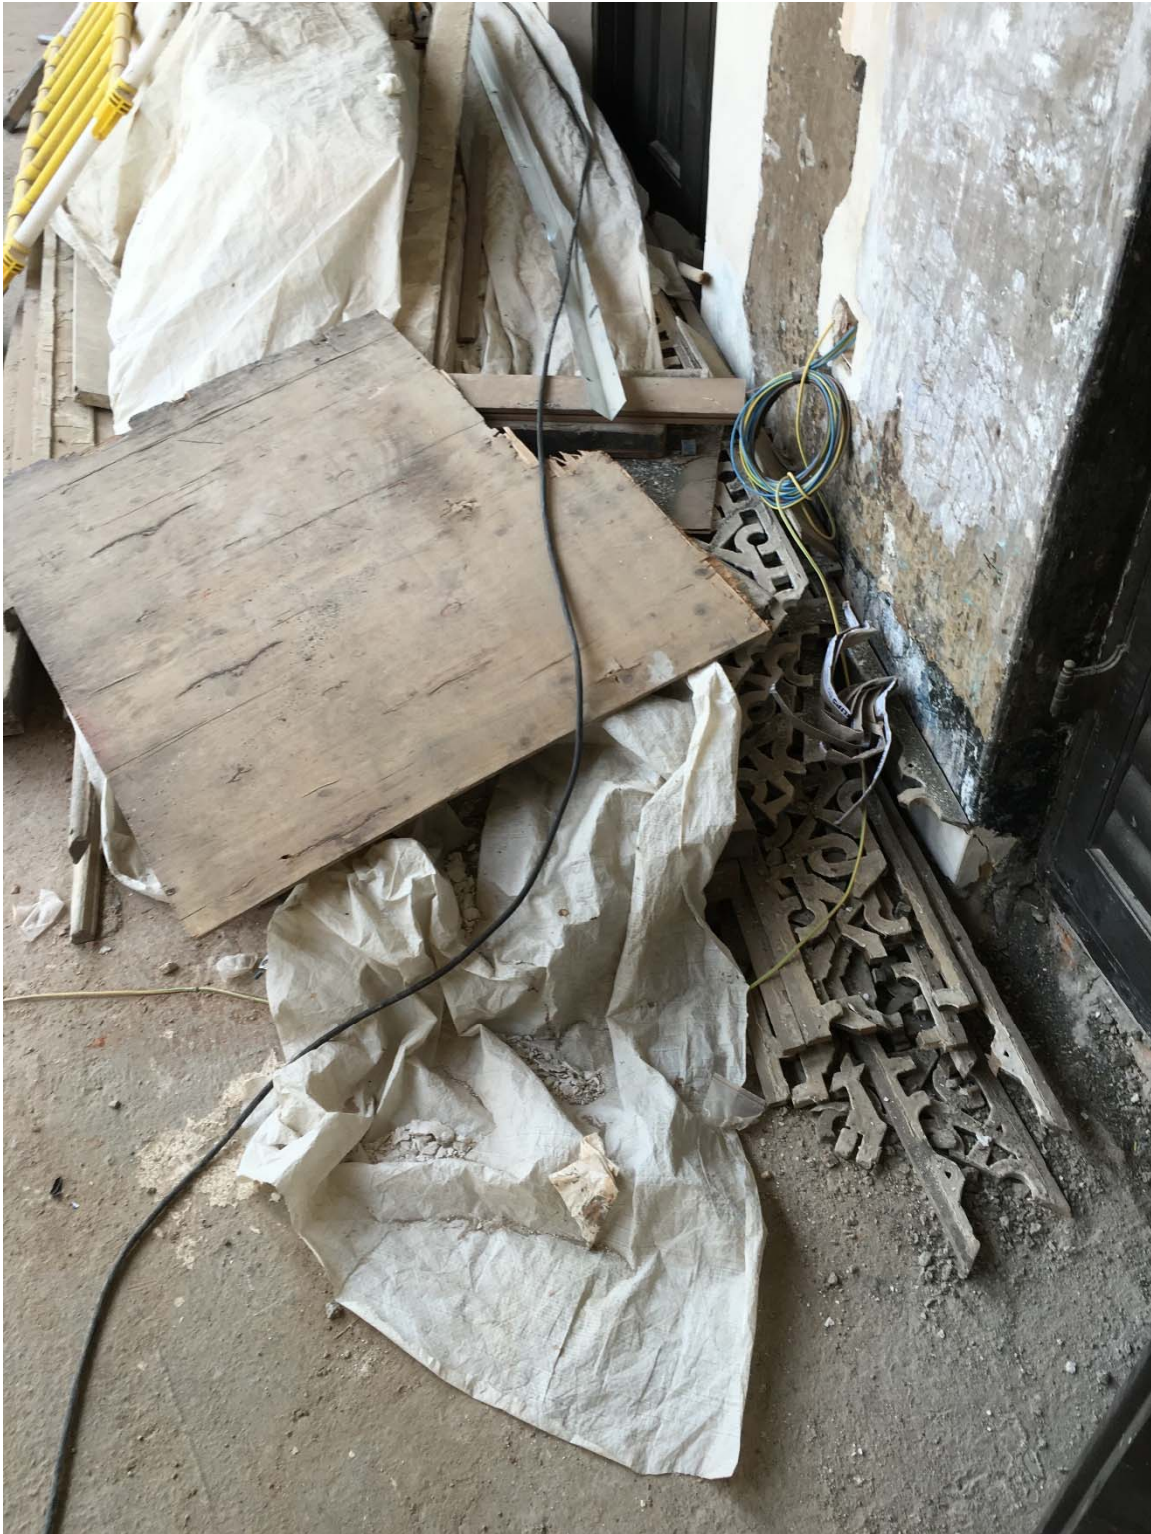
Above, photograph taken on 2nd March, 2016, showing timber fretwork was stored inappropriately with trashes.

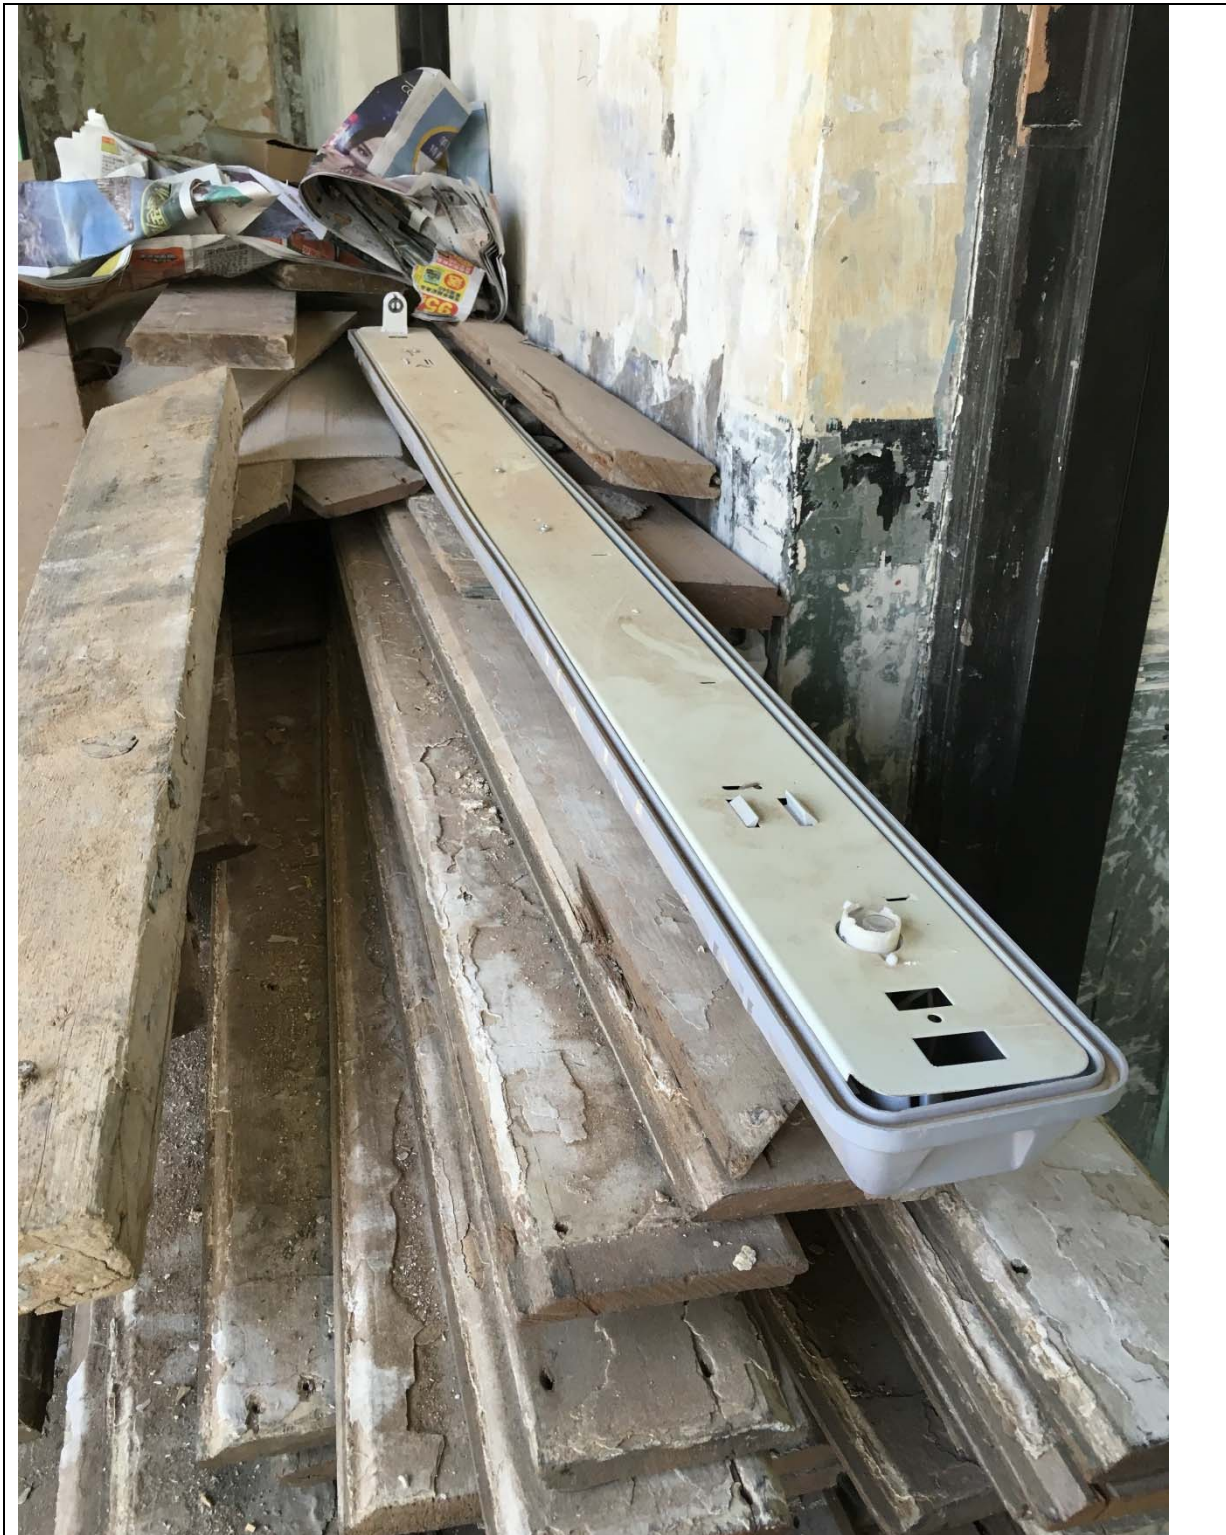
Above, photograph taken on 2nd March, 2016, showing timber boarded ceiling was stored inappropriately with trashes.

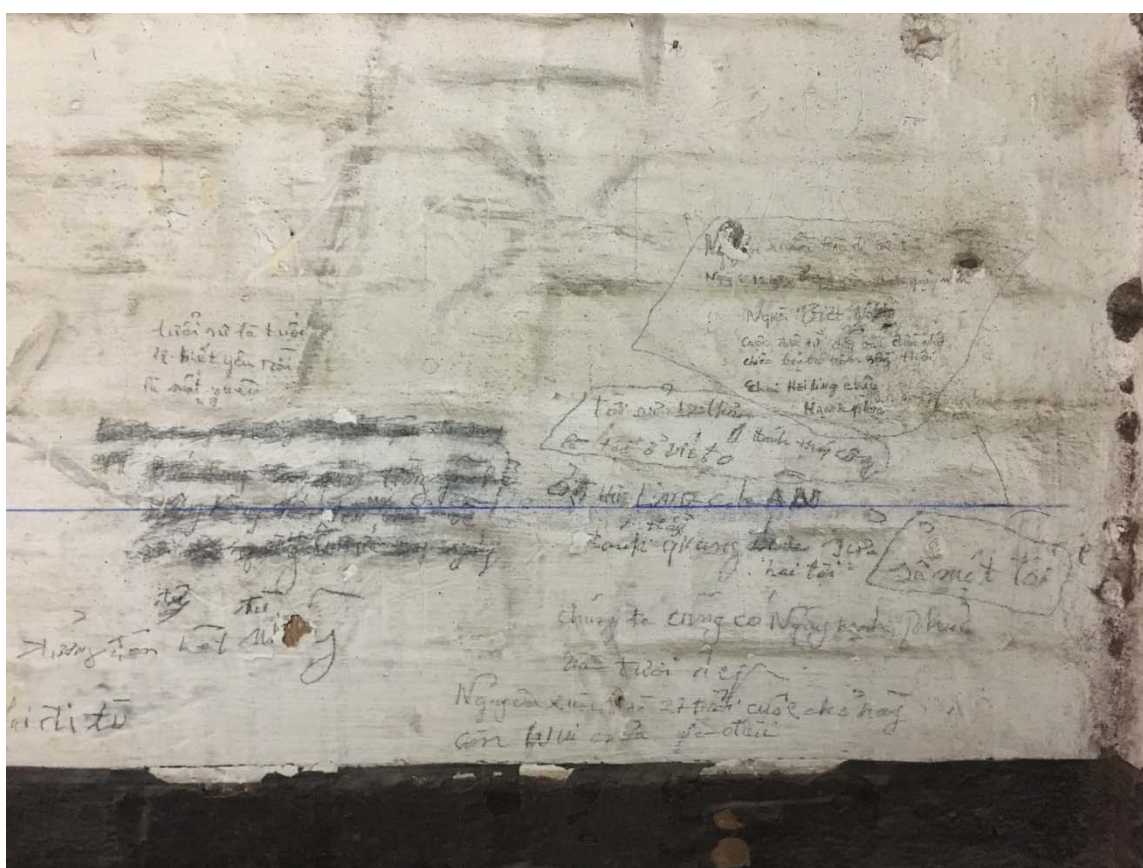
Above, photograph taken on 2nd March 2016, showing blue datum line was incorrectly drawn through the middle of the historic graffiti.

7. The above rectification works shall be at neutral cost to the contract.

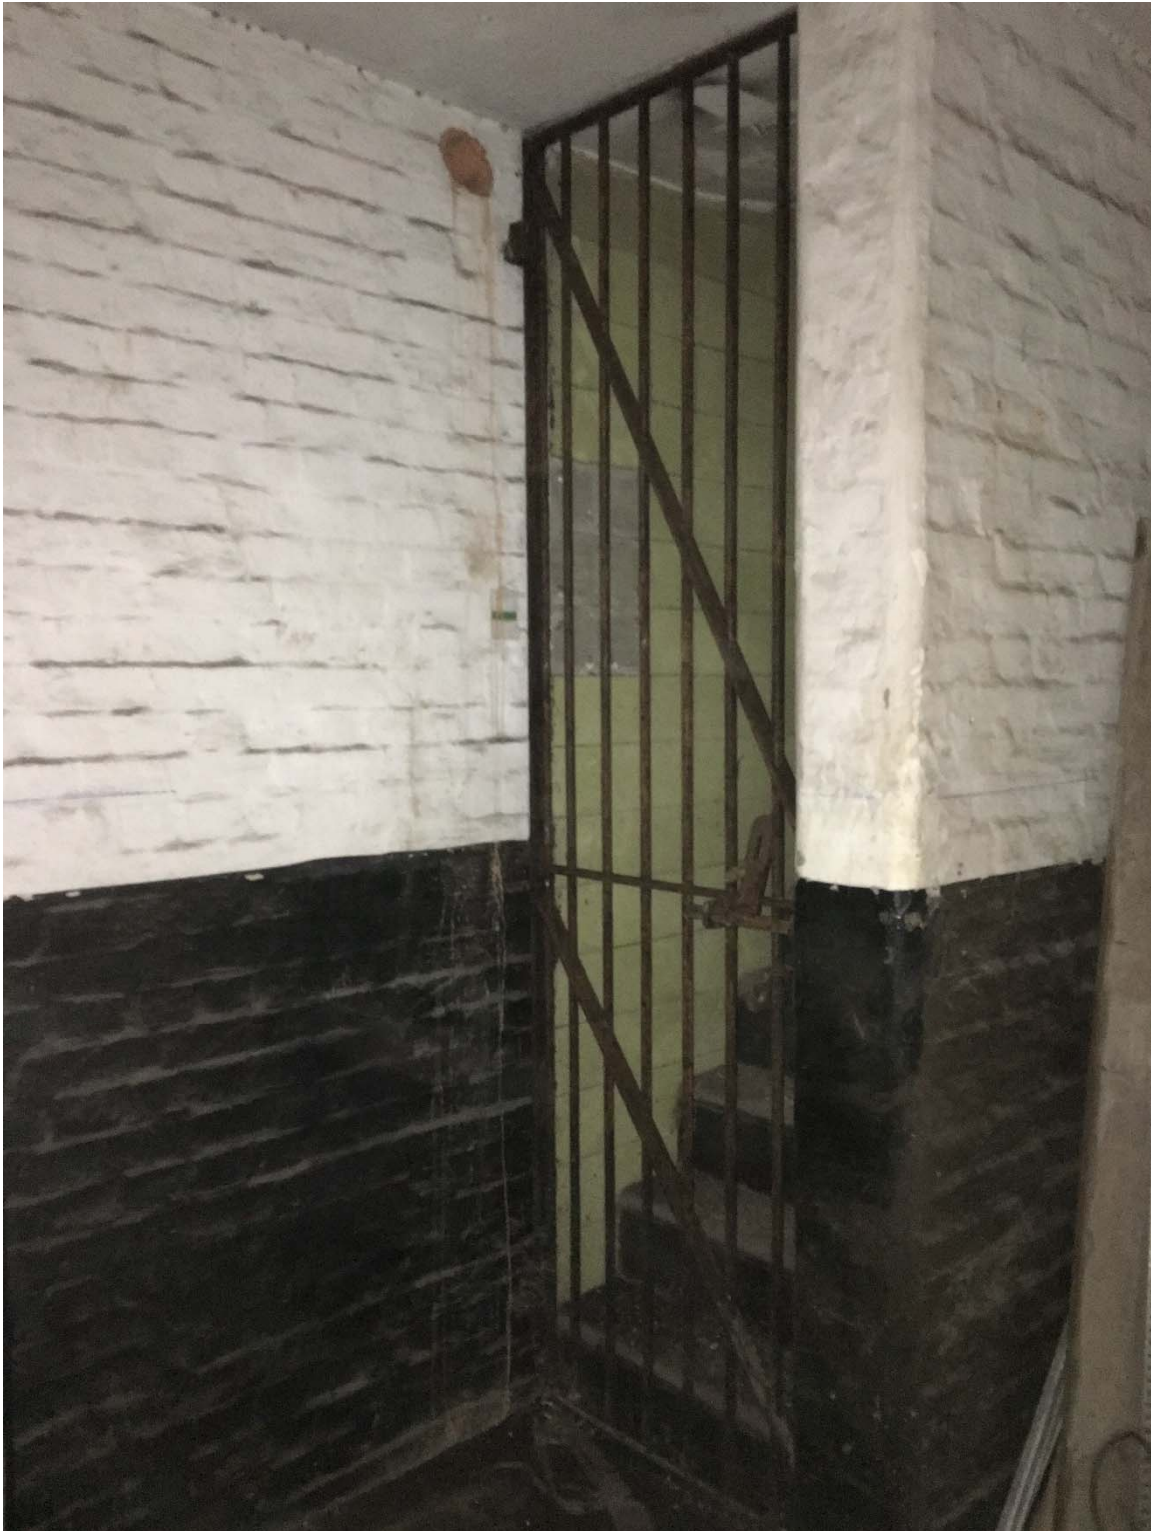
Above, photograph taken on 25th February 2016, the mesh and the paint were incorrectly removed from the gate.

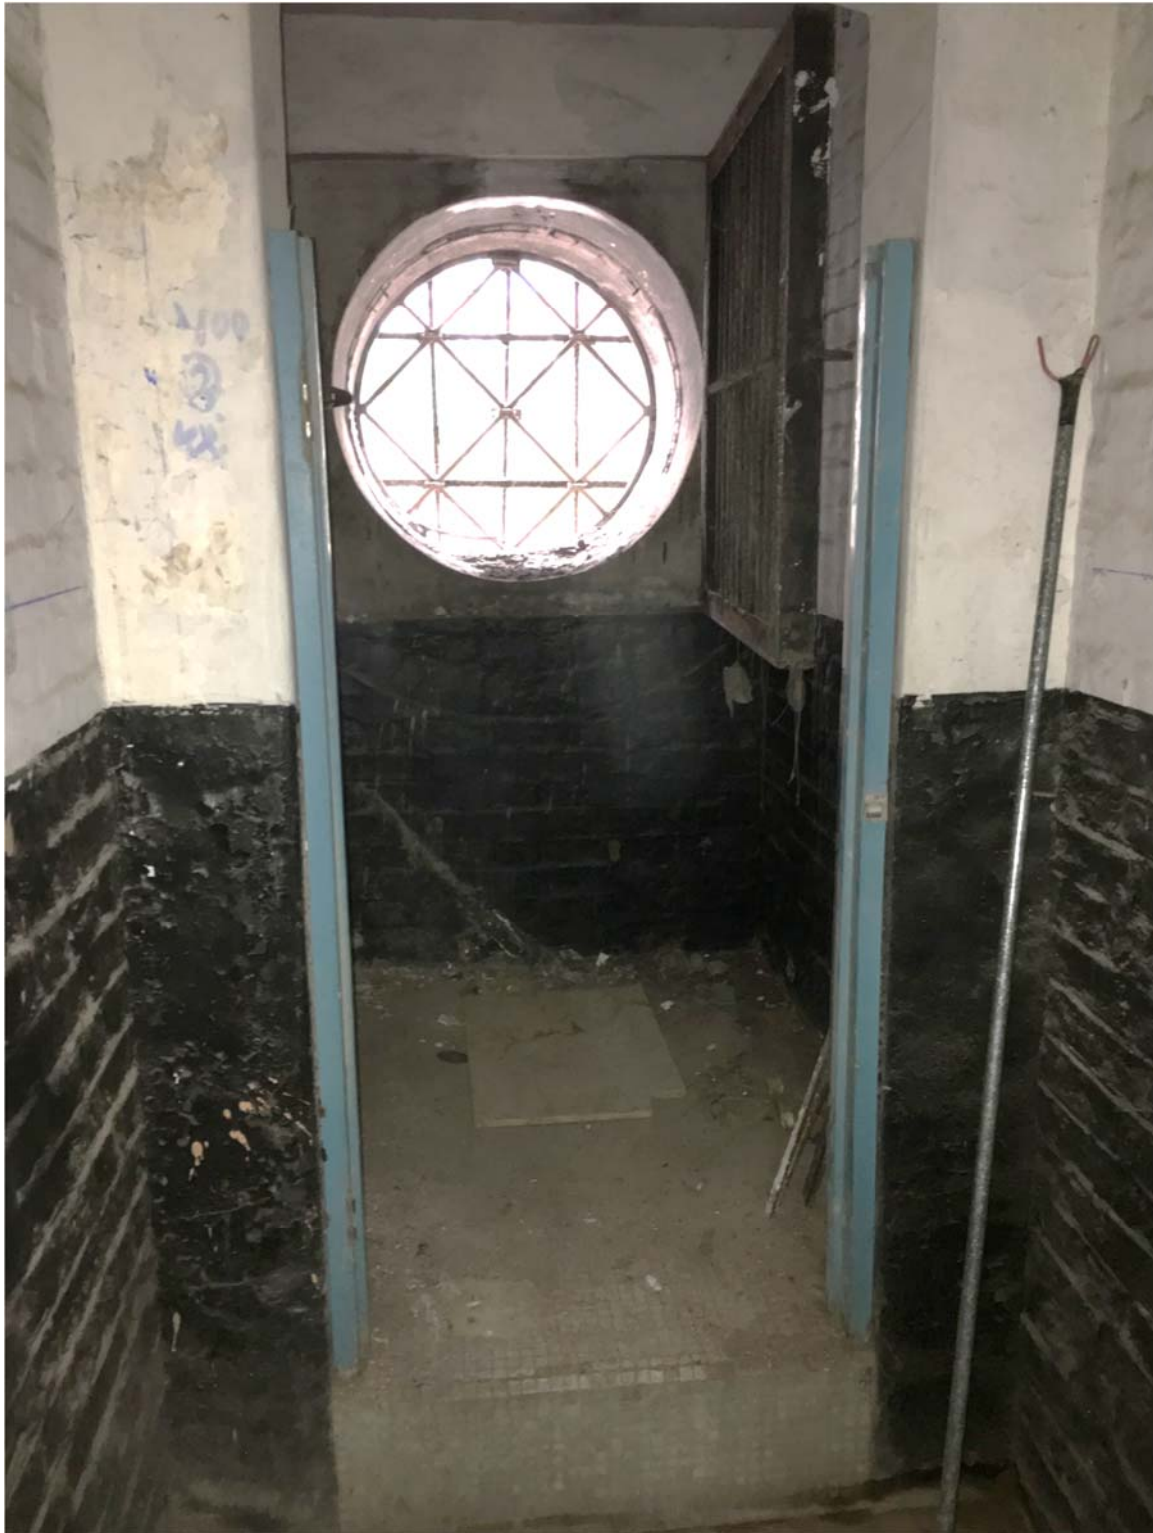
Above, photograph taken on 25th February 2016, the conduits, lighting, mesh and fan on the window, timber panel door were incorrectly removed.

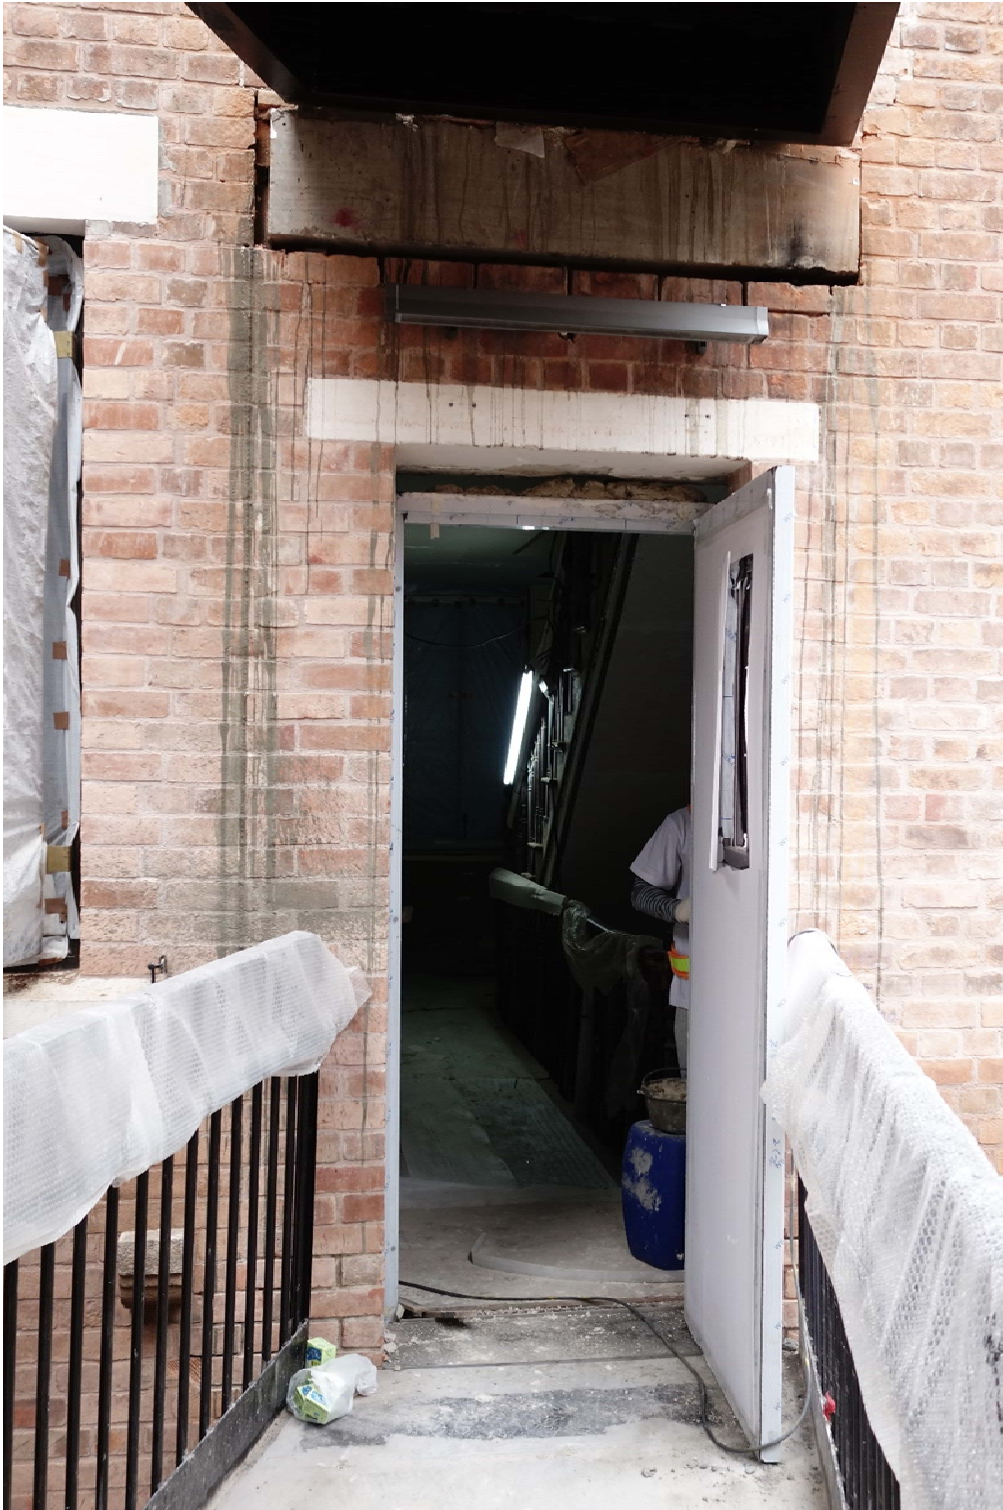
Above, photo taken on 18th March 2016, showing spilt concrete on the Block 7 North elevation (1/F).

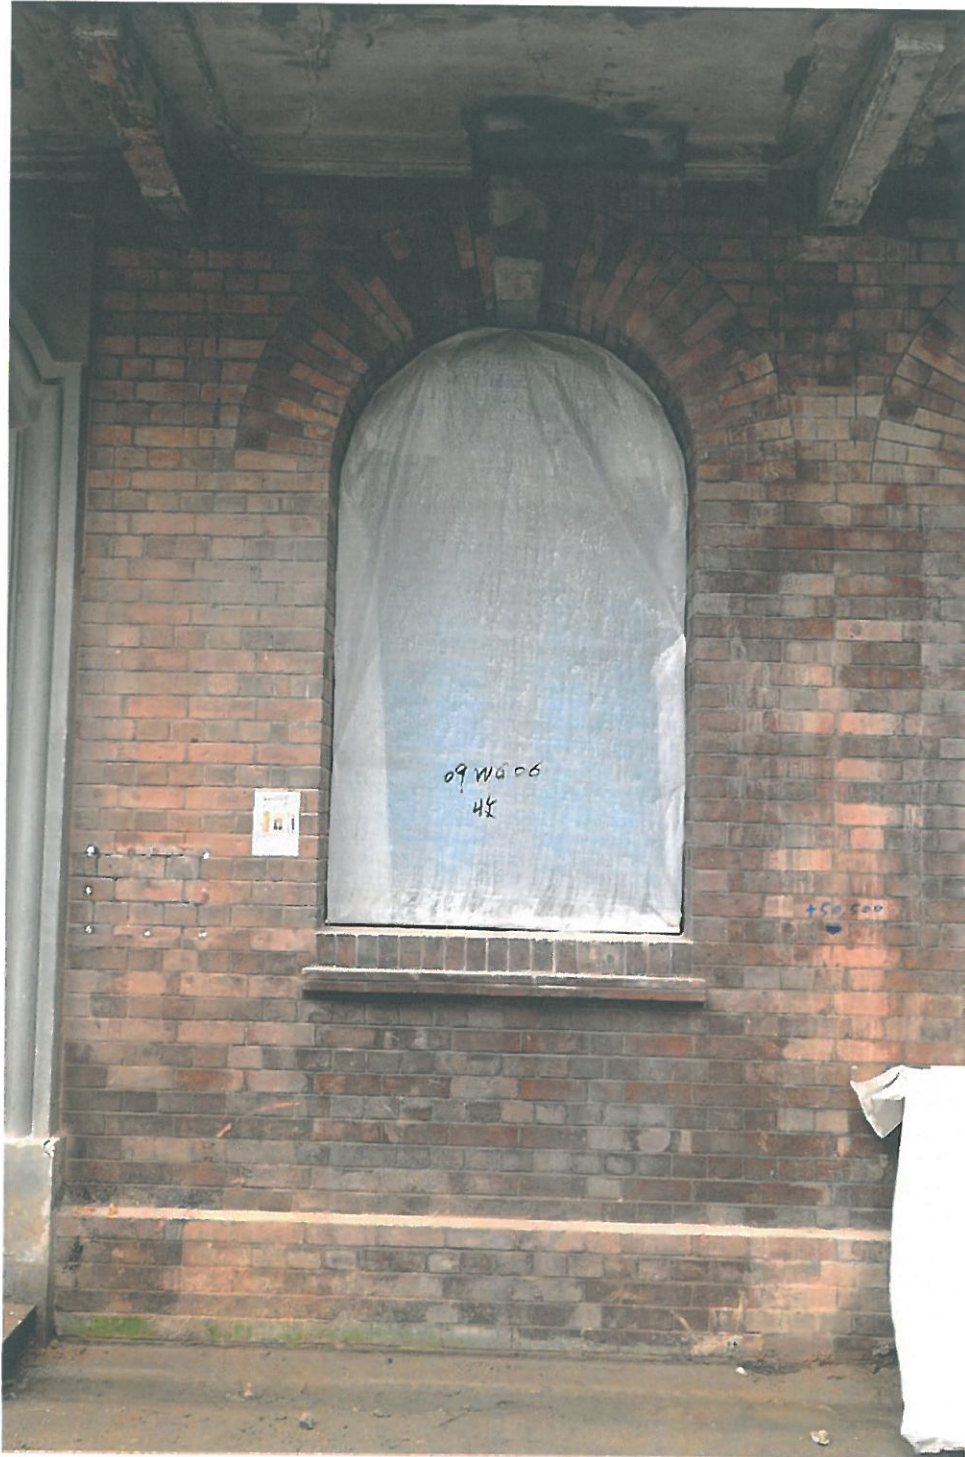
Above, photo taken on 18th March 2016, showing spilt concrete on the Block 9 Magistracy West elevation (G/F).

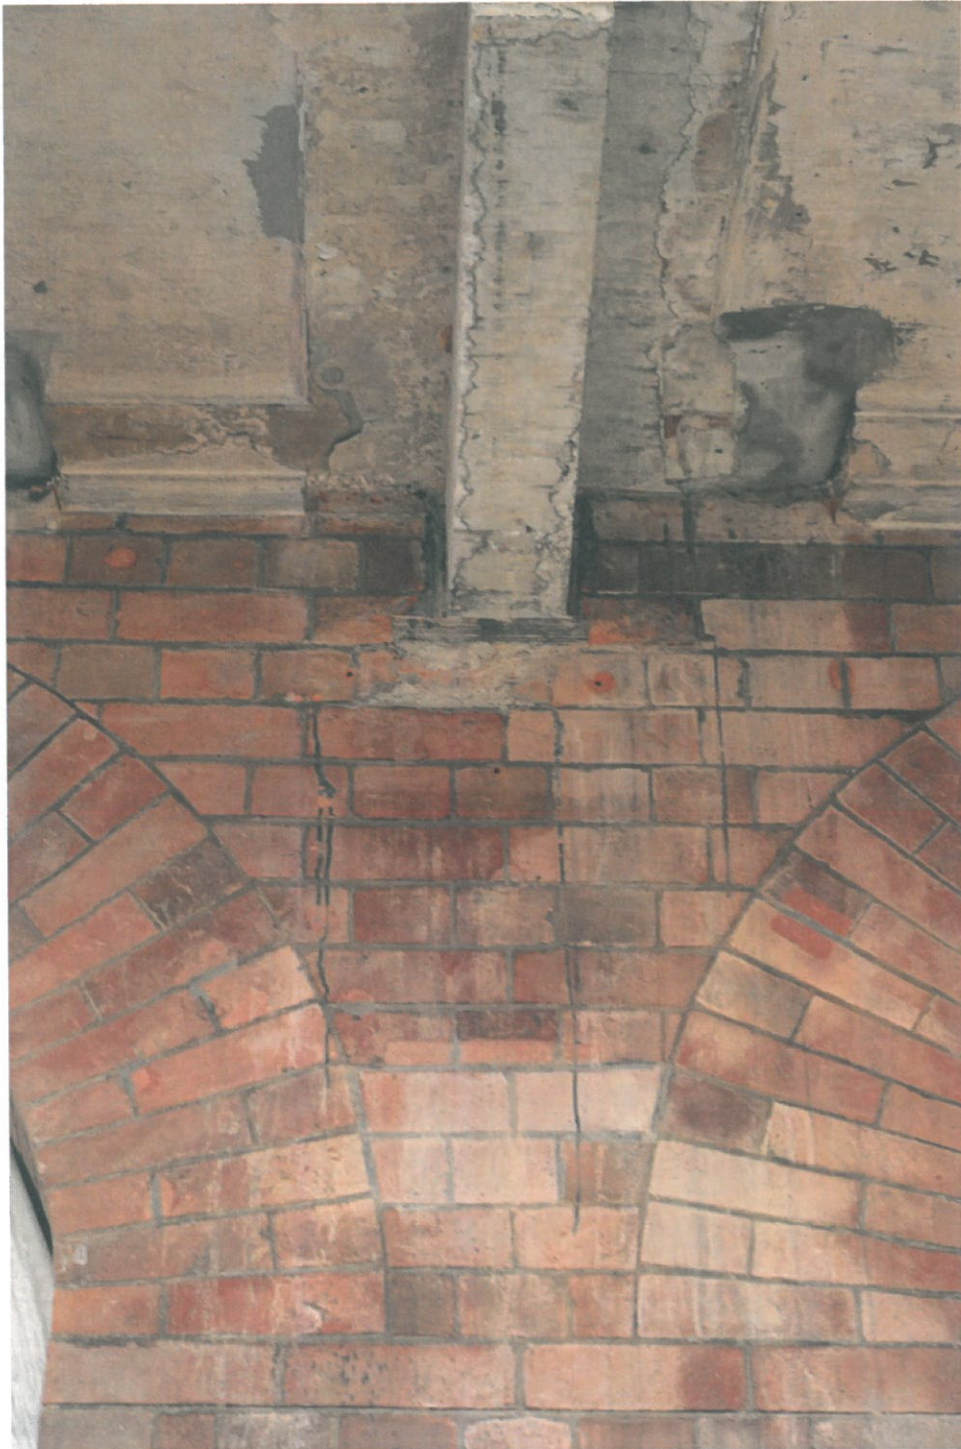
Above, photo taken on 18th March 2016, showing spilt concrete on the Block 9 Magistracy West elevation (G/F).

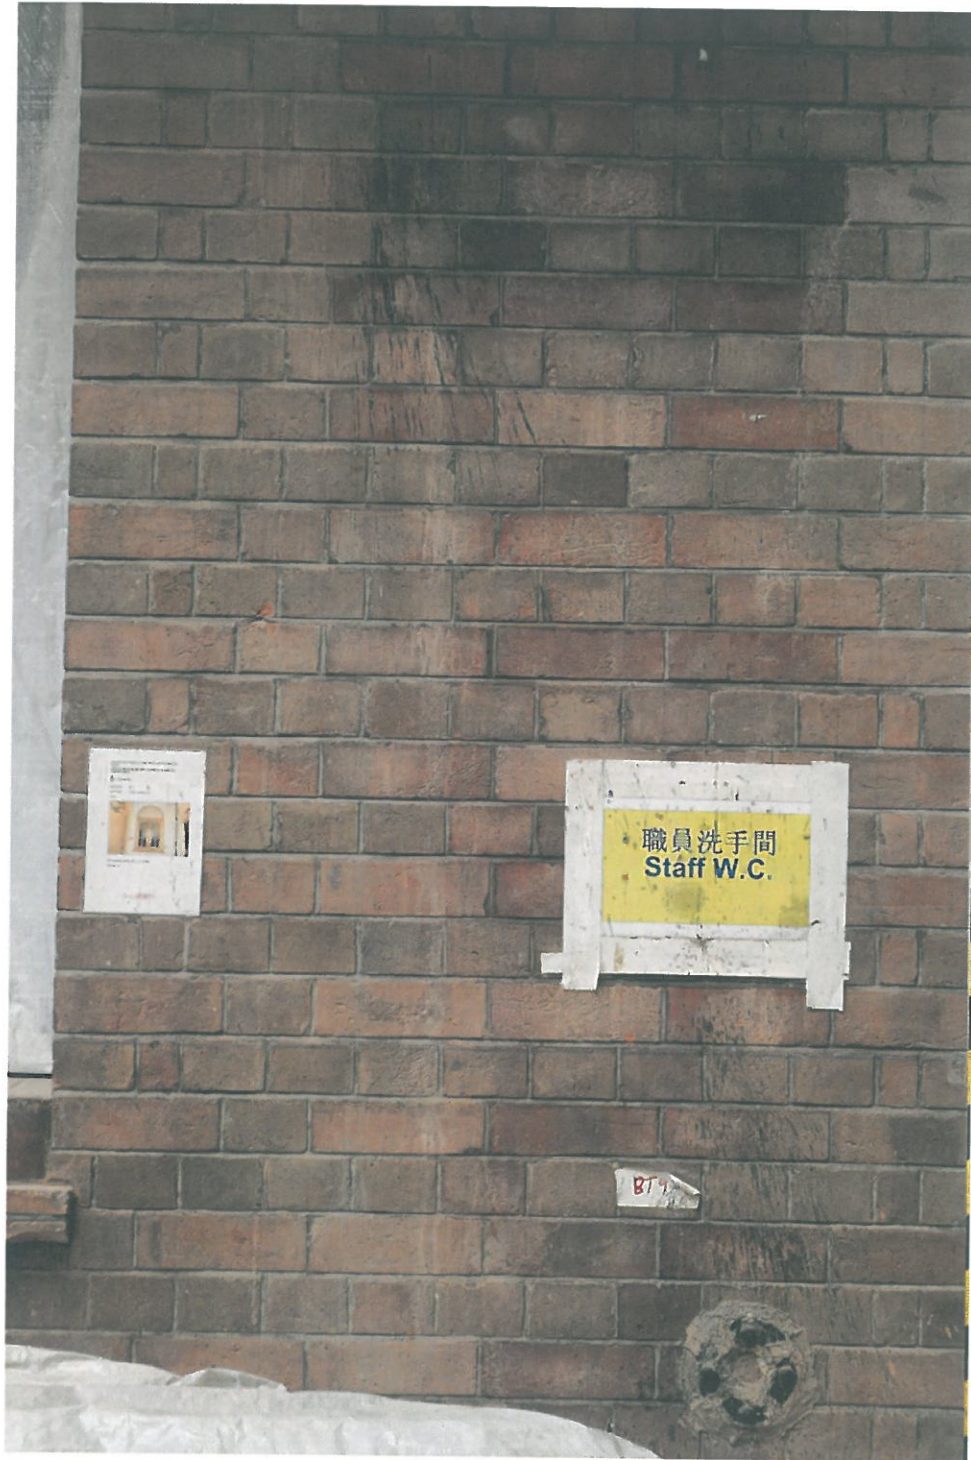
Above, photo taken on 18th March 2016, showing spilt concrete on the Block 9 Magistracy West elevation (G/F).

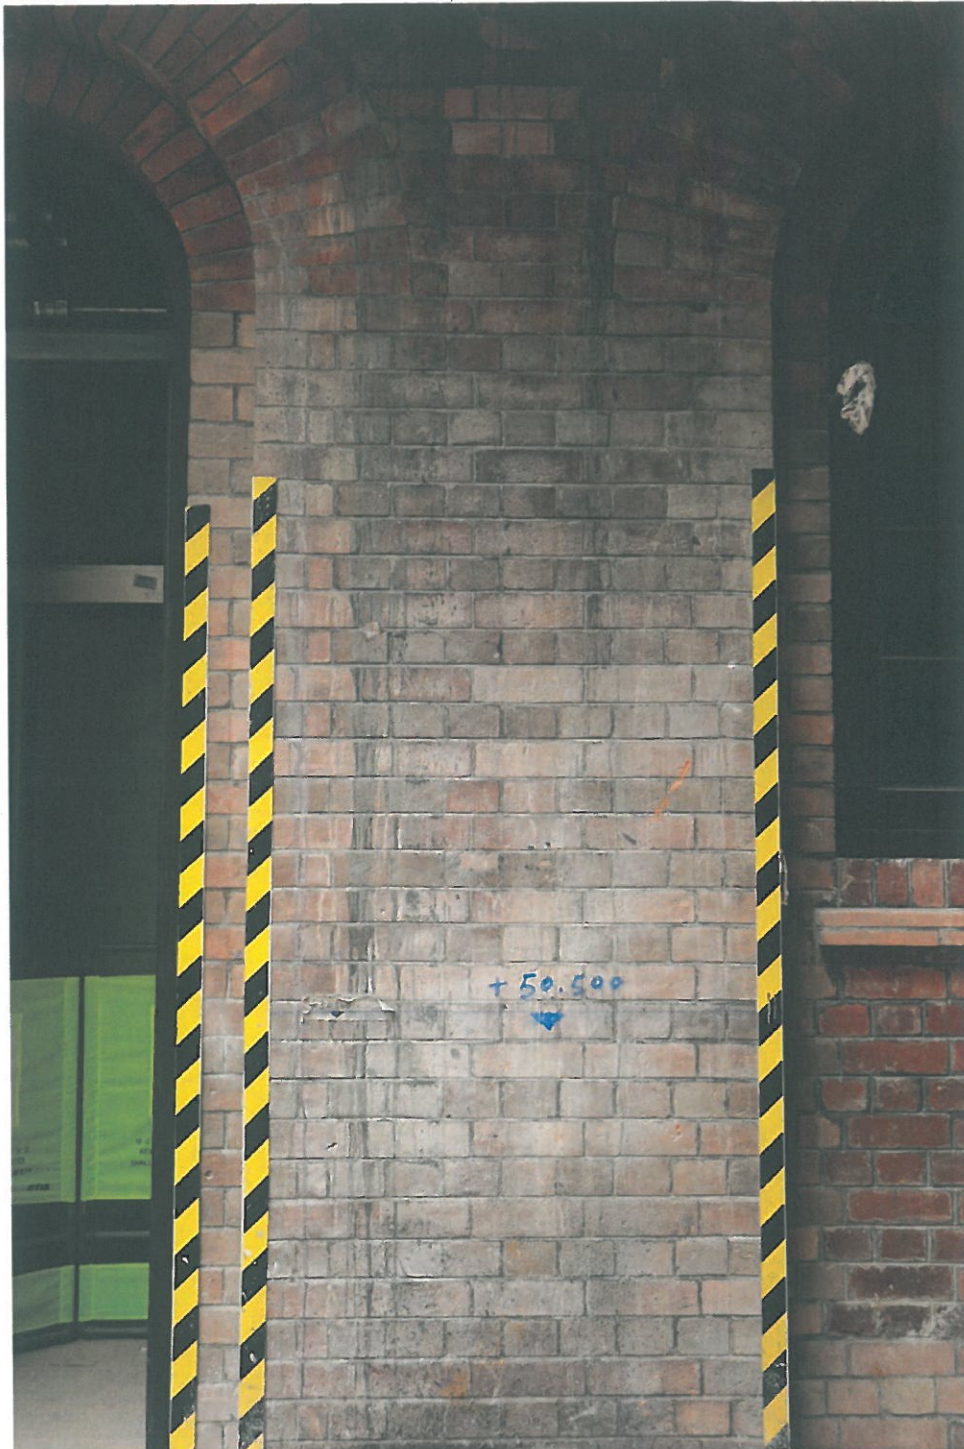
Above, photo taken on 18th March 2016, showing spilt concrete on the Block 9 Magistracy West elevation (G/F).

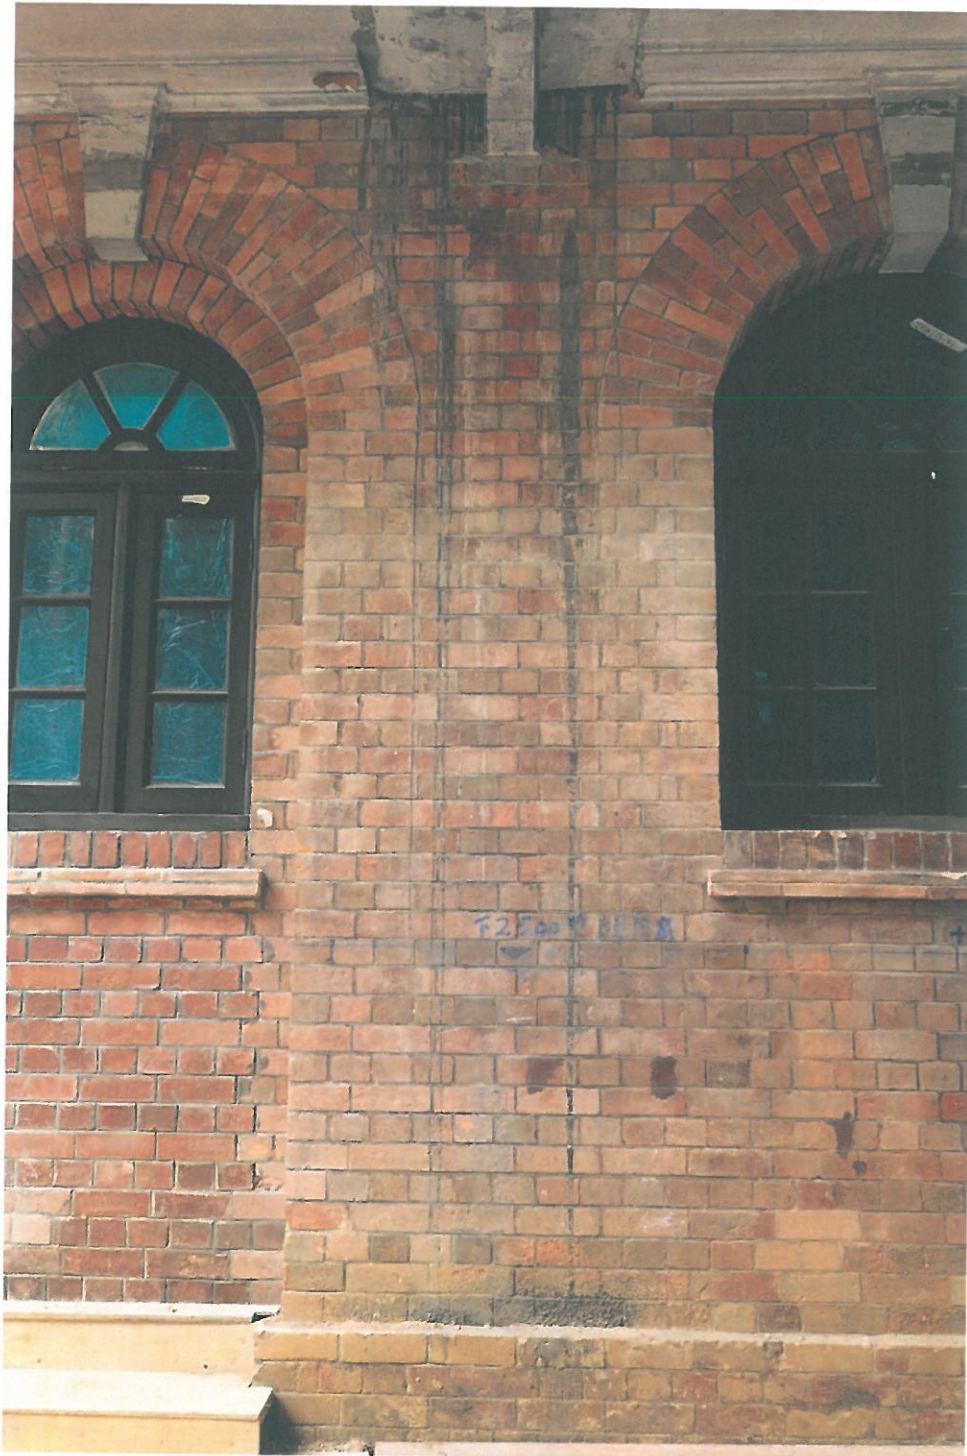
Above, photo taken on 18th March 2016, showing spilt concrete on the Block 9 Magistracy West elevation (G/F).
