Central Police Station Conservation
and Revitalisation Project:
5th Annual EM&A Review Report
(1 November 2015 to 31 October
2016)

Issue Date: May 2017

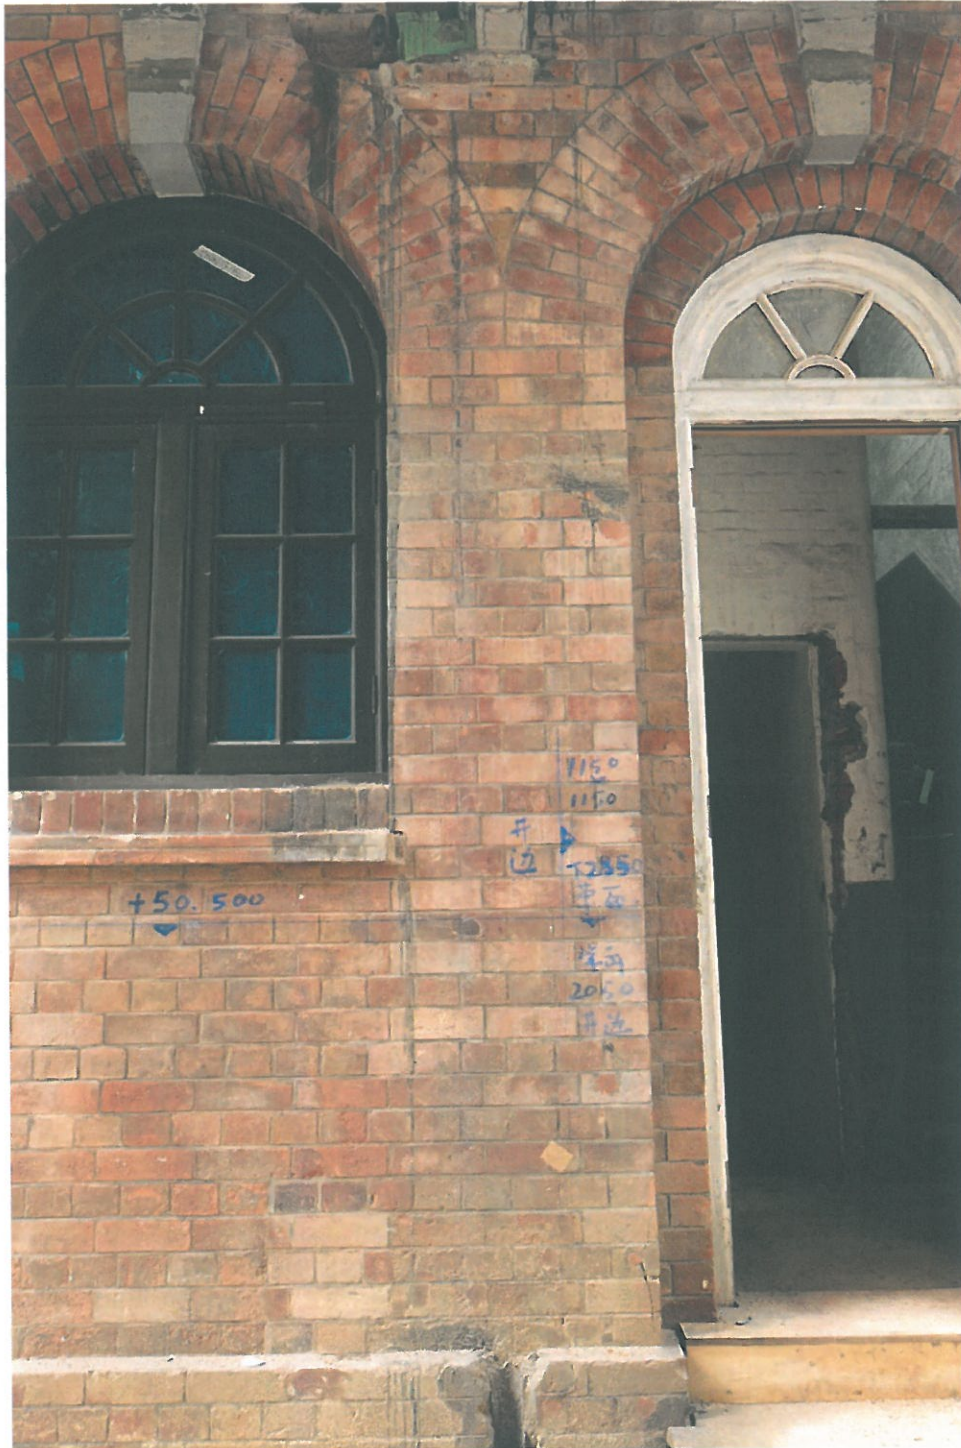
Above, photo taken on 18th March 2016, showing spilt concrete on the Block 9 Magistracy West elevation (G/F).

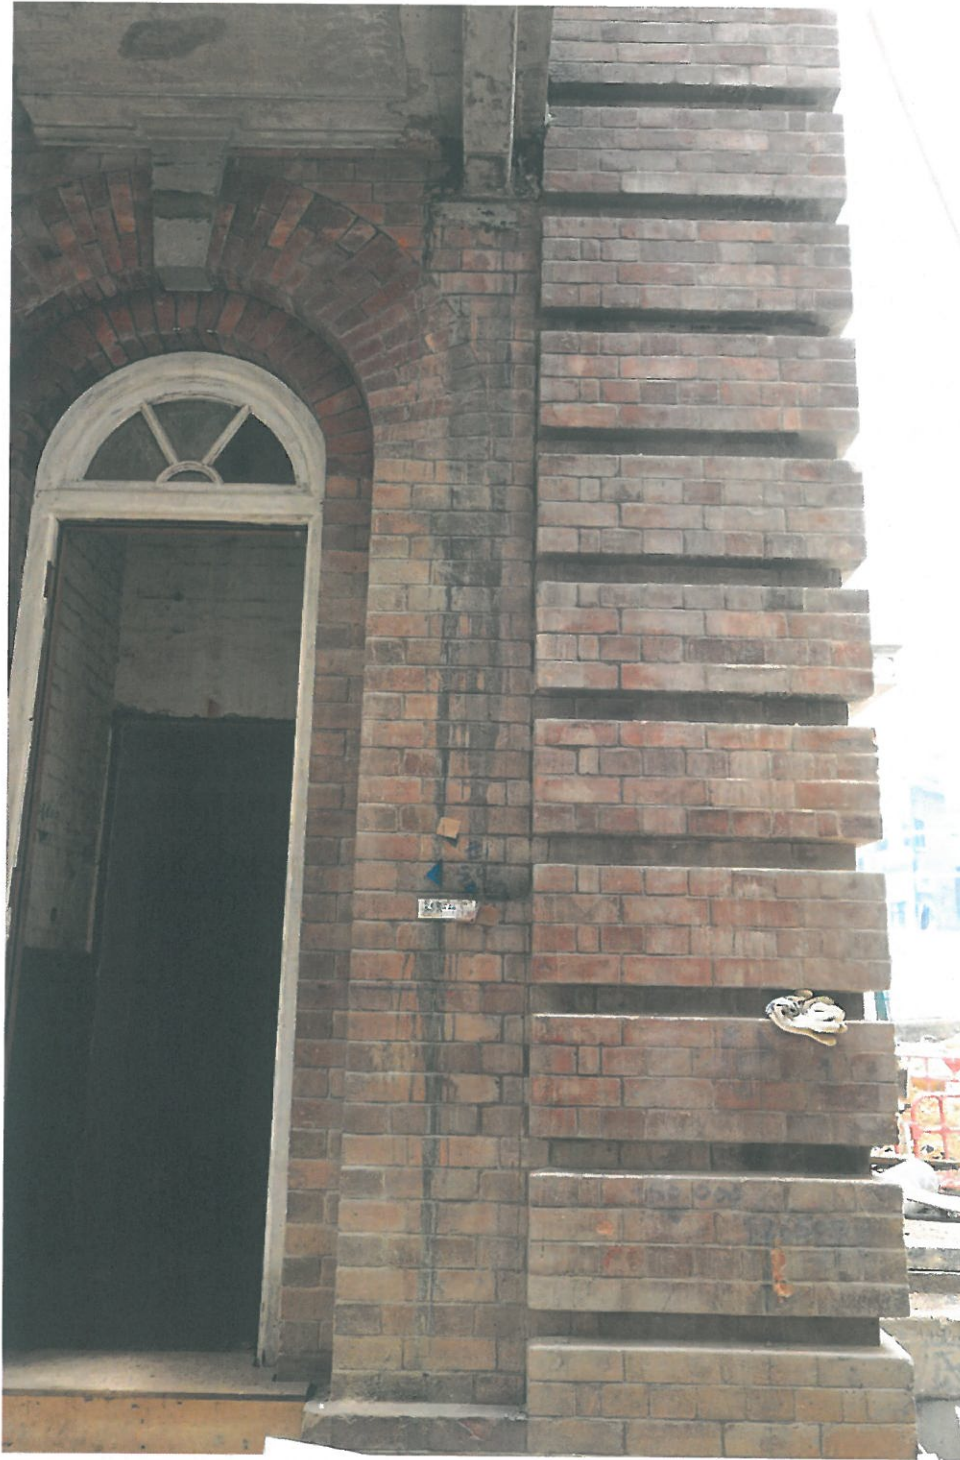
Above, photo taken on 18th March 2016, showing spilt concrete on the Block 9 Magistracy West elevation (G/F).

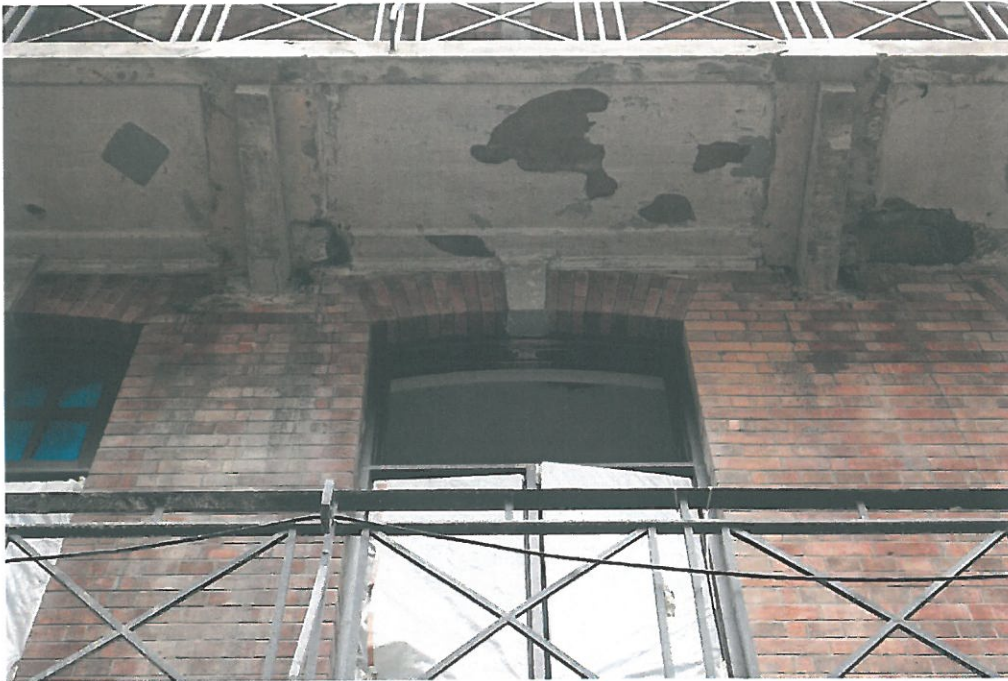
Above, photo taken on 18th March 2016, showing spilt concrete on the Block 9 Magistracy West elevation (1/F).

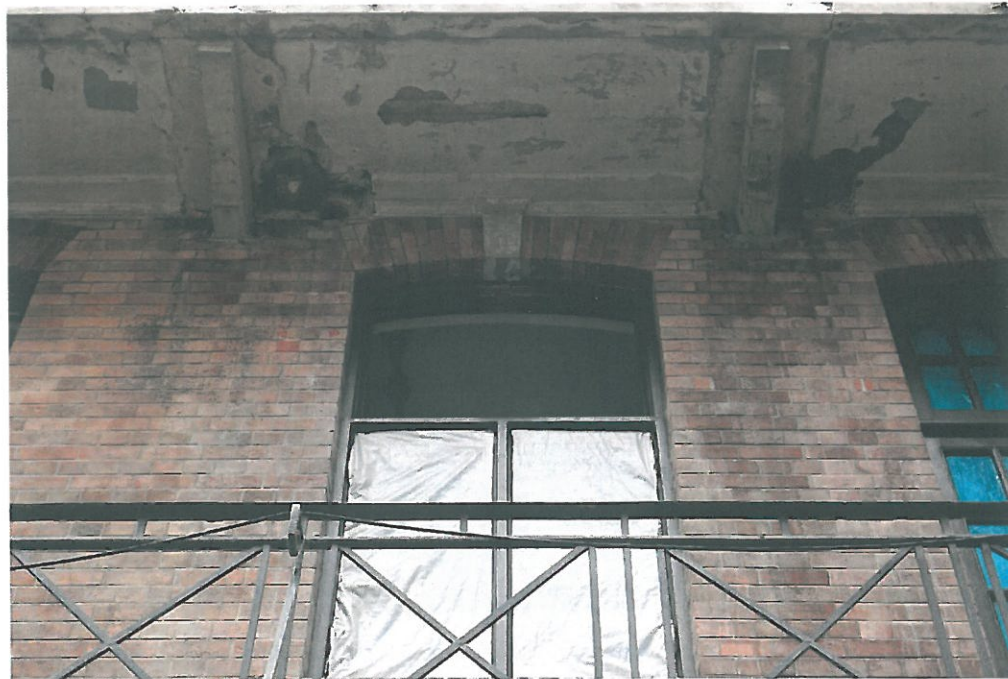
Above, photo taken on 18th March 2016, showing spilt concrete on the Block 9 Magistracy West elevation (1/F).

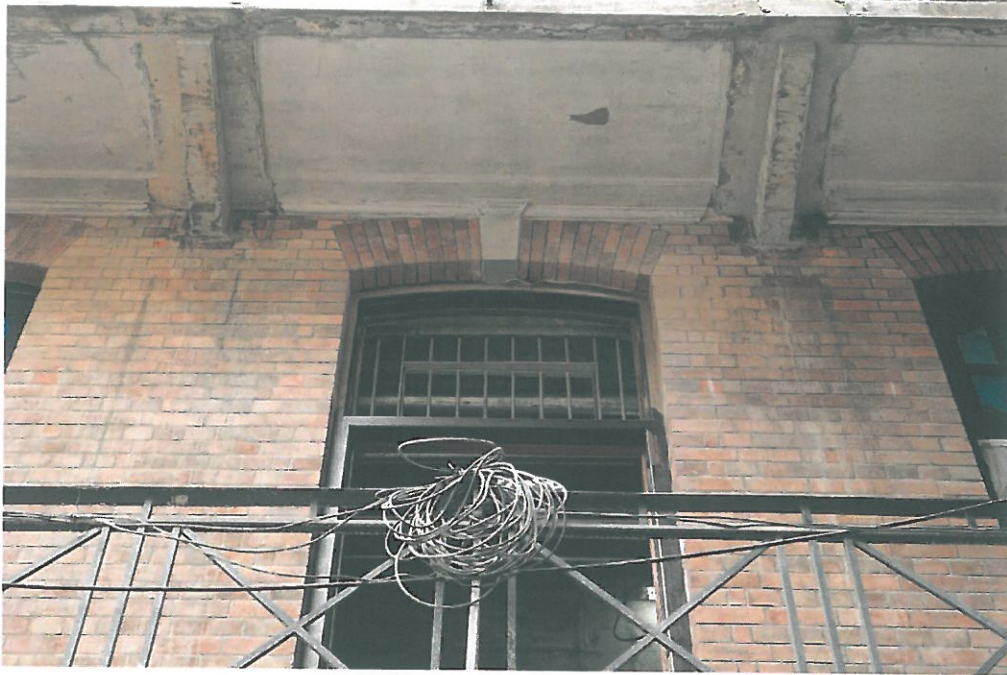
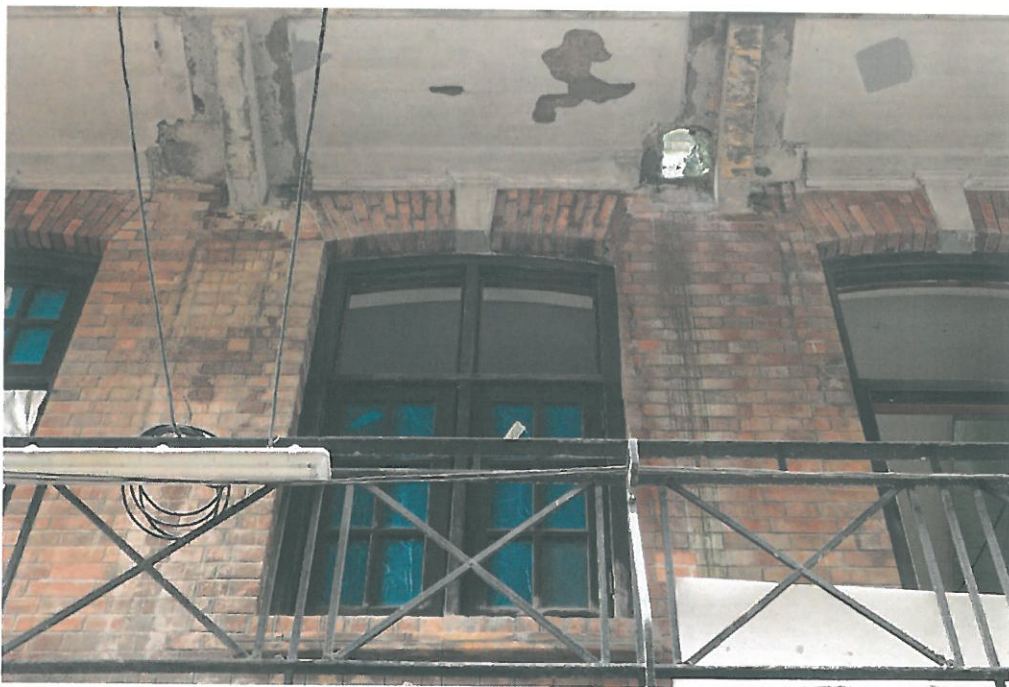
Above, photo taken on 18th March 2016, showing spilt concrete on the Block 9 Magistracy West elevation (1/F).

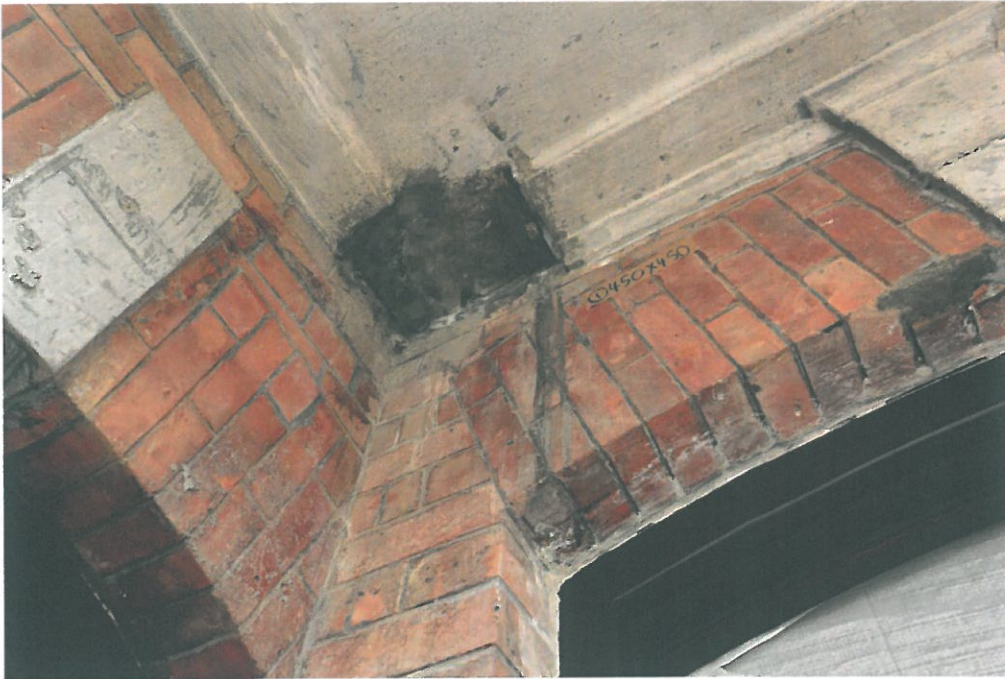
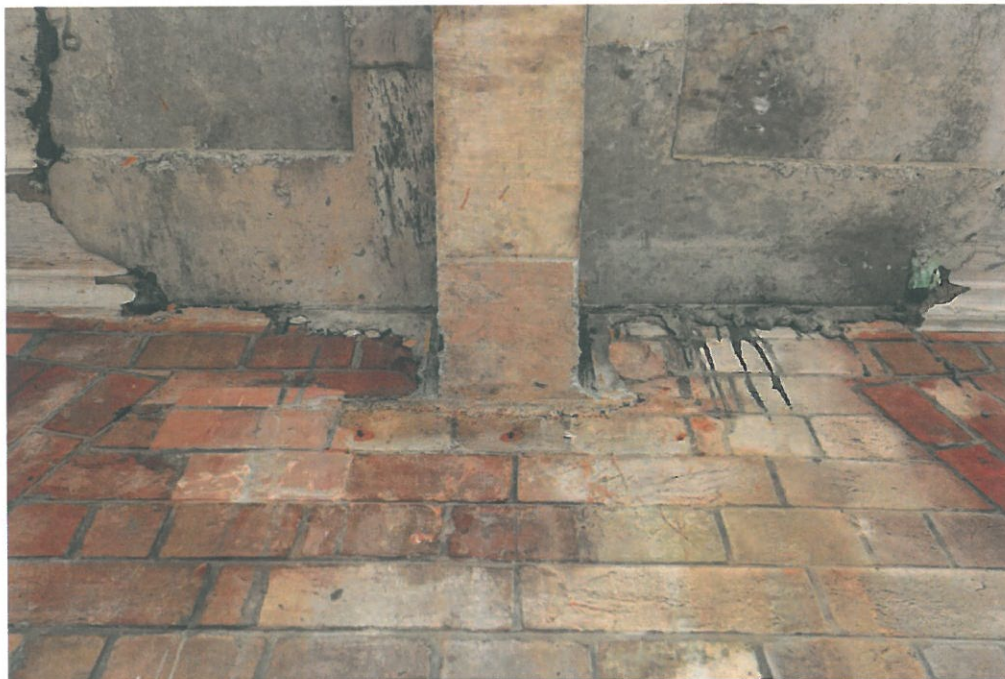
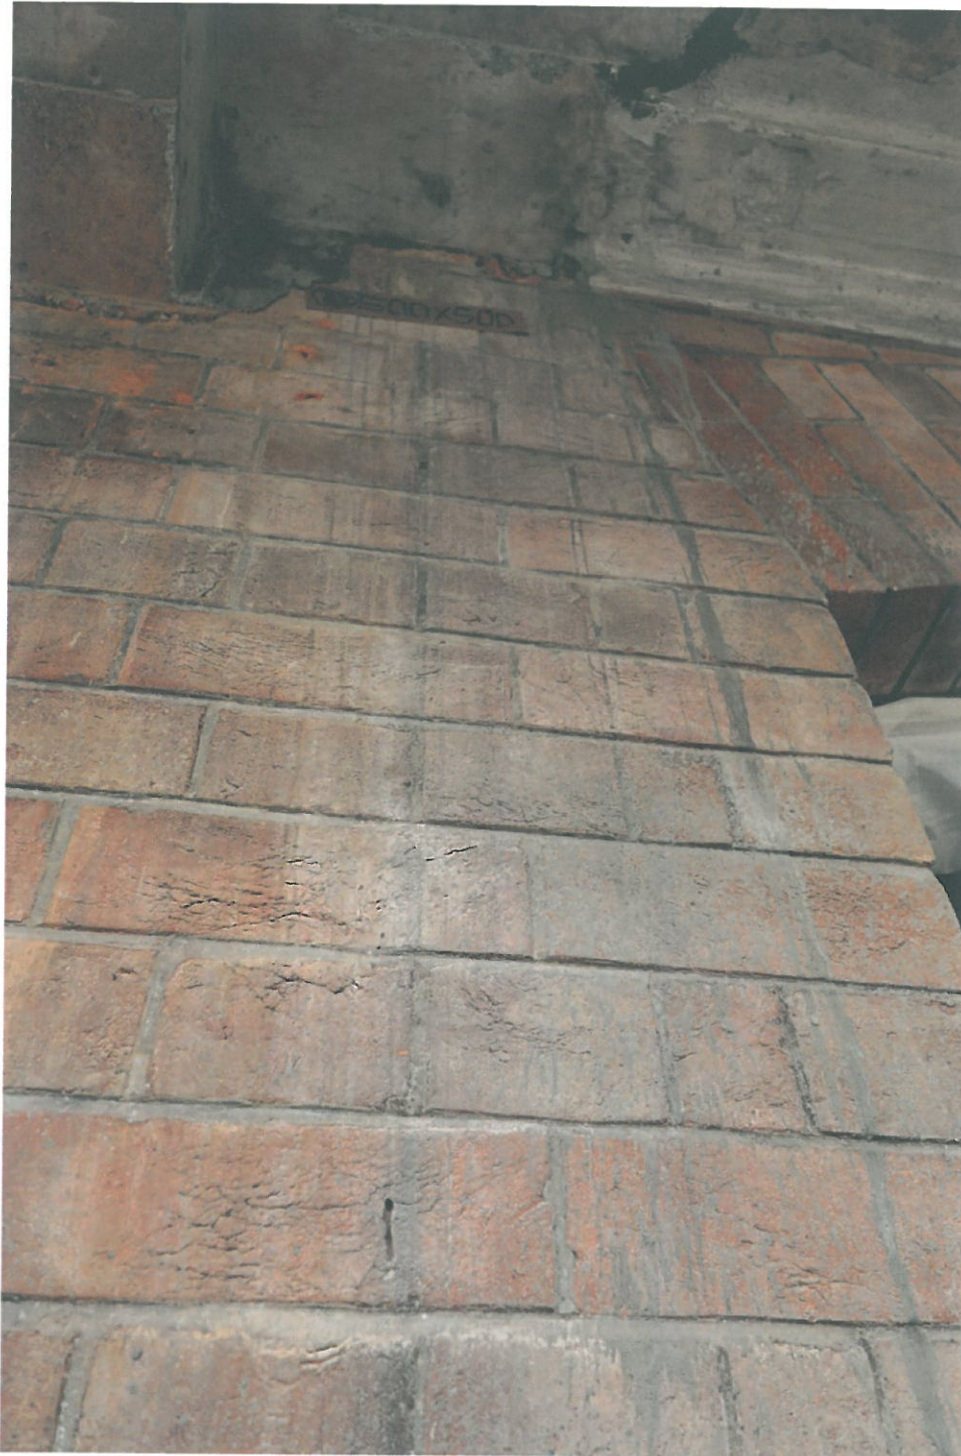
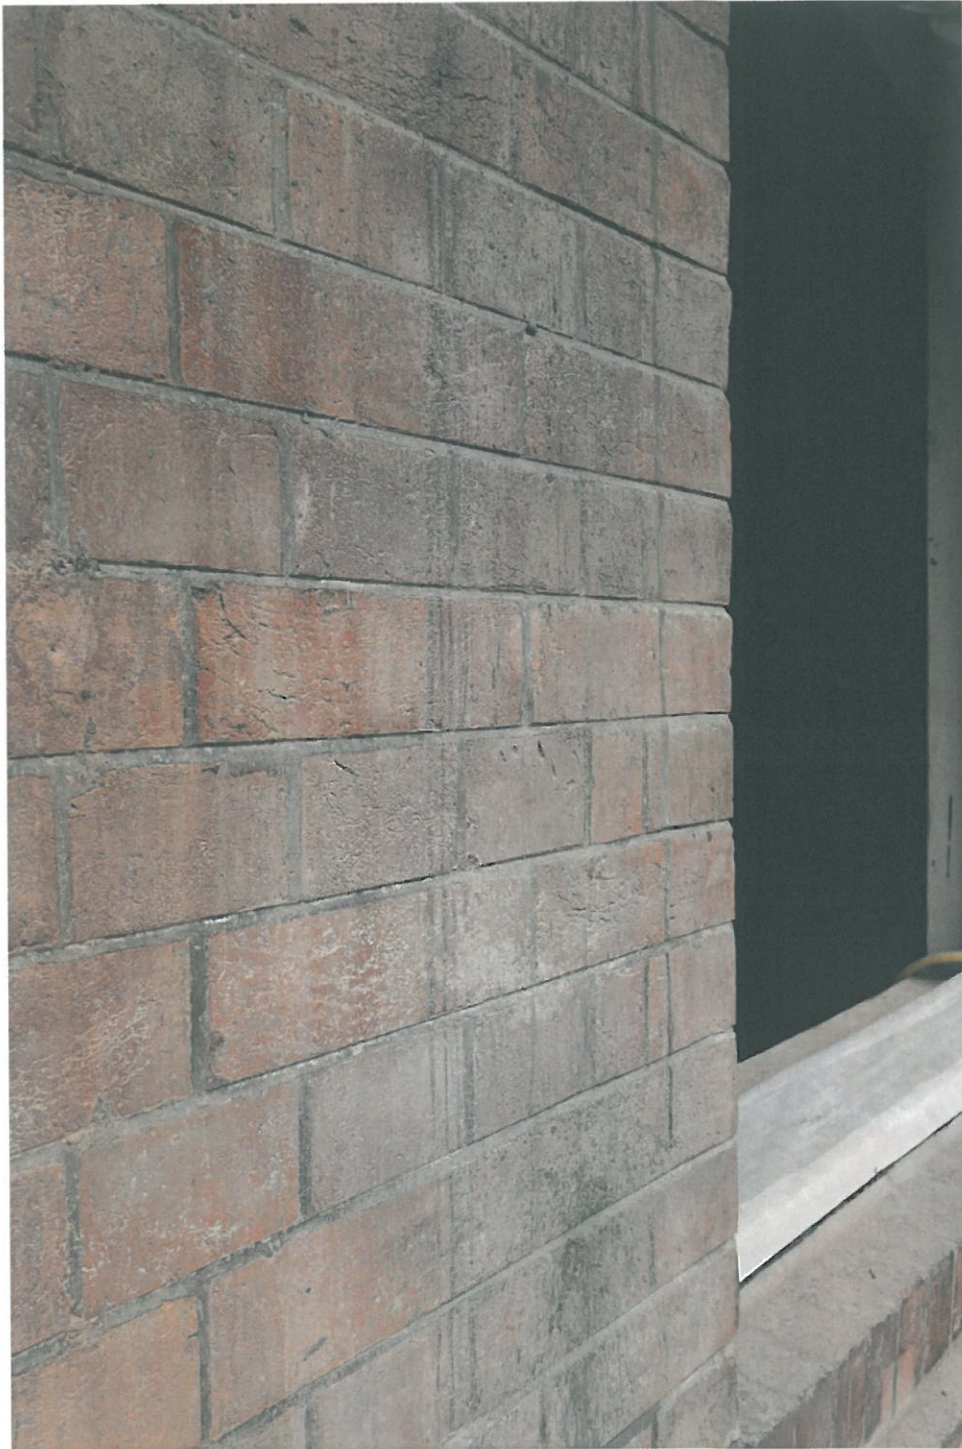
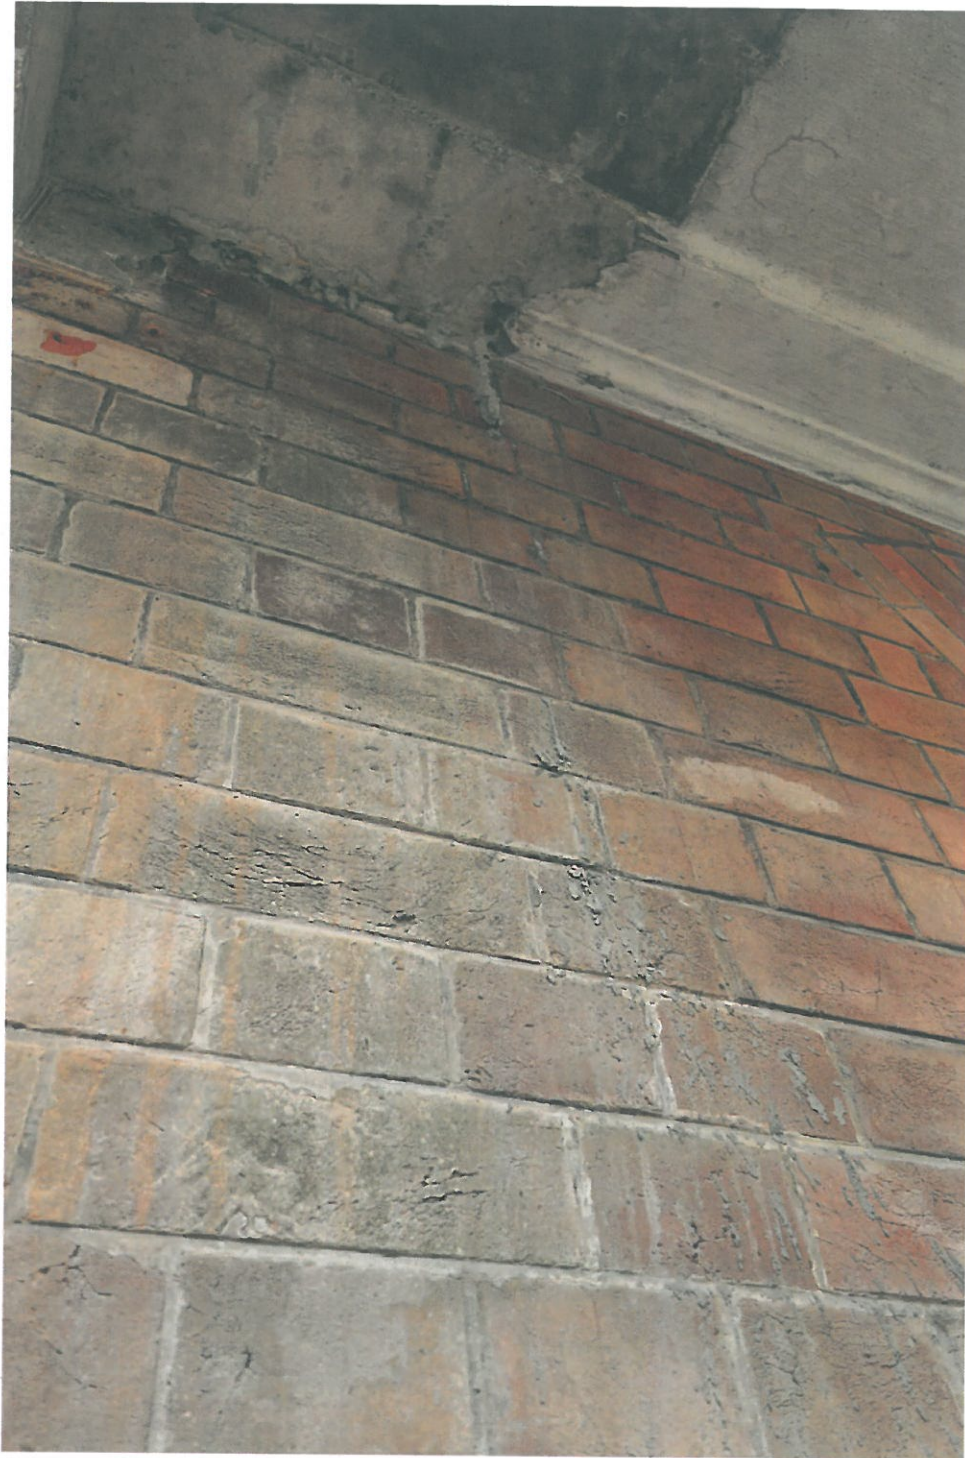
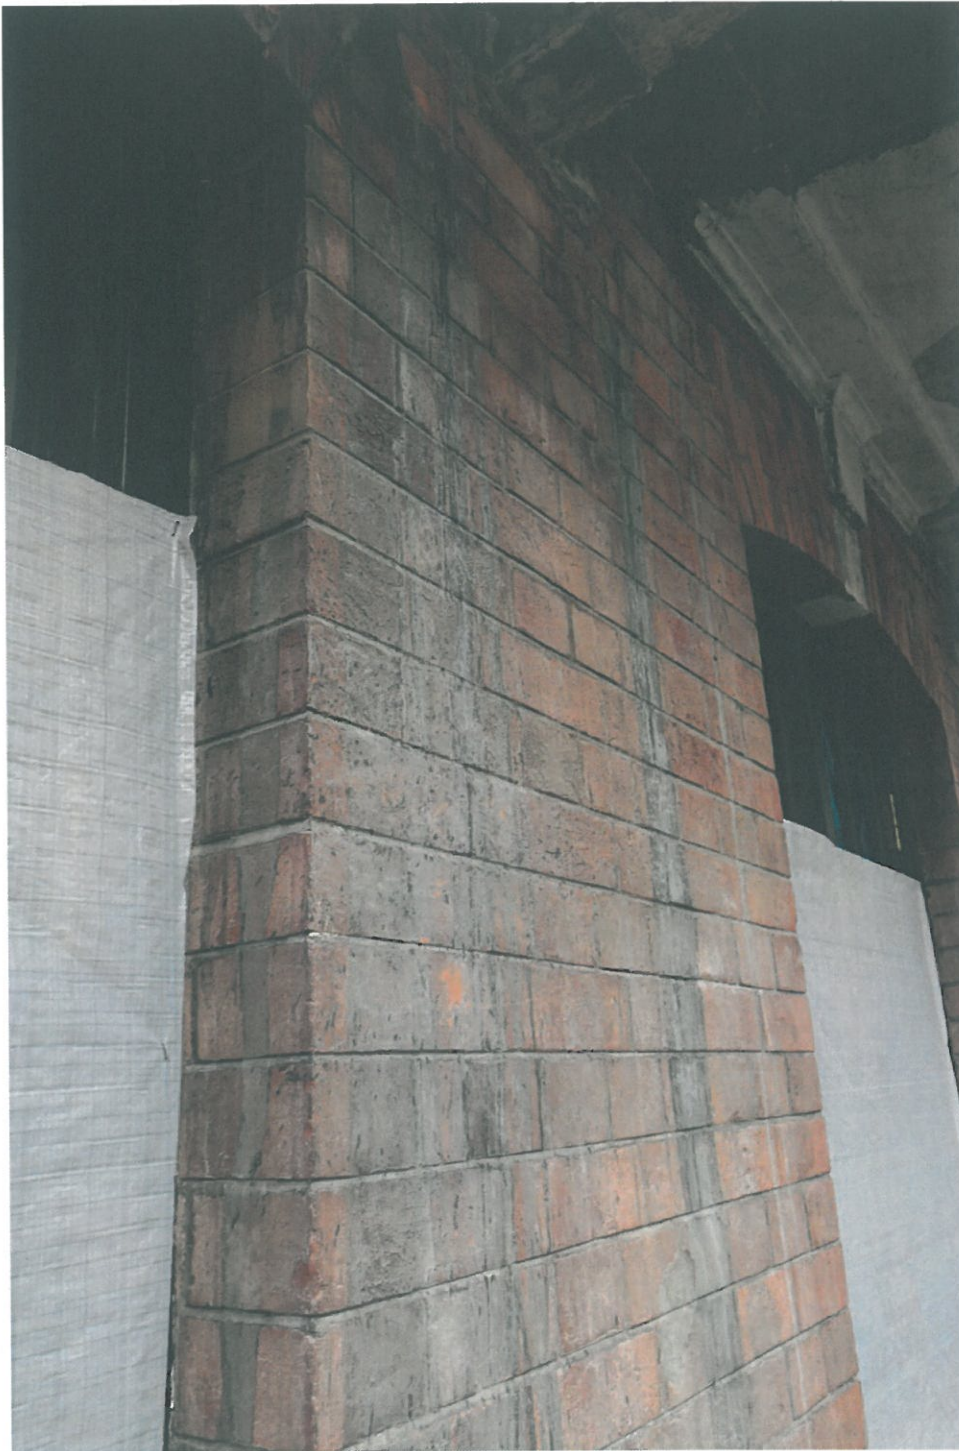
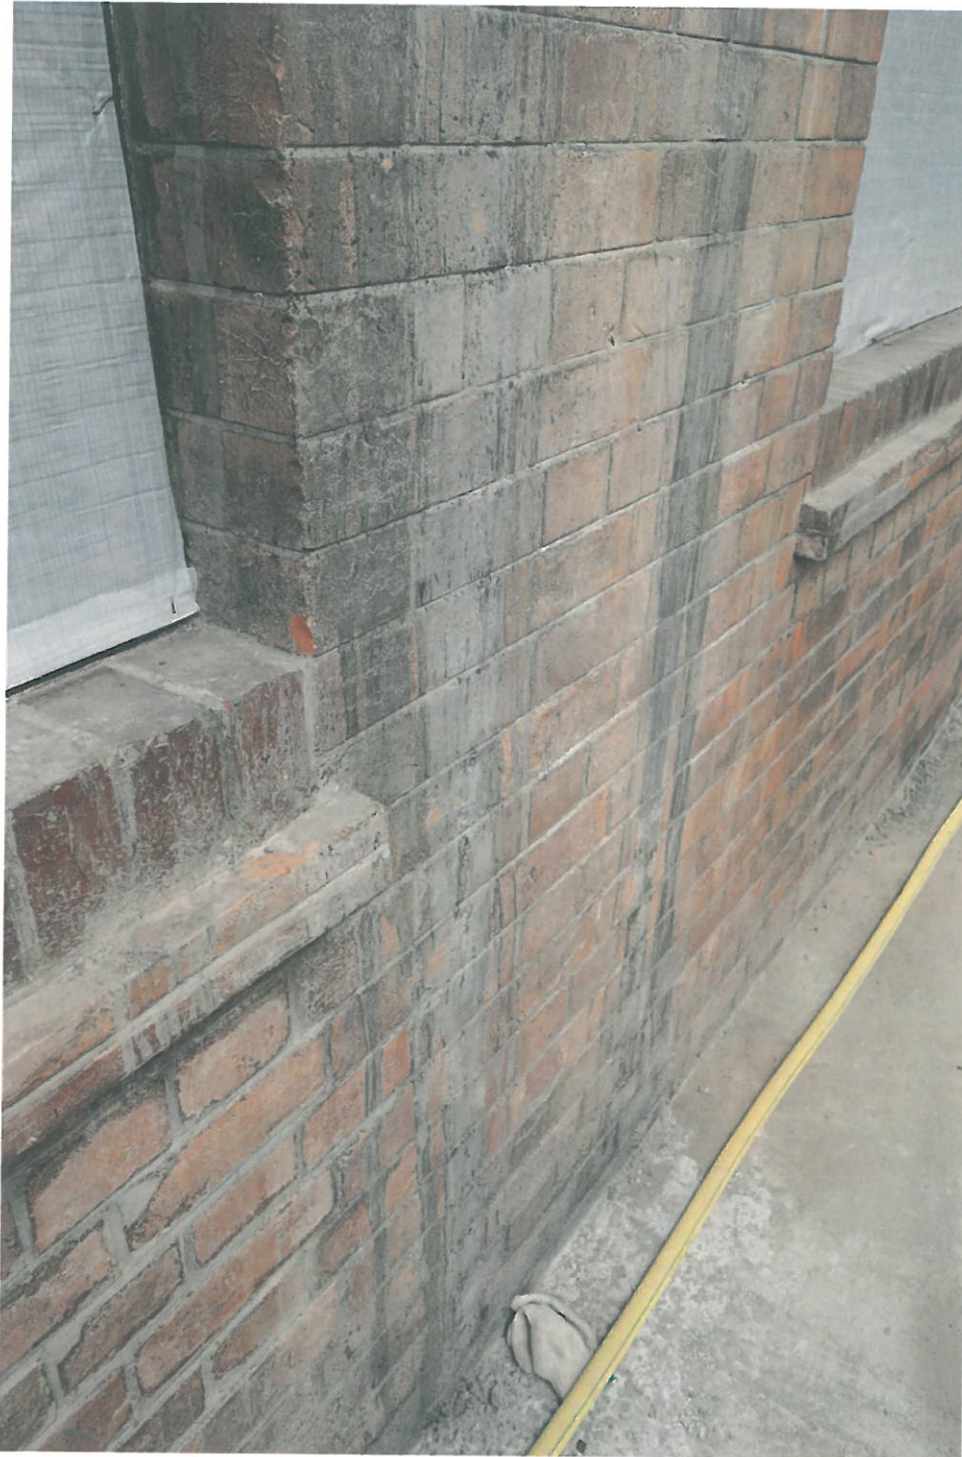
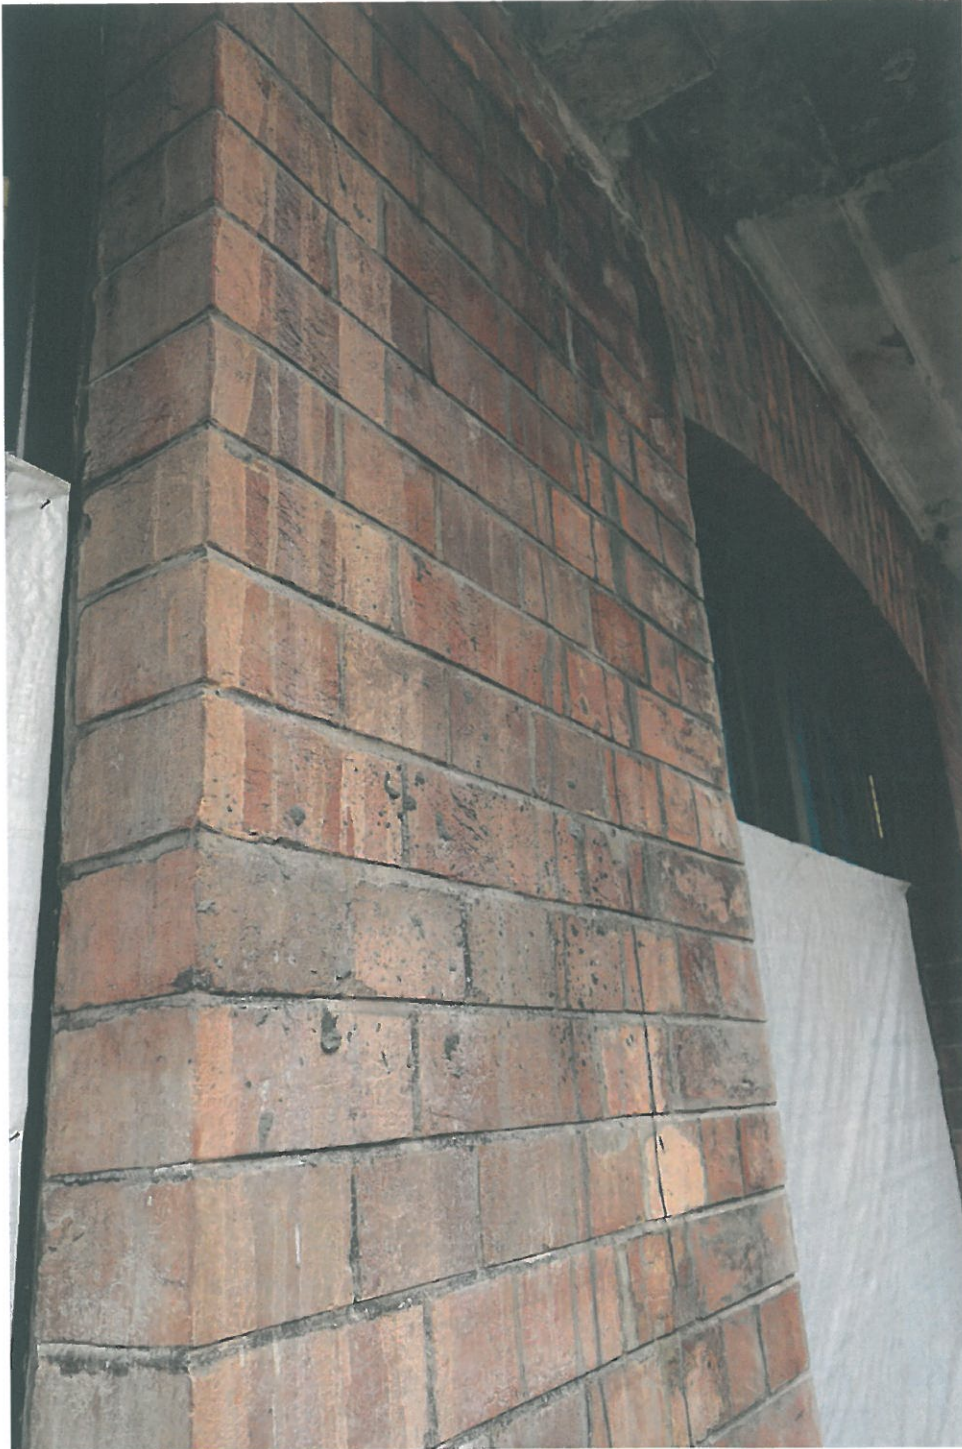
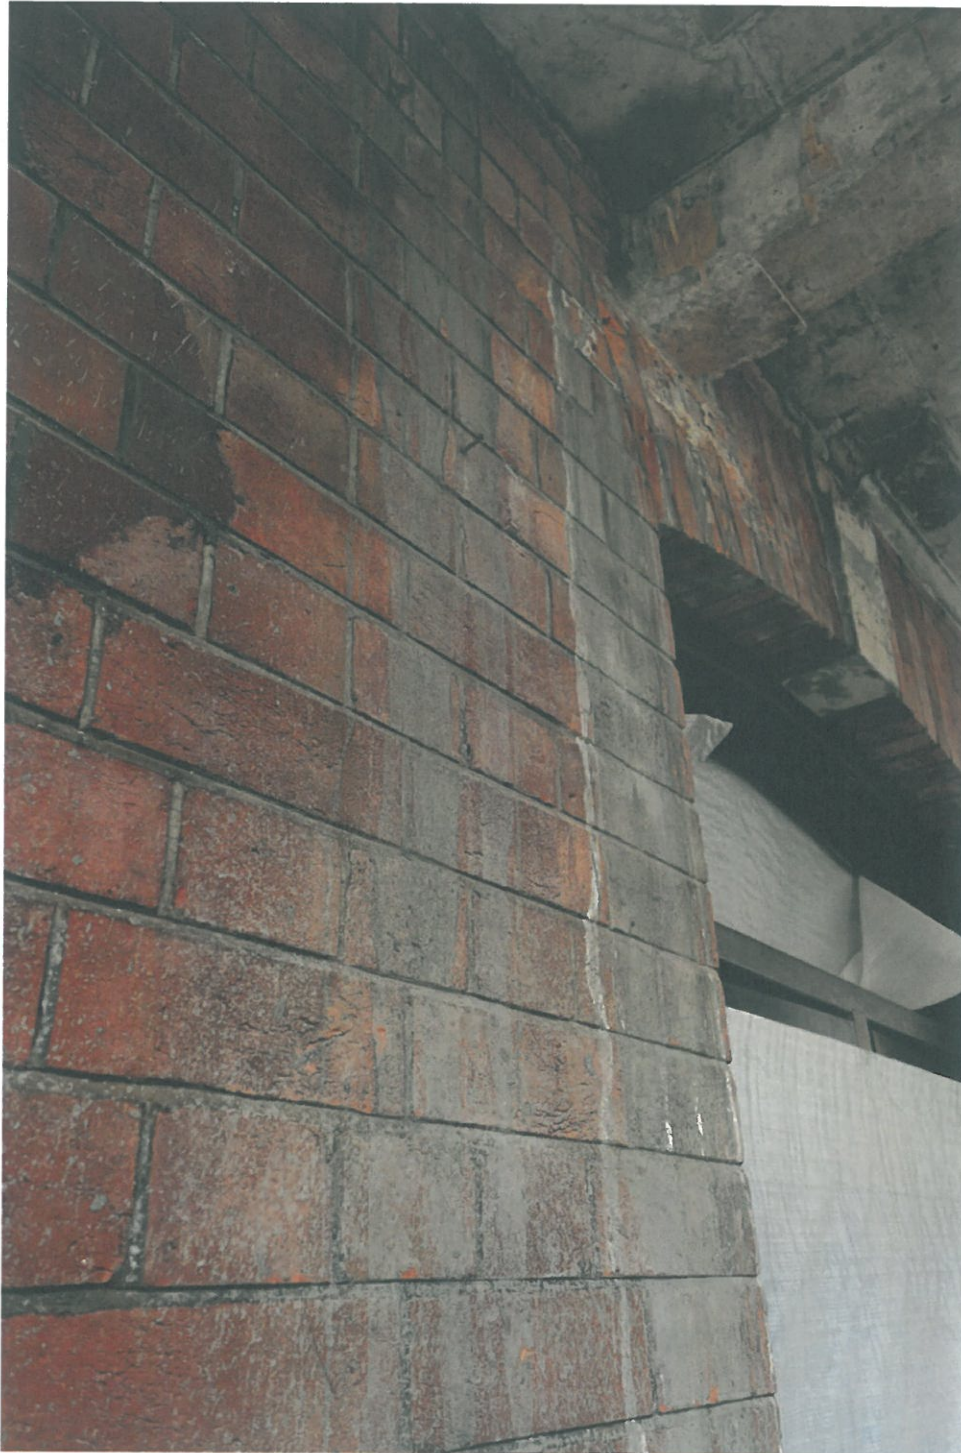
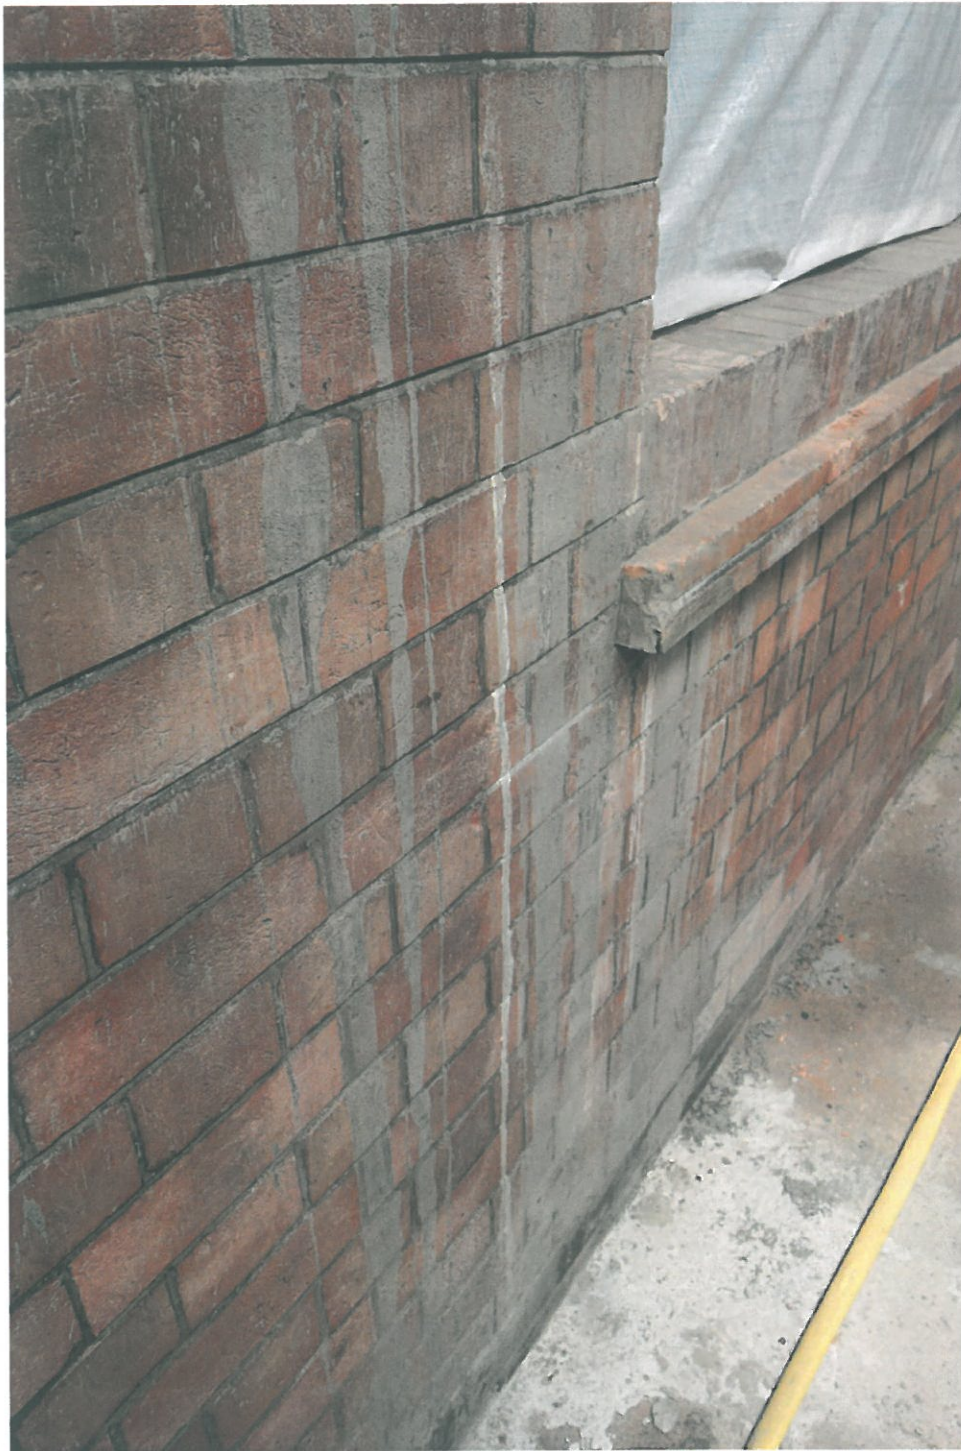
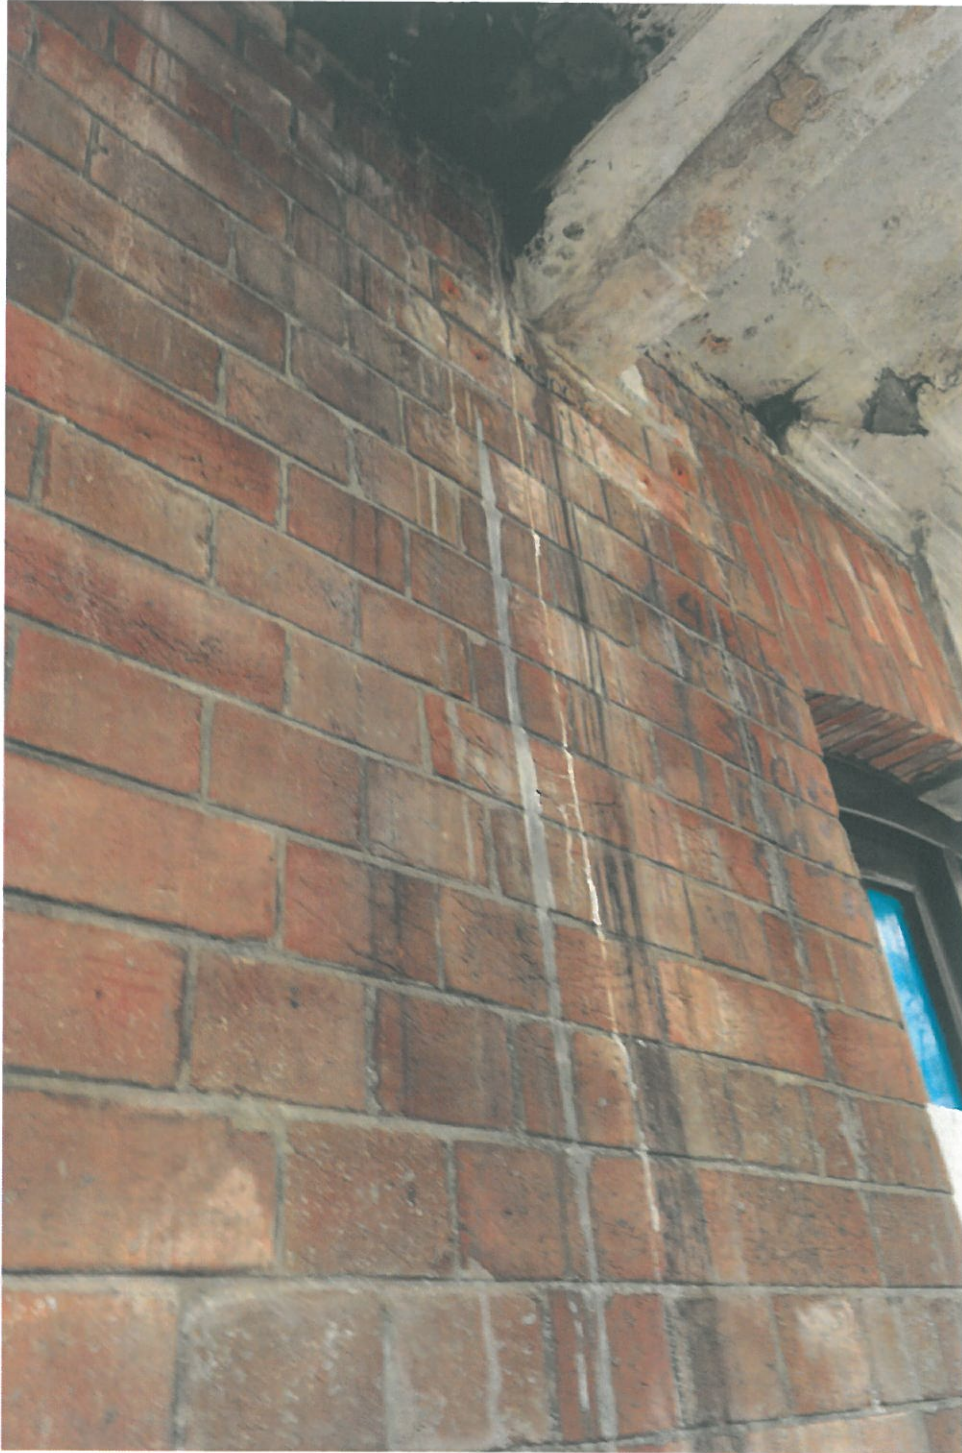
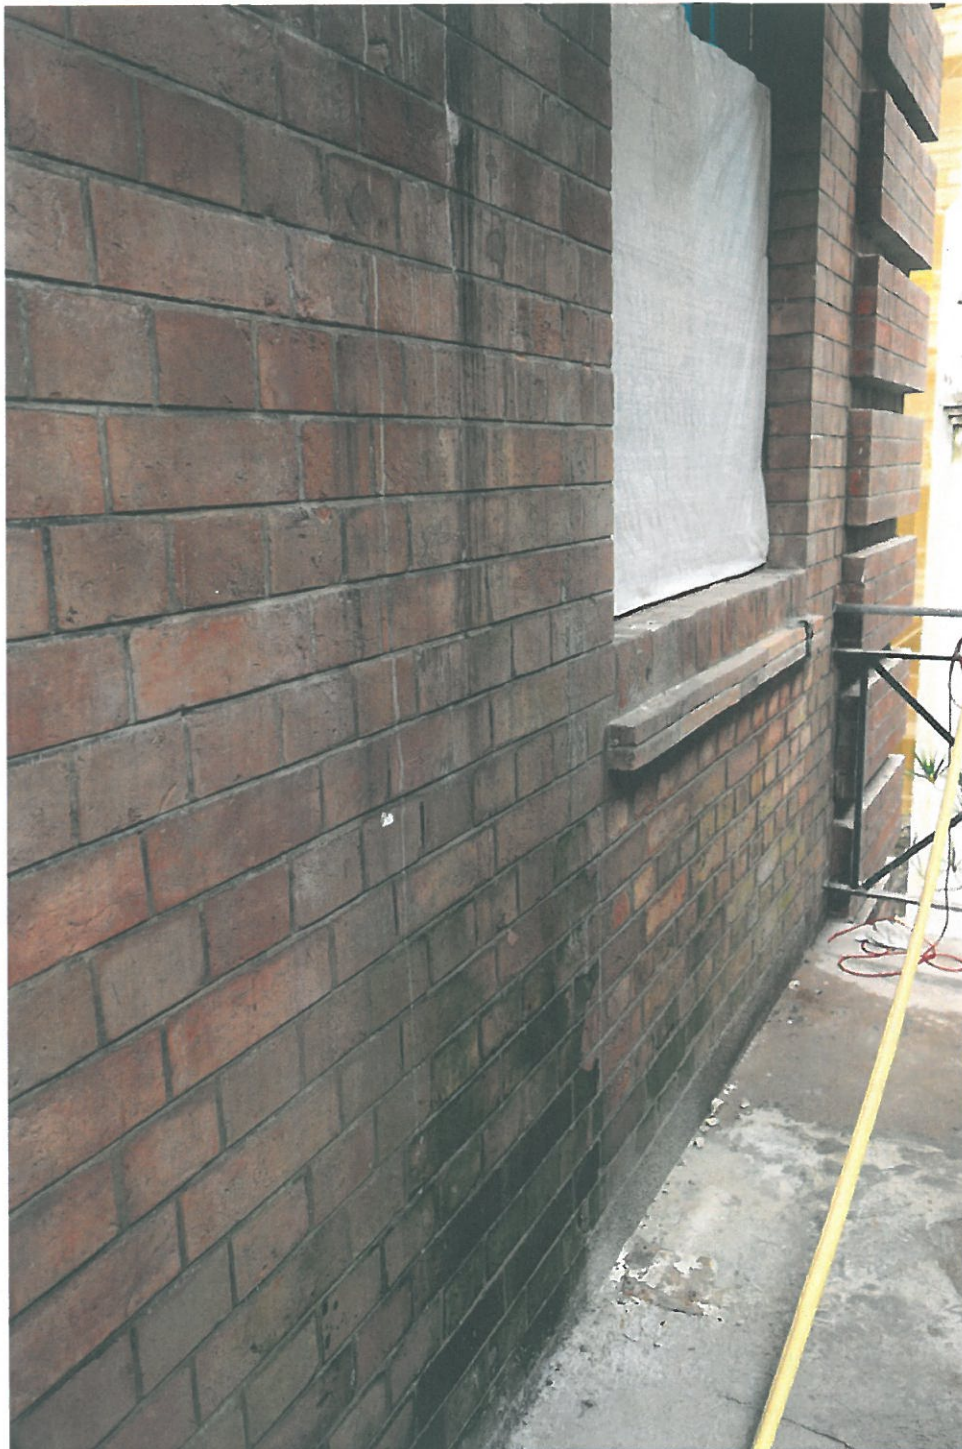
Above, photo taken on 18th March 2016, showing spilt concrete on the Block 9 Magistracy Terrace (2/F West elevation).

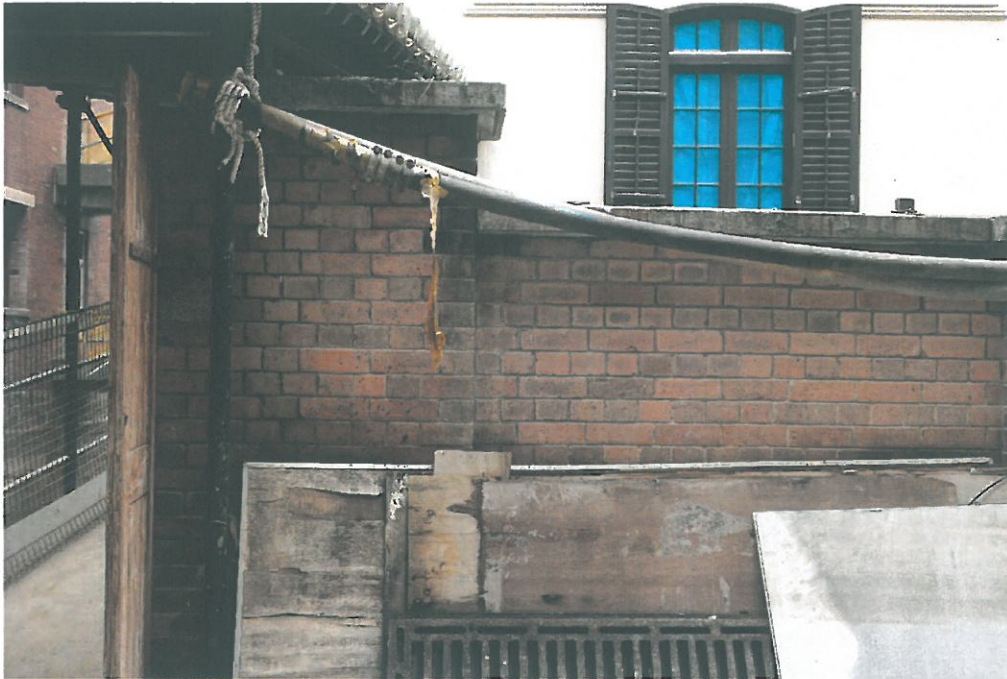
Above, photo taken on 18th March 2016, showing spilt concrete on the boundary wall opposite Block 9 Magistracy West elevation.

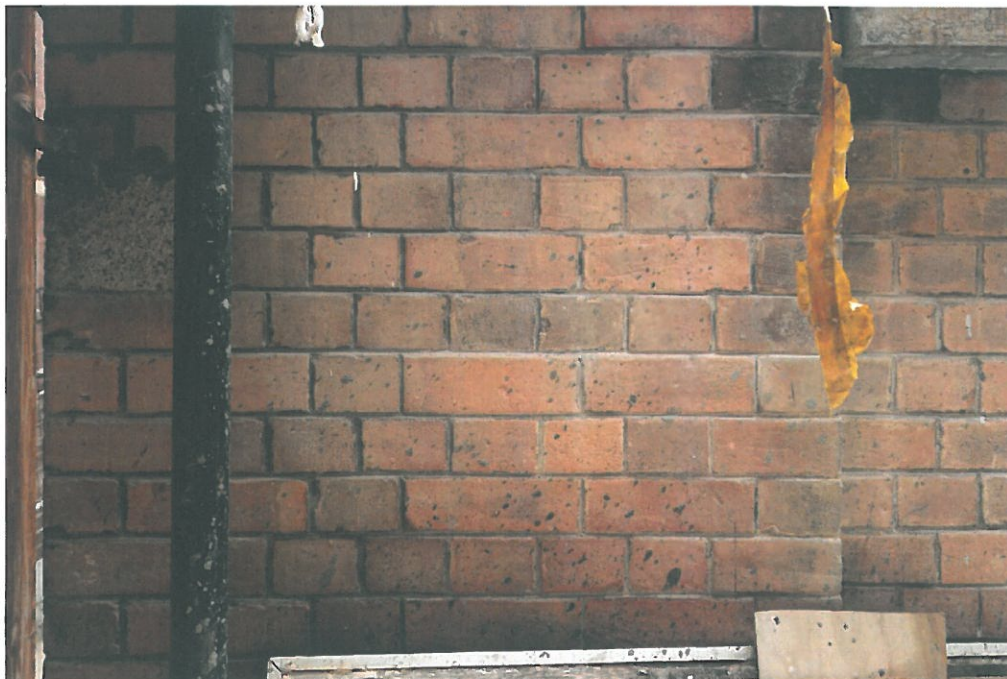
Above, photo taken on 18th March 2016, showing the close-up of the spilt concrete on the boundary wall opposite Block 9 Magistracy West elevation.
