Central Police Station Conservation
and Revitalisation Project:
5th Annual EM&A Review Report
(1 November 2015 to 31 October
2016)

Issue Date: May 2017

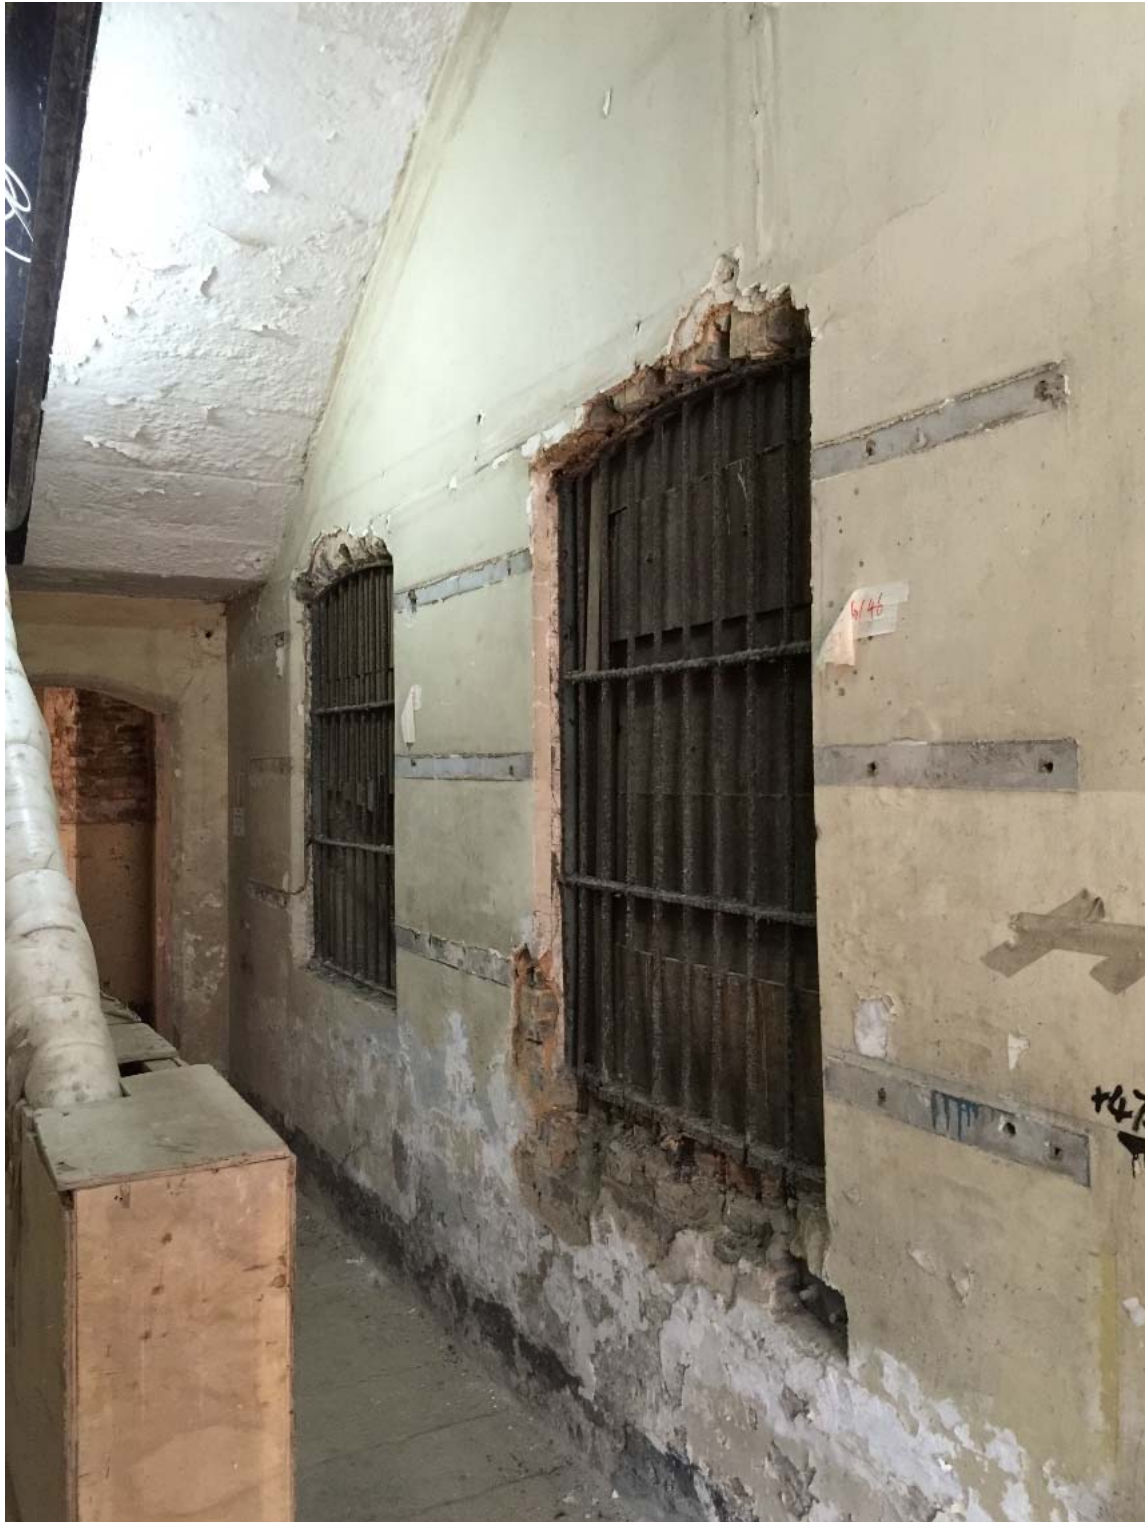
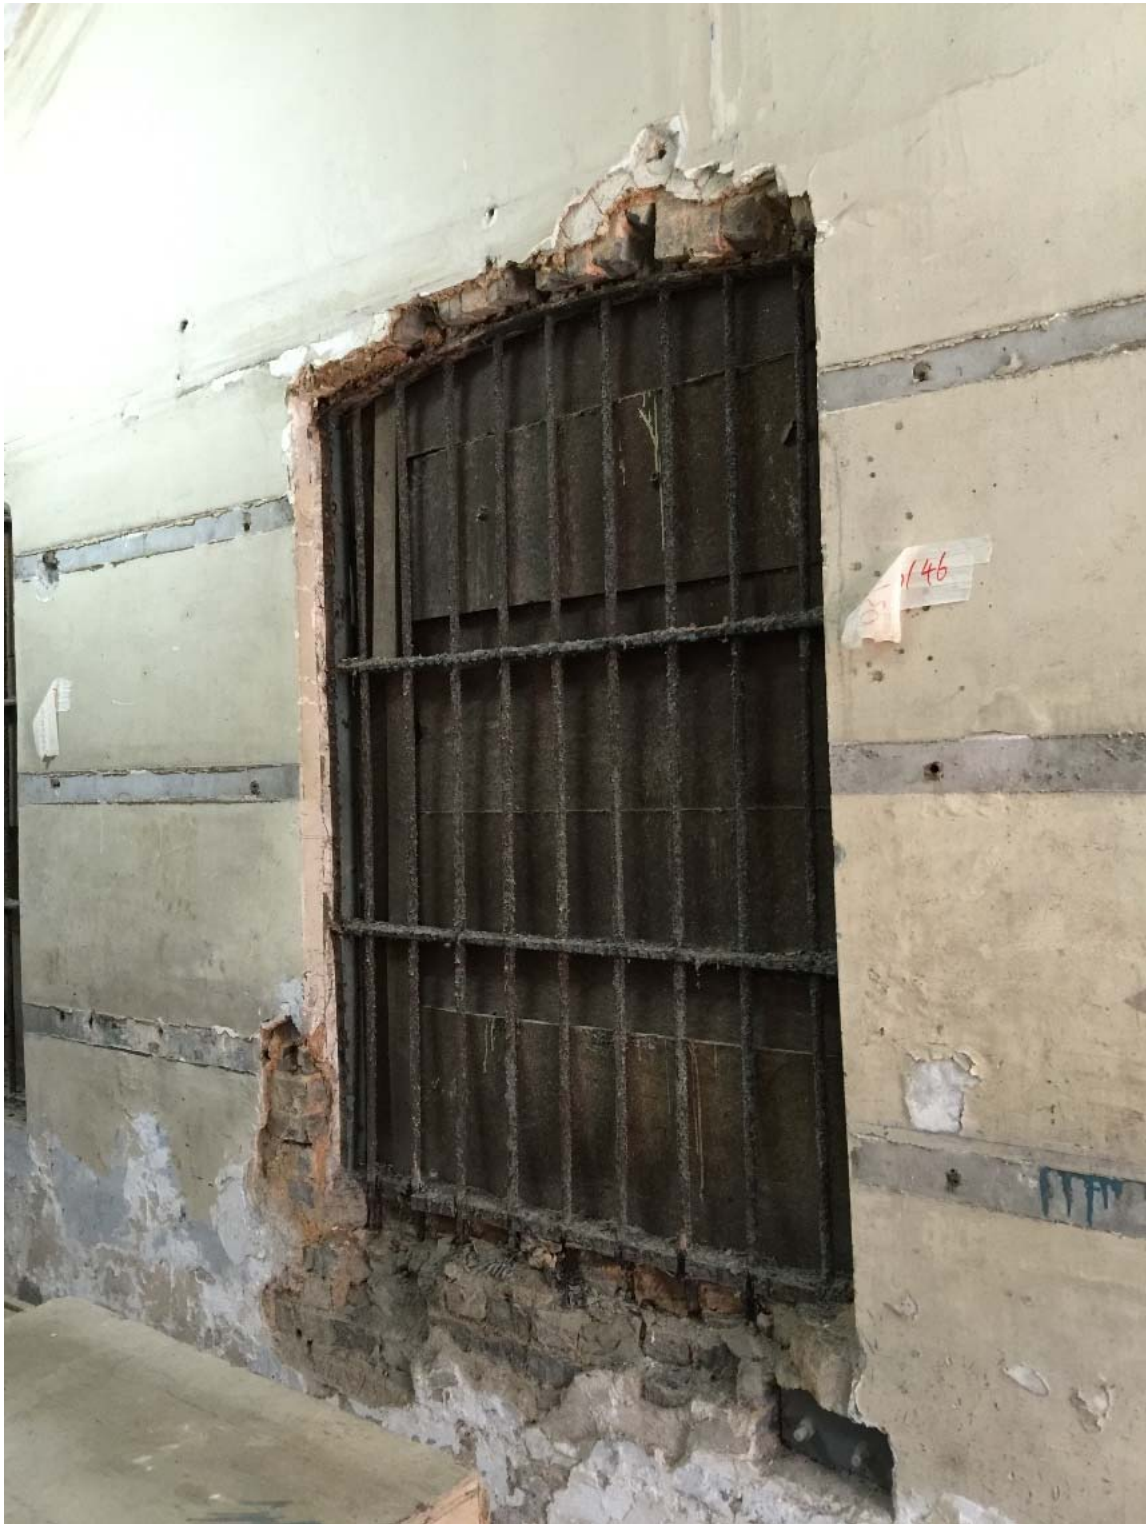
We were informed by the Management Contractor on 24th March 2016 that two security bar screens from windows 03/WG/46 and 03/WG/47 were lost due to improper storage. The contract work includes the removal, repair, redecoration and refixing the two metal bar screens.

Above, photograph taken by the Management Contractor on 10th March 2015, showing the metal bar screen.

1. Review and revise the work practices of the works package contractors and improve the storage procedure of historic fabric.
2. Supervise the work operations to ensure compliance with the Contract Documents.
3. Ensure all measures have been fully exhausted to locate the missing metal bar screens, if the screens still cannot be located within seven days of this notice, notify the Conservation Architect and submit proposals to fabricate two metal bar screen to match the existing pattern in like for like materials at neutral cost to the contract.

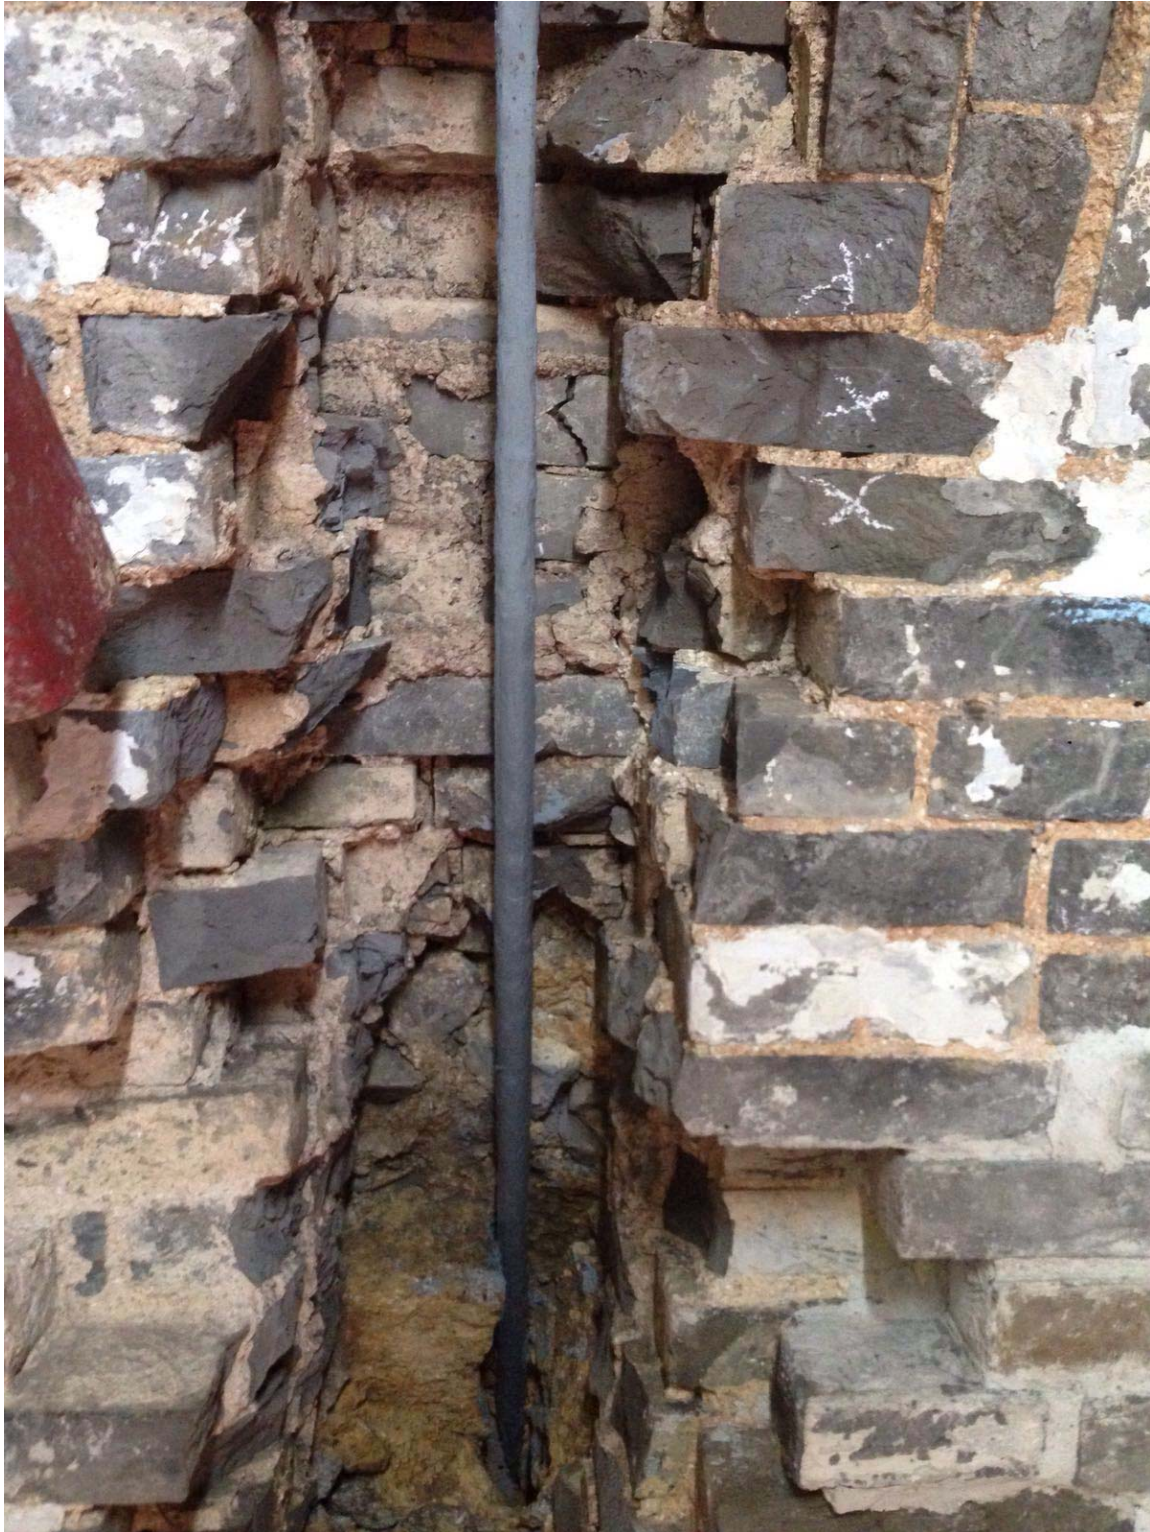
Cracks on the brickwork vault were observed in Lower Ground Floor of Block 14. A method of “Helifix system” was proposed to repair the cracks on the brickwork vault dated 19th March 2016. However we were informed by the Management Contractor on 14th April 2016 that the brickwork adjacent to the cracks had been removed to fully expose the tie bars embedded within the brickwork vault. This works had not been instructed and we believe this work was unnecessary which has damaged the existing building fabric.

Photograph taken by the Management Contractor. The existing brickwork vault was damaged due to the exposure of tie bars.

1. Review and revise the work practices of the works package contractors to ensure that the Conservation Architect have been consulted for all works related to historic building fabric
2. Supervise the work operations to ensure compliance with the Contract Documents.
3. Assess the extent of damage, submit rectification proposal to the Conservation Architect and prevent recurrence.

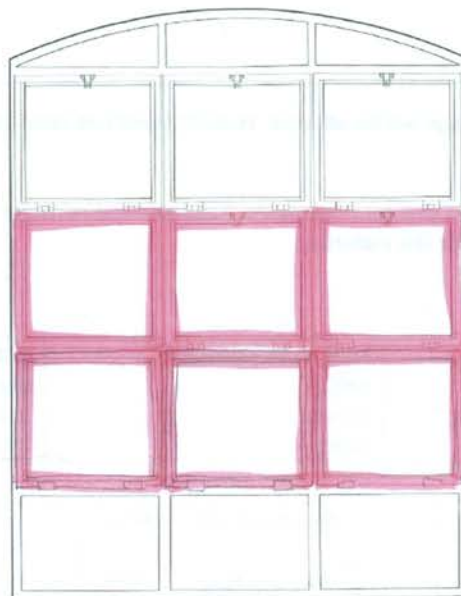
MARK-UP FOR METAL
CASEMENTS TO FIX SHUT

- Casements to be fixed shut
- No new hinge shall be installed.
- Keep any salvaged hinge in position if feasible.

Above, abstract of site memo 655 dated 26th May 2015, instructing the six casements to be fixed shut.

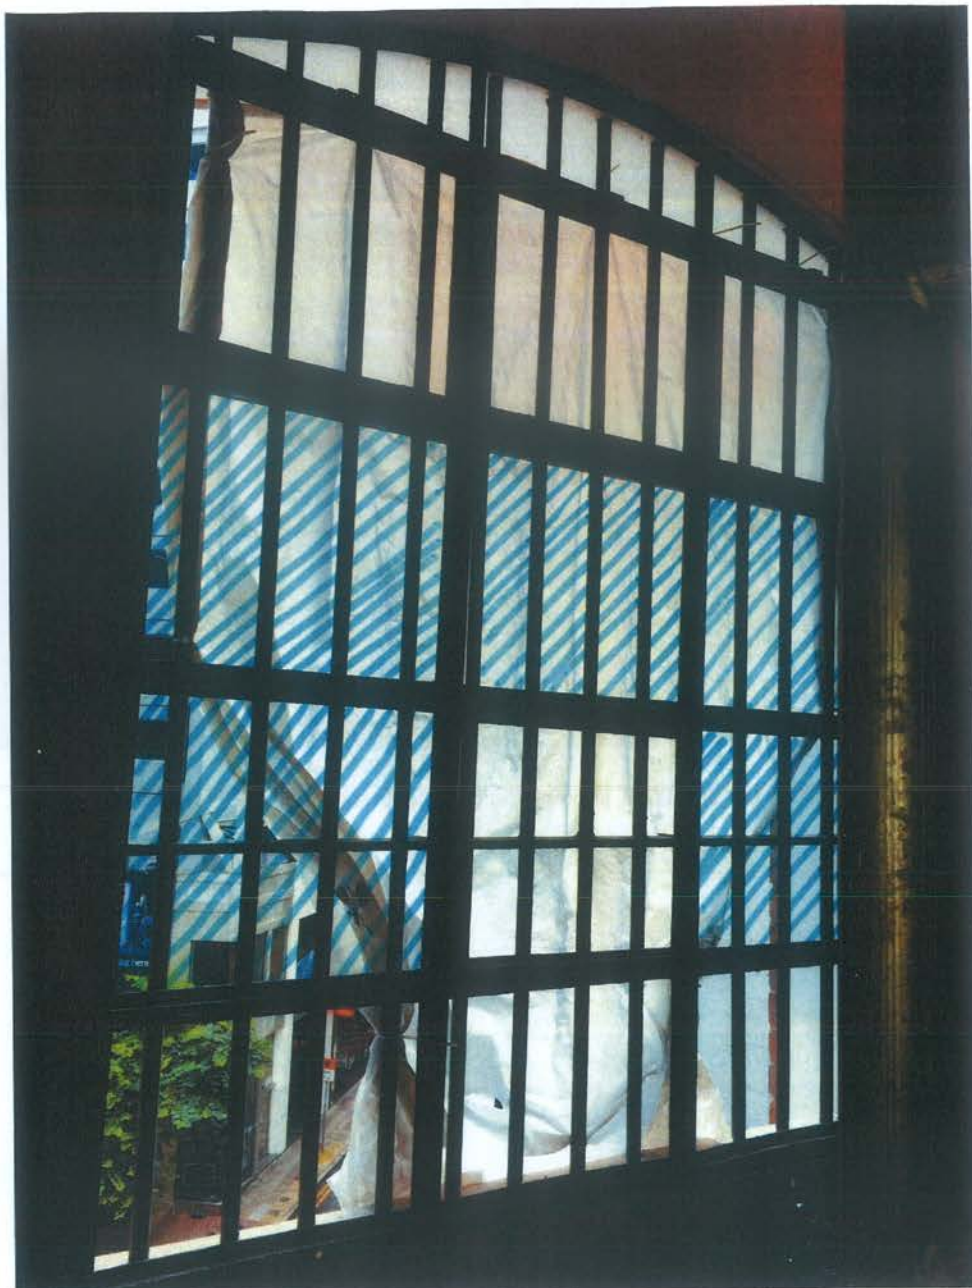
During a site inspection 27th June 2016, it was observed that five metal window casements to 15/WS/14 were missing and had been cut above the hinges. This work is not in accordance with the contract documents. It is assumed that the missing casements have been tipped.

MISSING CASEMENT TO BE REINSTATED.

Above, photograph taken on 15th July, showing the location of missing casements.

1. Review and revise the work practices of the works package contractors.
2. Supervise the work operations to ensure compliance with the Contract Documents.
3. Fabricate and reinstate the five missing metal casements with hinges to match the existing pattern in like for like materials at neutral cost to the contract.

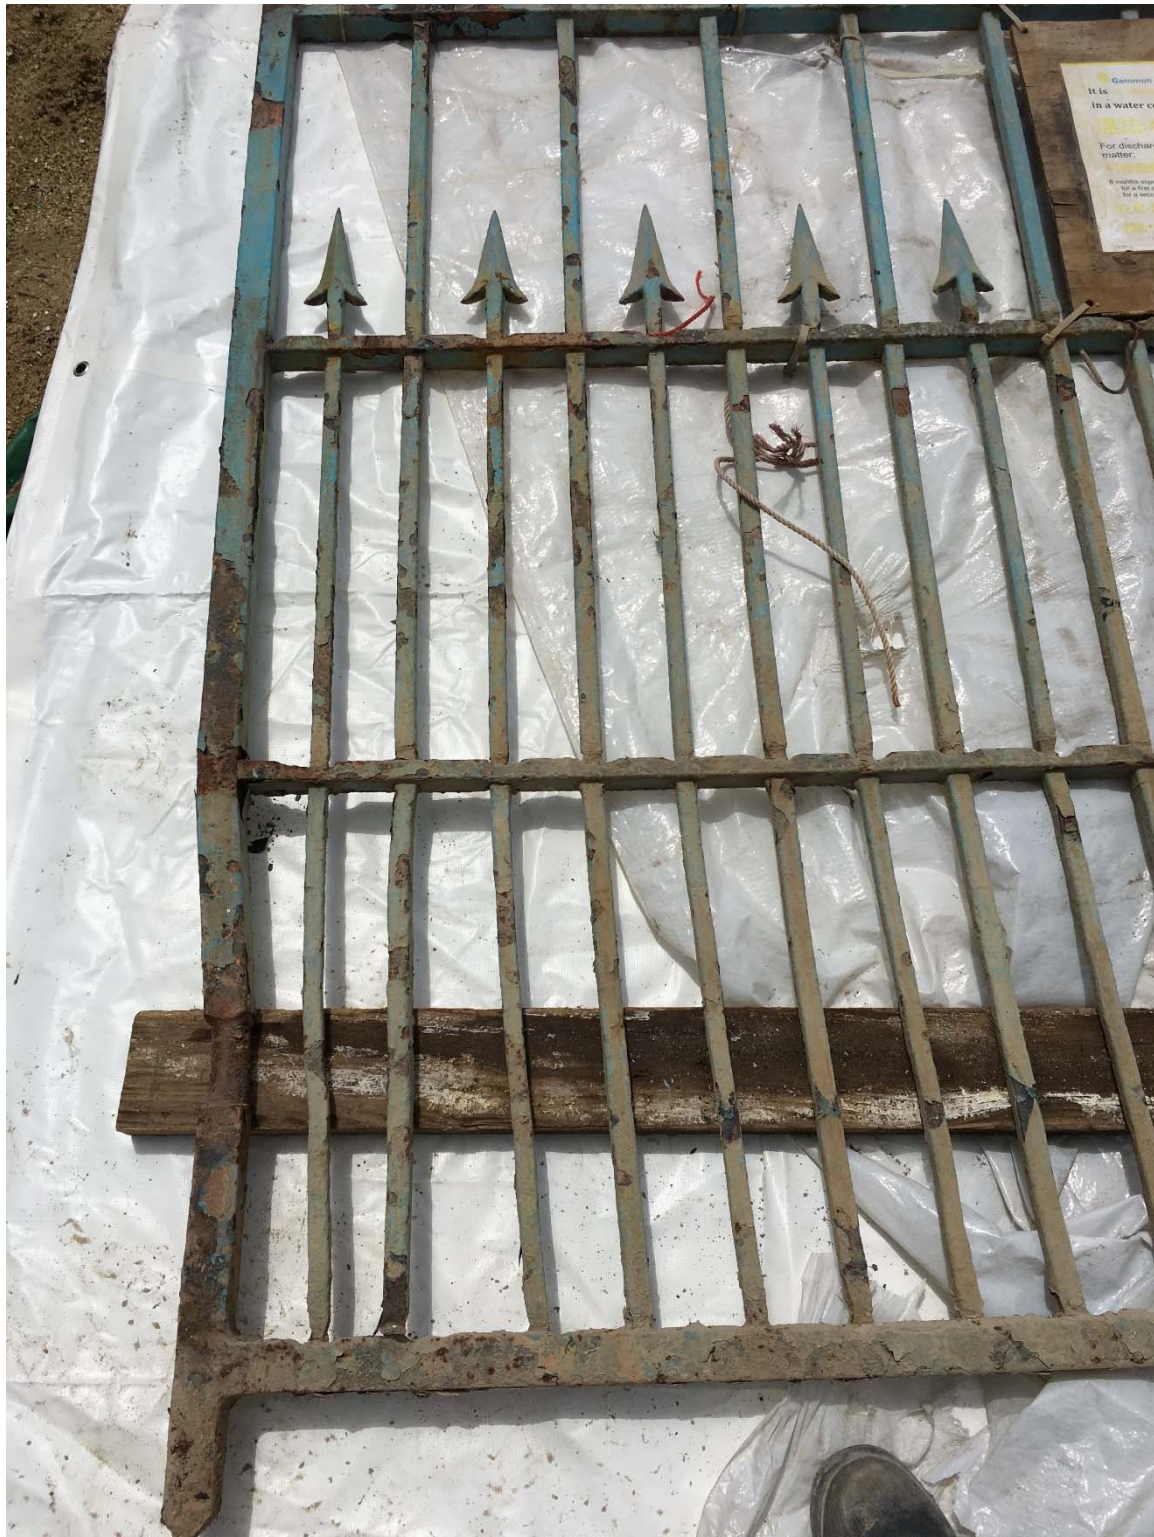
Above, photo taken on 21st July 2016, showing the bottom of the right hand side leaf was out of shape.

1. Review and revise the work practices of the works package contractors and improve the storage procedure of historic fabric.
2. Supervise the work operations to ensure compliance with the Contract Documents.
3. Repair and reinstate the gate at neutral cost to the contract, a separate instruction will be given for the repairs.

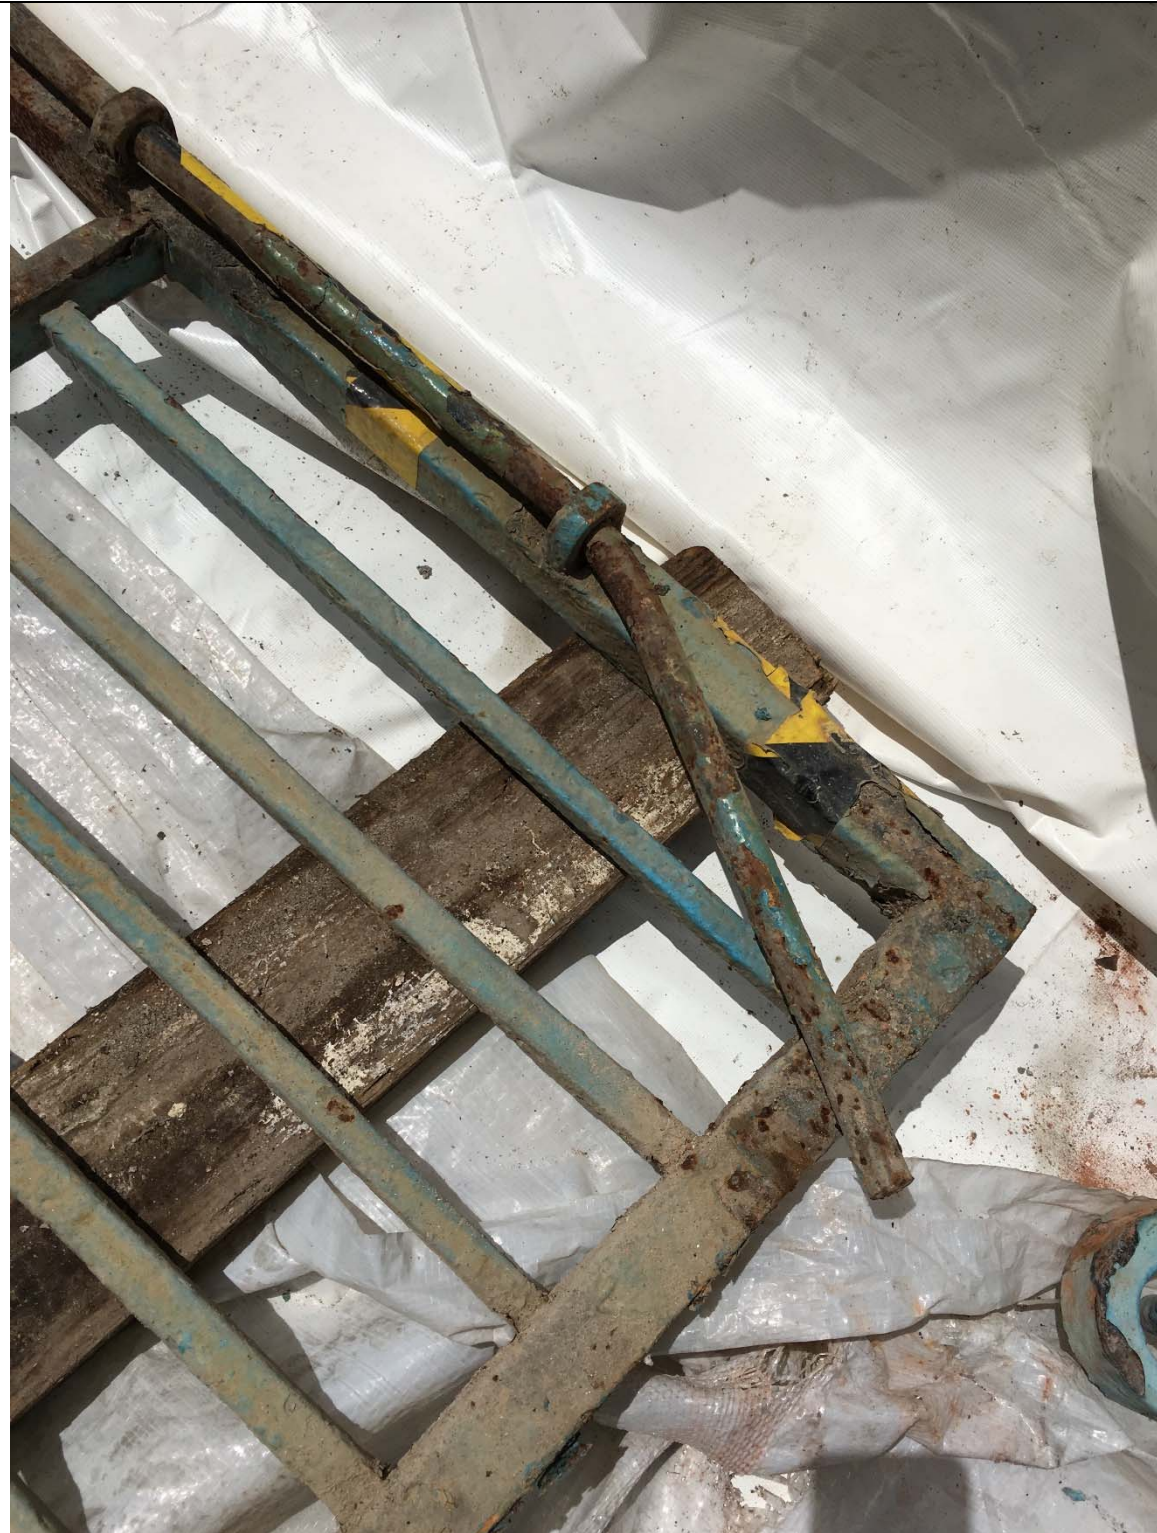
Above, photo taken on 21st July 2016, showing the drop bolt on the right hand side leaf was bent.

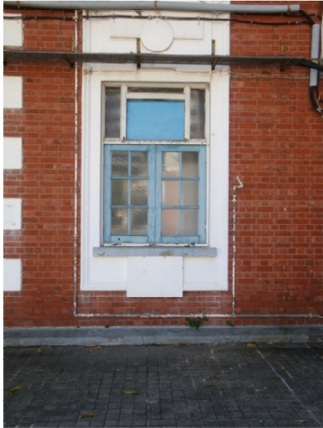
Element no.	Description	Photo ref	Significance	Proposal	Mitigation	Impact
01.016	Altered doors and windows

Adverse	Repair or renew as necessary existing frames to match original patterns	Not applicable	High
01.017	Mezzanine floor in room 01/LG1/13

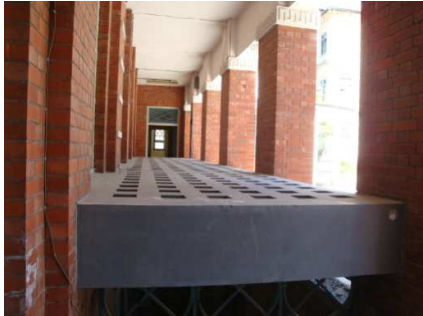
High	Remove existing steel sheet covering [alterations to grilles awaiting confirmation from HdM]		
01.019	Perforated concrete deck above lightwell

Adverse	Remove deck and make good brickwork at abutments	Not applicable	High

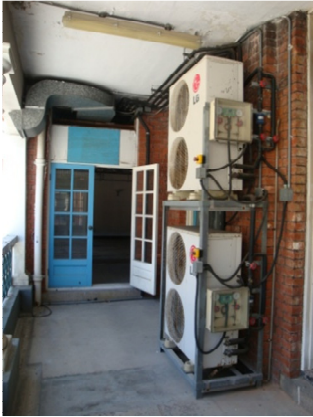
Element no.	Description	Photo ref	Significance	Proposal	Mitigation	Impact
01.020	External airconditioning units and other external services

Adverse	Remove and make good brickwork	Not applicable	High
01.021	Stair balustrades

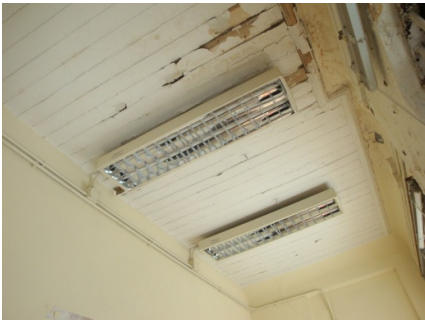
Low	Remove	Record on measured drawings and photographs	Low
01.028	Tongued and grooved flat and sloped timber boarded ceilings

Moderate	Repair where necessary and reinstate where missing	Not applicable	Moderate

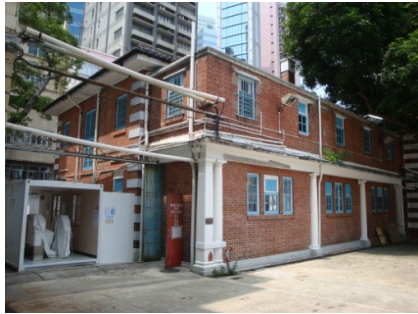
Element no.	Description	Photo ref.	Significance	Proposal	Mitigation	Impact
02.007	Rainwater goods

Adverse	Replace with cast iron in pattern to match original and in correct locations	No applicable	High

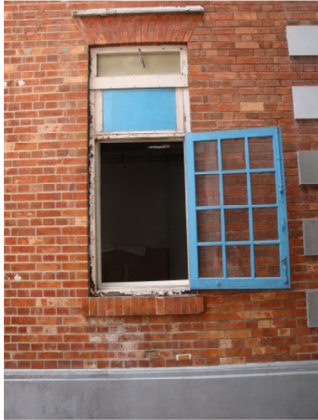
Element no.	Description	Photo ref.	Significance	Proposal	Mitigation	Impact
02.008	Altered doors and windows

Adverse	Repair or renew as necessary existing frames to match original patterns	Not applicable	High

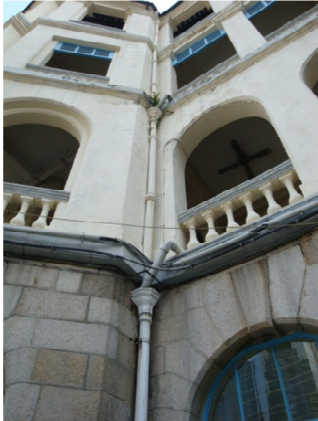
Element no.	Description	Photo ref.	Significance	Proposal	Mitigation	Impact
03.007	Rainwater goods

Adverse	Replace with cast iron in pattern to match original and in correct locations	No applicable	High

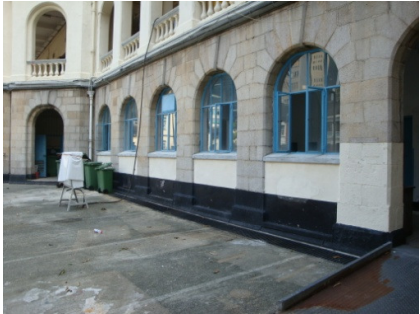
Element no.	Description	Photo ref.	Significance	Proposal	Mitigation	Impact
03.008	Exterior decorations

Adverse	Strip off and redecorate	Sample and analyse existing paint media; select new media to suit substrate and significance	High
03.009	Block existing door openings

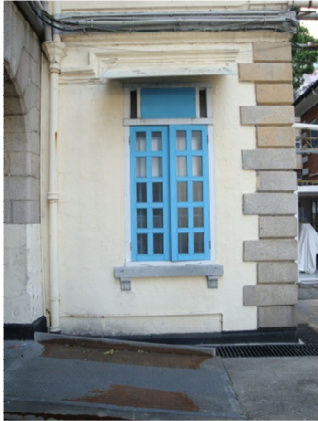
Element no.	Description	Photo ref.	Significance	Proposal	Mitigation	Impact
03.011	Altered doors and windows

Adverse	Repair or renew as necessary existing frames to match original patterns	Not applicable	High

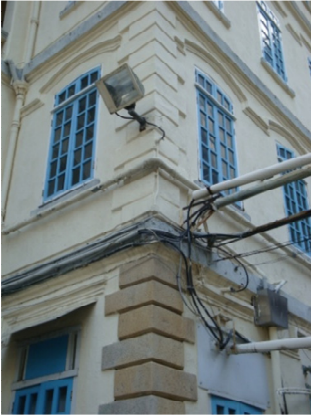
Element no.	Description	Photo ref.	Significance	Proposal	Mitigation	Impact
03.012	External airconditioning units and other external services

Adverse	Remove and make good brickwork	Not applicable	High
03.013	Stair balustrades

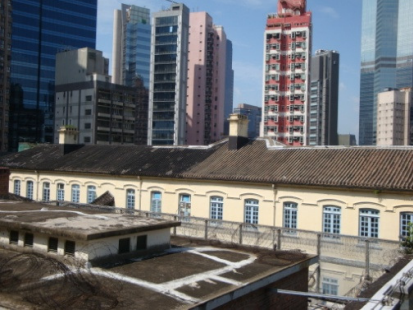
Element no.	Description	Photo ref.	Significance	Proposal	Mitigation	Impact
03.016	Pitched roofs

High	New penetrations through roofs for ventilation ducts and other services	<p>Arrange new penetrations so that they conform with the geometry of the existing roof.</p> <p>Model the size and shape of the new ducts so that the impact on the roofscape is minimised.</p> <p>Finish the new ducts in a non-reflective material that is neutral in colour and mid-tone.</p>	High
03.017	Lean-to structure adjacent North wall

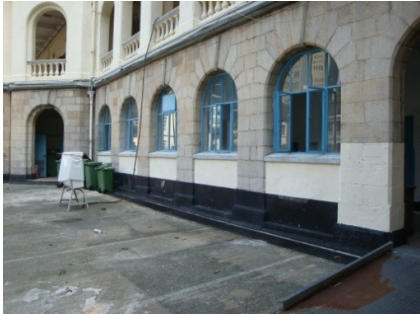
Element no.	Description	Photo ref.	Significance	Proposal	Mitigation	Impact
03.018	Metal-frames windows at GF North elevation

Adverse	Remove window frames, masonry spandrel panels below and reinstate verandah	Not applicable	High
03.019	Internal walls at Ground Floor level

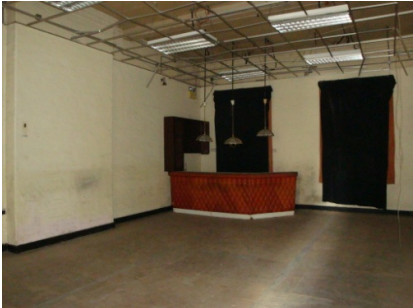
Element no.	Description	Photo ref.	Significance	Proposal	Mitigation	Impact
03.020	Assembly rooms at centre of building (all floors)

Moderate	Sub-divide two rooms on each floor to provide service core, comprising: lifts, toilets, plant rooms, stores	Form new sub-visions using lightweight partitions to achieve reversibility. Form straight joints at abutments with existing retained walls. Notch new partitions around existing brick corbels at high level as a reminder of current condition.	Moderate
03.021	Exposed soffits of timber floors

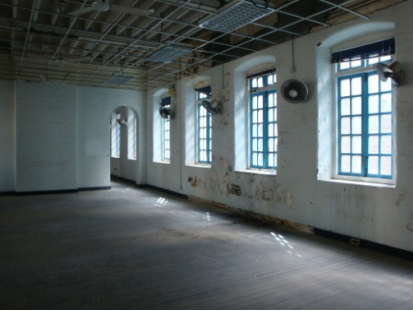
Element no.	Description	Photo ref.	Significance	Proposal	Mitigation	Impact
03.022	Existing window frames/openings

High	Open up selected openings to form new fire escape doors	Retain any salvageable material for possible re-use elsewhere. Retain existing window jambs intact. Cut away masonry to form door openings along same line as window jamb; do not re-bind cut brickwork. Record existing condition on measured survey drawings.	Low
03.023	Single storey outbuildings on south side

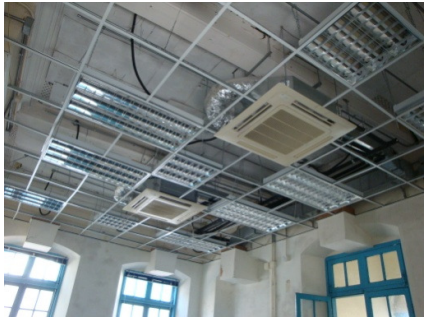
Element no.	Description	Photo ref.	Significance	Proposal	Mitigation	Impact
04.001	Lay-in grid suspended ceiling

Adverse	Remove	Not applicable	High
04.002	Timber thresholds at external doors and internal doors between main corridor and individual rooms

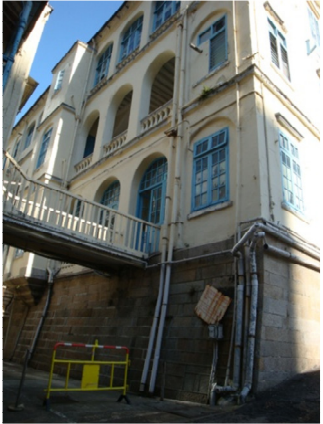
Element no.	Description	Photo ref.	Significance	Proposal	Mitigation	Impact
04.004	Rainwater goods

Adverse	Replace with cast iron in pattern to match original and in correct locations	No applicable	High

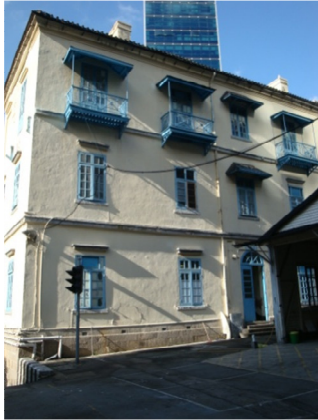
Element no.	Description	Photo ref.	Significance	Proposal	Mitigation	Impact
04.005	Exterior decorations

Adverse	Strip off and redecorate	Sample and analyse existing paint media; select new media to suit substrate and significance	High

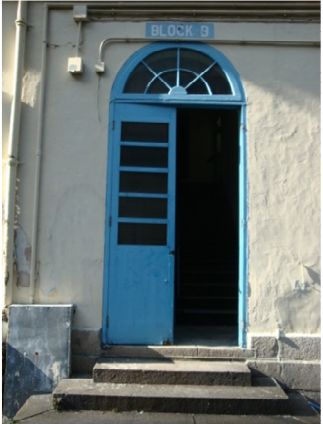
Element no.	Description	Photo ref.	Significance	Proposal	Mitigation	Impact
04.008	Altered doors and windows

Adverse	Repair or renew as necessary existing frames to match original patterns	Not applicable	High

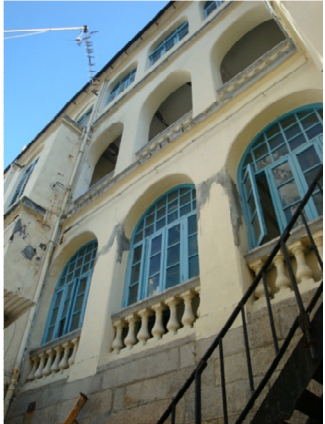
Element no.	Description	Photo ref.	Significance	Proposal	Mitigation	Impact
04.009	Window frames in arcades of North and East elevations

Adverse	Remove window frames and make good masonry reveals and reinstate verandah	Not applicable	High

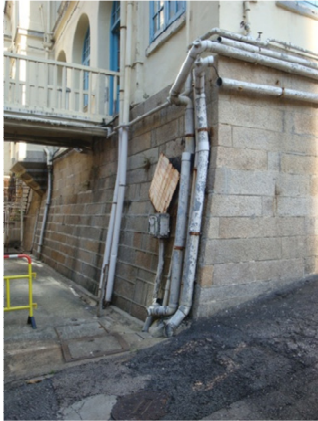
Element no.	Description	Photo ref.	Significance	Proposal	Mitigation	Impact
04.010	External airconditioning units and other external services

Adverse	Remove and make good brickwork	Not applicable	High

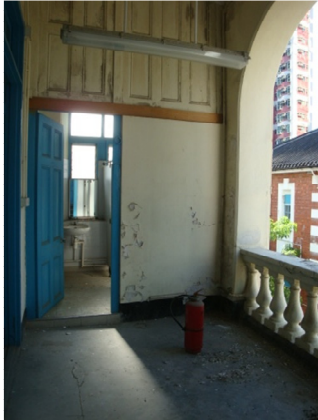
Element no.	Description	Photo ref.	Significance	Proposal	Mitigation	Impact
04.017	Toilets at ends of verandahs

Adverse	Remove and make good finishes	Not applicable	High

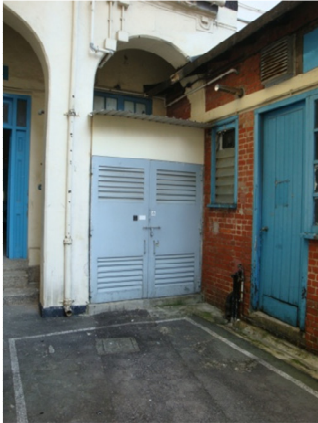
Element no.	Description	Photo ref.	Significance	Proposal	Mitigation	Impact
04.019	Switchgear in old porch 04/G/13

Adverse	Open up porch, remove electrical switchgear and make good	Not applicable	High

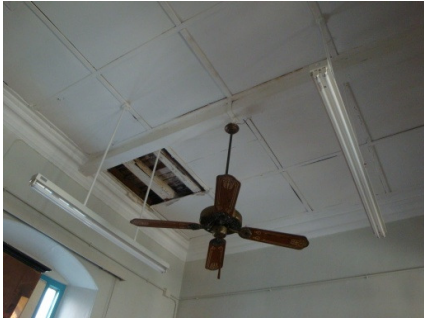
Element no.	Description	Photo ref.	Significance	Proposal	Mitigation	Impact
04.020	Flat plywood ceiling lining with plain rectangular cover battens

Adverse	Replace with T&G boarding to match existing	Not applicable	High

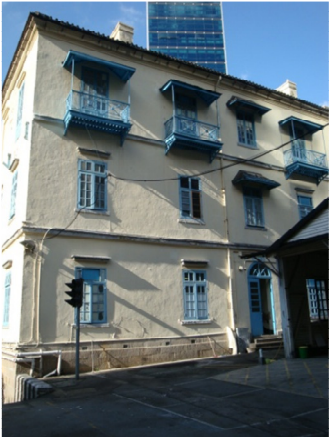
Element no.	Description	Photo ref.	Significance	Proposal	Mitigation	Impact
04.023	Cantilever balconies

High	<p>Retain and repair as necessary.</p> <p>Reinstate balcony on west elevation.</p>	<p>Avoid highly visible intervention to enhance structural integrity and/or compliance with building codes.</p> <p>Restrict access if necessary to achieve this objective.</p>	Low

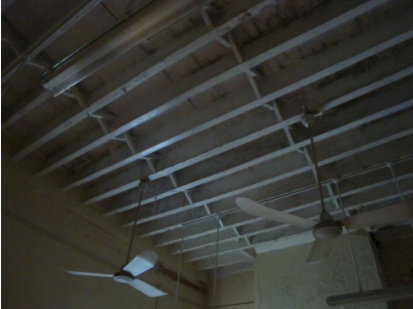
Element no.	Description	Photo ref.	Significance	Proposal	Mitigation	Impact
10.016	Open-joisted ceiling on Ground Floor of south-east wing

Moderate	Underline floor to provide fire protection.	Avoid intrusive alteration. Use fire-proofing products and methods that enable existing structure and boarding to be retained.	Low
10.017	Moulded timber picture rail

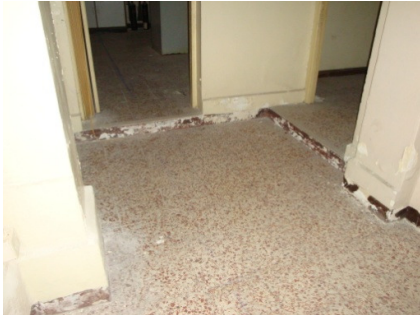
Element no.	Description	Photo ref.	Significance	Proposal	Mitigation	Impact
10.020	Clay/terrazzo tile floor on Ground Floor and steps

Adverse	Adjust levels to enable level access and replace floor finish	Not applicable	Low
10.024	Granite wall on North elevation

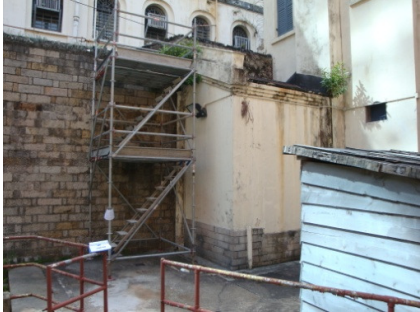
Element no.	Description	Photo ref.	Significance	Proposal	Mitigation	Impact
10.025	Single storey outbuilding at South East corner

Moderate	Demolish outbuilding and make good at abutments	Record outbuilding on measured drawings	Low
10.026	Blocked archway on East elevation

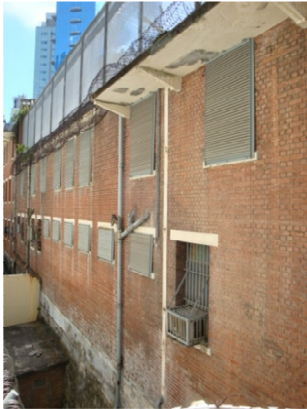
Element no.	Description	Photo ref.	Significance	Proposal	Mitigation	Impact
11.002	External airconditioning units and other external services

Adverse	Remove and make good brickwork	Not applicable	High
11.003	Painted signs

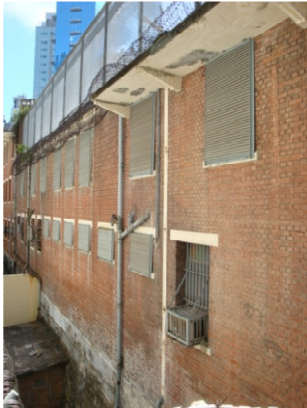
Element no.	Description	Photo ref.	Significance	Proposal	Mitigation	Impact
11.008	Rainwater goods

Adverse	Replace with cast iron in pattern to match original and in correct locations	Not applicable	High

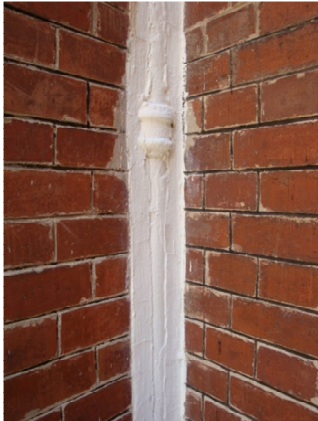
Element no.	Description	Photo ref.	Significance	Proposal	Mitigation	Impact
11.009	Rainwater goods

Low	Remove embedded cast iron pipework set into wall to reduce long term maintenance burden	Record on measured survey drawings. Make good cavity.	Low

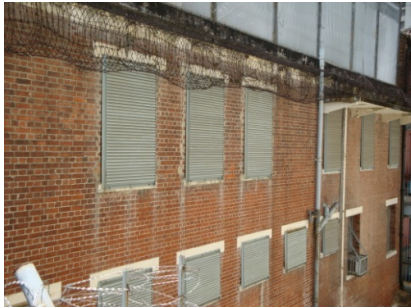
Element no.	Description	Photo ref.	Significance	Proposal	Mitigation	Impact
11.013	Metal louvres on window openings

Adverse	Remove	Not applicable	Low

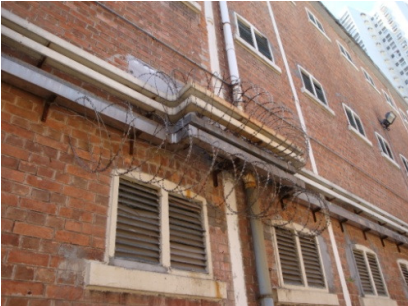
Element no.	Description	Photo ref.	Significance	Proposal	Mitigation	Impact
12.003	External airconditioning units and other external services

Adverse	Remove and make good brickwork	Not applicable	High
12.004	Painted signs

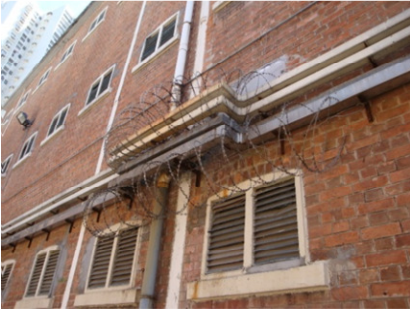
Low-High	Remove and refix/display in visitors' centre/discard	Record each sign and assess significance individually and treat accordingly	N/A
12.006	Rainwater goods

Adverse	Replace with cast iron in pattern to match original and in correct locations	Not applicable	High

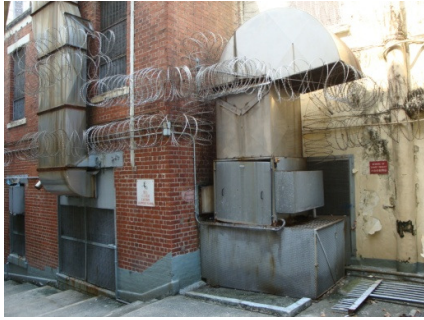
Element no.	Description	Photo ref.	Significance	Proposal	Mitigation	Impact
13.001	External airconditioning units and other external services

Adverse	Remove	Not applicable	Moderate
