The Jockey Club CPS Limited

Central Police Station Conservation
and Revitalisation Project:
73rd Monthly EM&A Report
(1 November to 30 November 2017)

Environmental Resources Management

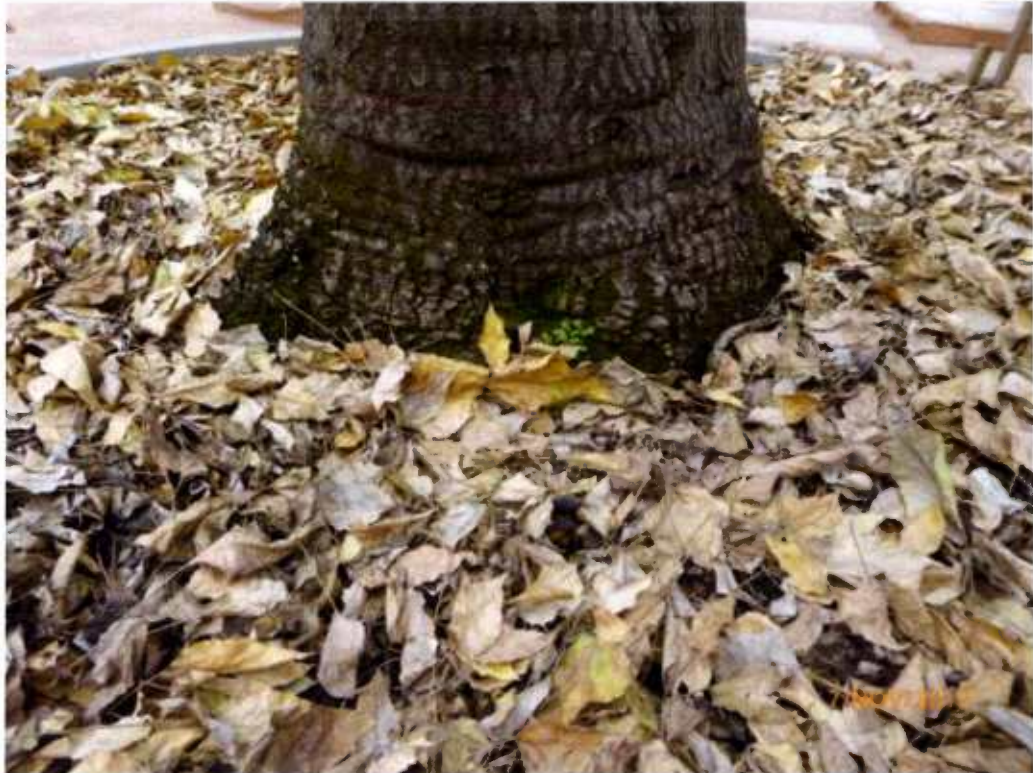
Fig 3. Health condition of the lower trunk is fair.

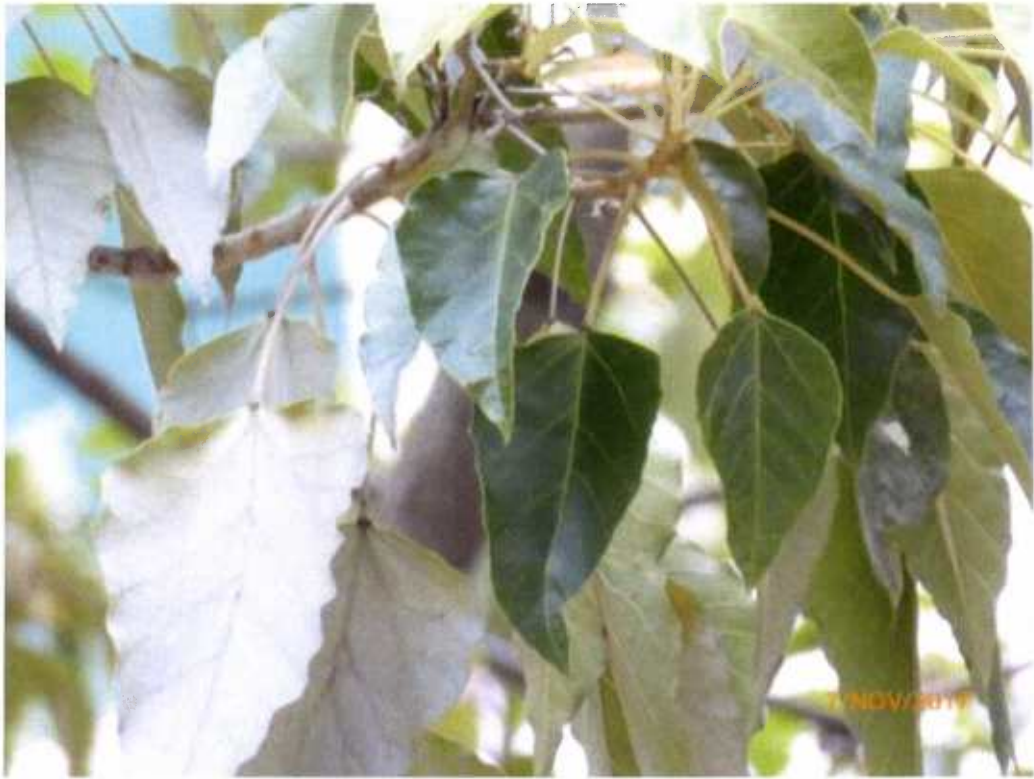
Fig. 9 Flowers still appear on the tree.

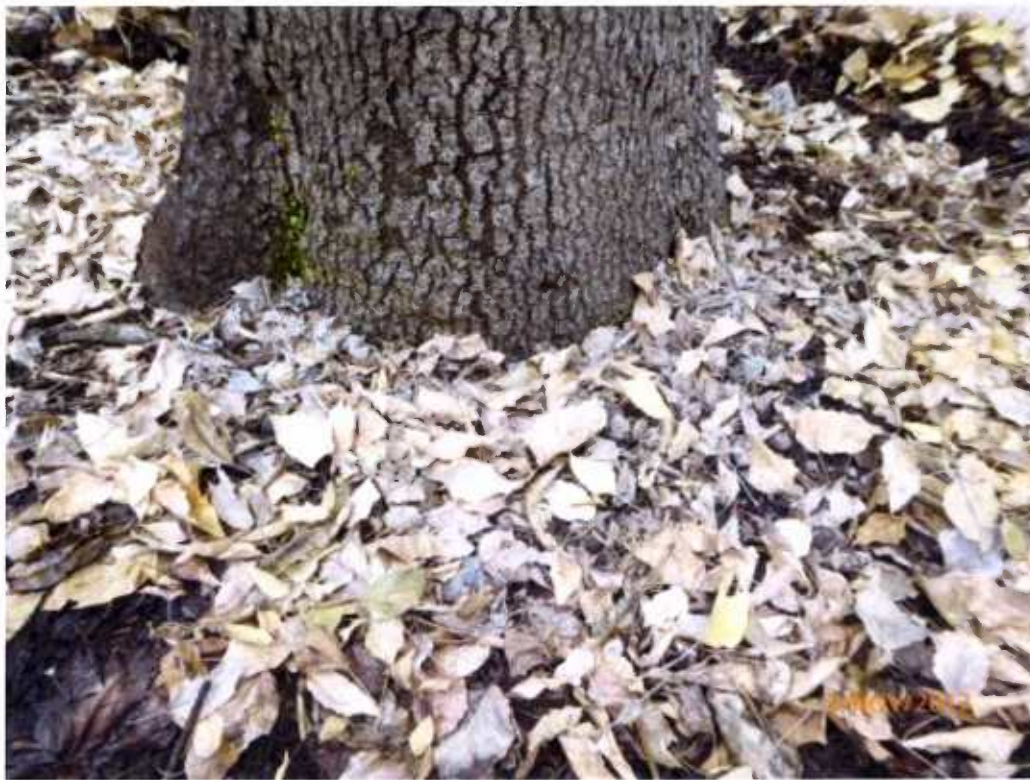
Fig 3. Health condition of the lower trunk is fair.

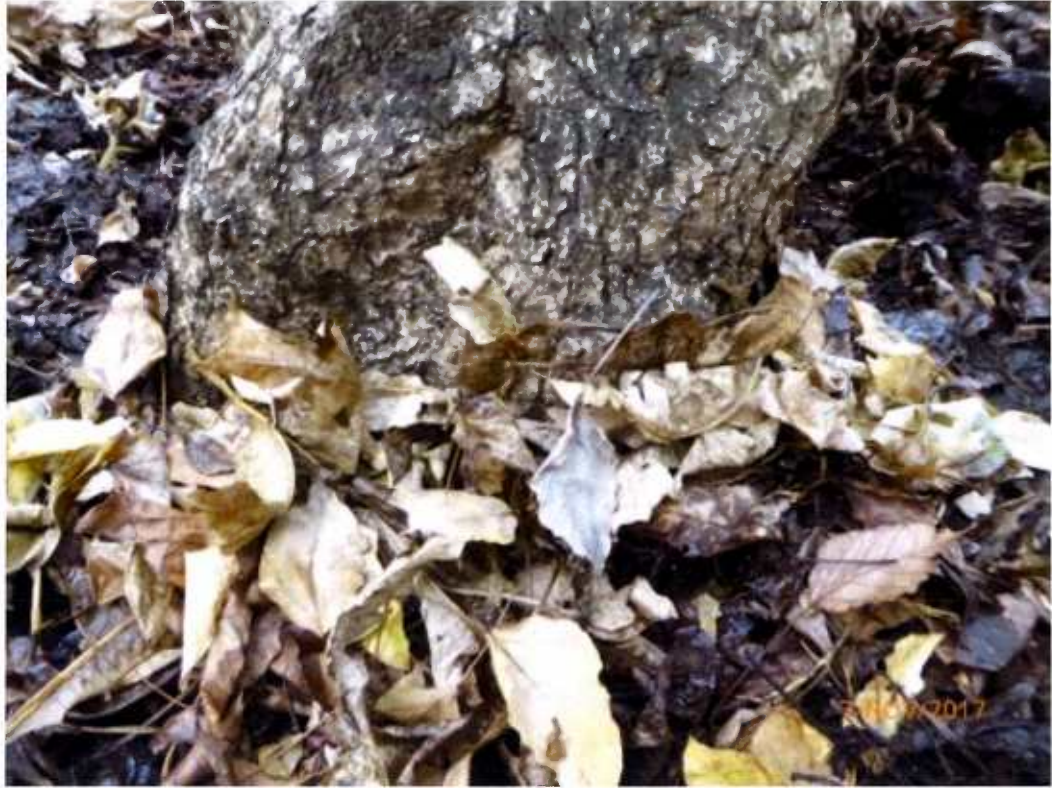
Fig. 3 Health condition of the lower trunk is fair.

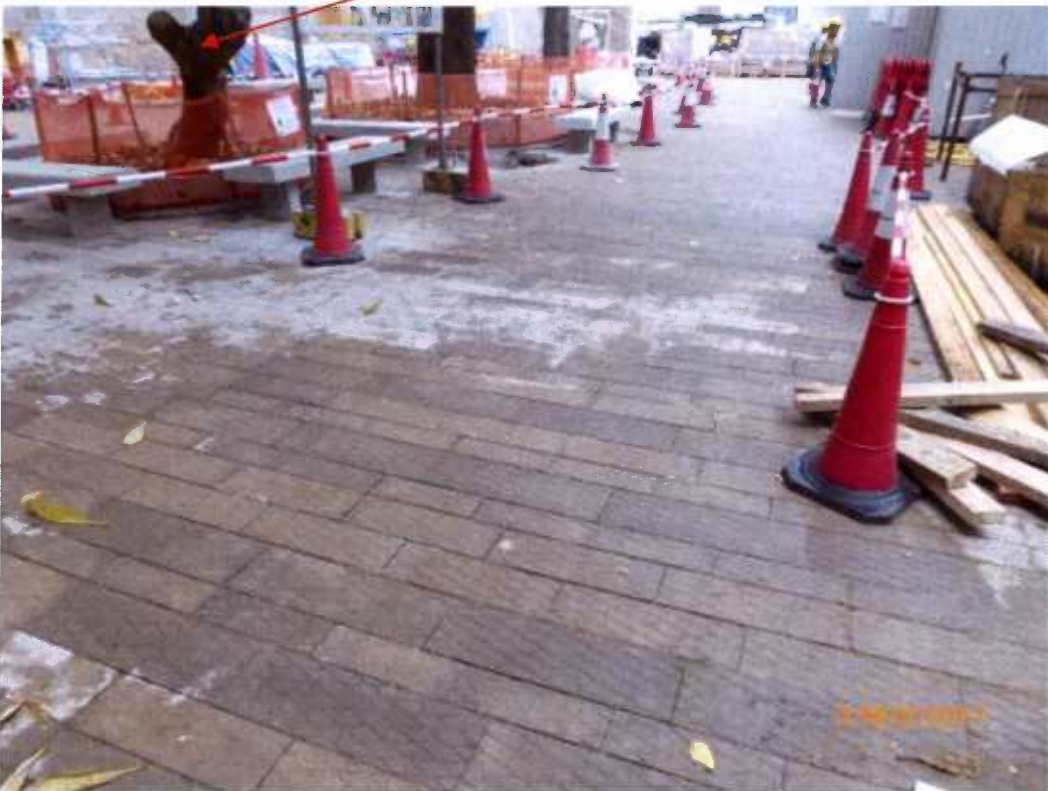
Fig. 12 Overall view of Tree-8 during inspection on 7th Nov. 2017.

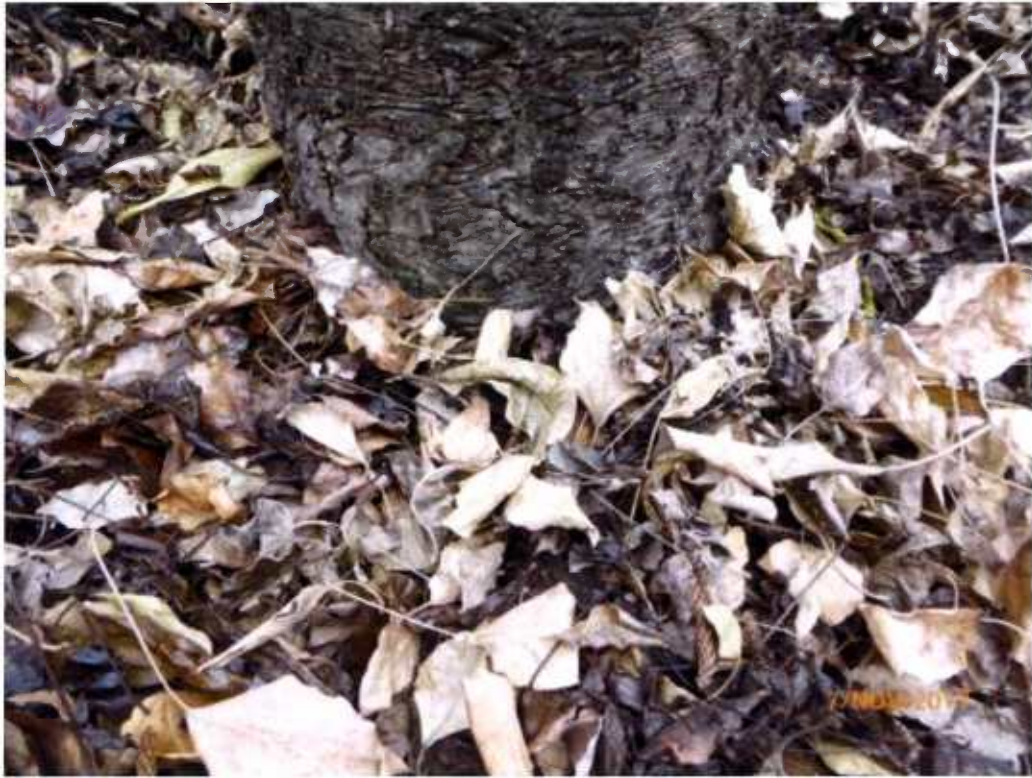
Fig. 3 Health condition of the lower trunk is fair.

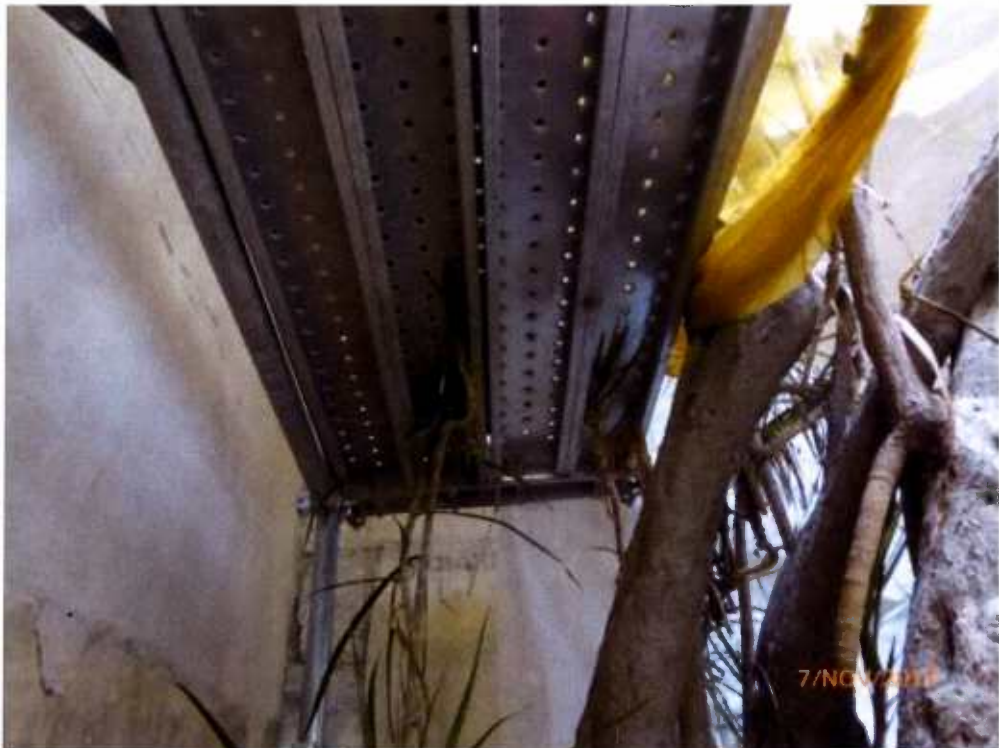
Fig. 8 The tree protection zone is in good order.

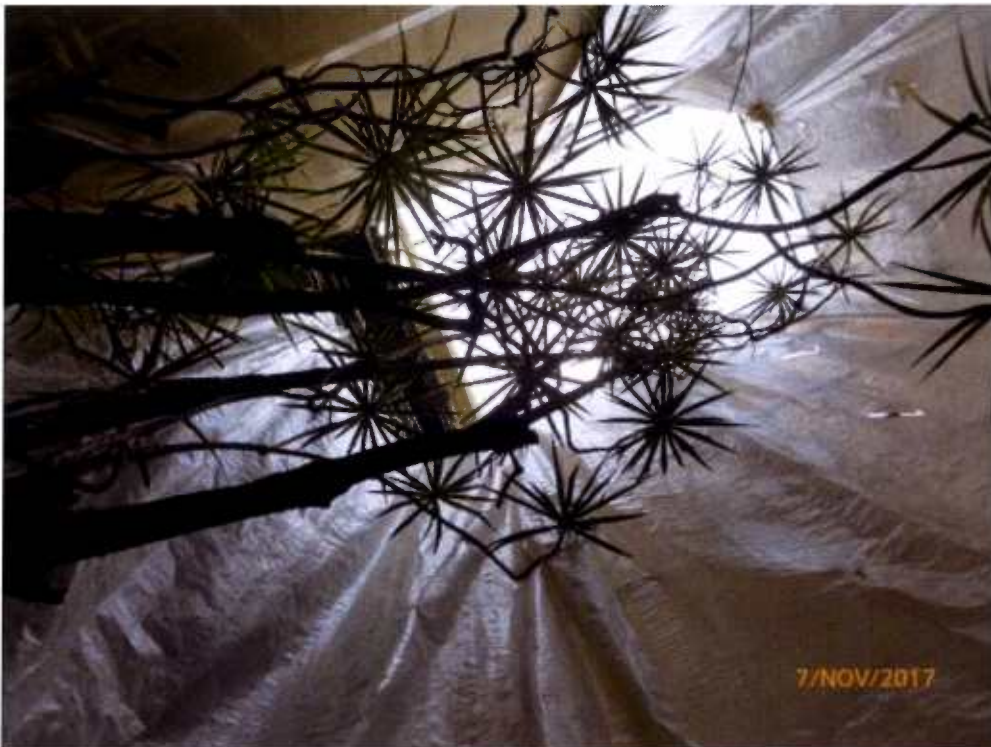
Fig. 10 Renovation works are in progress near Tree 11

1. Keep close monitoring on the growth of the tree especially during the nearby renovation works are in progress.

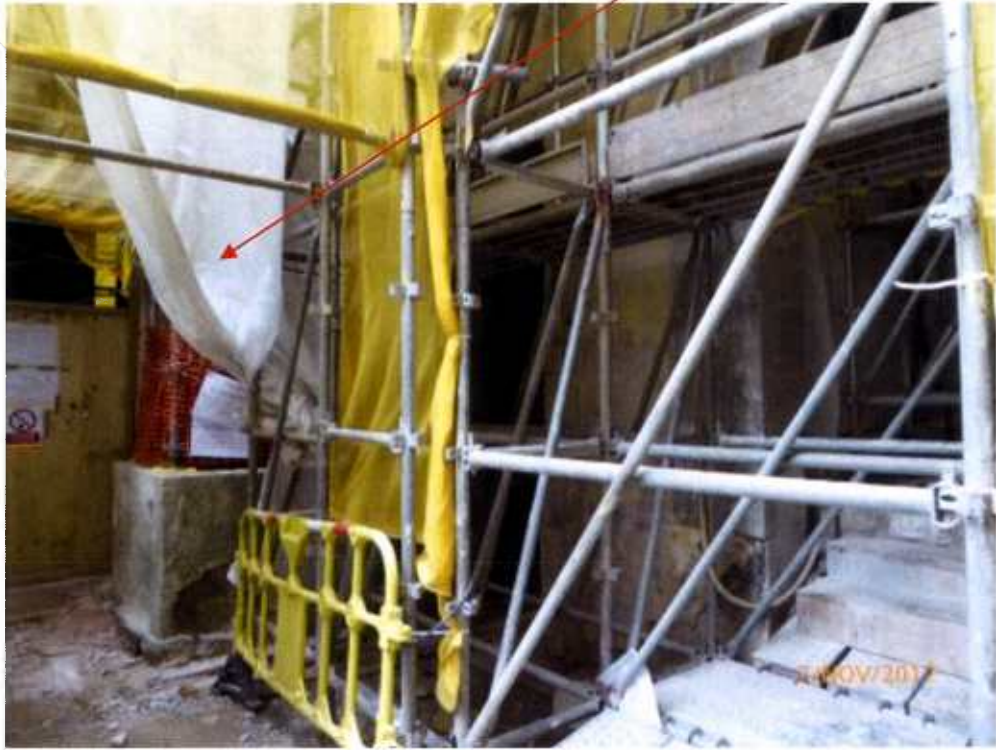
Fig. 11 Cleanliness of the nearby access is acceptable.
