The Jockey Club CPS Limited

Central Police Station Conservation
and Revitalisation Project:
76th Monthly EM&A Report
(1 February to 28 February 2018)

Issue Date: March 2018

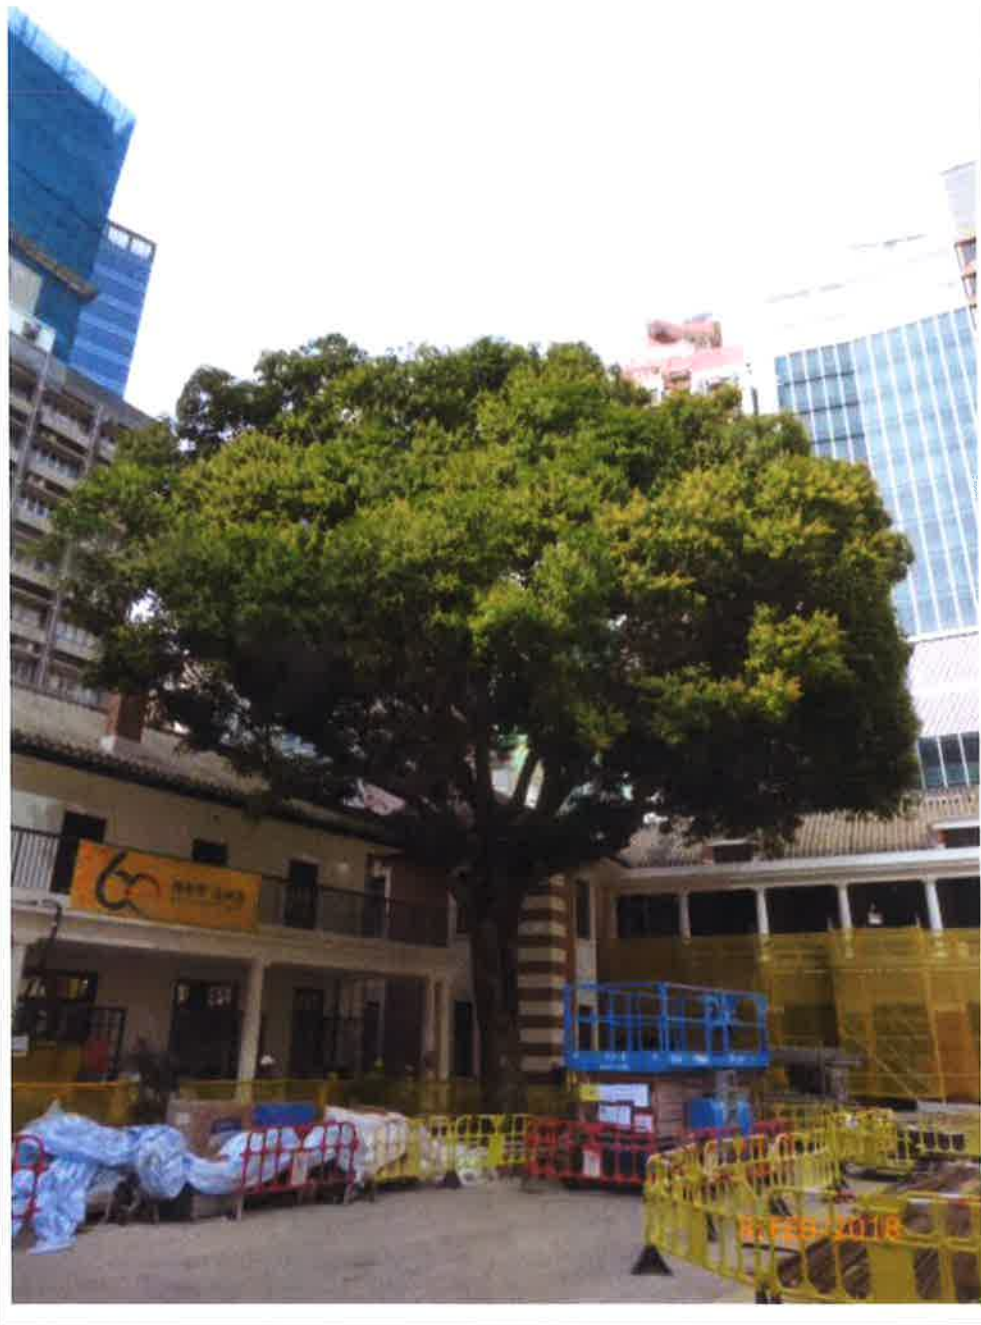
Fig. 12 Overall view of Tree-5 during inspection on 8th February 2018.

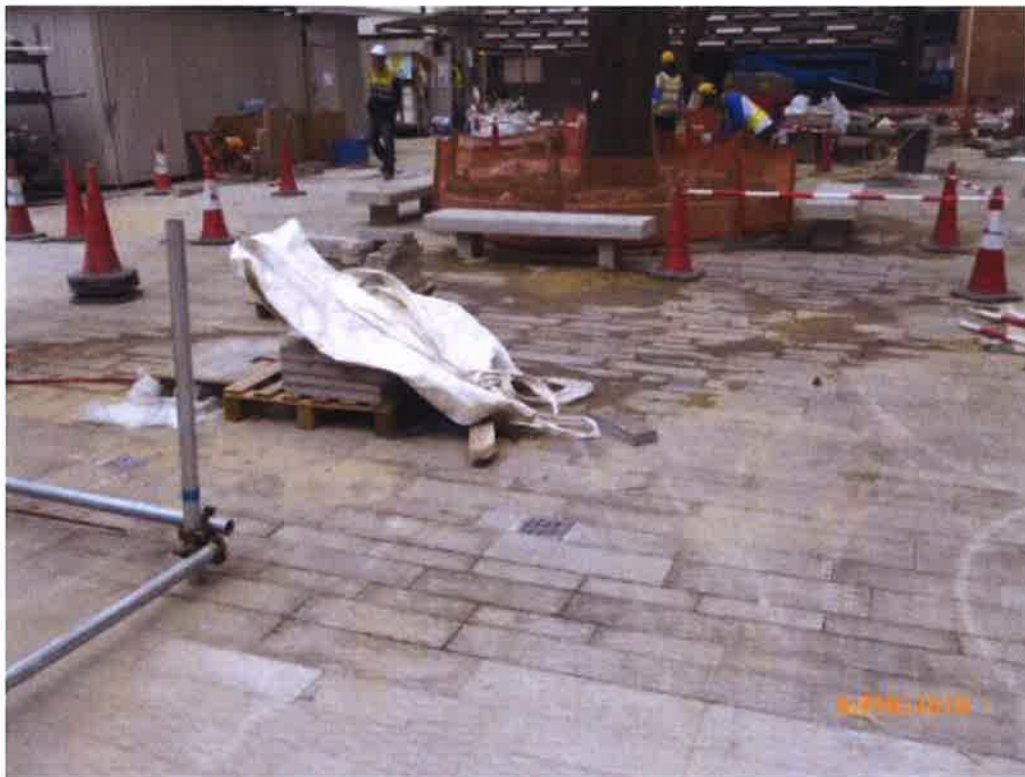
Fig. 12 Overall view of Tree-6 during inspection on 8th February 2018.

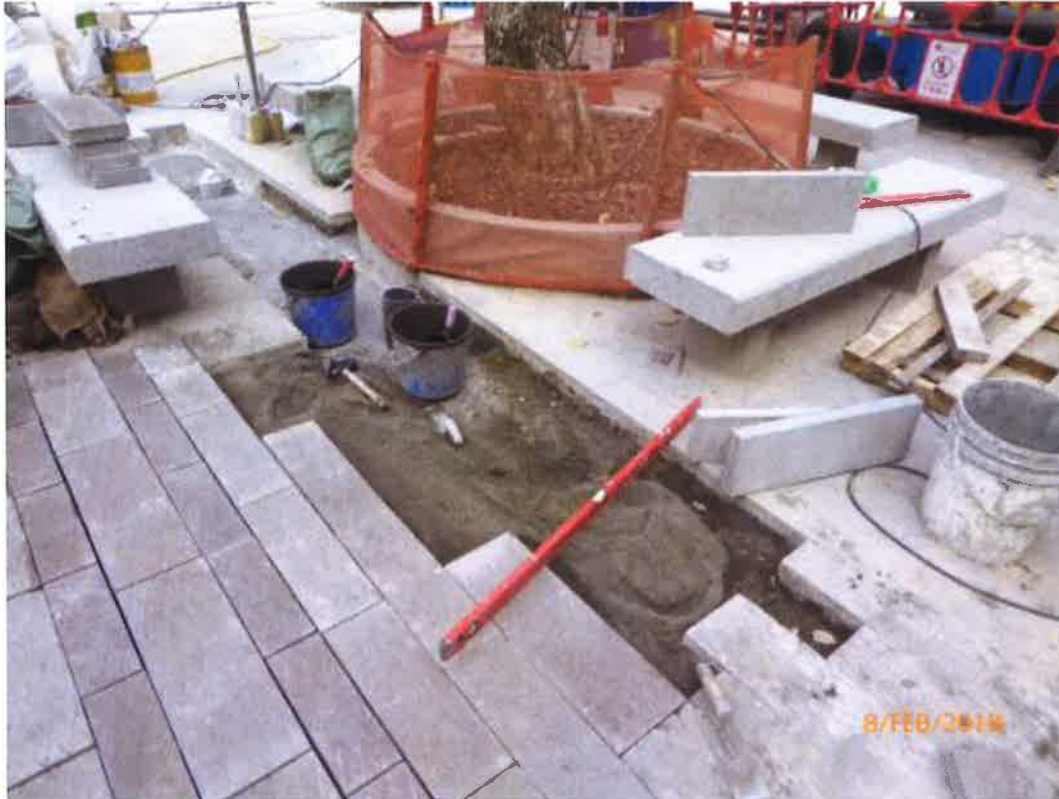
Fig. 11 Many construction materials are placed near the tree.

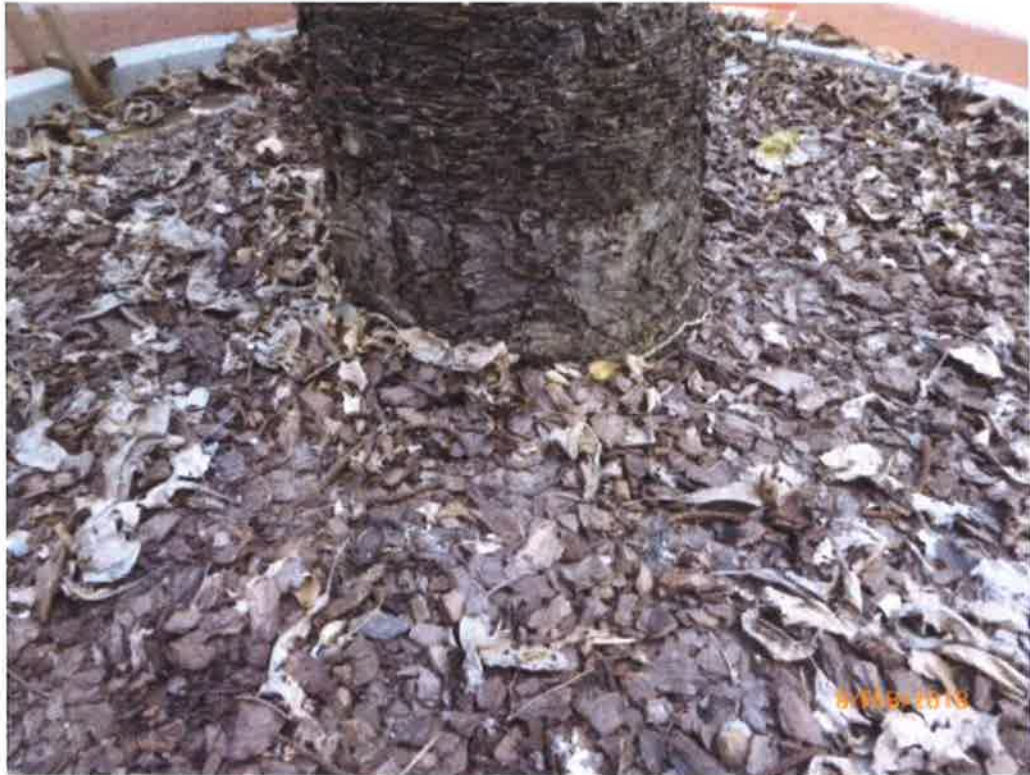
Fig. 3 Health condition of the lower trunk is fair.
