The Jockey Club CPS Limited

Central Police Station Conservation  
and Revitalisation Project:  
*79<sup>th</sup> Monthly EM&A Report*  
*(1 May to 25 May 2018)*

Issue Date: June 2018

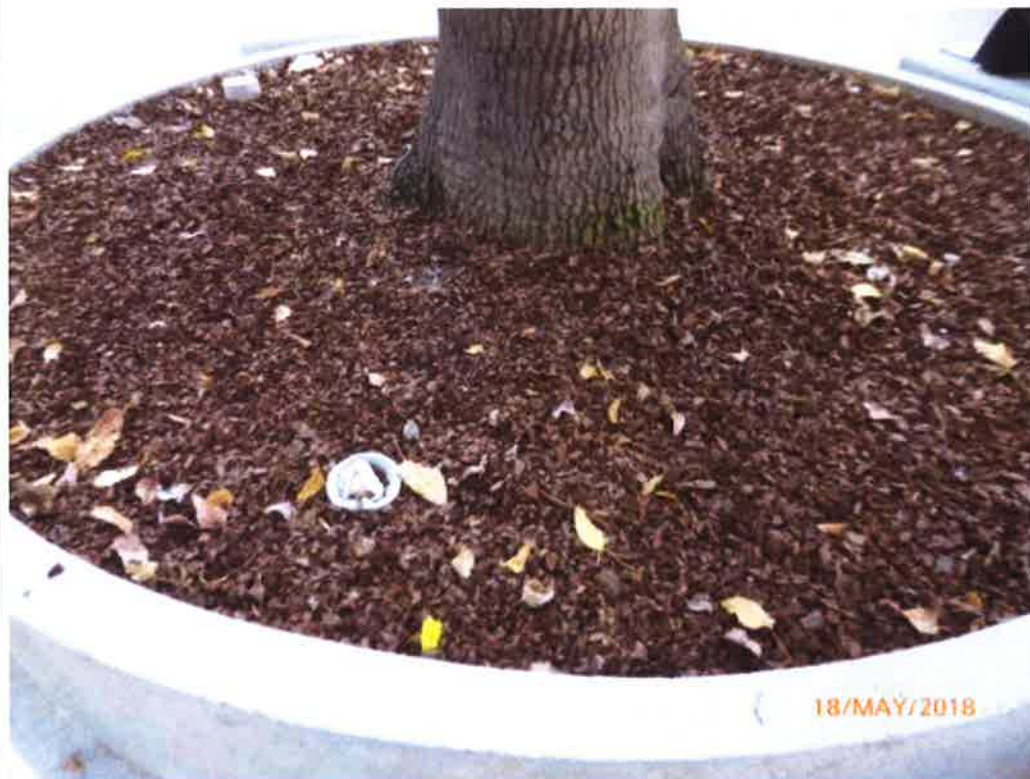
Fig. 4 Health condition of the lower trunk is fair.

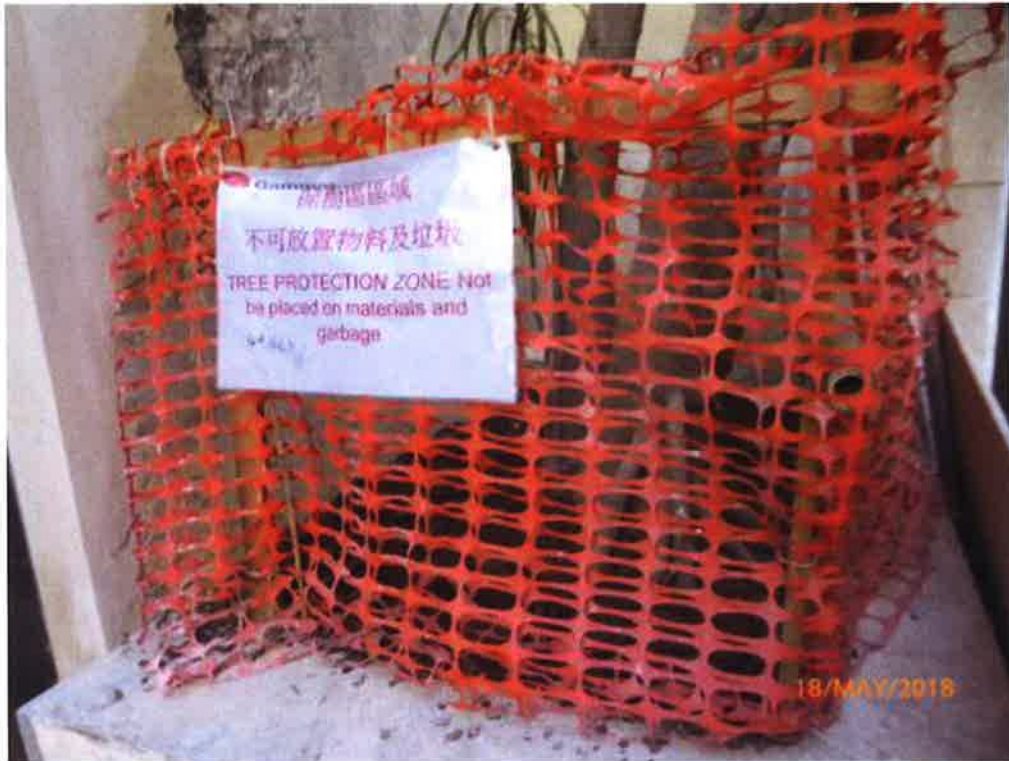
Fig. 11 The site near Tree-11 appears clean and tidy.
