The Jockey Club CPS Limited

Central Police Station Conservation and Revitalisation Project: 25th Quarterly EM&A Report (1 November 2017 to 31 January 2018)

Issue Date: March 2018

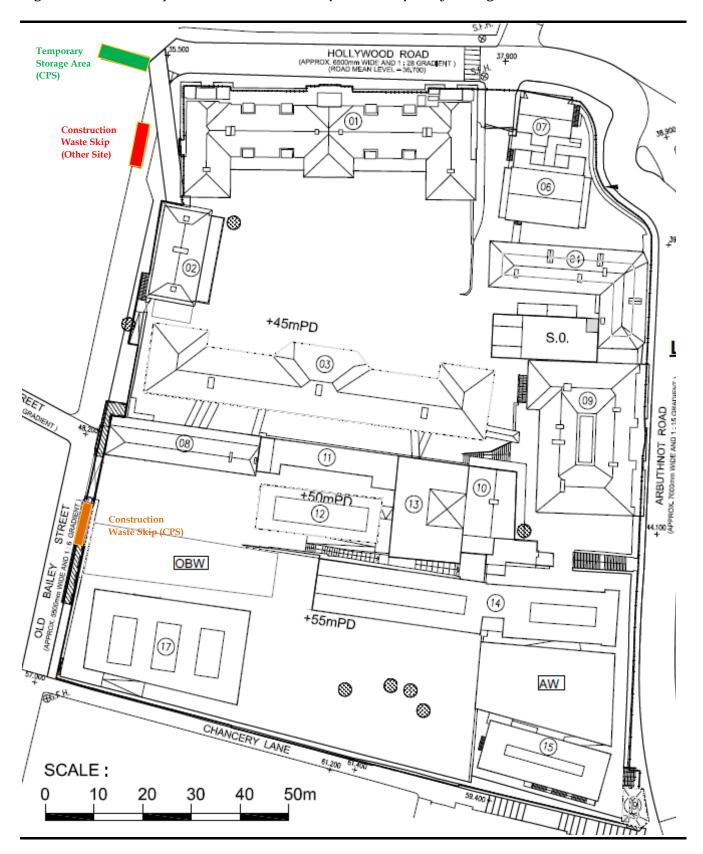
Figure 1 - Locations of Construction Waste Skips and Temporary Storage Area

- 1. As advised by Gammon Construction Limited (the Contractor), one waste skip belonging to the CPS Site is located near the main entrance gate (blue gate) on the sidewalk of Old Bailey Street. The waste skip is located within the barricaded area on the east sidewalk of Old Bailey Street which is part of the approved road works area for CPS. The waste skip would not cause obstruction to road or pedestrians. A photo of the waste skip is shown in *Photo 1* and its location is shown in *Figure 1*. Construction waste generated from the CPS Site would be temporarily deposited in the waste skip, which will be cleared at the end of each working day. There is no illegal dumping of construction waste from the CPS Site. It should be noted that this waste skip has been in the same location for at least the past 1-2 years.

- 3. A waste skip which belongs to a construction site opposite to the CPS Site is located on the west side of Old Bailey Street near the junction of Old Bailey Street and Hollywood (*Figure 1*). A photo of the waste skip is shown in *Photo 3*. As the complainant mentioned the presence of the waste skip causing obstruction of road at Old Bailey Street, it is suspected that the complainant is referring to this waste skip which is not managed by the CPS Site.

All construction works are carried out strictly following the necessary requirements specified in EIA, EM&A Manual, EMP, Method Statements, General and Particular Specifications of this Project. The Contractor has been reminded to maintain tidiness of the construction waste skip and its surroundings. Construction waste should only be stored inside the waste skip and should be cleared on a daily basis to prevent accumulation. With regard to the temporary storage area at the junction of Old Bailey Street and Hollywood Road, the Contractor was also reminded to keep the temporary storage area tidy and clear of litter.
