**- Contract No.: ND/2019/04**

**Baseline Condition Survey and Baseline Vibration Impact Assessment Report (Condition 2.10 and 3.3)**

**Baseline Condition Survey**  
**for the**  
**Built Heritages**  
**for**  
**Fanling North New Development Area,**  
**Phase1:**  
**Fanling Bypass Eastern Section**  
**(Shek Wu San Tsuen North**  
**to**  
**Lung Yeuk Tau)**  
**Under Contract No. ND/2019/04**

**Condition Survey Report**

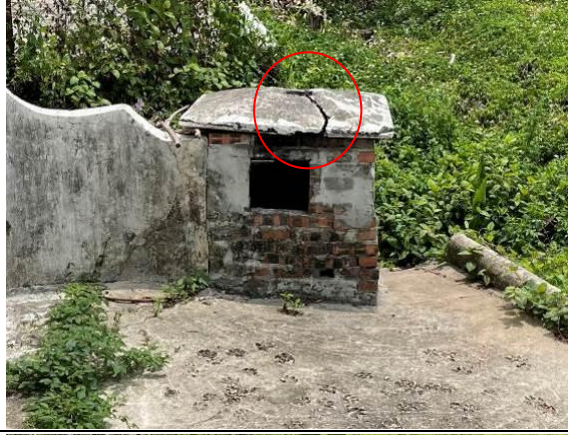
A photograph showing a section of a weathered concrete wall. A thin, vertical crack is visible, highlighted by a red oval. The wall is situated outdoors, with some greenery and a concrete base visible.
<p>Defect No.: FL10-EW-04 Location / Structure: External Envelope Defect Category: Cracking Concrete Size: 1000 mm x 1000 mm Influenced Area: 1.00 m<sup>2</sup></p>

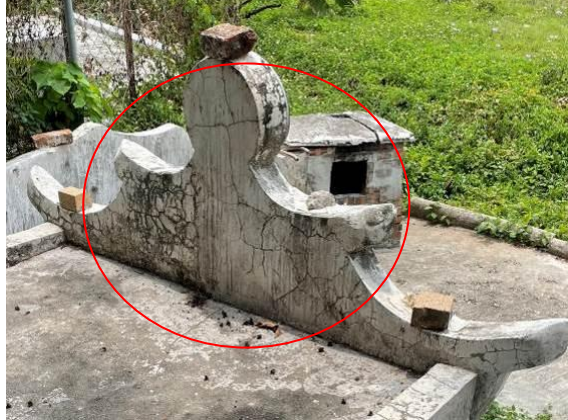
A photograph of a small, square brick structure, possibly a well or a small shrine, with a dark opening. The roof is made of concrete and shows a significant crack, circled in red. The structure is surrounded by lush green vegetation.
<p>Defect No.: FL10-EW-05 Location / Structure: External Envelope Defect Category: Multiple Cracks Size: 2500 mm x 1 mm (w) in total Influenced Area: 0.0025 m<sup>2</sup></p>

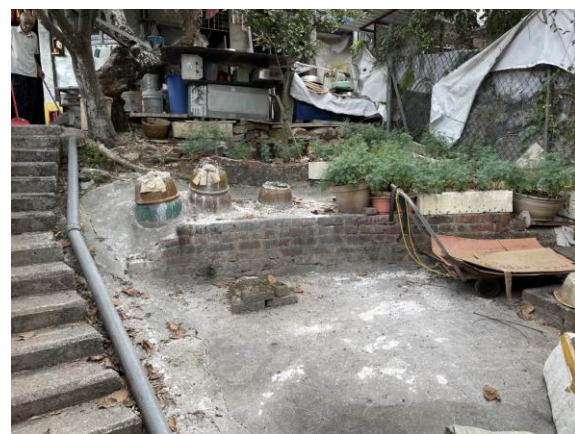
General View

No structural defect was observed
