Proposed Golf Course Development at Tai Po Lot No. 246 Shuen Wan

Tai Po Golf Club Limited

Land Contamination Review

Reference: 289499-REP-001-02

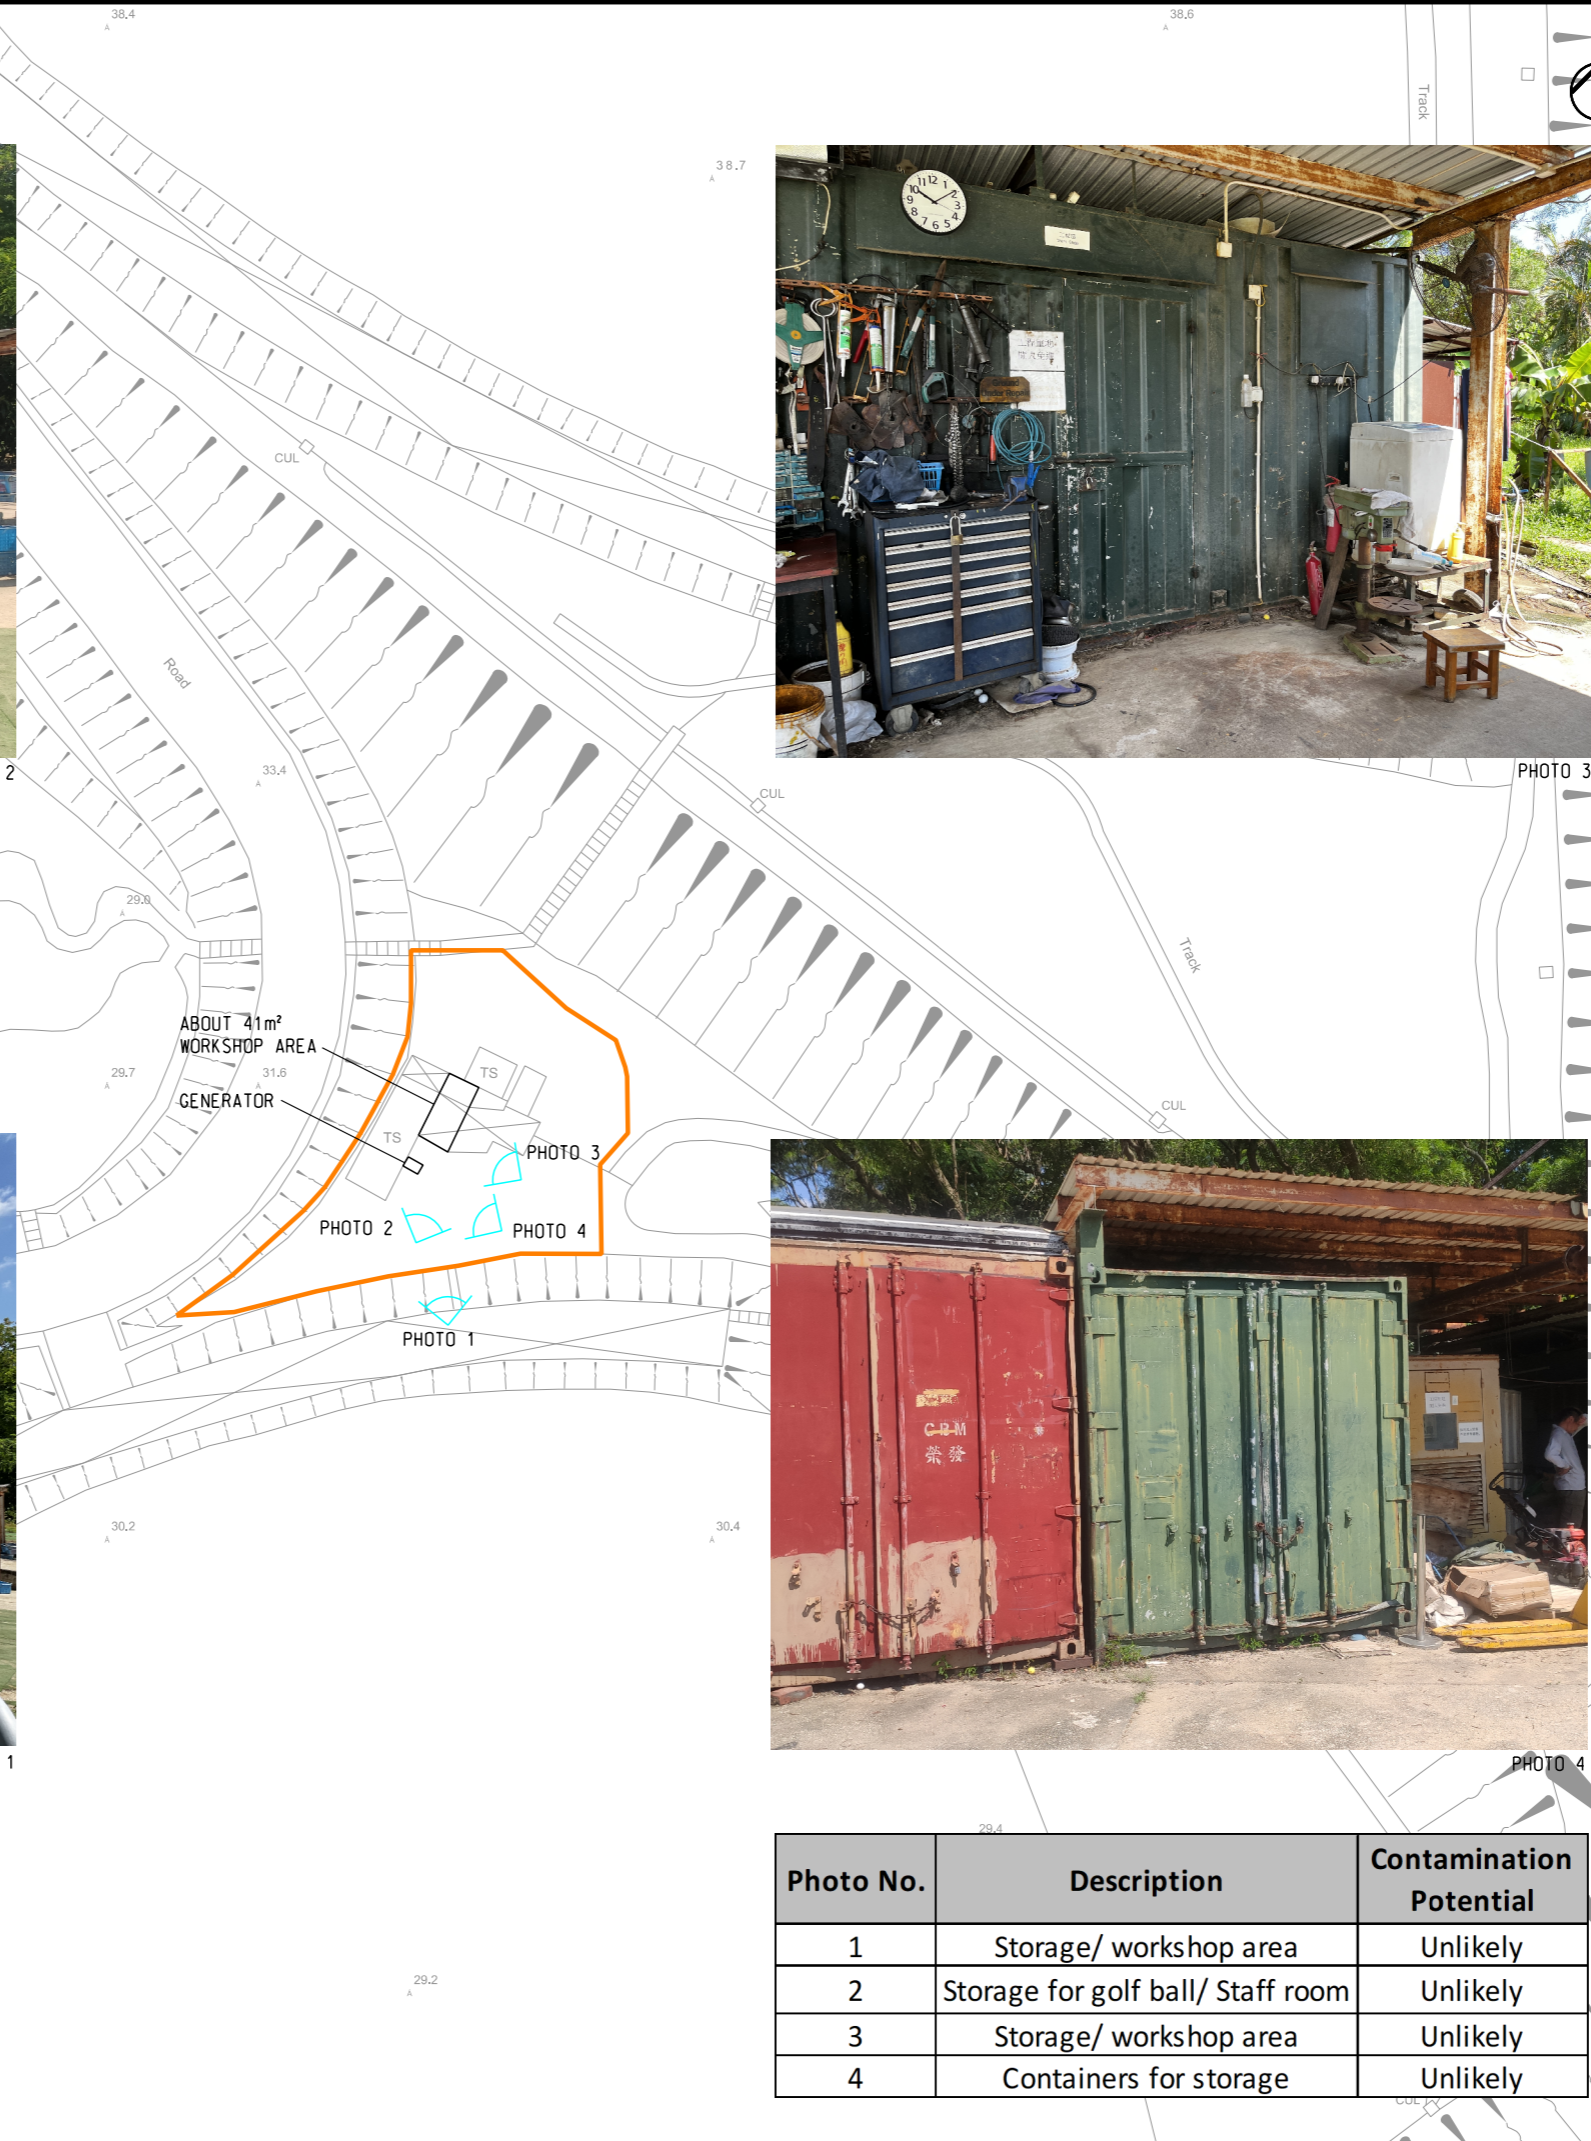
PHOTO 1
PHOTO 2
PHOTO 3
PHOTO 4

- 2.4.2.2 Photos records of the site survey are given in **Figure 2.1**. The site walkover checklist is given in **Appendix 2.2**. In general, the findings in the supplementary site survey were mostly identical with those in the approved EIA Report. The storage/ workshop area (photo 1) was mainly vacant with electric golf carts parked and covered with grass and trees along the perimeter of the boundary. Temporary shelters were mainly located at the central area of the storage/ workshop area.

- 2.4.2.3 The temporary shelter at the north eastern side of the storage/ workshop area was comprised of staff rest room and an area for storing and washing golf ball in baskets (photo 2). Besides, cleaning solvent was not observed. As advised by the workers of the closed Golf Driving Range (“the workers”), golf balls were washed with water. The baskets storing golf balls were placed on concrete-paved ground with no observable cracks. Therefore, the land contamination potential due to the storage of staff rest room and golf balls and staff room is unlikely.

- 2.4.2.4 The containers at the western side of the storage/ workshop area were used for the storage of golfing equipment (e.g. golf balls, baskets, trolleys, etc.) and staff room (photo 4). Generator was observed next to the containers. As advised by the workers, the generator would only be used during emergency situation, and it had not been used since its installation. In addition, the generator was placed on concrete-paved ground with no observable cracks or oil stains. Therefore, the land contamination potential due to the emergency generator is unlikely, which aligned with the findings in the approved EIA Report (AEIAR-221/2019).

ABOUT 41m²
WORKSHOP AREA
GENERATOR
