## **APPENDIX – 12-1**

### **Built Heritage Survey Catalogue**

## **APPENDIX – 12-2**

### Preliminary Built Heritage Condition Survey Catalogue

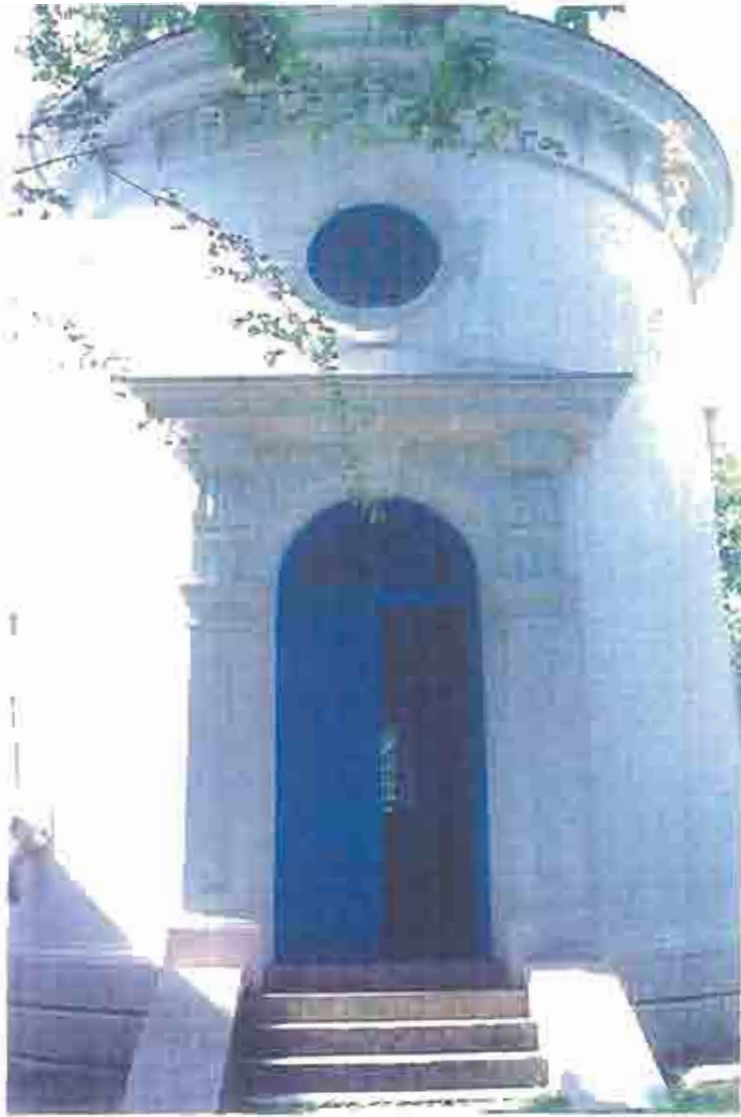
Photograph B: Detail of entrance

**Entranceway:** Ornate entranceway with half pilasters and capitals supporting mock roof, cut granite steps leading to wooden door (painted blue), glass and wooden framed transom above door.

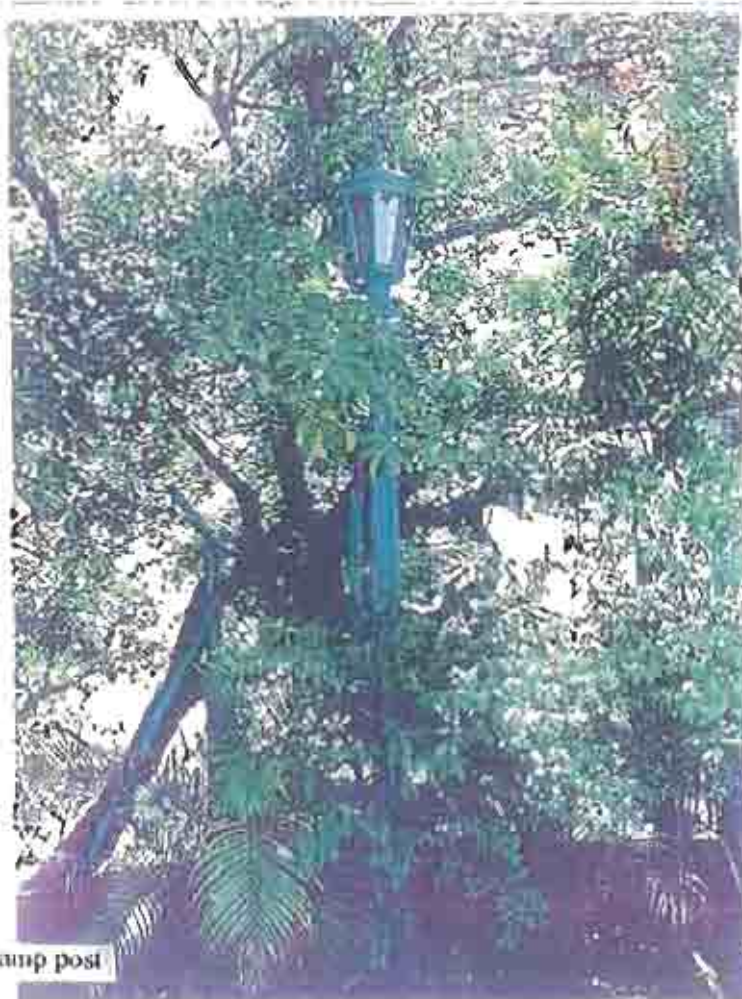
Photograph D. General view of lamp post

<b>Location:</b> FMPHQ, T.S.T.	<b>Project ref#:</b> KSL-02 -02
<b>Type:</b> Metal Lamppost	<b>Map ref#:</b> N/A
<b>Date:</b> 13.03.02	
<b>Construction date:</b> c. 1900	<b>Renovation date:</b> various
<b>Ownership:</b> SAR Government	
<b>Description:</b> Metal lamp post painted blue, moulded vertical ridges as decoration on shaft. Base has circular ridges around it. Base and shaft are hollow. Metal lamp frame has eight panes of glass; one glass pane with hinge for access to interior. Top of lamp frame has ball and finial decoration.	
<b>Orientation:</b> Not applicable. The lamppost is not fixed to the ground and can be moved.	
<b>Condition:</b> Fair	<b>Modifications:</b> No
<b>Present use:</b> Decorative lamp	<b>Past uses:</b> Lighting
<b>Historical Associations:</b> FMPHQ compound	
<b>Additional Notes:</b> The lamppost is not undergoing regular maintenance and is showing signs of corrosion, especially around the base.

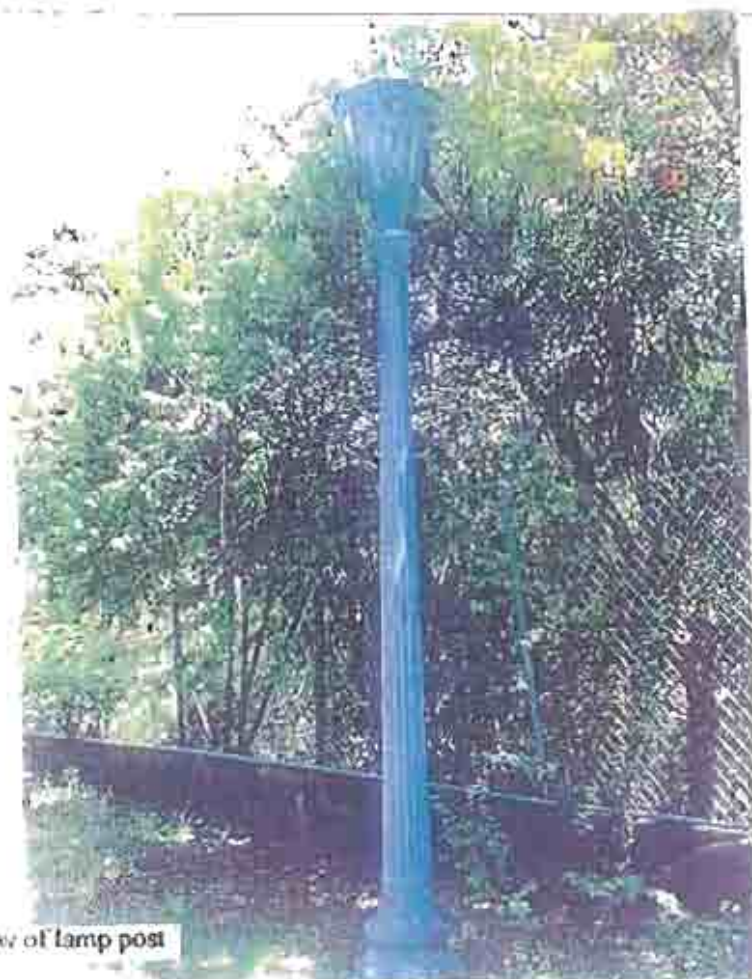
Photograph 2: General view of lamppost

<b>Location:</b> FMPHQ, T.S.T.		<b>Project ref#:</b> KSL-020-04	
<b>Type:</b> Metal Lamppost		<b>Map ref#:</b> N/A	
<b>Date:</b> 13.08.02			
<b>Construction date:</b> c 1900		<b>Renovation date:</b> various	
<b>Ownership:</b> SAR Government			
<b>Description:</b> Metal lamp post painted blue, moulded vertical ridges as decoration on shaft. Base has circular ridges around it. Base and shaft are hollow. Metal lamp frame has eight panes of glass; one glass pane with hinge for access to interior. Top of lamp frame has ball and finial decoration.			
<b>Orientation:</b> Not applicable. The lamppost is not fixed to the ground and can be moved.			
<b>Condition:</b> Fair		<b>Modifications:</b> No	
<b>Present use:</b> Decorative lamp		<b>Past use:</b> Lighting	
<b>Historical Associations:</b> FMPHQ compound			
<b>Additional Notes:</b> The lamppost is not undergoing regular maintenance and is showing signs of corrosion, especially around the base.

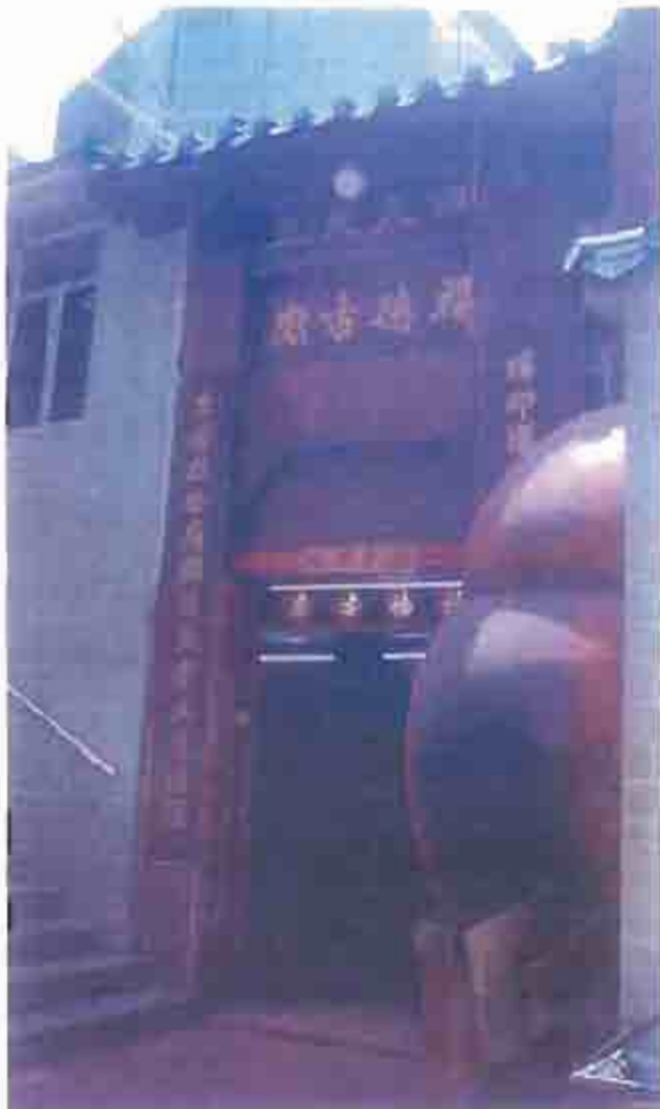
Photograph V: Detail of entrance

**Entranceway:** Brown granite frame with engraving above door and on sides. Engraving is painted gold geometric decorative brackets under the eaves. There is a large red rounded offerings burner beside the entrance. (See Photo V).

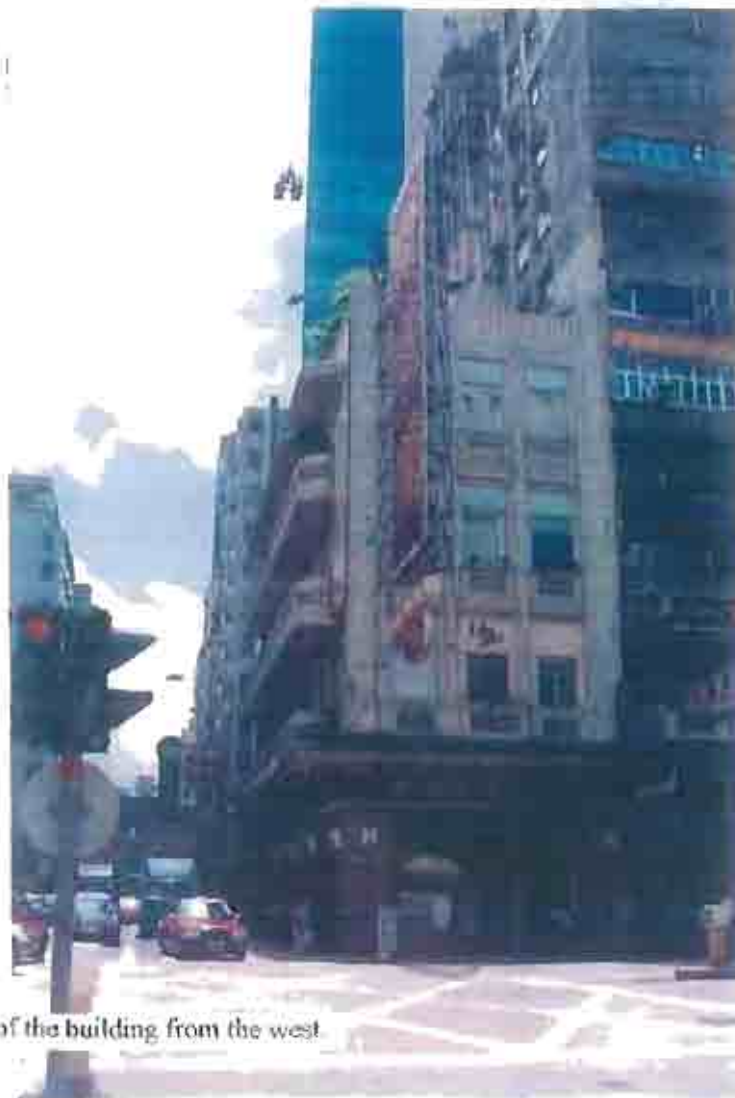
Photograph D110: View of the building from the west.

The balconies on the north wall are in poor structural condition and support braces have been added to them. The building has maintained its external decorative features and is a very good example of a building having its historical integrity maintained, whilst continuing to be functional.

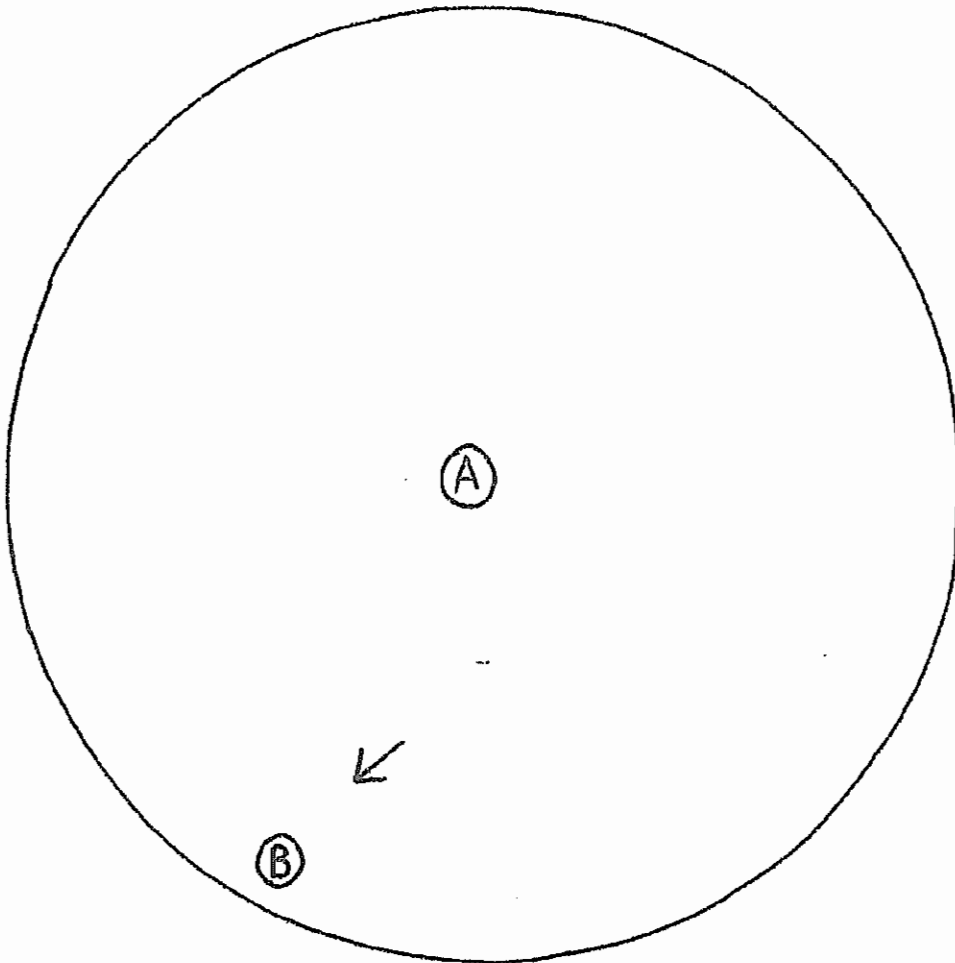
Location of photographs in the Signal Tower (KSL.02.01)

<b>Roof/ Ceiling:</b> The exterior of the roof is in adequate condition. The ceiling on the top floor shows signs of minor cracks around the central opening.
<b>Walls:</b> The exterior walls are painted white and no cracks were observed. The interior walls showed signs of mould growth.
<b>Doors:</b> The wooden entrance doors are in good condition.
<b>Windows:</b> On the upper floor windows, the wooden frames are separating from the walls and the paint is peeling.
<b>Fragile Elements:</b> All of the exterior features appear to be in good condition.

The structure is in fair condition. The exterior shows no obvious signs of cracks. The interior walls have mould growth on the upper floor and the ceiling on the upper floor has minor cracks.
---

- (A) Ceiling: Moisture damage and cracks
- (B) Interior wall at south of building on 1<sup>st</sup> floor: Moisture damage and mould growth

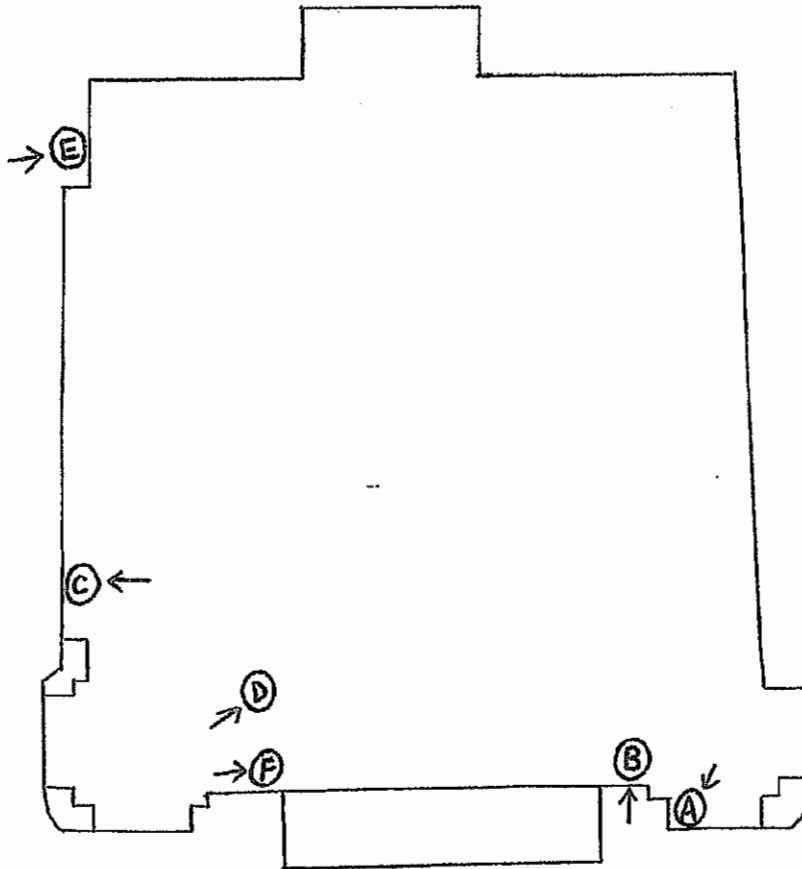
Location of photographs:

The building is in poor condition. Exposure to dampness and moisture have left many of the wooden elements in the building in an advanced state of decay. Rotten wood in window frames and shutters was noted. There are large cracks in the exterior walls, one of which was being monitored at the time of the survey. The lack of maintenance on the building has advanced the state of decay and major restoration works will be required to reinstate the structural integrity of the building.
--

(A) Vegetation growth and water damage

(B) Cracking in pipe

(D) Concrete patch repair

(E) Crack in exterior wall

(F) Crack in concrete walkway

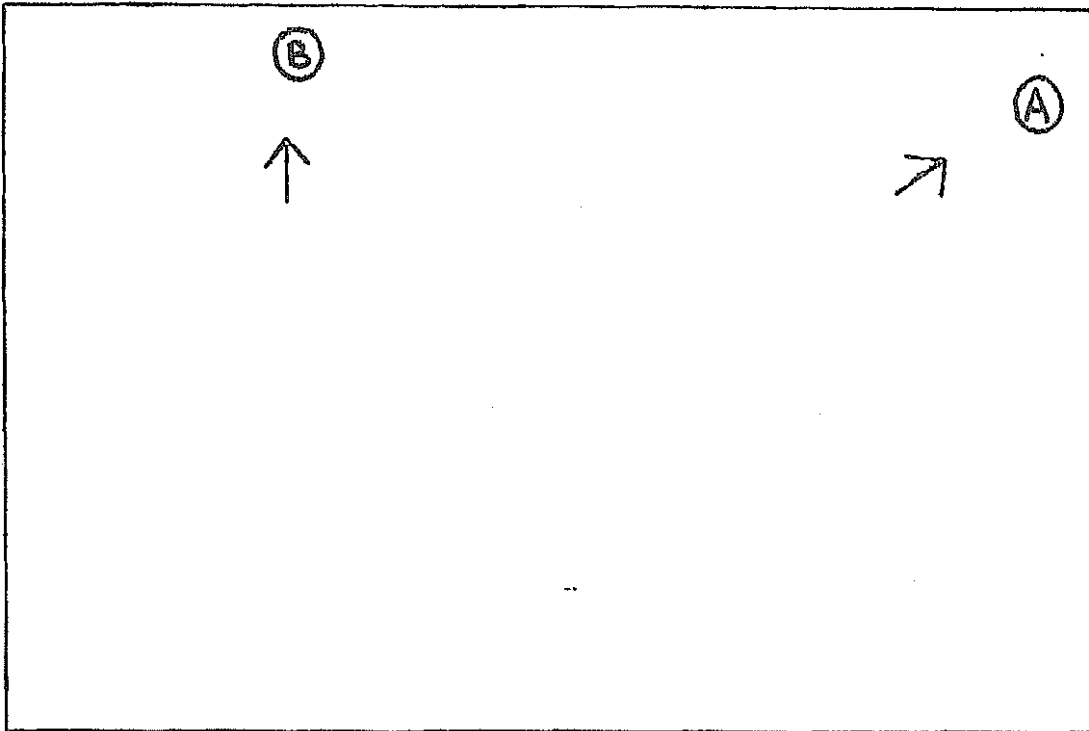
Location of Photographs in the Out Building (KSL-02-07)

The structure is generally in poor condition, continued exposure to damp will promote the decay of the wooden elements. The overall structure is at risk from the decay noted in the bricks.

**(A) Moisture damage and crack in wall**

**(B) Rotting wood at ceiling**

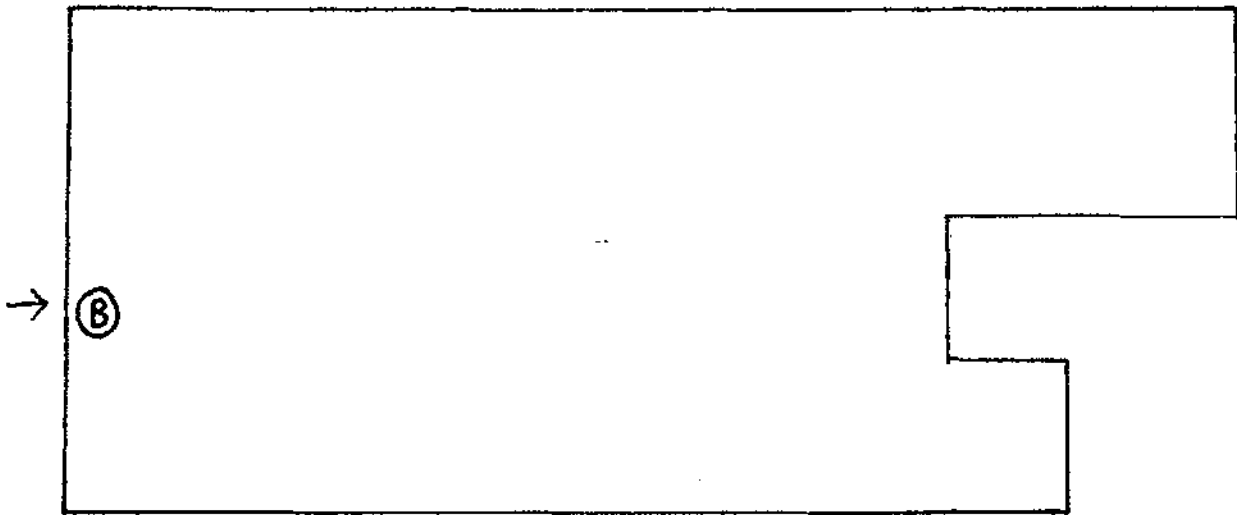
Location of Photograph of Former Fire Station Hall (KSL-02-10)

The general condition of the structure is good. The bricks are decaying in places and the very thin tile canopies over the windows are breaking.
--

(A) Former Fire Station (KSL-02-10):  
Degrading bricks and concrete patching

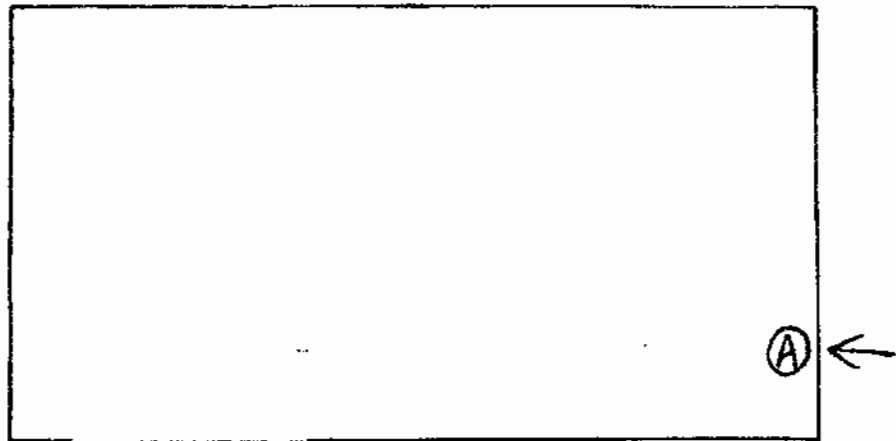
Location of Photograph of Former Fire Station Accommodation Block (KSL-02-11)

The general structure is in good condition. The brick work is in danger of decay and is not being treated correctly.
--

(B) Former Accommodation Block (KSL-02-11):  
Degrading bricks, broken window canopy and crack in wall
