# Provision of Cremators at Wo Hop Shek Crematorium

Tree Survey Report

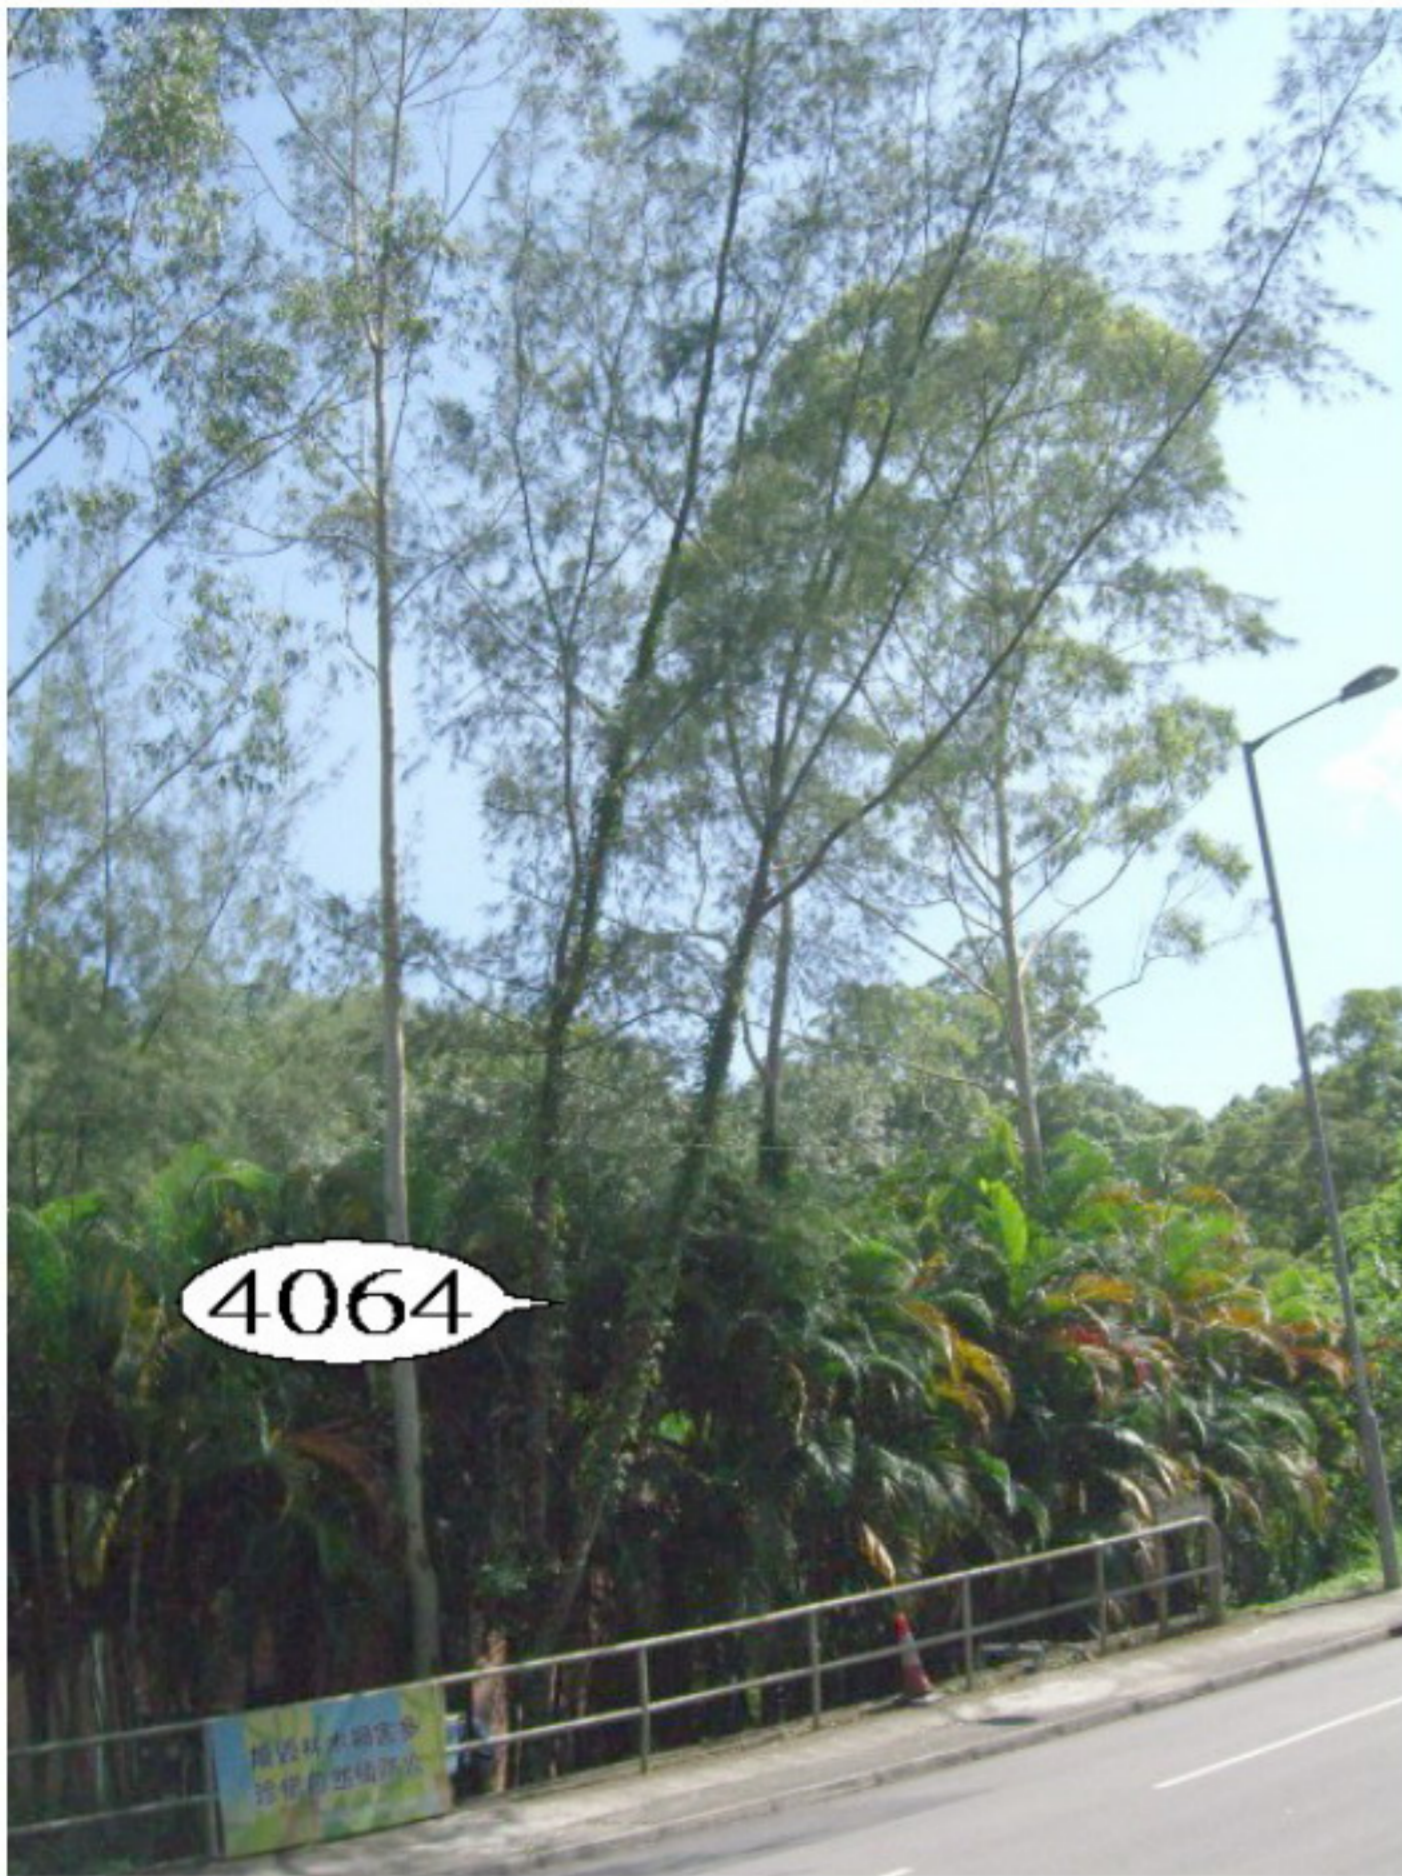
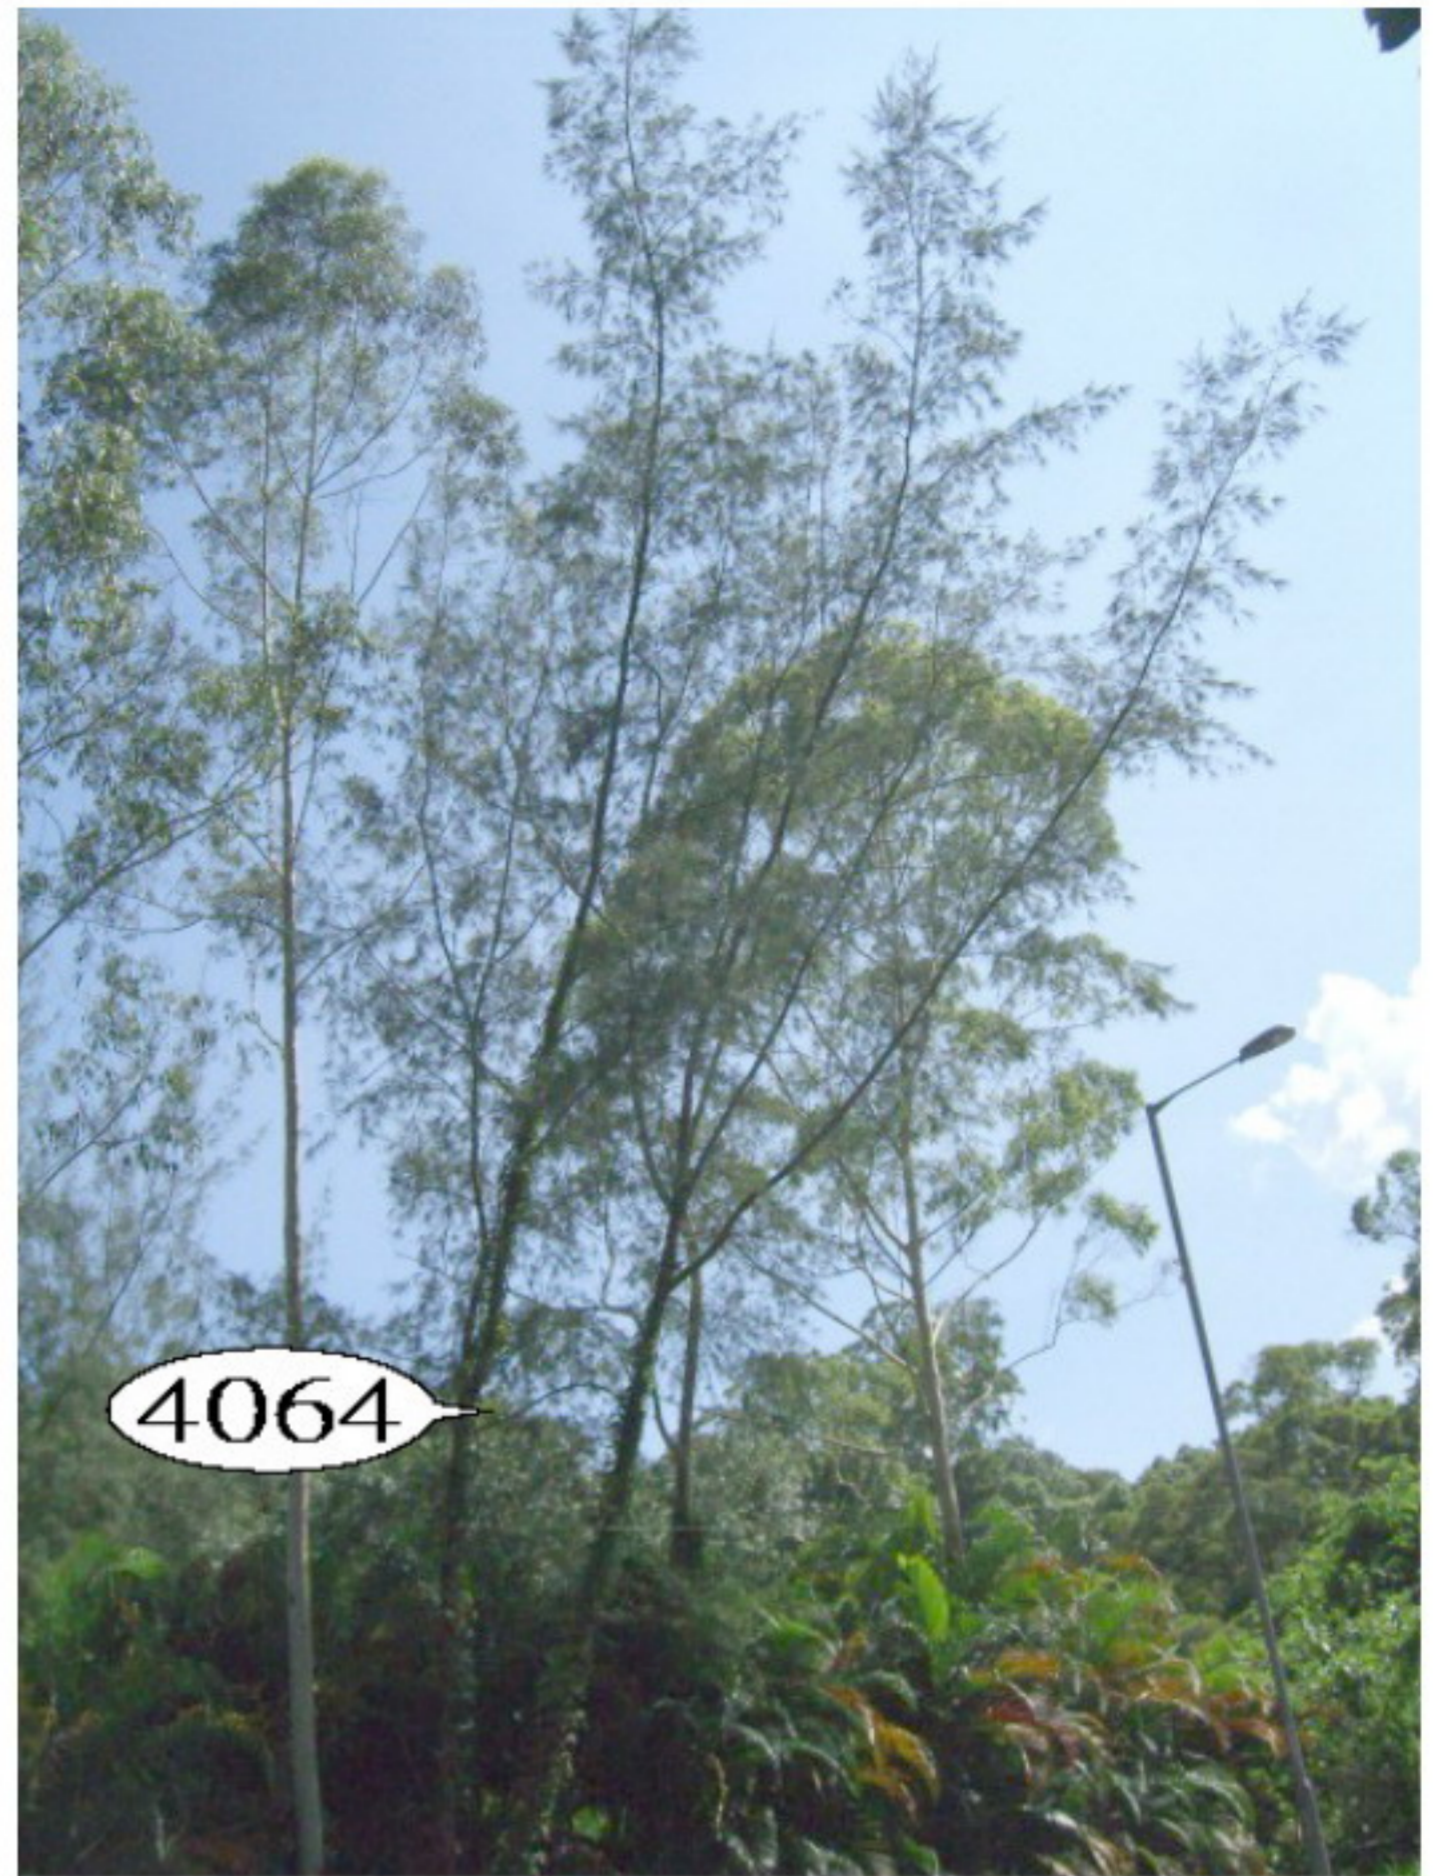
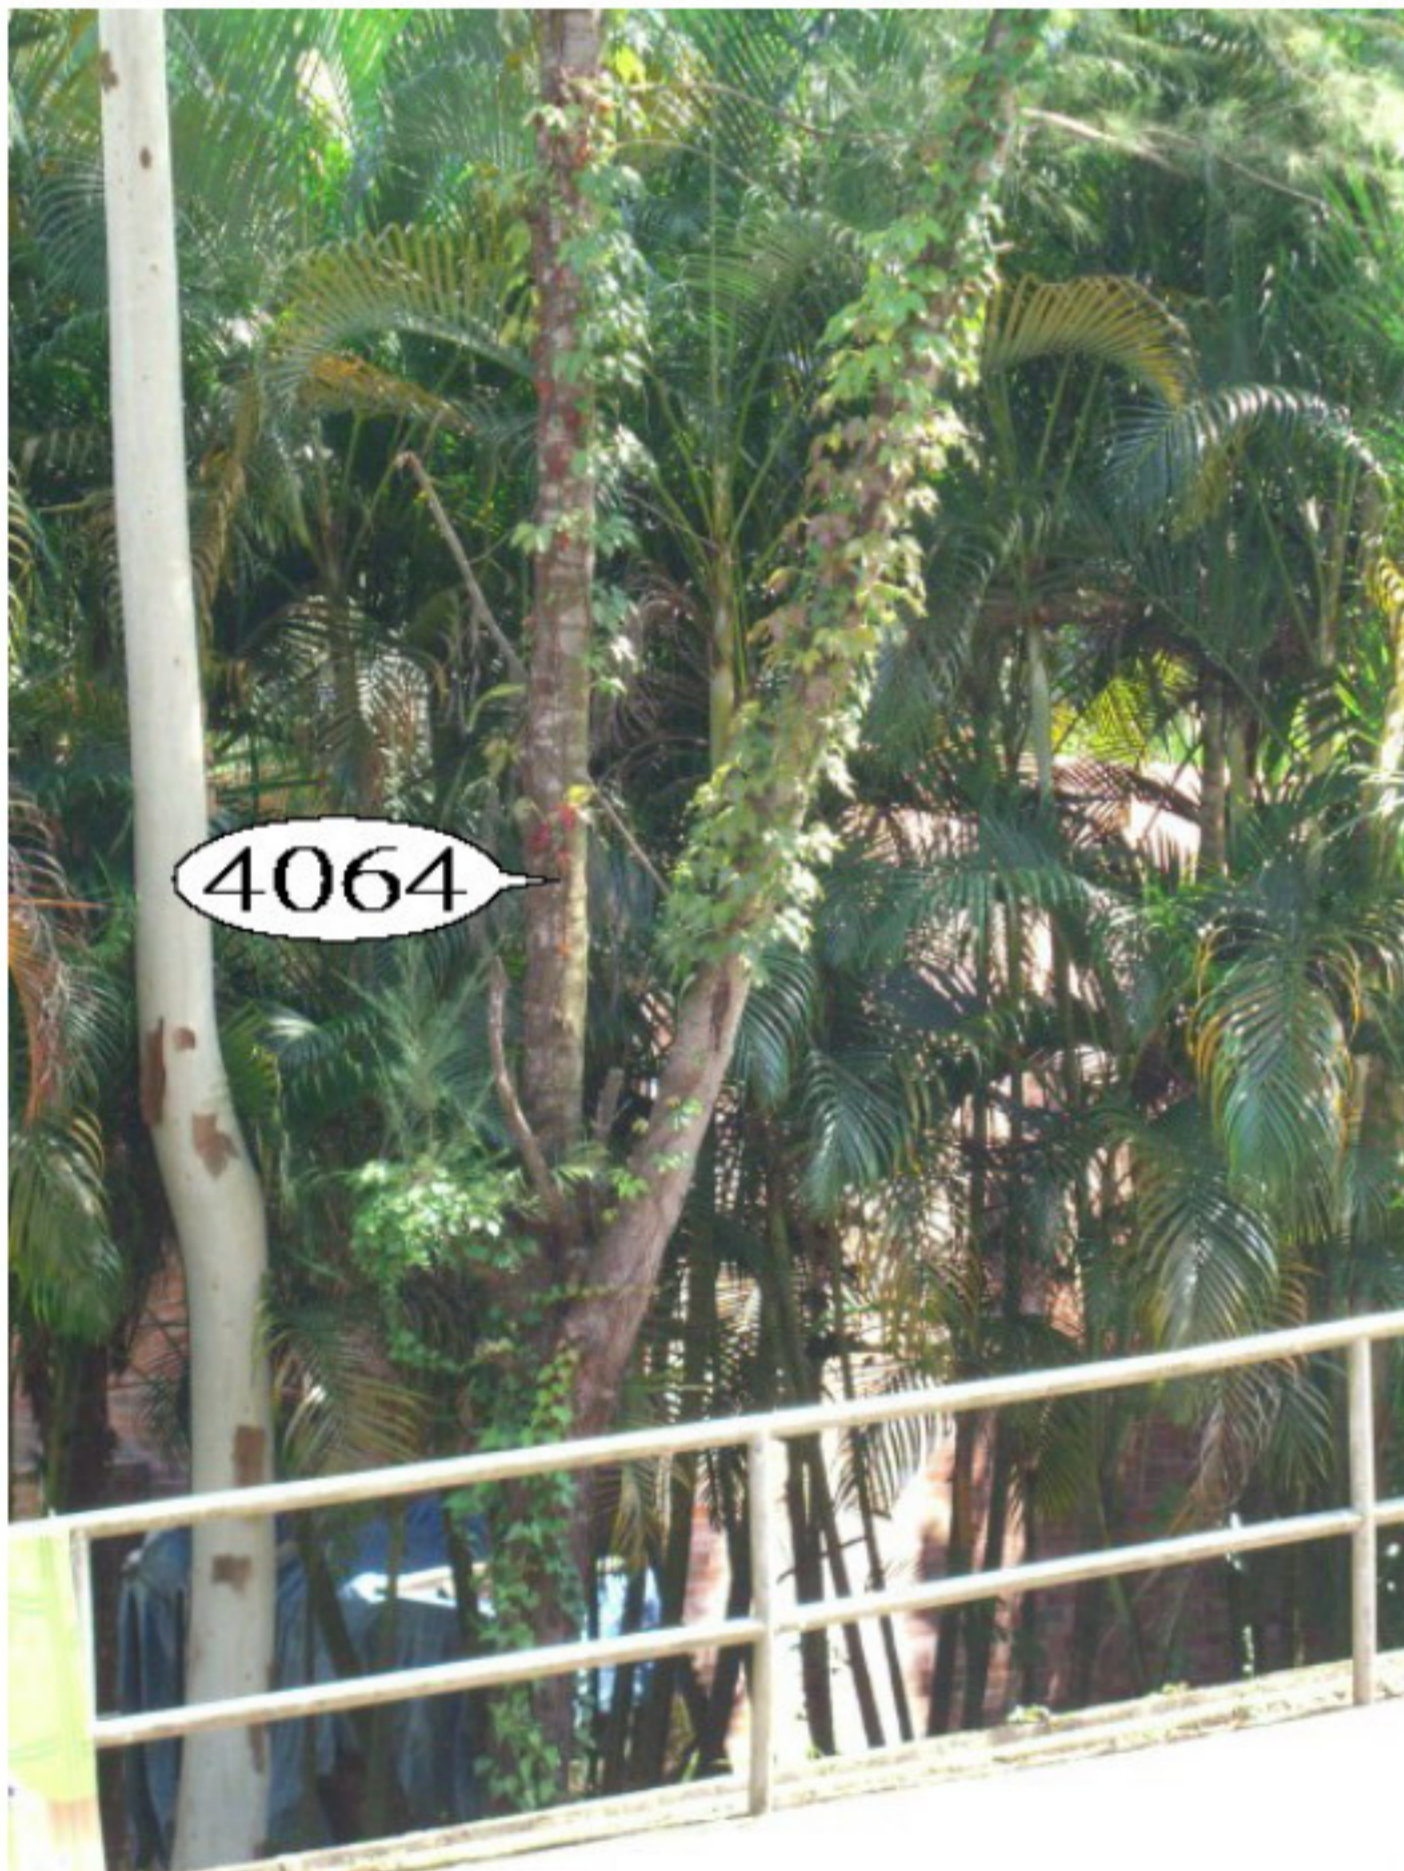
Tree 4056

Poor health lead to low transplantation survival rate. Cavity was found on tree trunk.

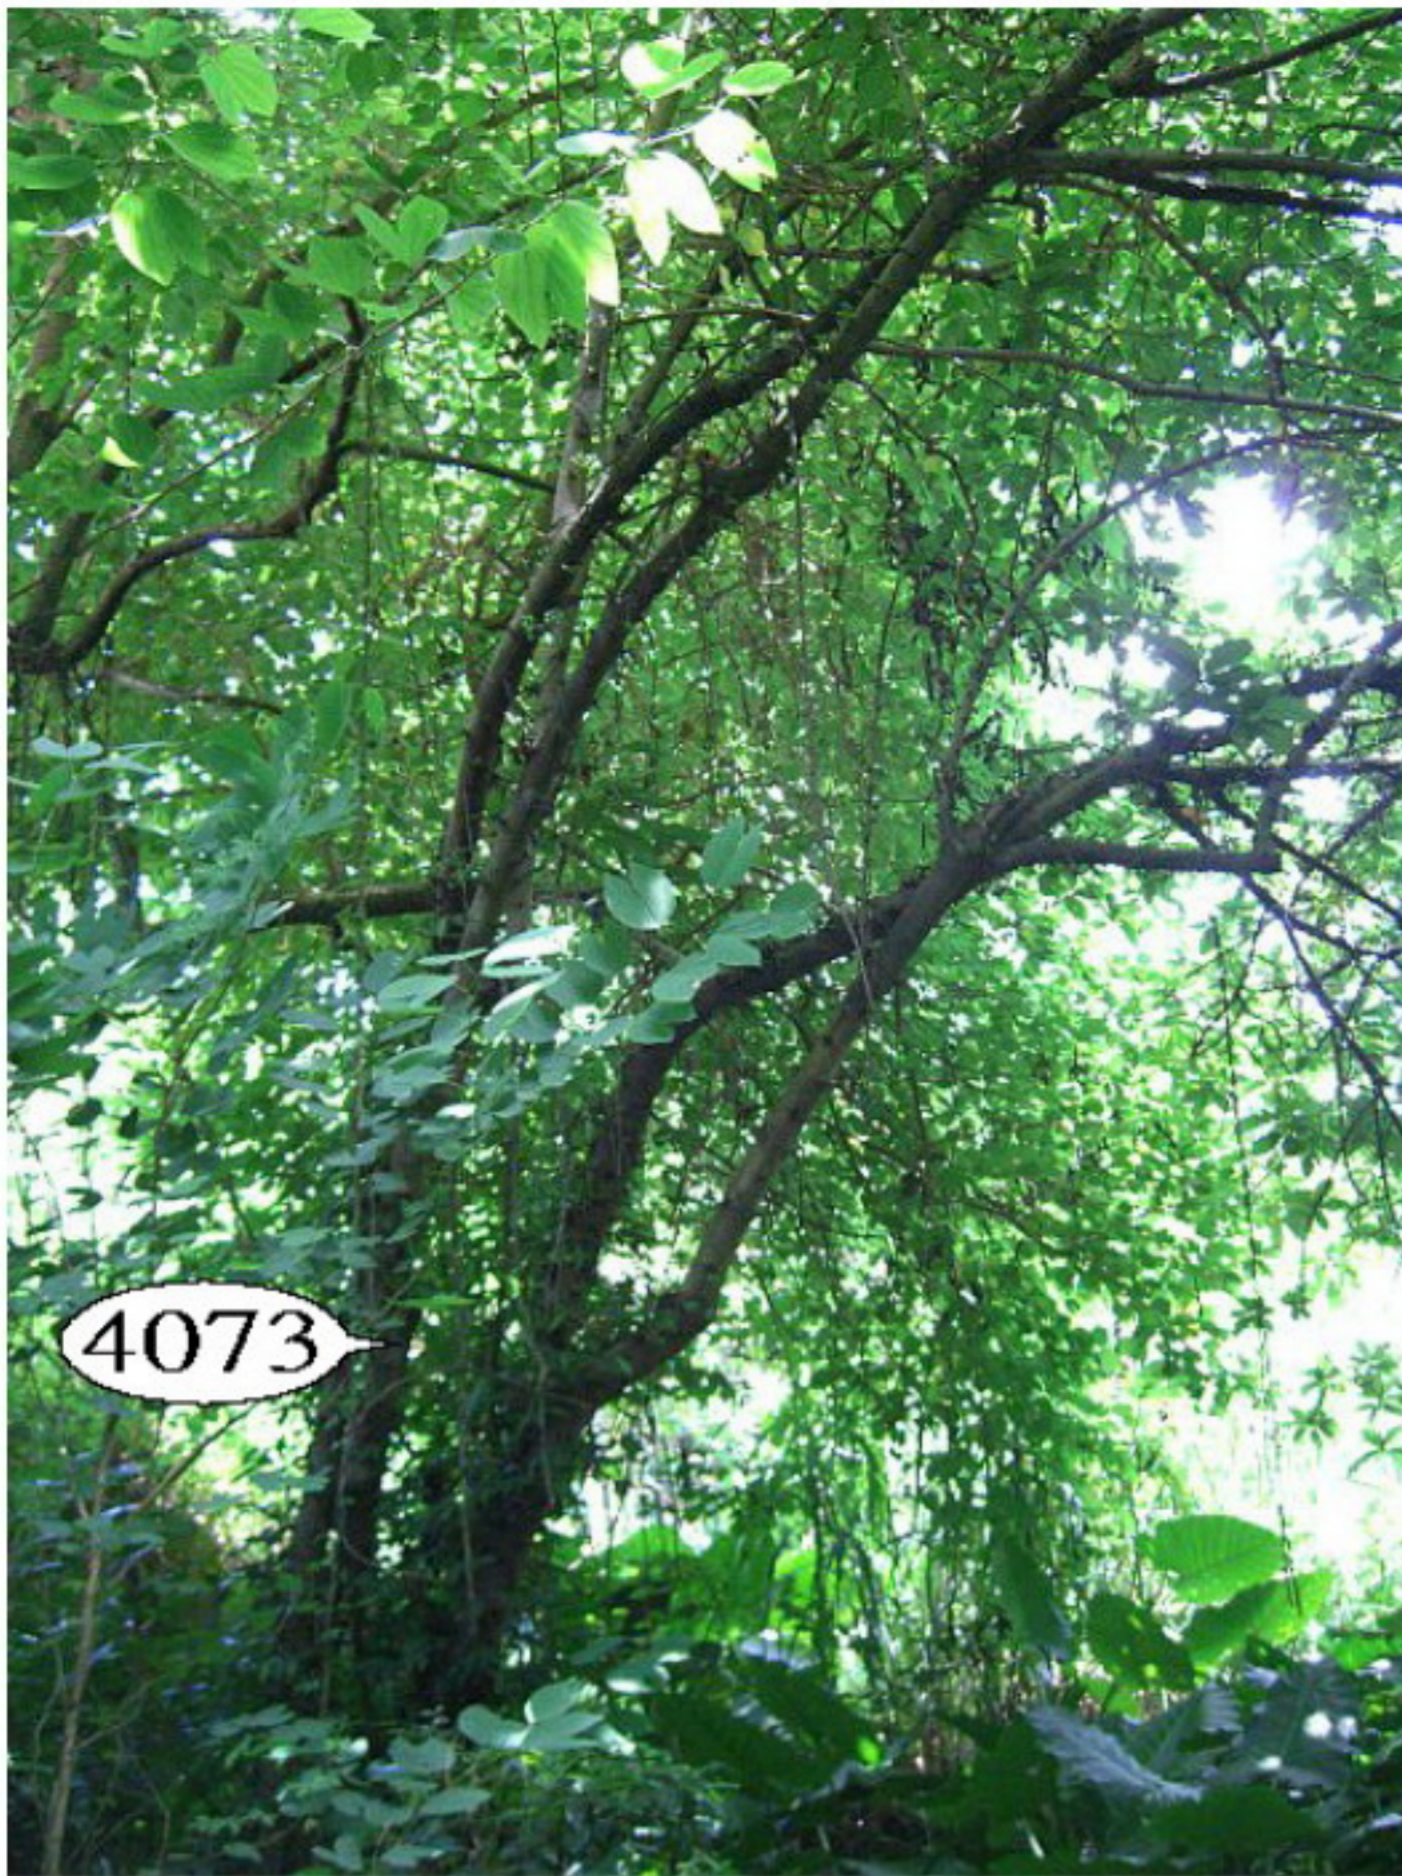
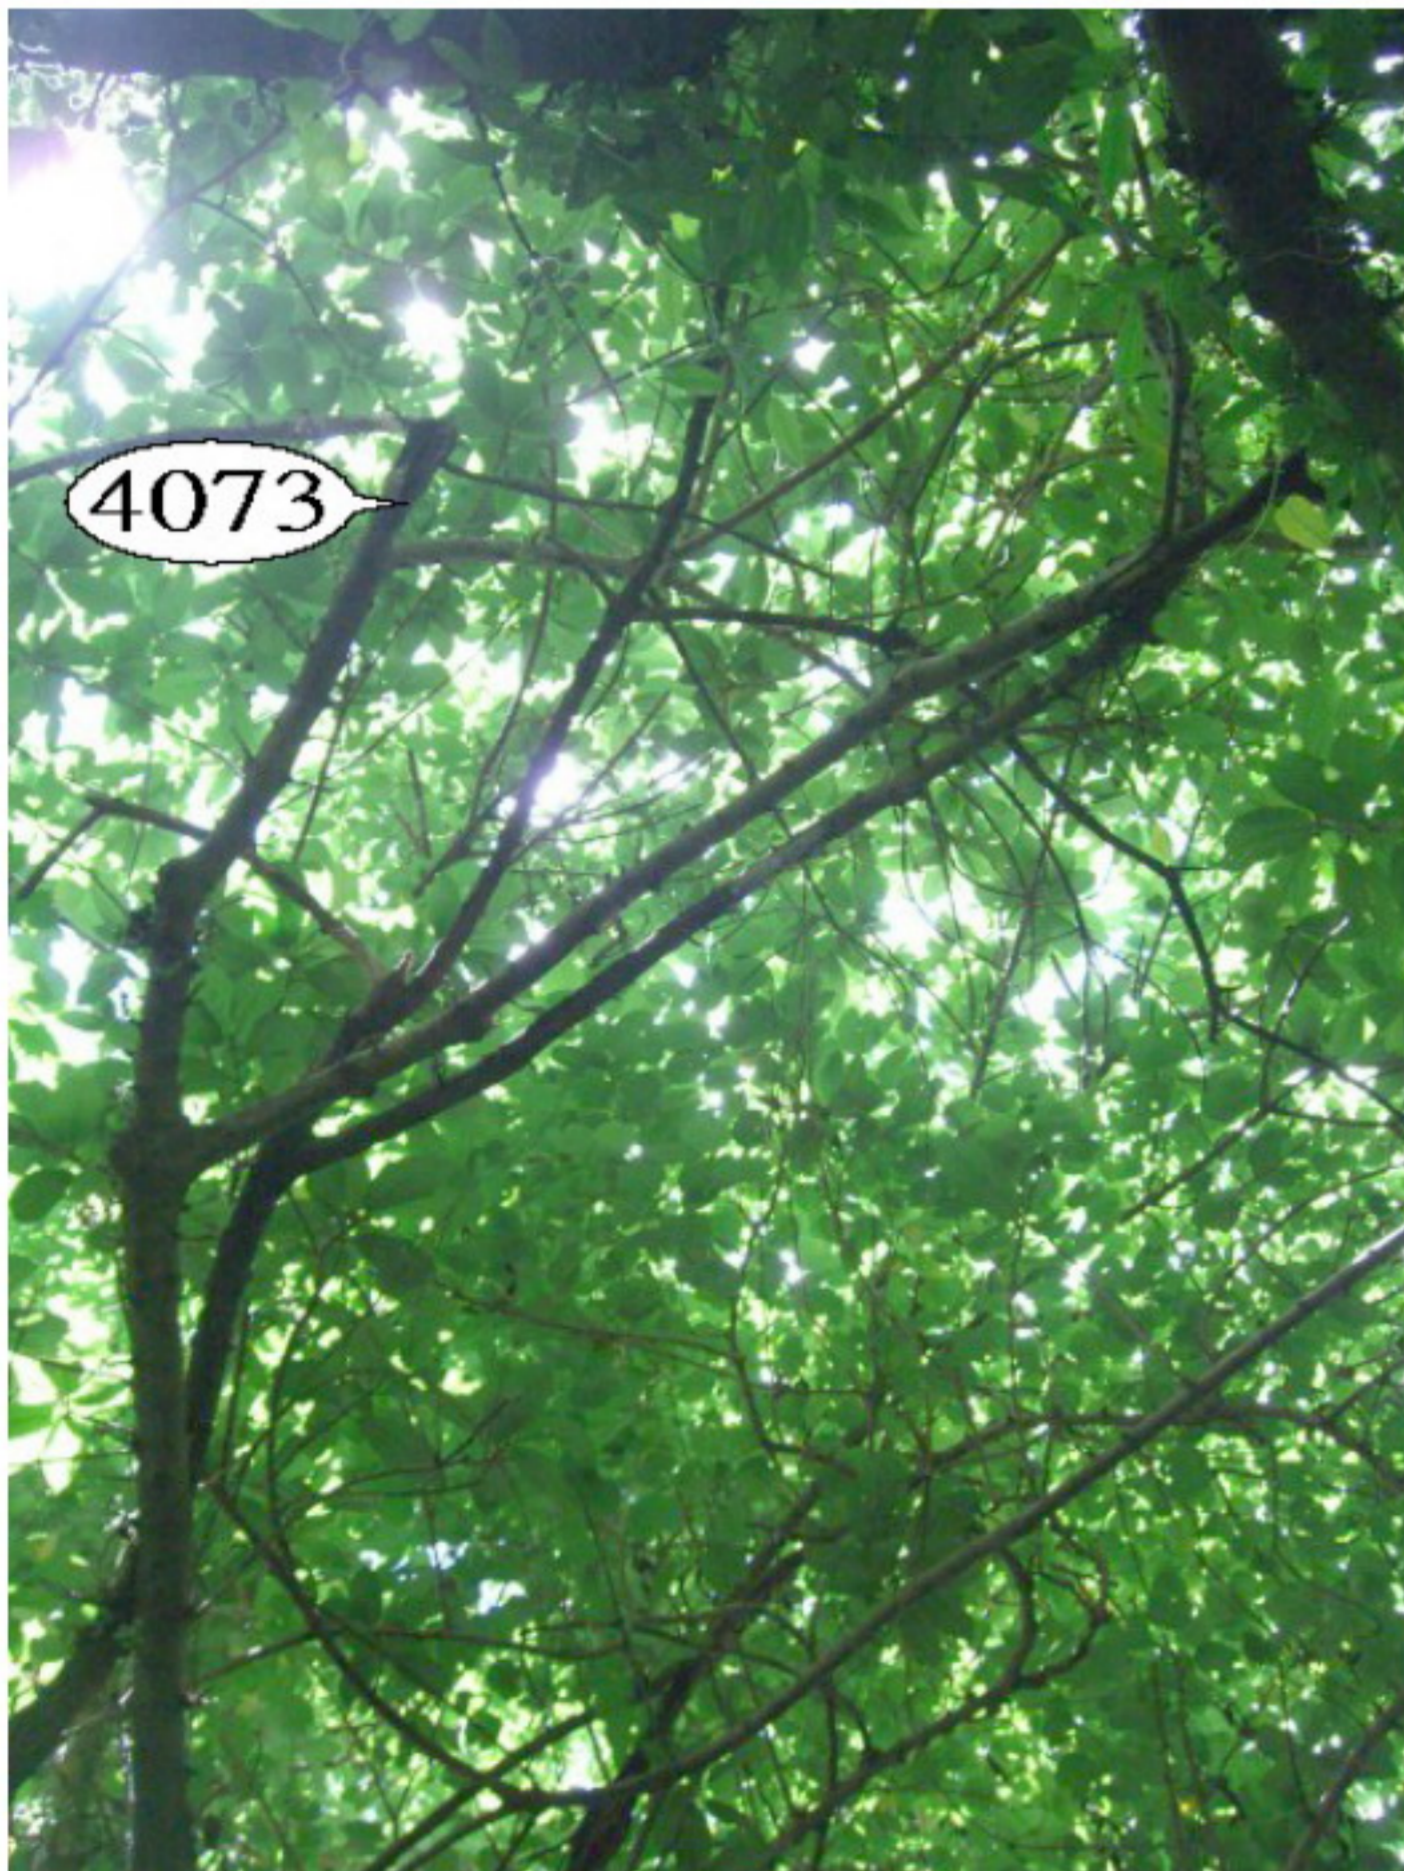
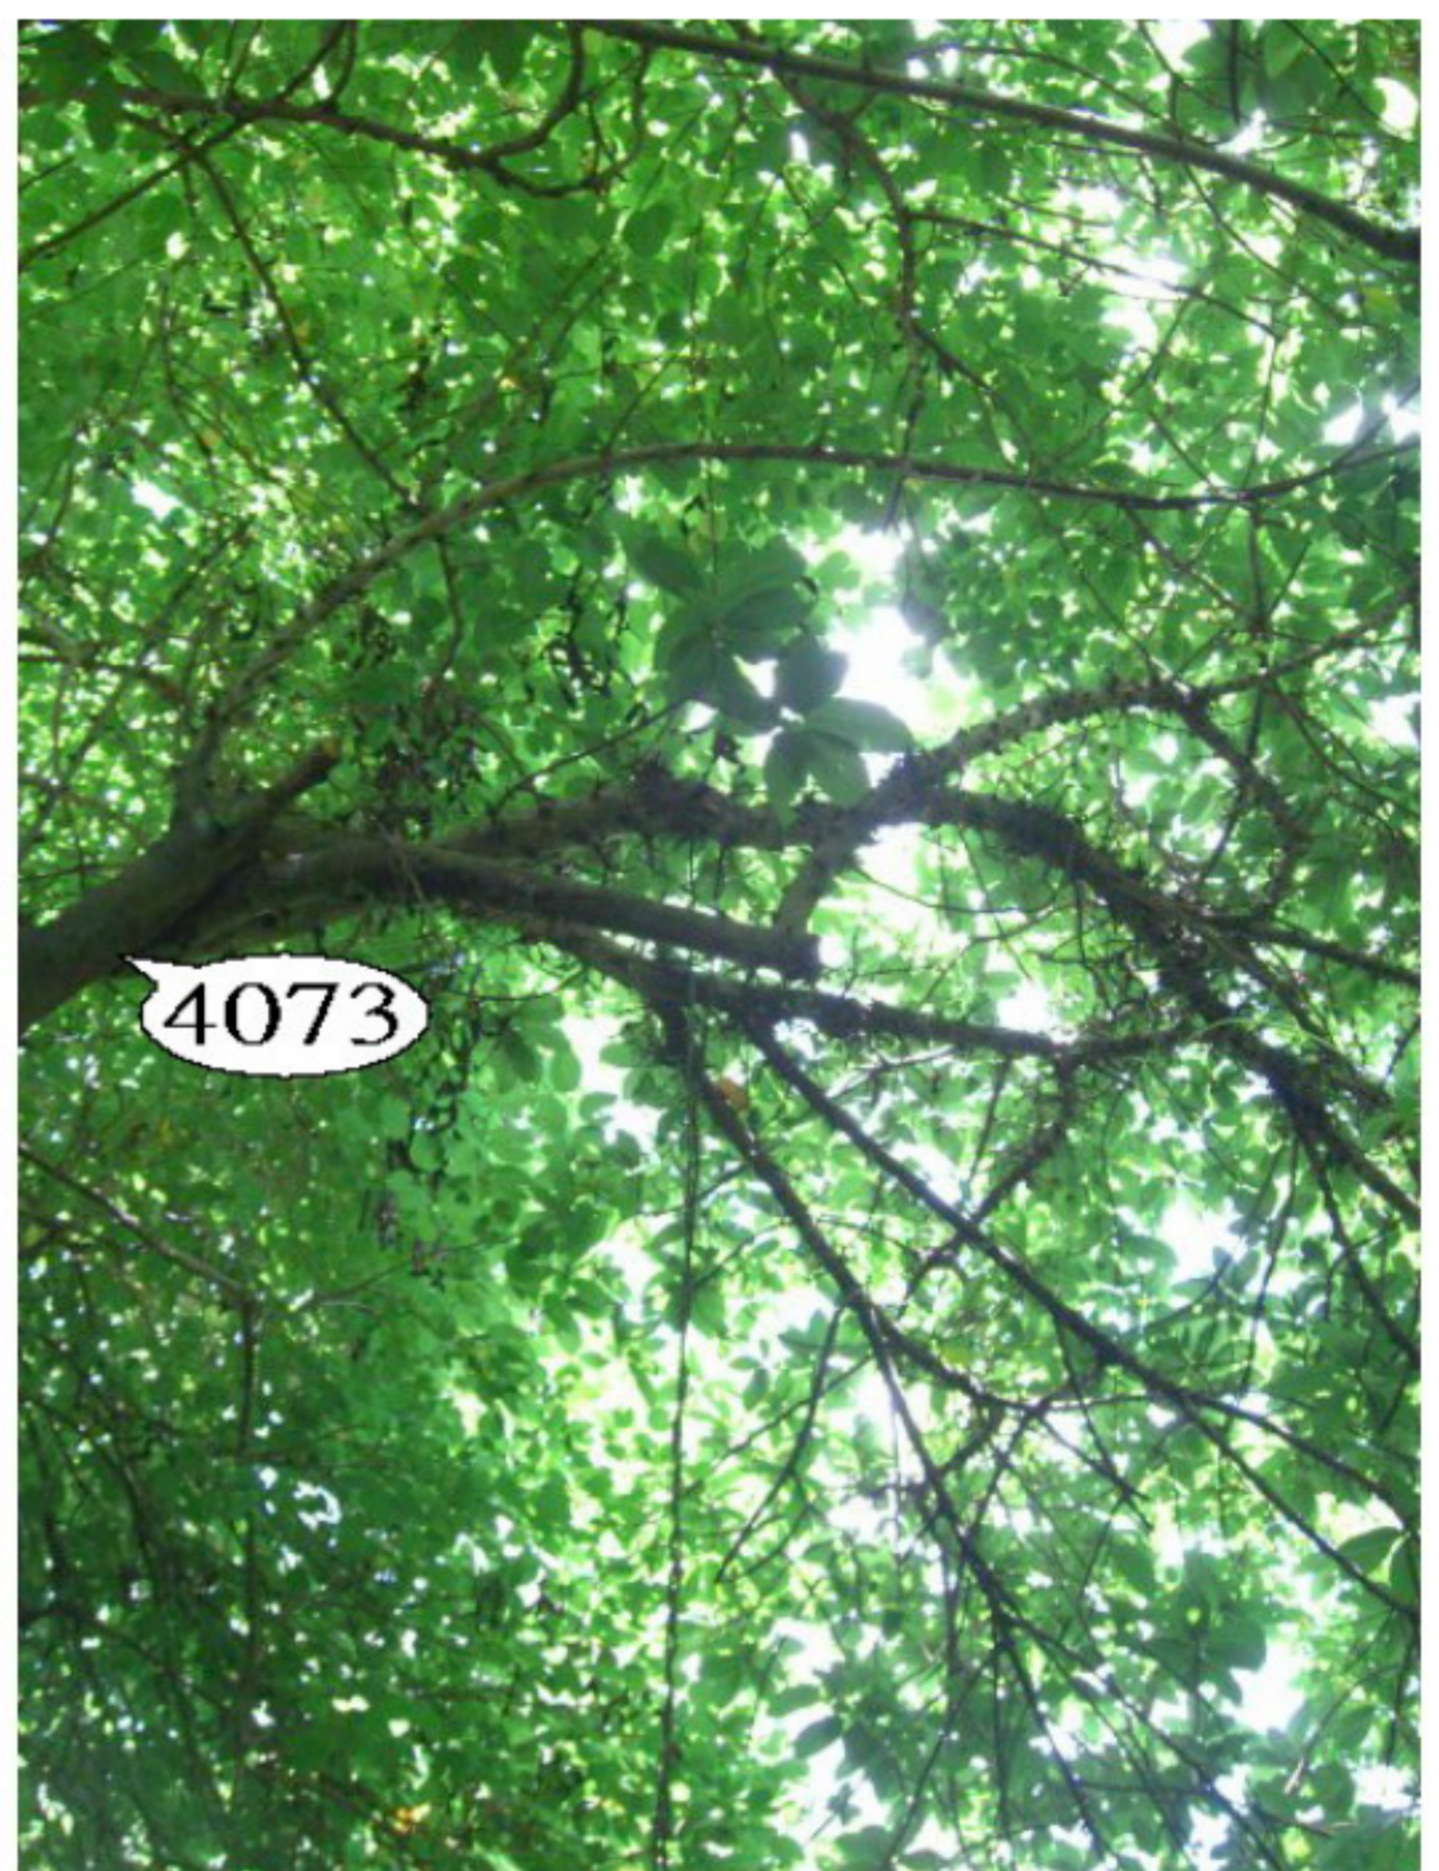
Tree 4064  
This species is generally low in transplantation survival rate.
