# Provision of Cremators at Wo Hop Shek Crematorium

Tree Survey Report

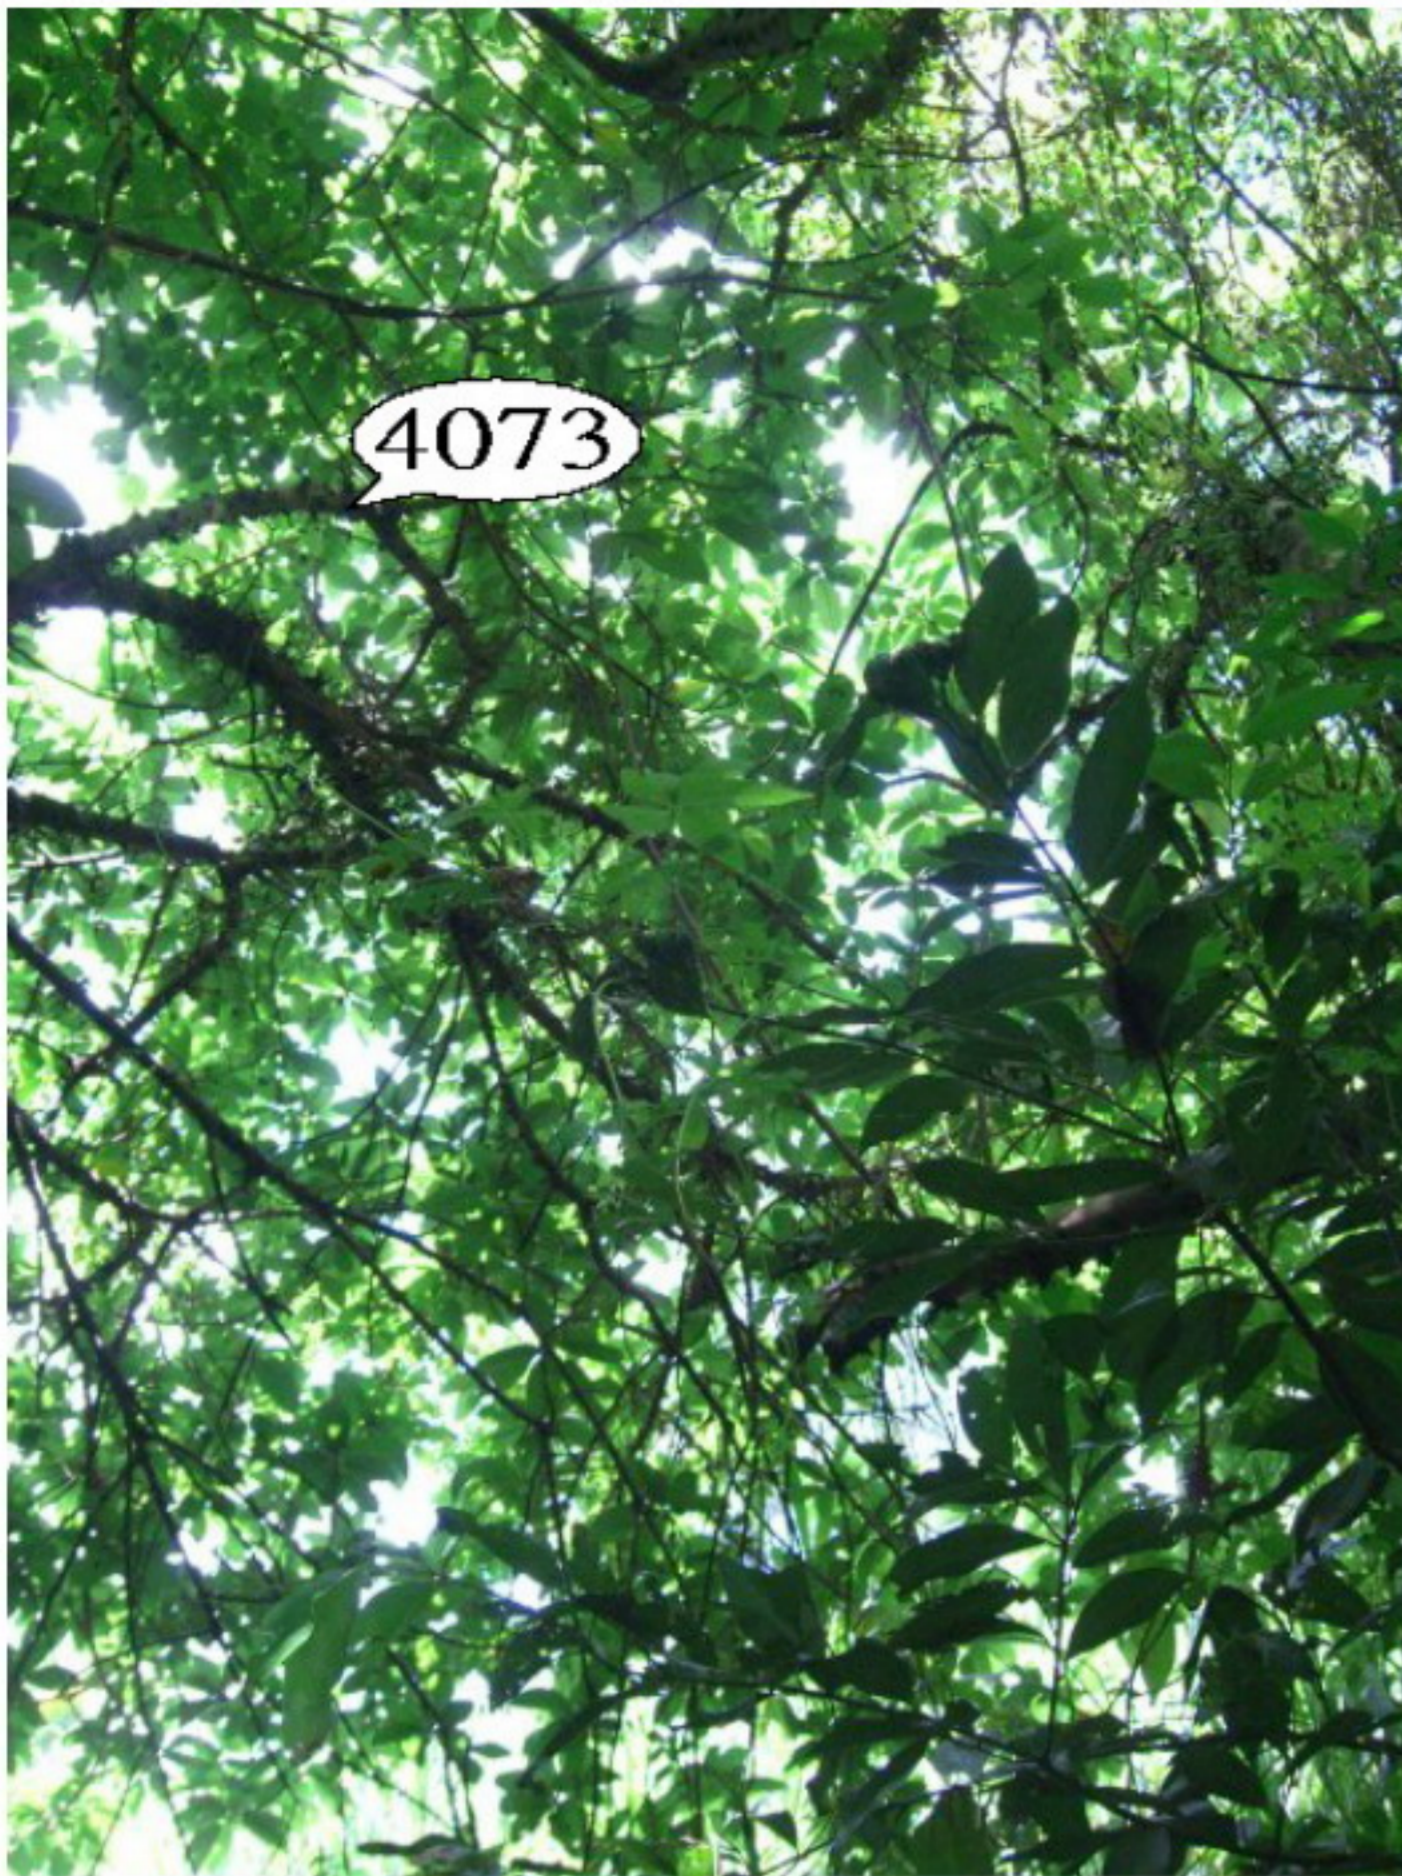
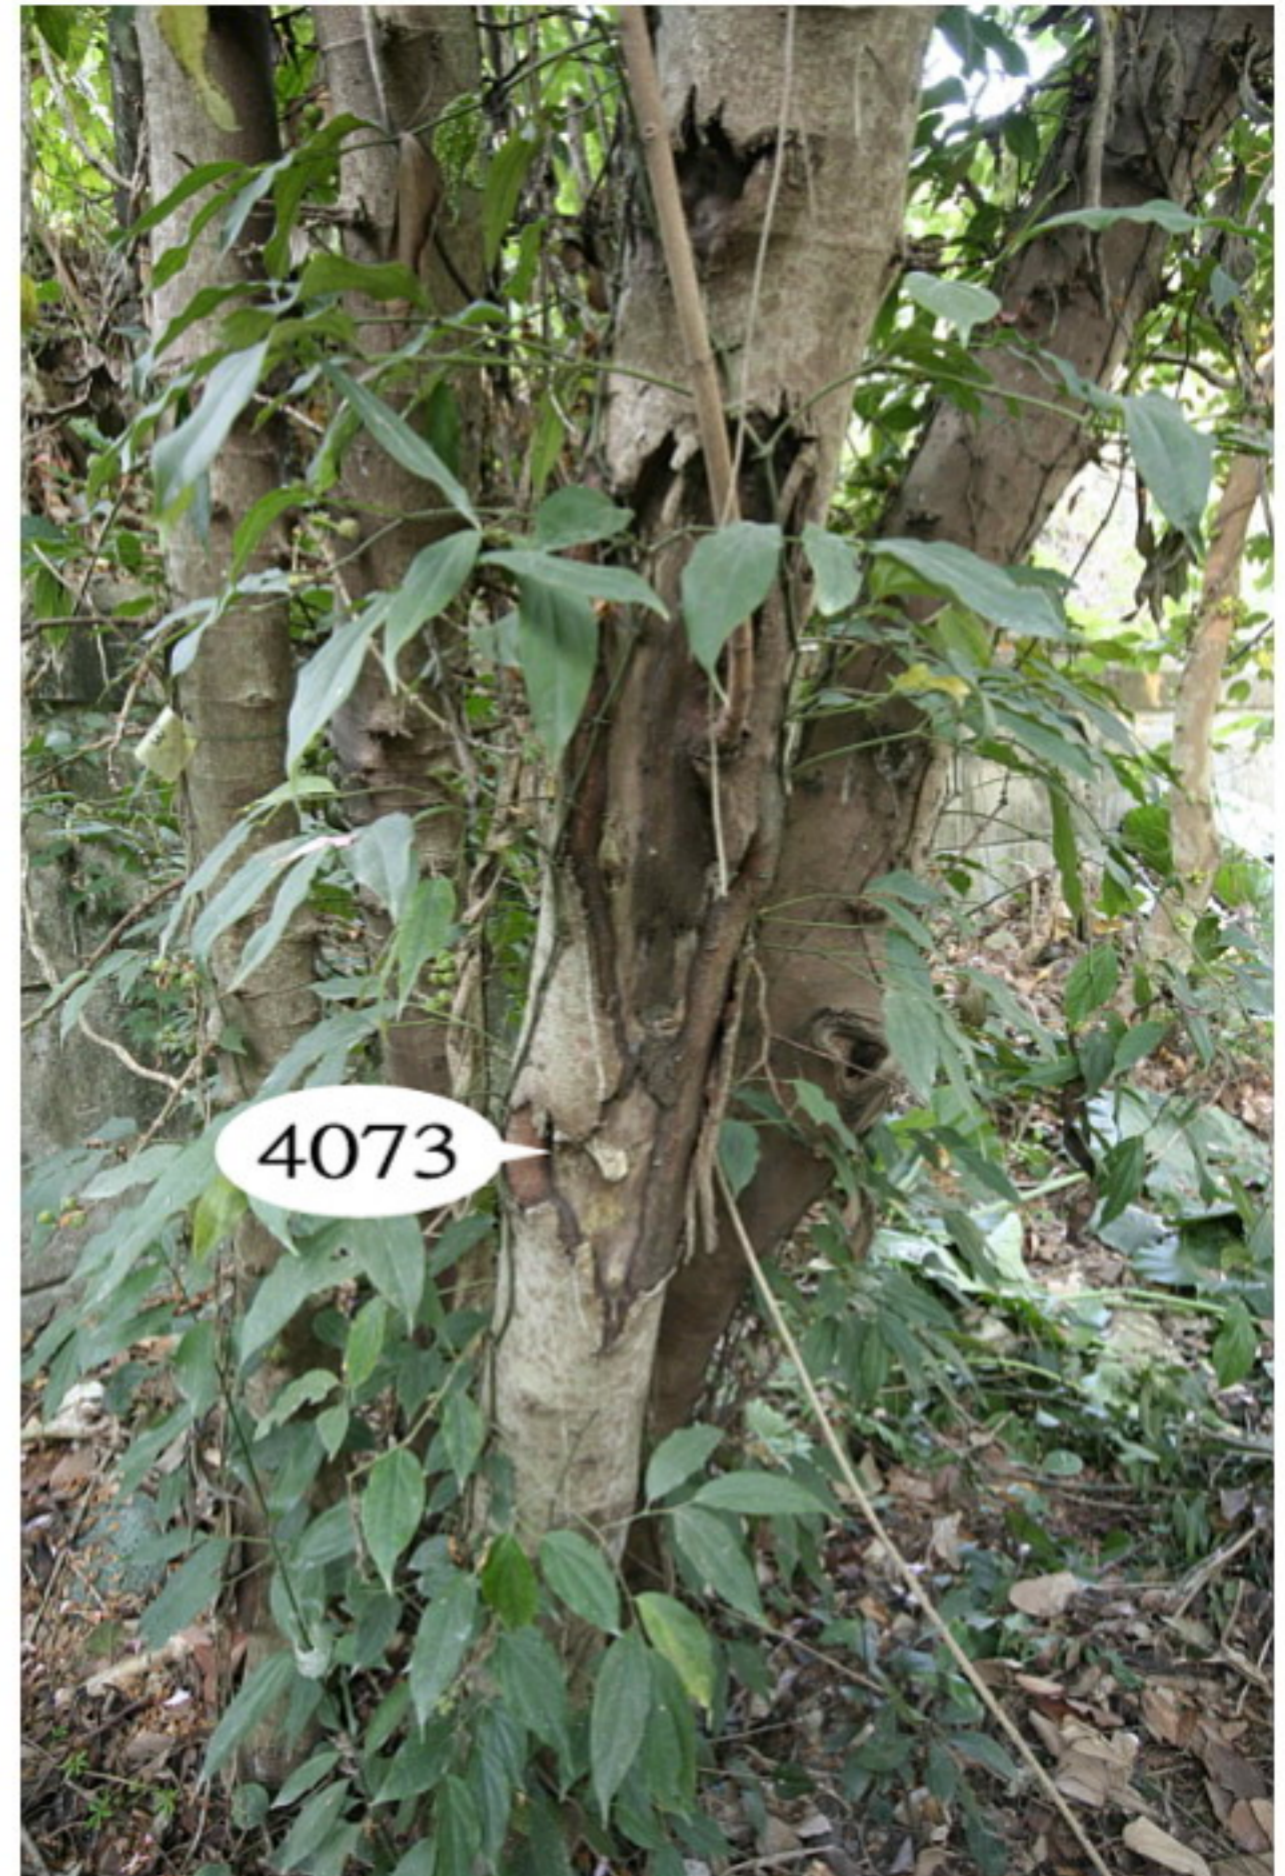
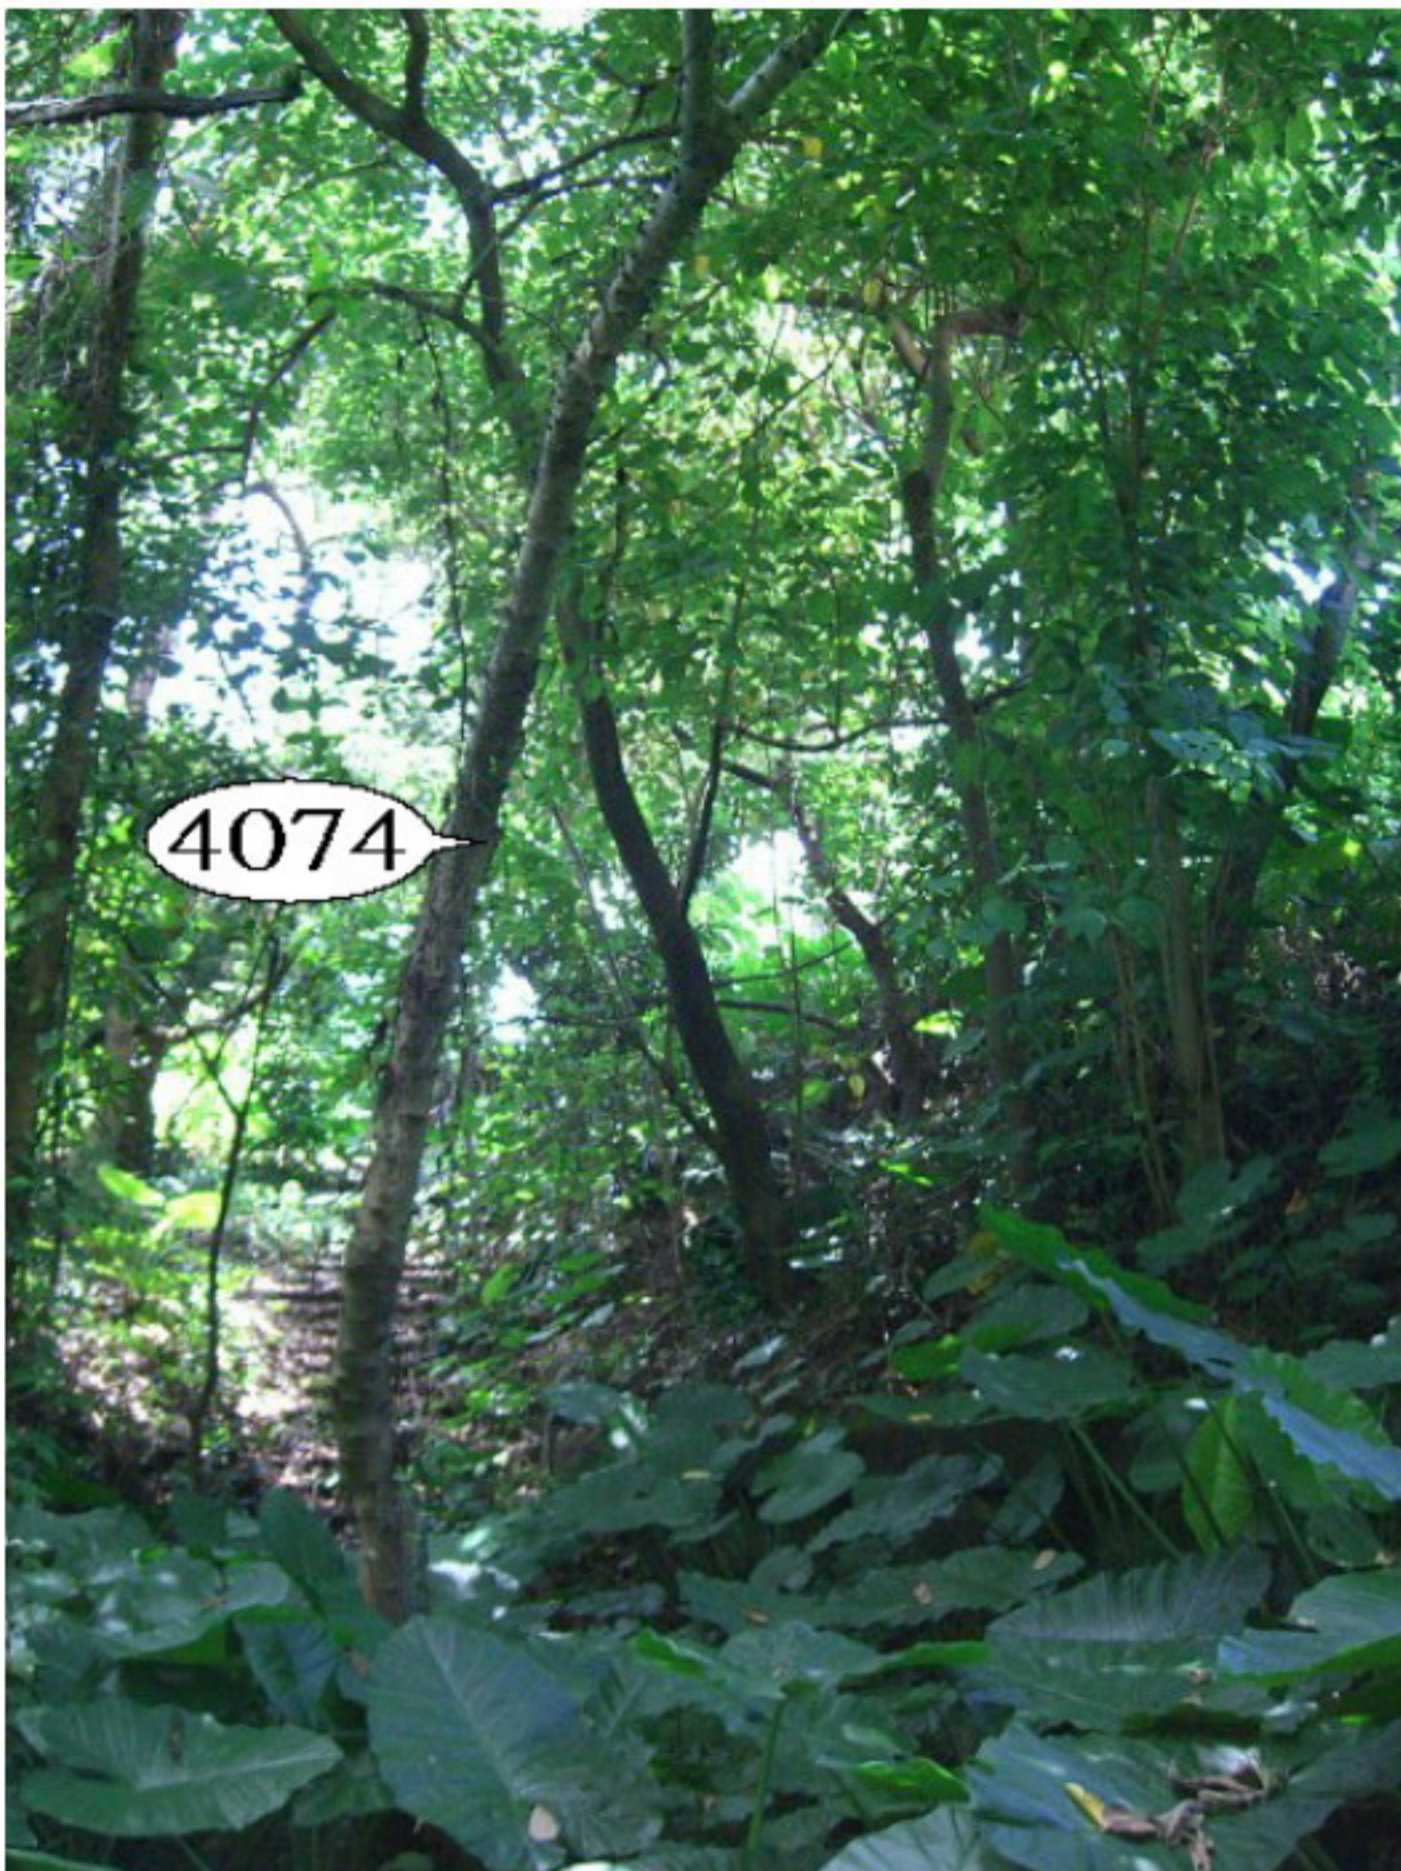
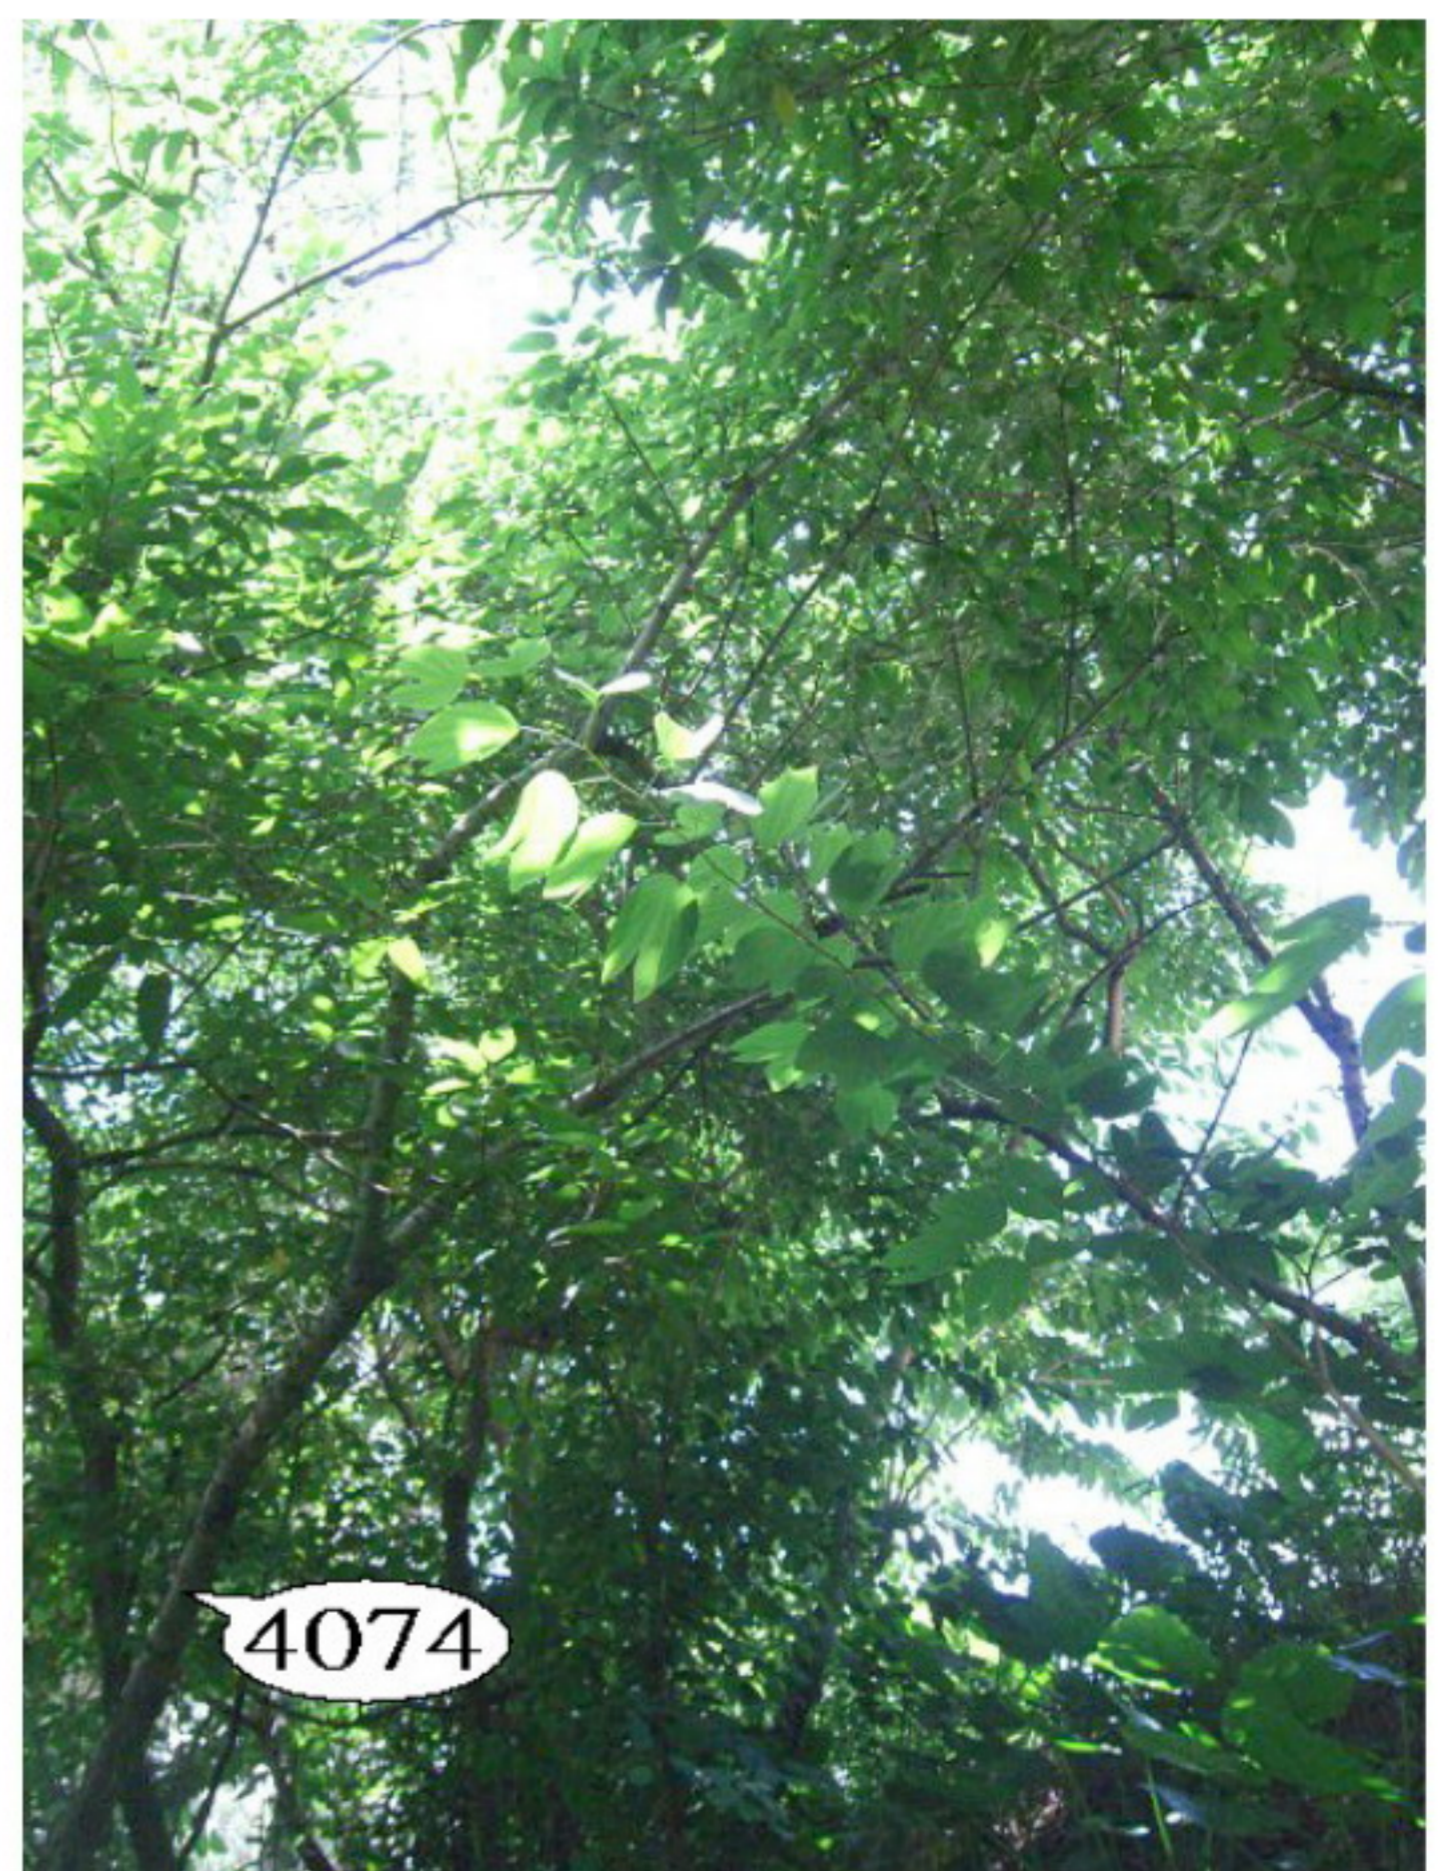
Tree 4073

Poor form which lead to low amenity value. Besides, the tree is unbalance. It may need heavy pruning after transplanted that will affect its transplanted survival rate. Moreover, the operation of the transplanted for poor form tree is also difficult.

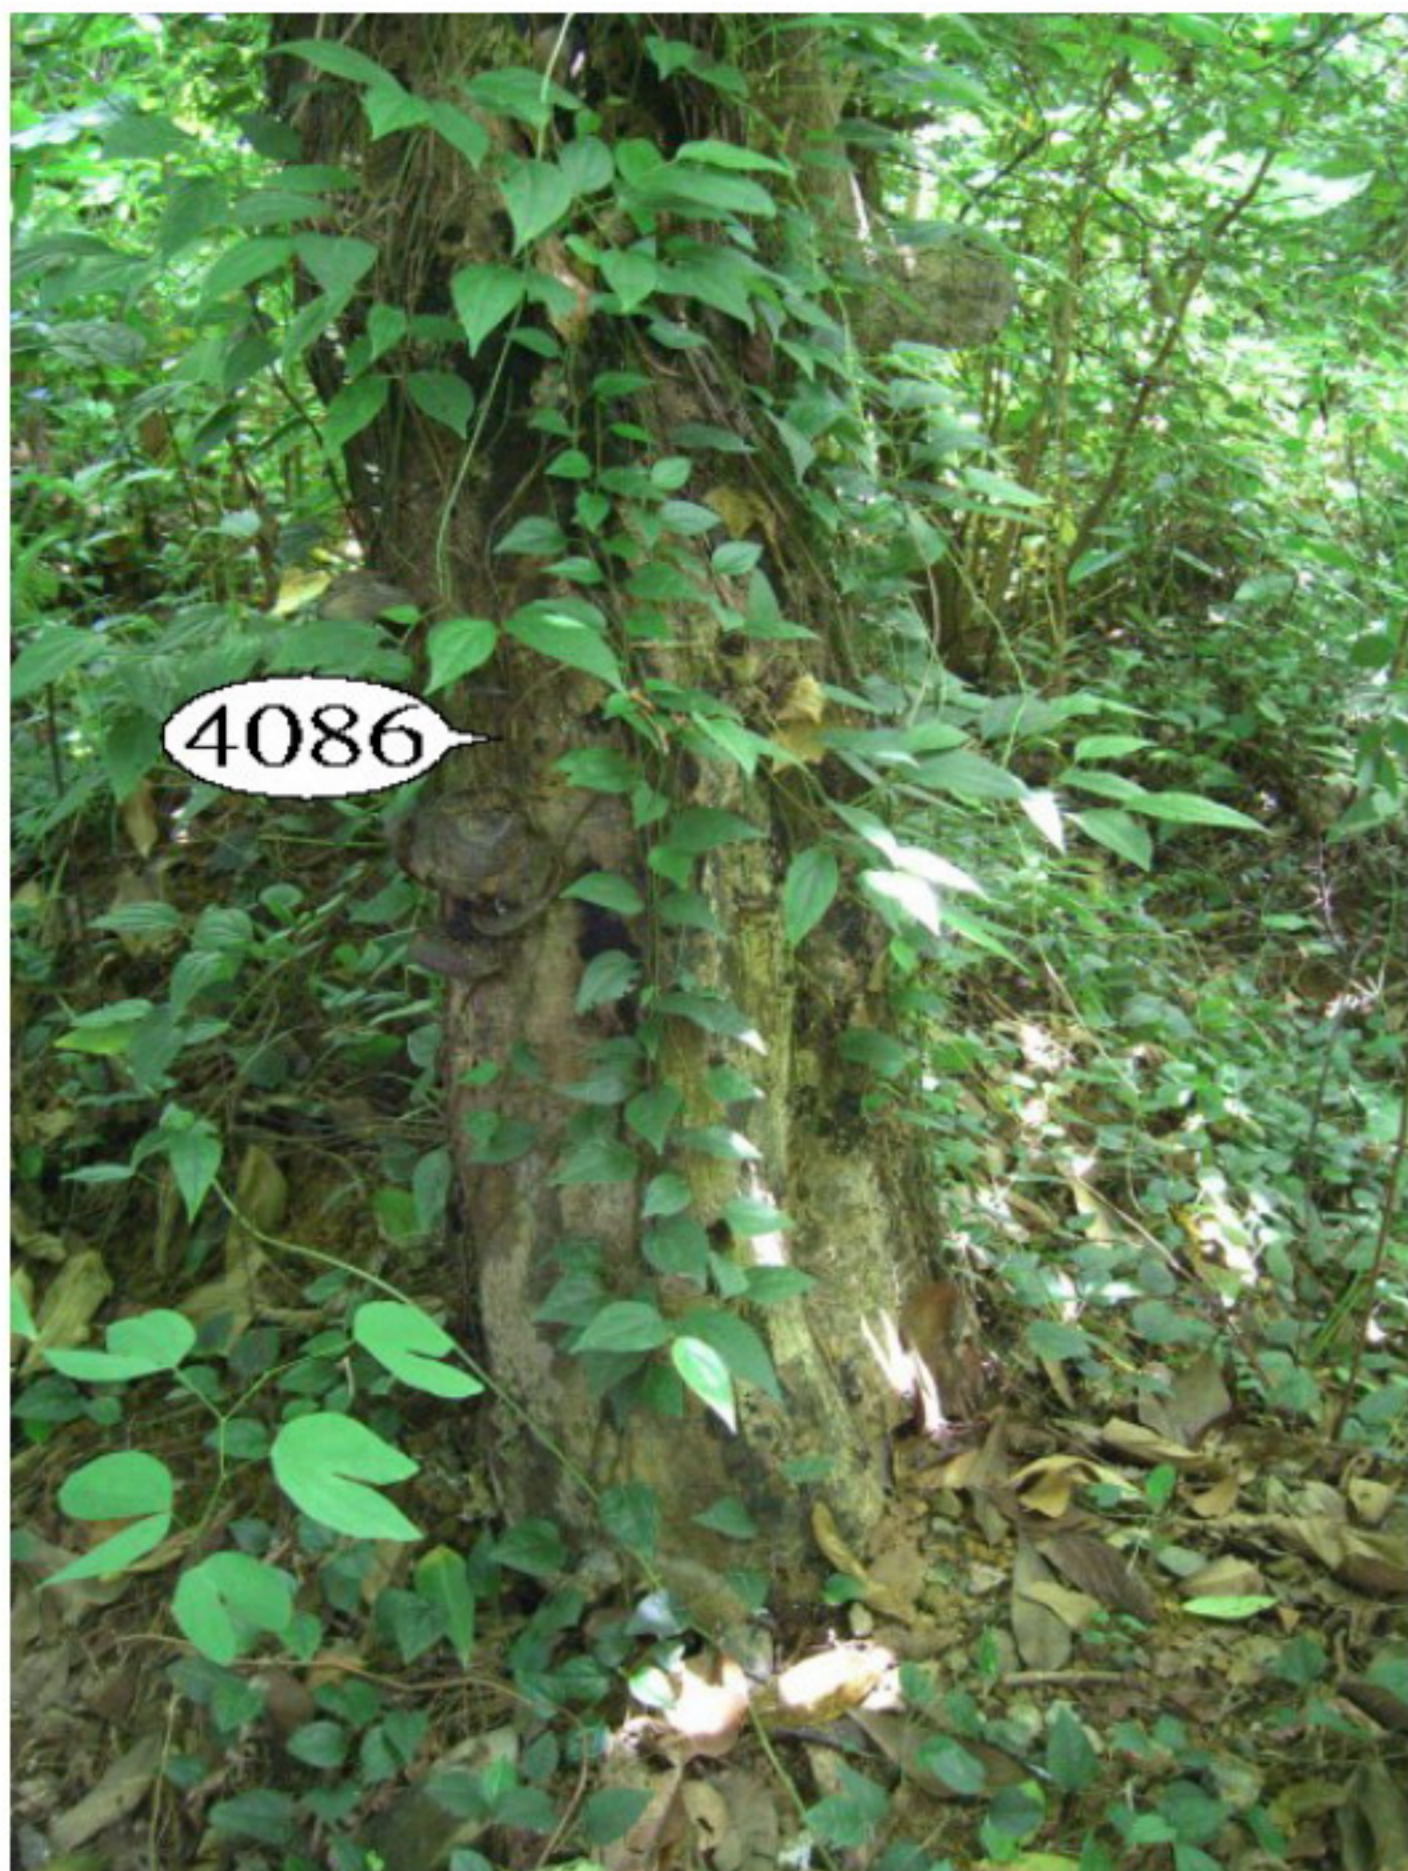
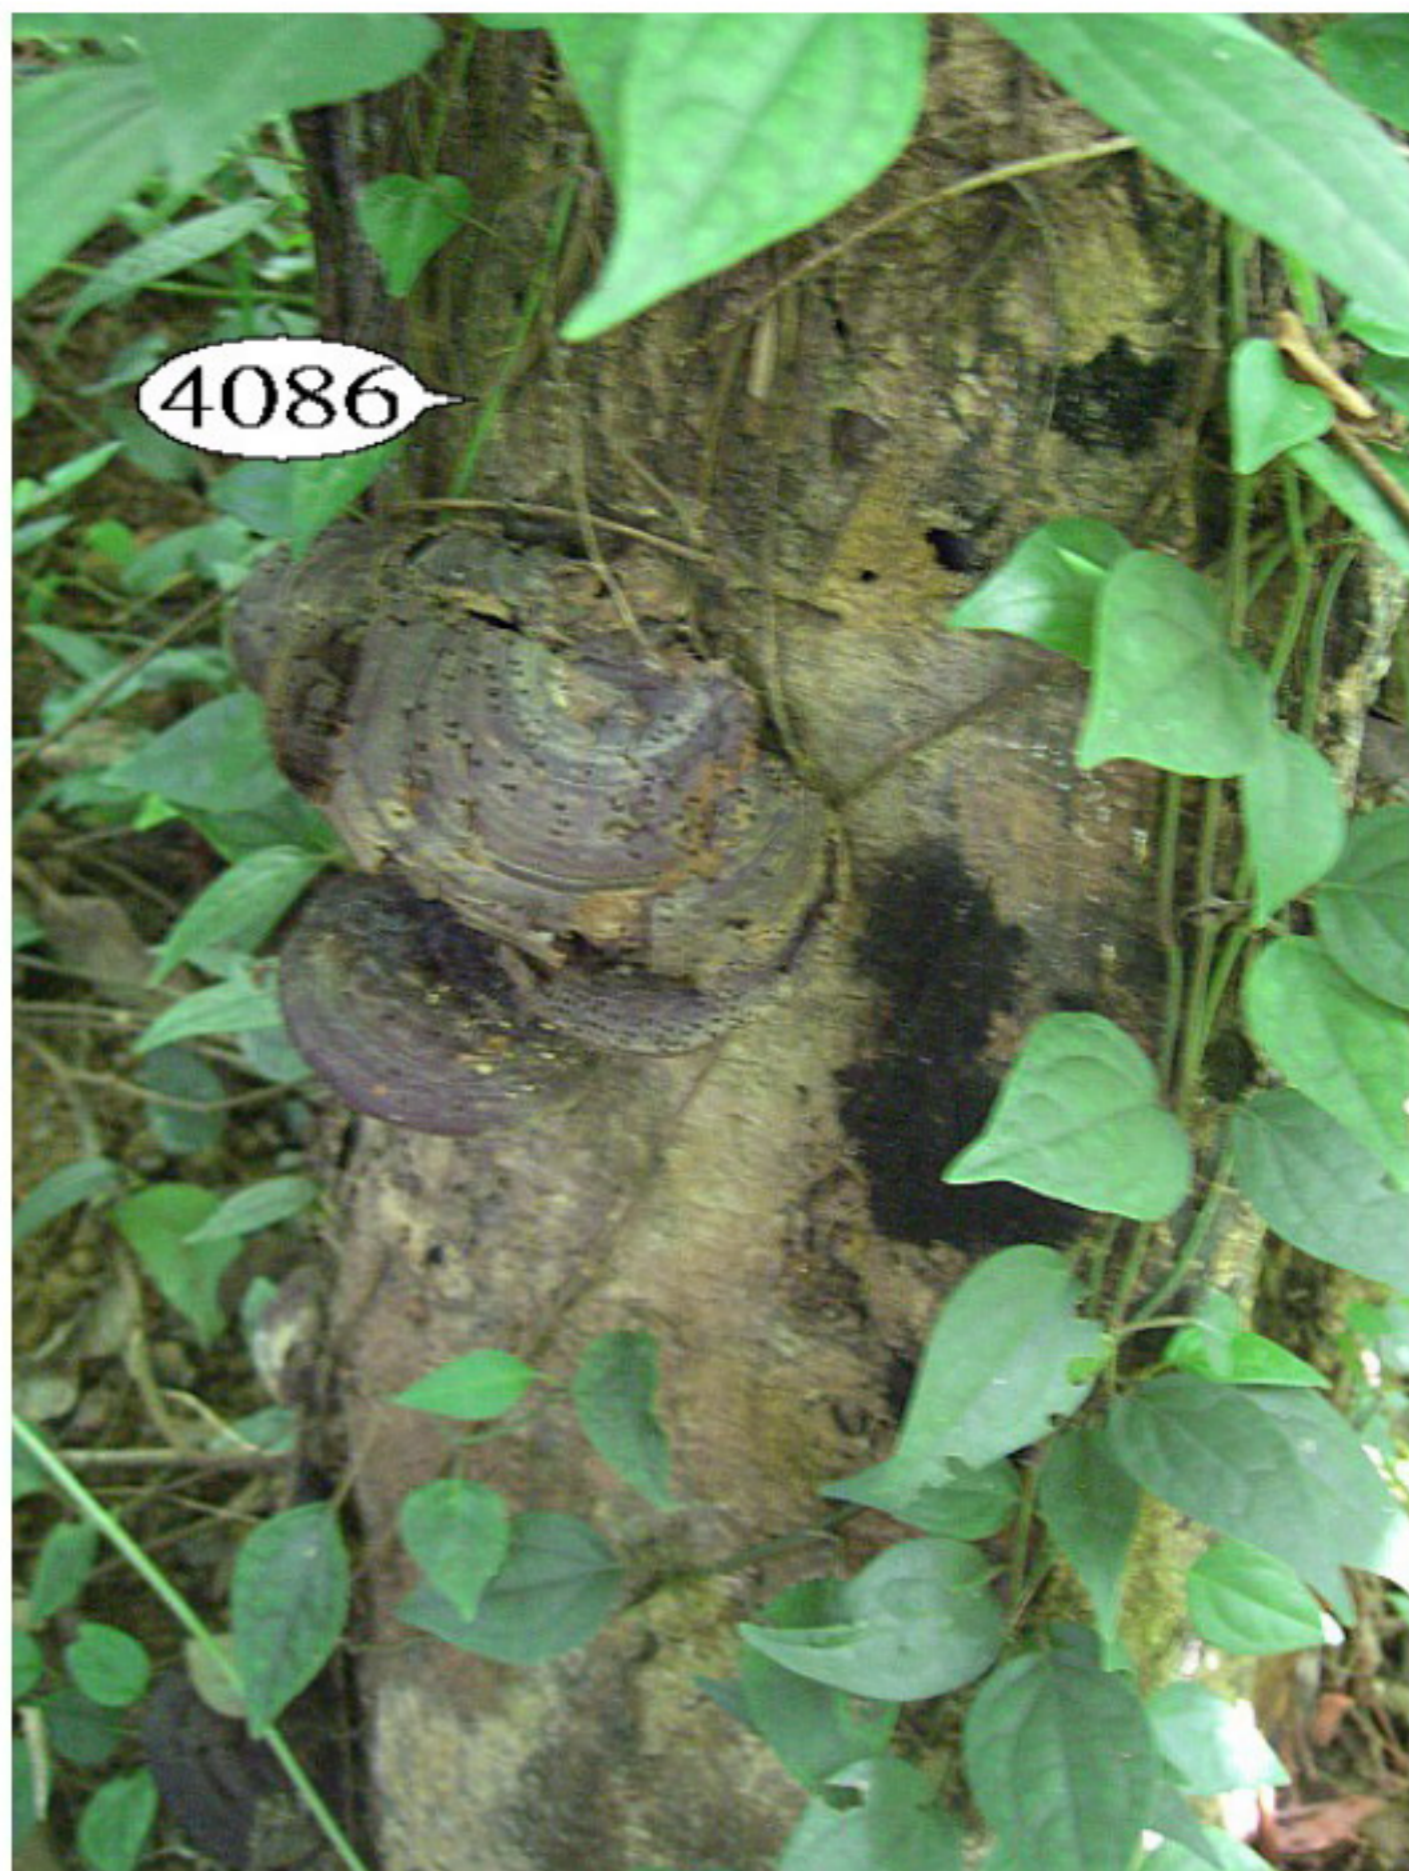
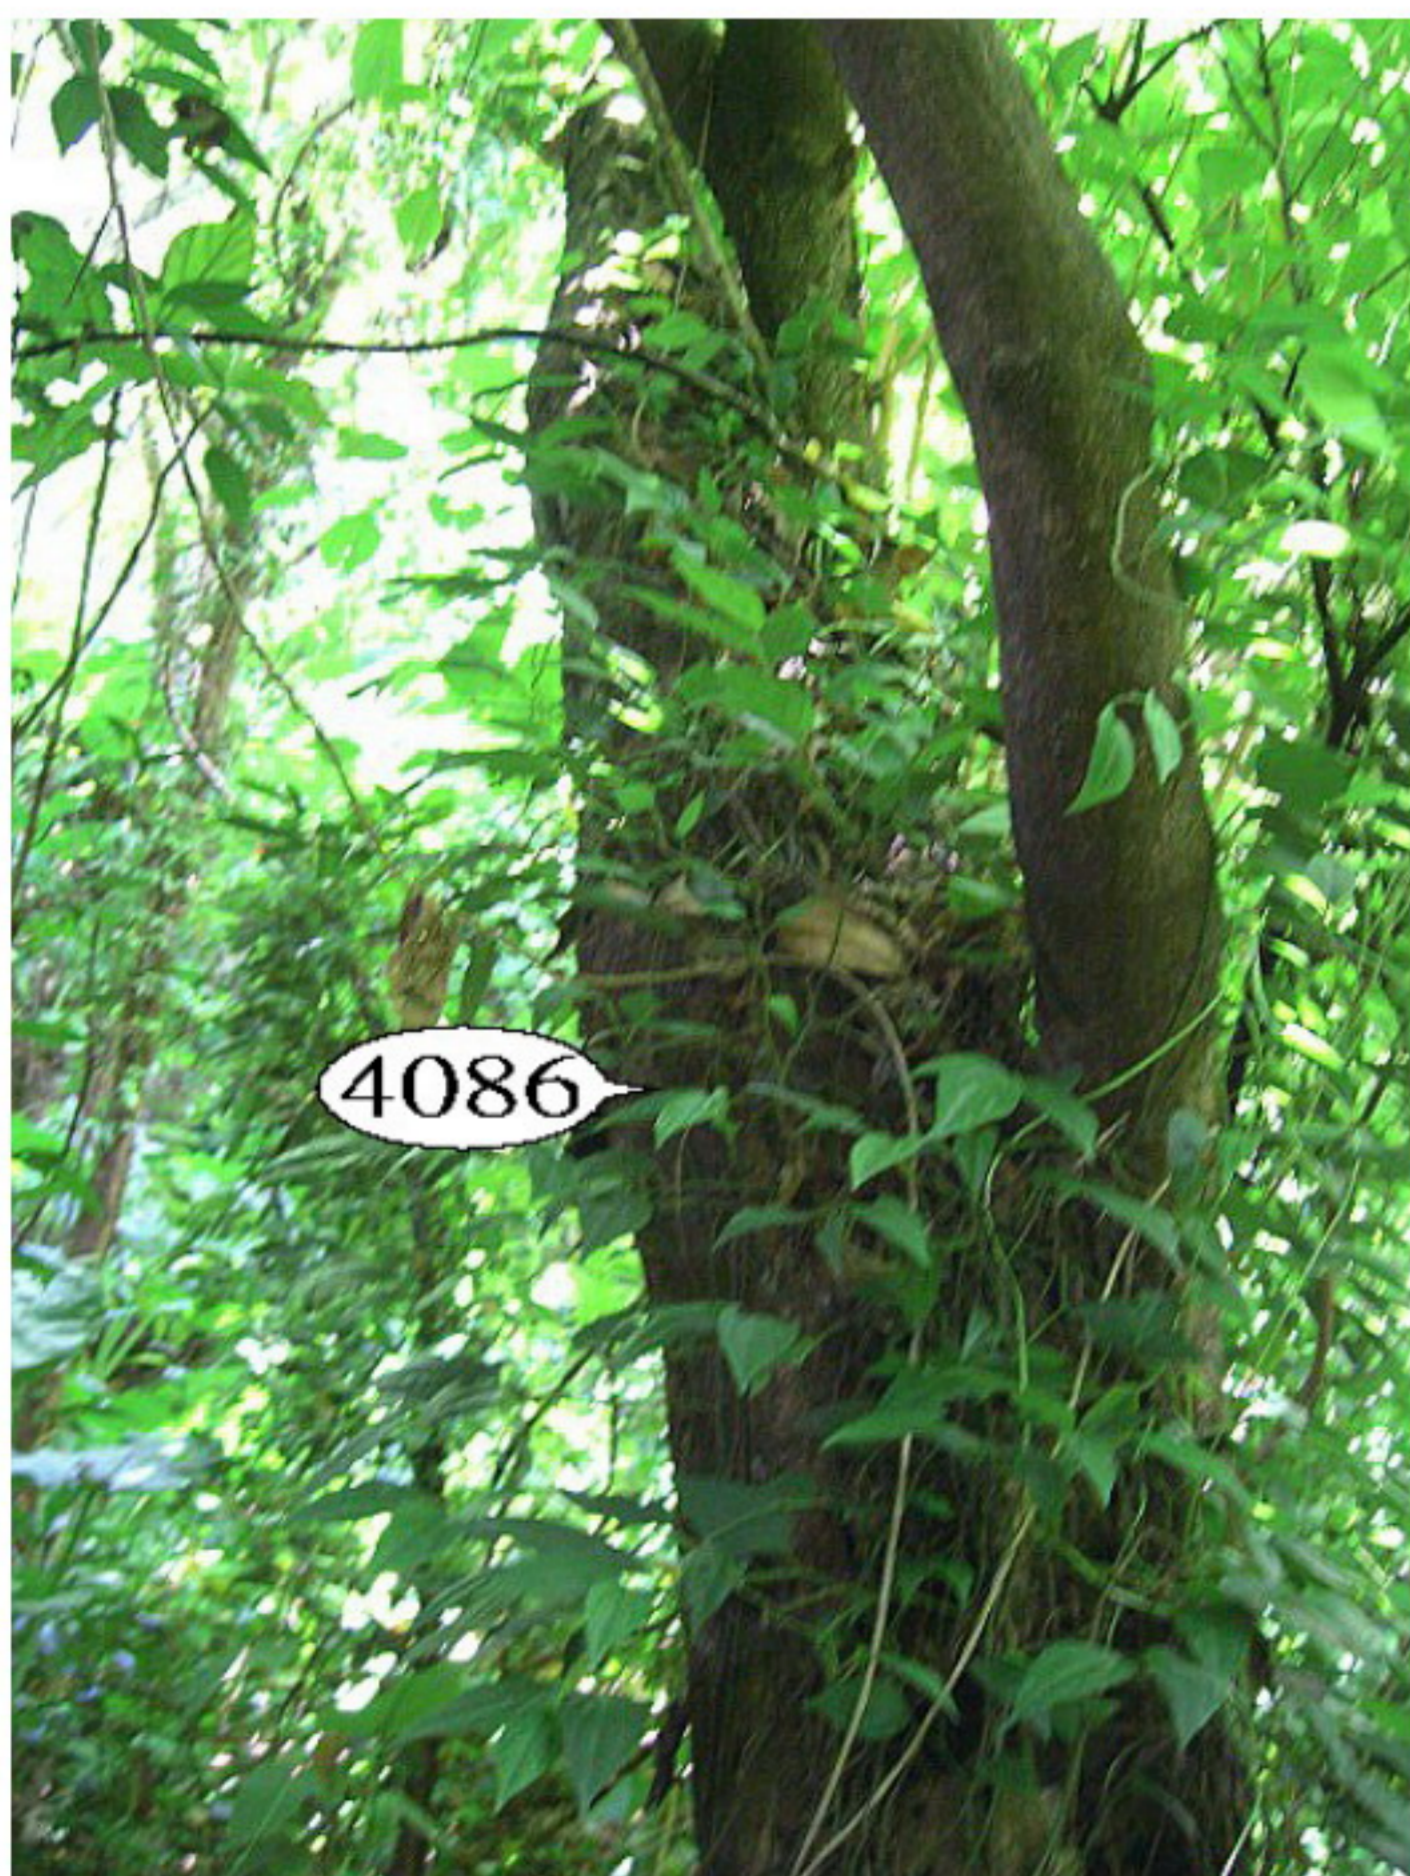
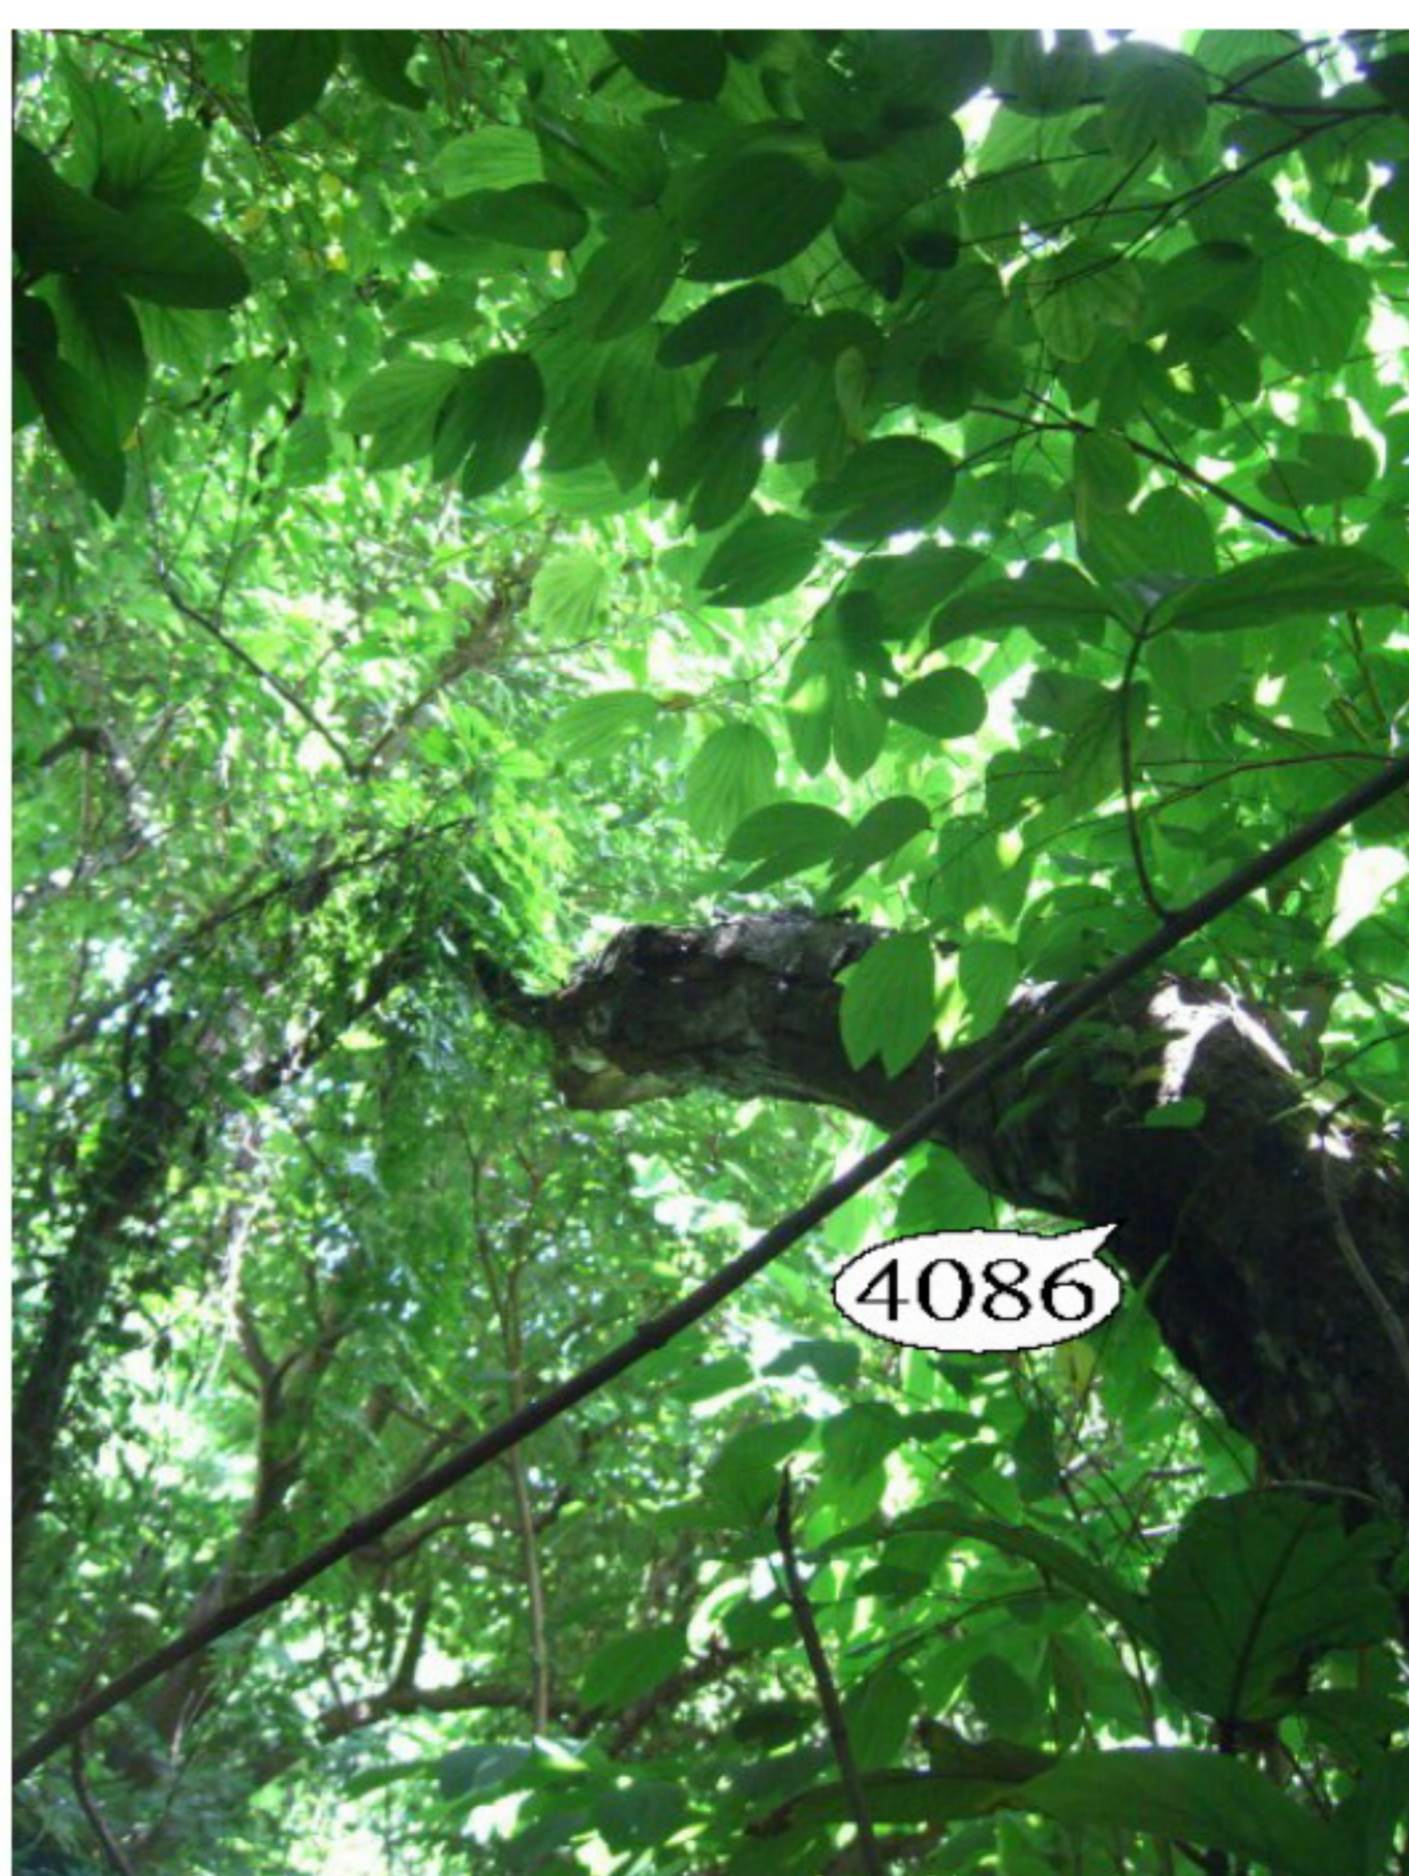
Tree 4073 and 4074

Poor form which lead to low amenity value. Besides, the tree is unbalance. It may need heavy pruning after transplantation that will affect its transplantation survival rate. Moreover, the operation of the transplantation for poor form tree is also difficult.
