# Provision of Cremators at Wo Hop Shek Crematorium

Tree Survey Report

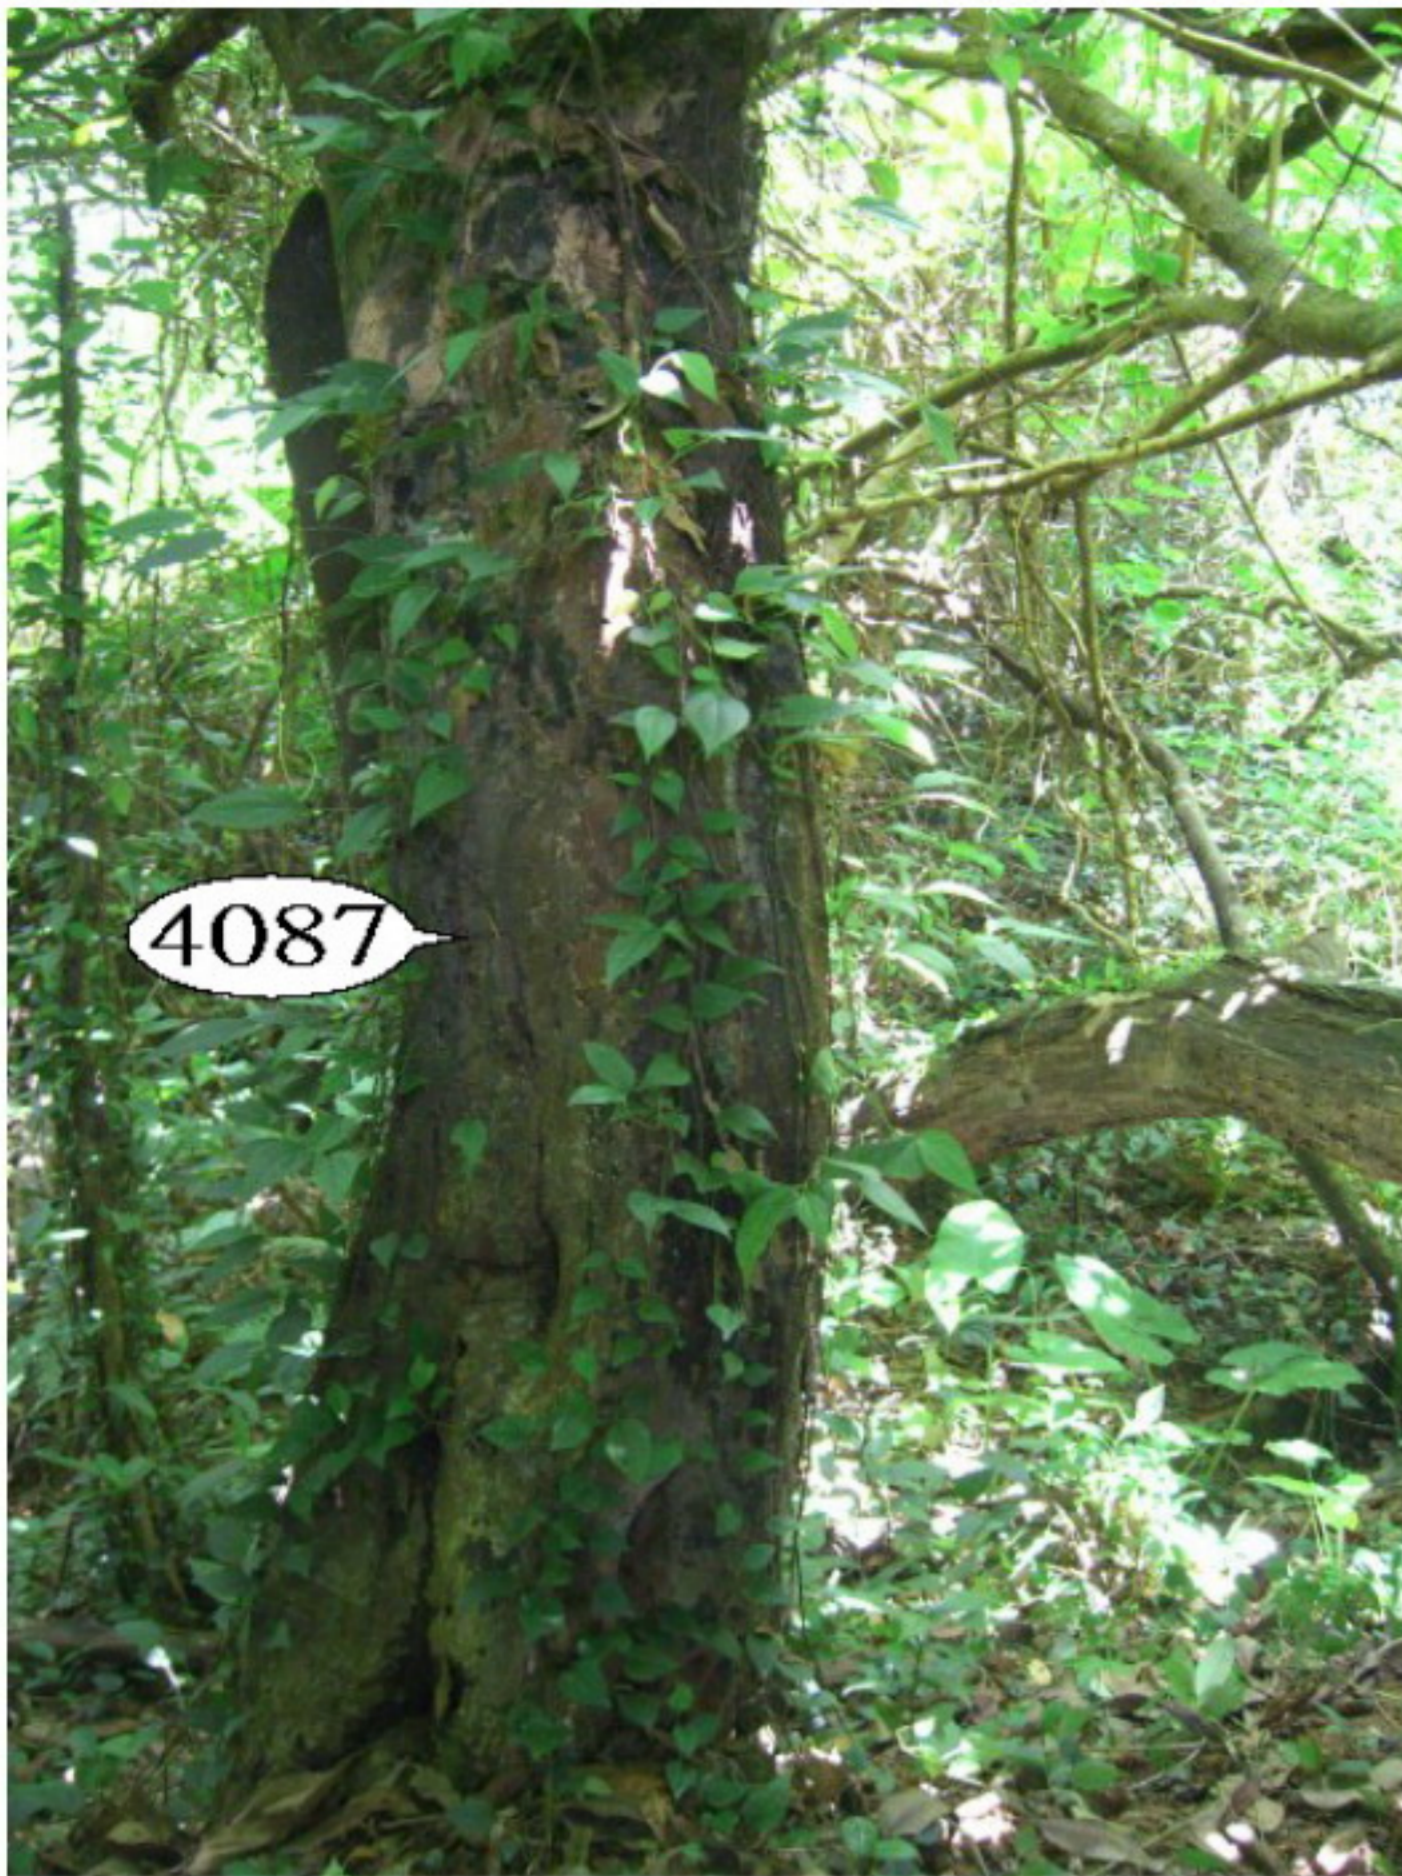
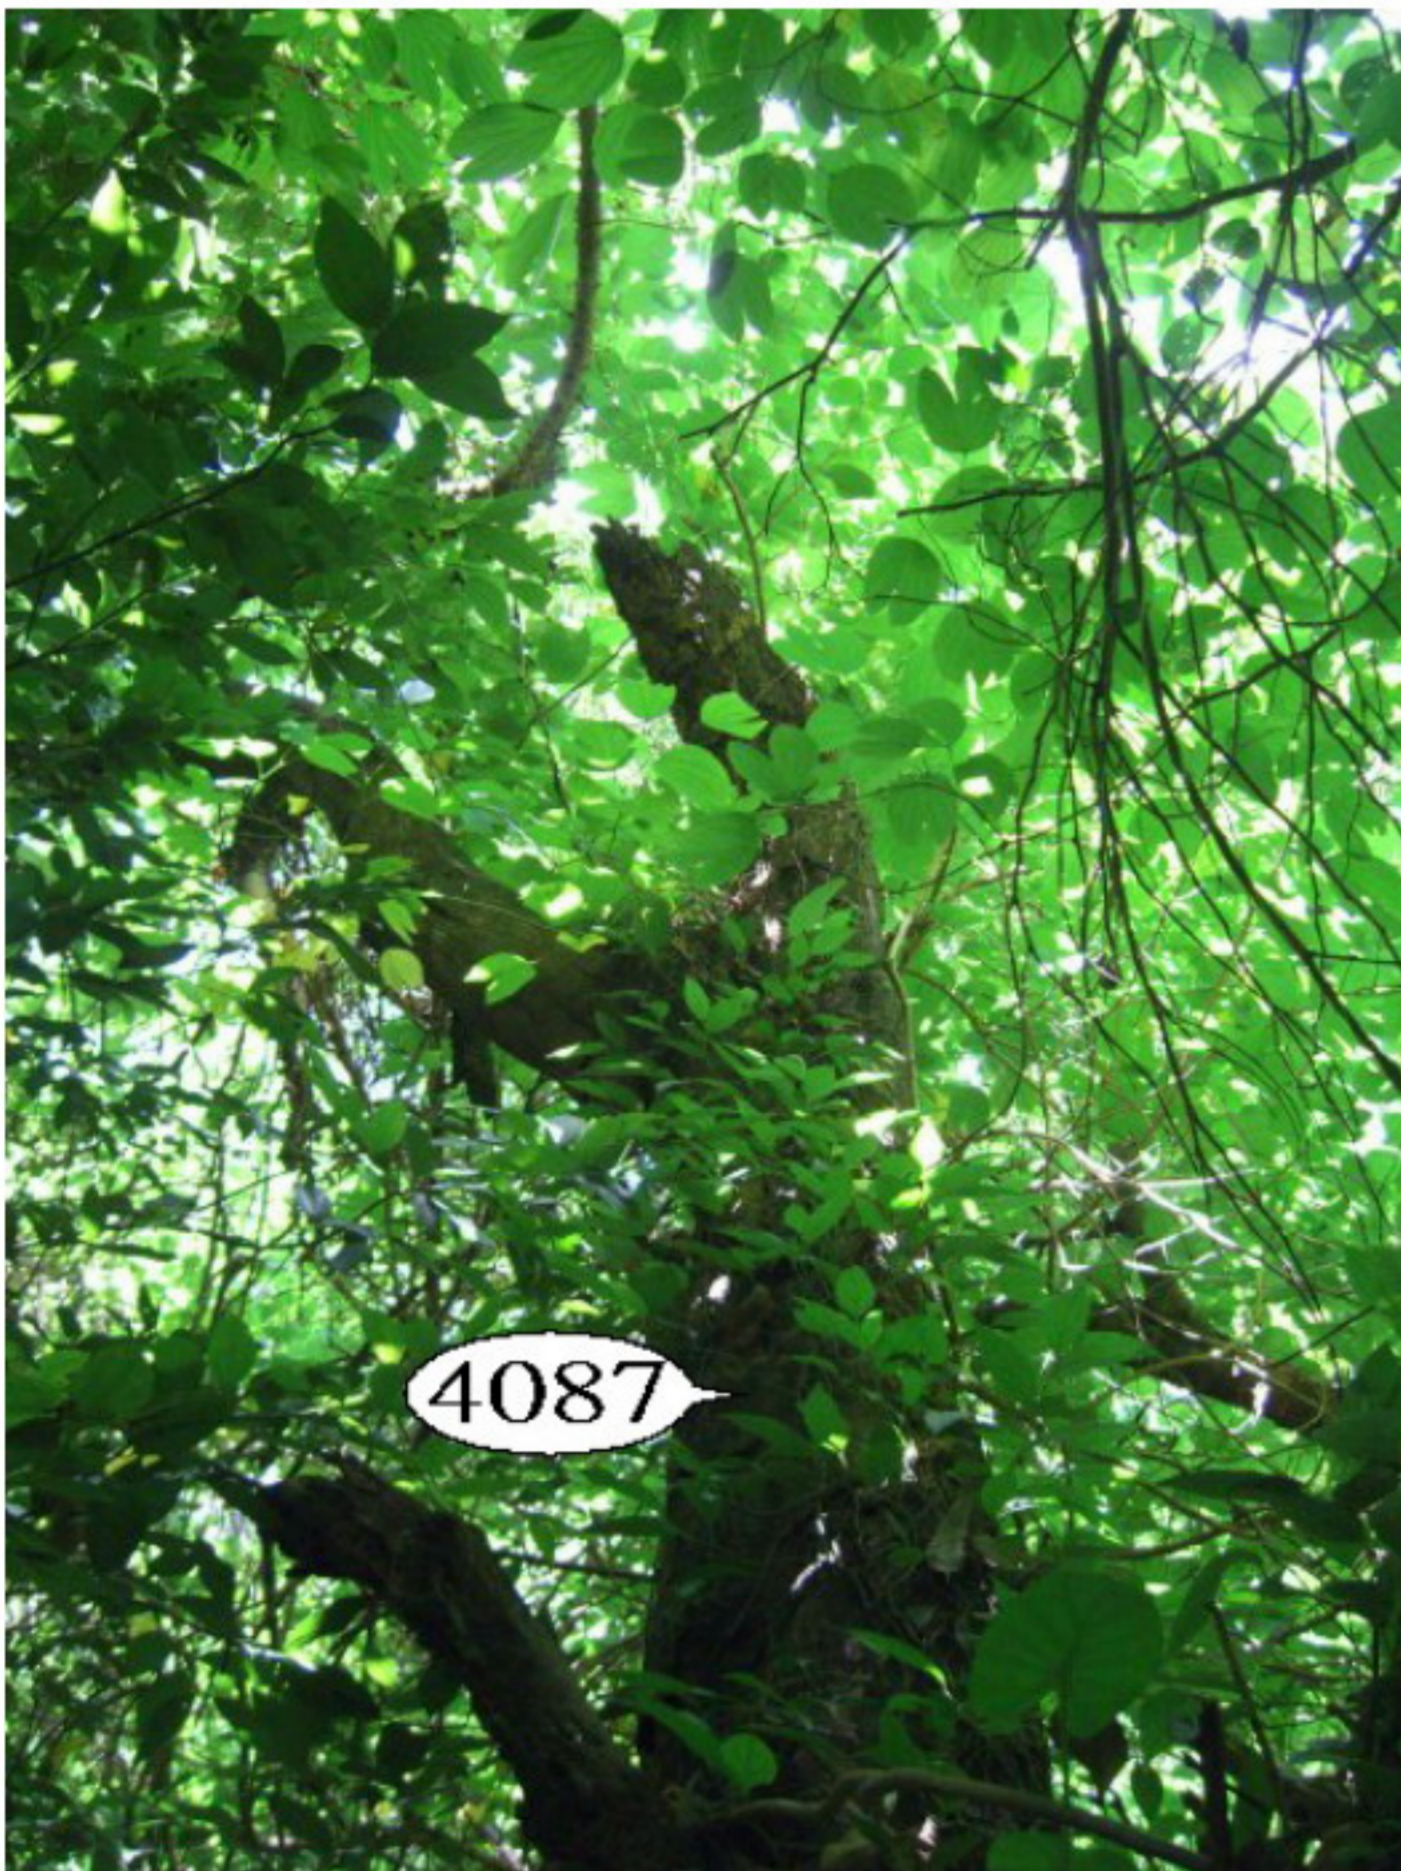
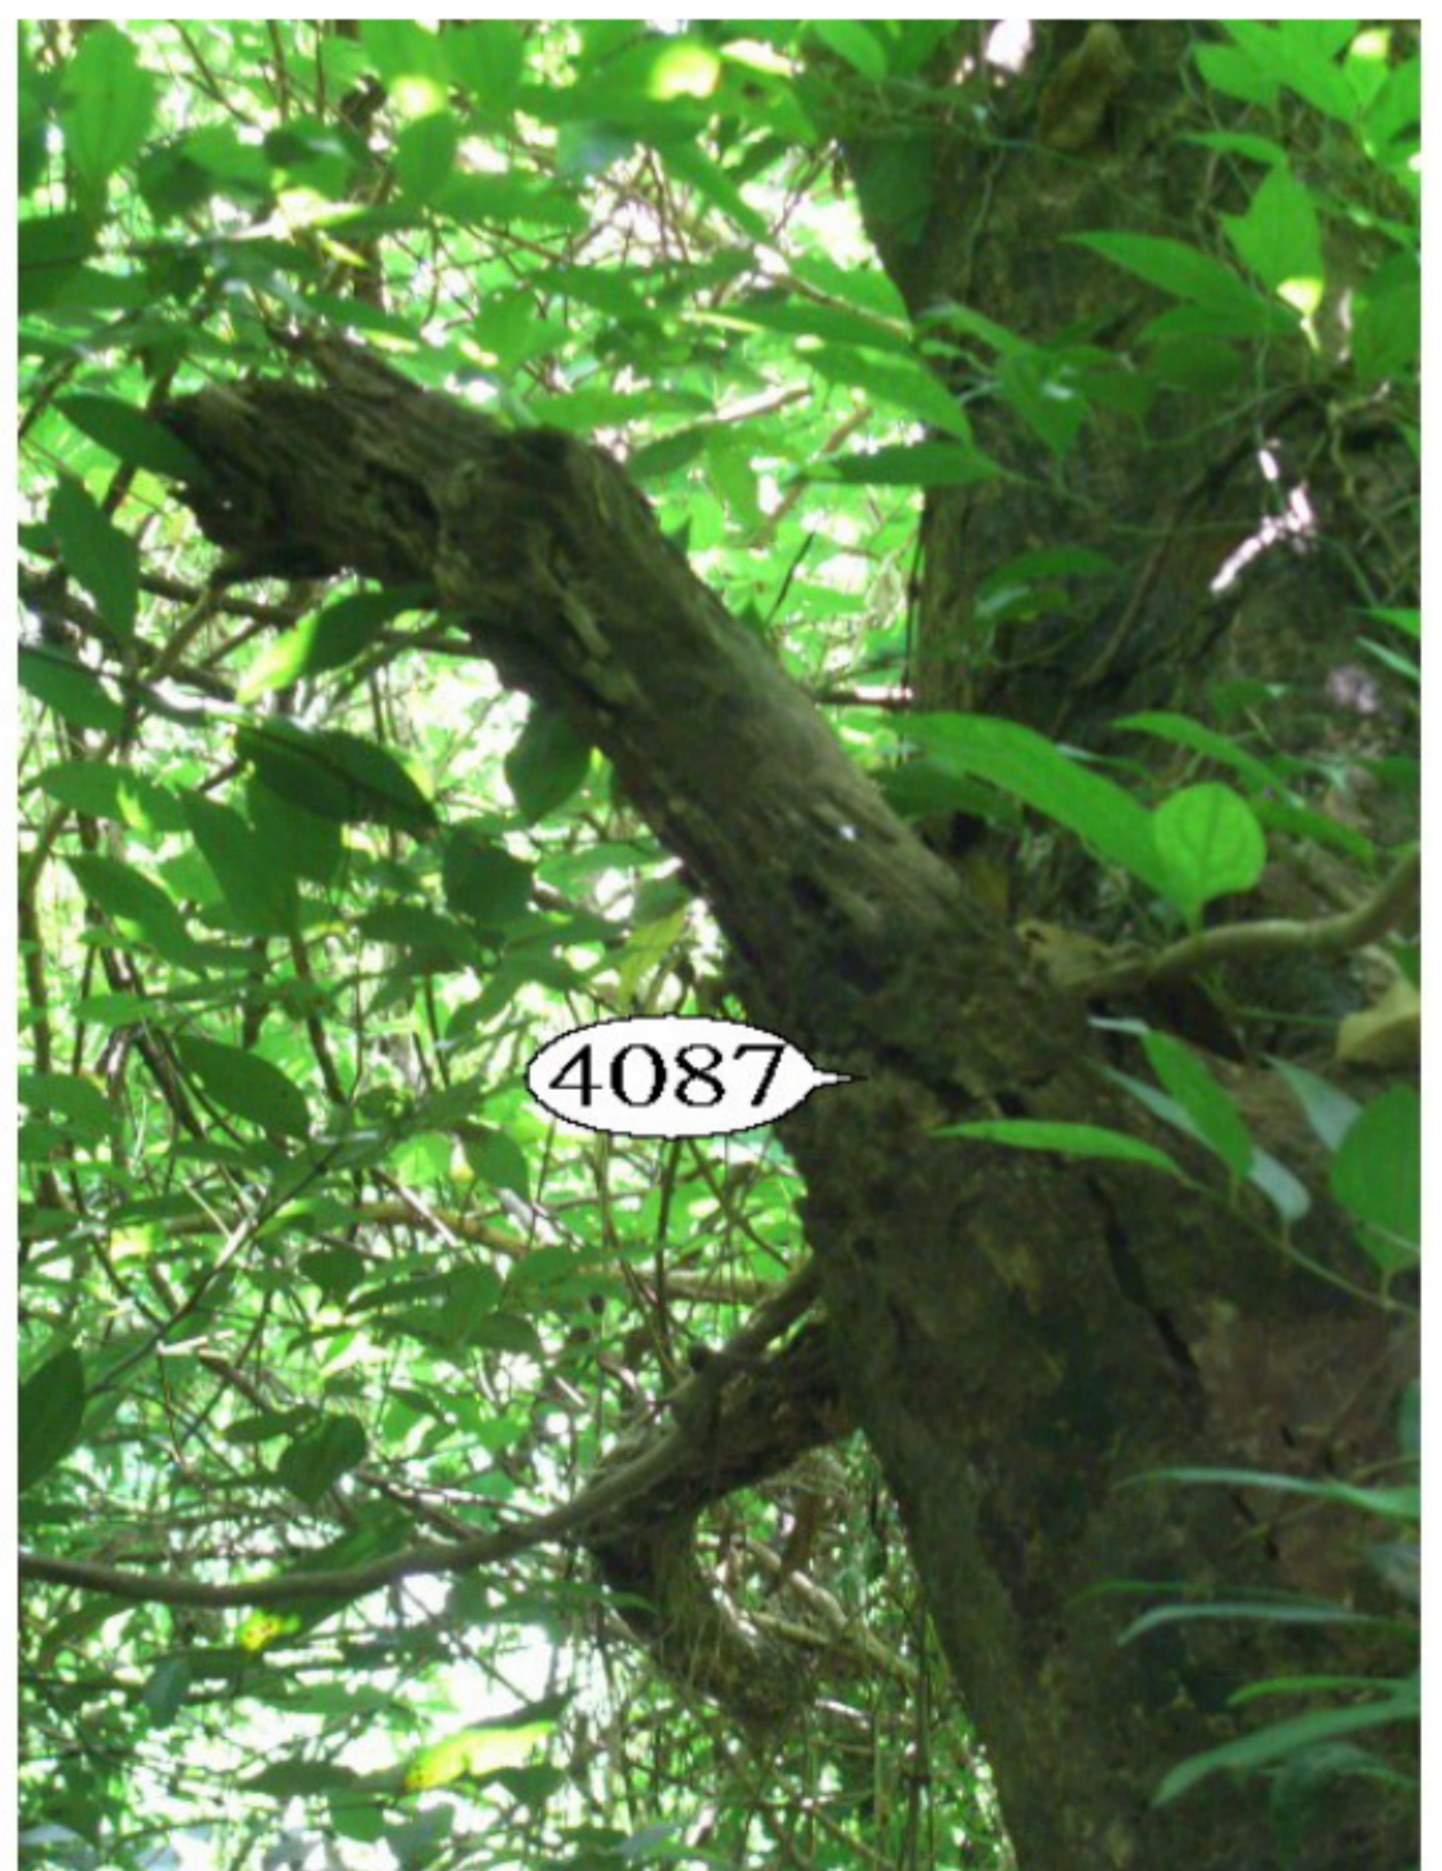
Tree 4086  
Dead Tree.

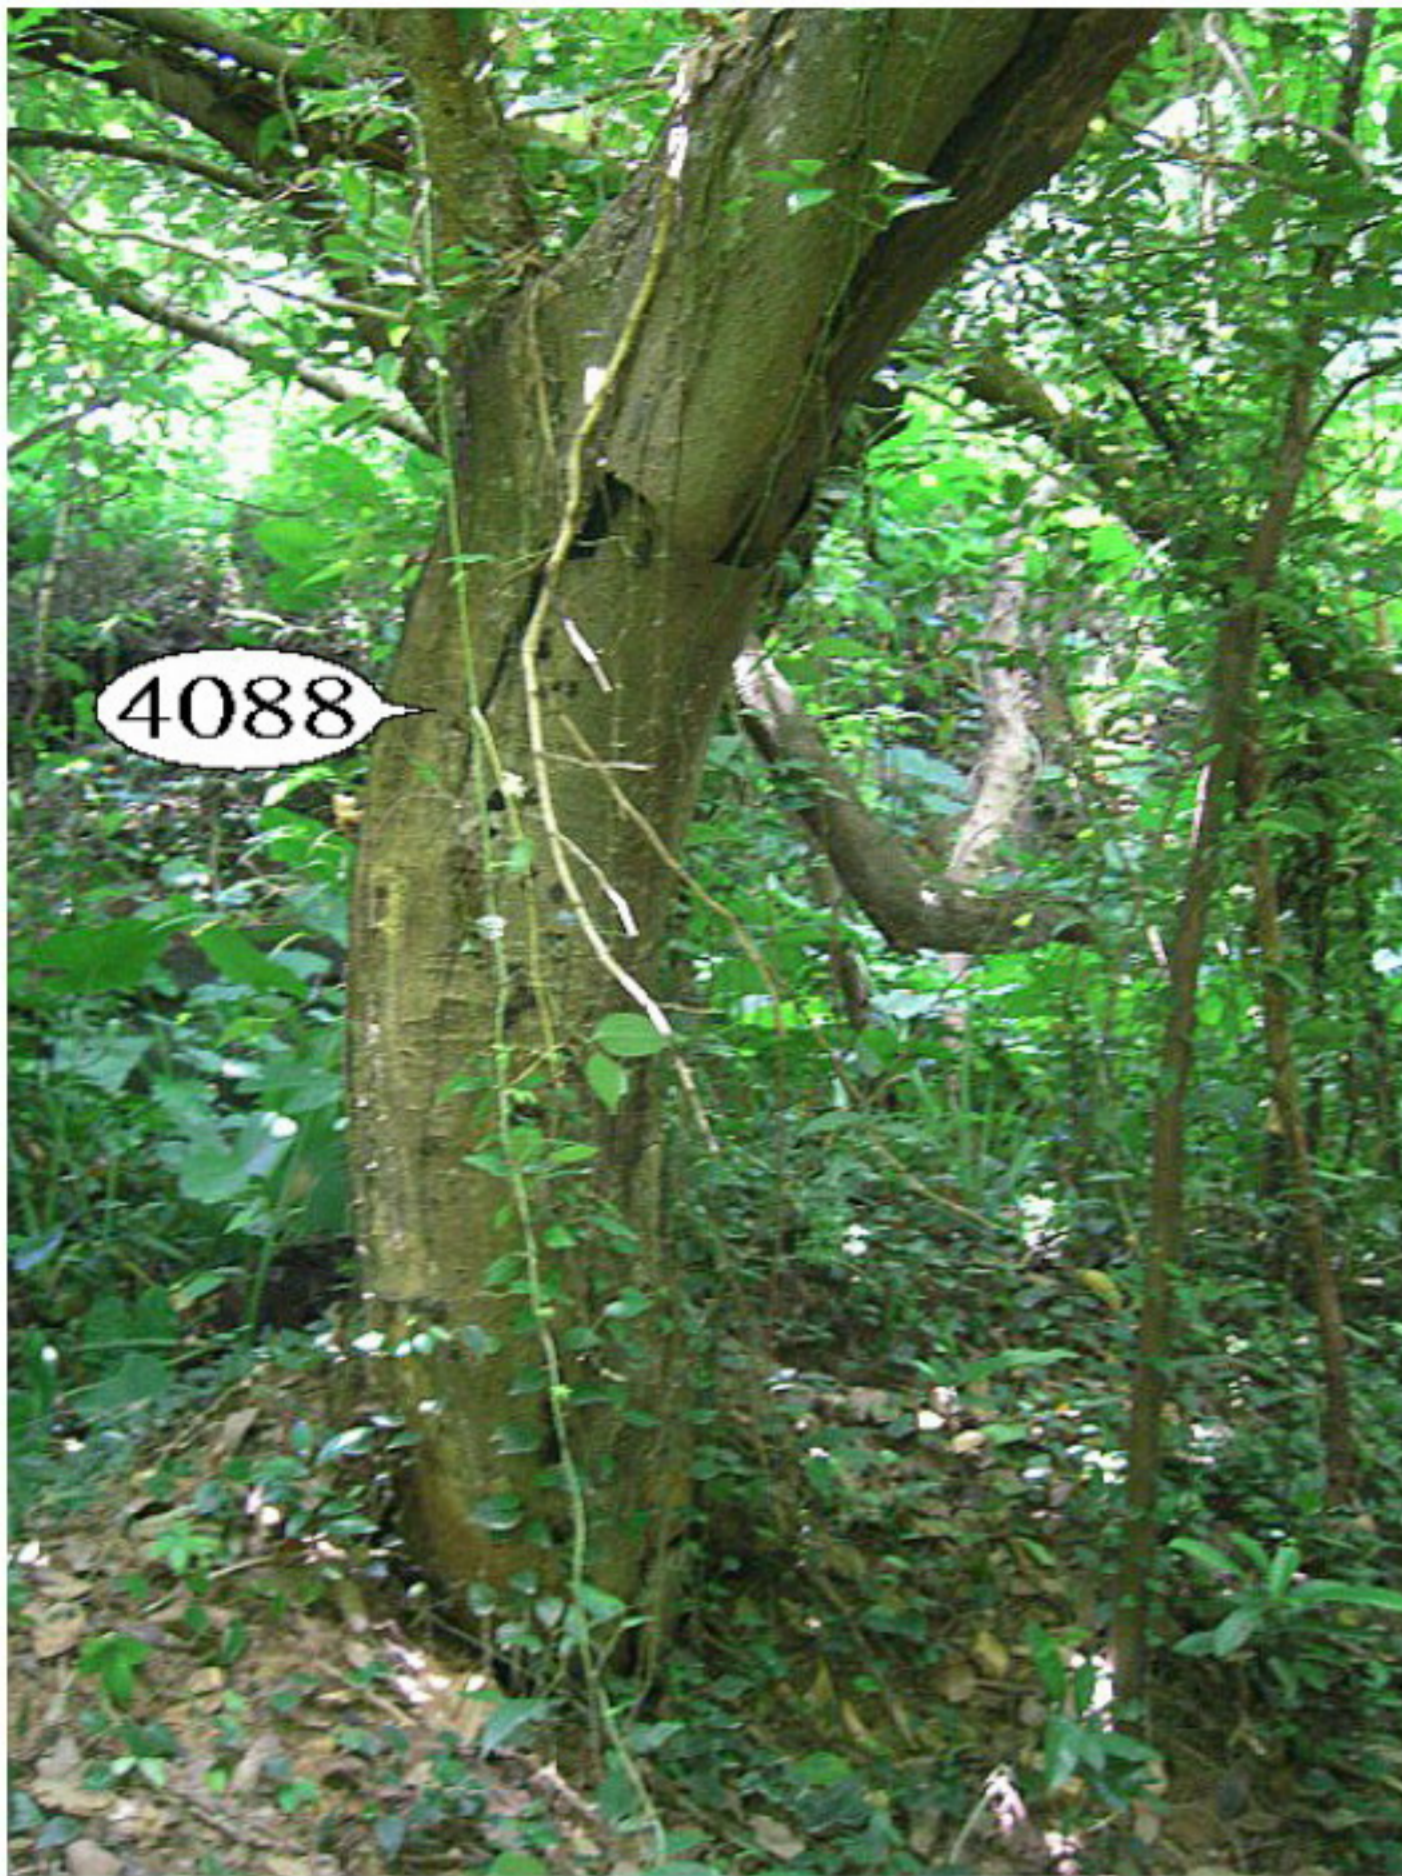
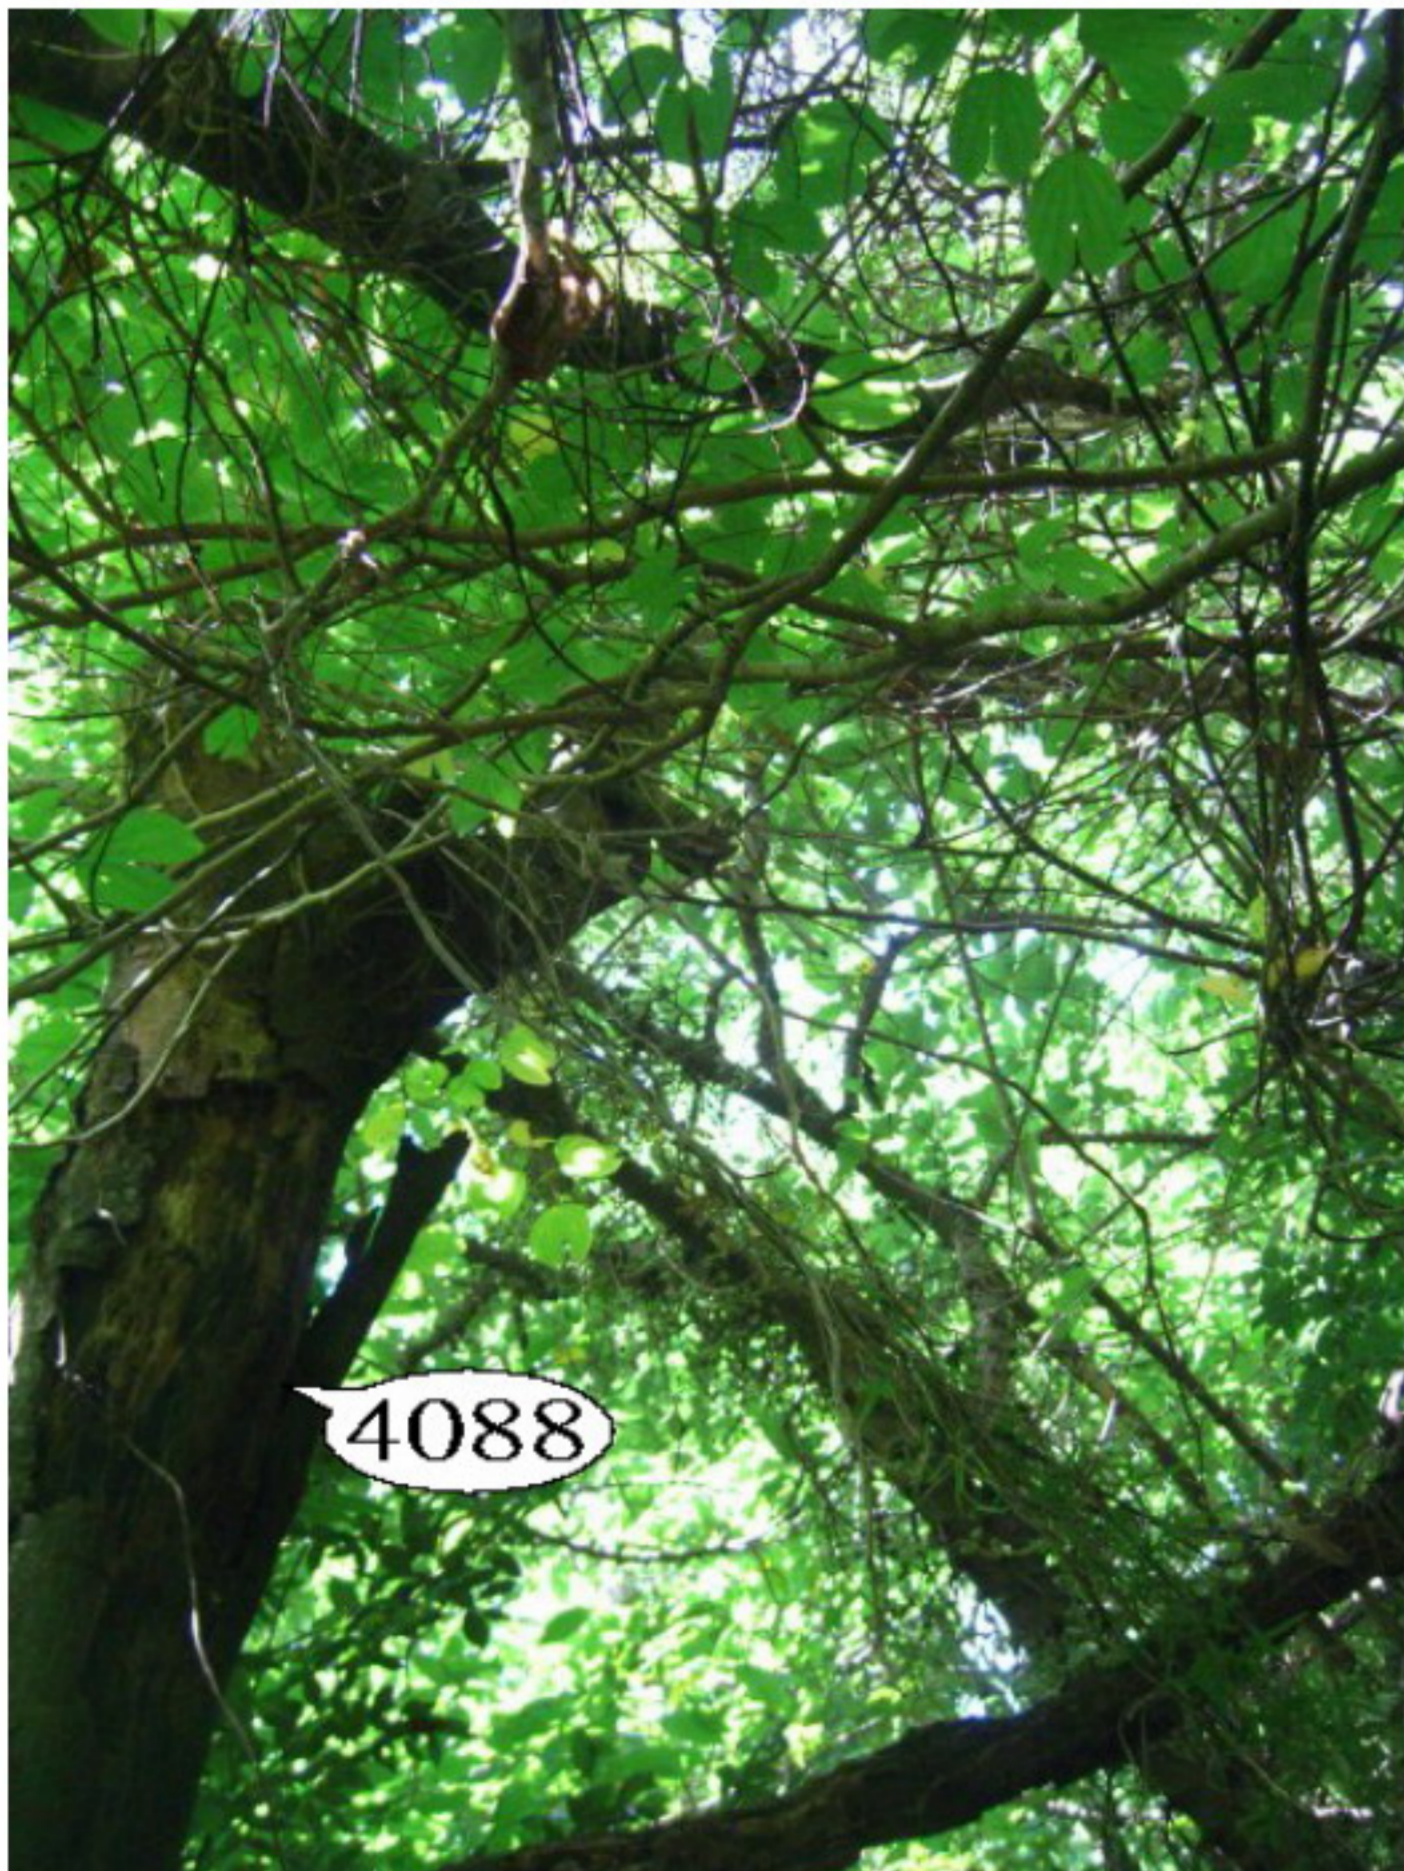
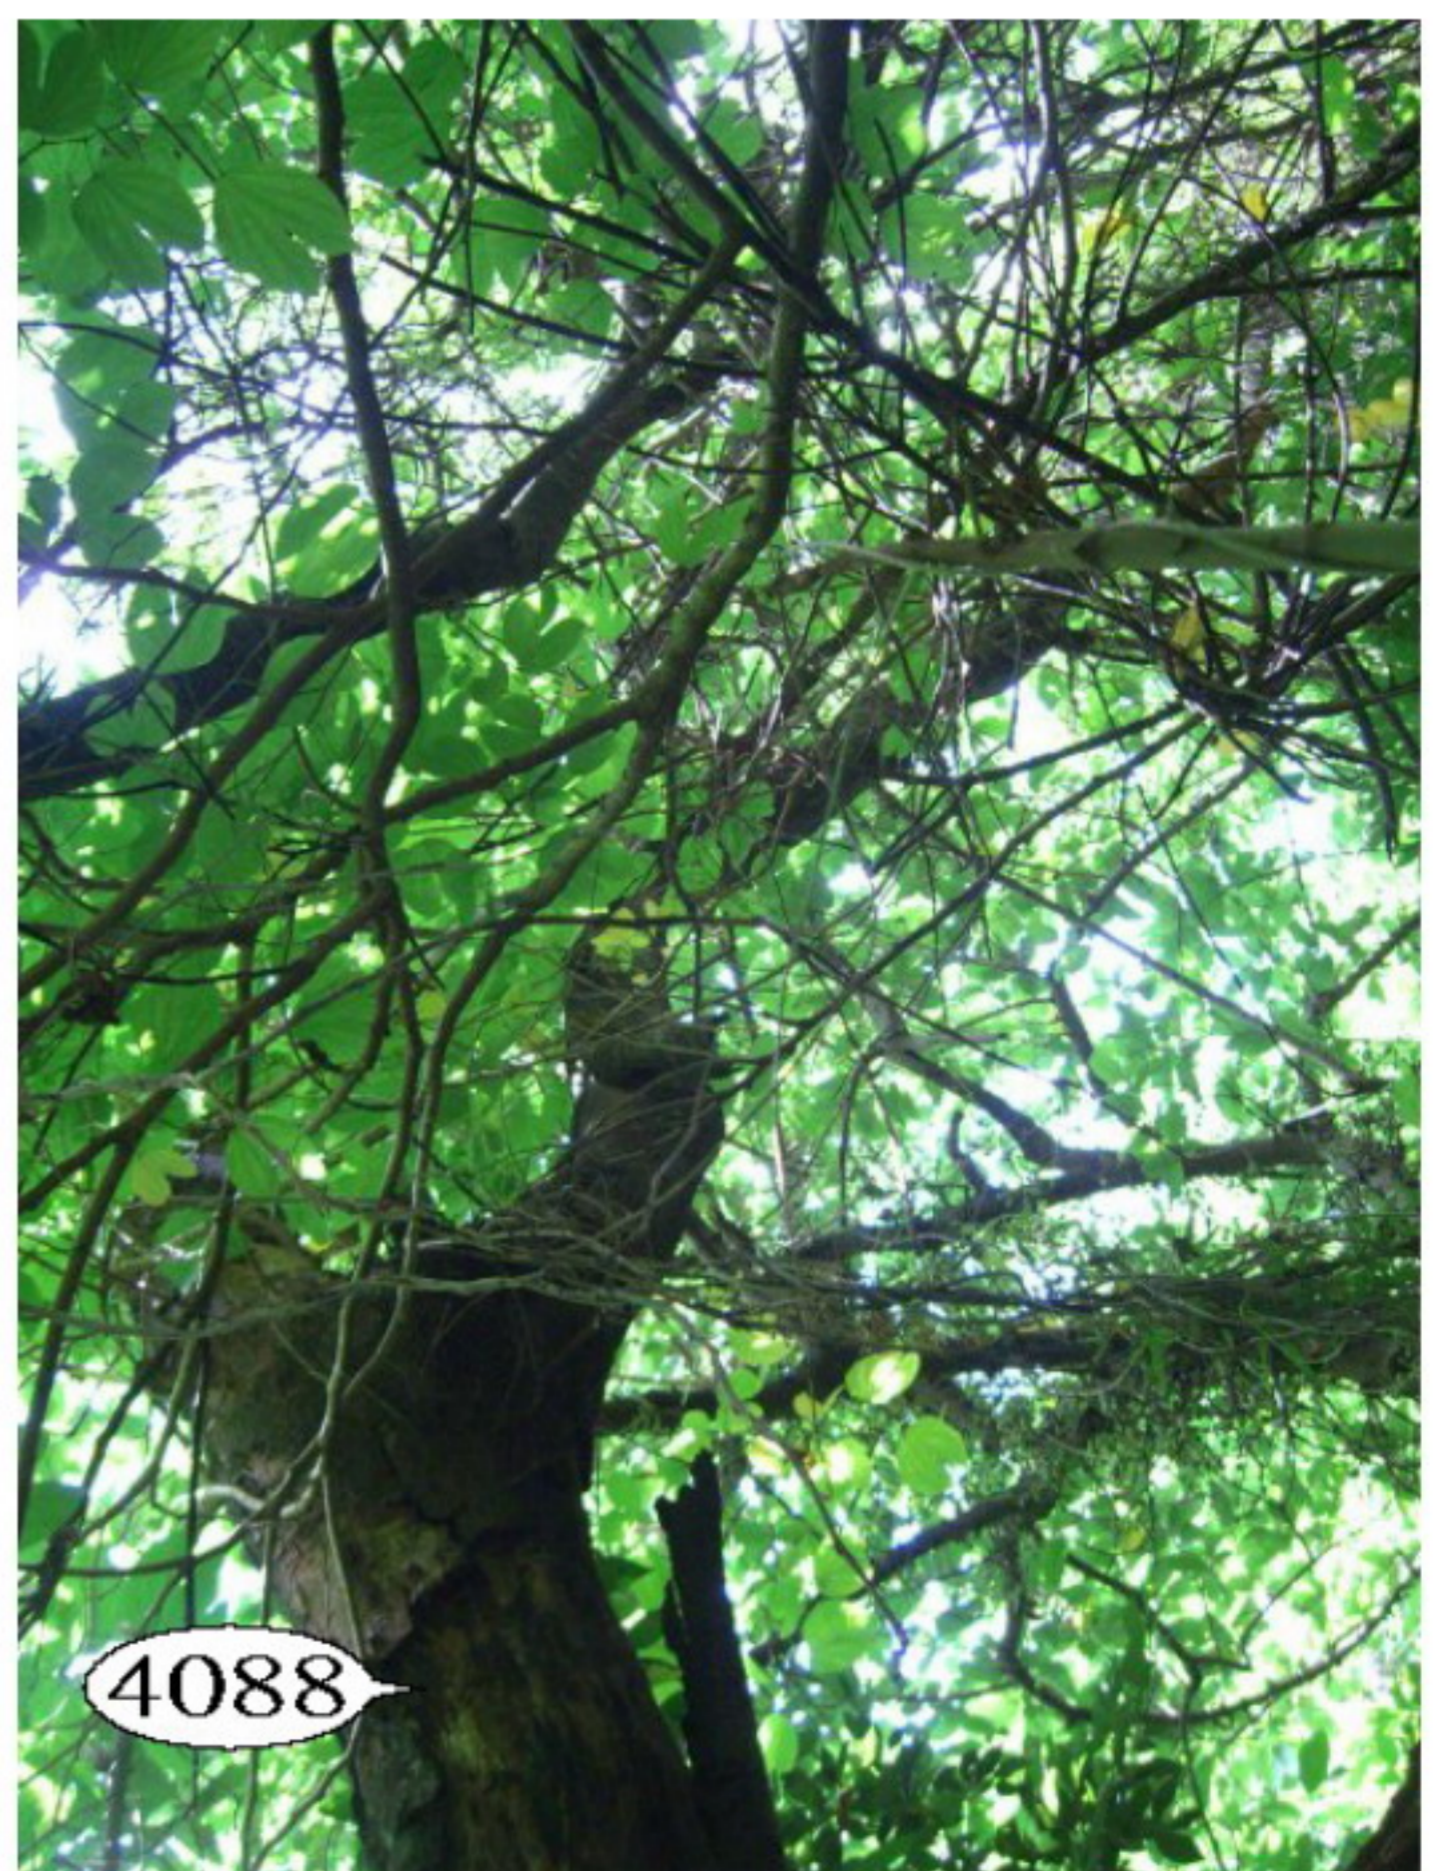
Tree 4087  
Dead Tree.

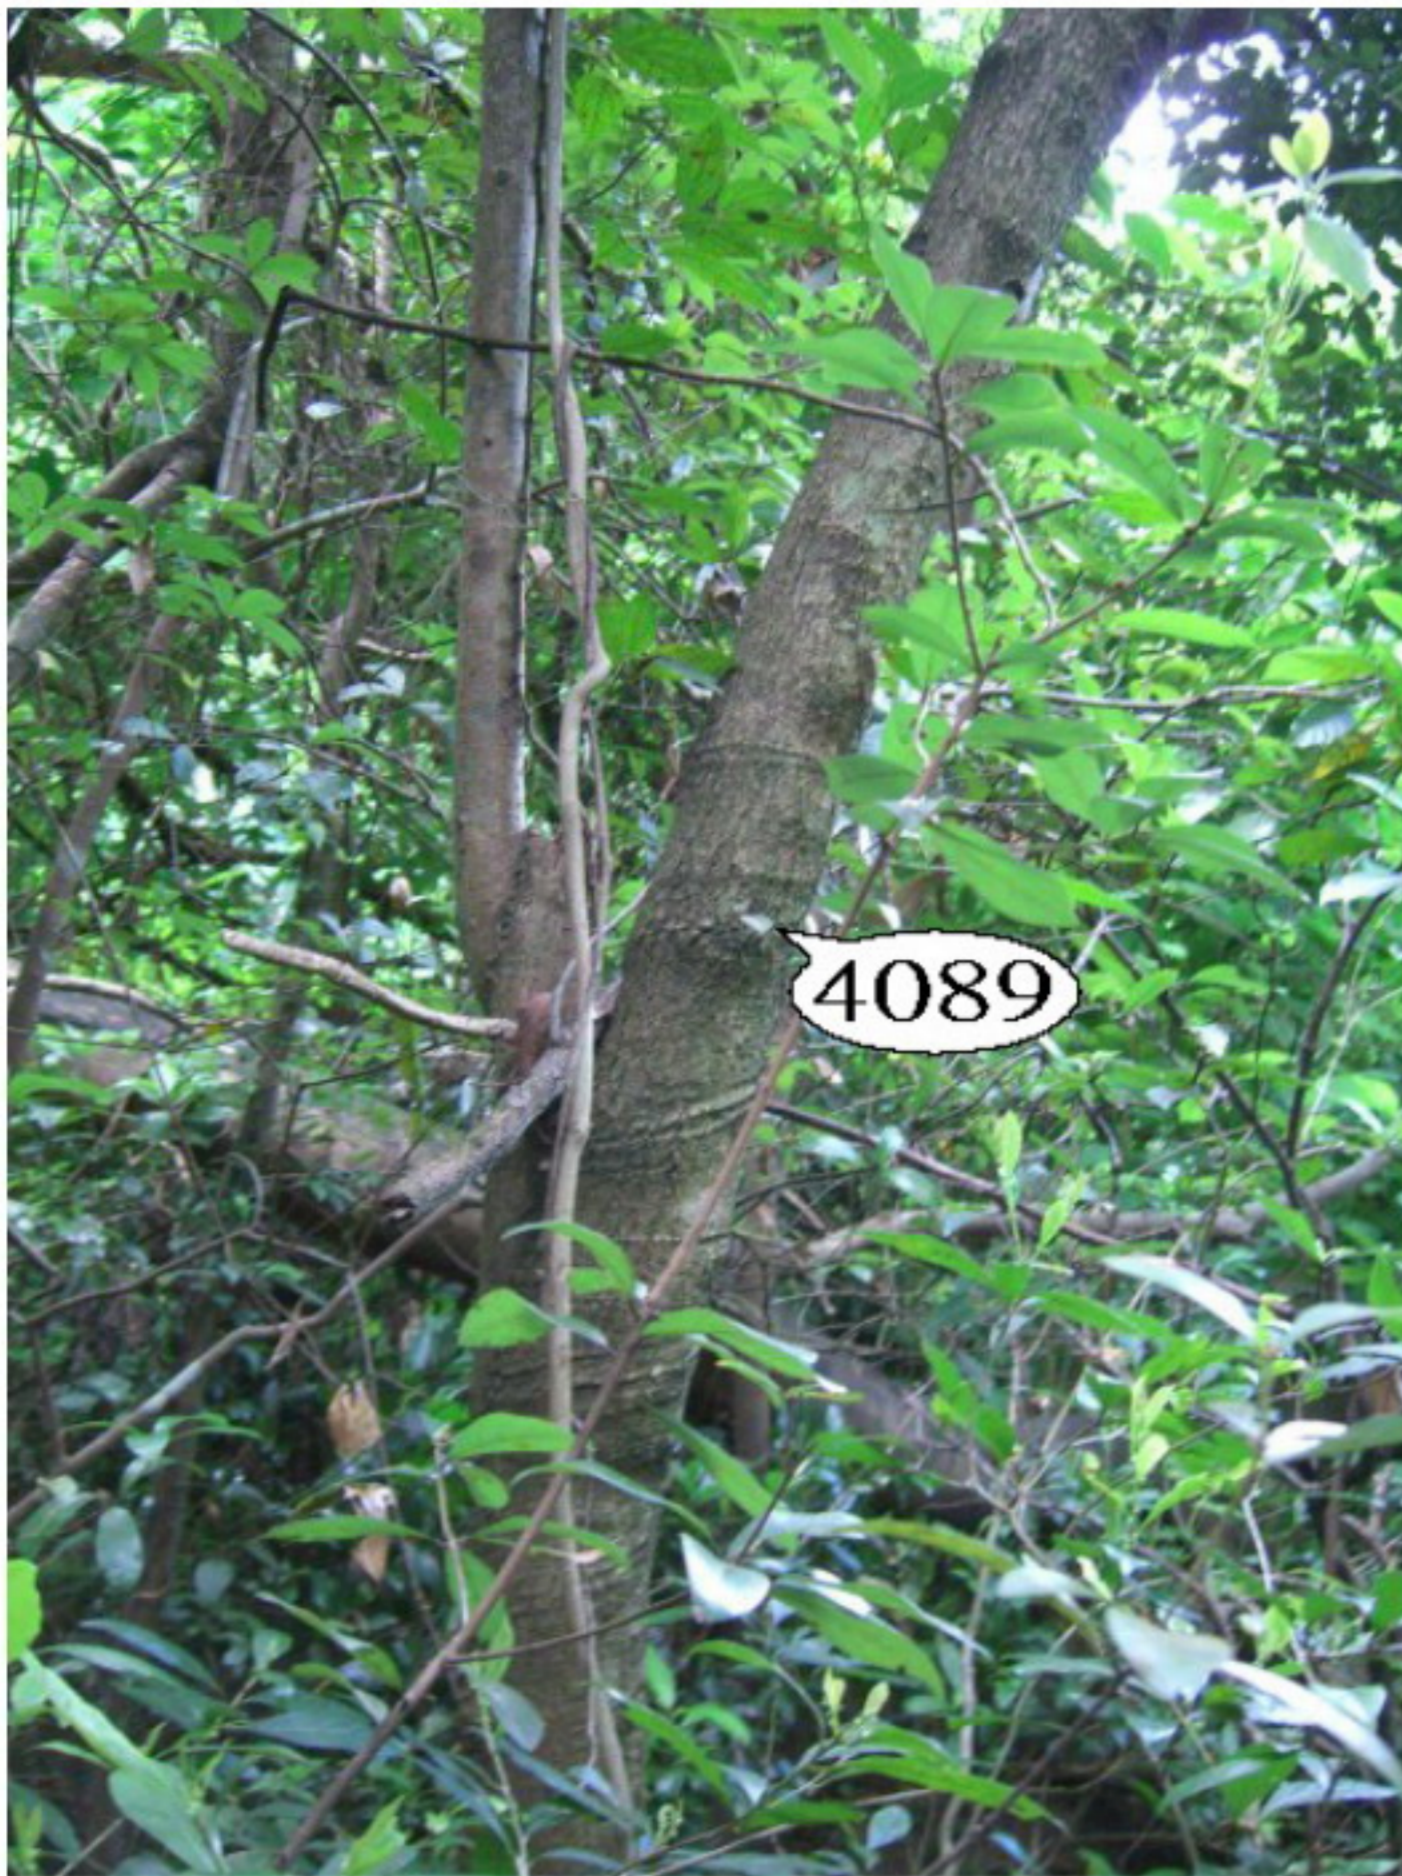
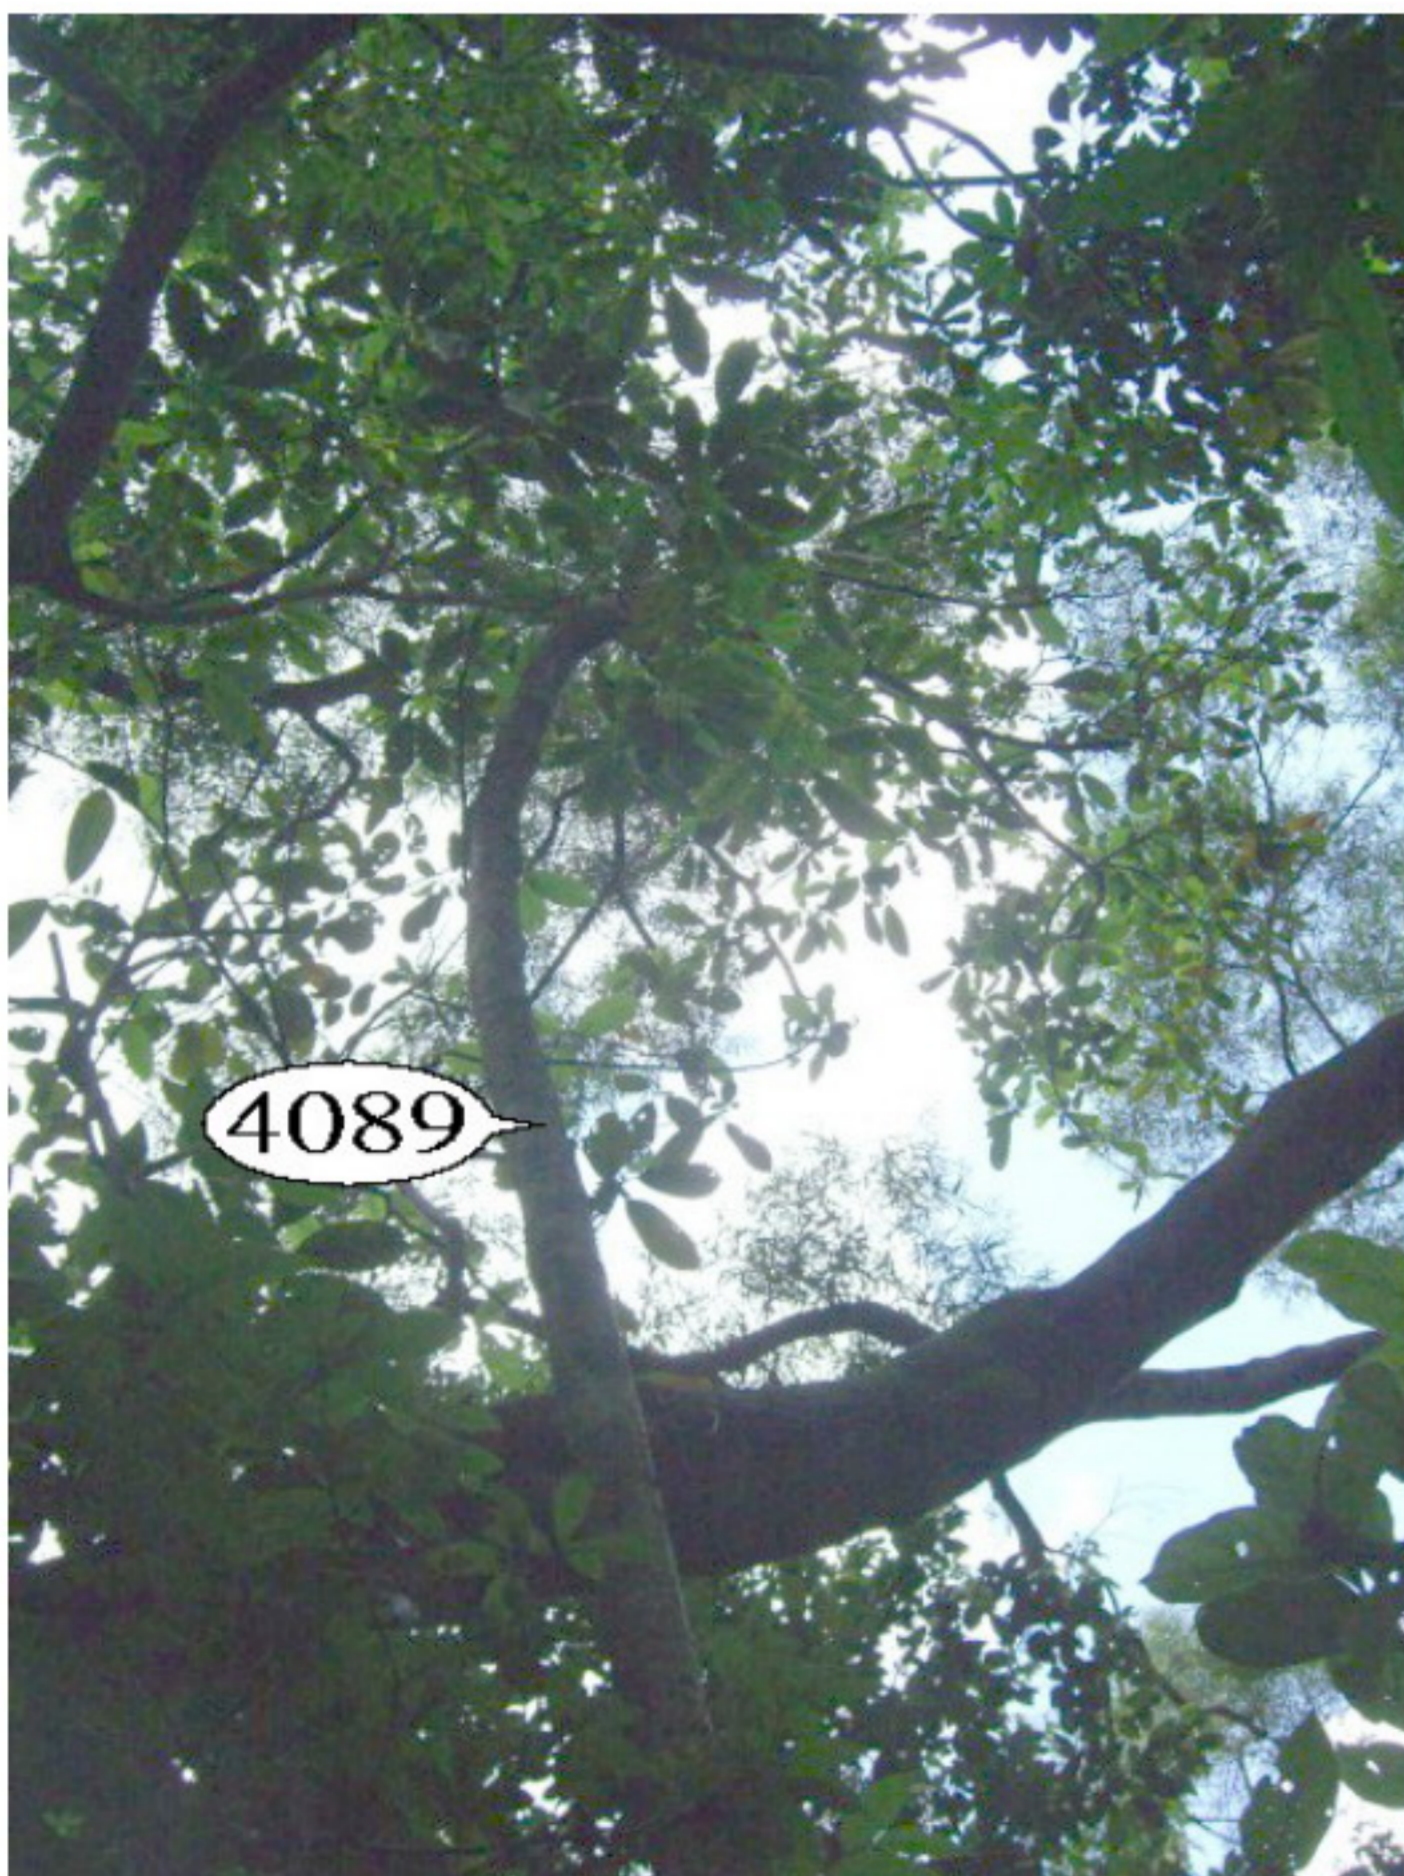
Tree 4088  
Poor health lead to low transplantation survival rate.
