# Provision of Cremators at Wo Hop Shek Crematorium

Tree Survey Report

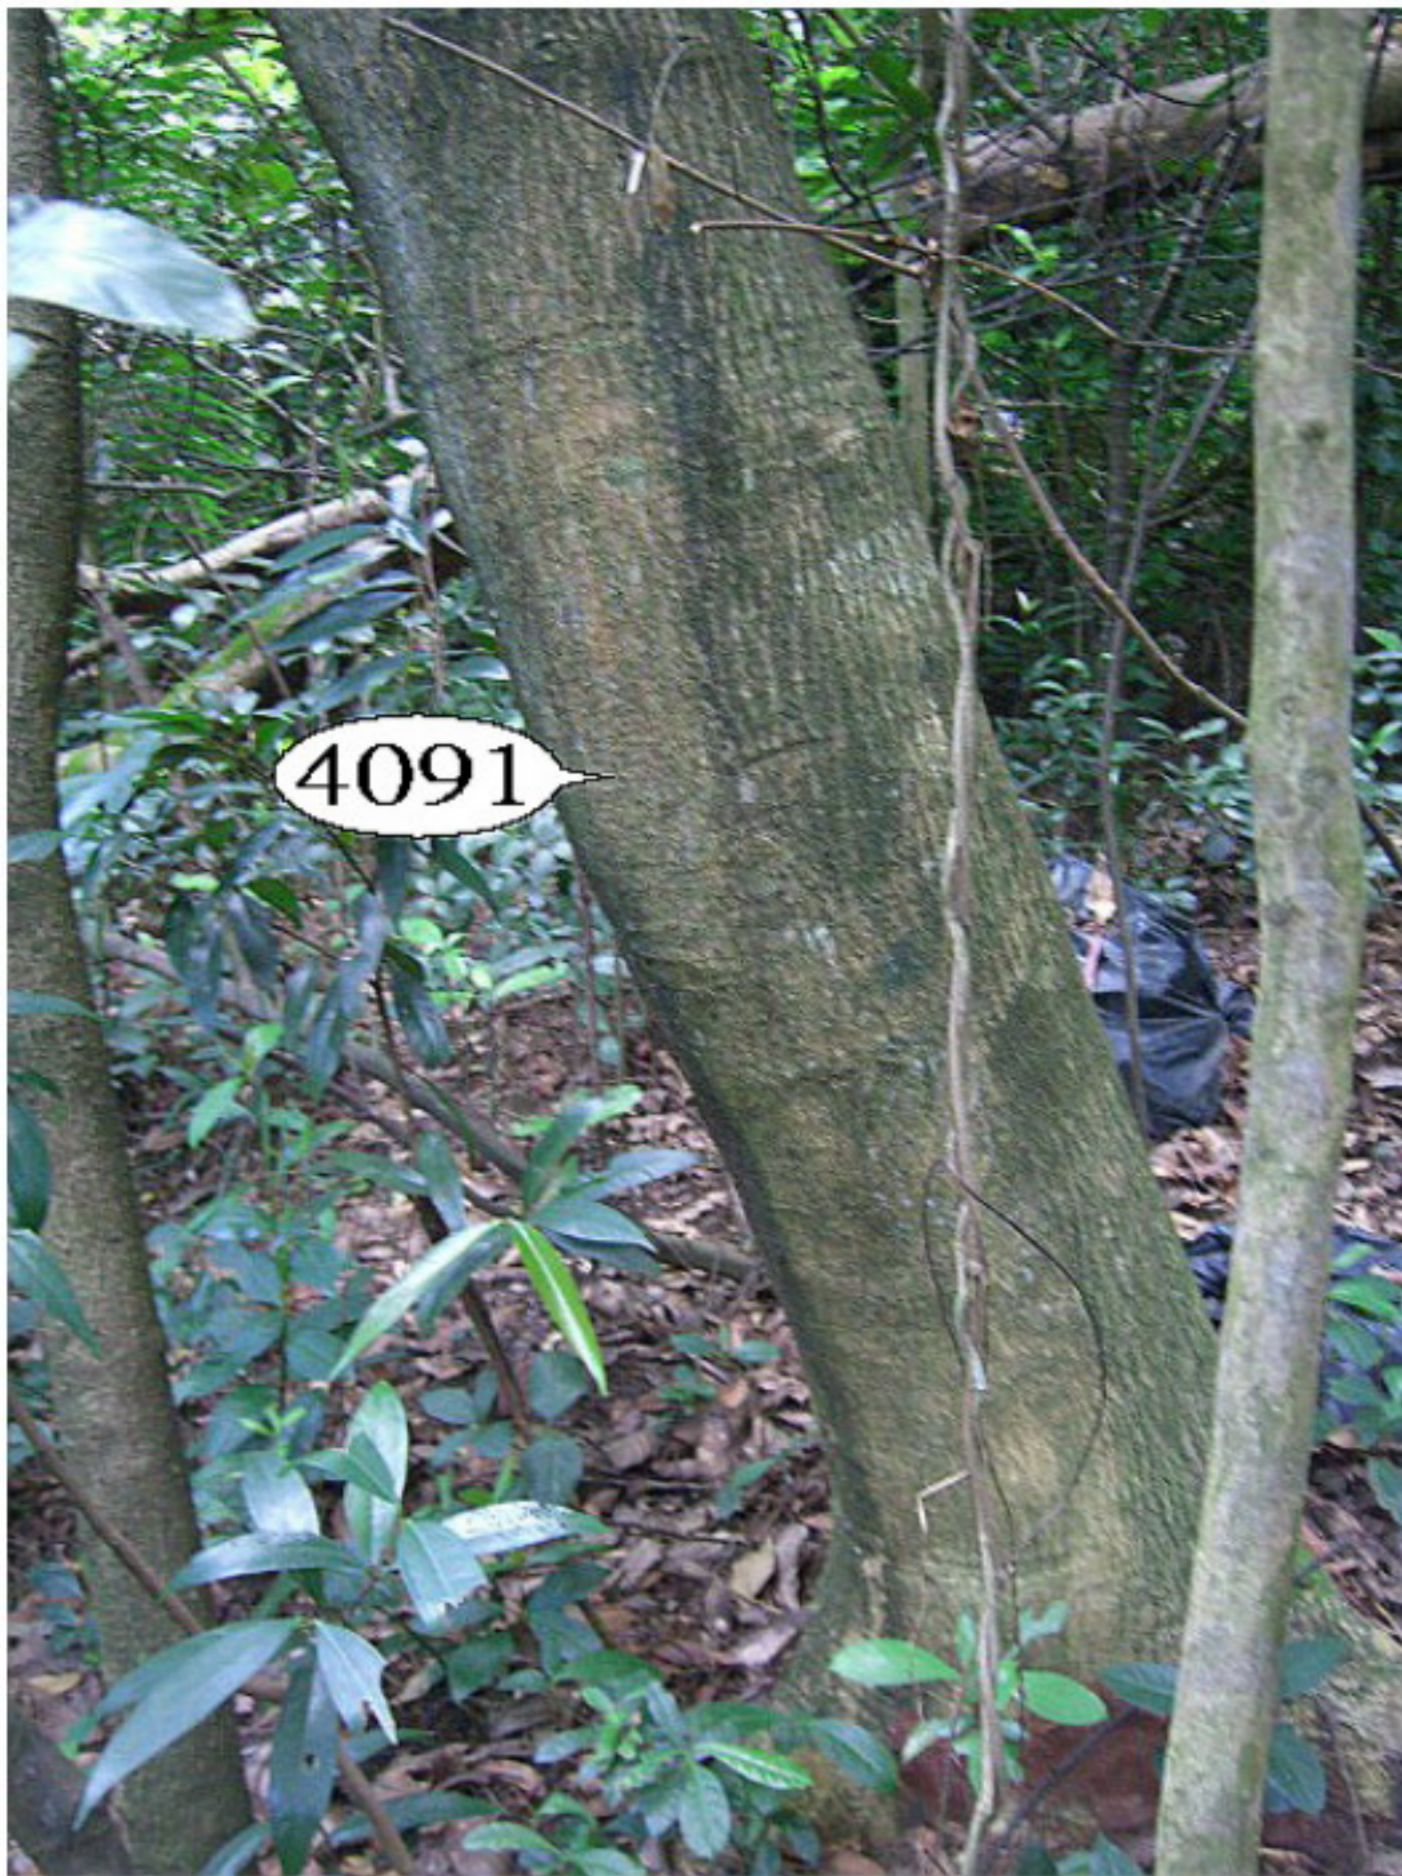
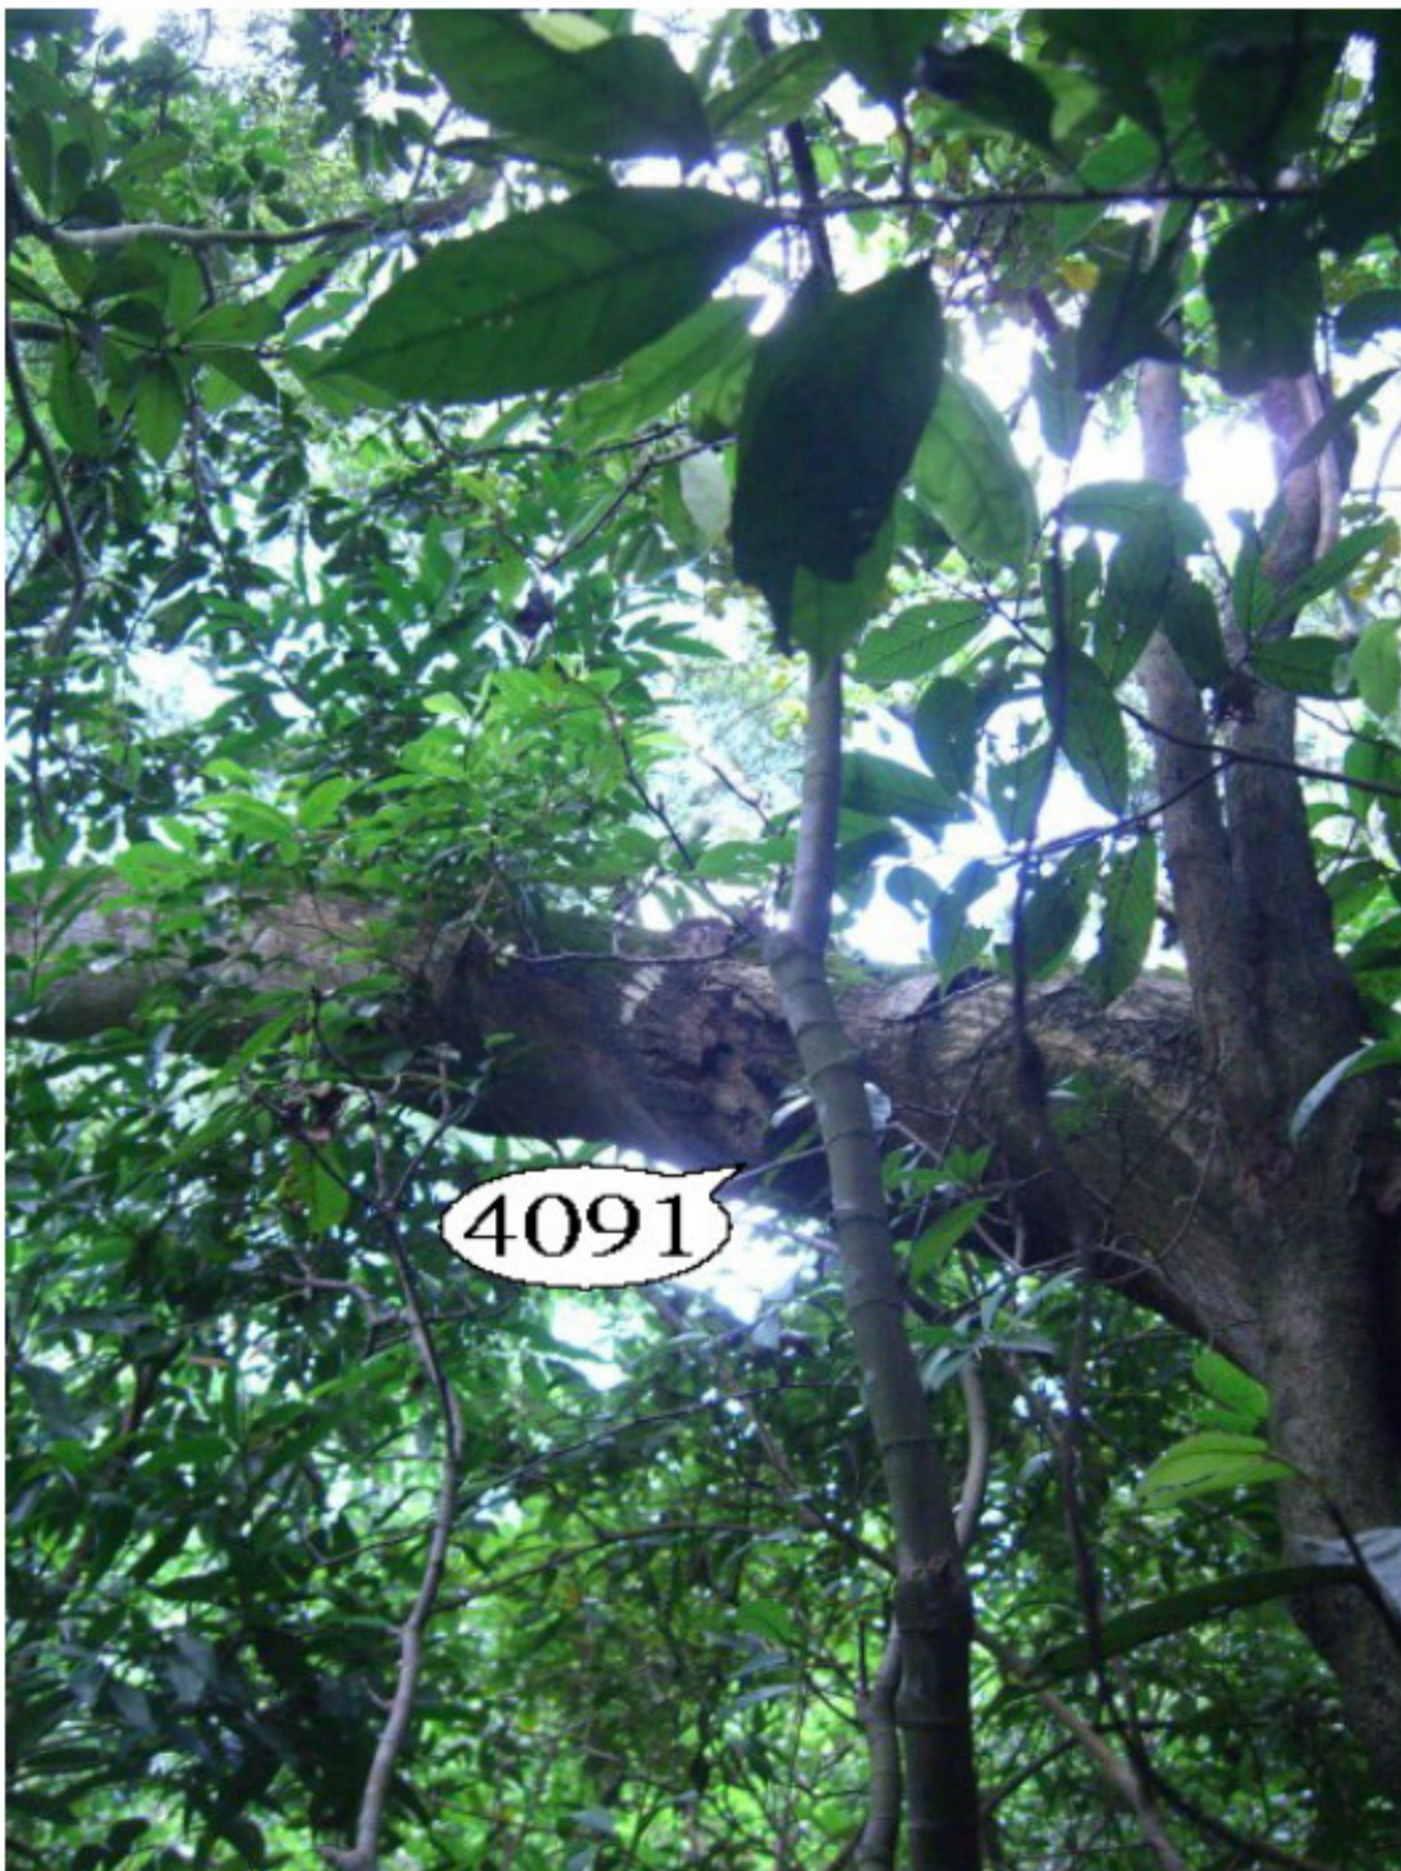
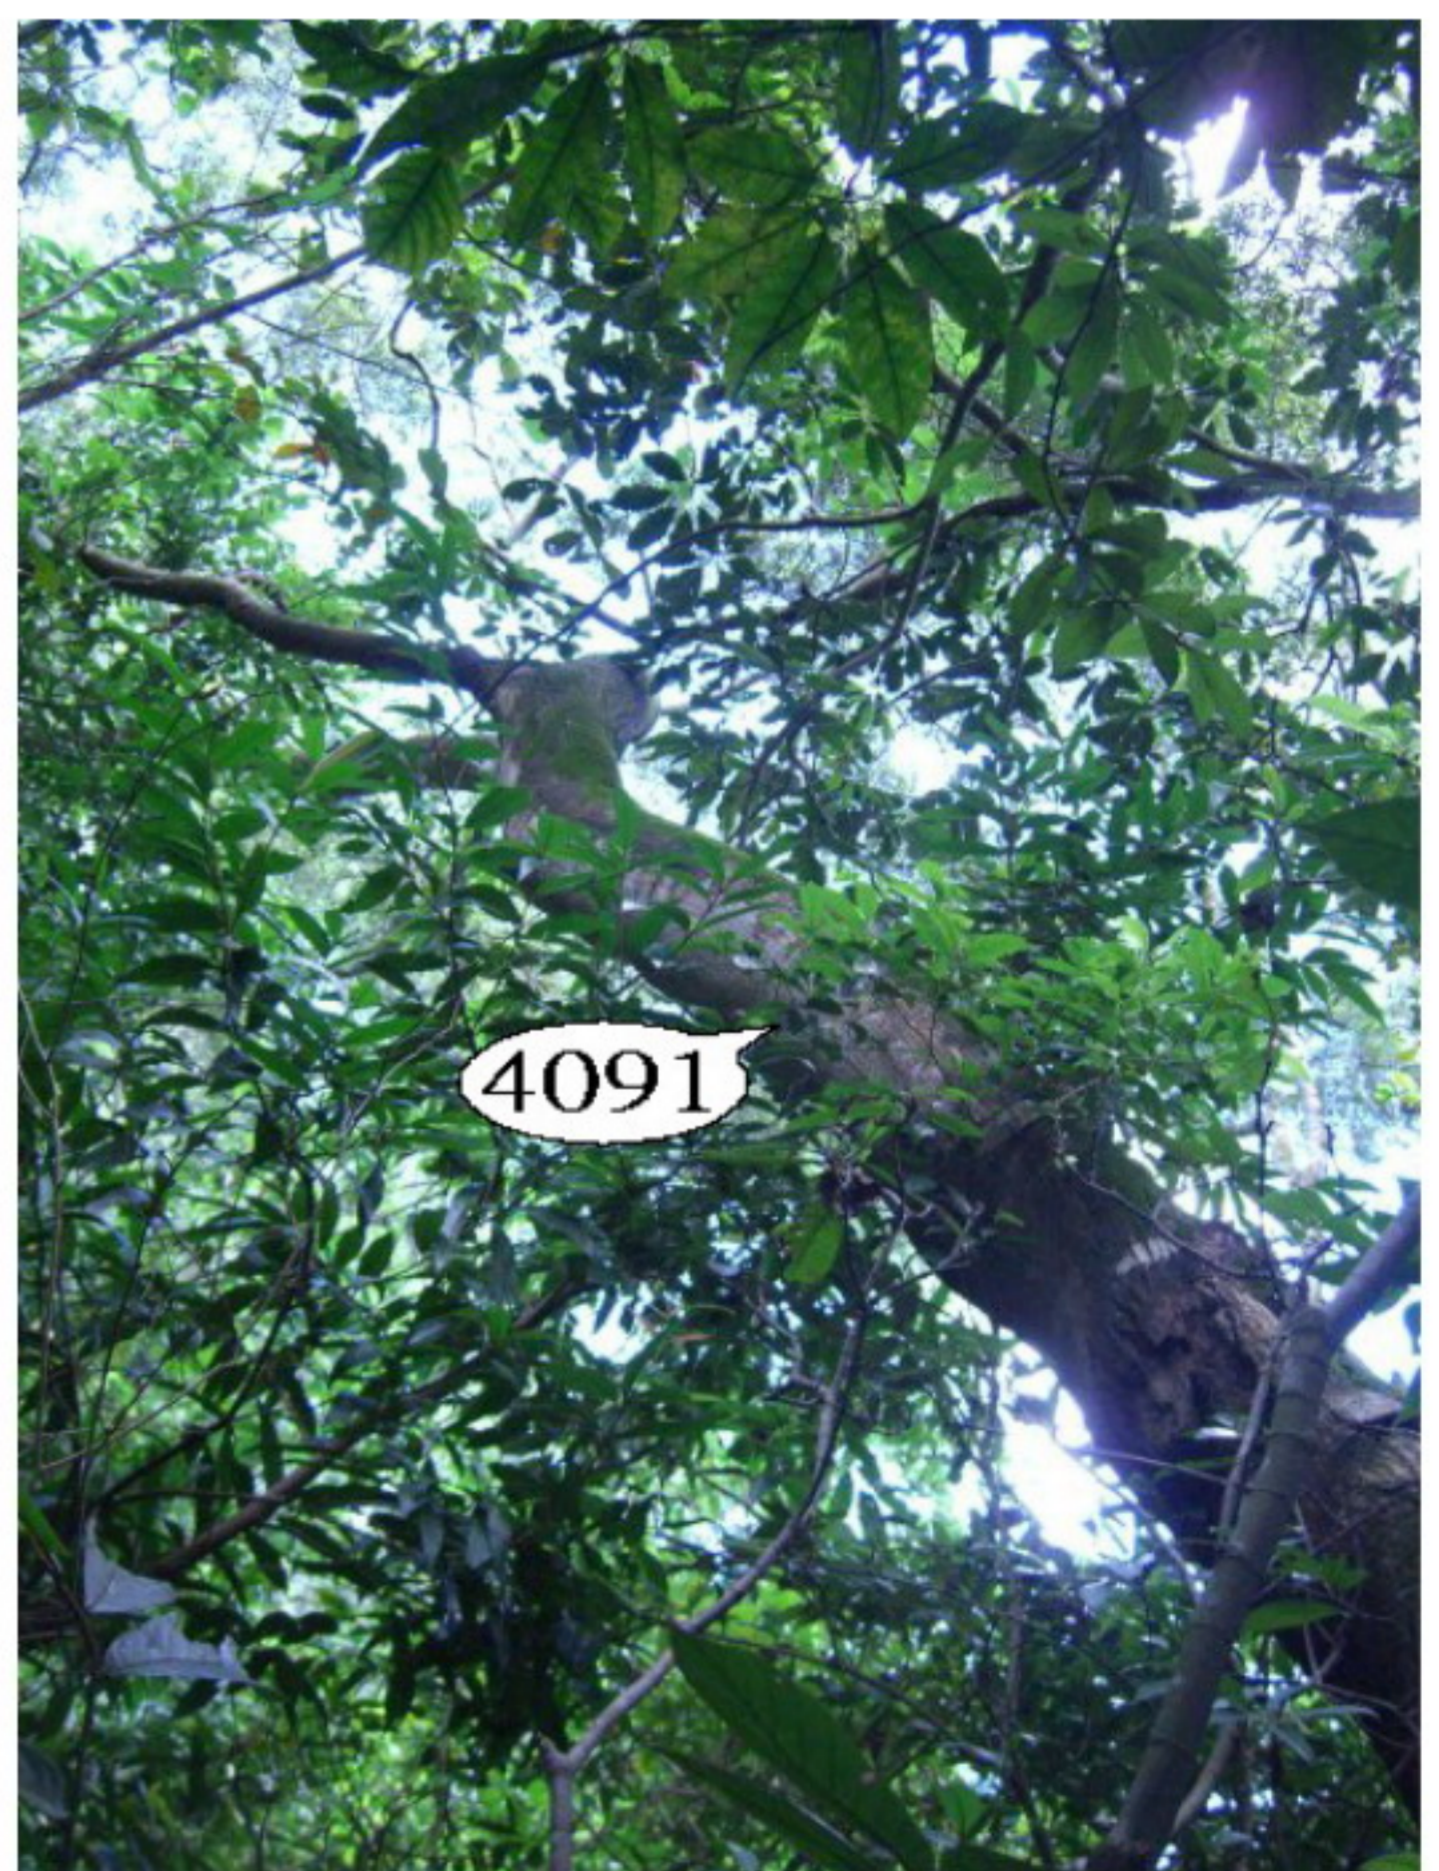
Tree 4089

This species is generally low in transplantation survival rate. Besides, poor form lead to low transplantation survival rate

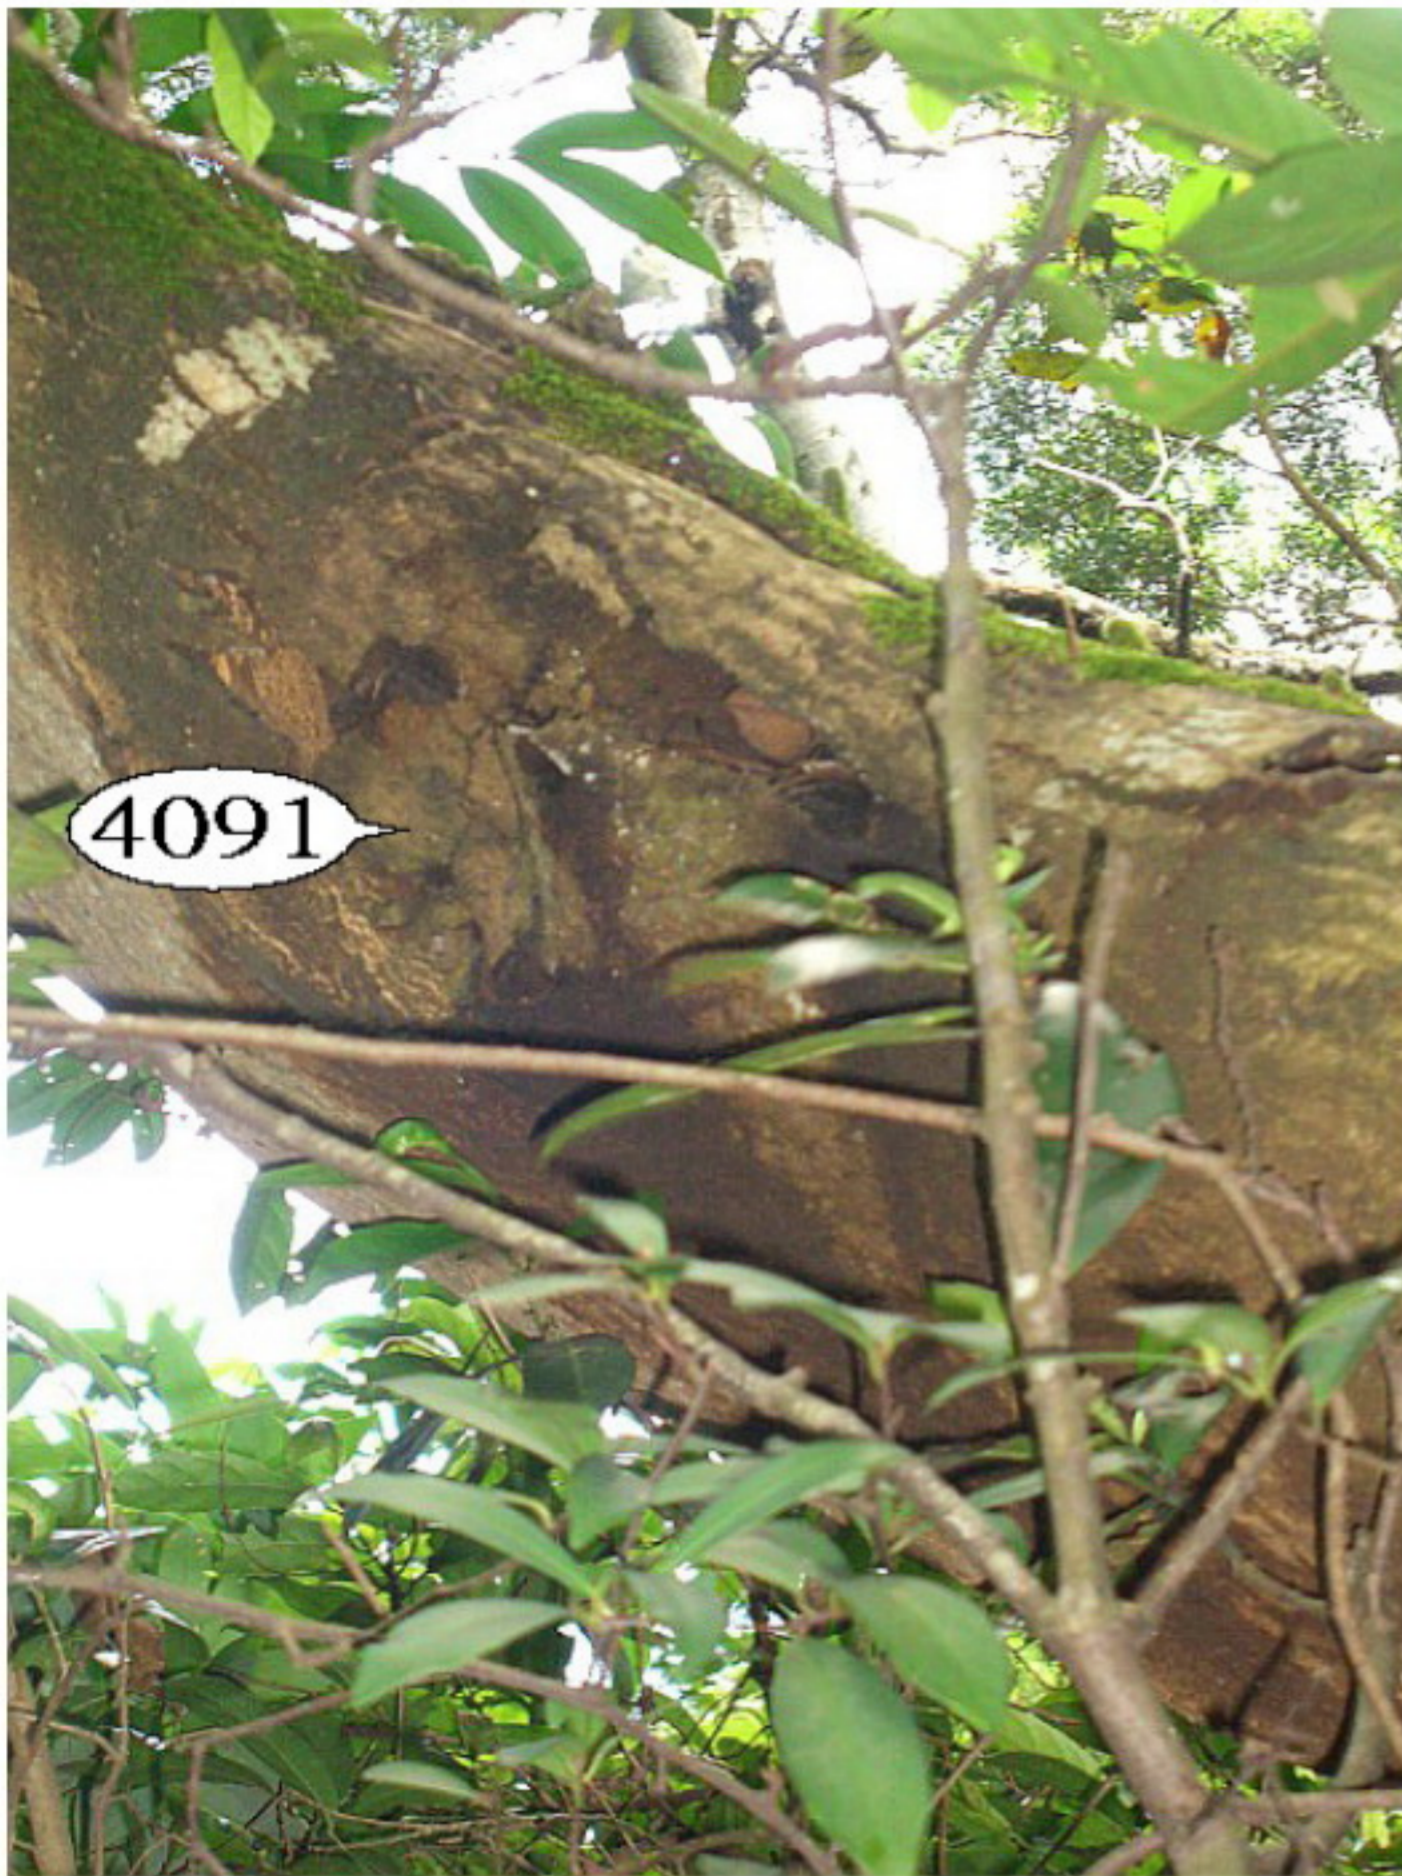
Tree 4091

Poor form which lead to low amenity value. Besides, the tree is unbalance. It may need heavy pruning after transplantation that will affect its transplantation survival rate. Moreover, the operation of the transplantion for poor form tree is also difficult.

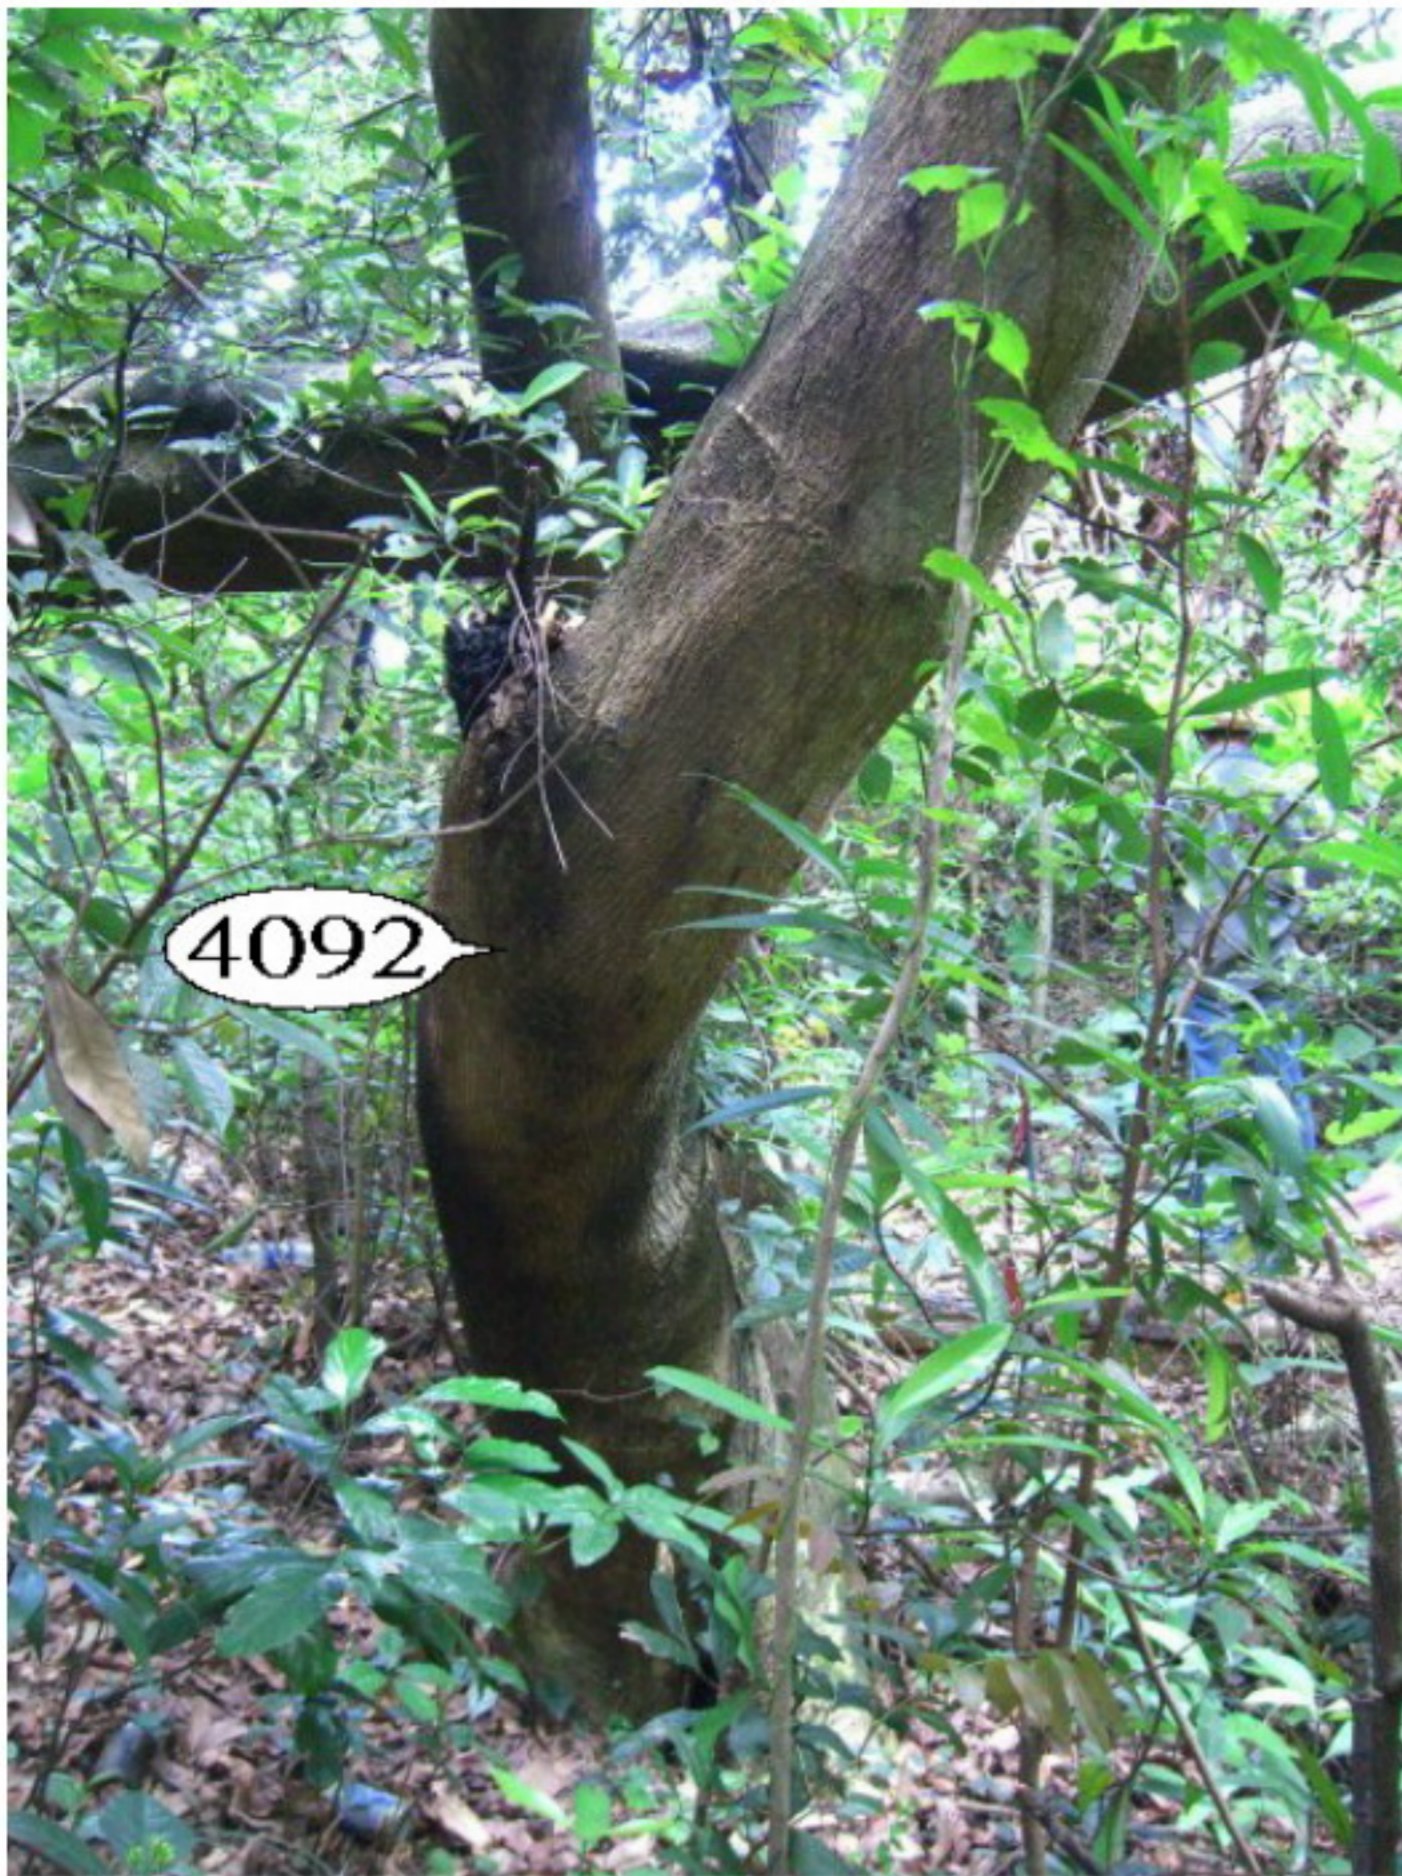
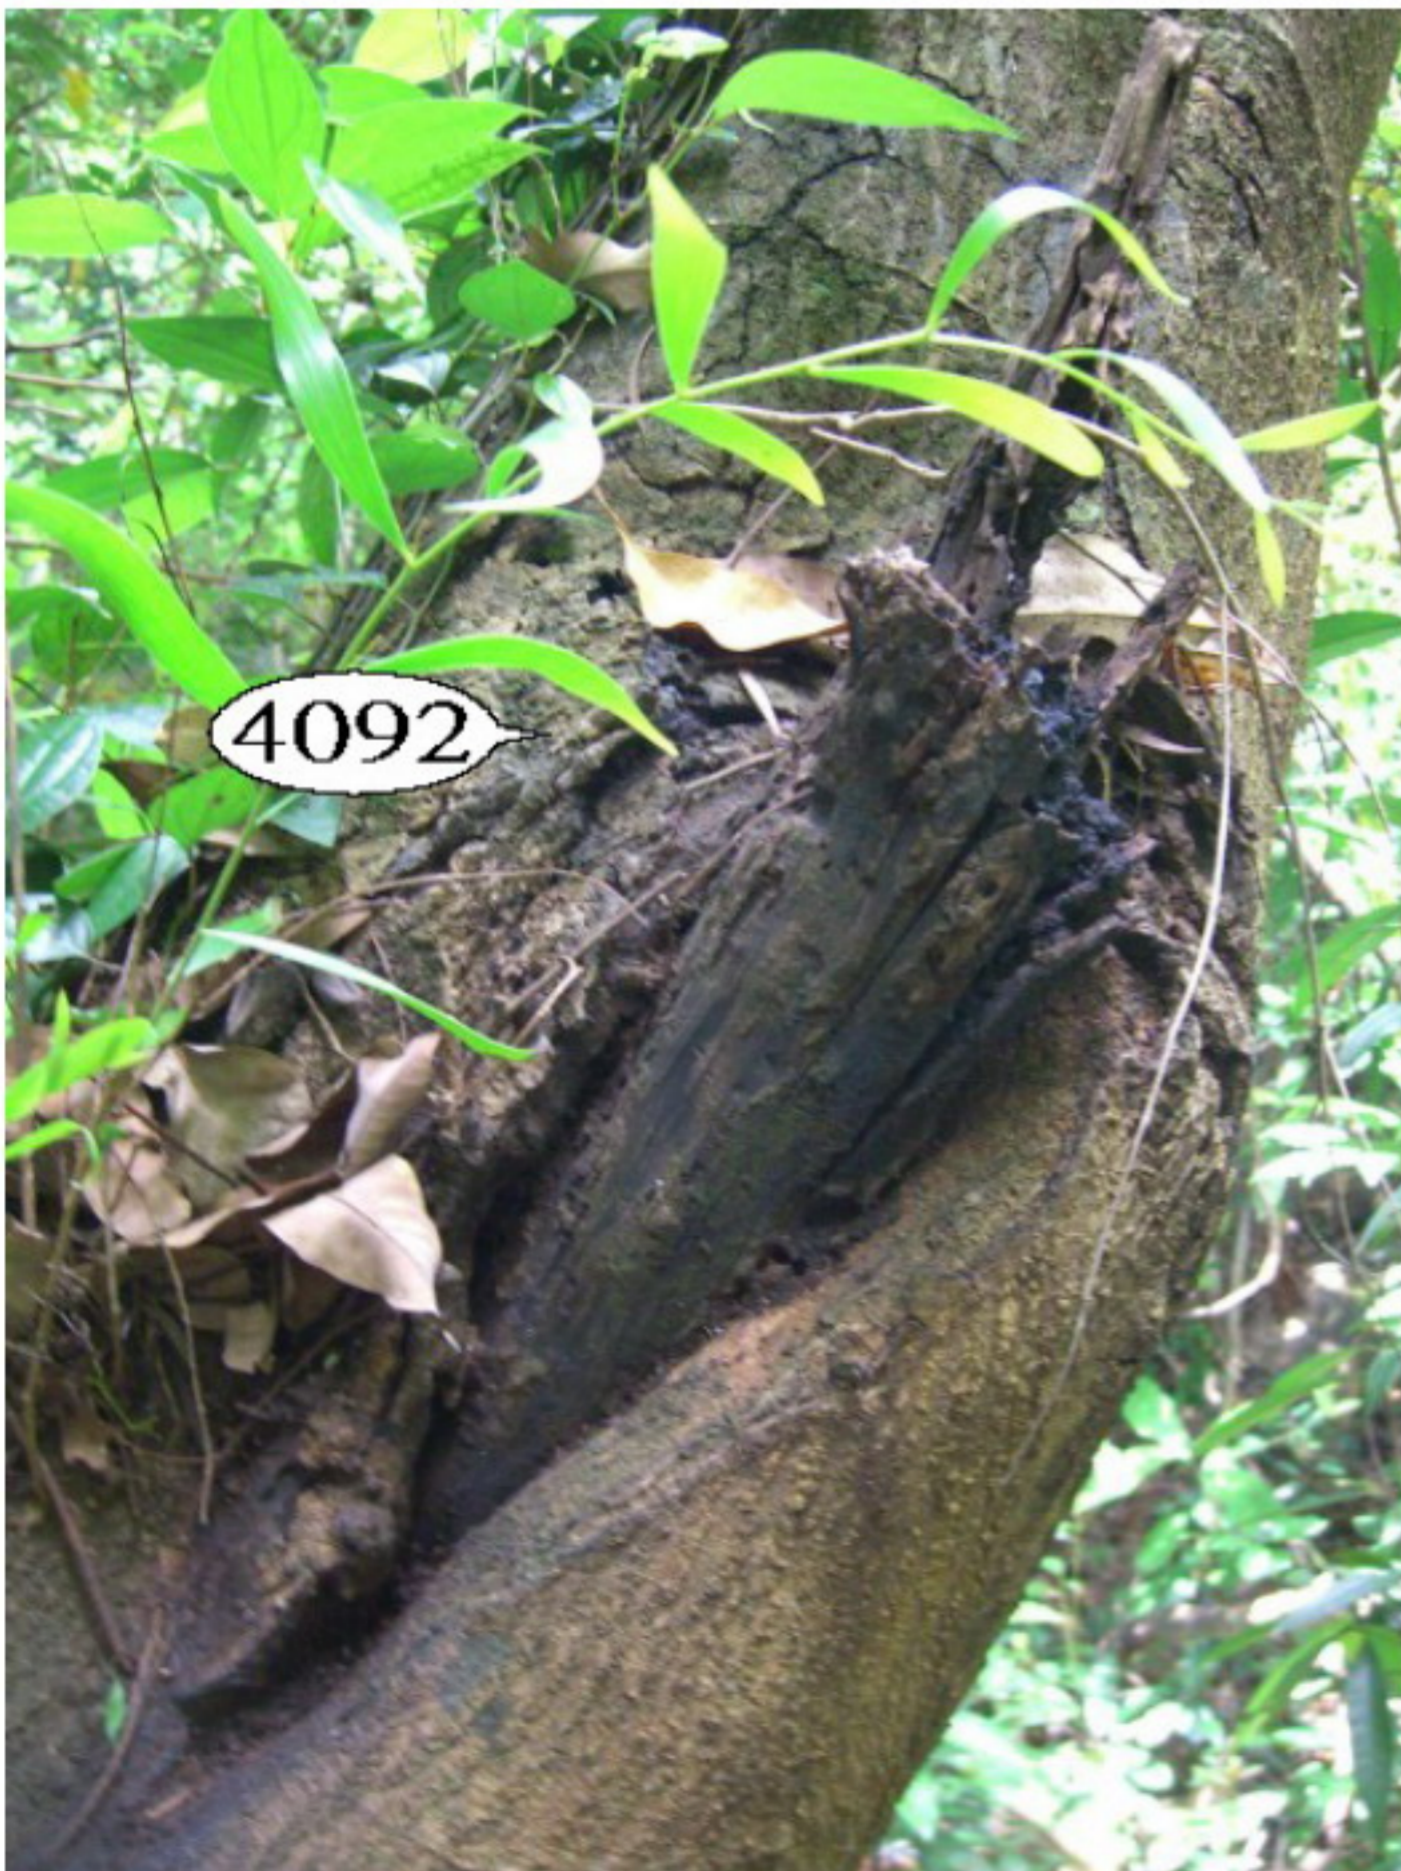
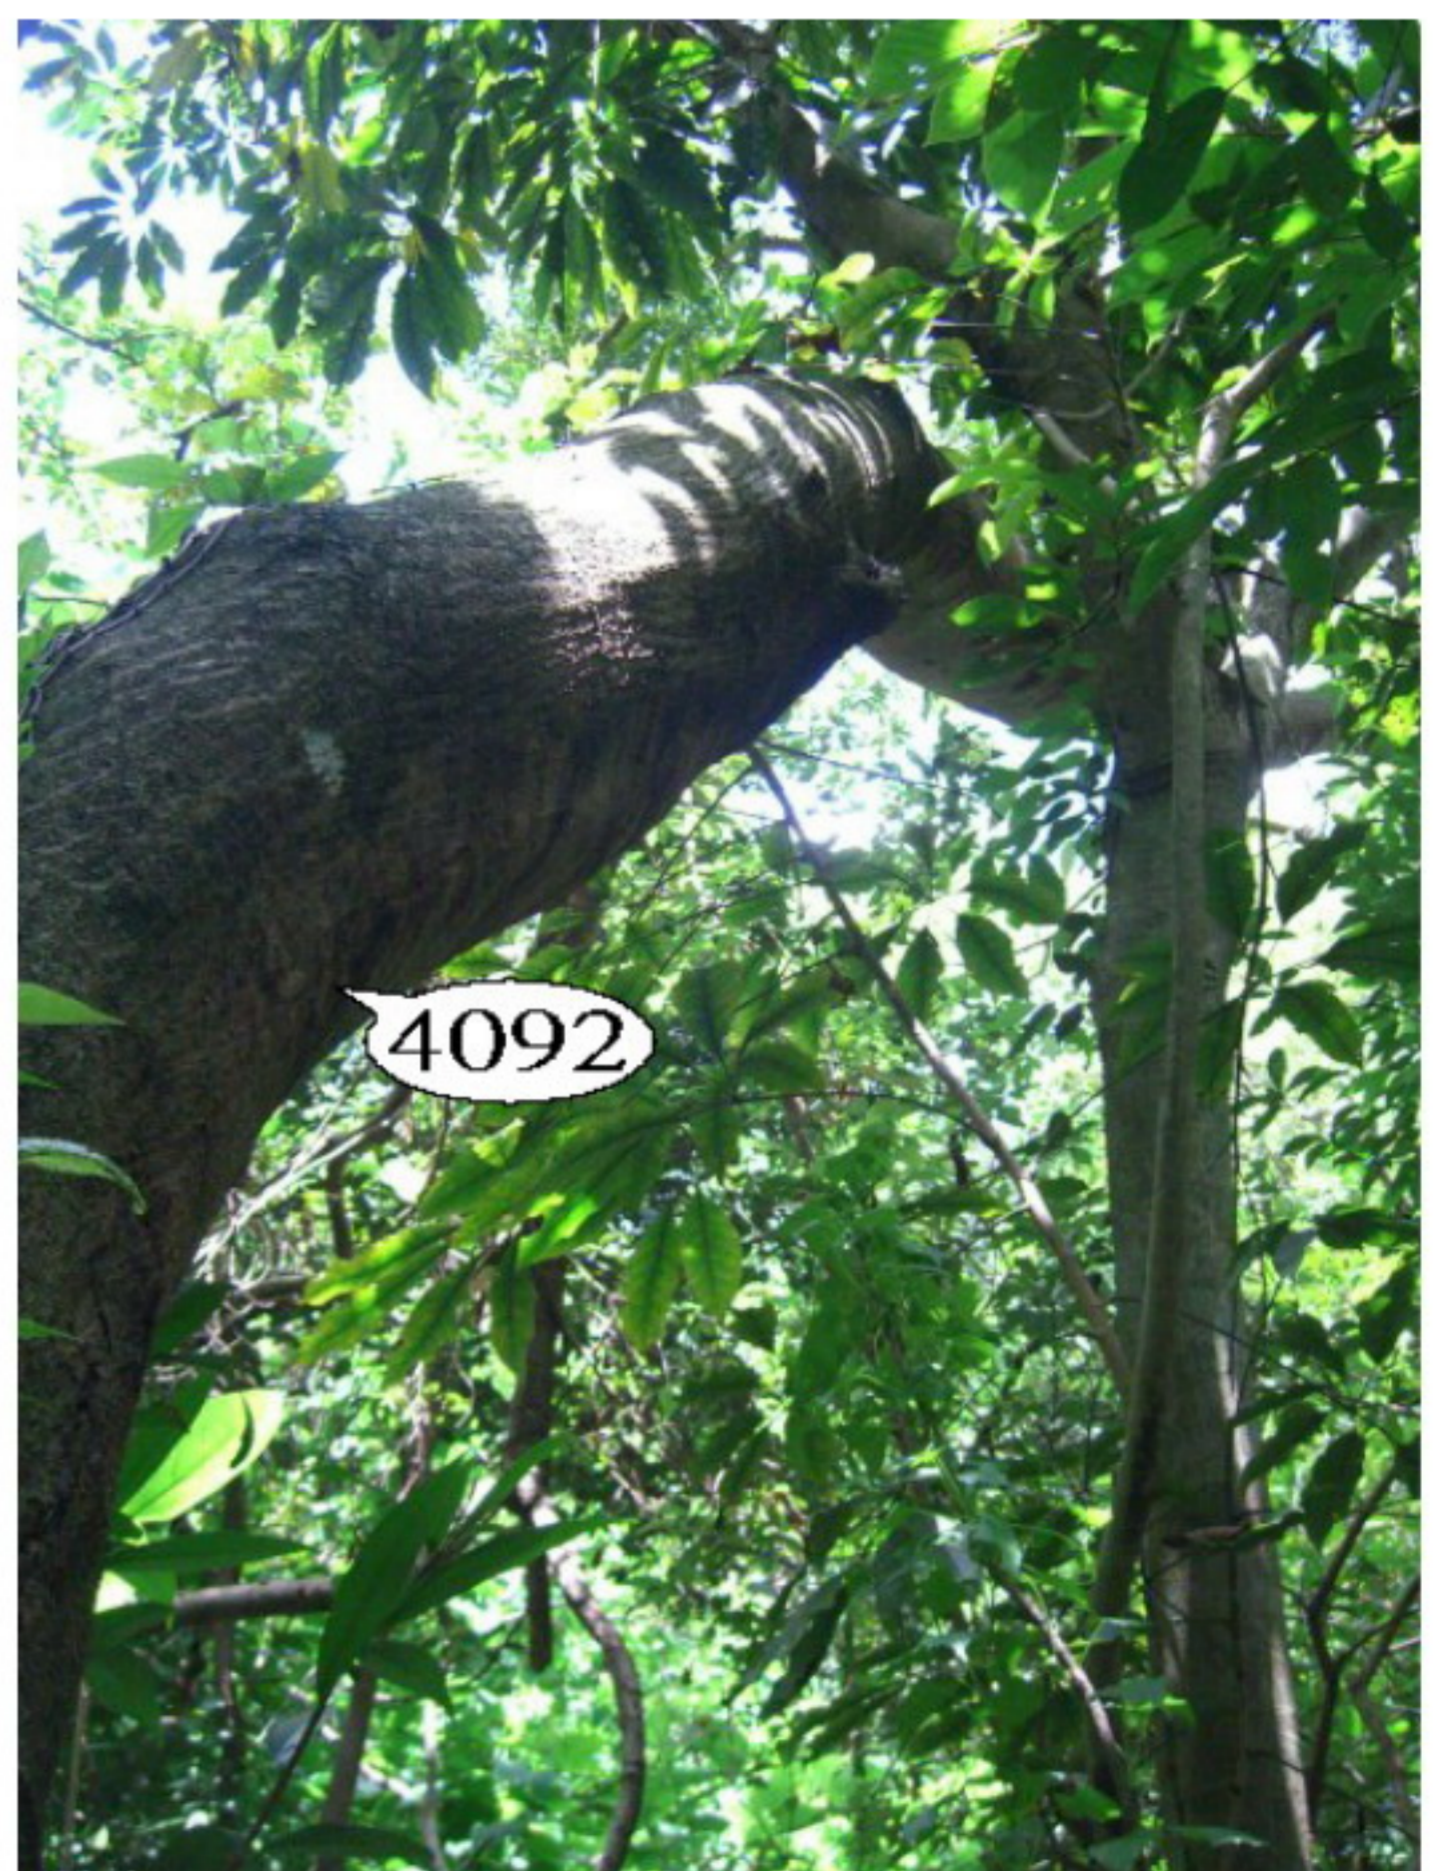
Tree 4091

Poor form which lead to low amenity value. Besides, the tree is unbalance. It may need heavy pruning after transplantation that will affect its transplantation survival rate. Moreover, the operation of the transplantation for poor form tree is also difficult.

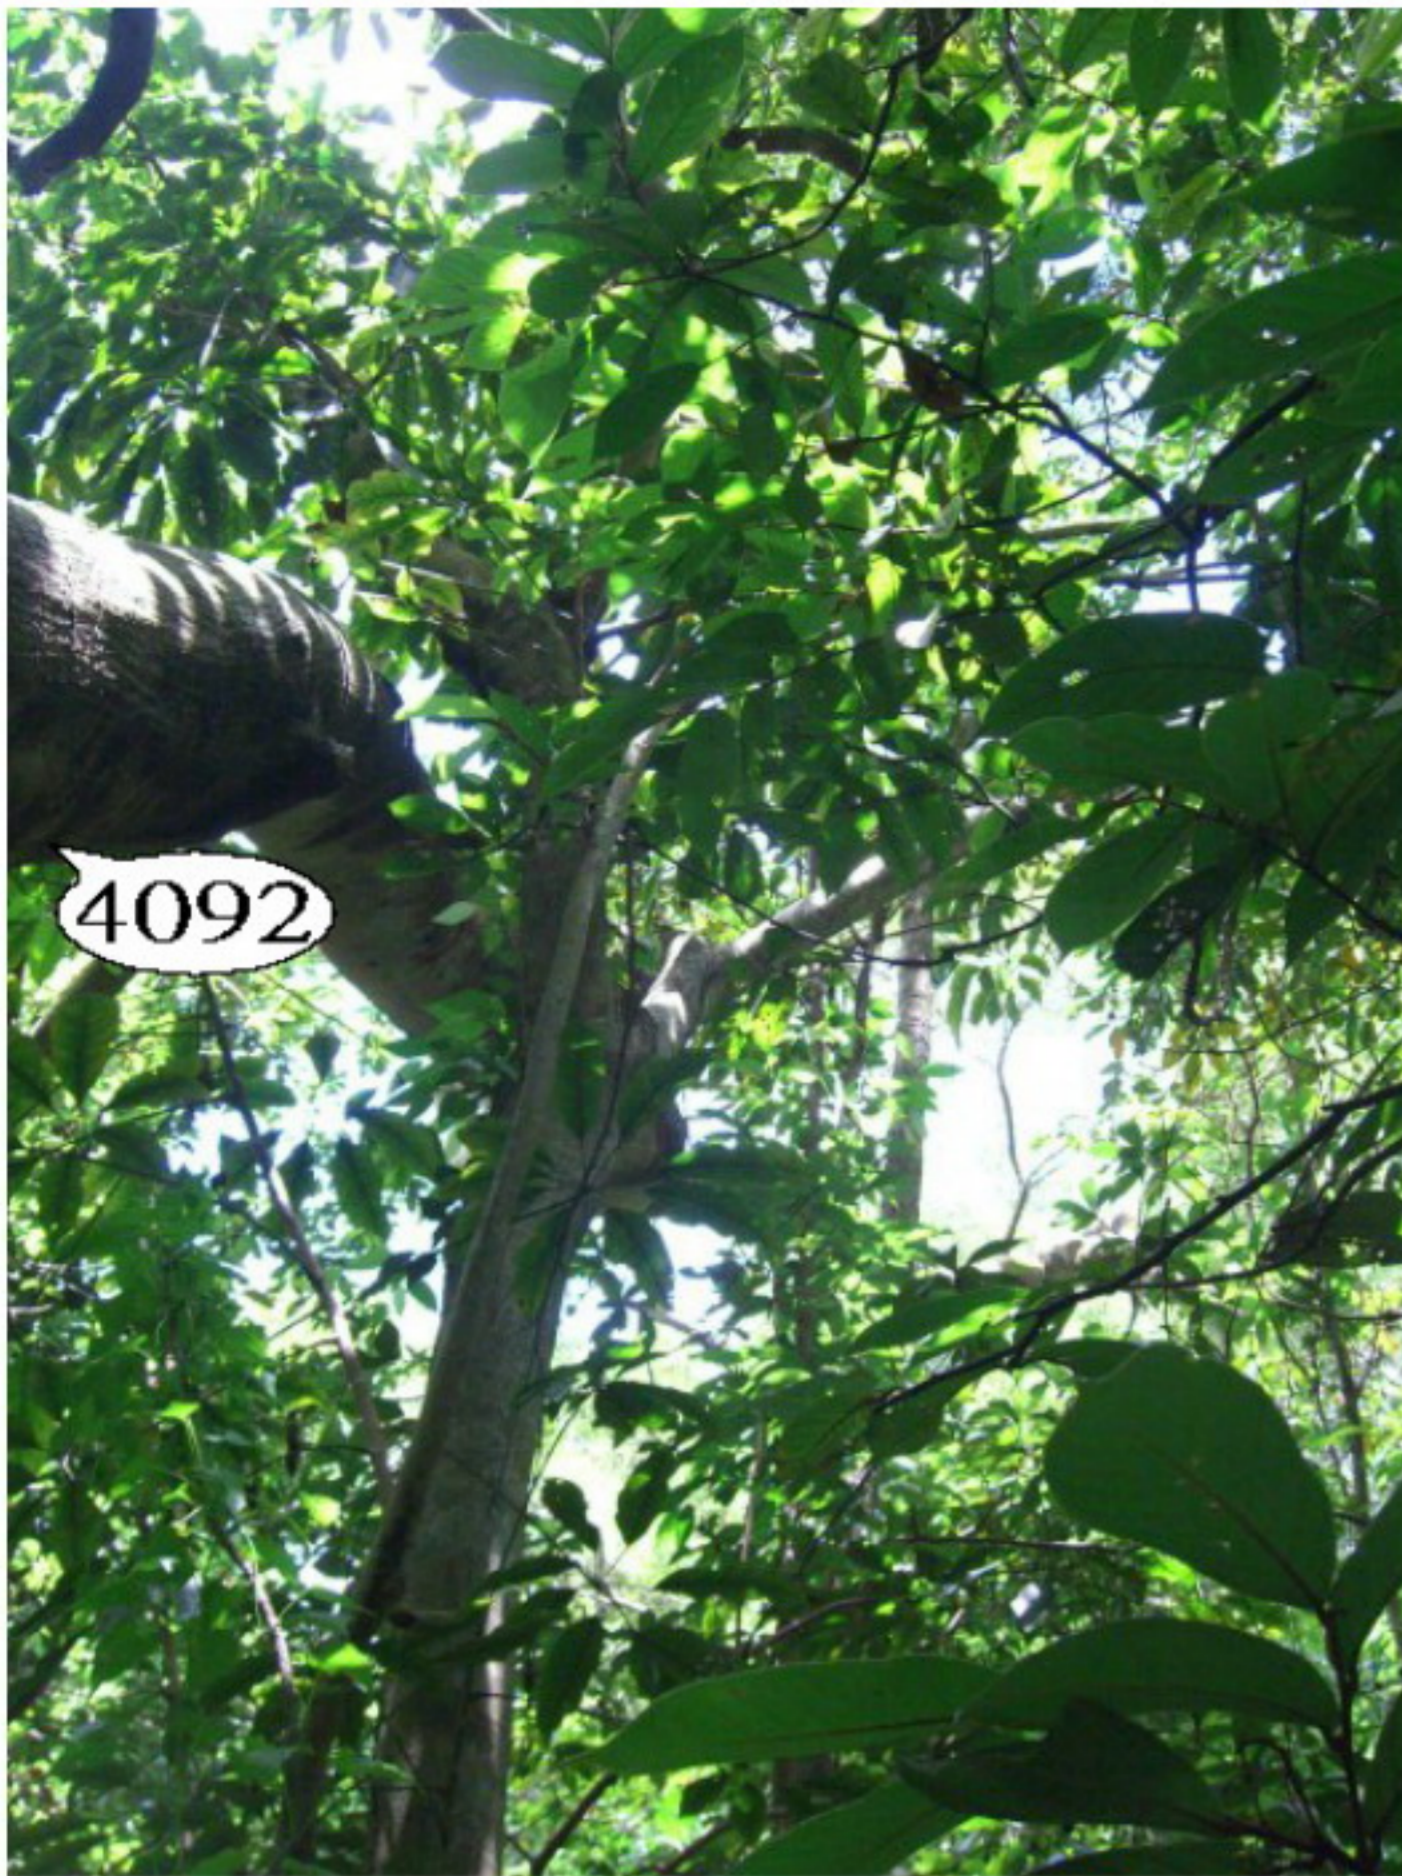
Tree 4092

Poor form which lead to low amenity value. Besides, the tree is unbalance. It may need heavy pruning after transplantation that will affect its transplantation survival rate. Moreover, the operation of the transplantation for poor form tree is also difficult.
