# Provision of Cremators at Wo Hop Shek Crematorium

Tree Survey Report

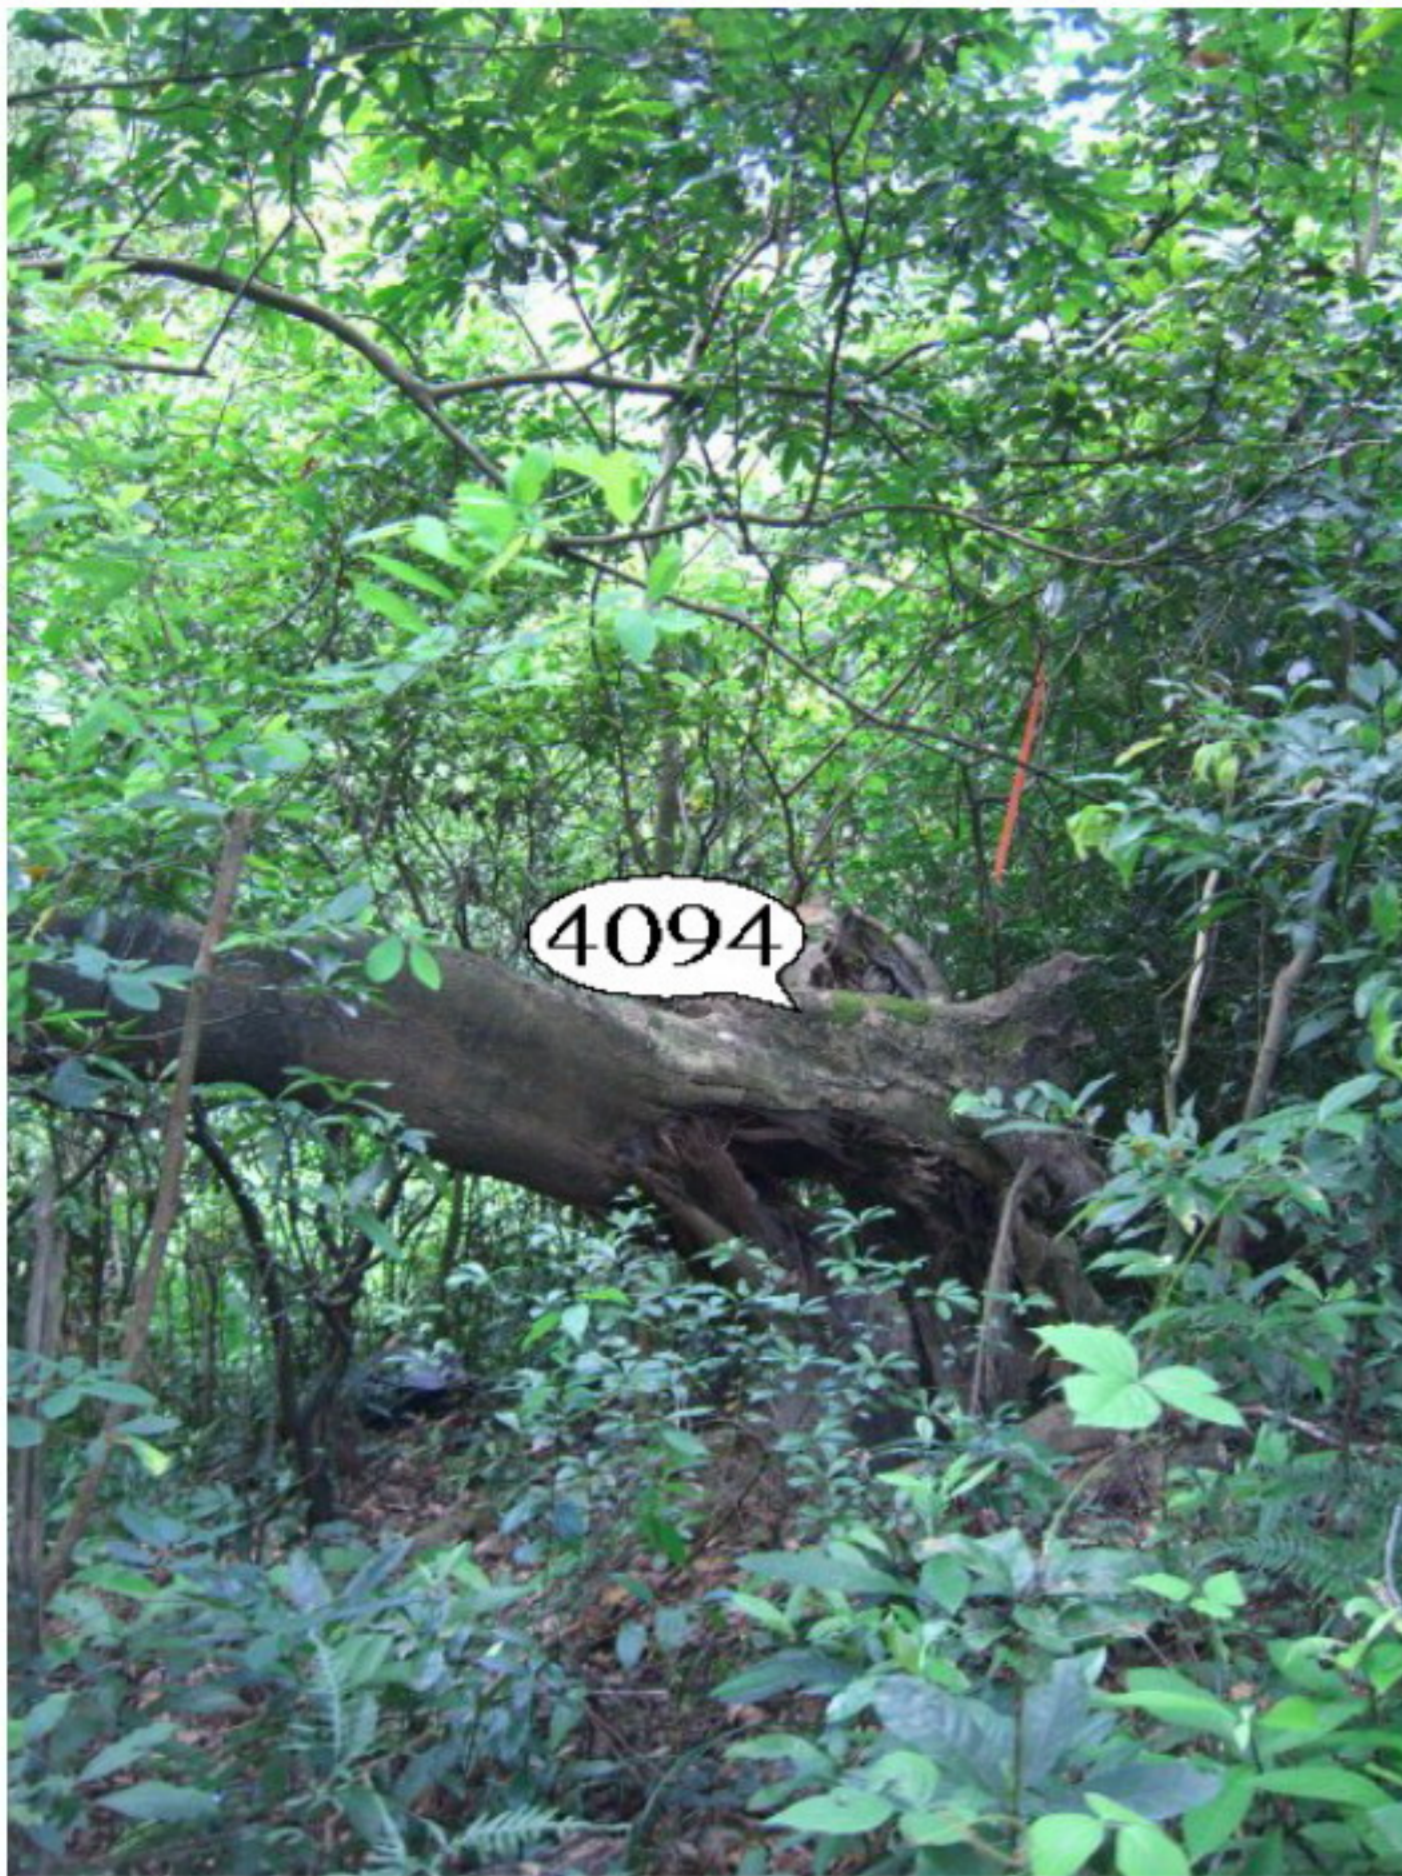
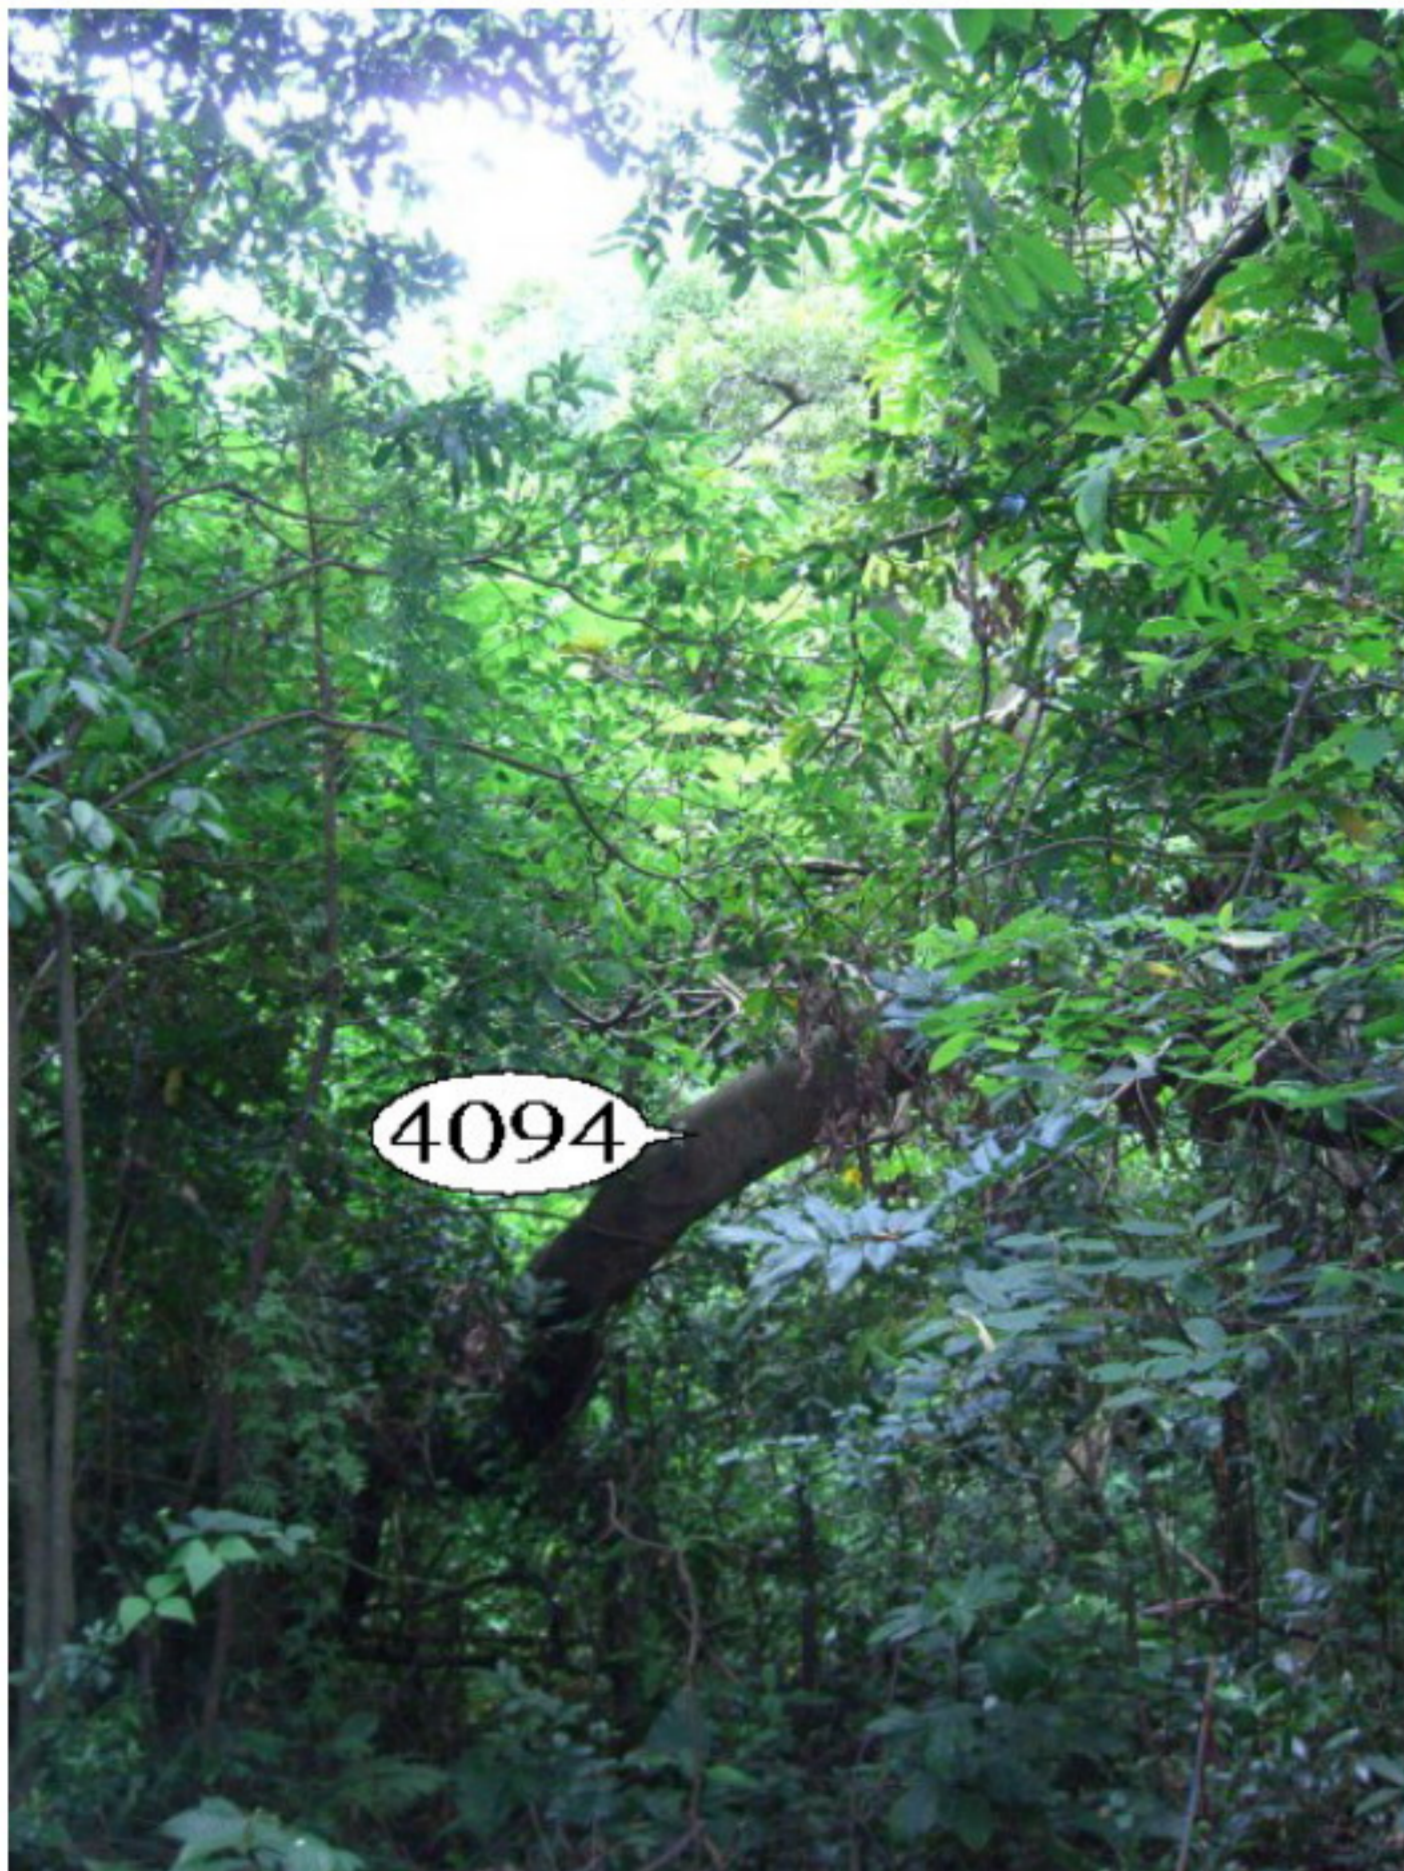
Tree 4092

Poor form which lead to low amenity value. Besides, the tree is unbalance. It may need heavy pruning after transplantation that will affect its transplantation survival rate. Moreover, the operation of the transplantation for poor form tree is also difficult.

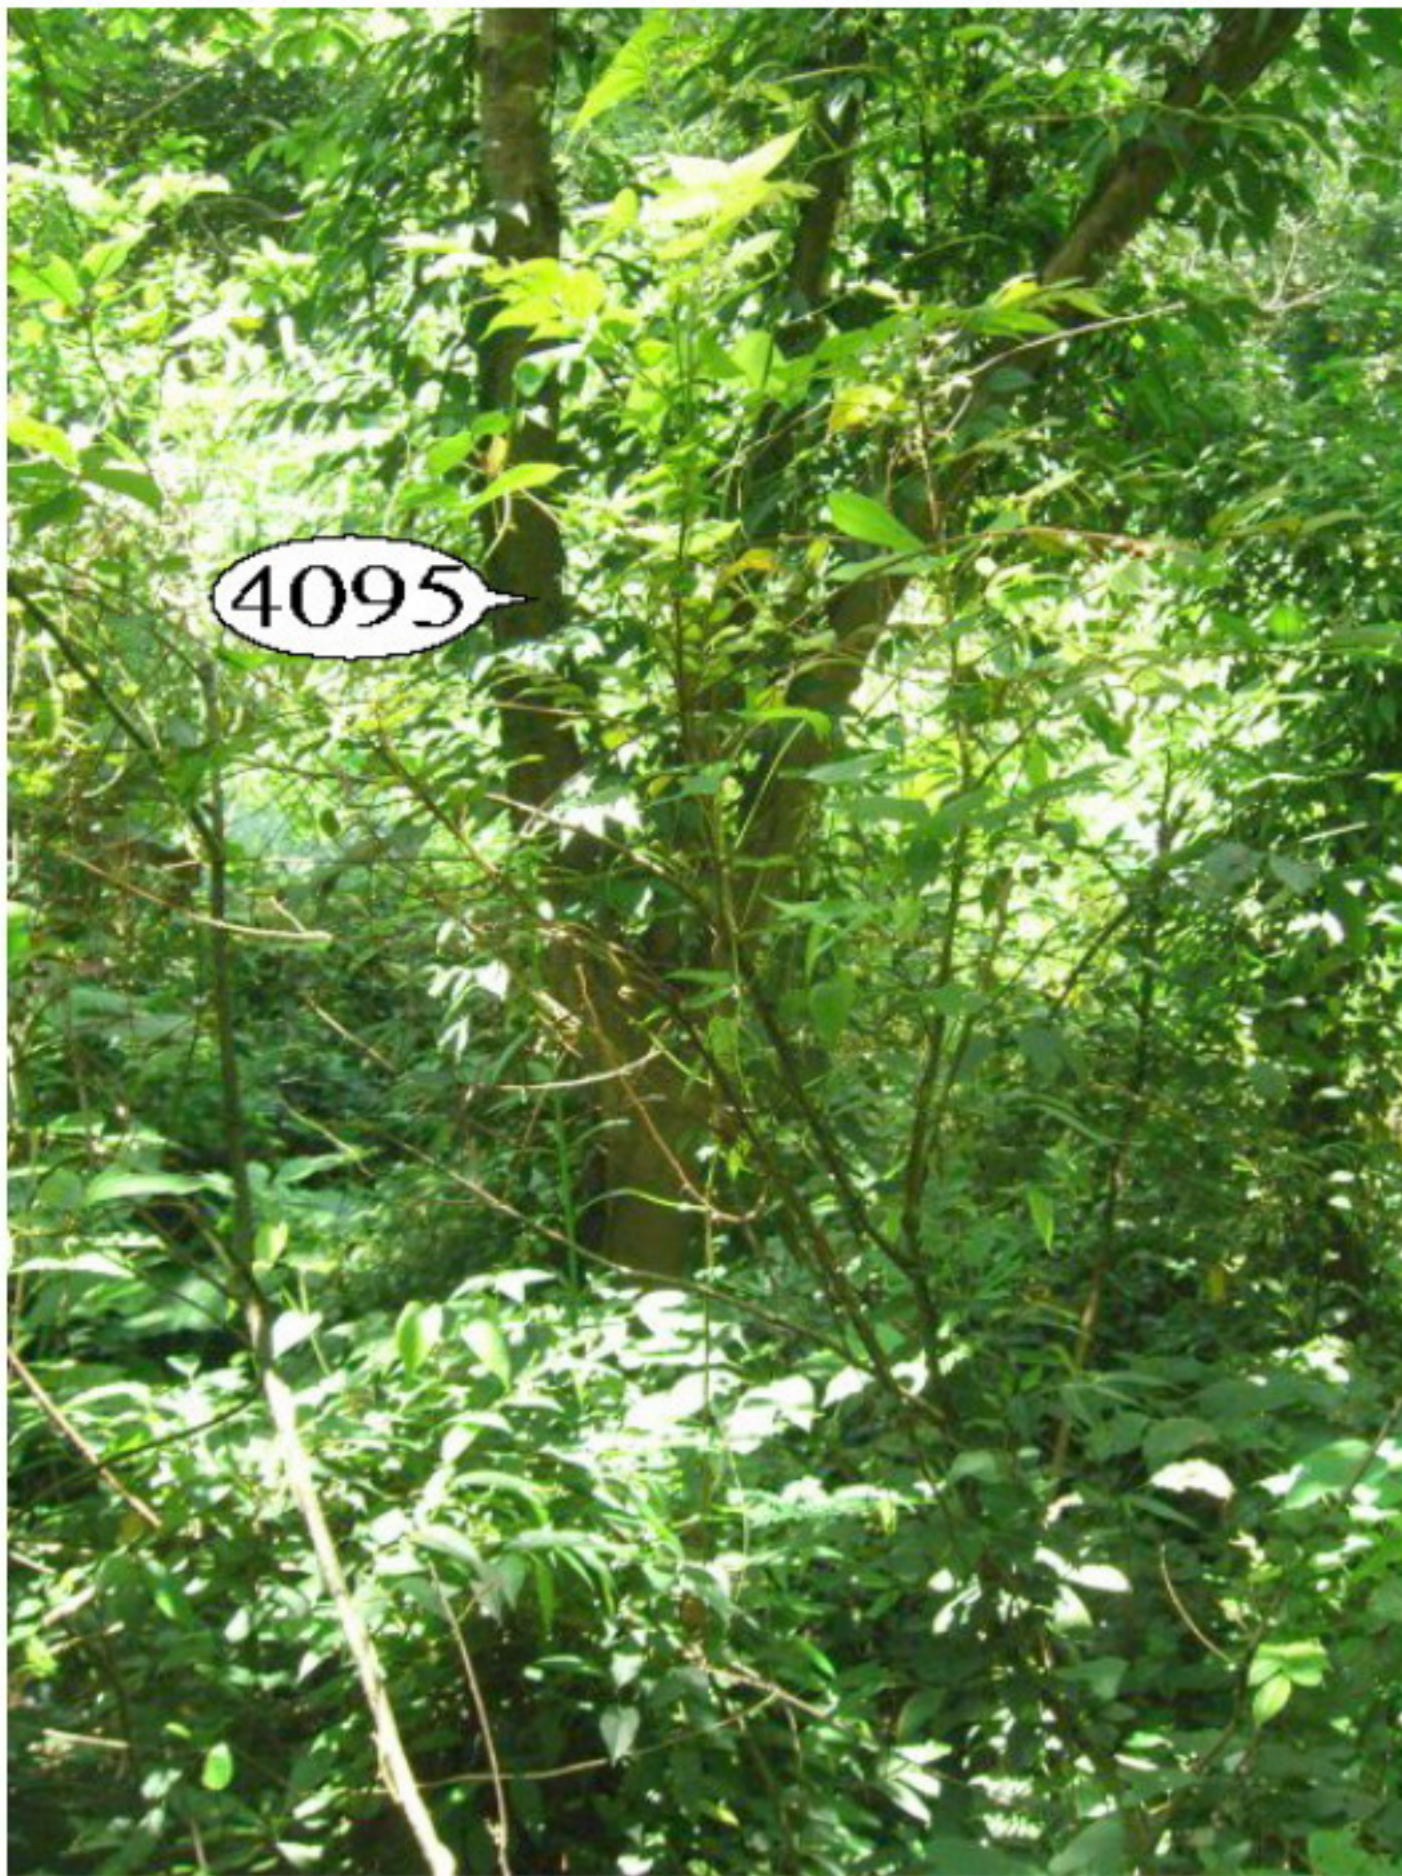
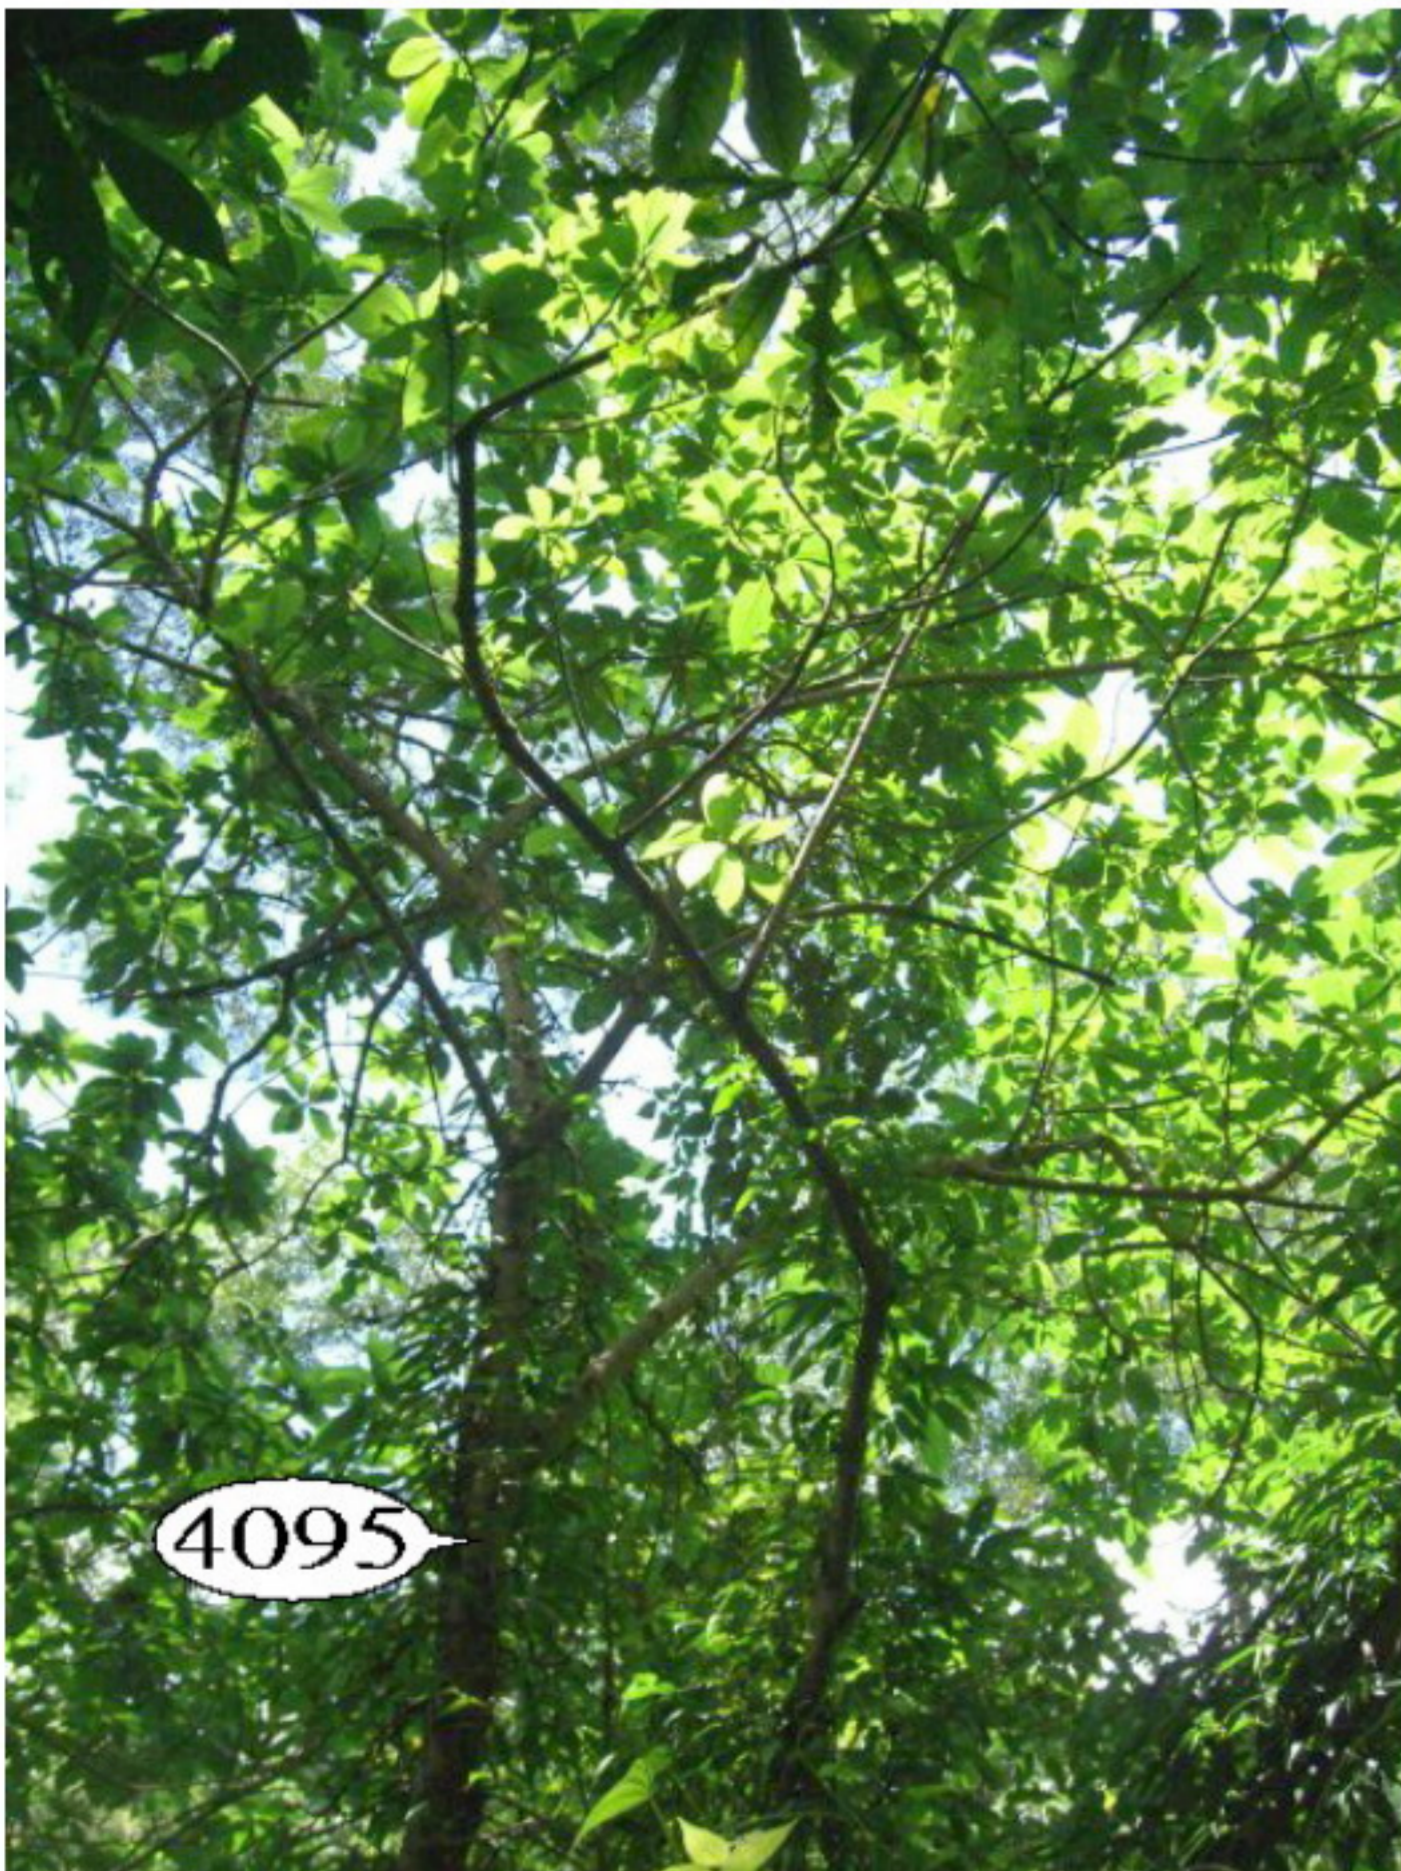
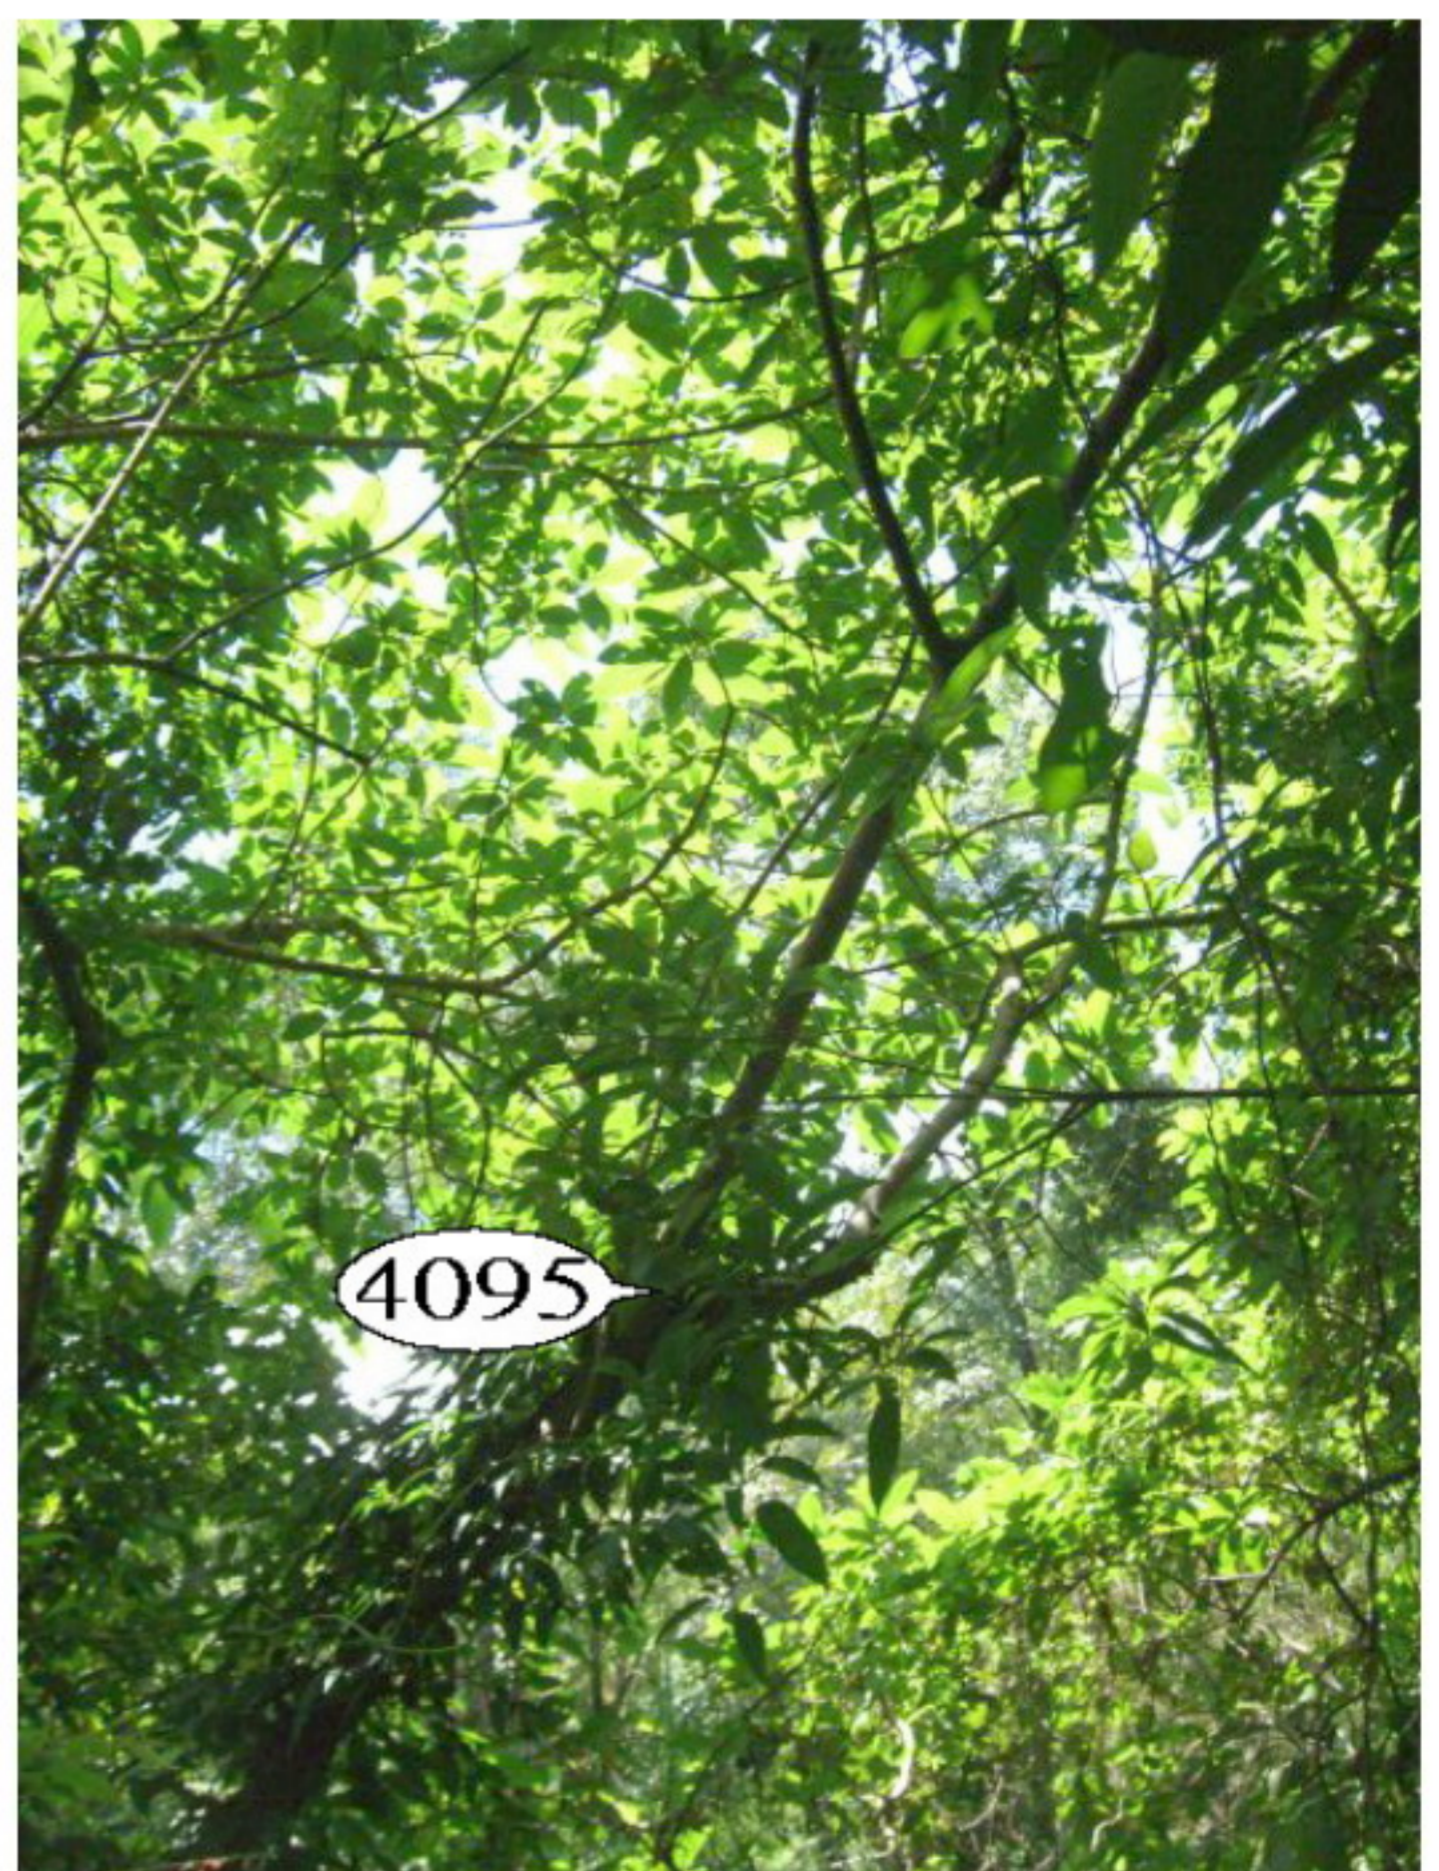
Tree 4094  
Poor health lead to low transplantation survival rate.
