# Provision of Cremators at Wo Hop Shek Crematorium

Tree Survey Report

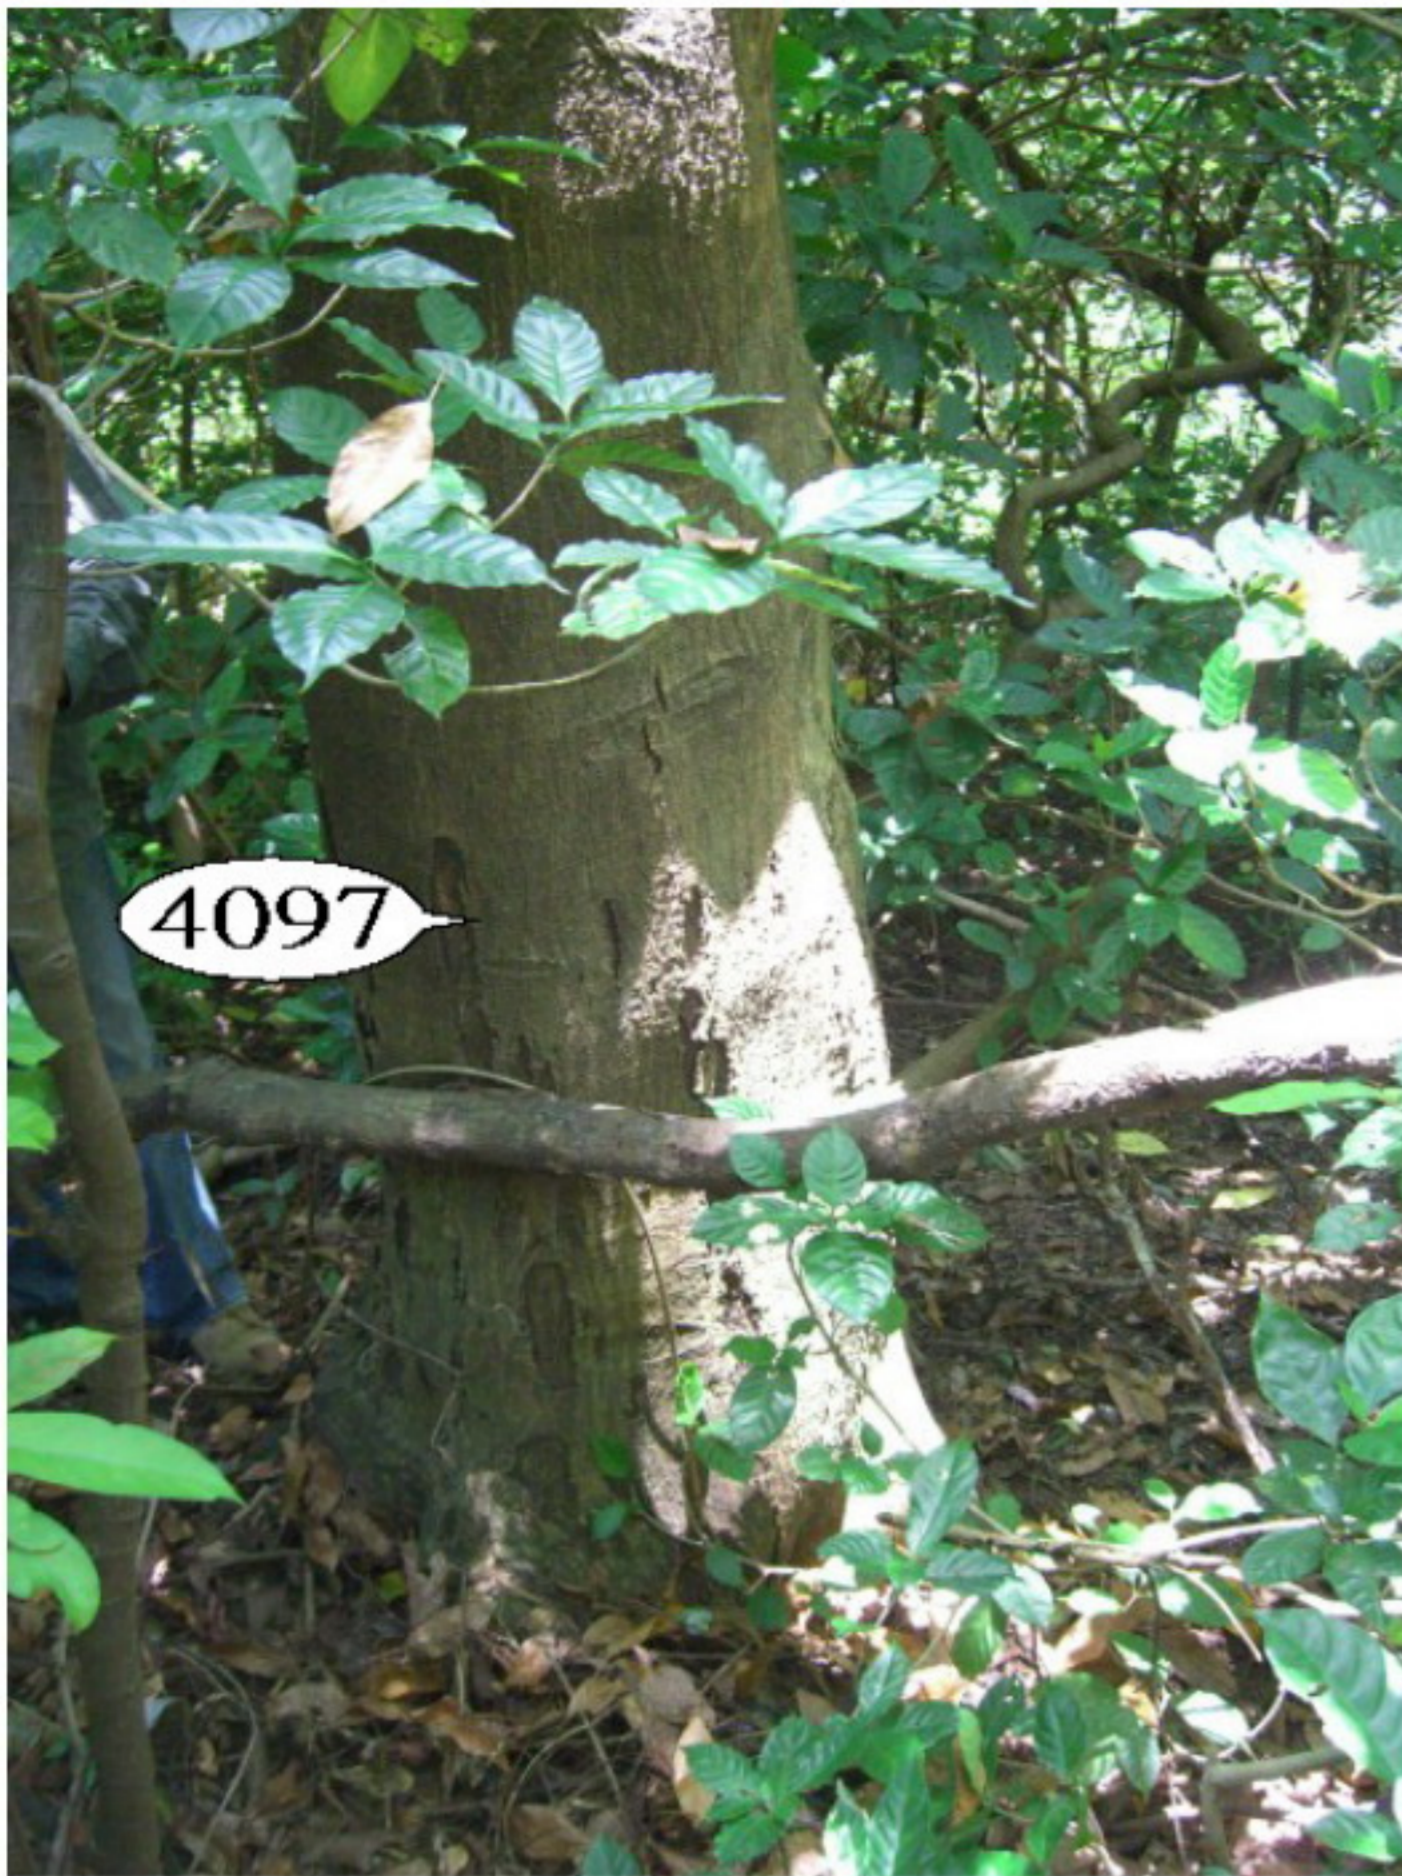
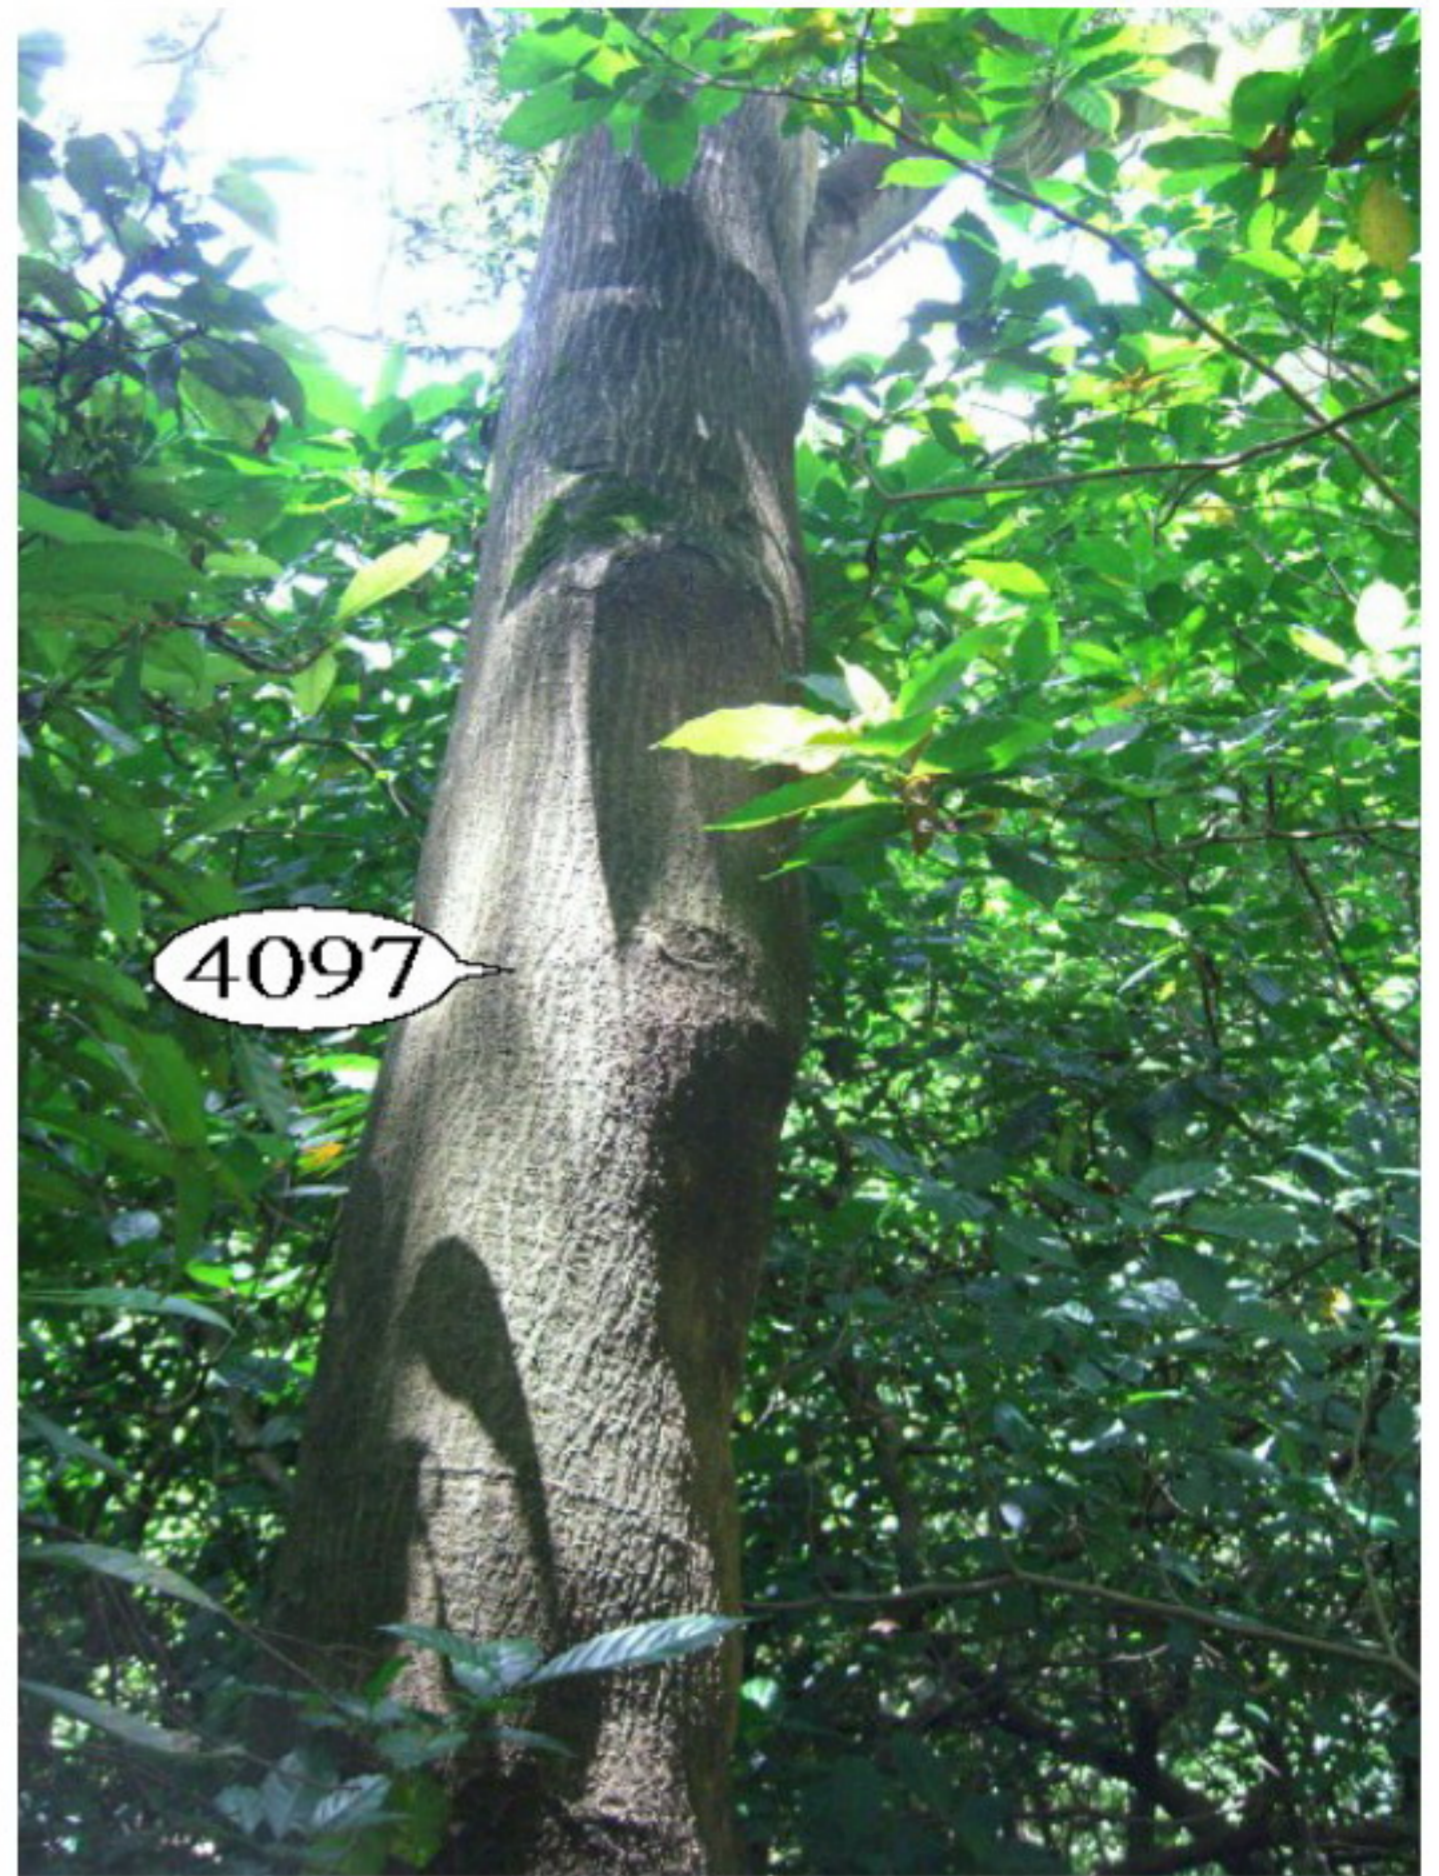
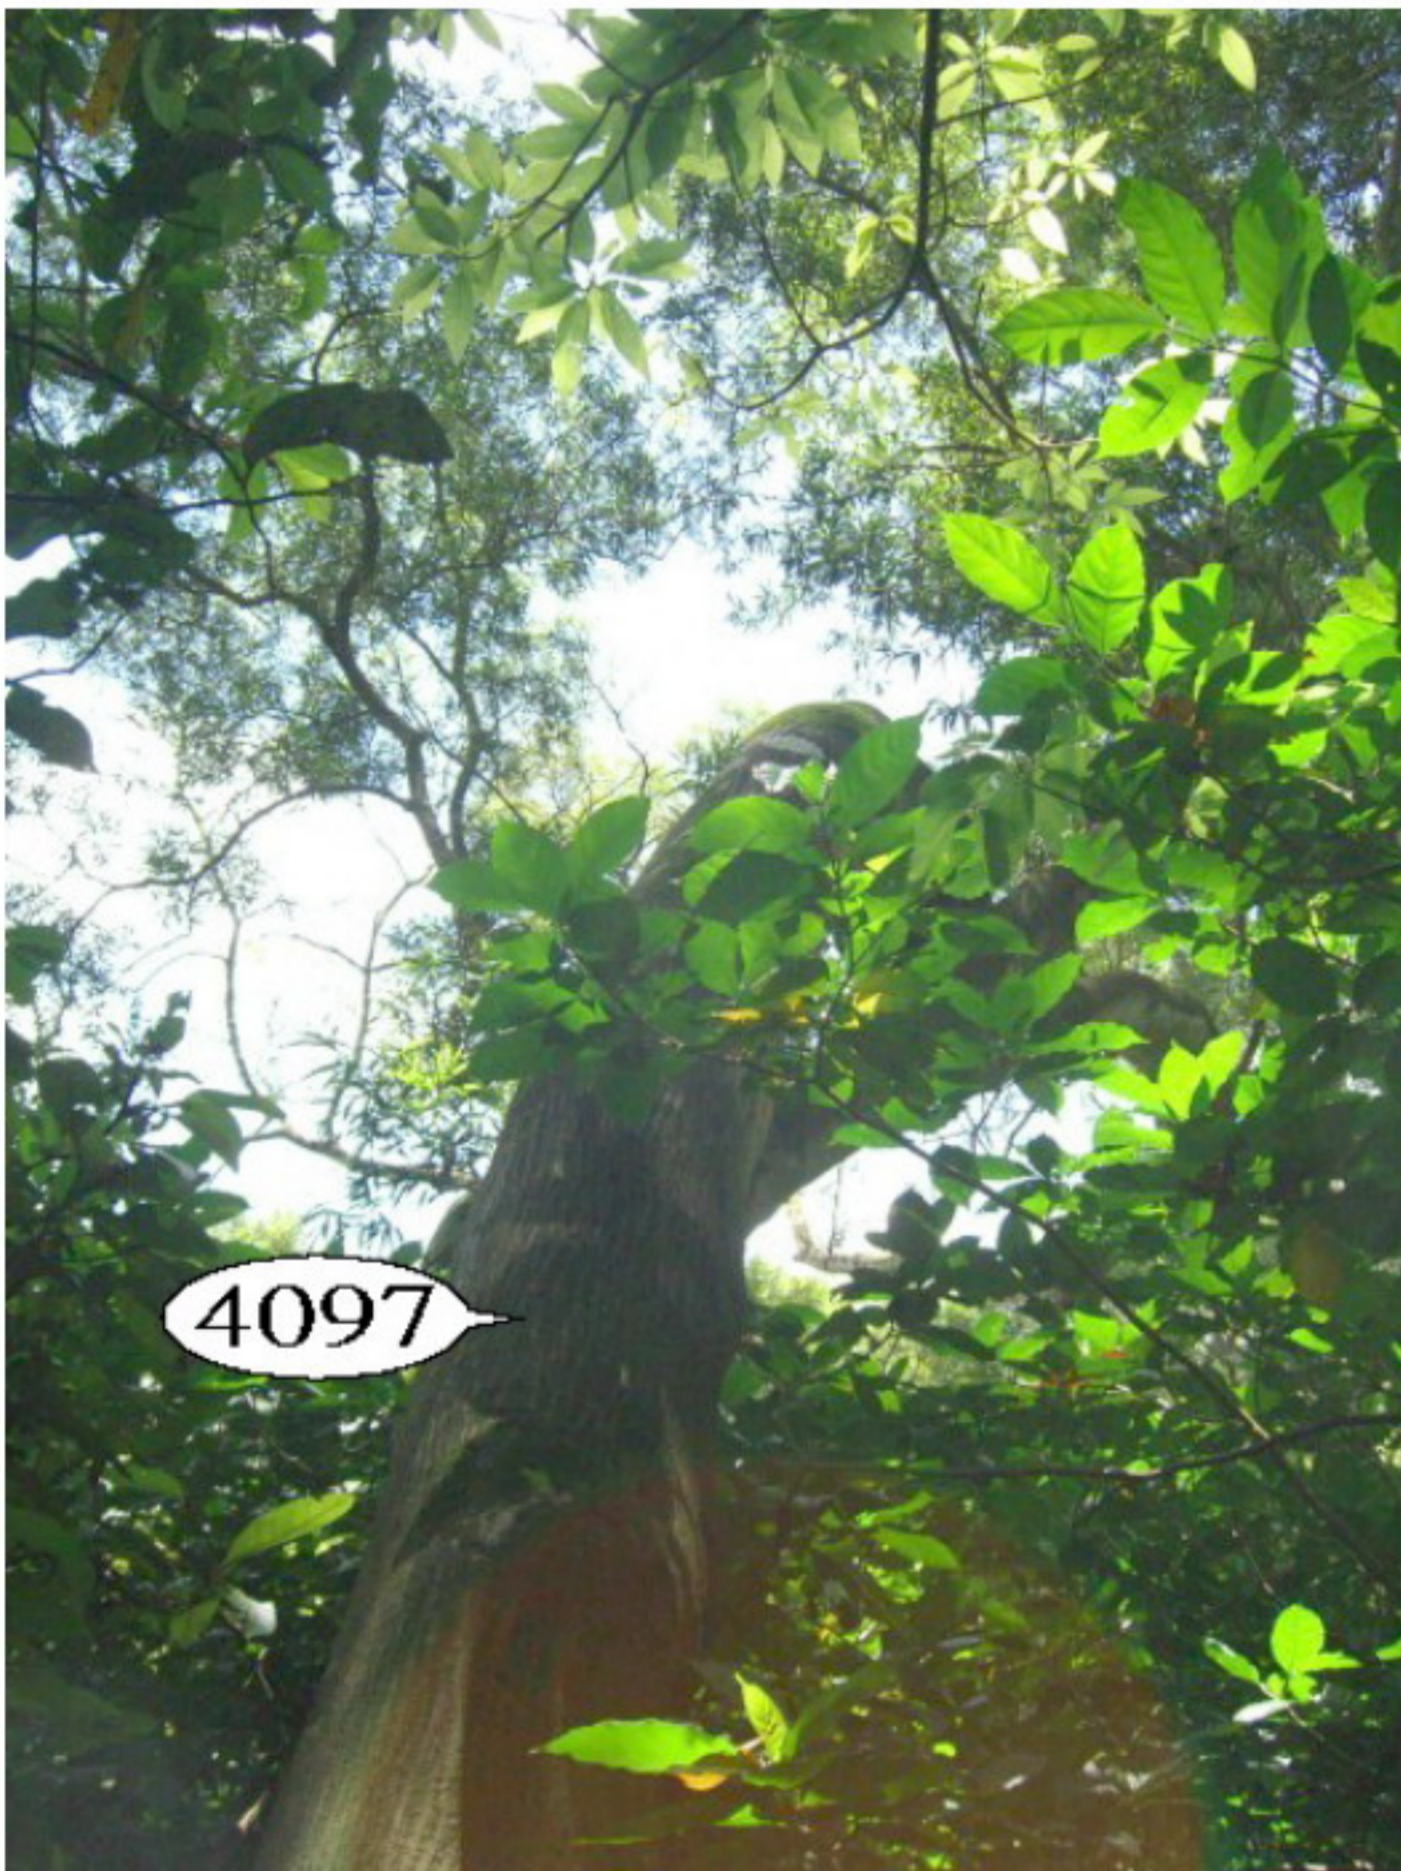
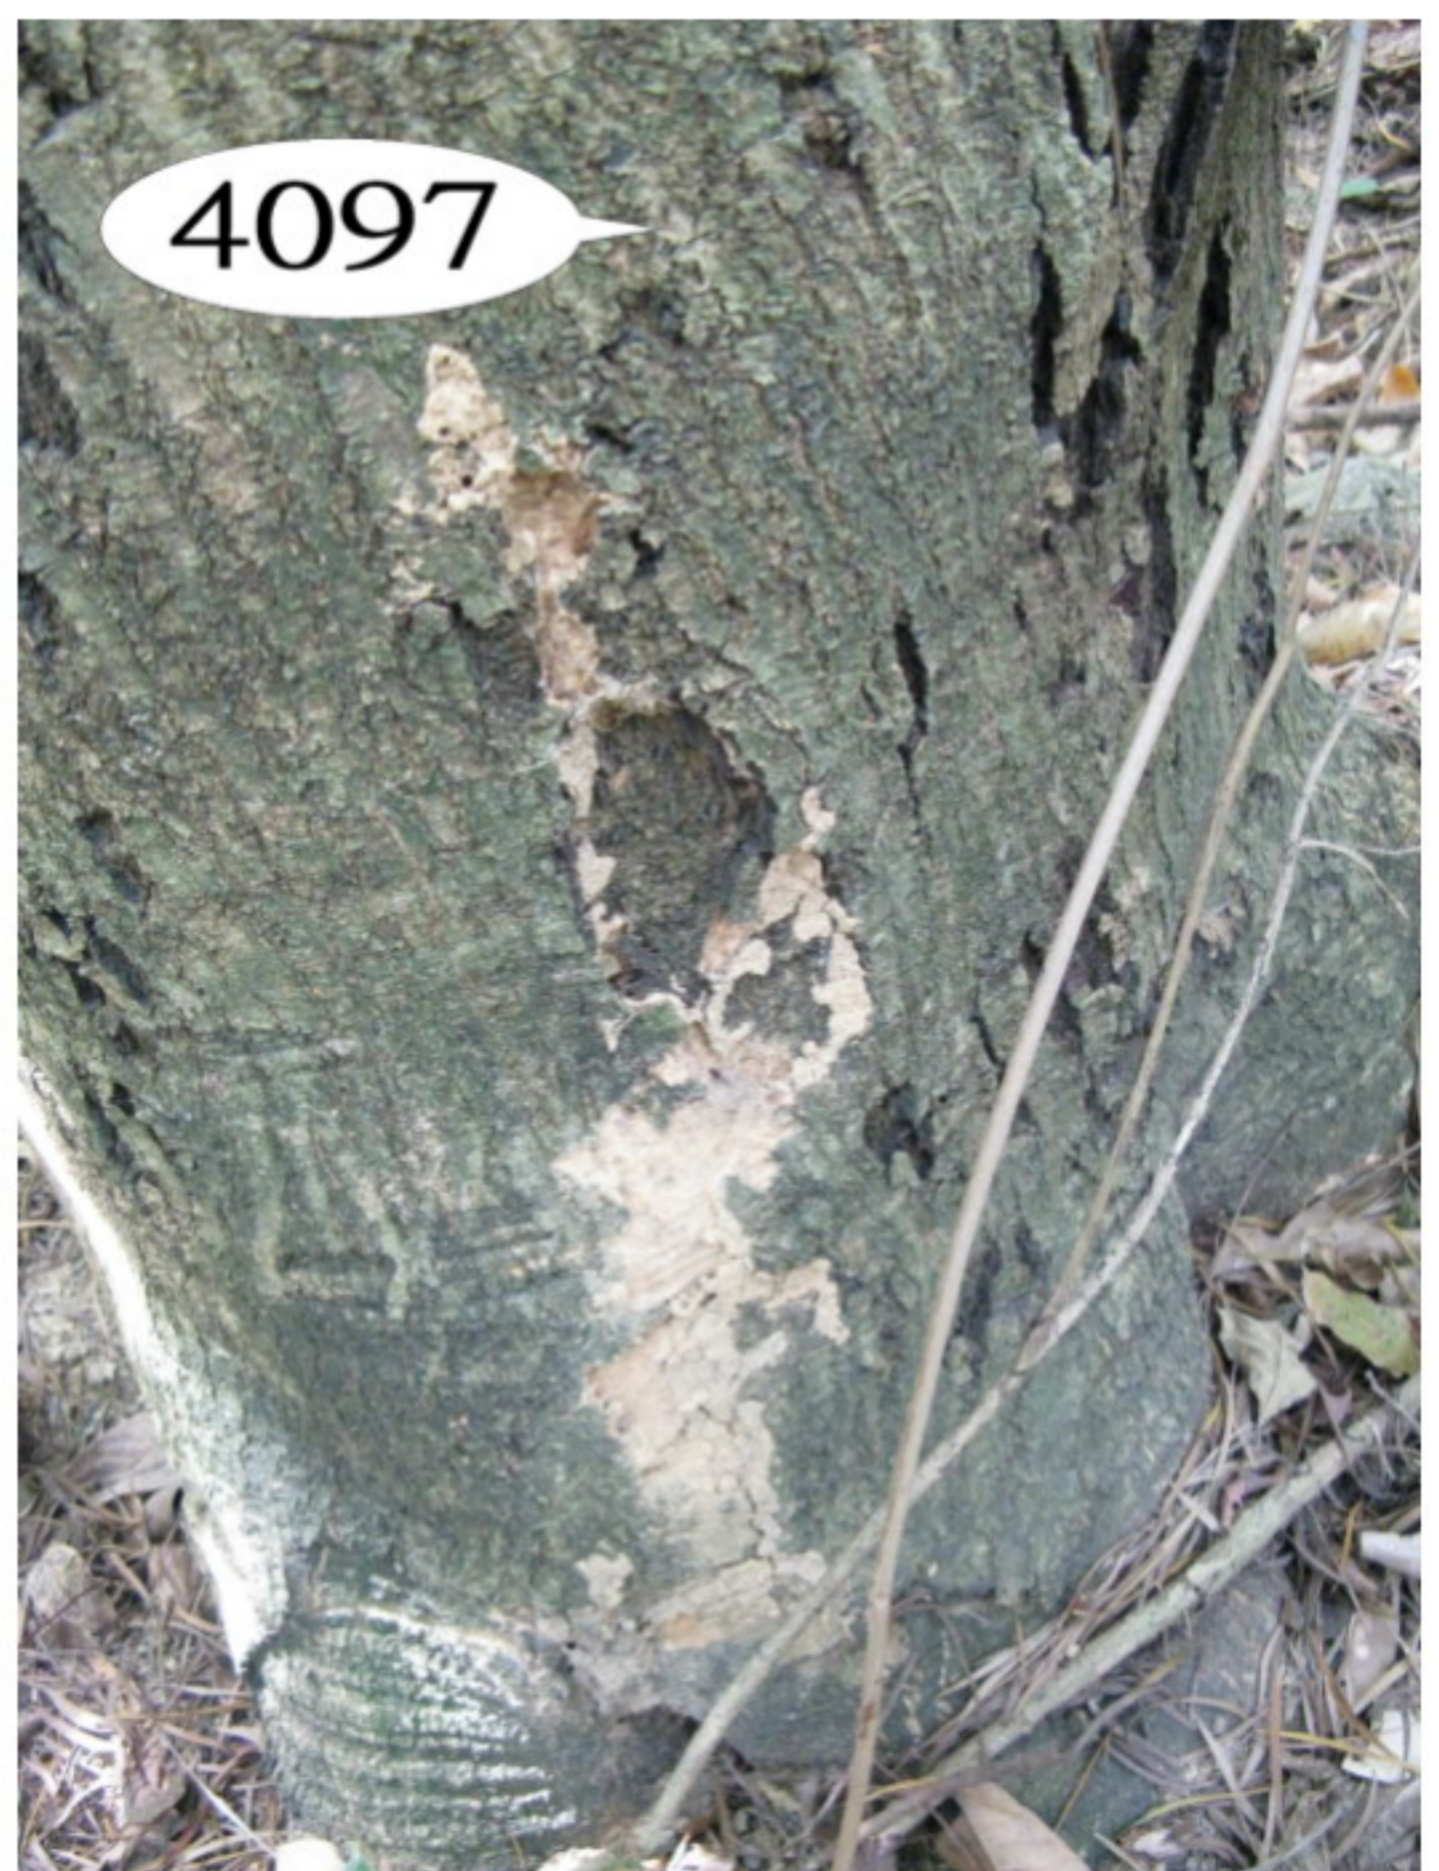
Tree 4096

Poor health lead to low transplantation survival rate. Branches decay was found.

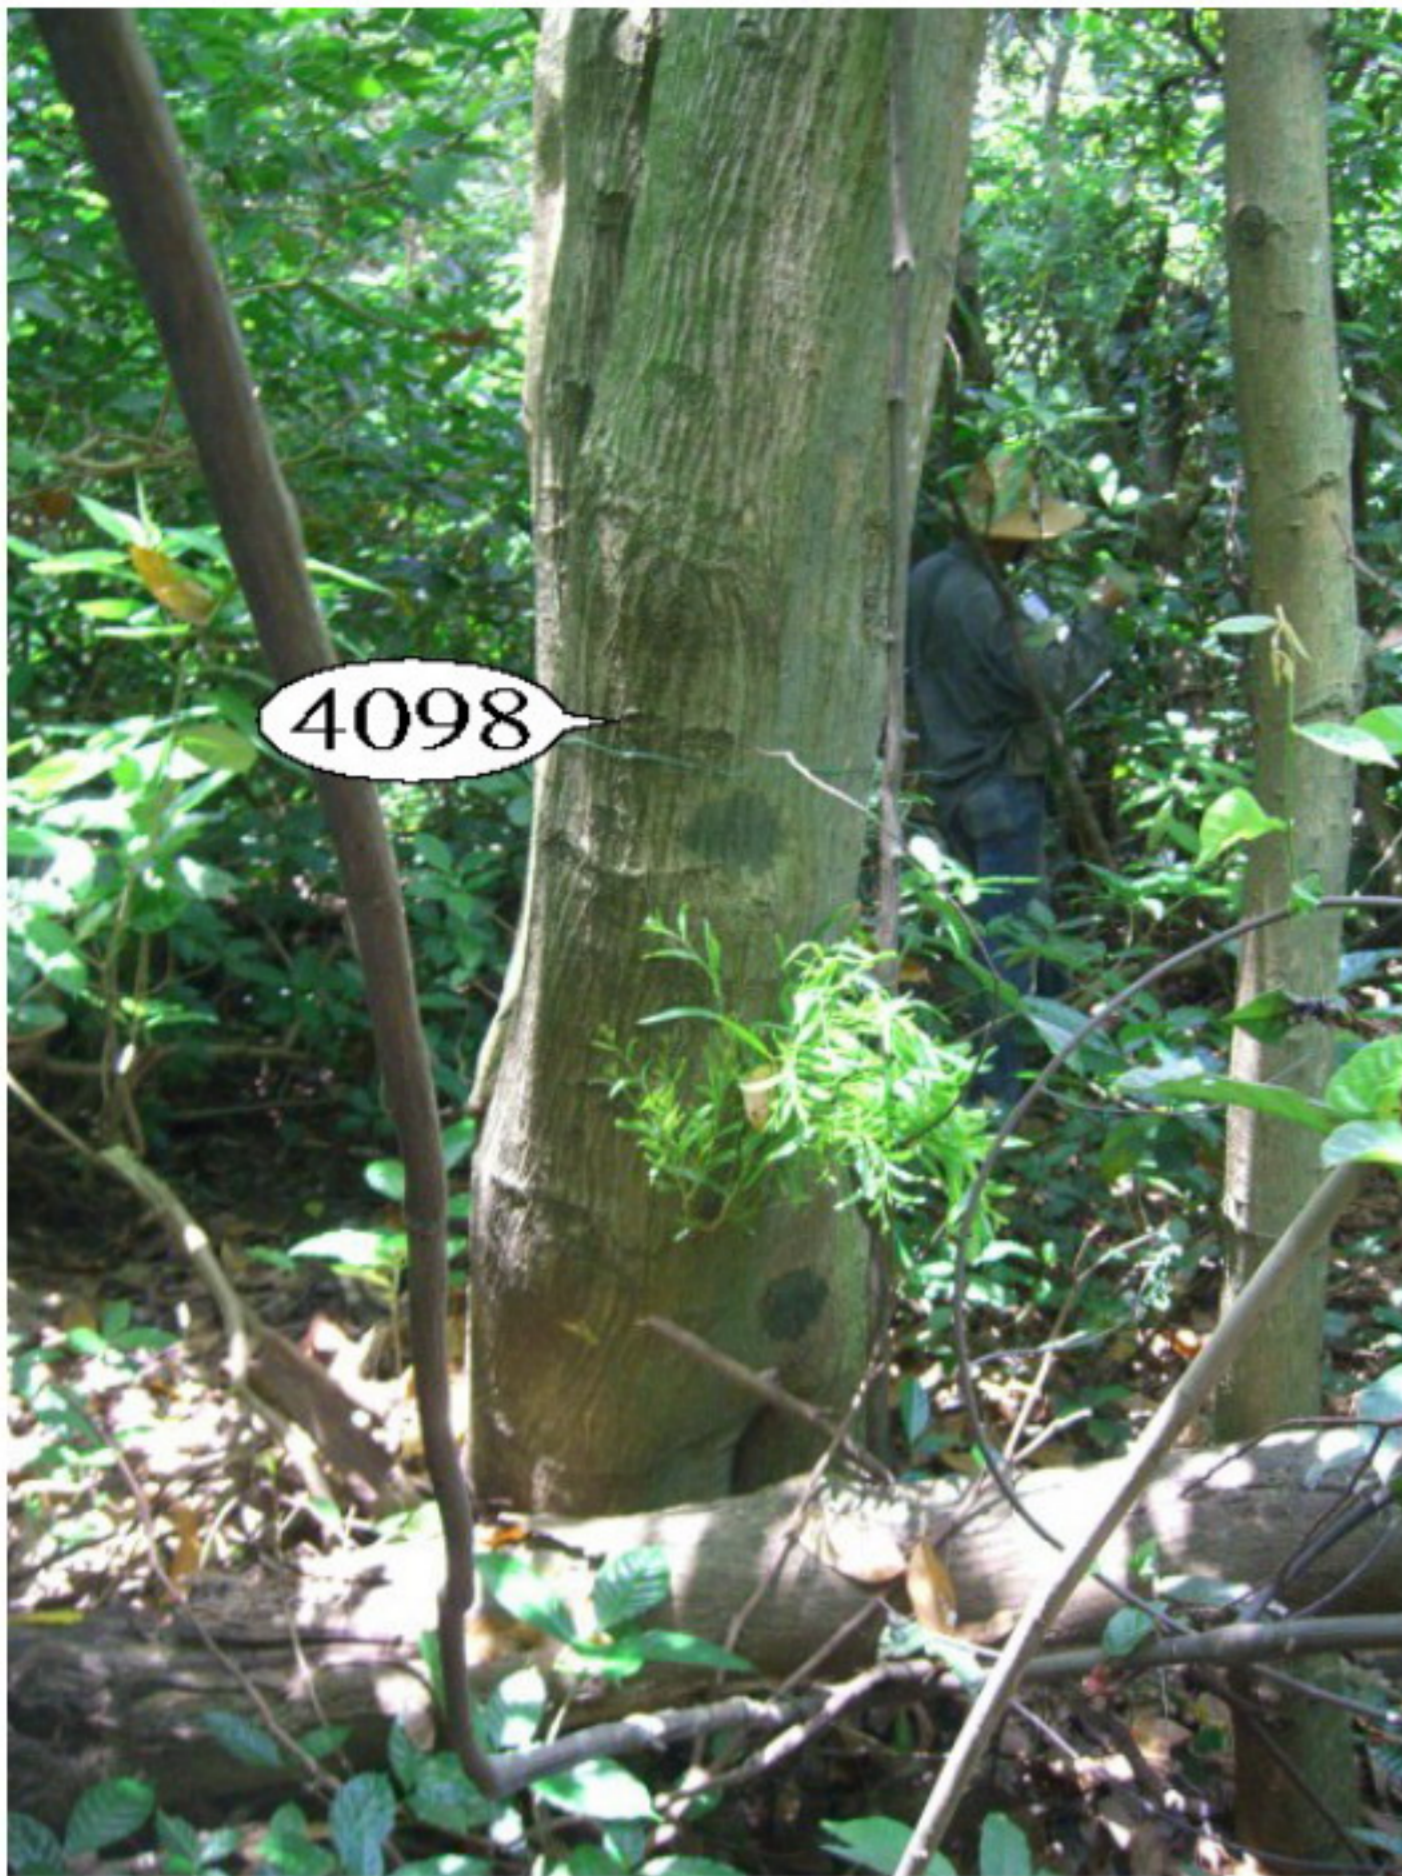
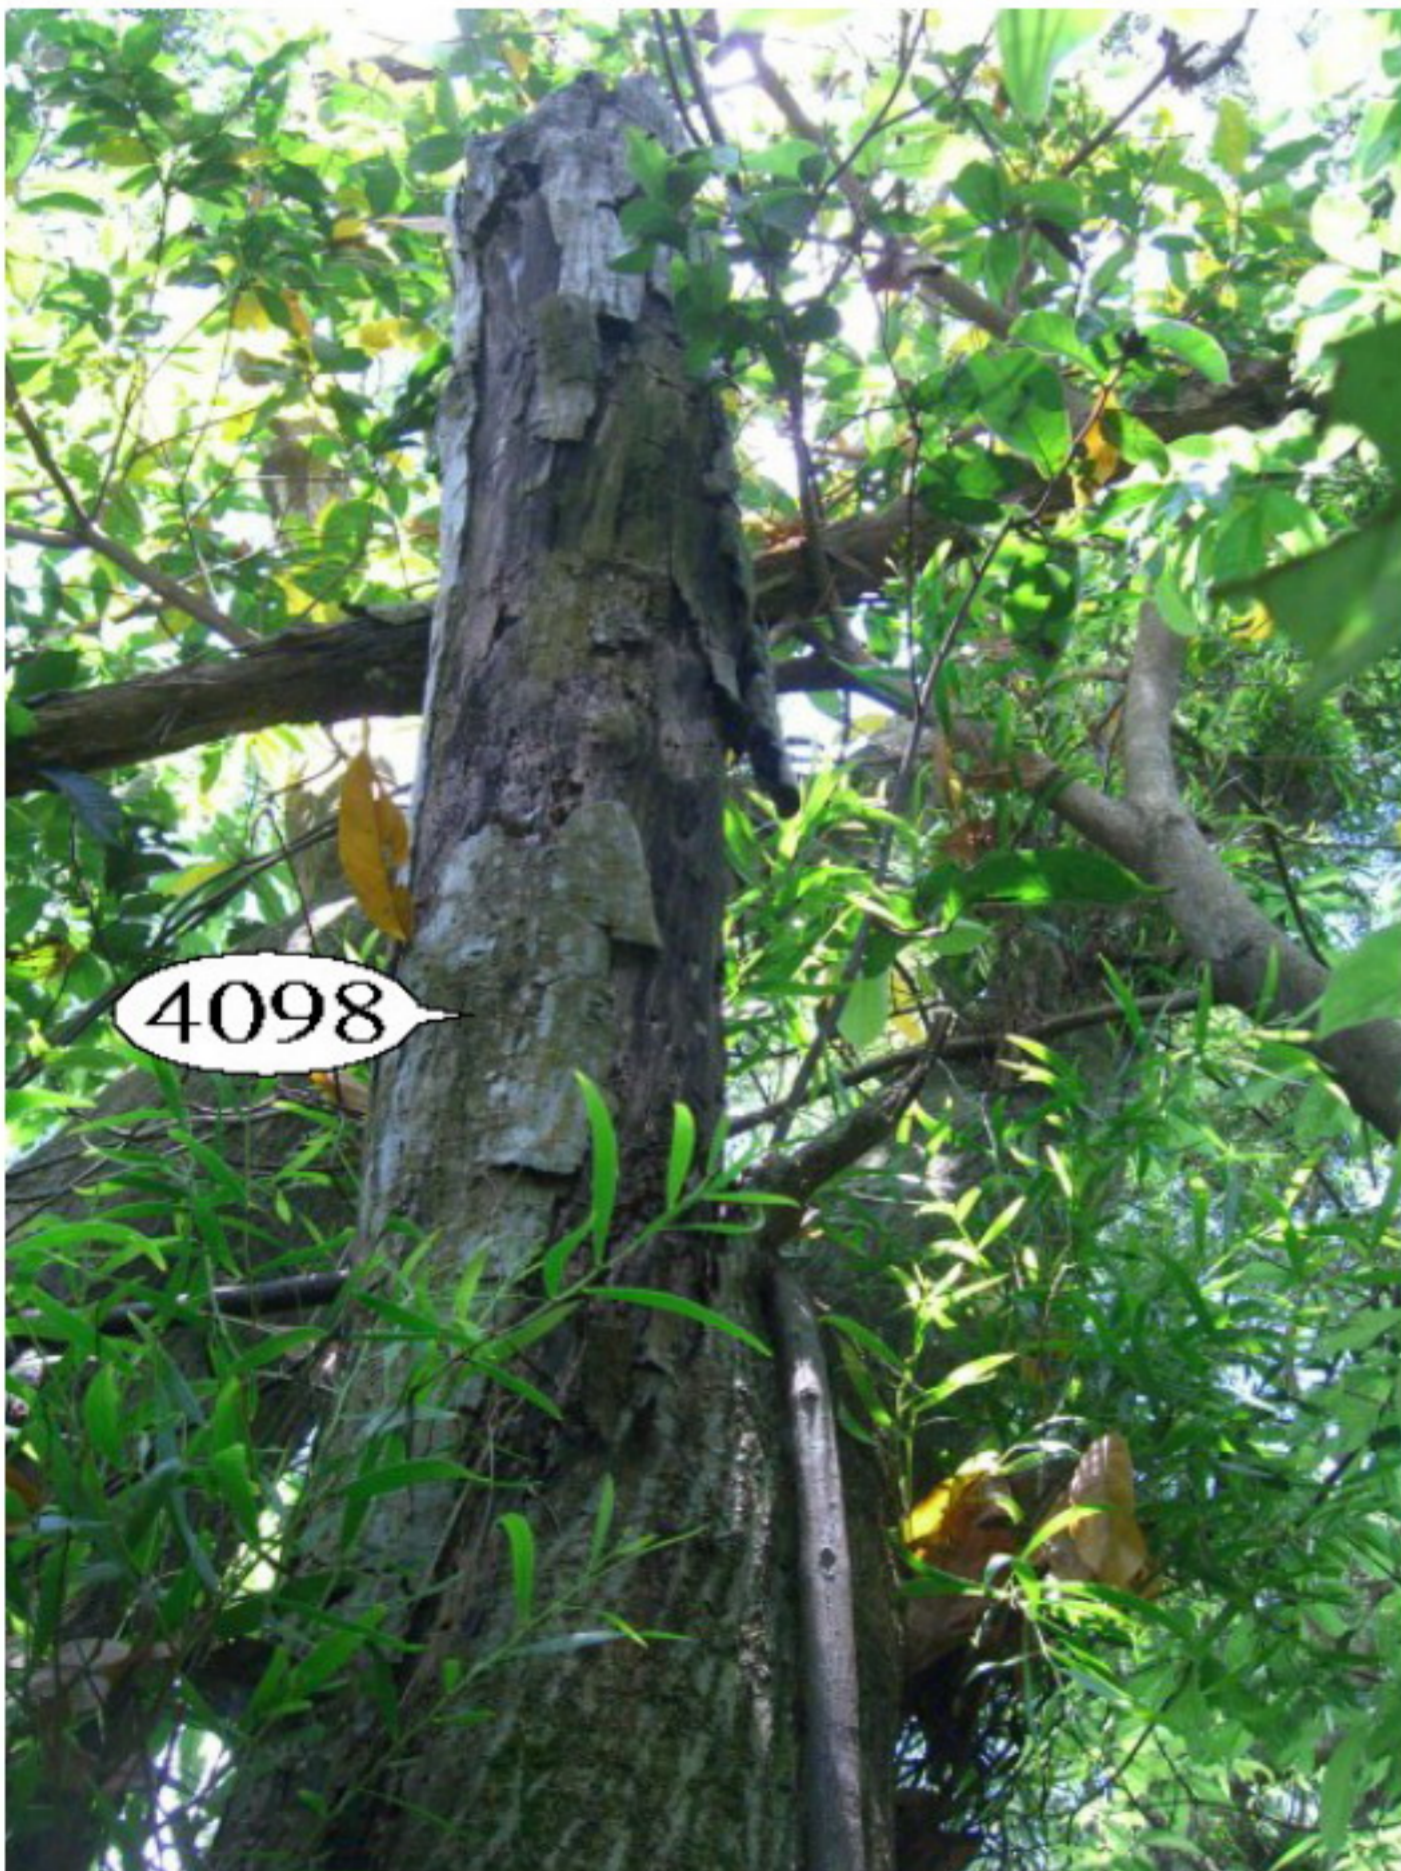
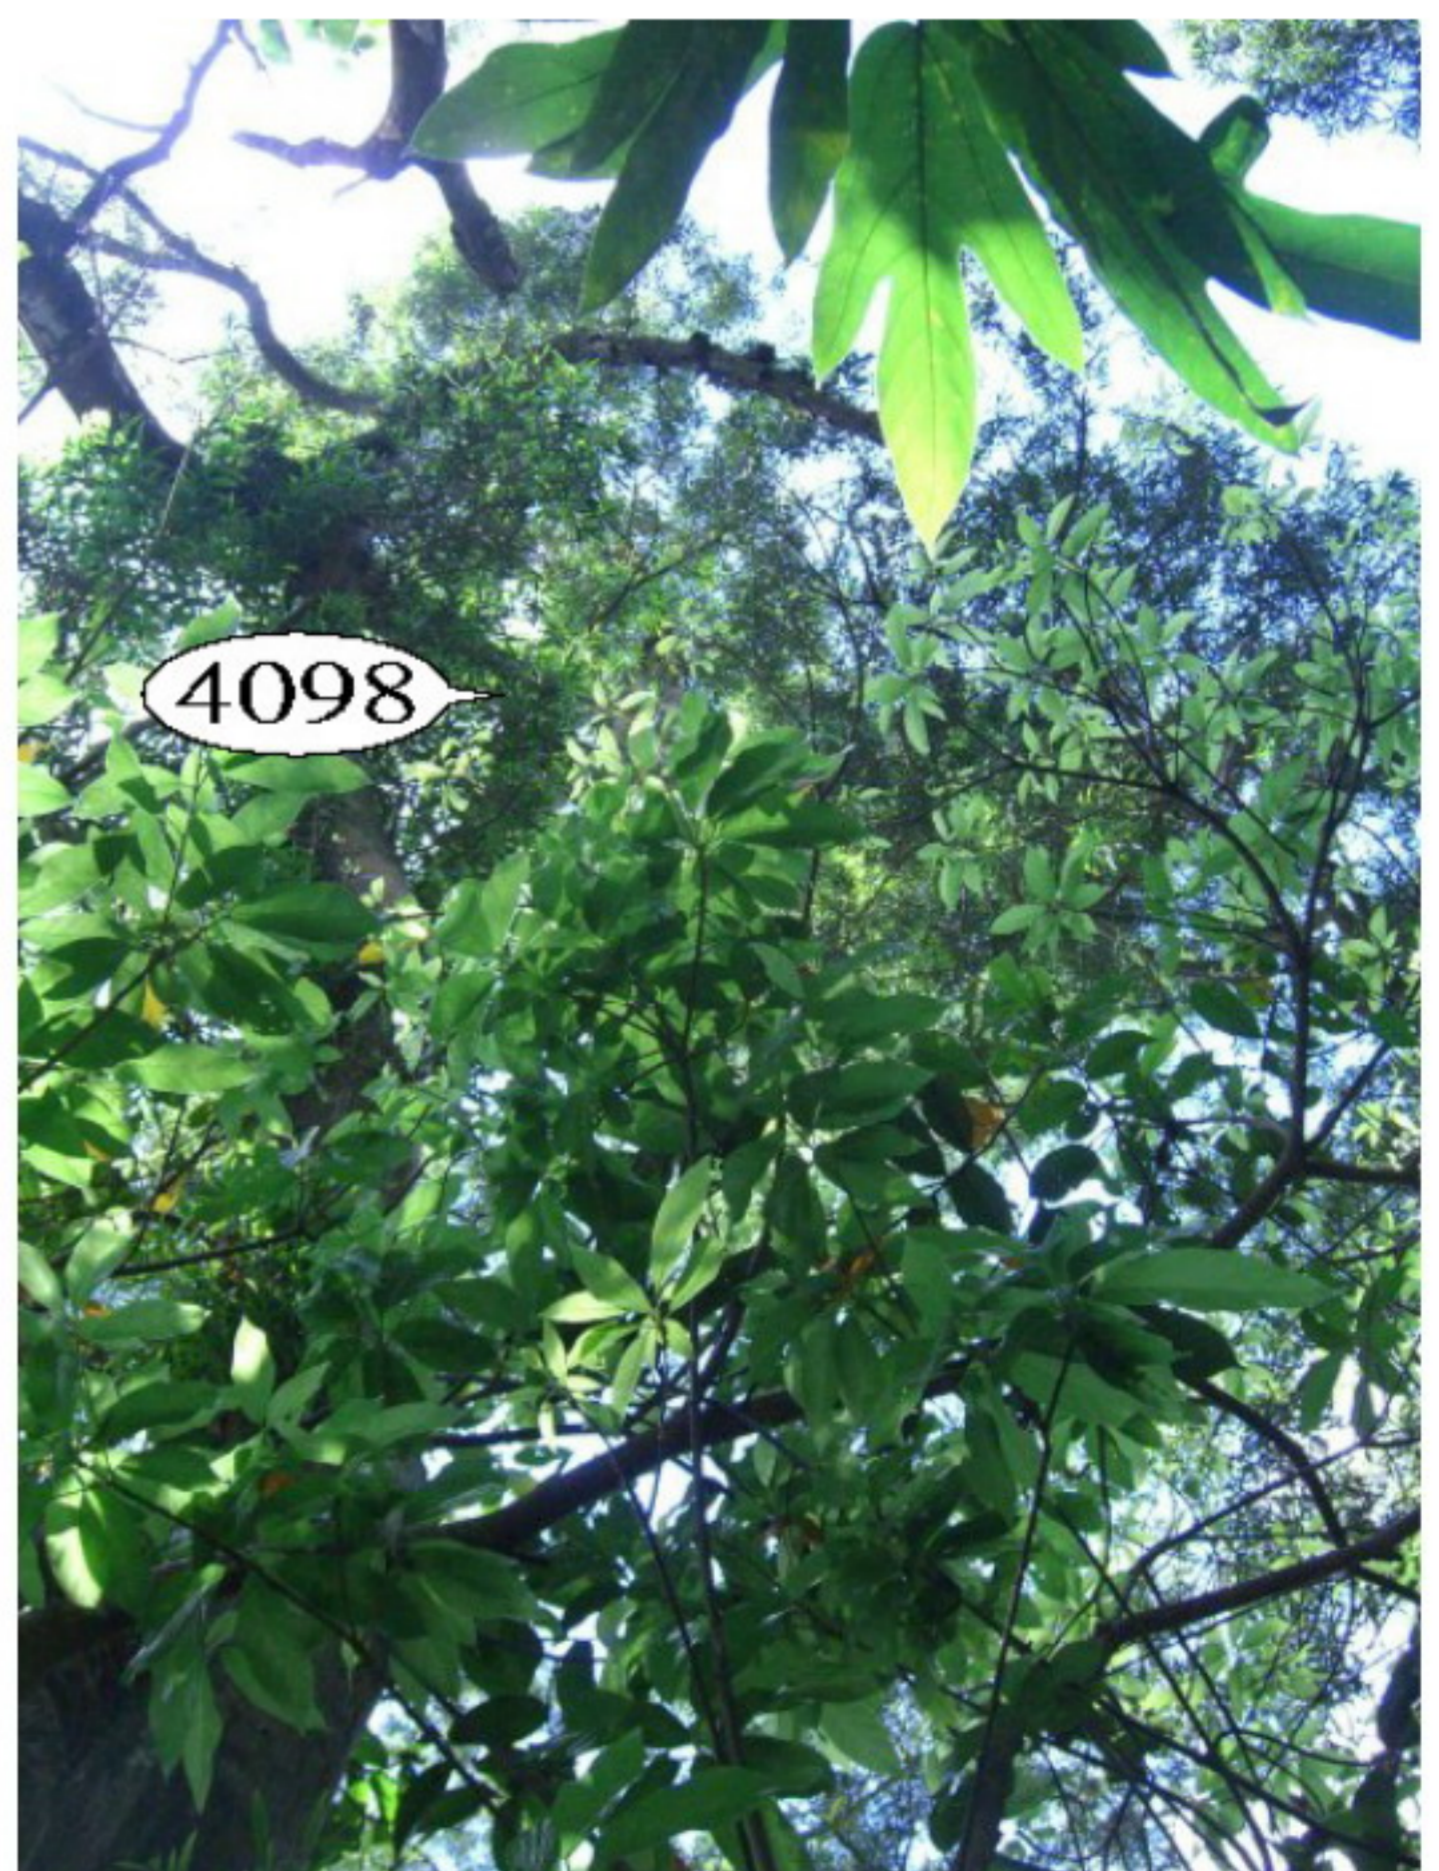
Tree 4097  
Poor health lead to low transplantation survival rate.

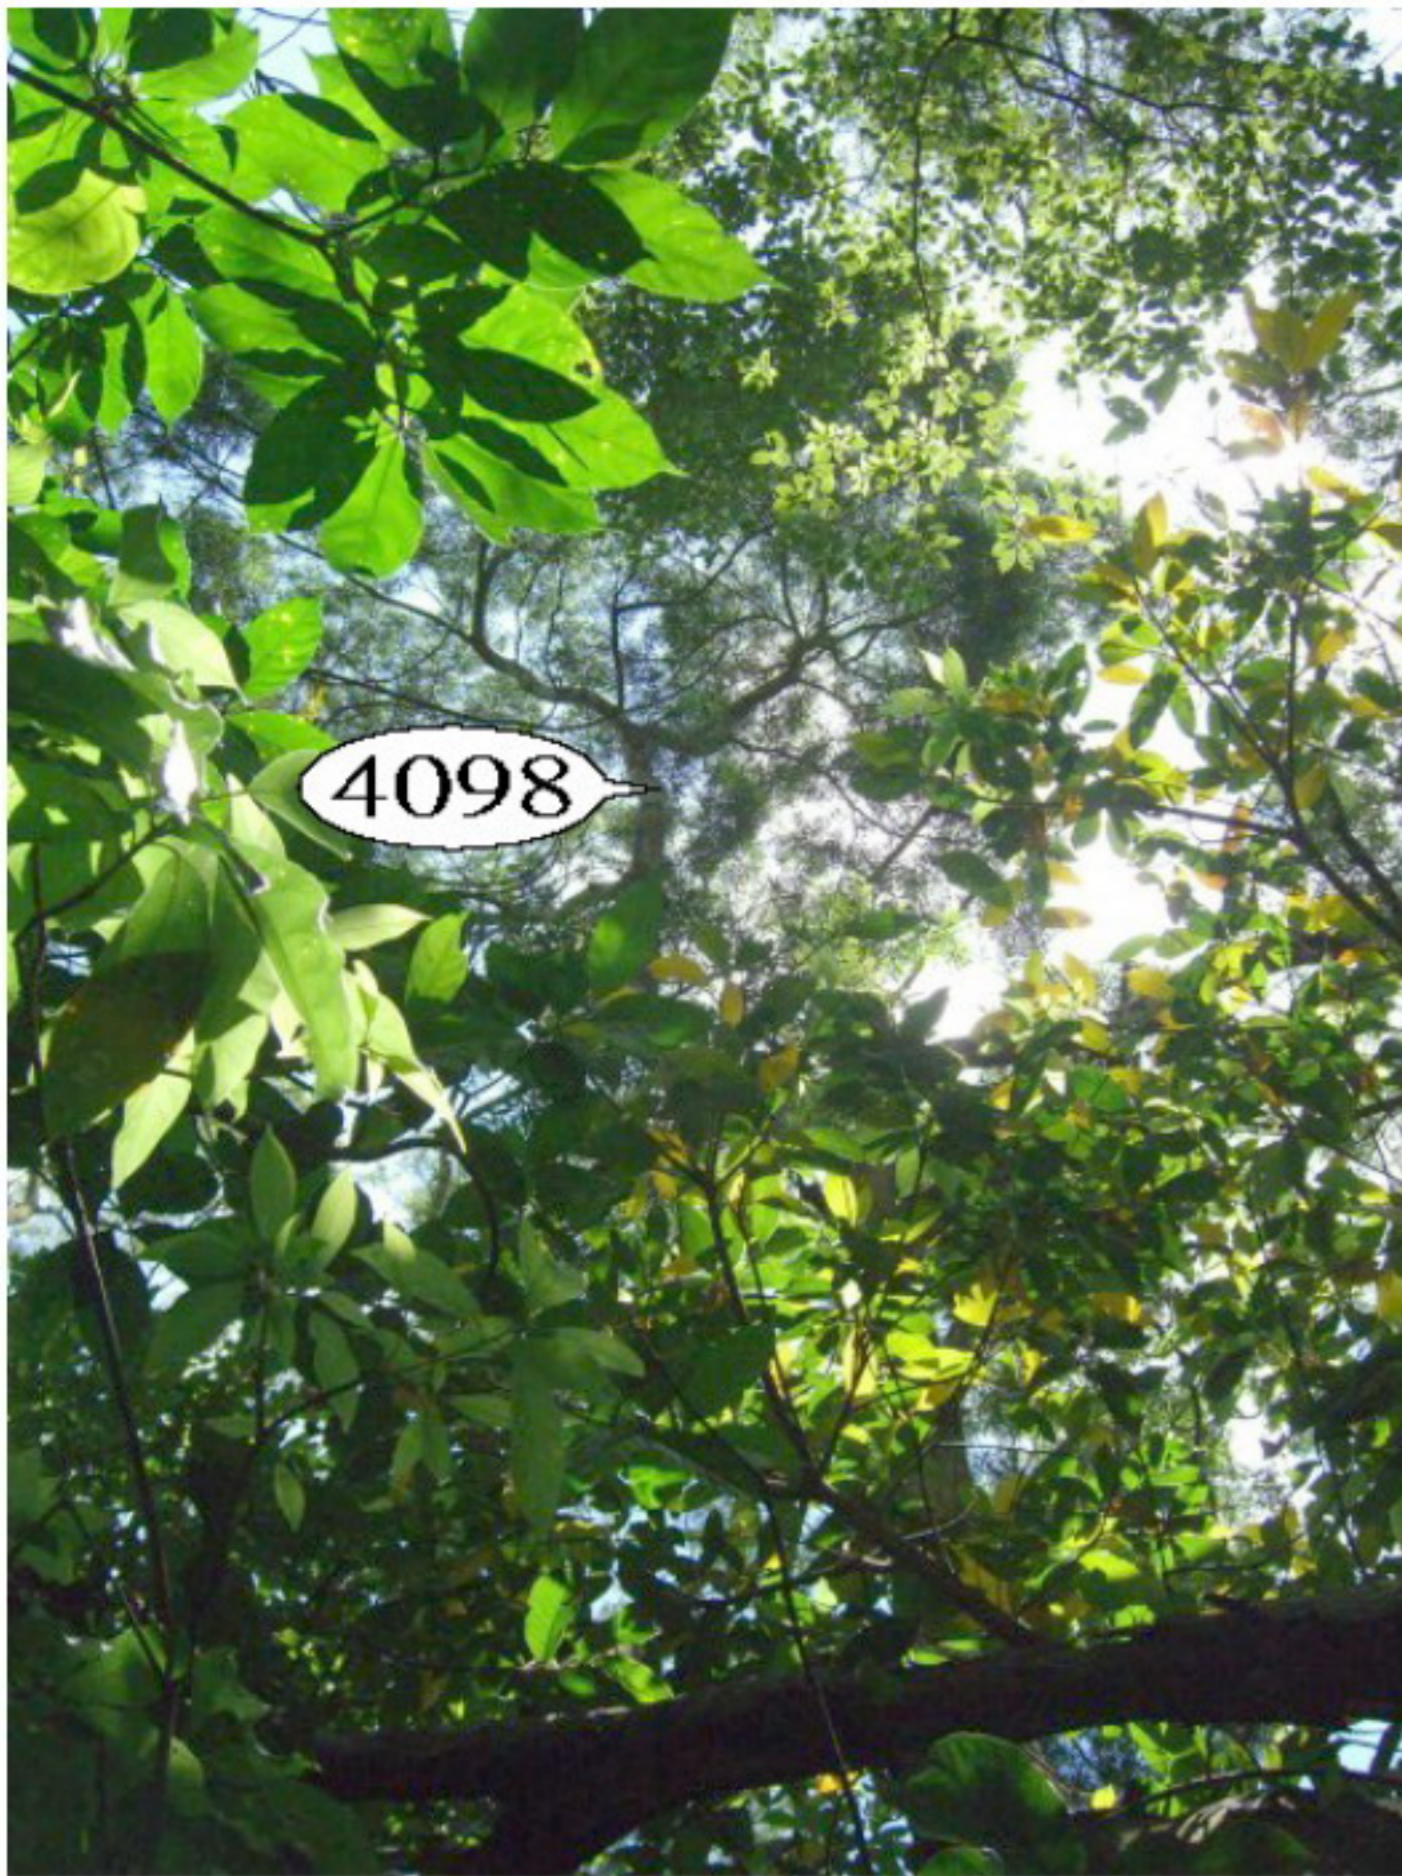
Tree 4098  
Poor health lead to low transplantation survival rate.
