# Provision of Cremators at Wo Hop Shek Crematorium

Tree Survey Report

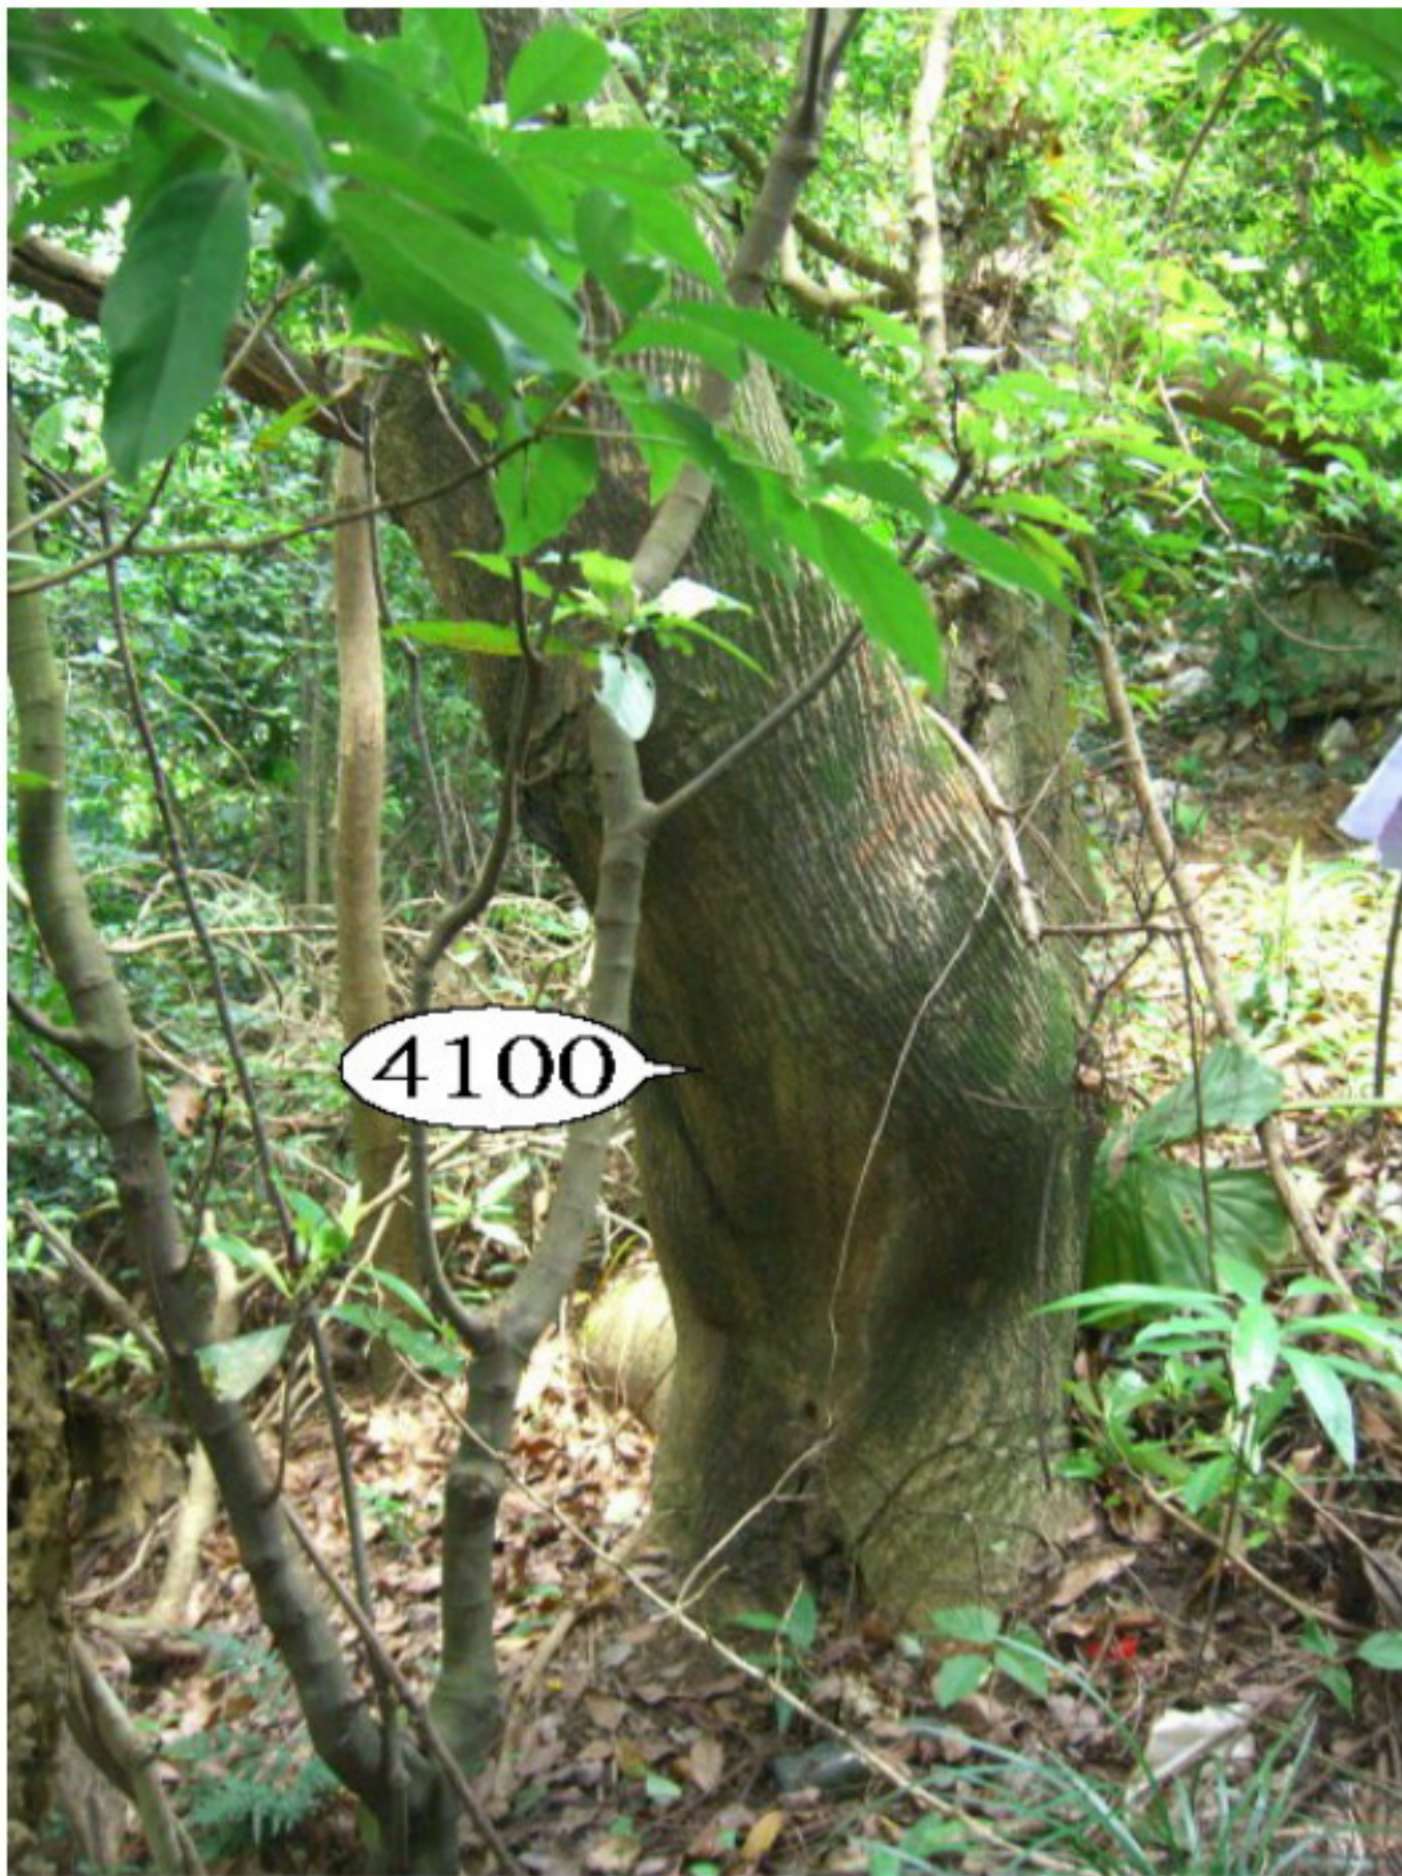
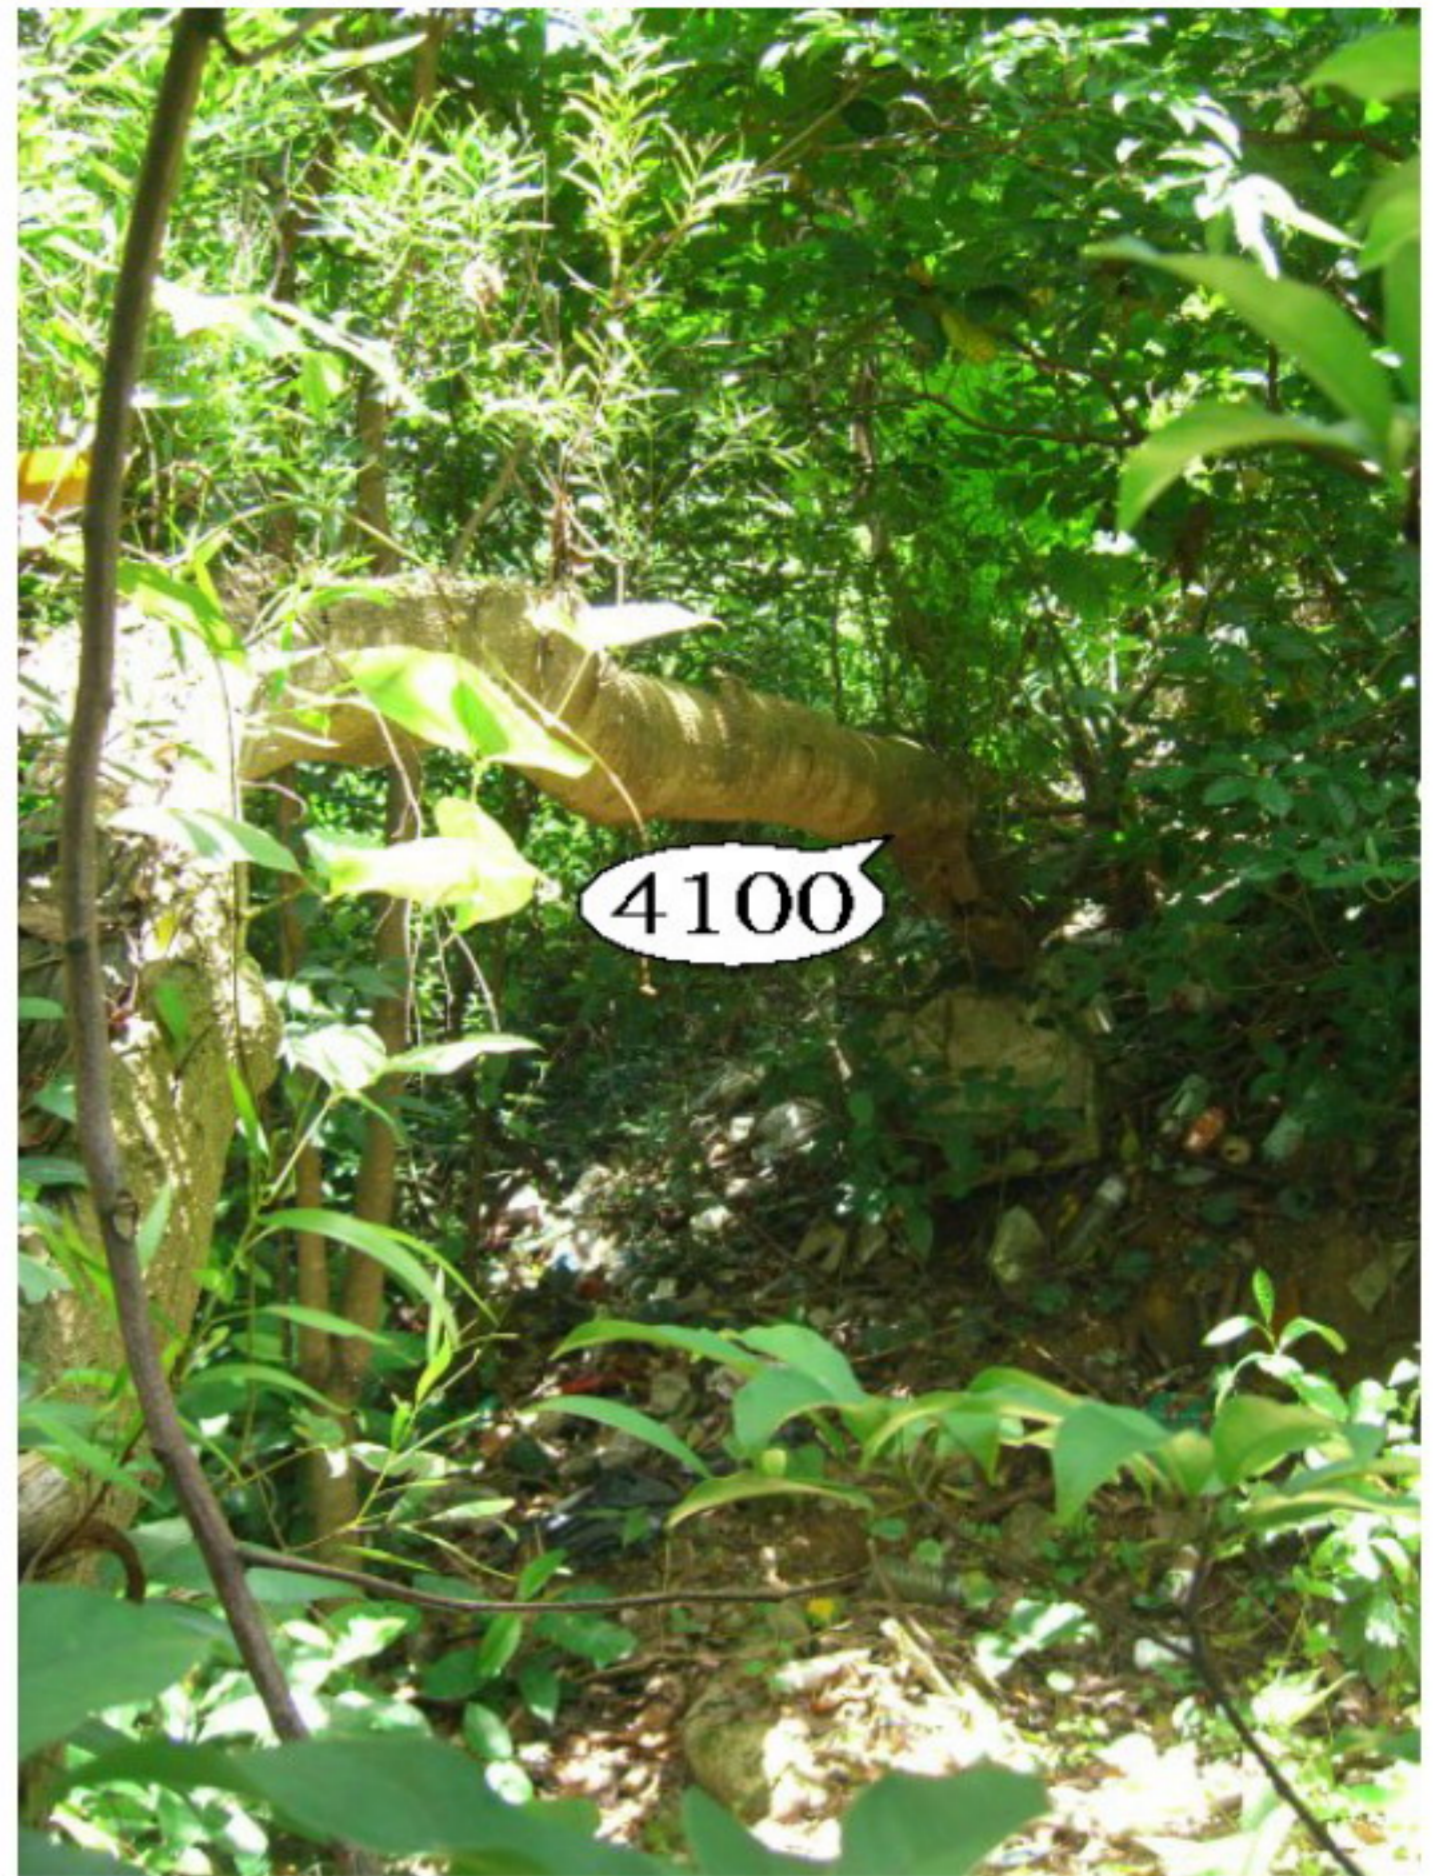
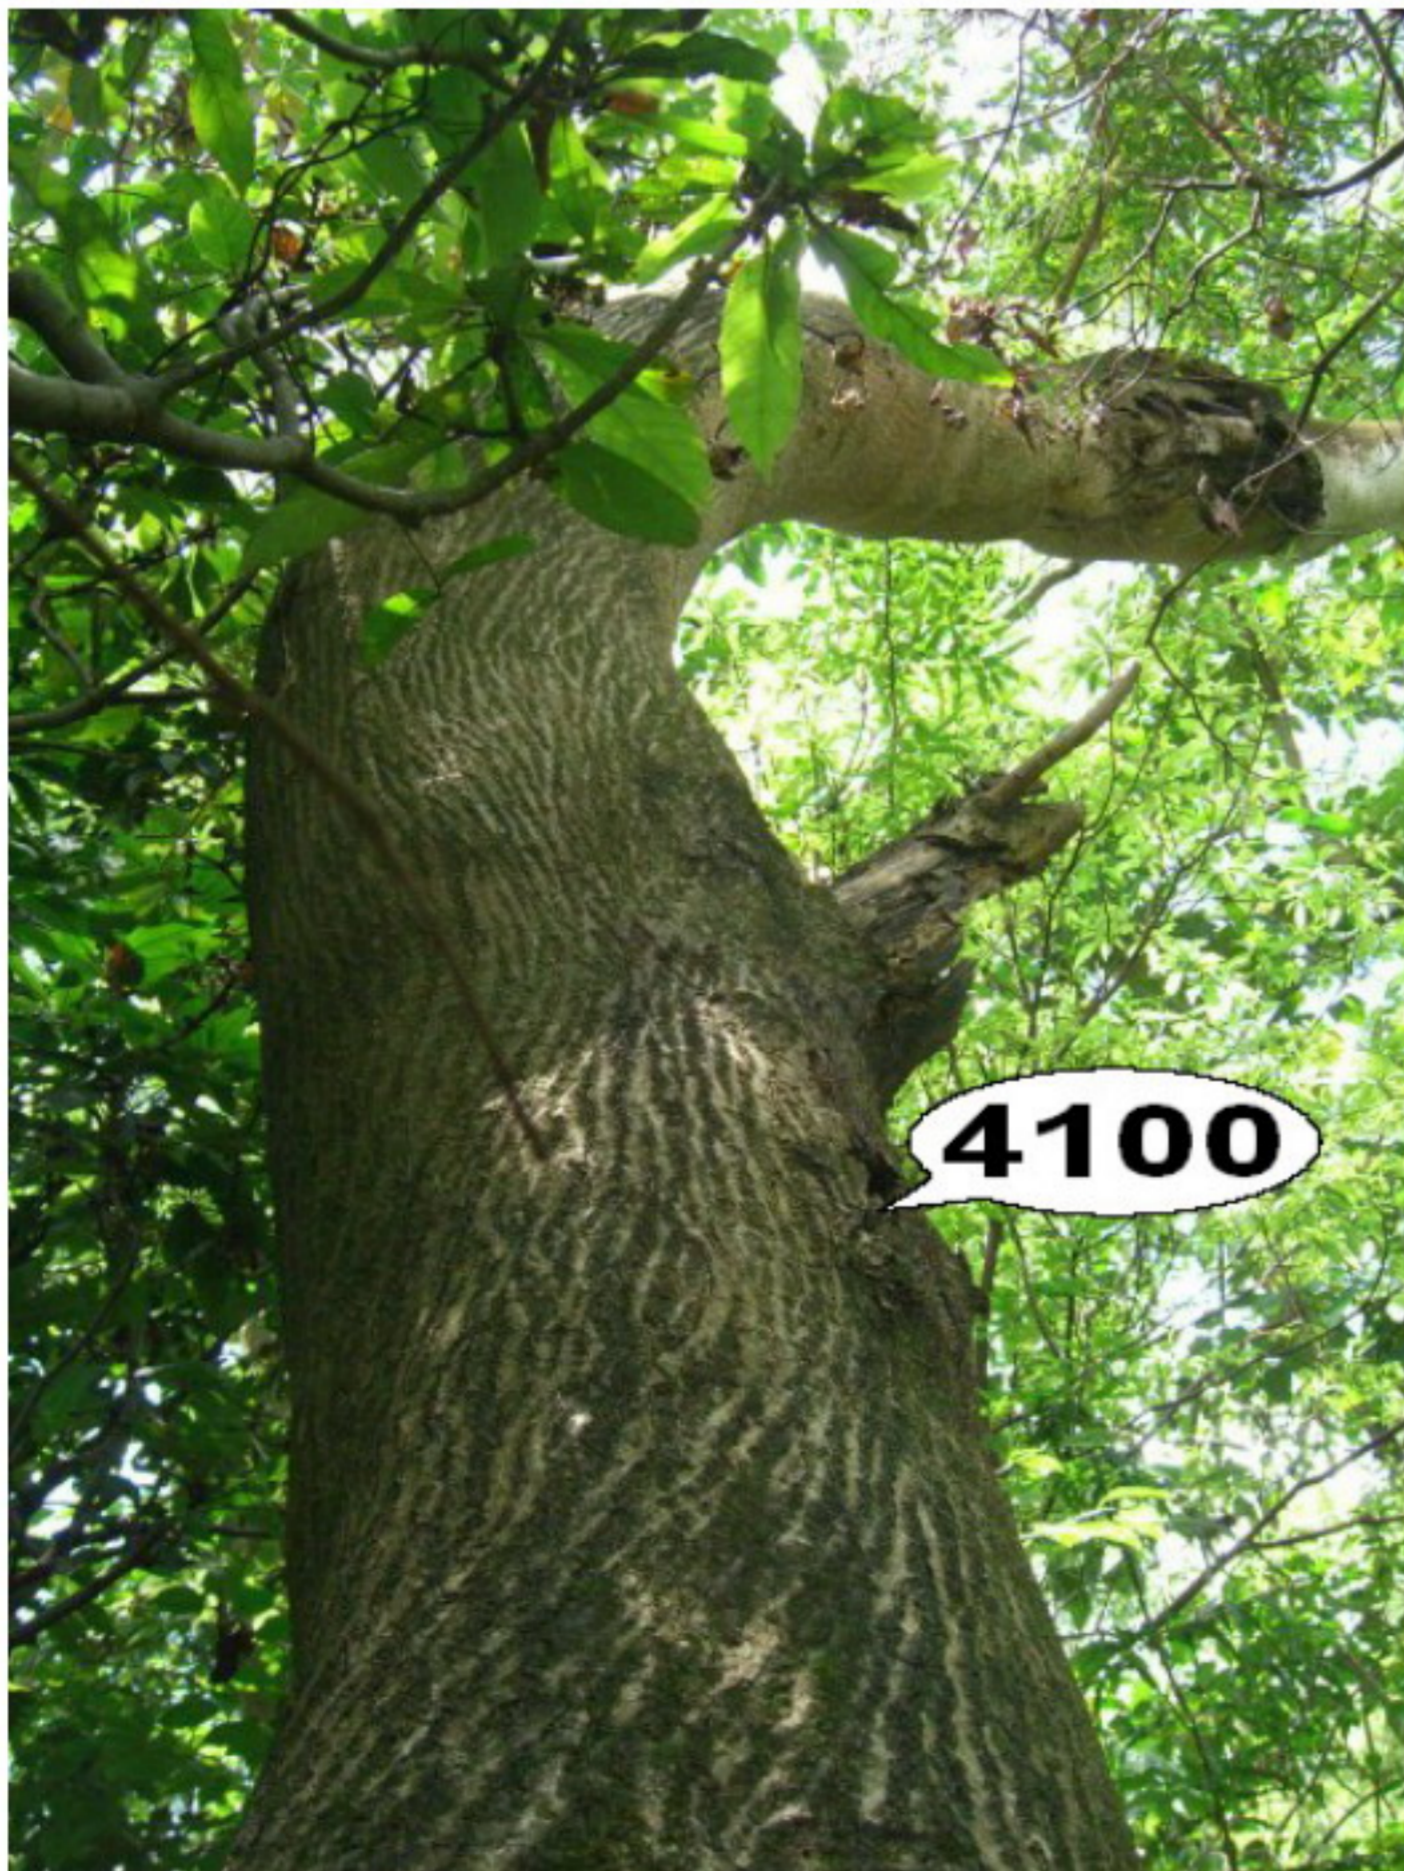
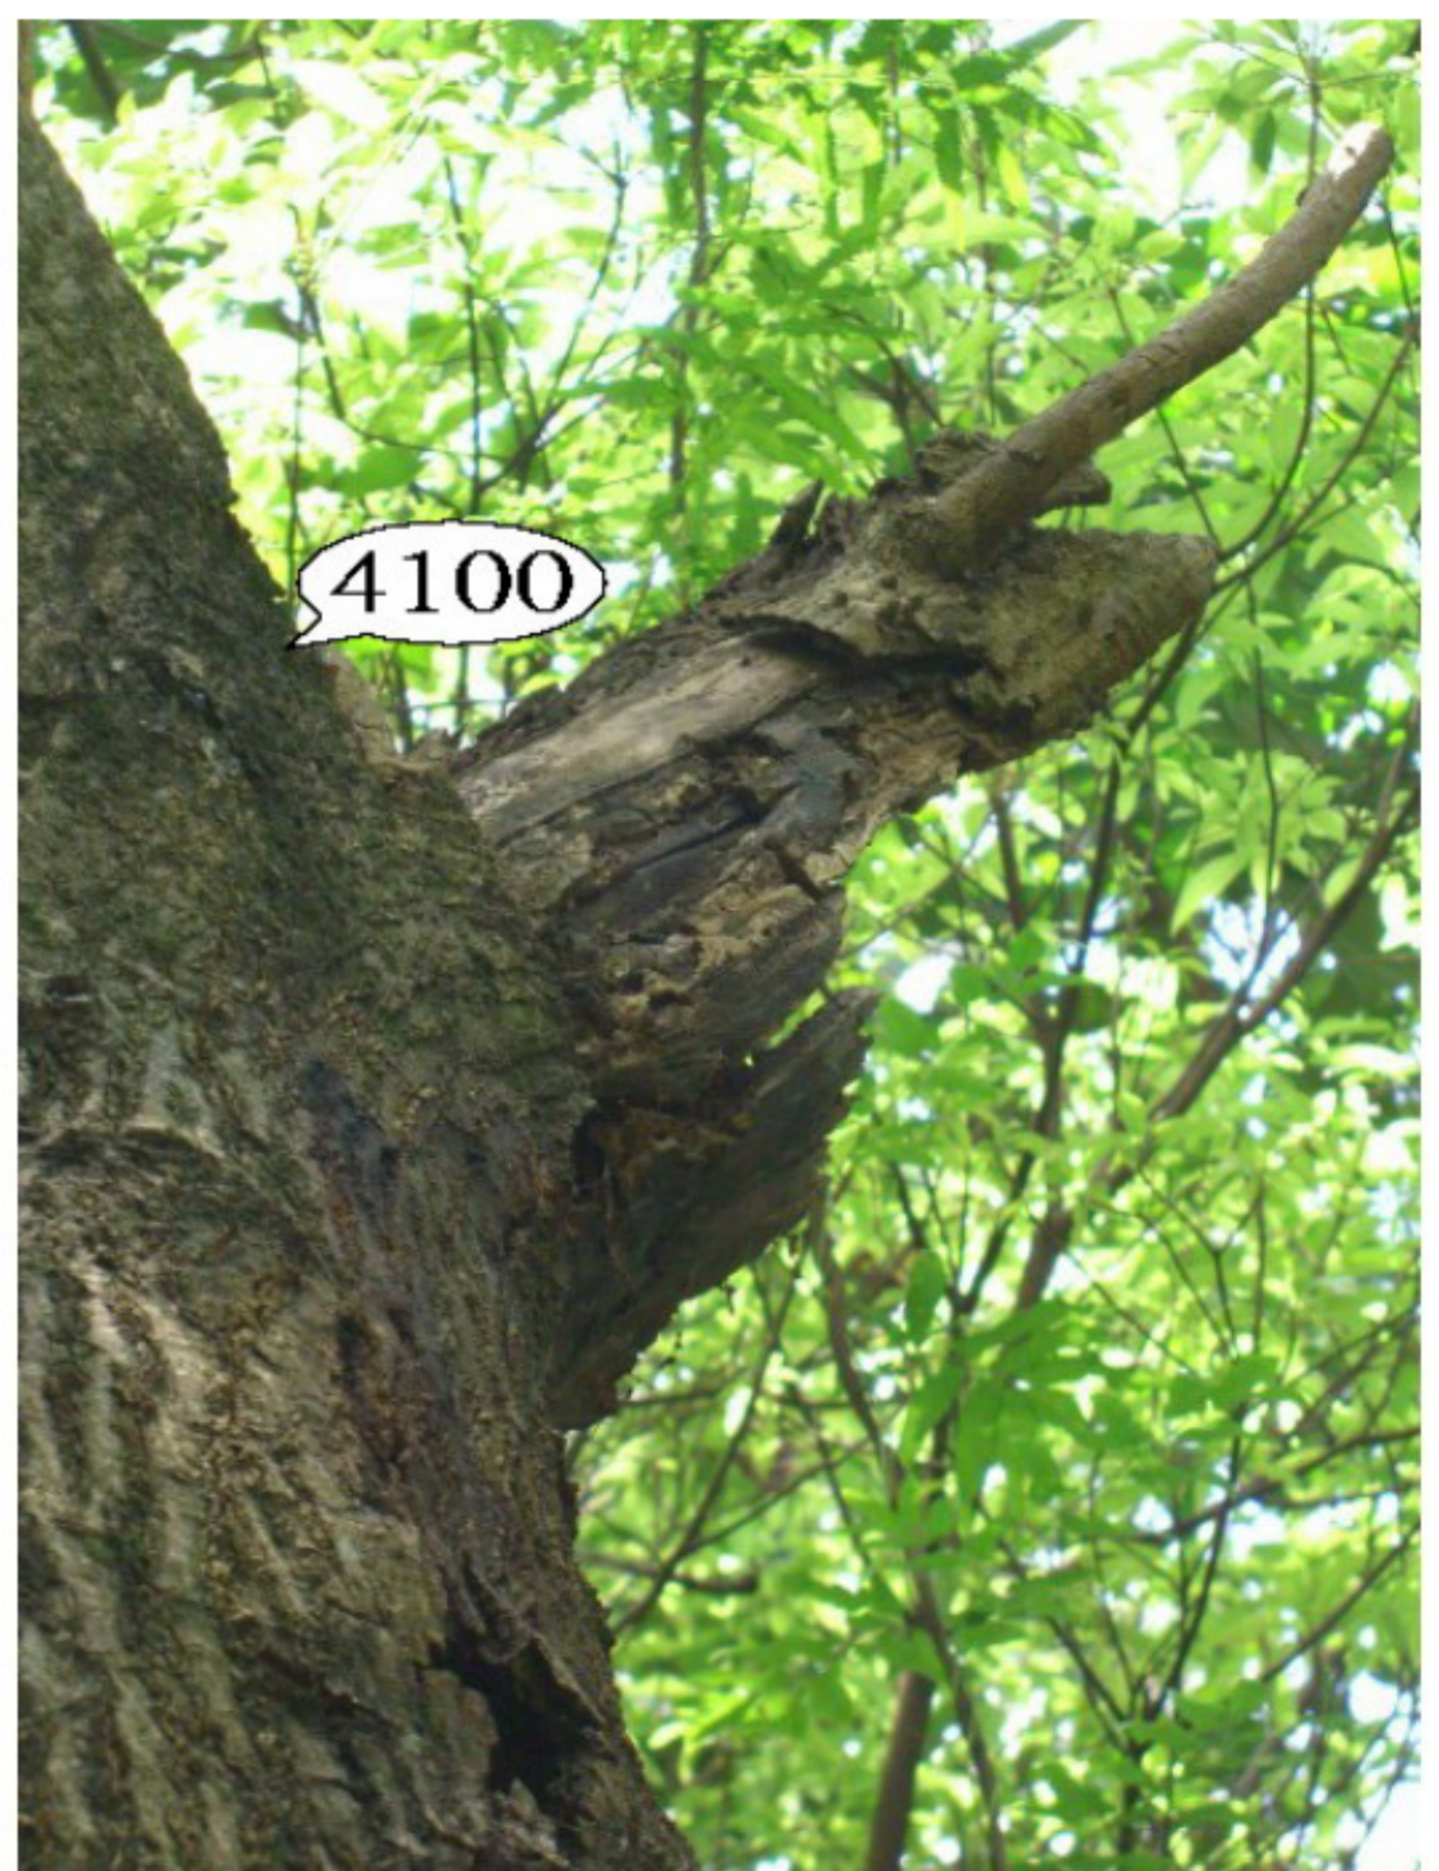
Tree 4099  
Poor health lead to low transplantation survival rate.

4098	台灣相思	1.2	0.38	9	5	P	P	L	L	N	Partial Branch Decay, Bending truck	F	Poor health lead to low transplantation survival rate.
4099	台灣相思	1.26	0.40	8	6	P	P	L	L	N	Branch Decay, Truck bending	F	Poor health lead to low transplantation survival rate.
4100	台灣相思	1.58	0.50	7	5	P	P	L	L	N	Truck bending	F	Poor health lead to low transplantation survival rate.
4101	樟樹	0.72	0.23	8	6	M	P	L	L	N	Partial Branch Decay, Bending truck, Unbalance crown	F	Poor form which lead to low amenity value. Besides, the tree is unbalanced. It may need heavy pruning during transplantation that will affect its transplantation survival rate. Moreover, the operation of the transplanion for poor form tree is difficult. The tree form of this tree is poor which leads to poor amenity value. It will reduce the overall amenity value of the receptor site should it be transplanted.
4102	台灣相思	1.54	0.49	8	6	P	P	L	L	N	Leaning, Truck damage, Partial Branch Decay	F	Poor health lead to low transplantation survival rate.

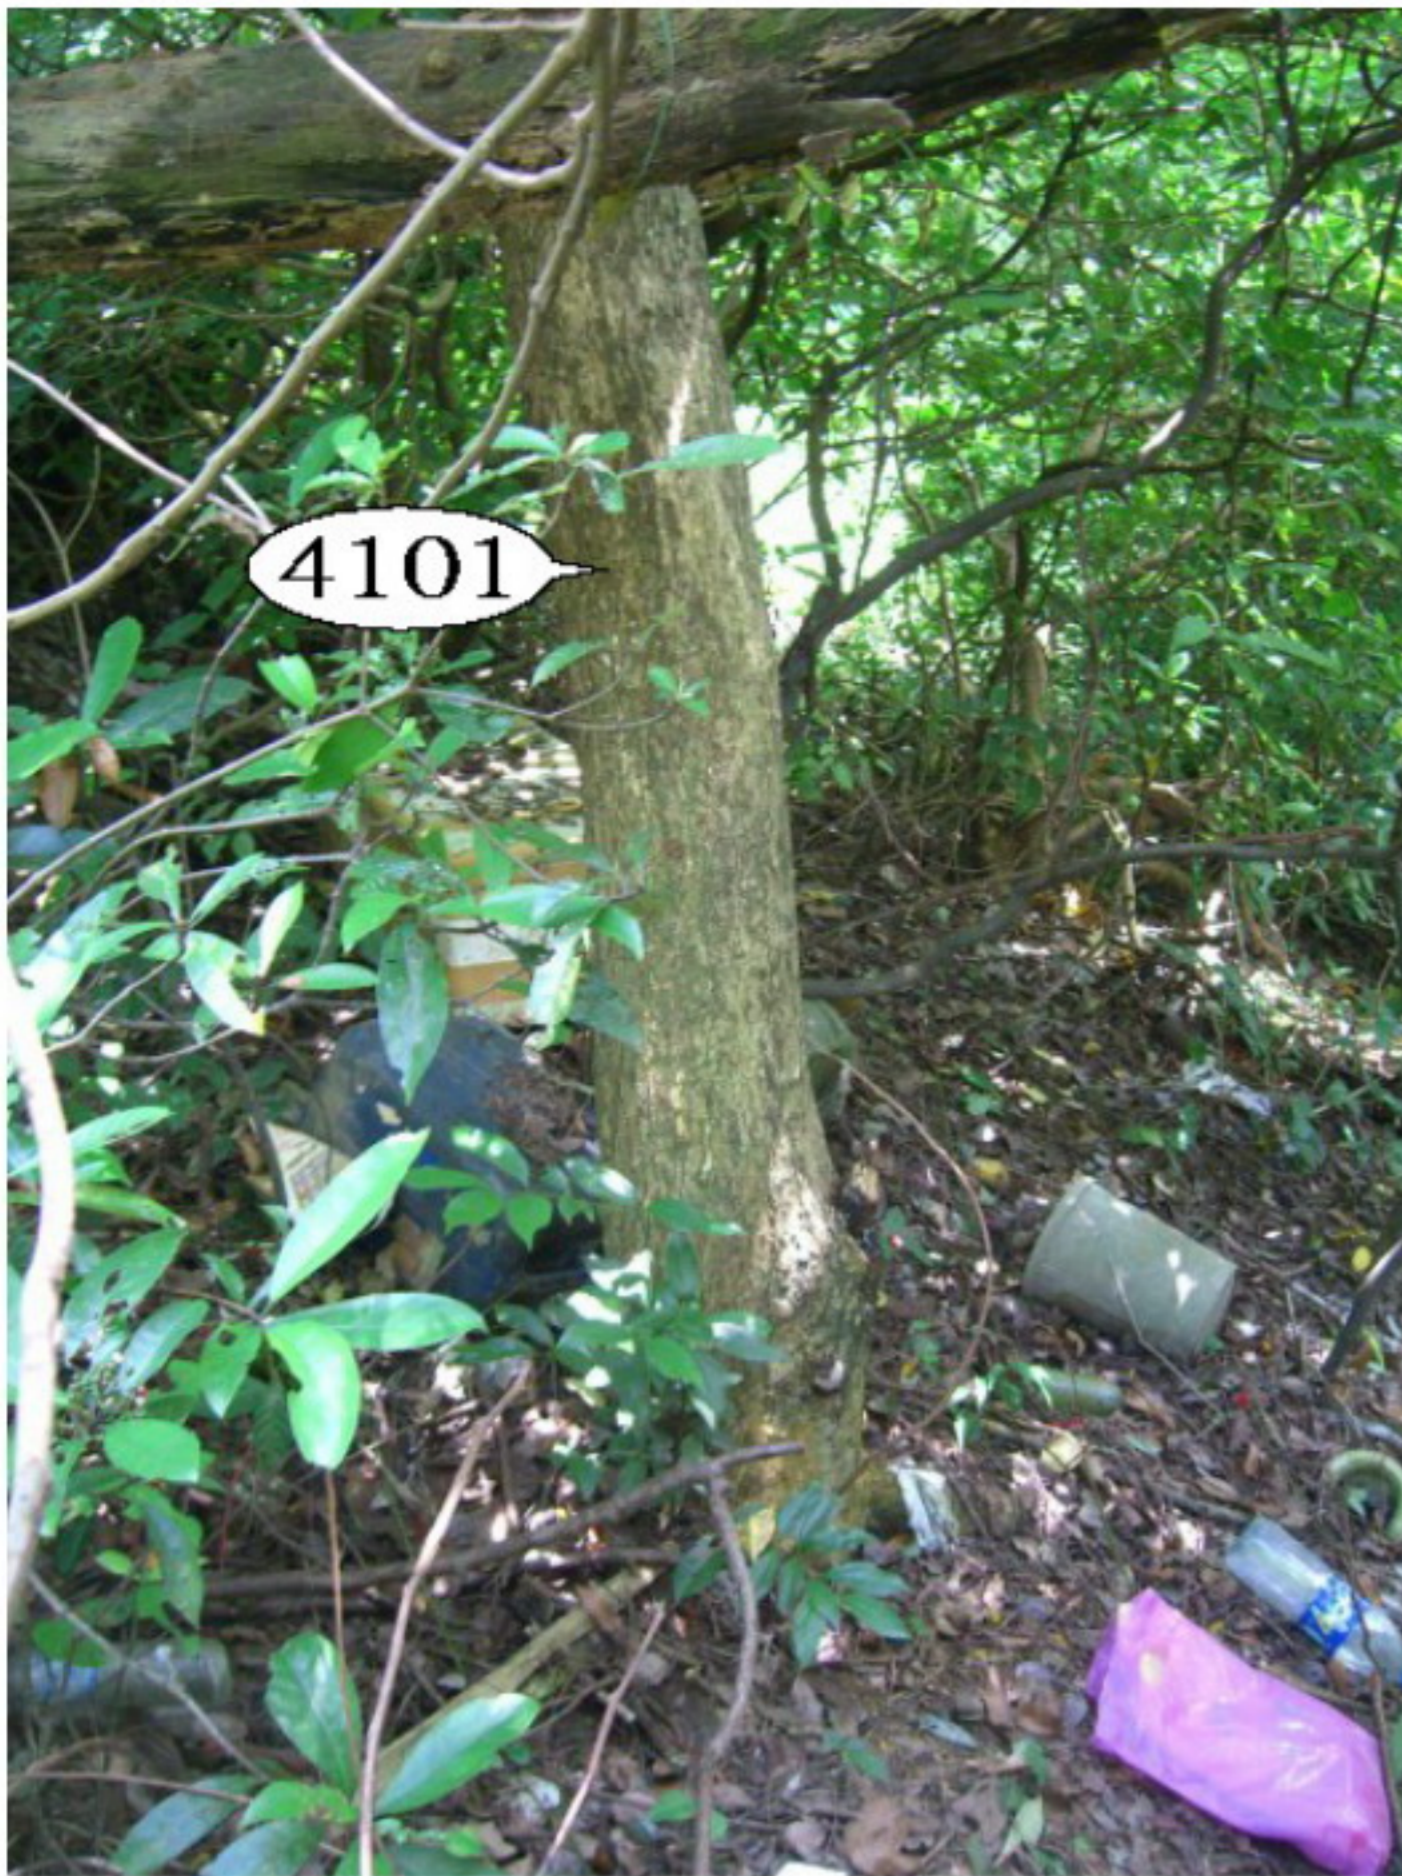
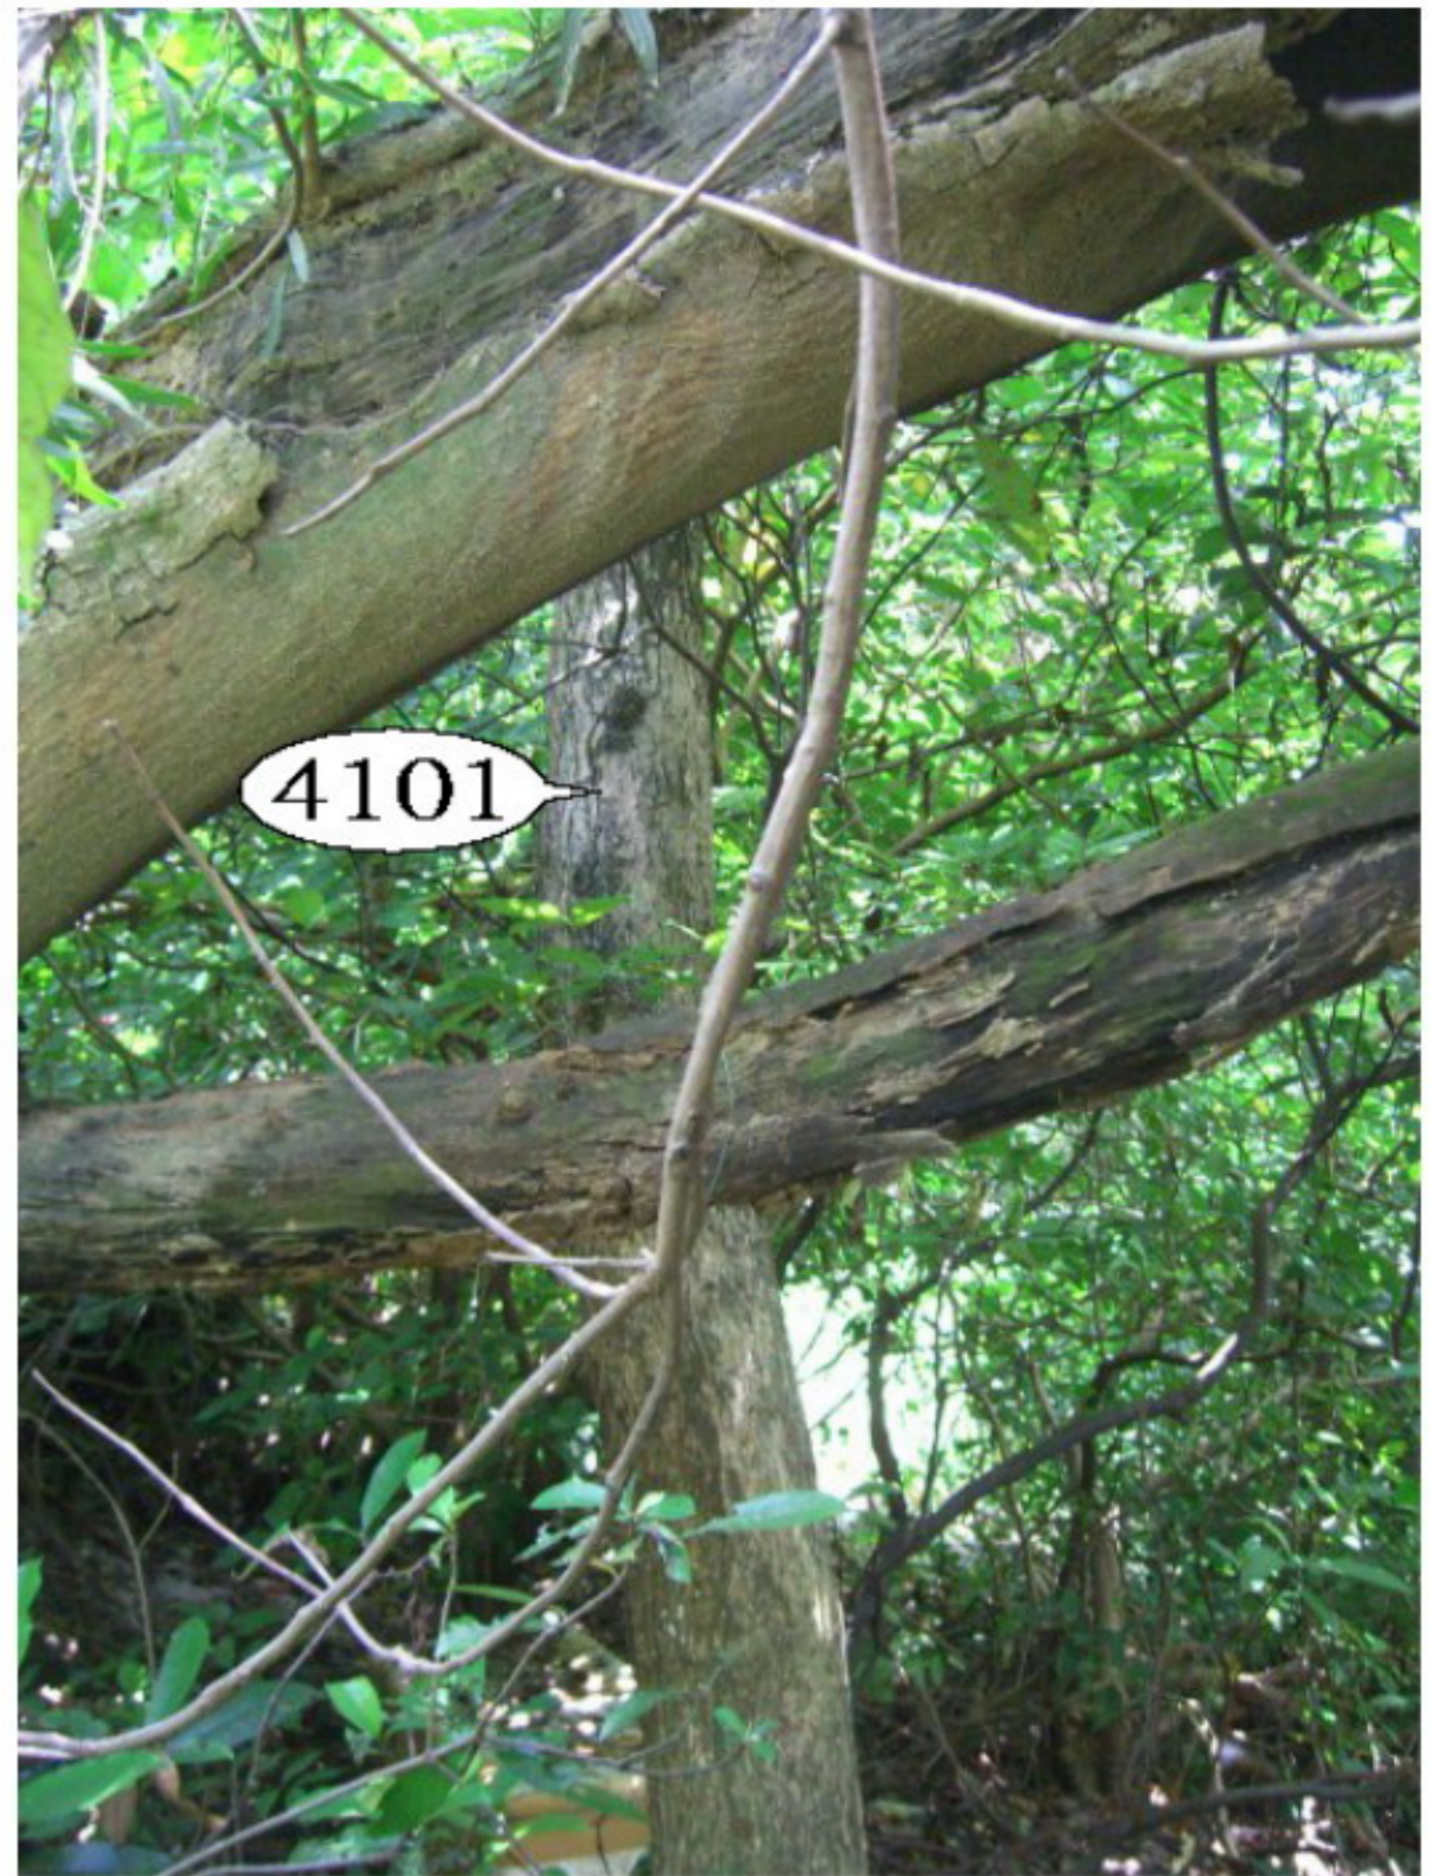
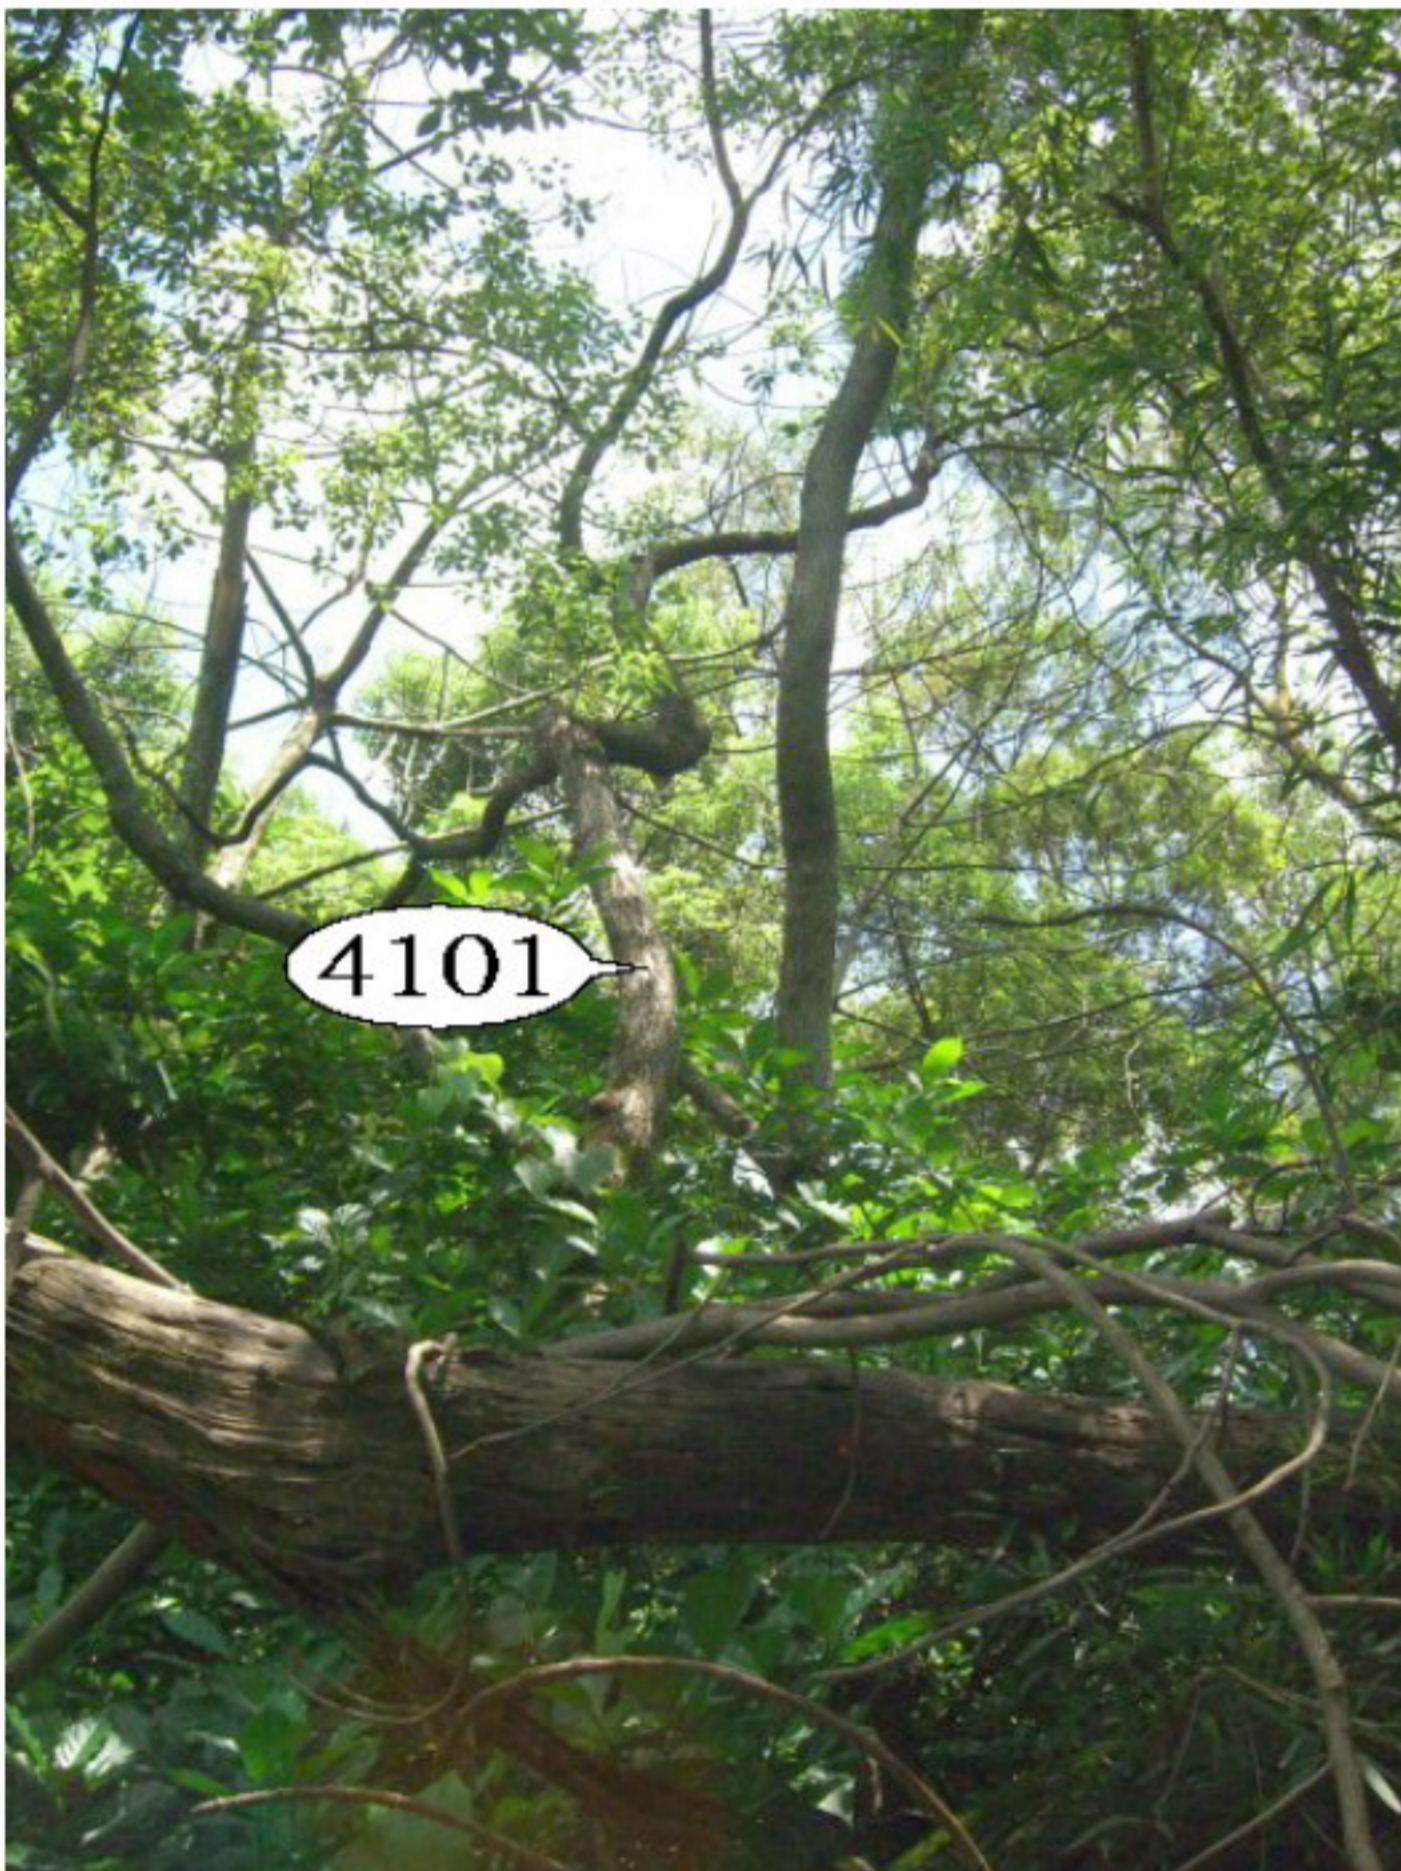
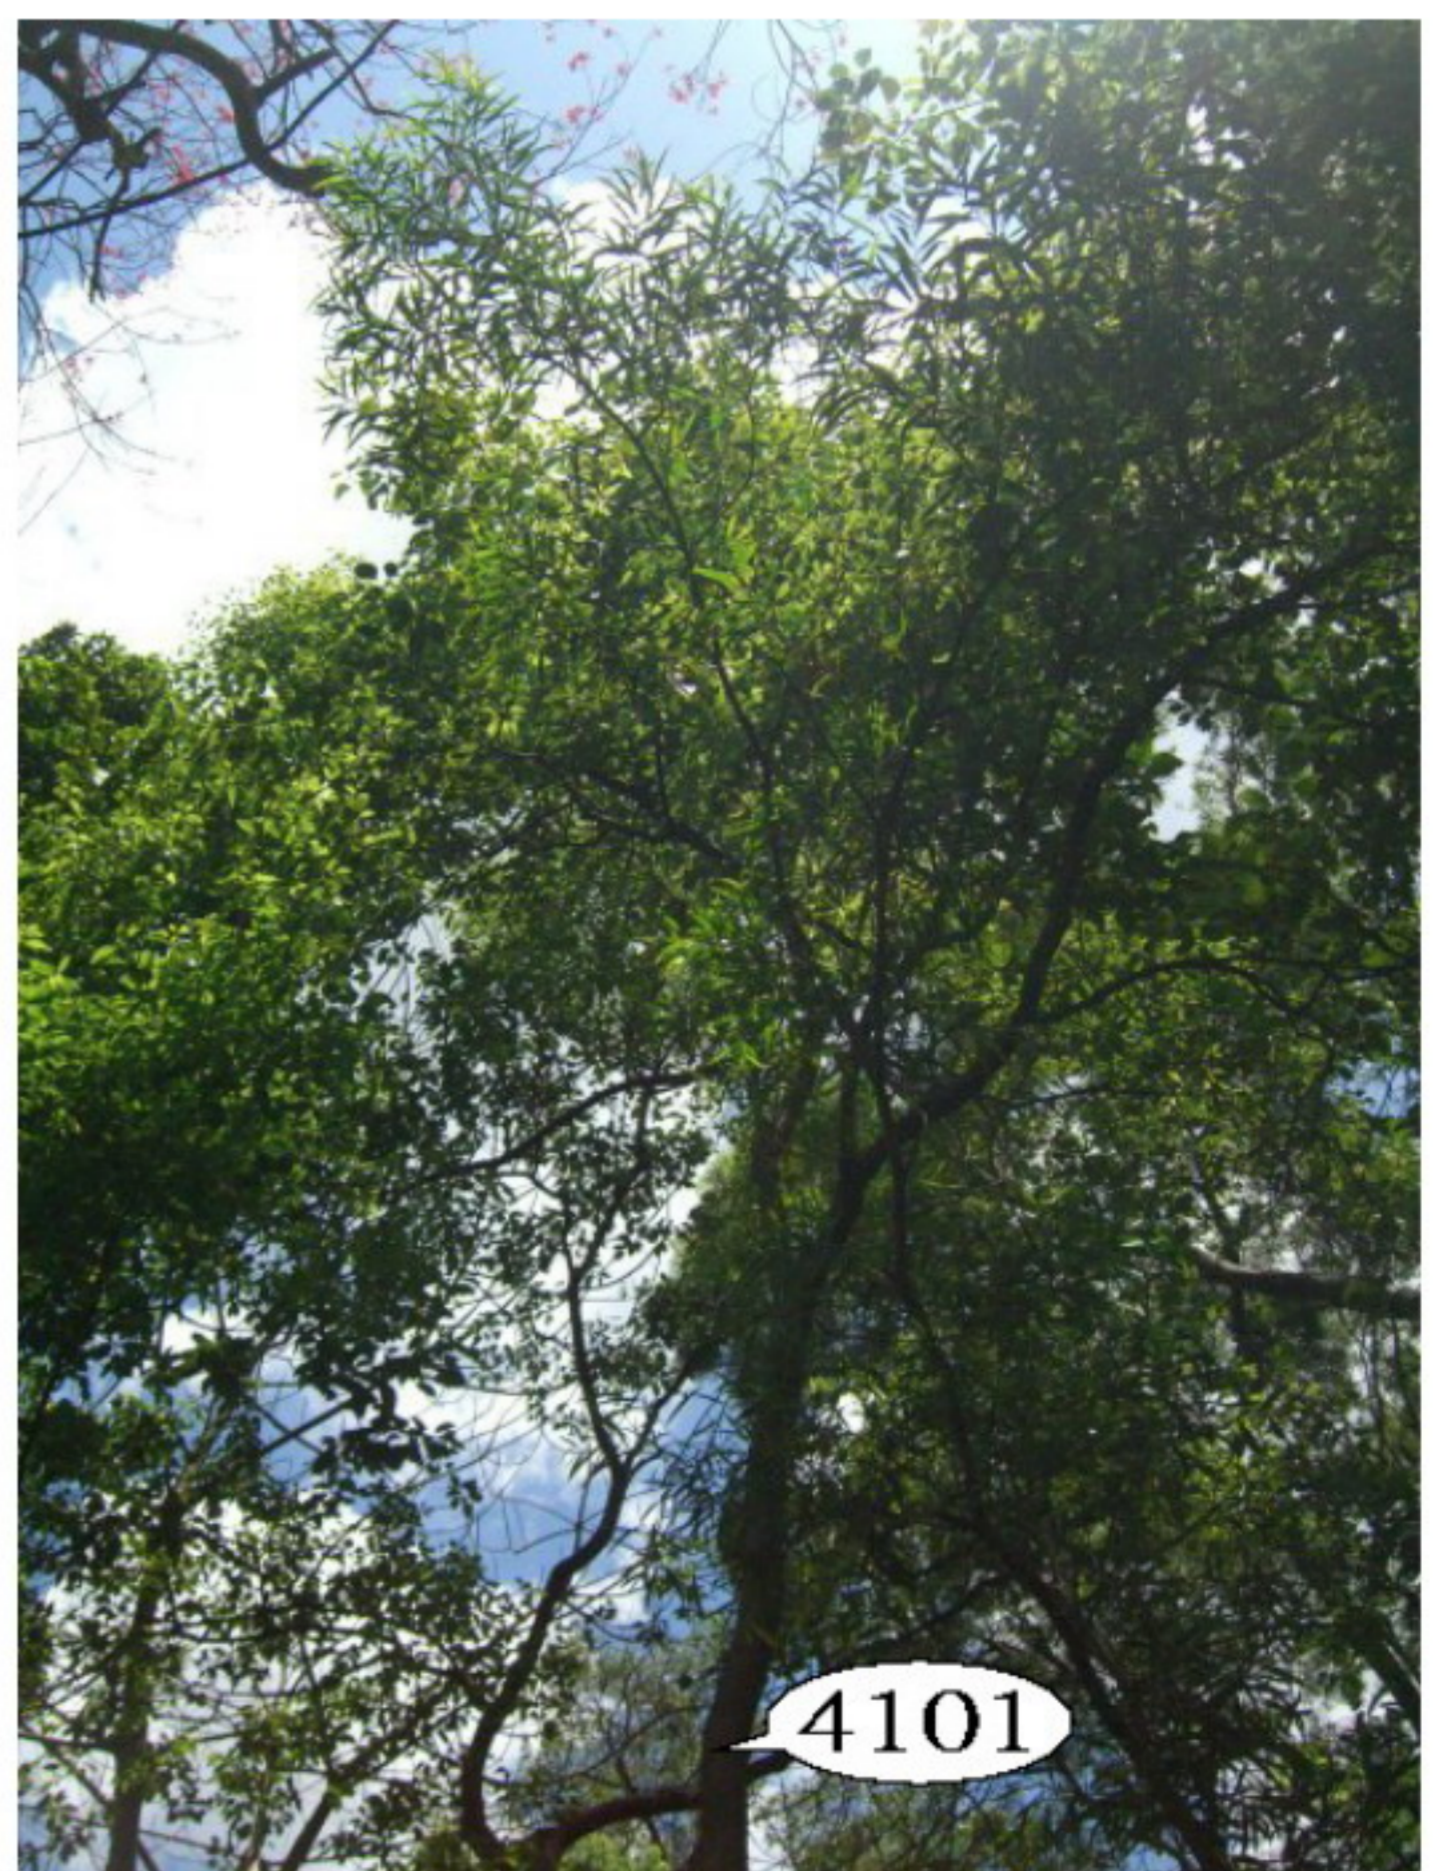
Tree 4100  
Poor health lead to low transplantation survival rate.
