# Provision of Cremators at Wo Hop Shek Crematorium

Tree Survey Report

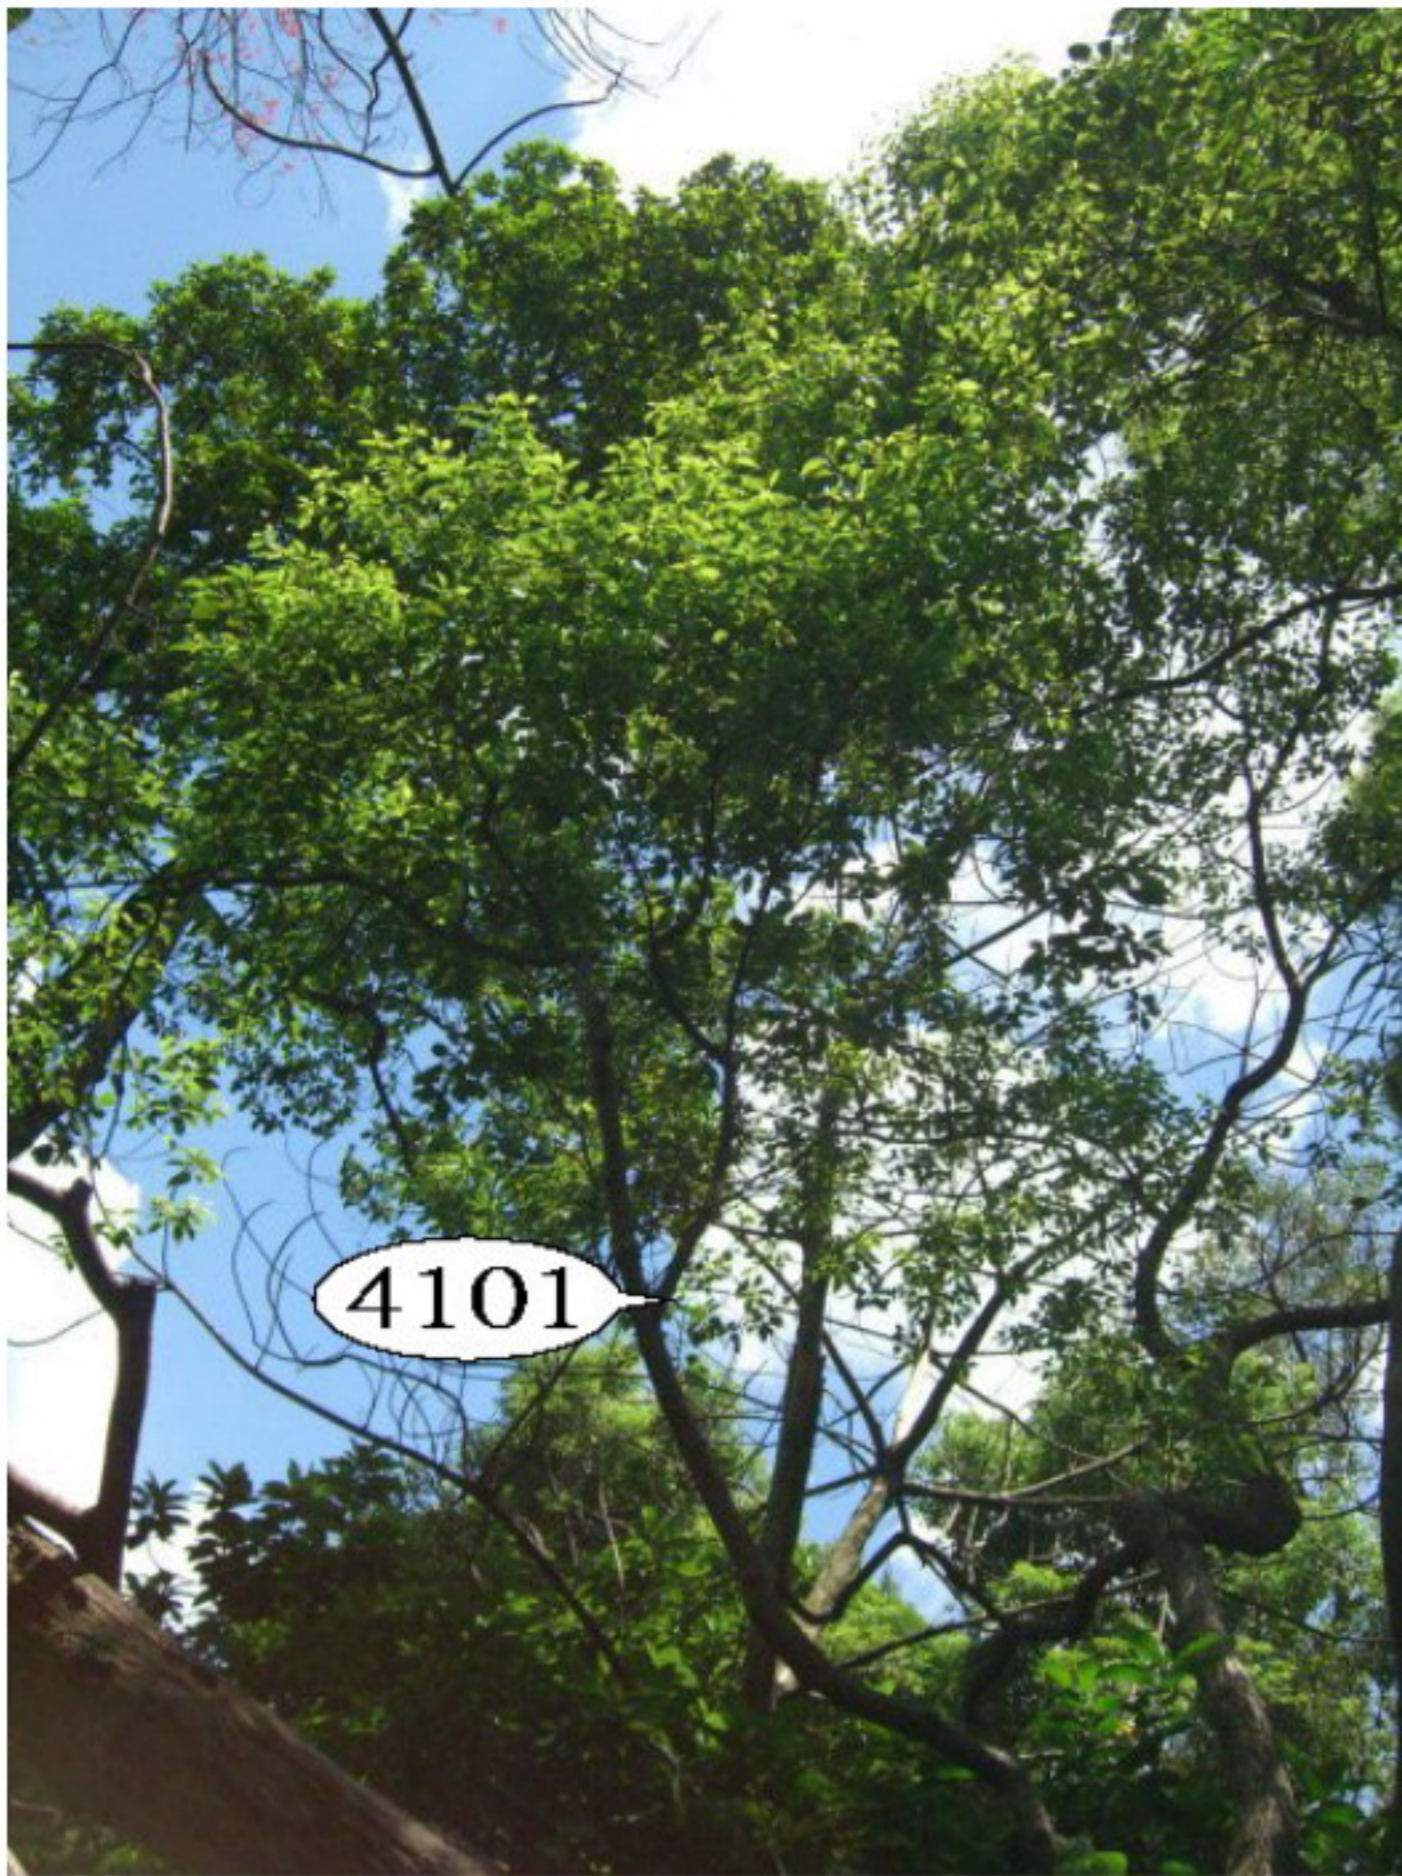
Tree 4101

Poor form which lead to low amenity value. Besides, the tree is unbalance. It may need heavy pruning after transplantation that will affect its transplantation survival rate. Moreover, the operation of the transplantation for poor form tree is also difficult.

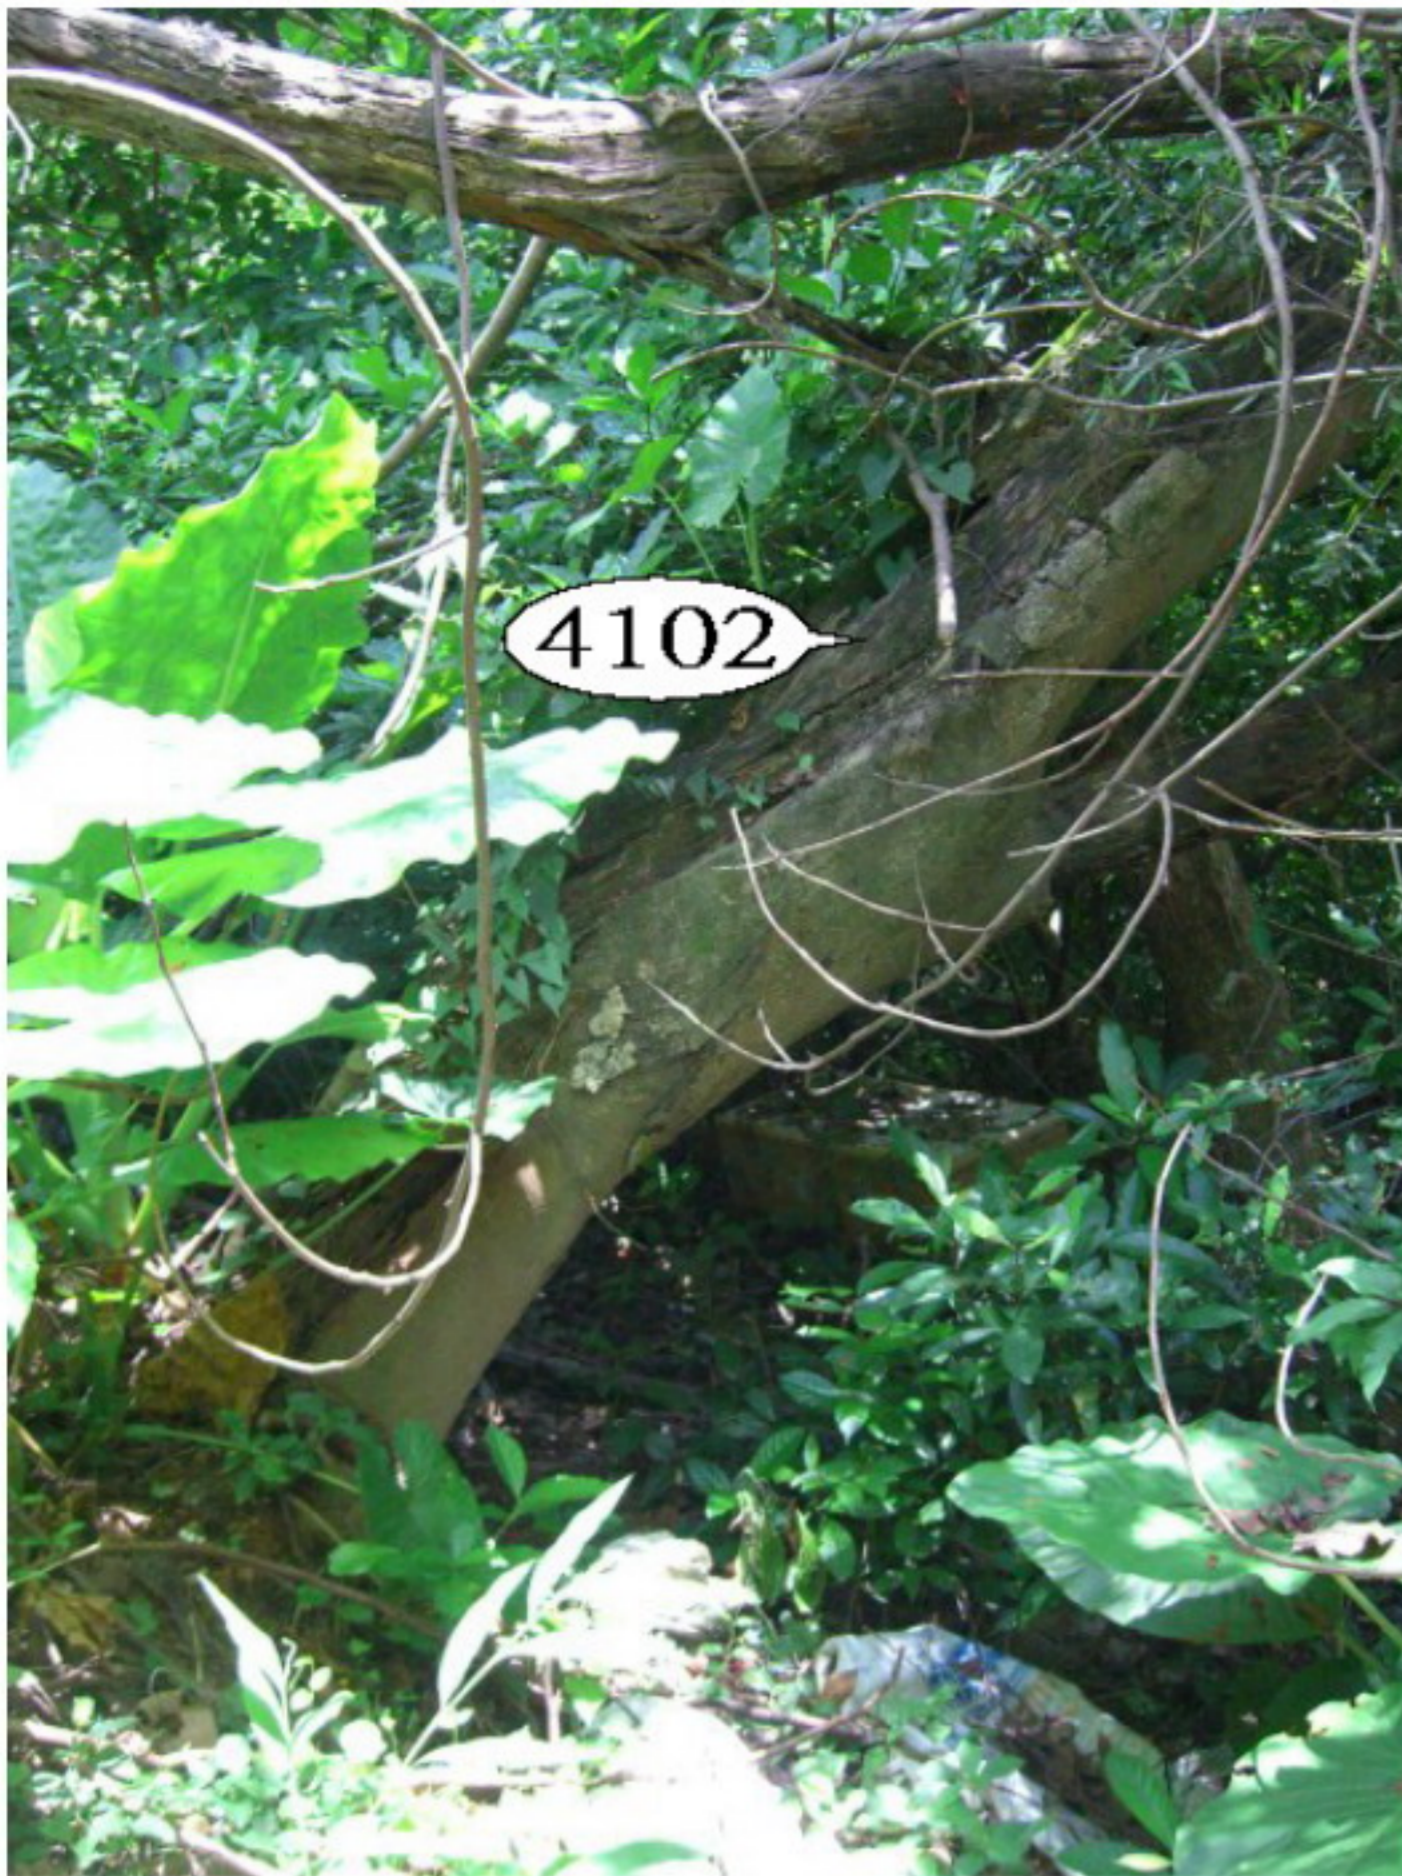
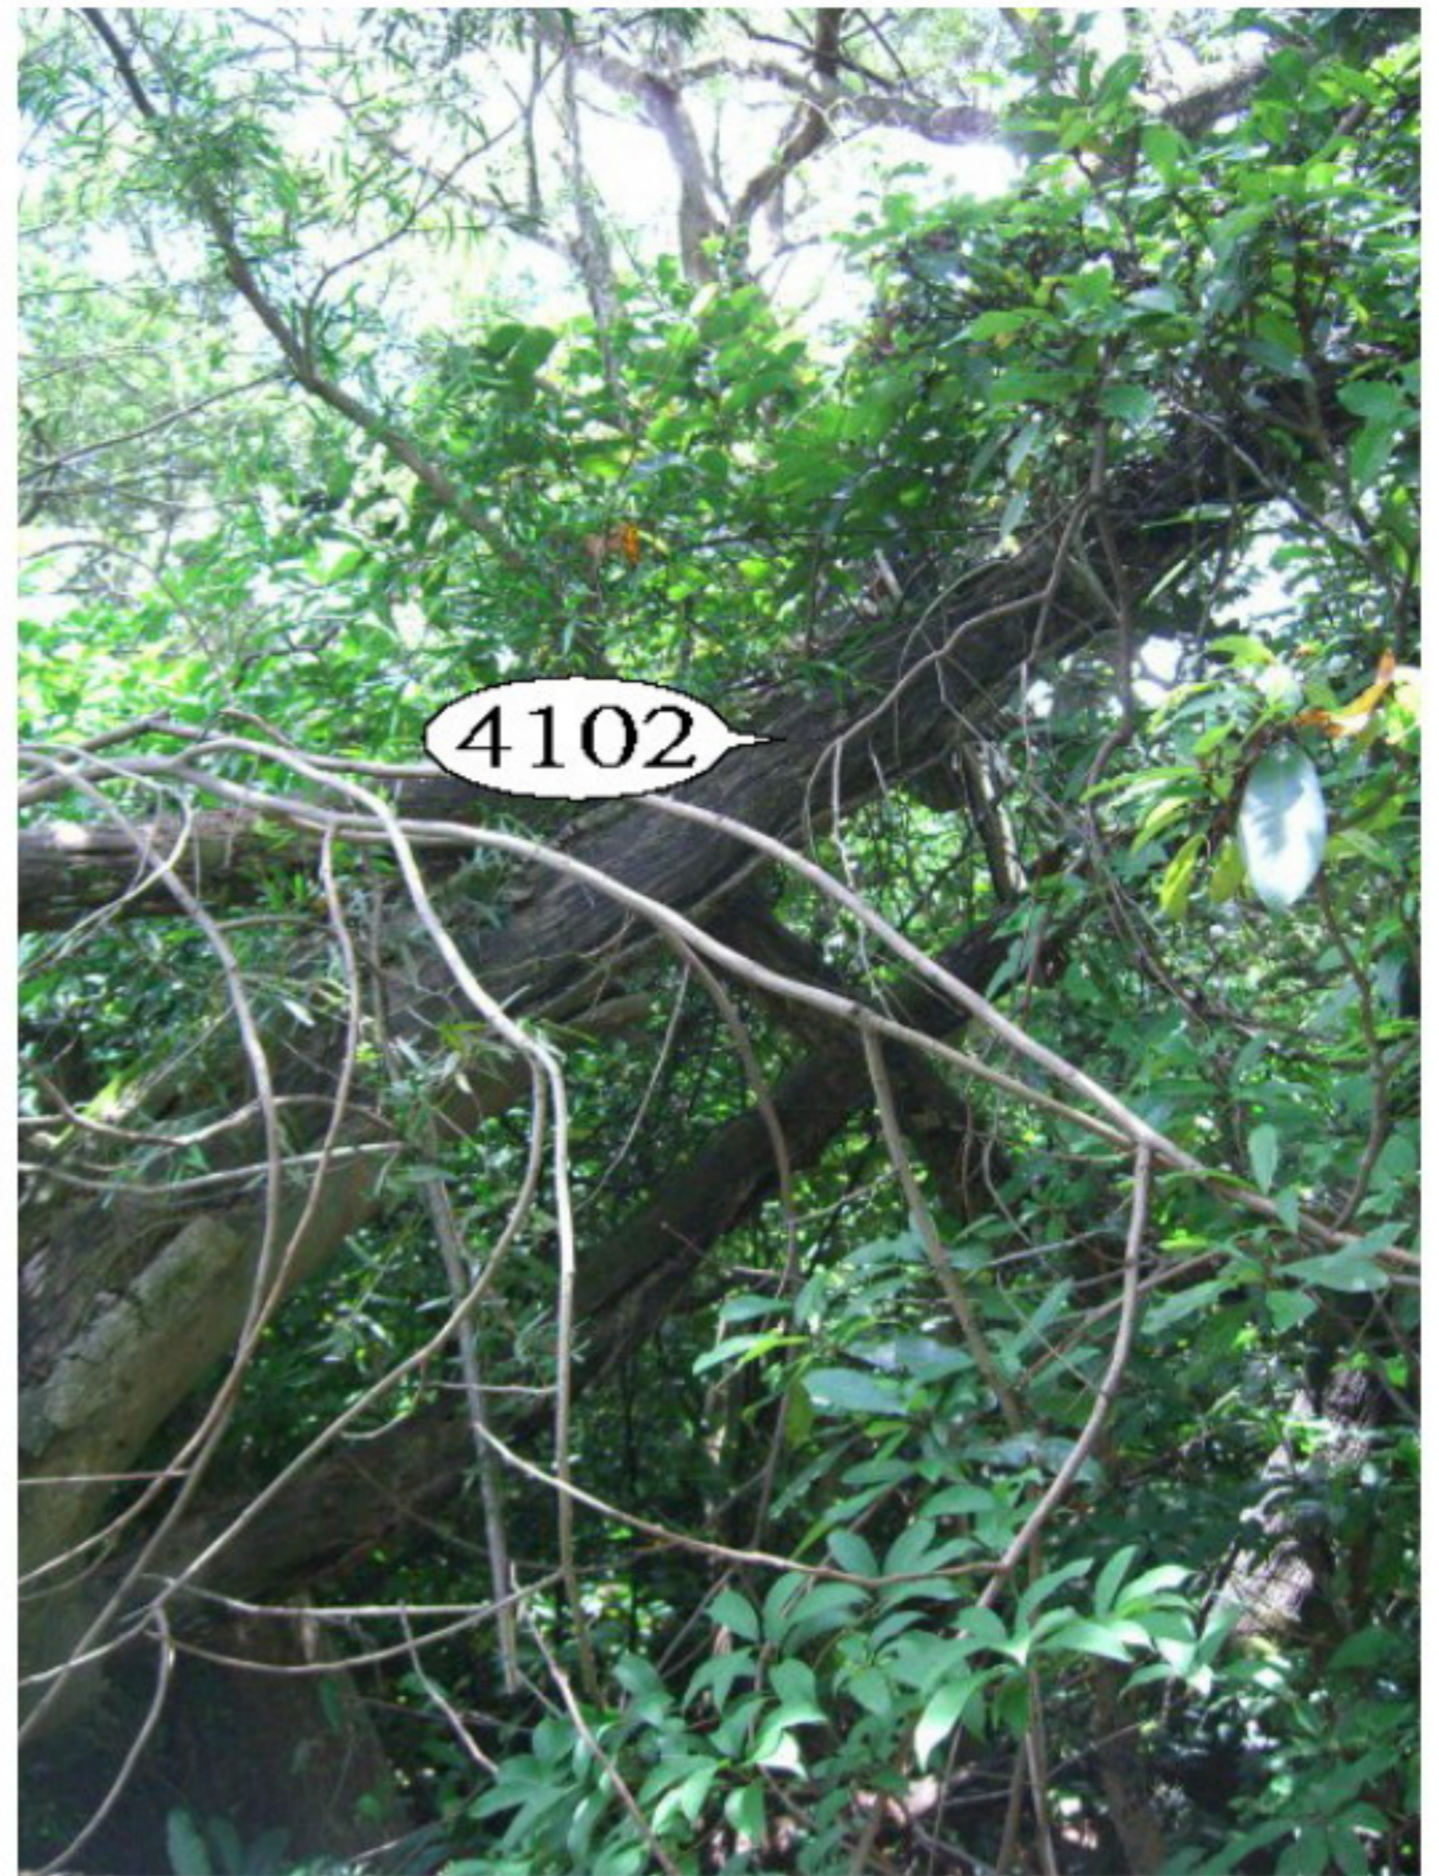
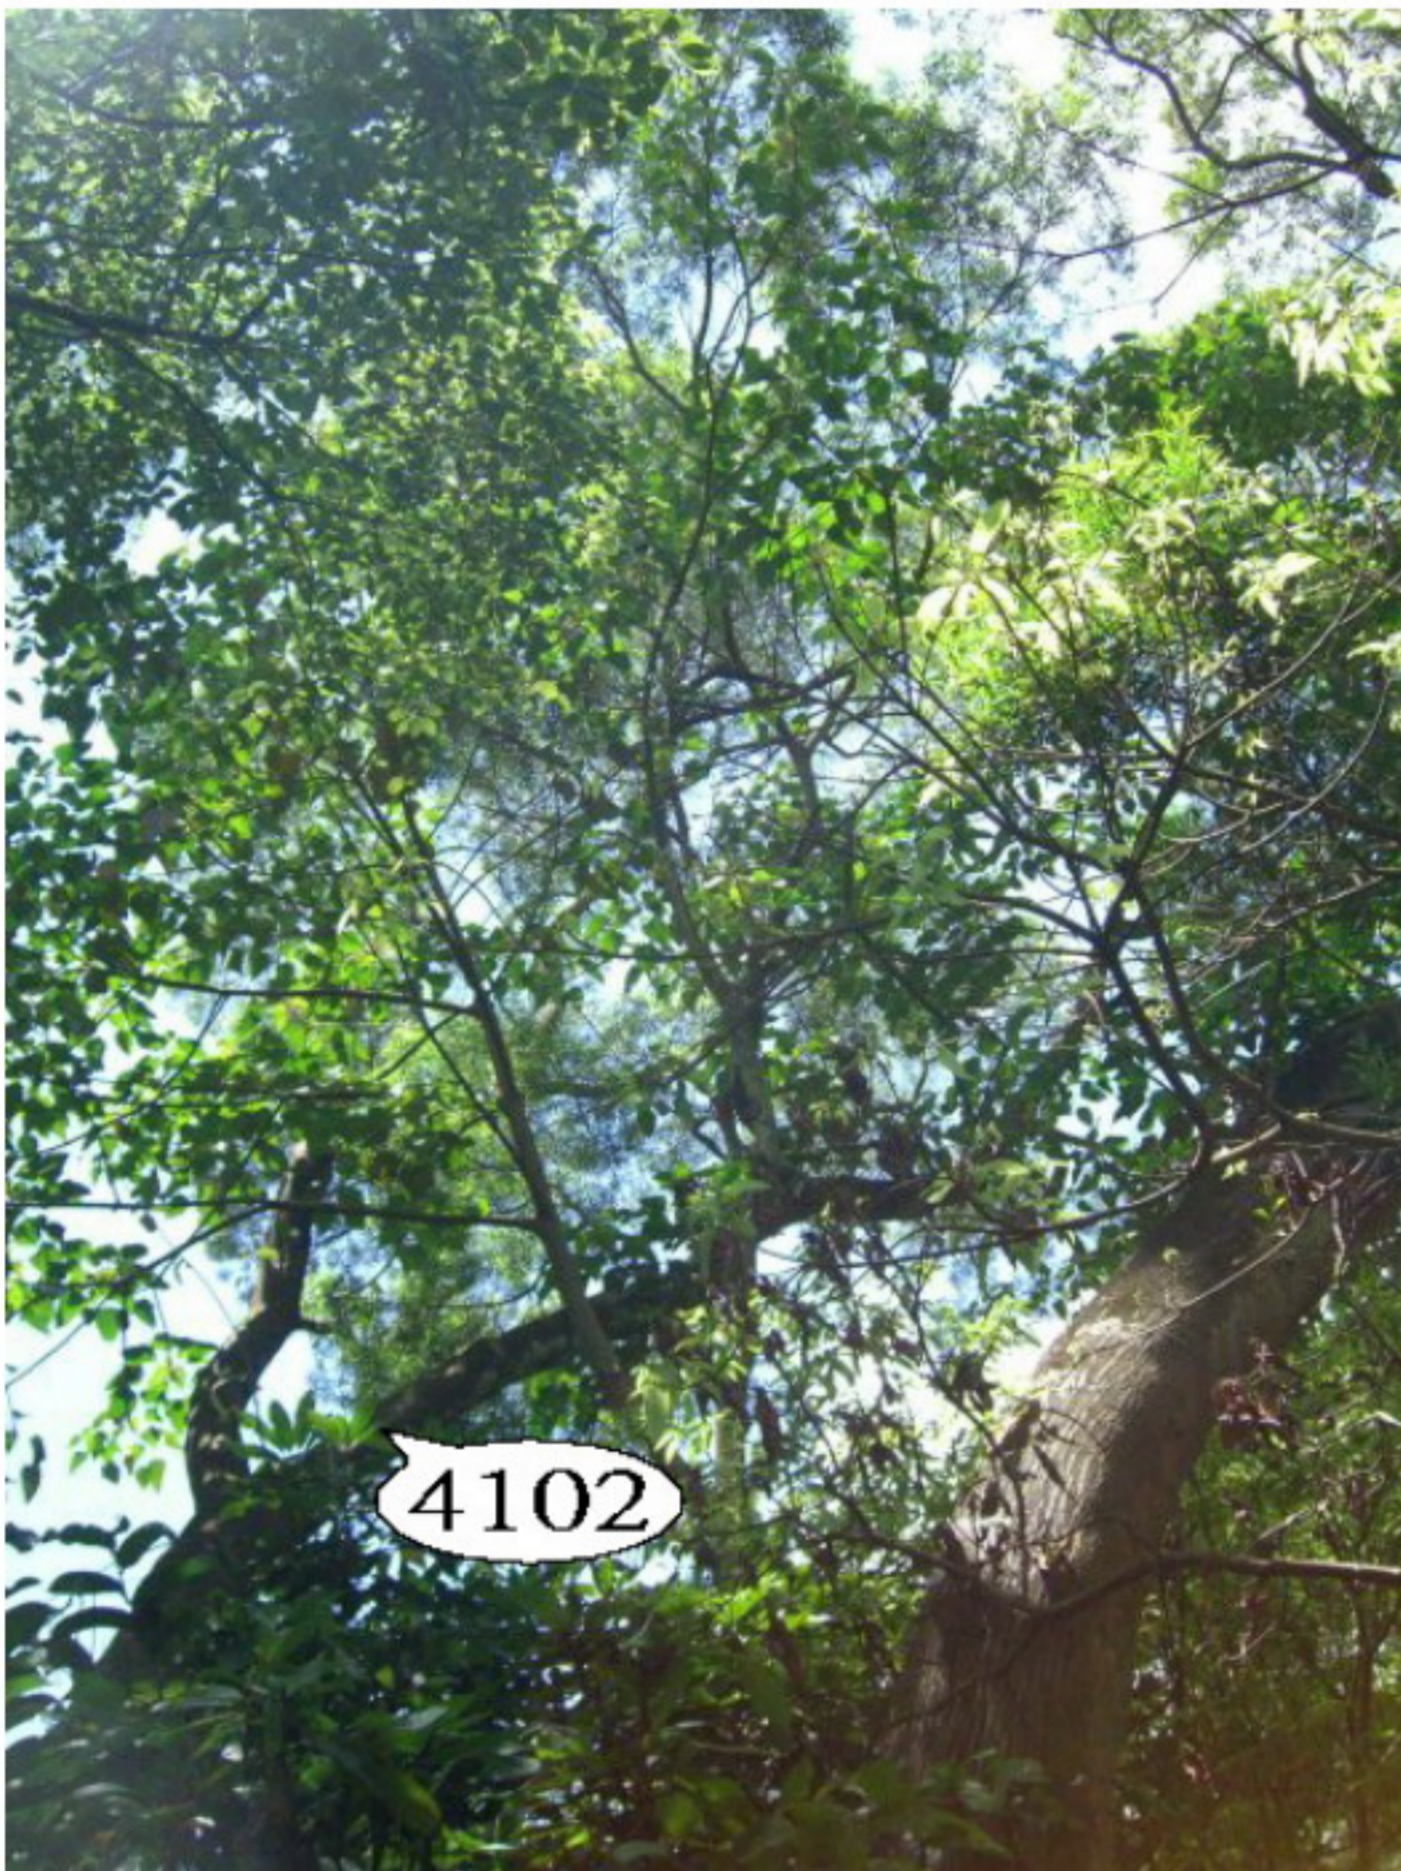
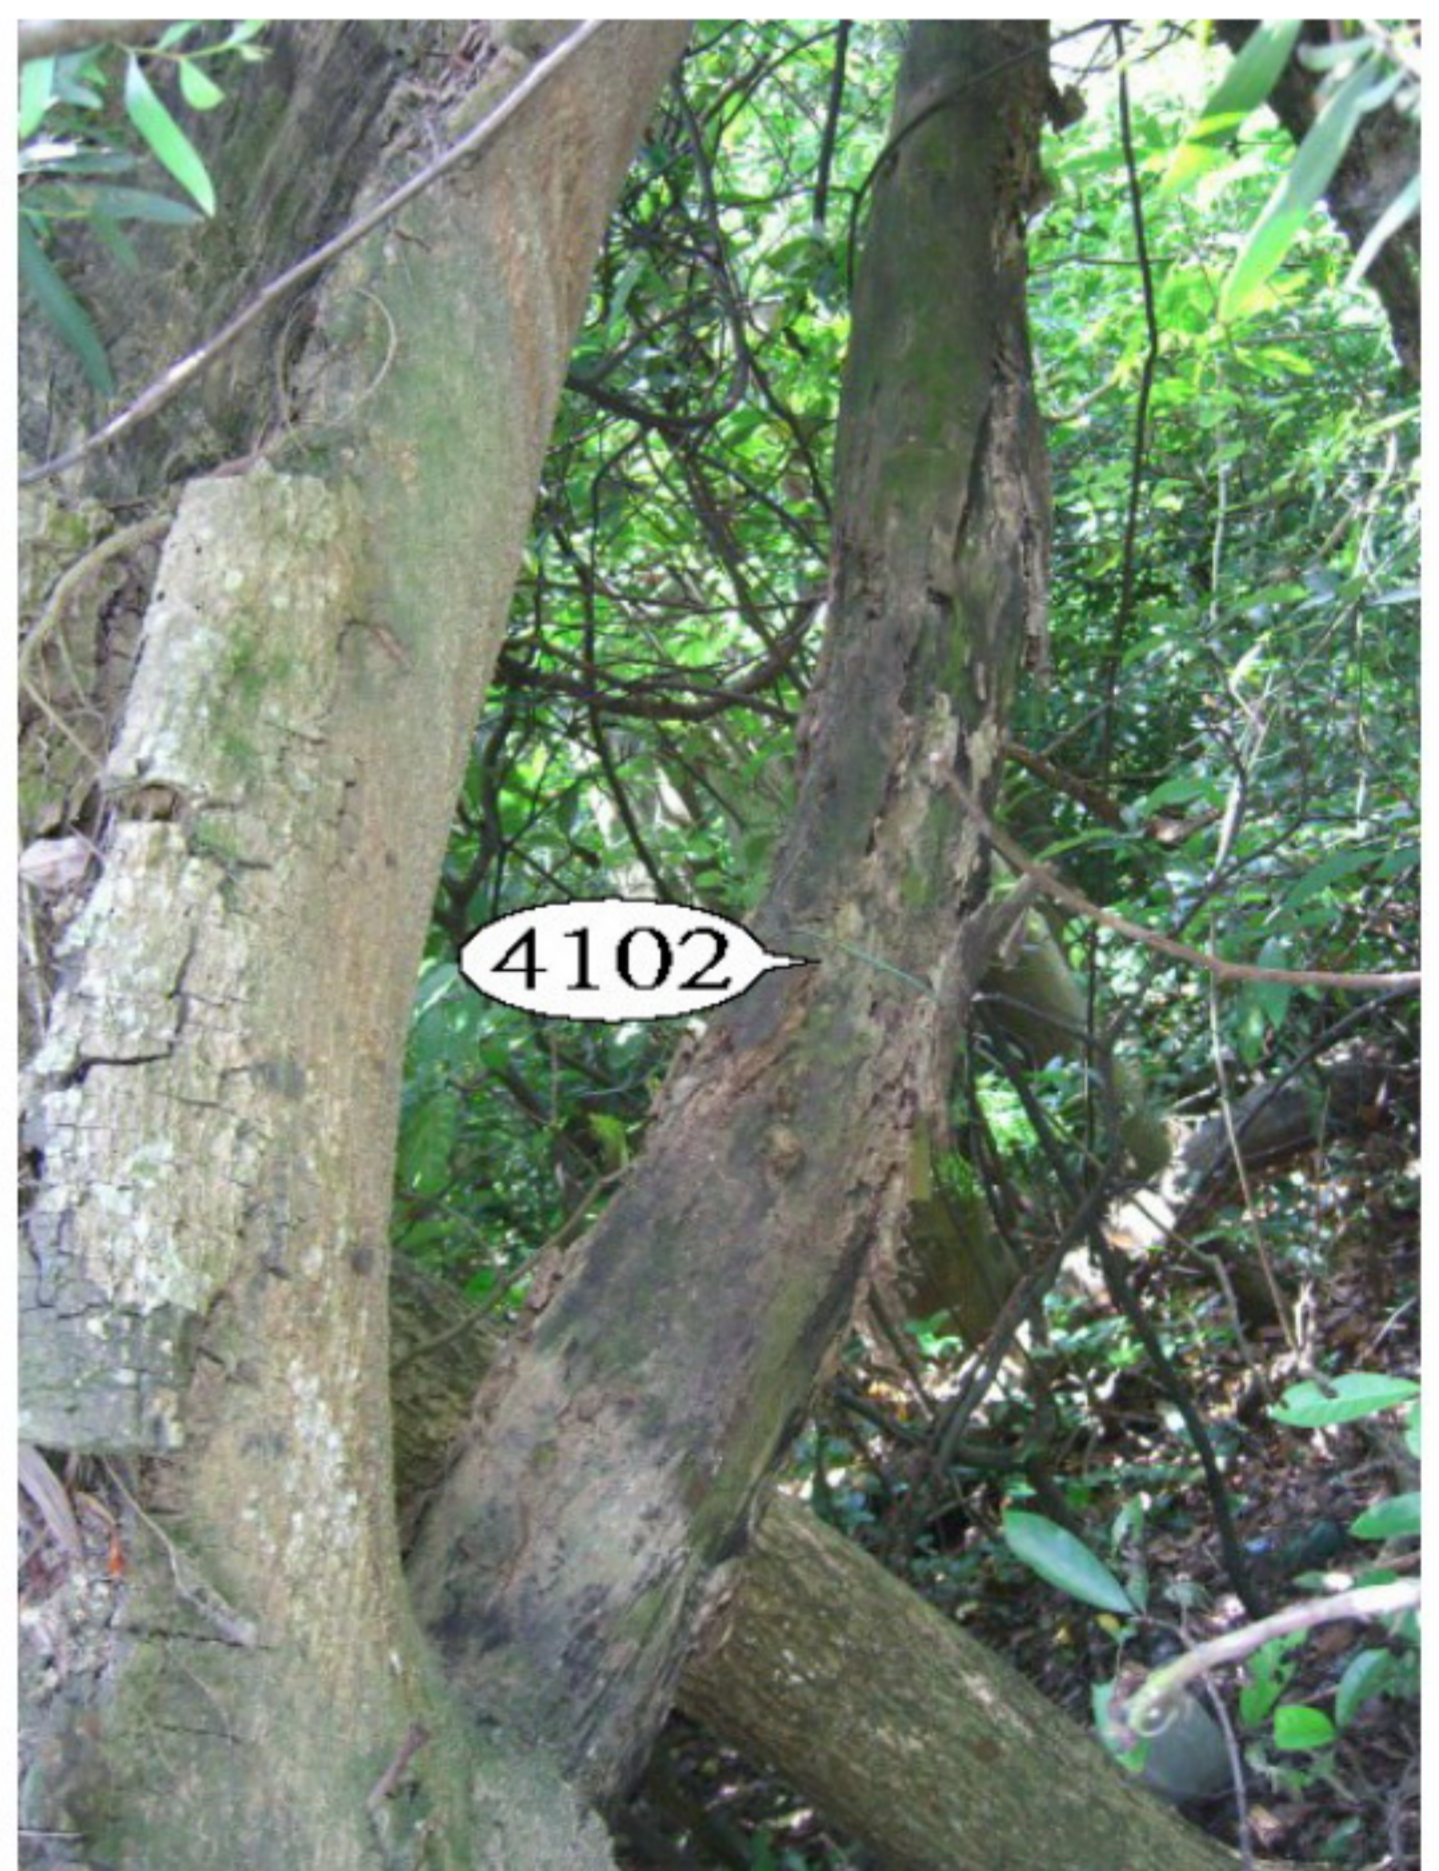
Tree 4101

Poor form which lead to low amenity value. Besides, the tree is unbalance. It may need heavy pruning after transplantation that will affect its transplantation survival rate. Moreover, the operation of the transplantation for poor form tree is also difficult.

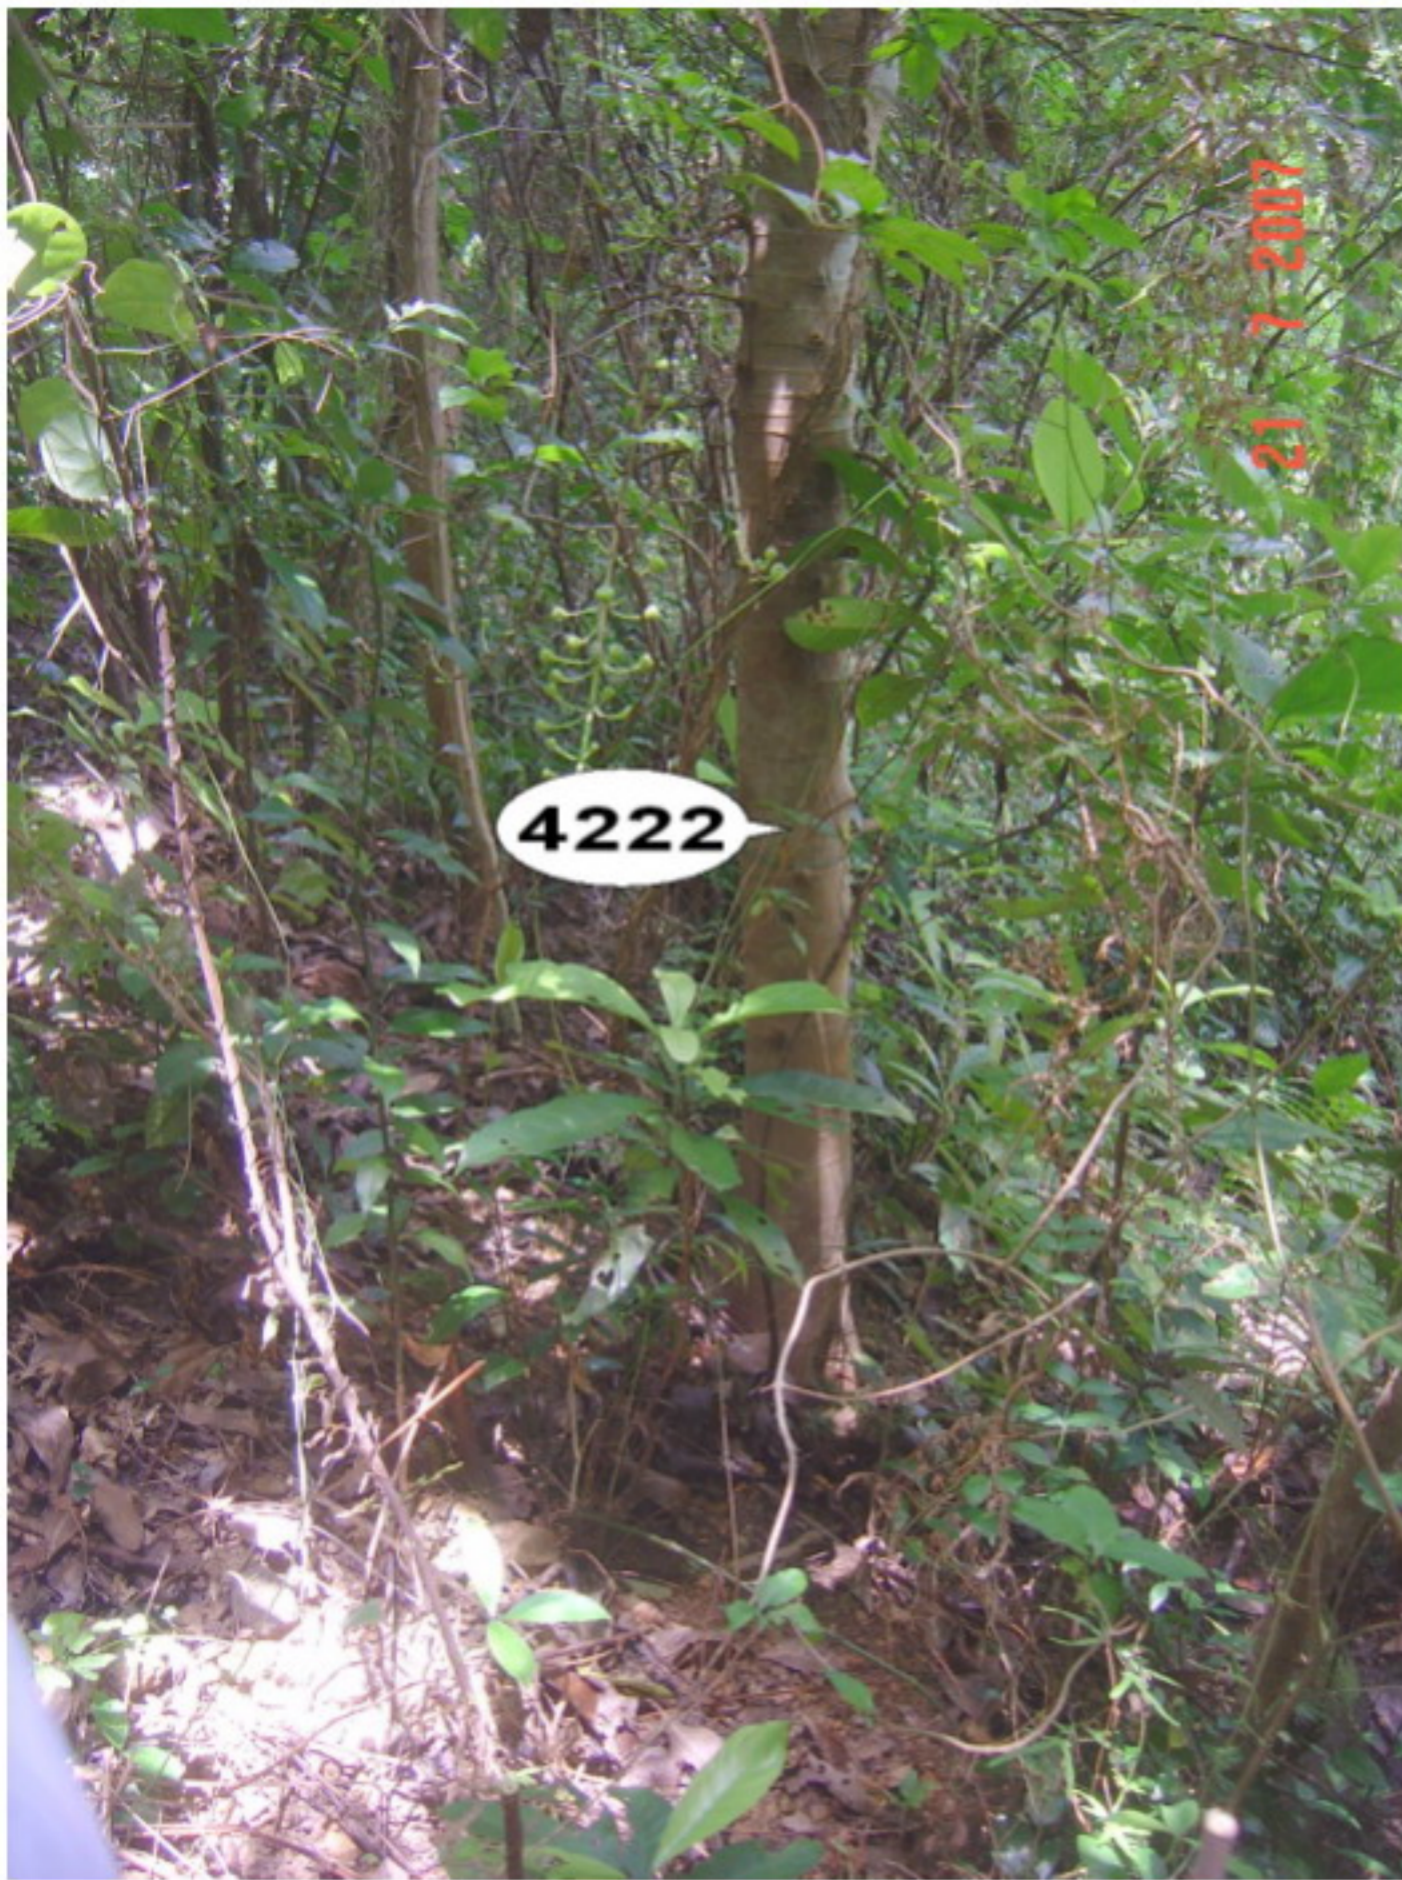
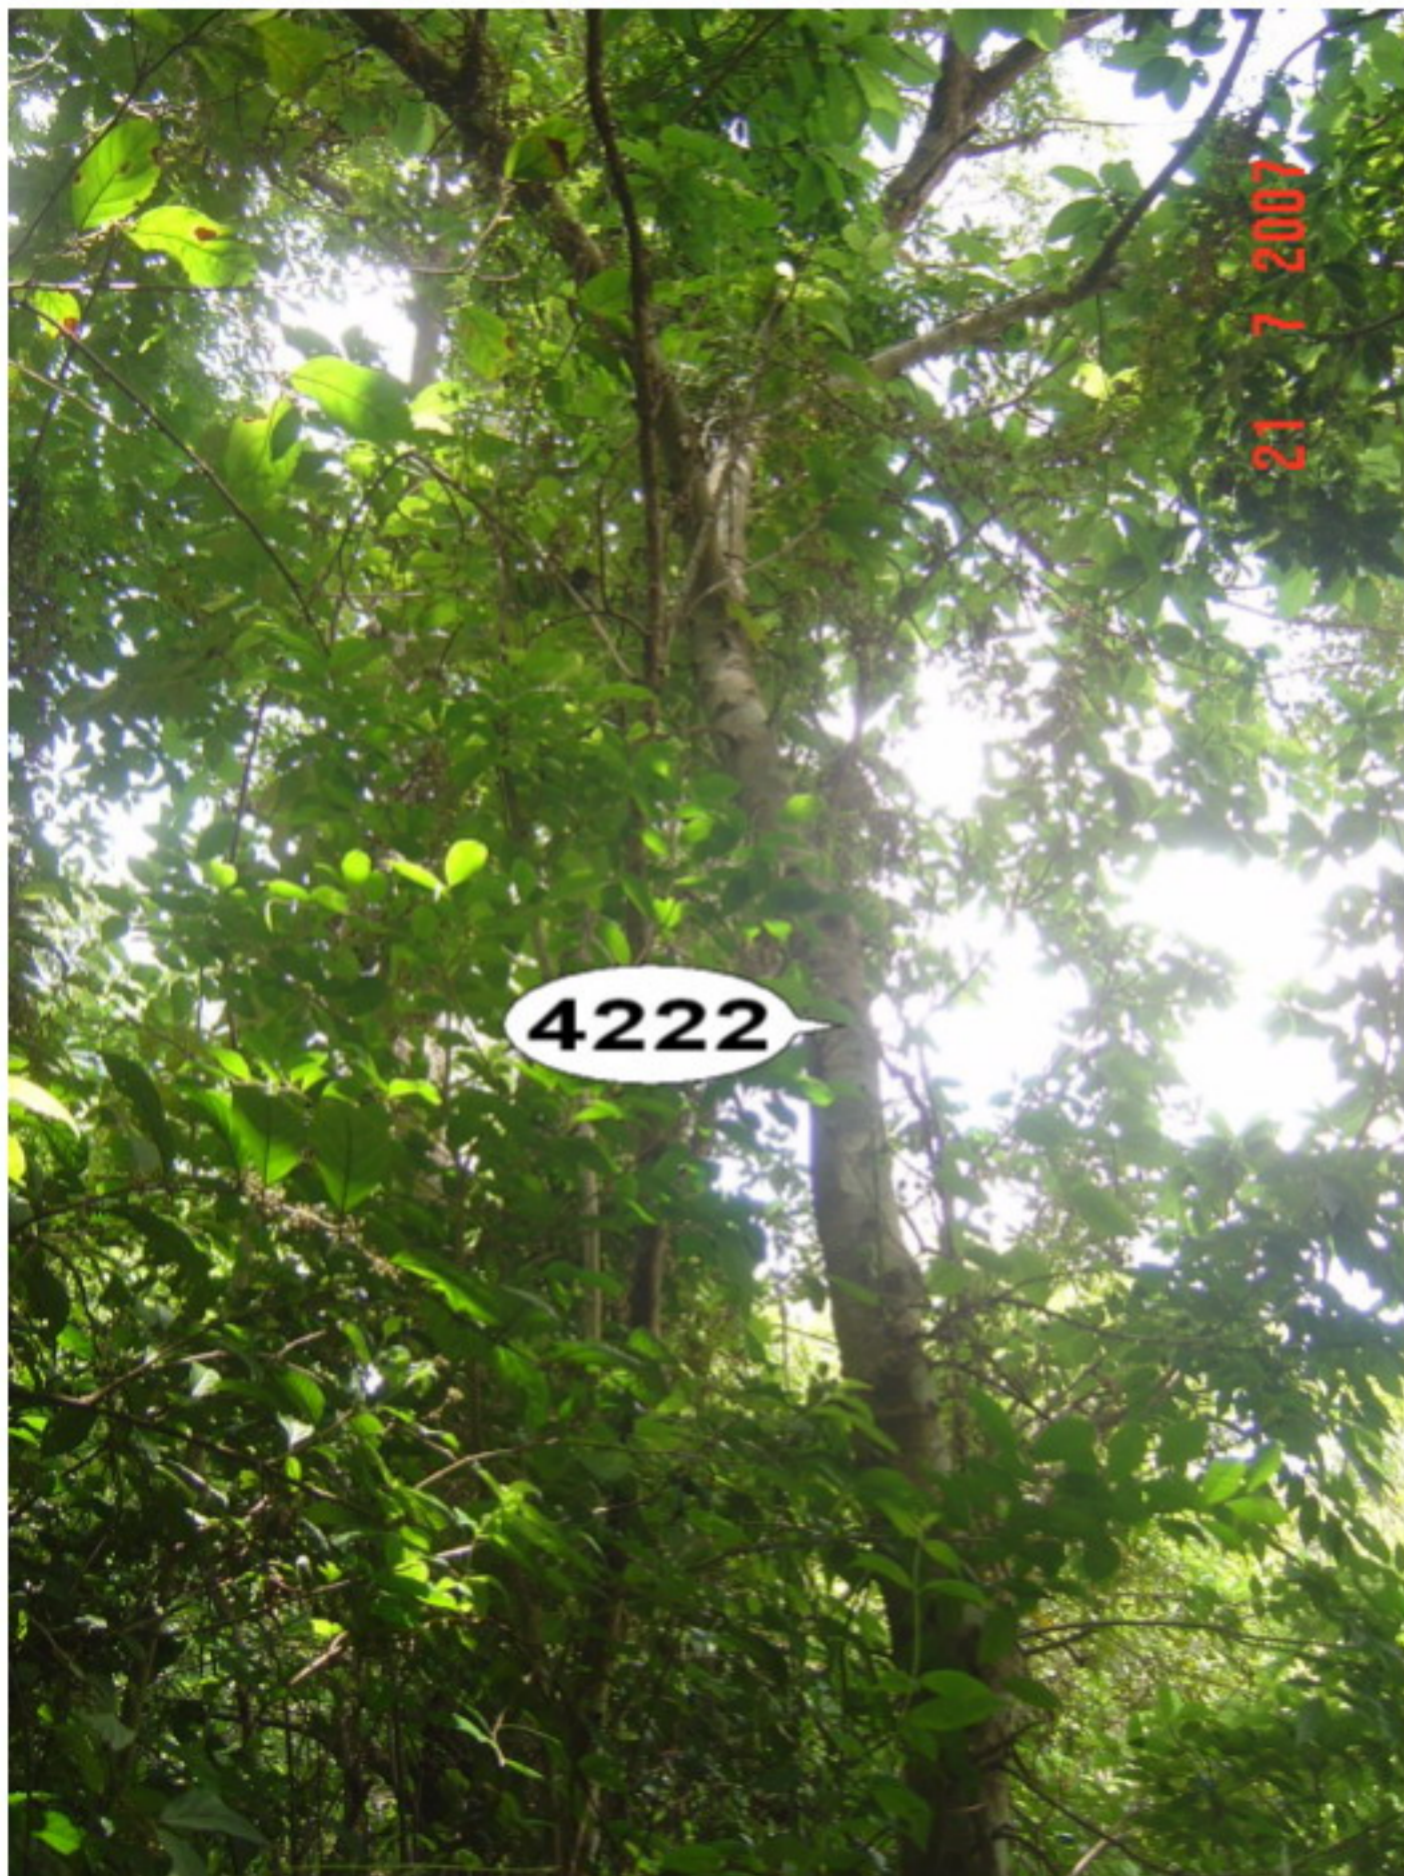
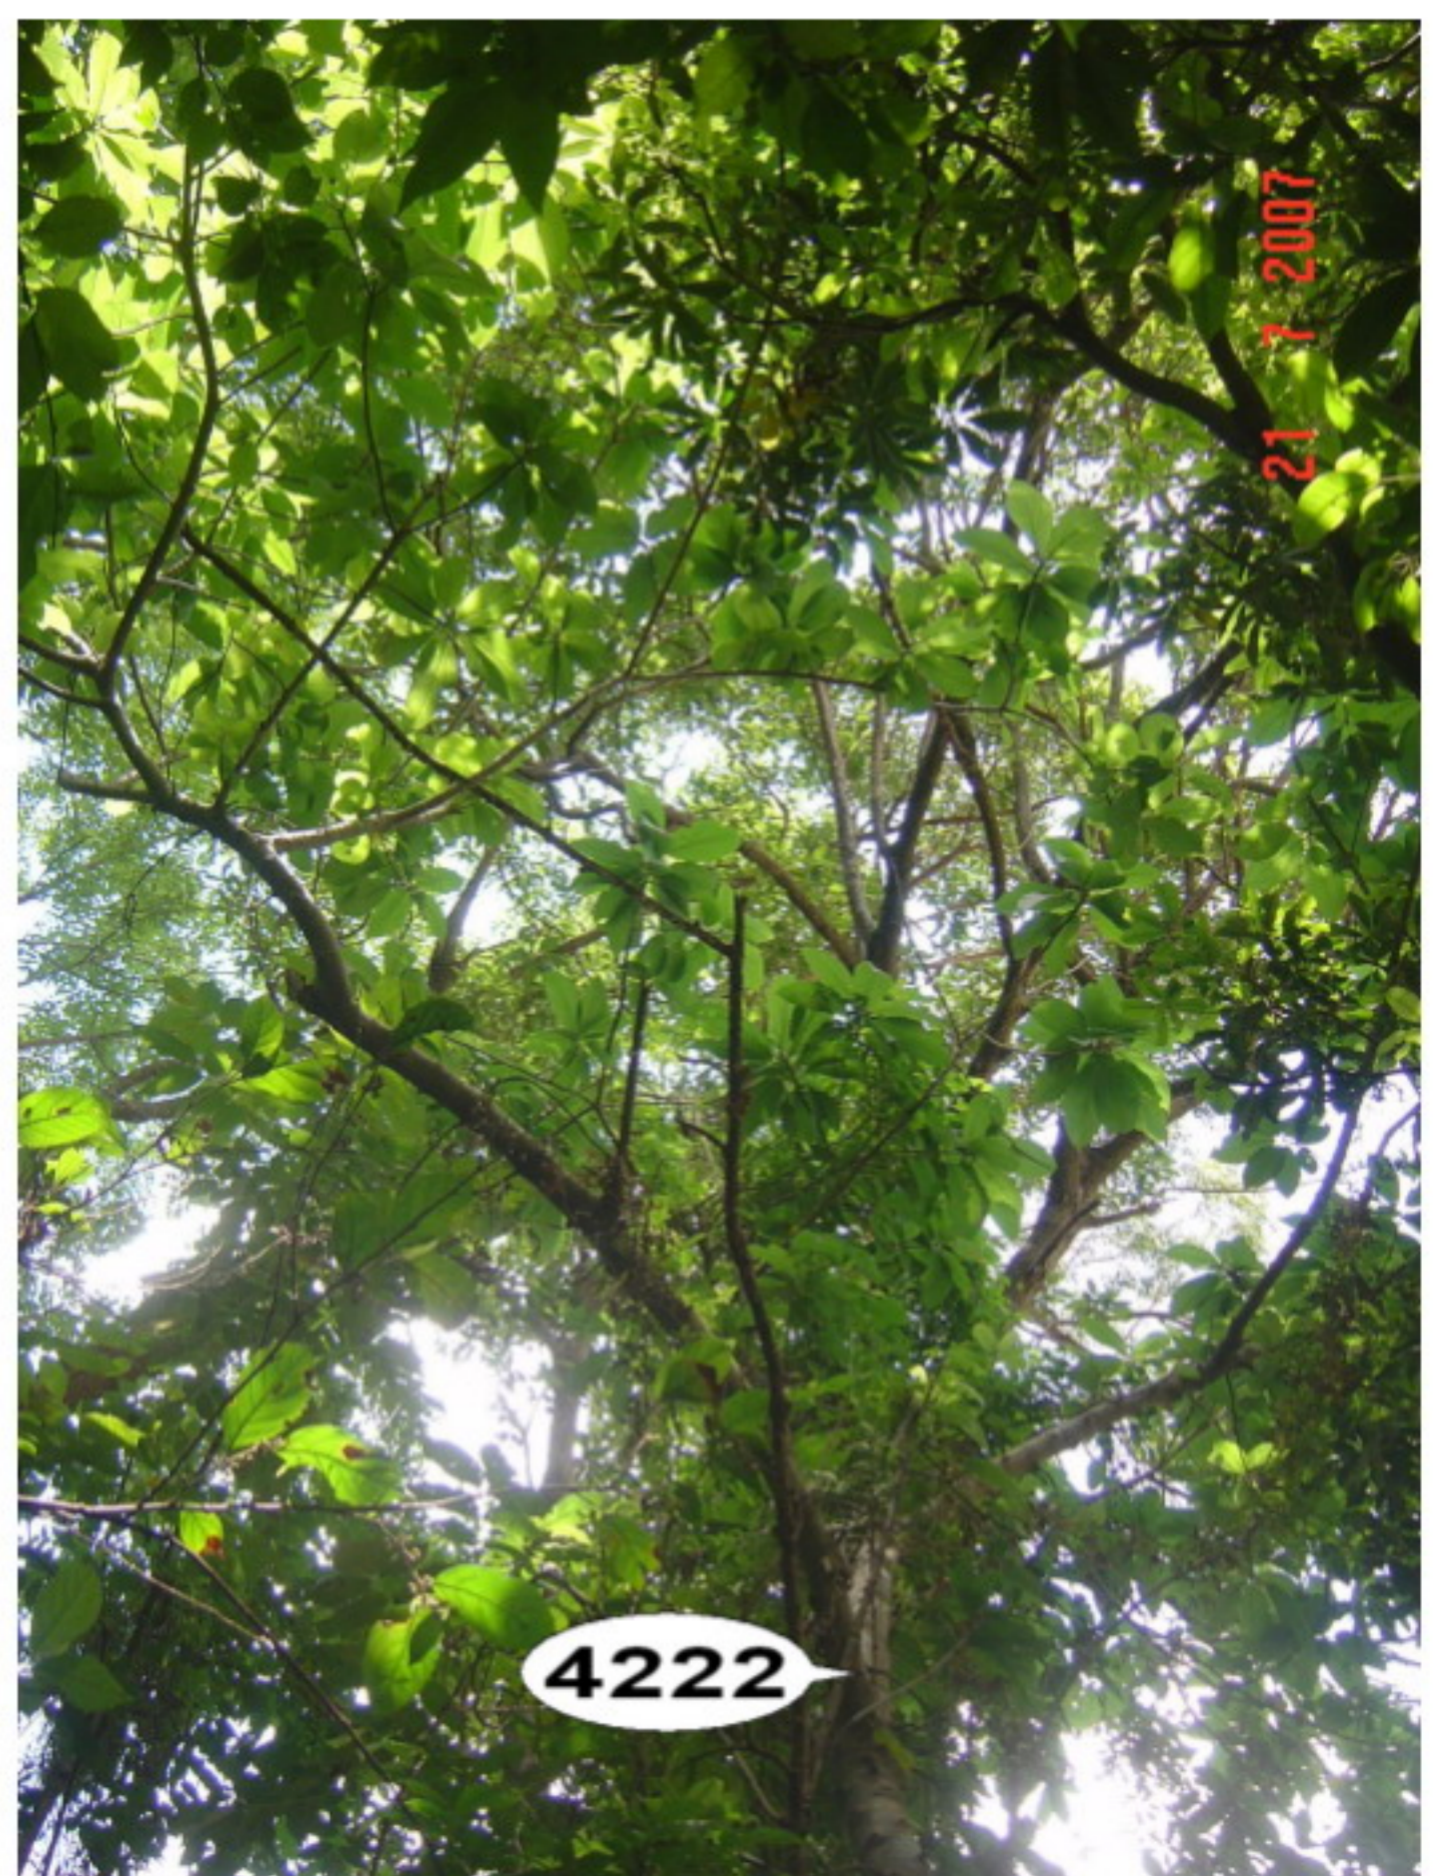
#### Tree 4211

Poor form which lead to low amenity value. Besides, the tree is unbalance. It may need heavy pruning after transplantaion that will affect its transplantaion survival rate. Moreover, the operation of the transplantaion for poor form tree is also difficult.
