# Provision of Cremators at Wo Hop Shek Crematorium

Tree Survey Report

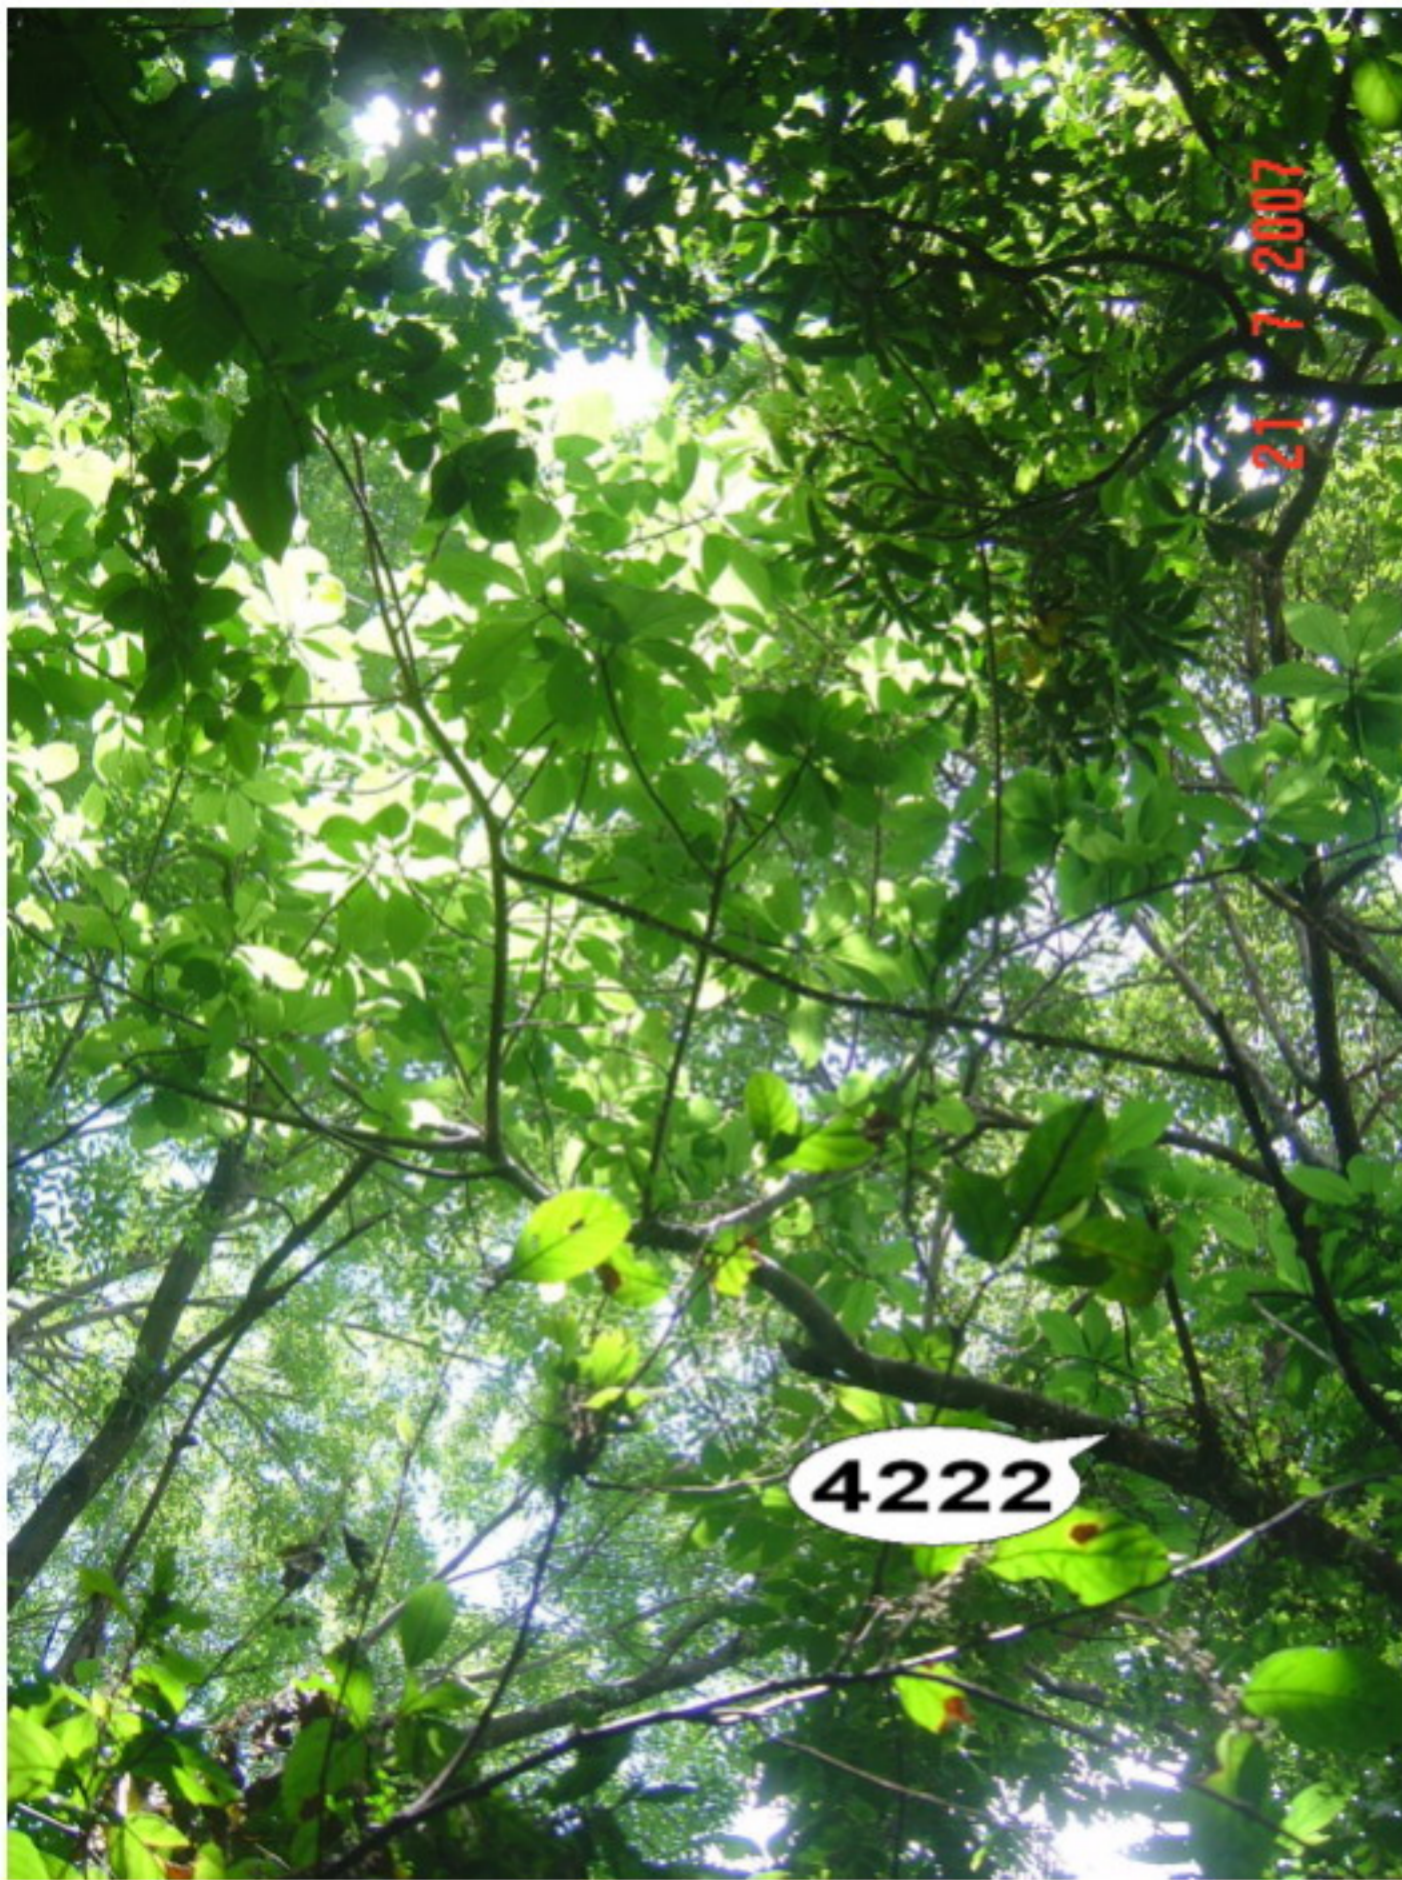
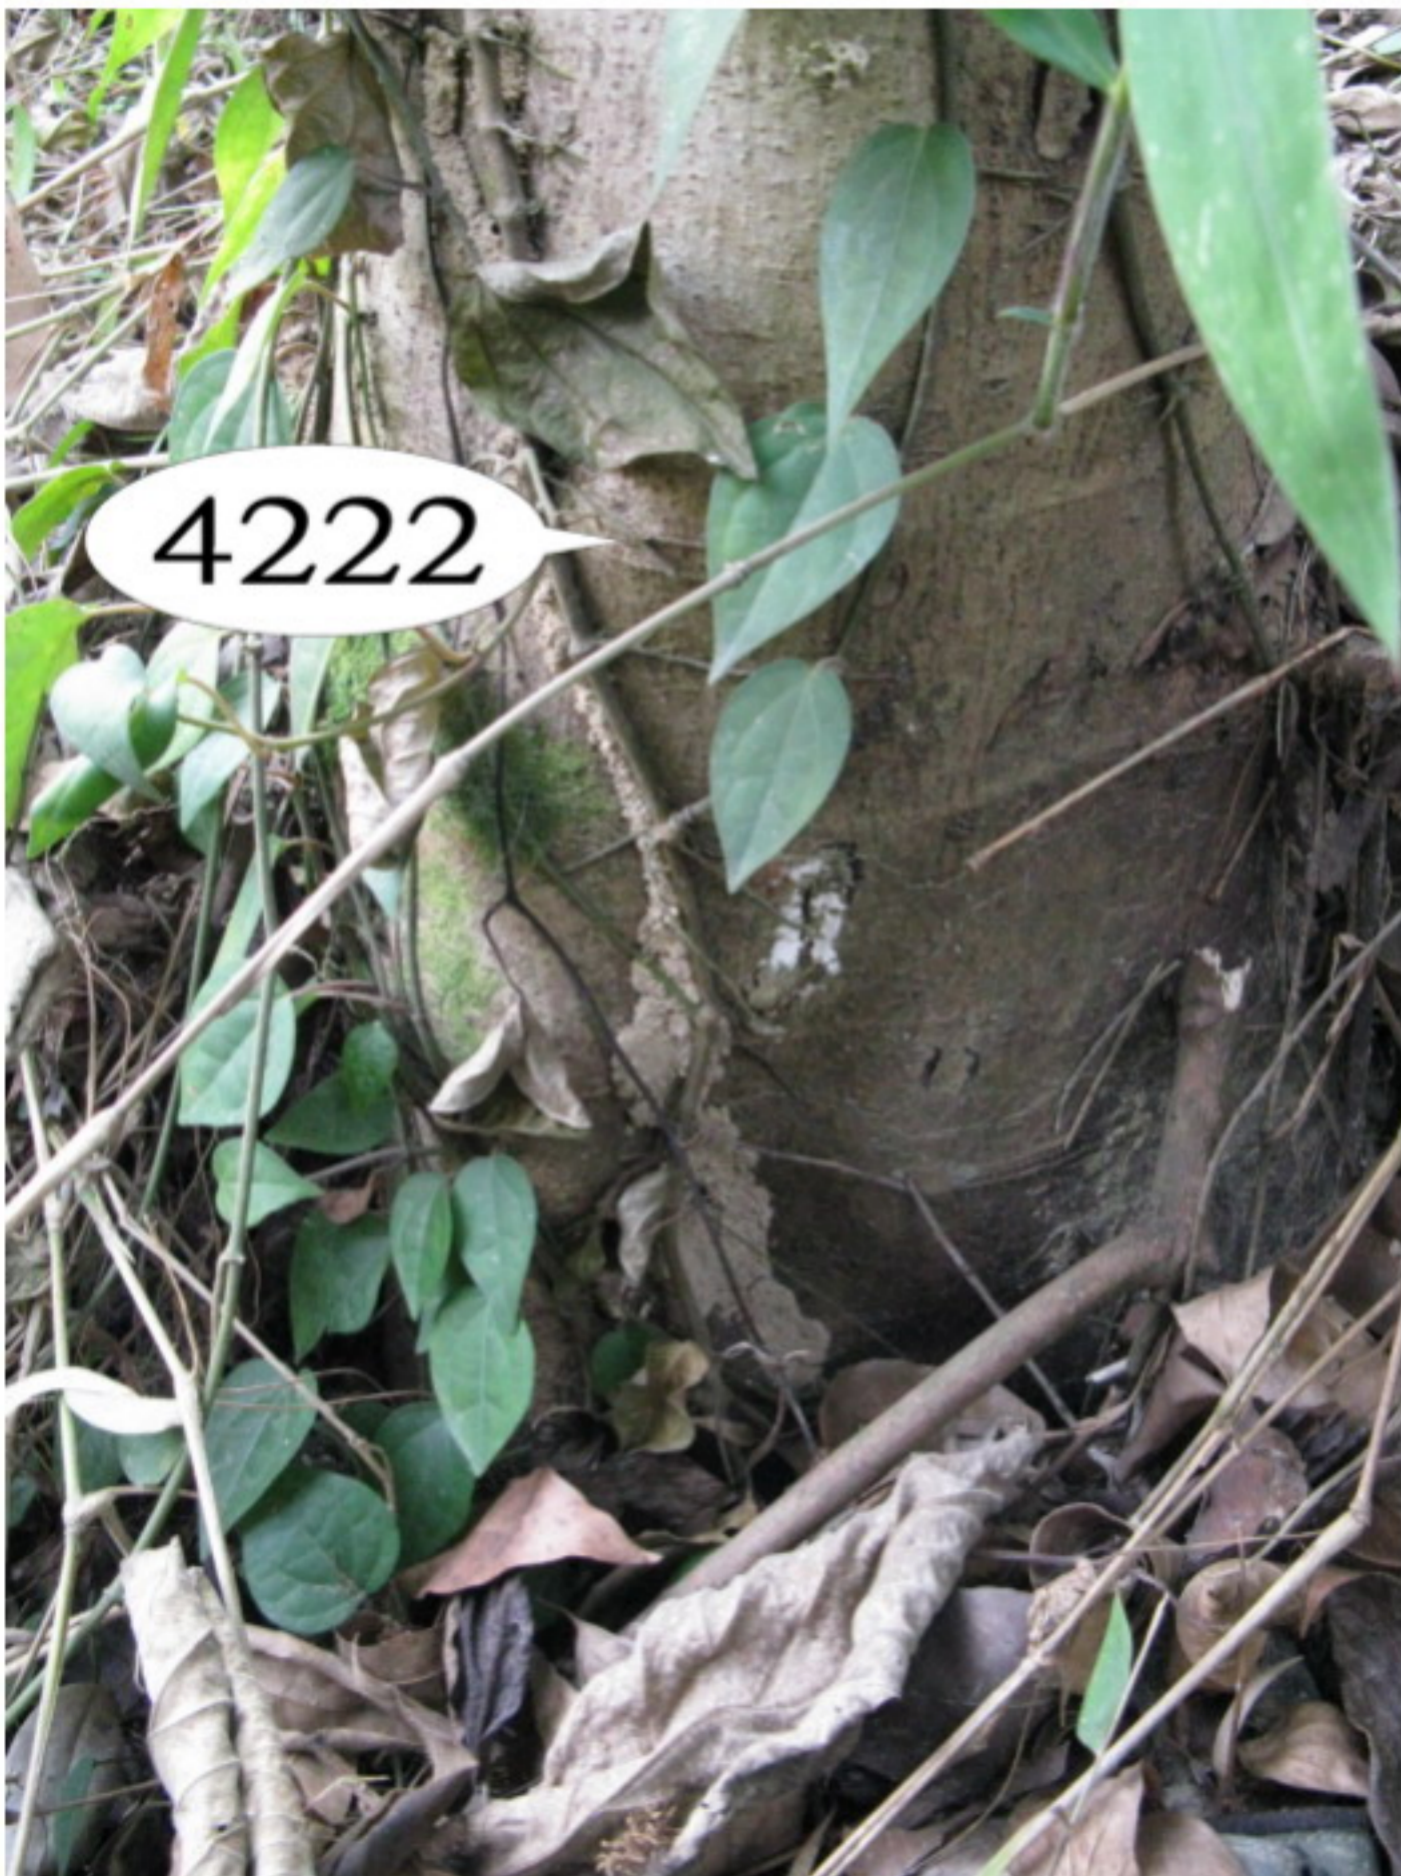
Tree 4222  
Poor health will lead to low transplantation survival rate.

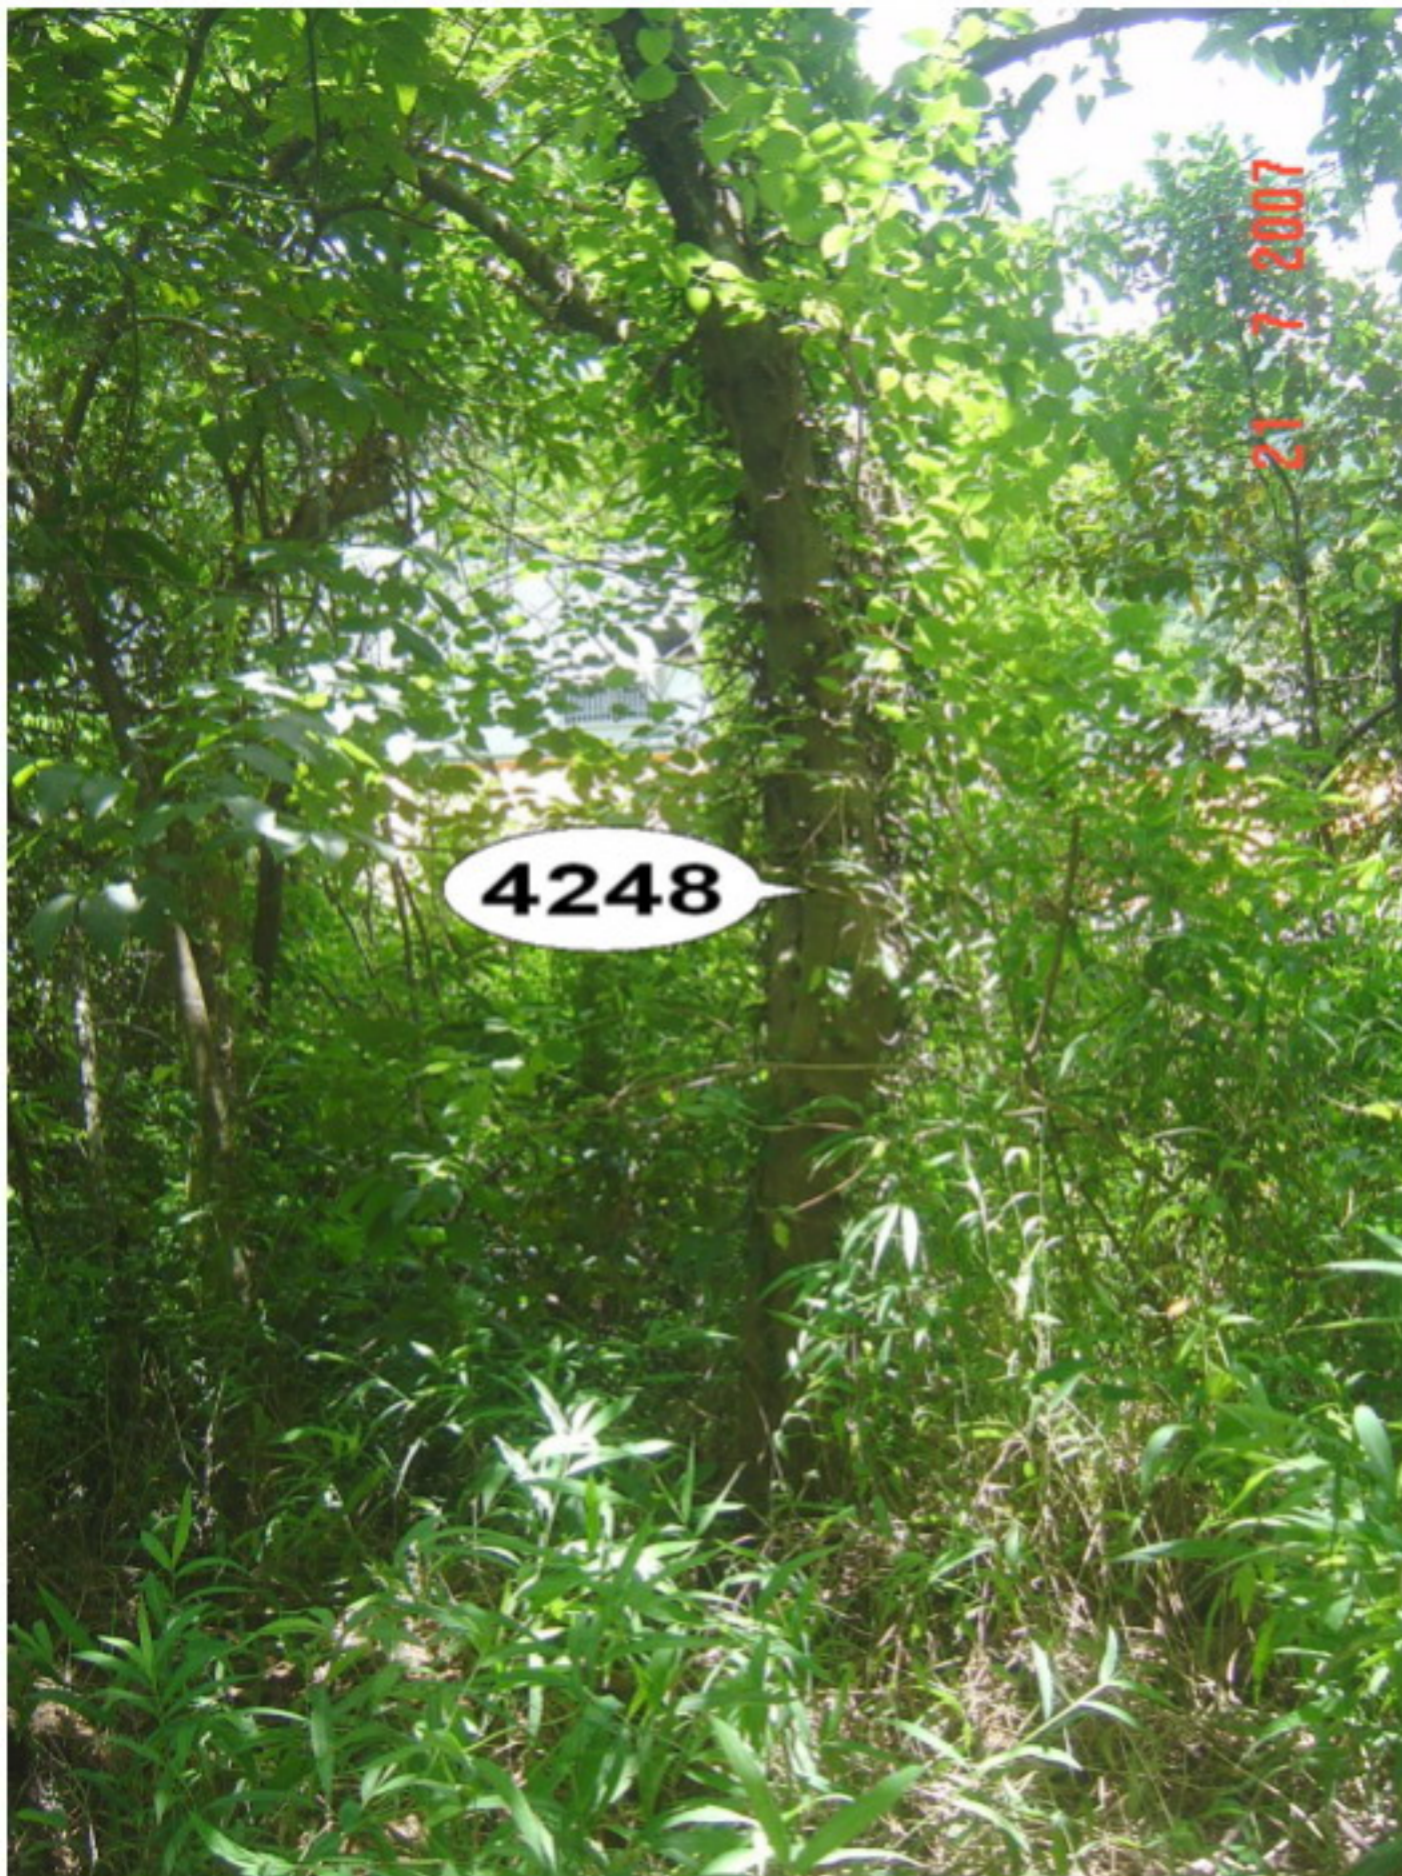
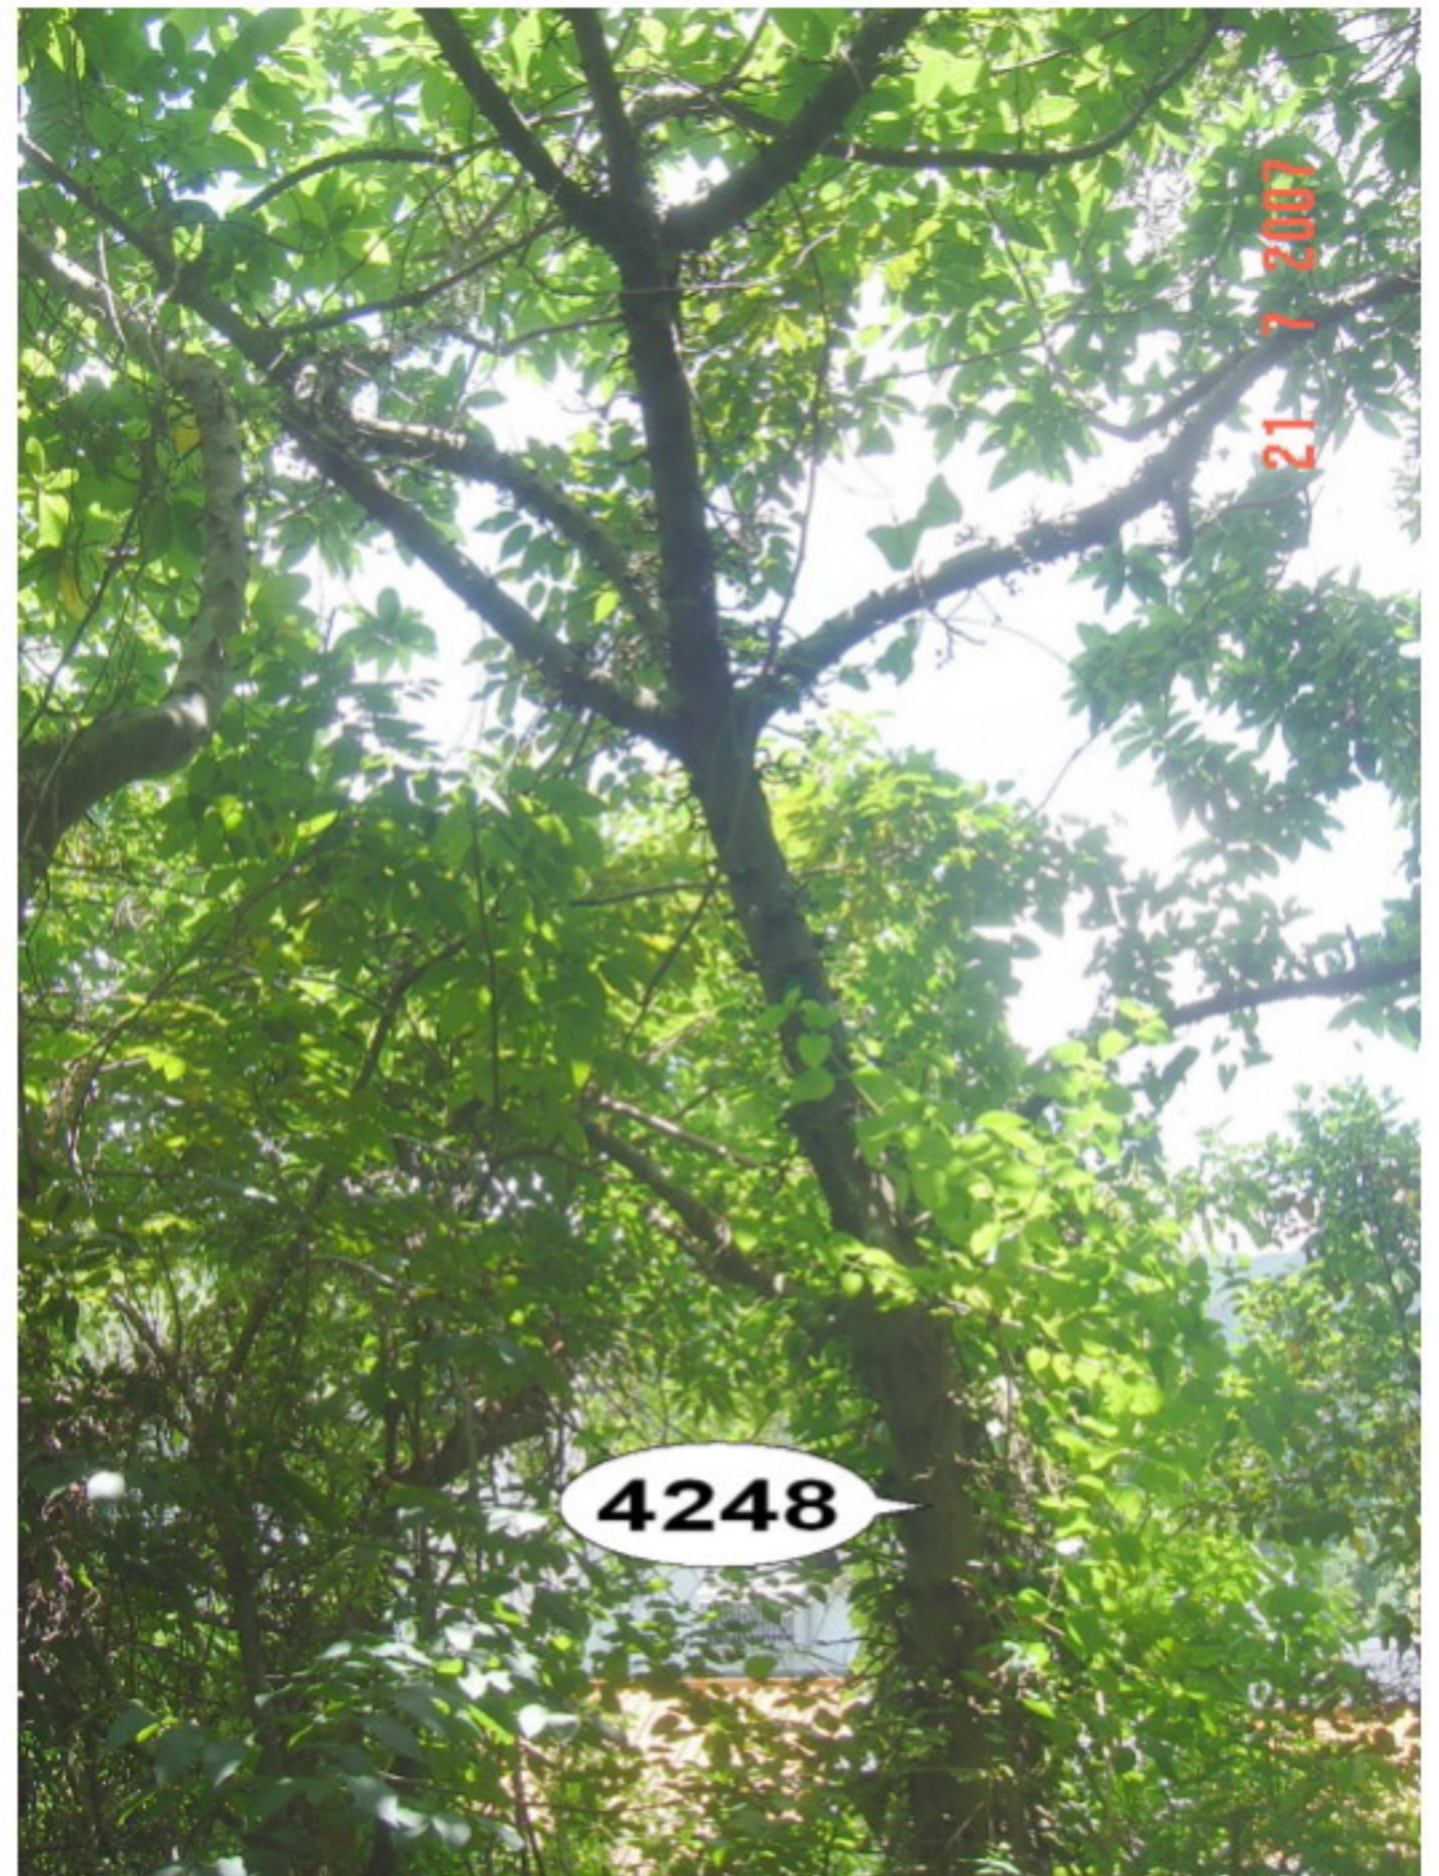
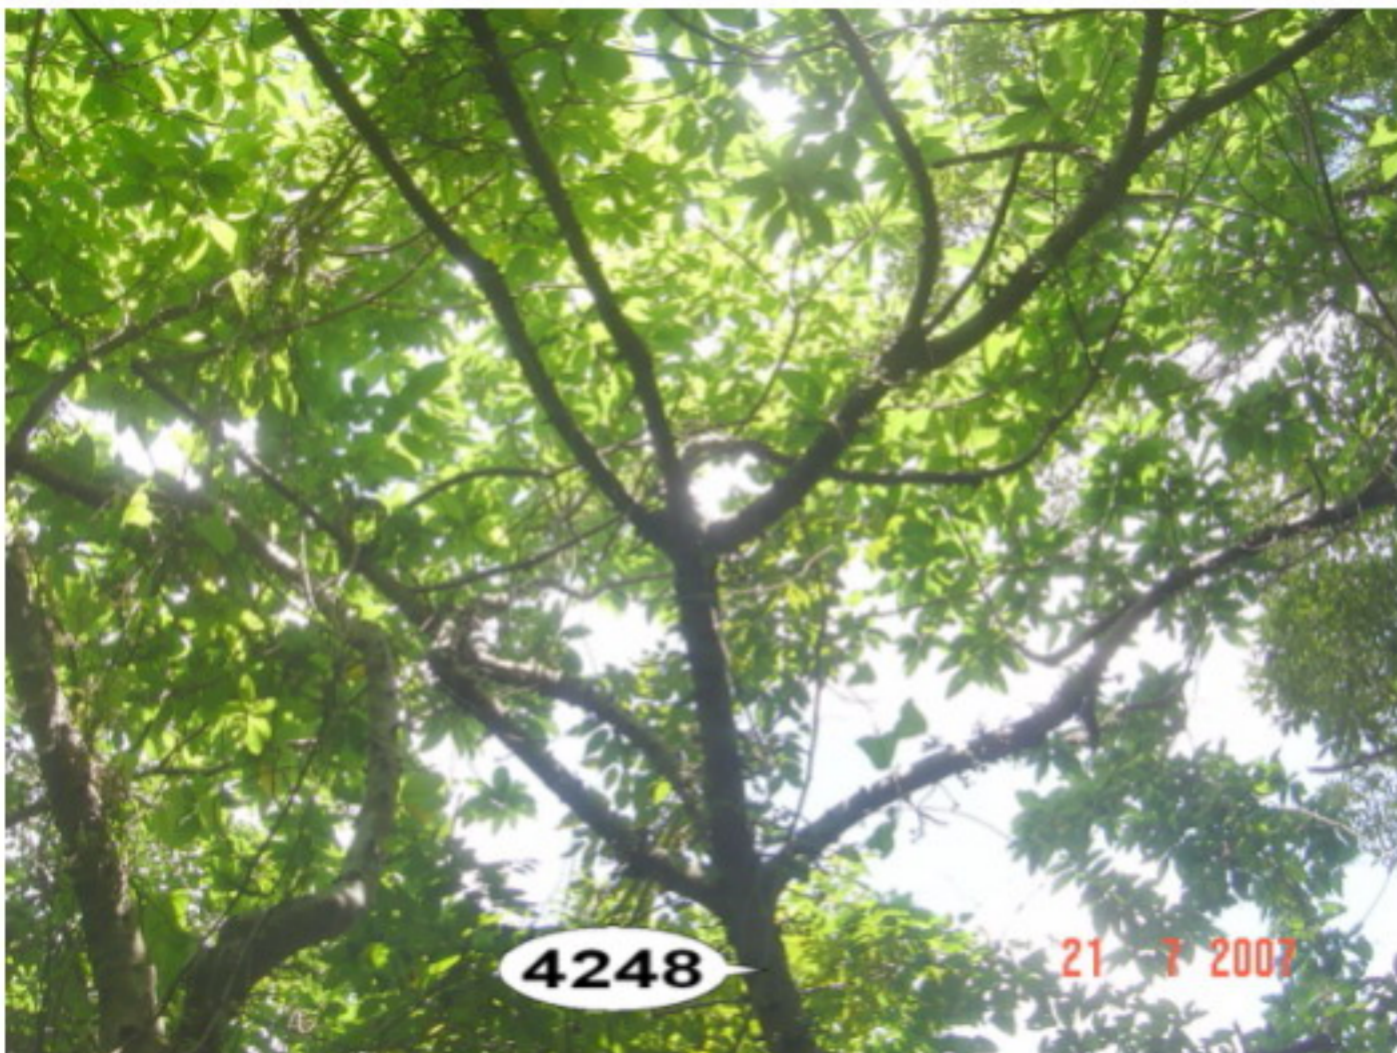
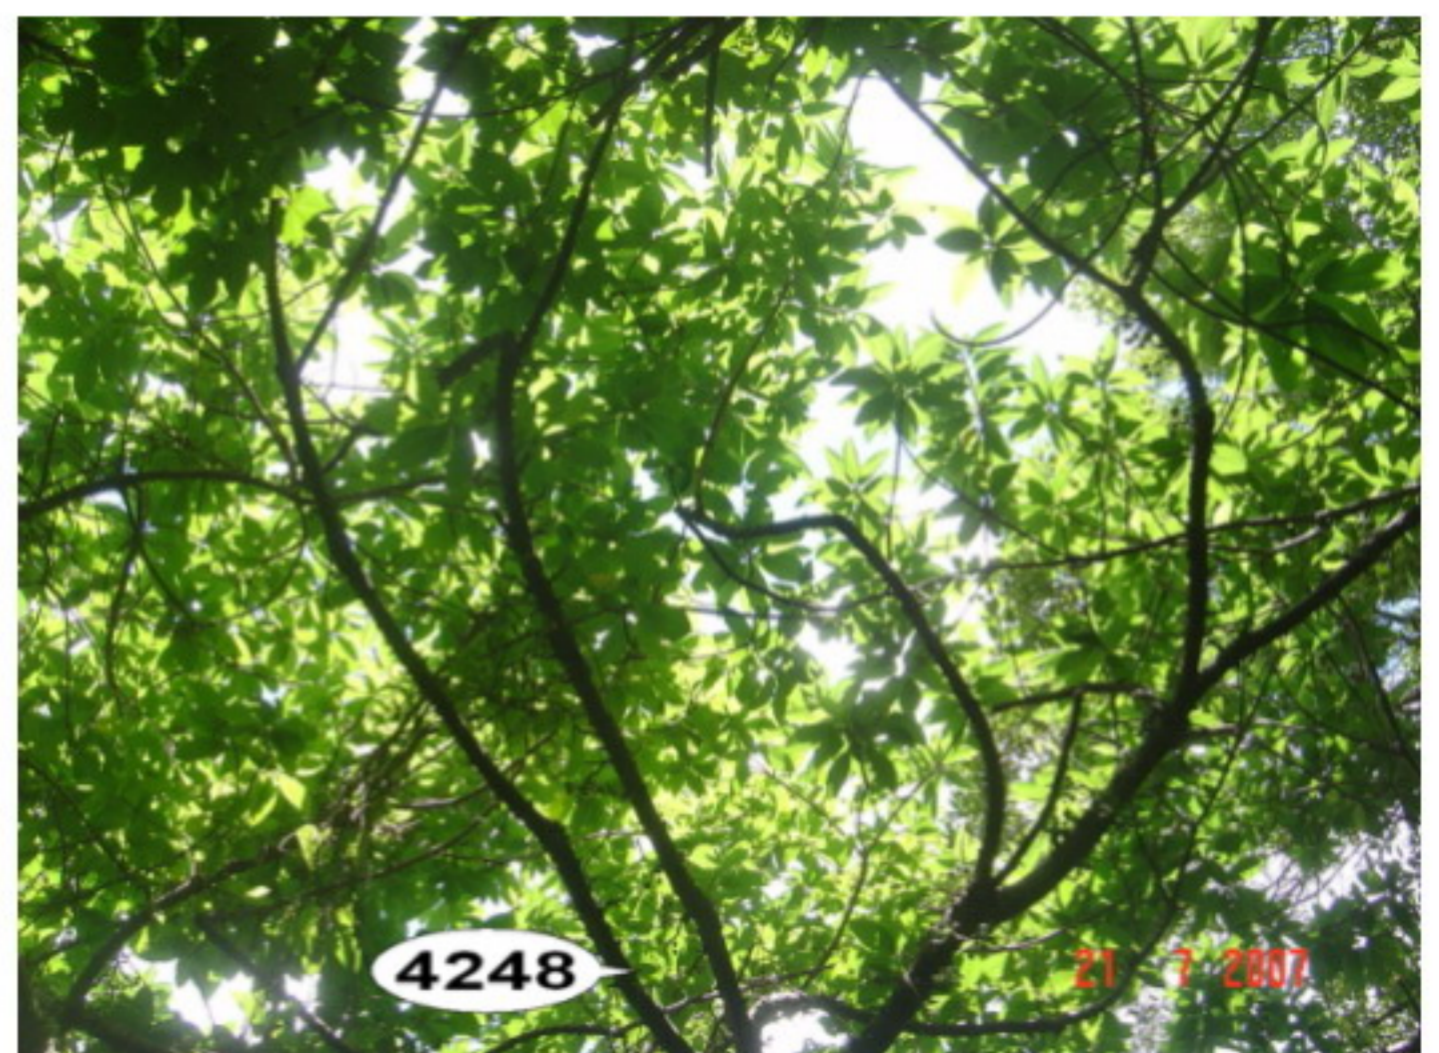
Tree 4247  
Poor health will lead to low transplantation survival rate.

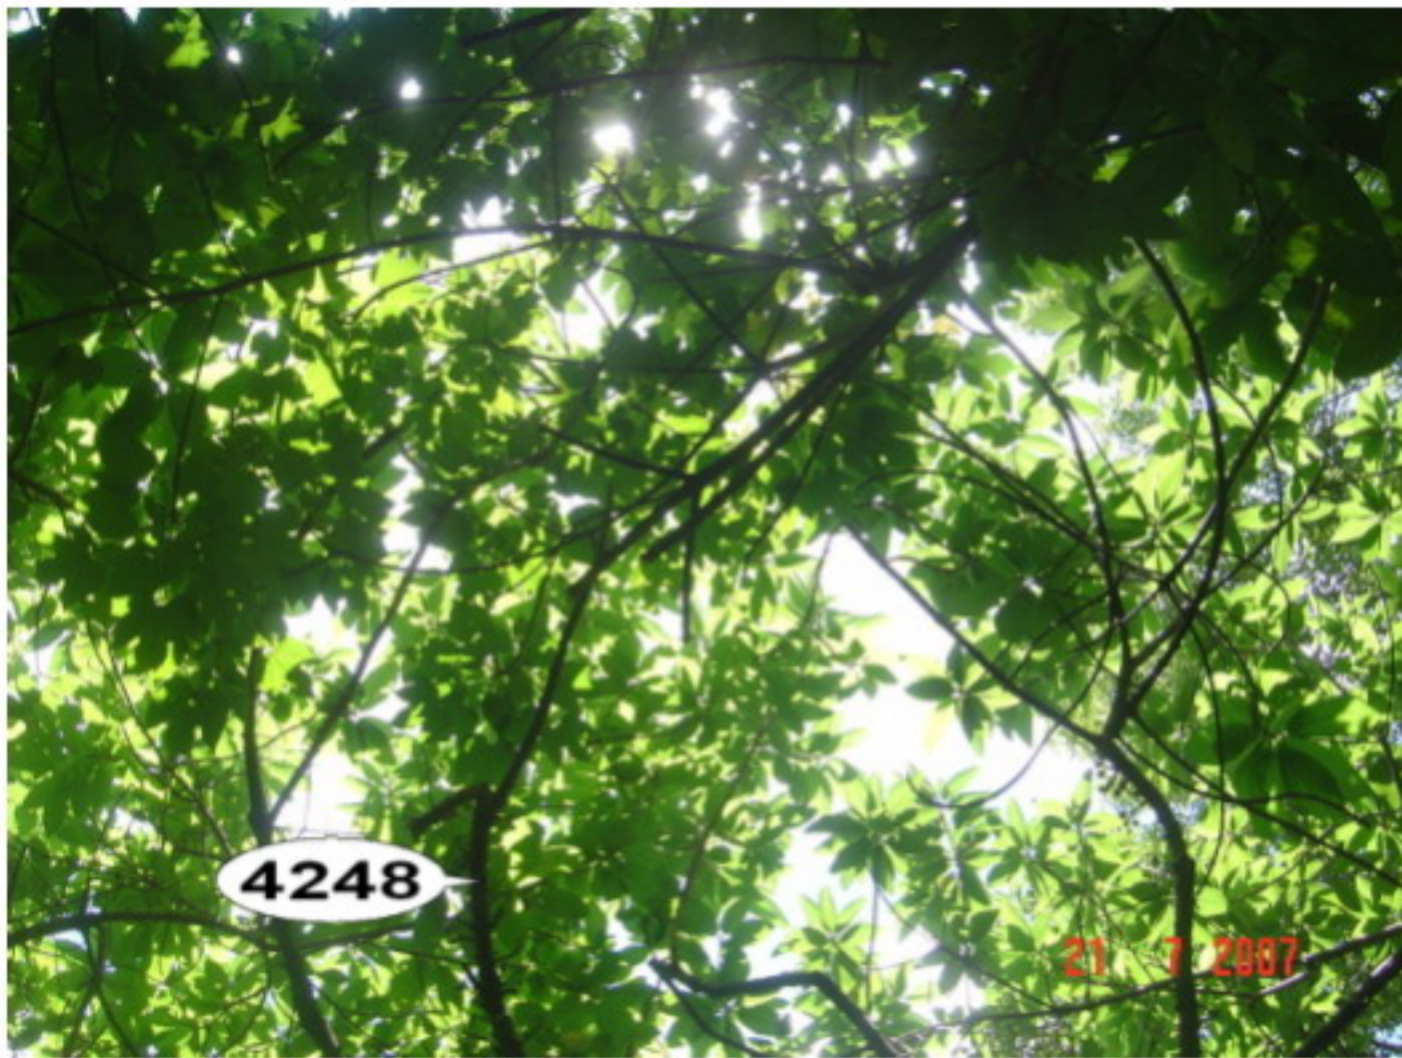
Tree 4248

Poor form which lead to low amenity value. Besides, the tree is unbalance. It may need heavy pruning after transplantaion that will affect its transplantaion survival rate. Moreover, the operation of the transplantaion for poor form tree is also difficult.
