# Provision of Cremators at Wo Hop Shek Crematorium

Tree Survey Report

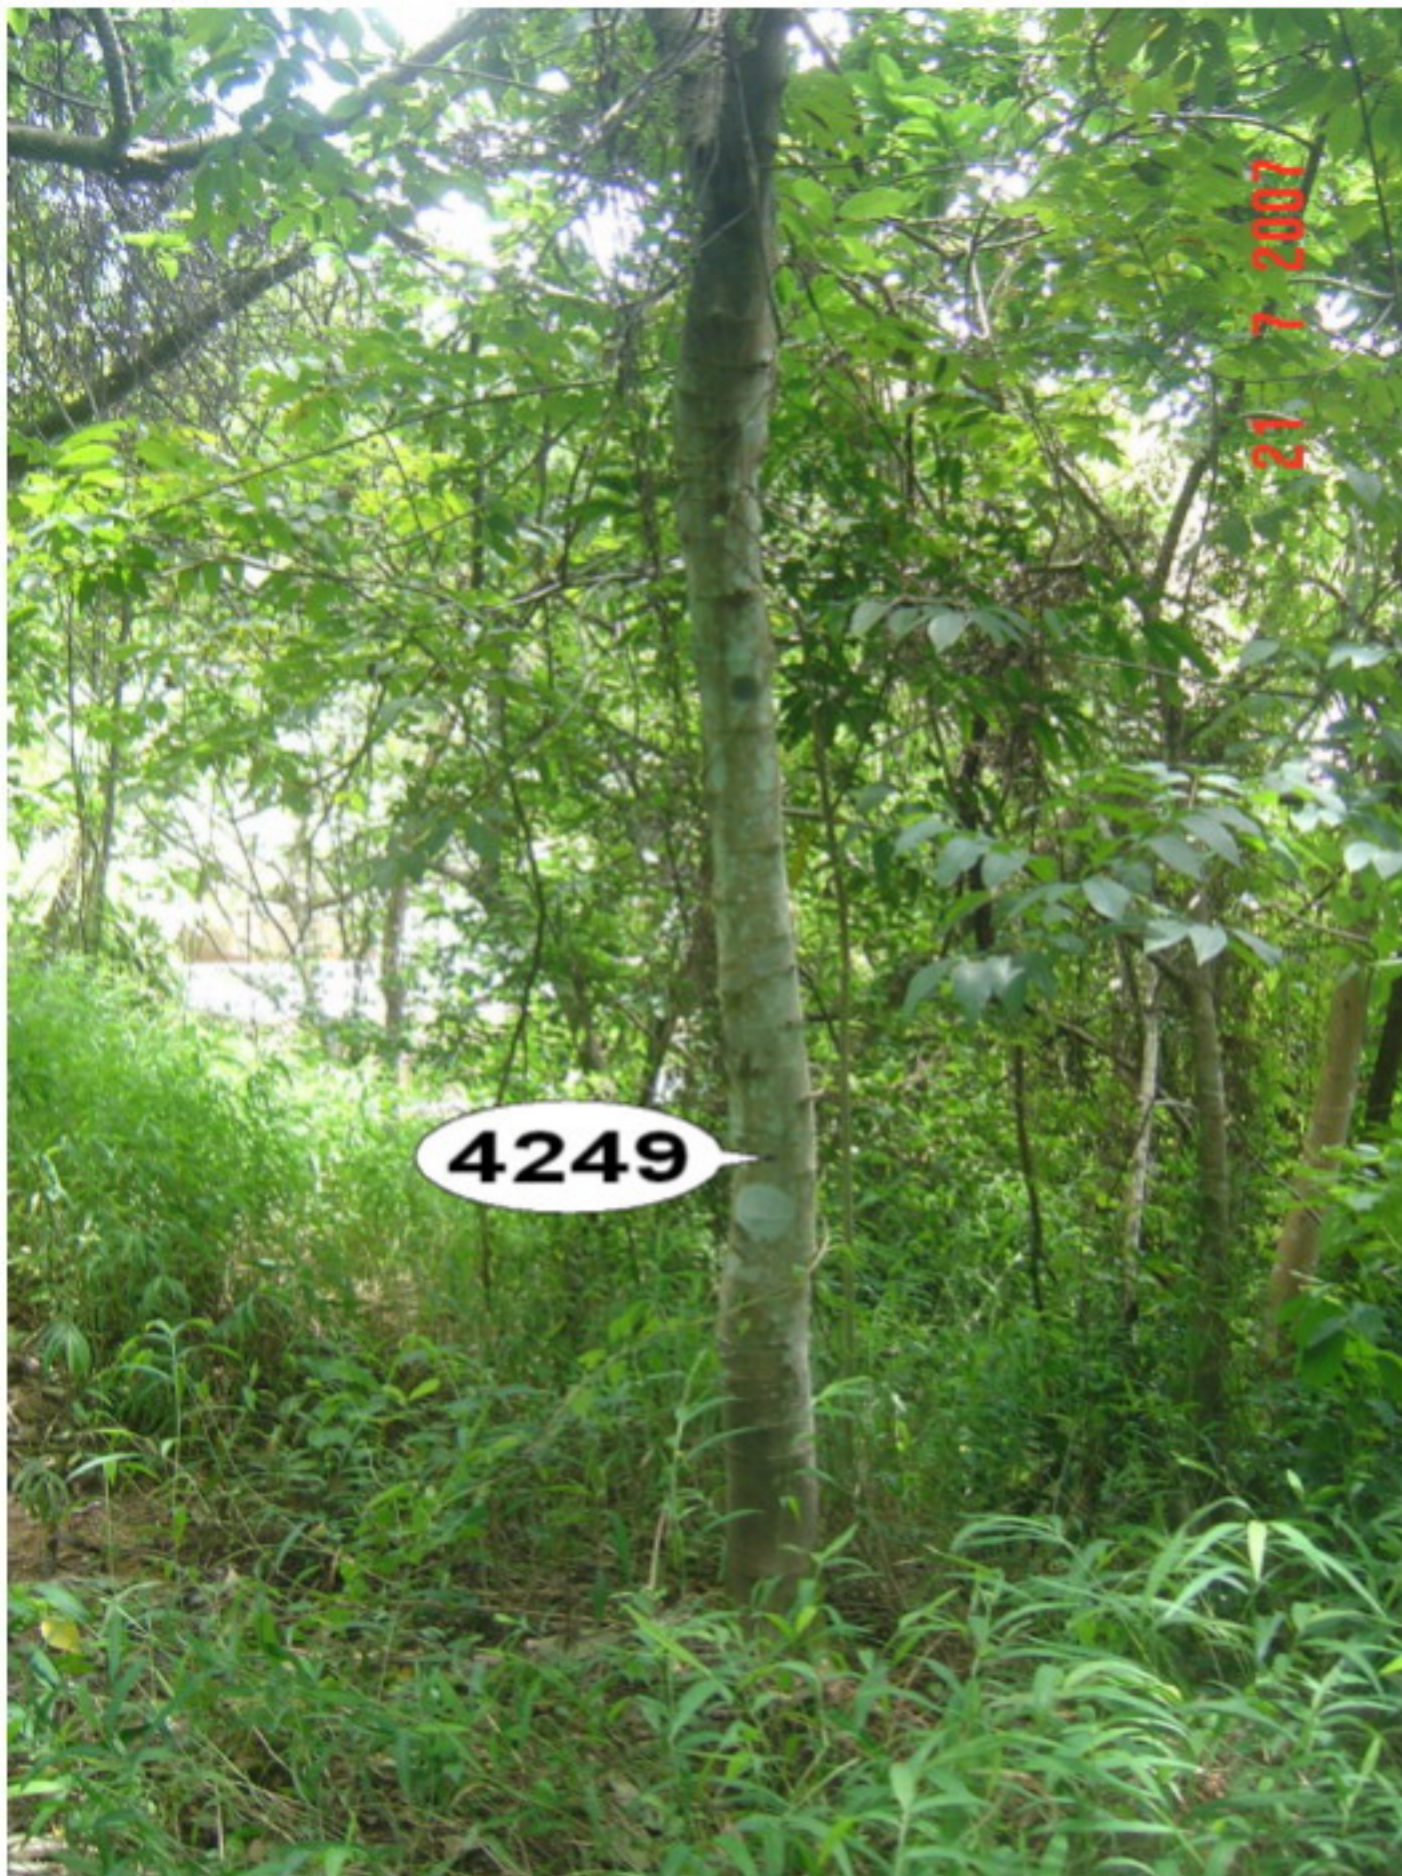
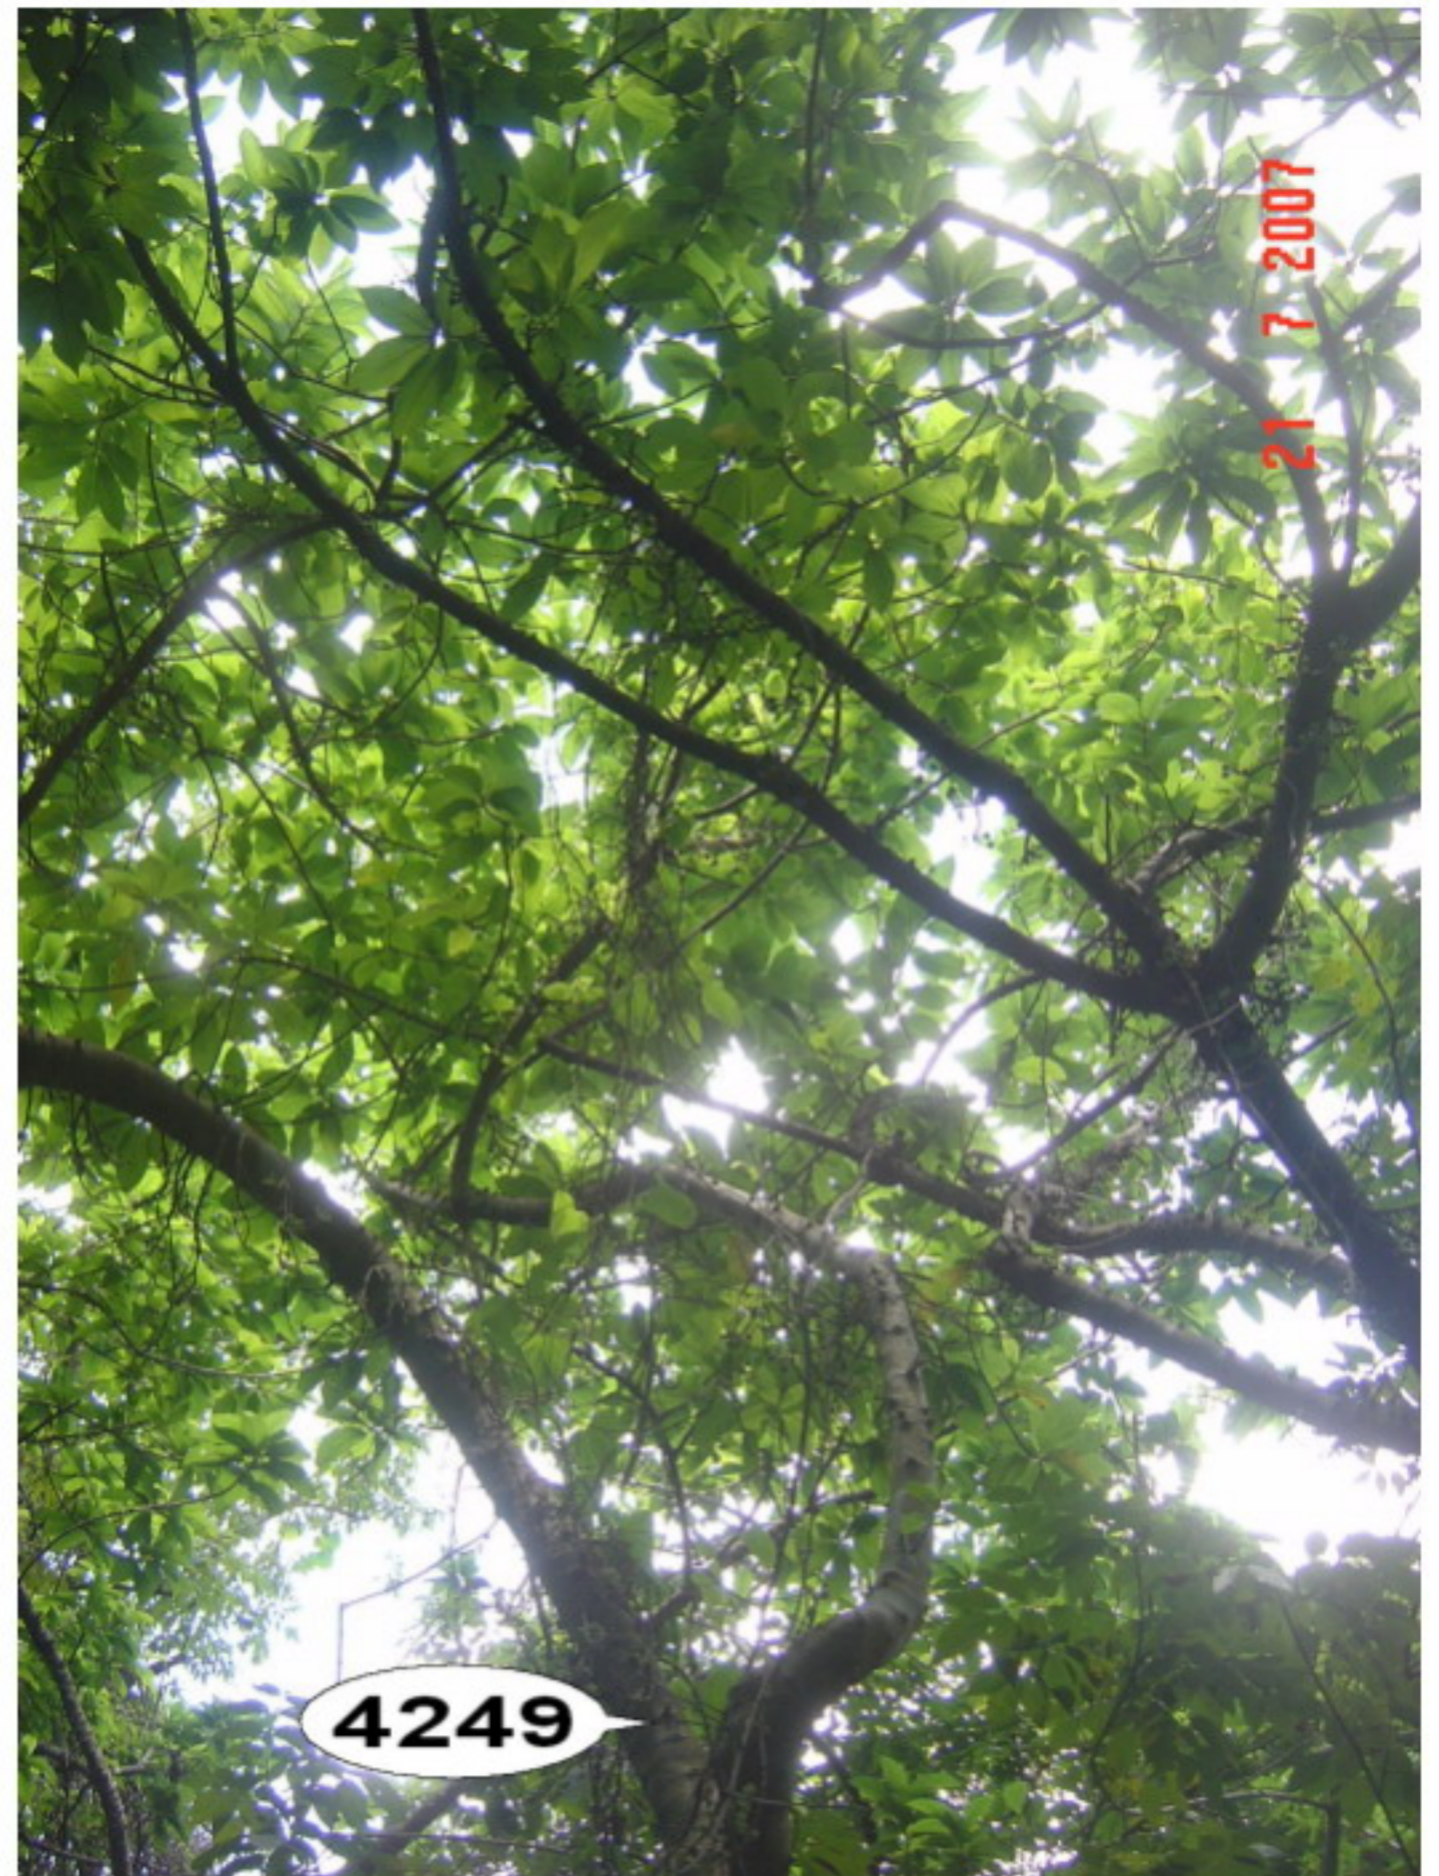
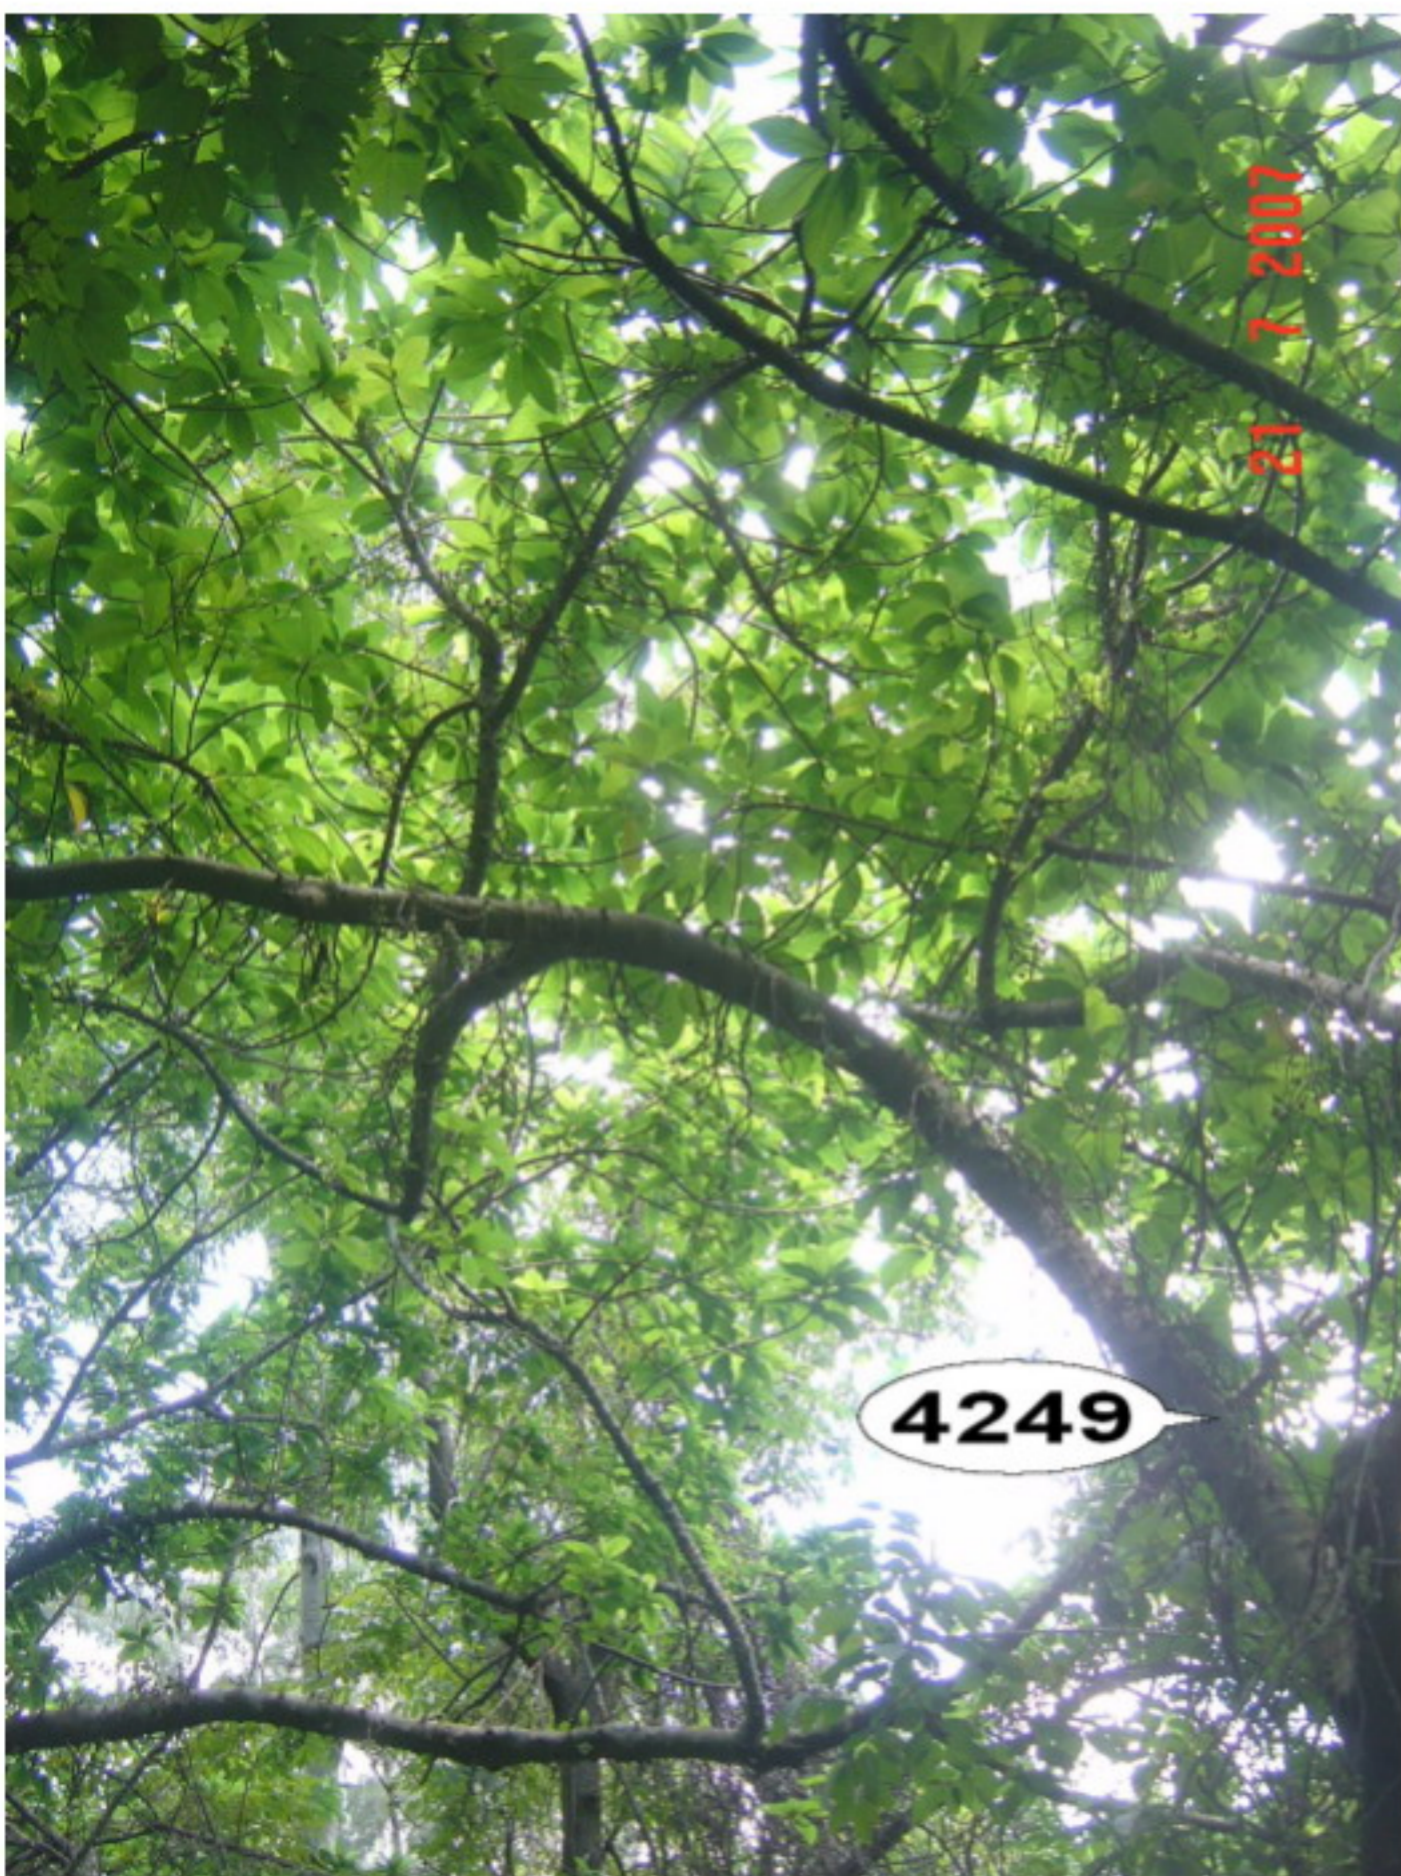
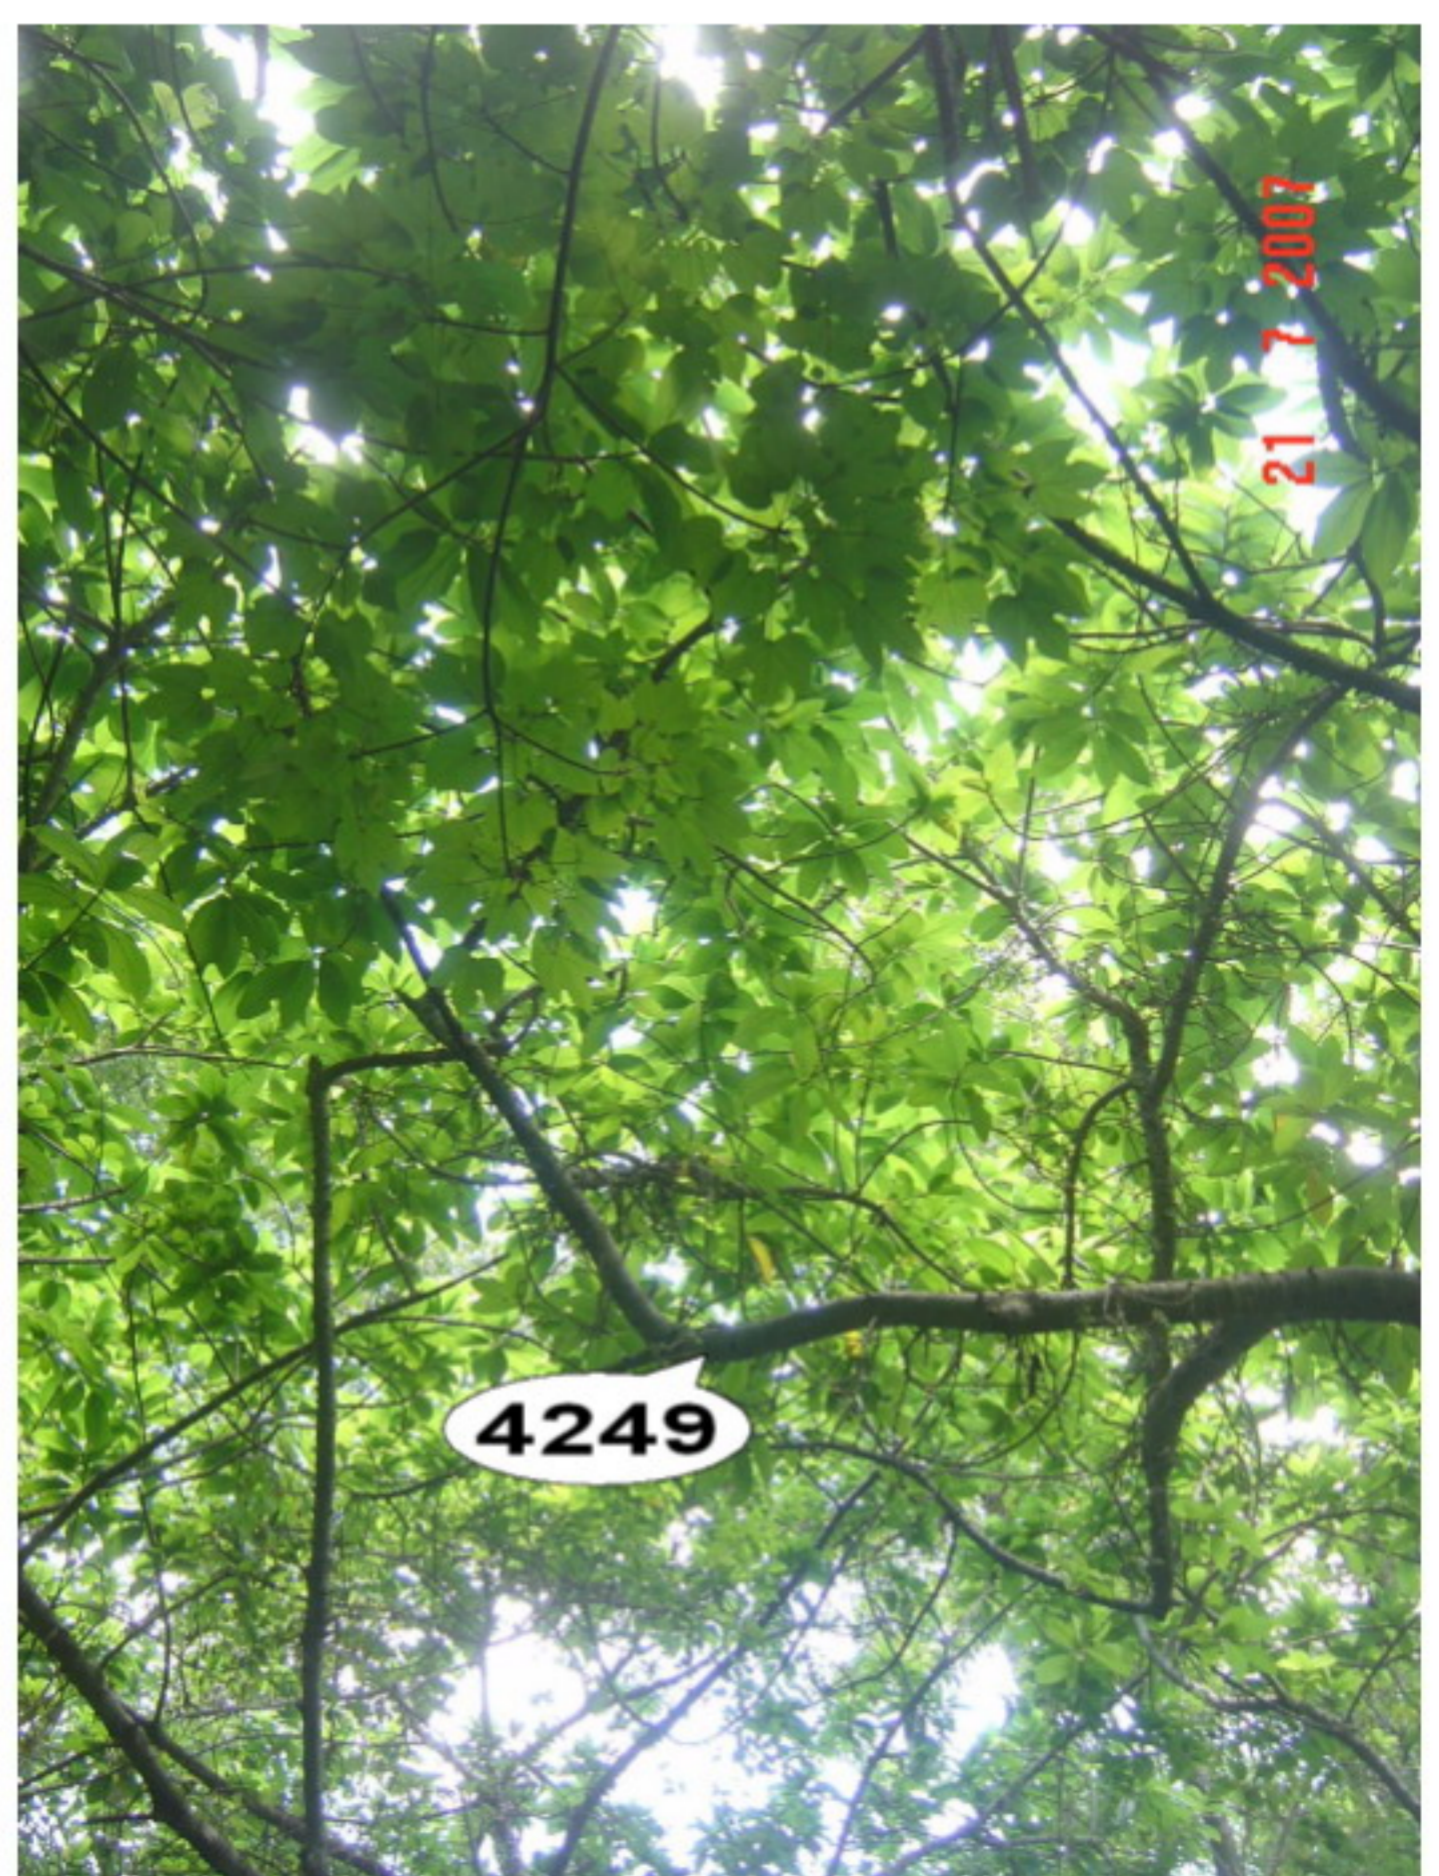
Tree 4248

Poor form which lead to low amenity value. Besides, the tree is unbalance. It may need heavy pruning after transplantation that will affect its transplantation survival rate. Moreover, the operation of the transplation for poor form tree is also difficult.

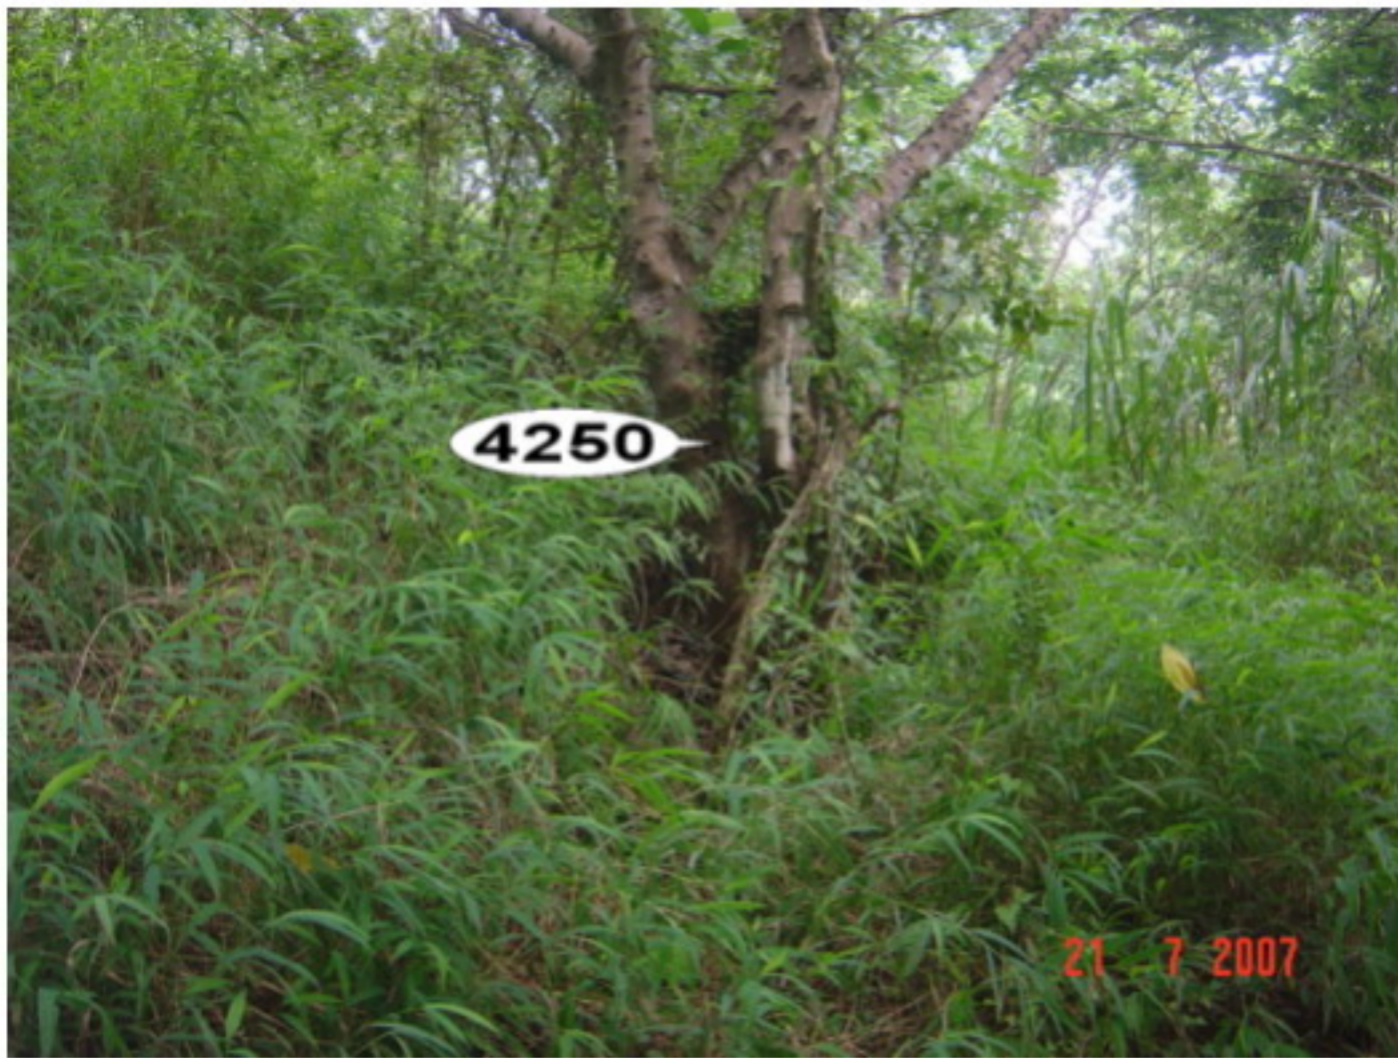
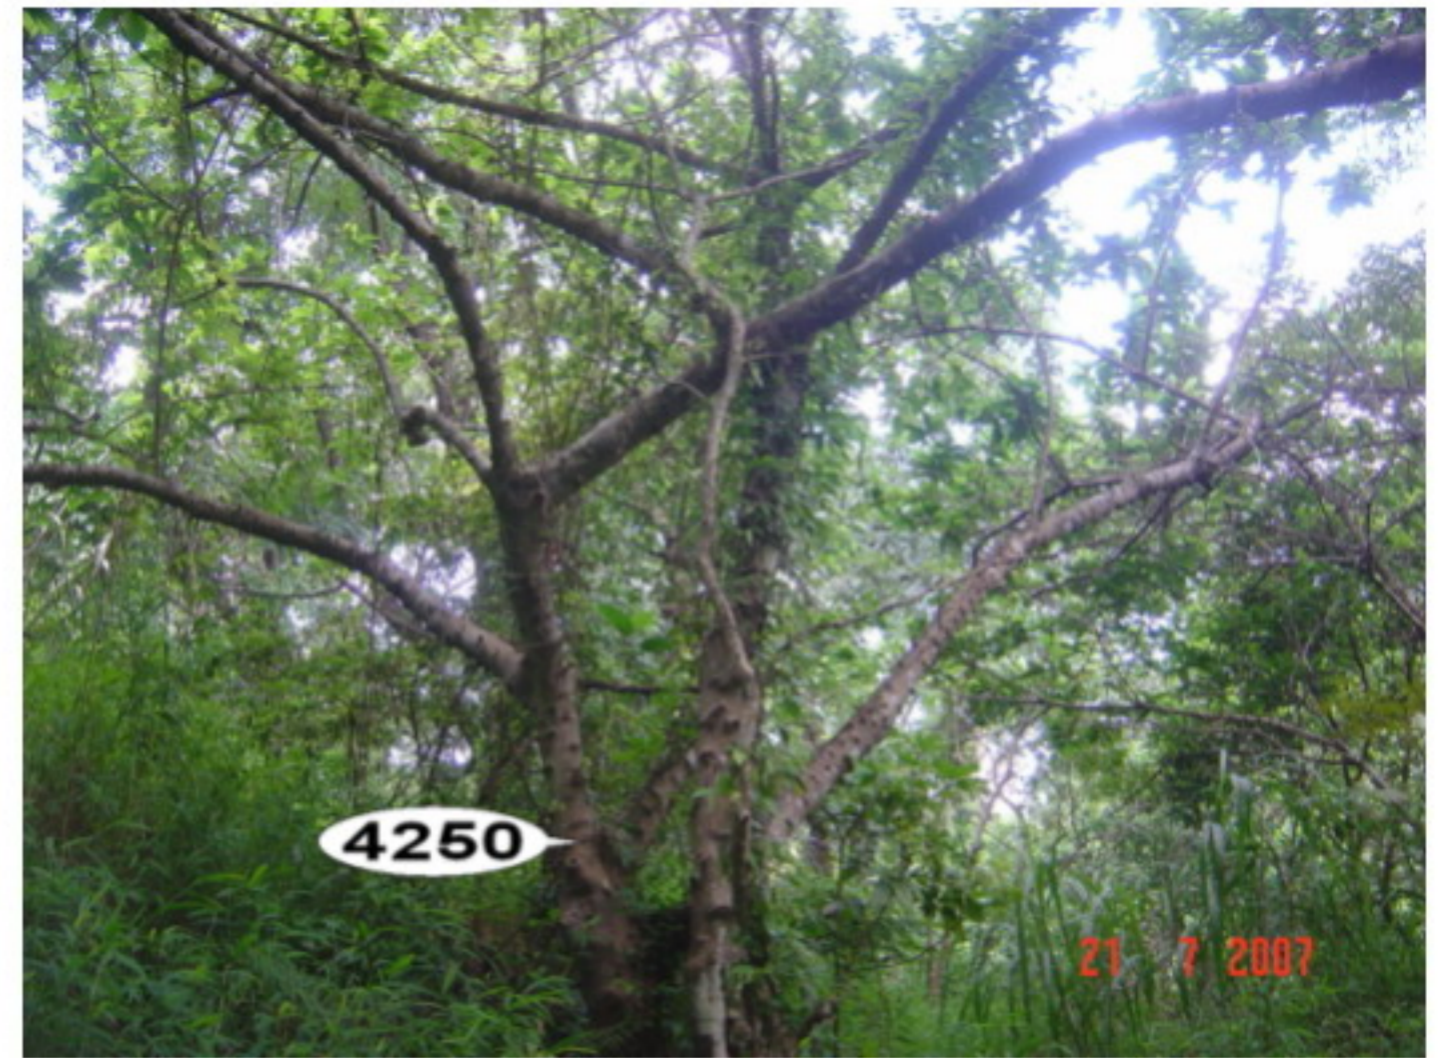
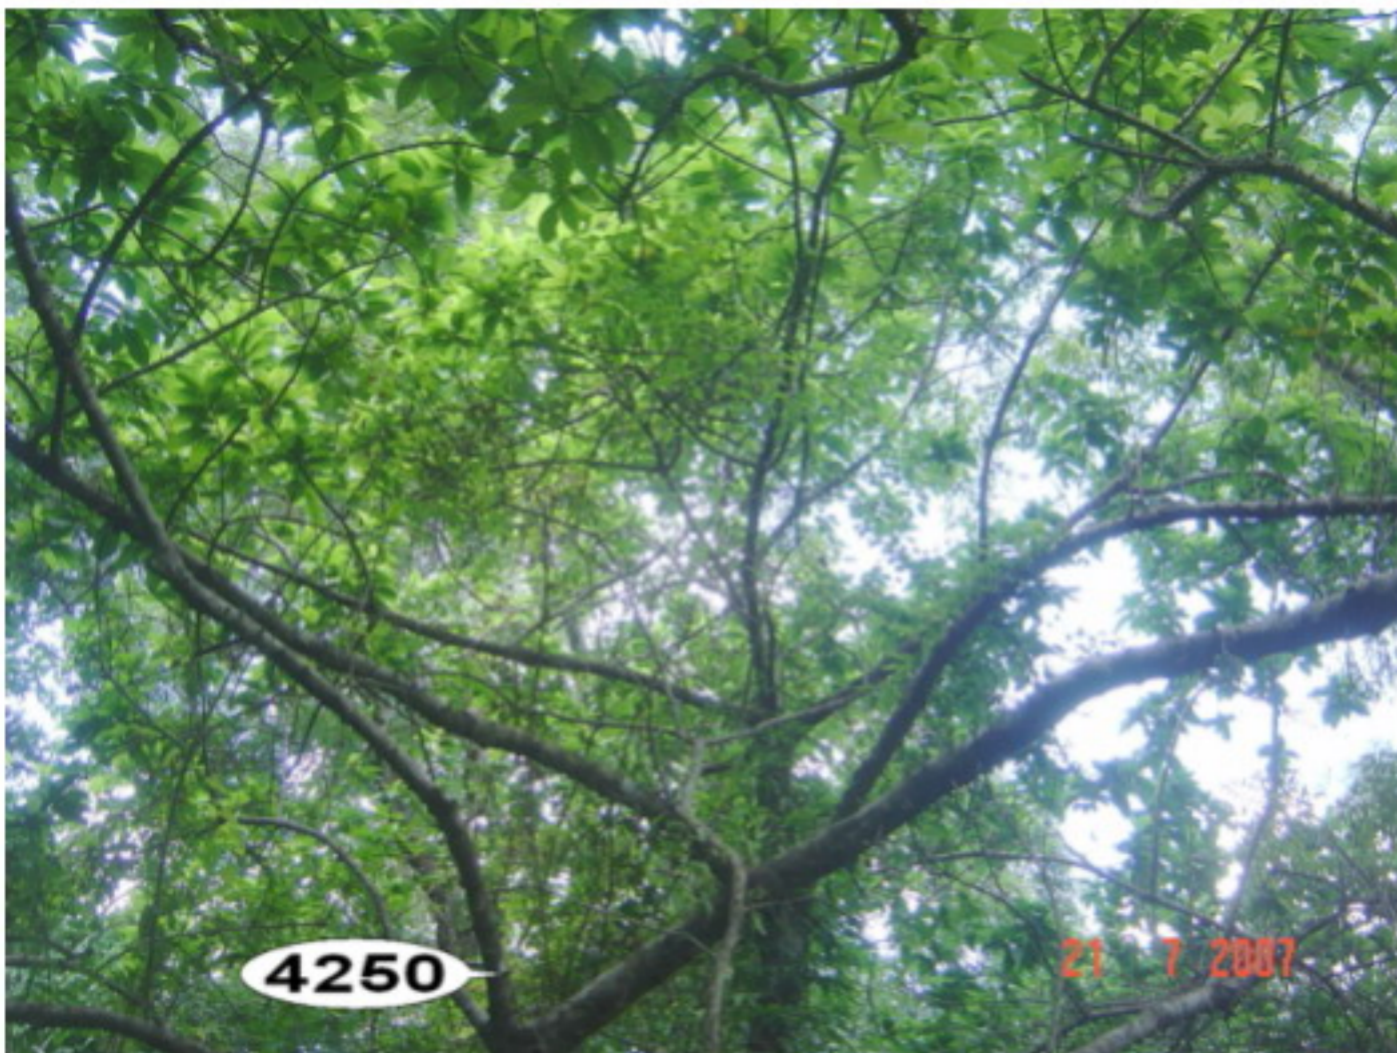
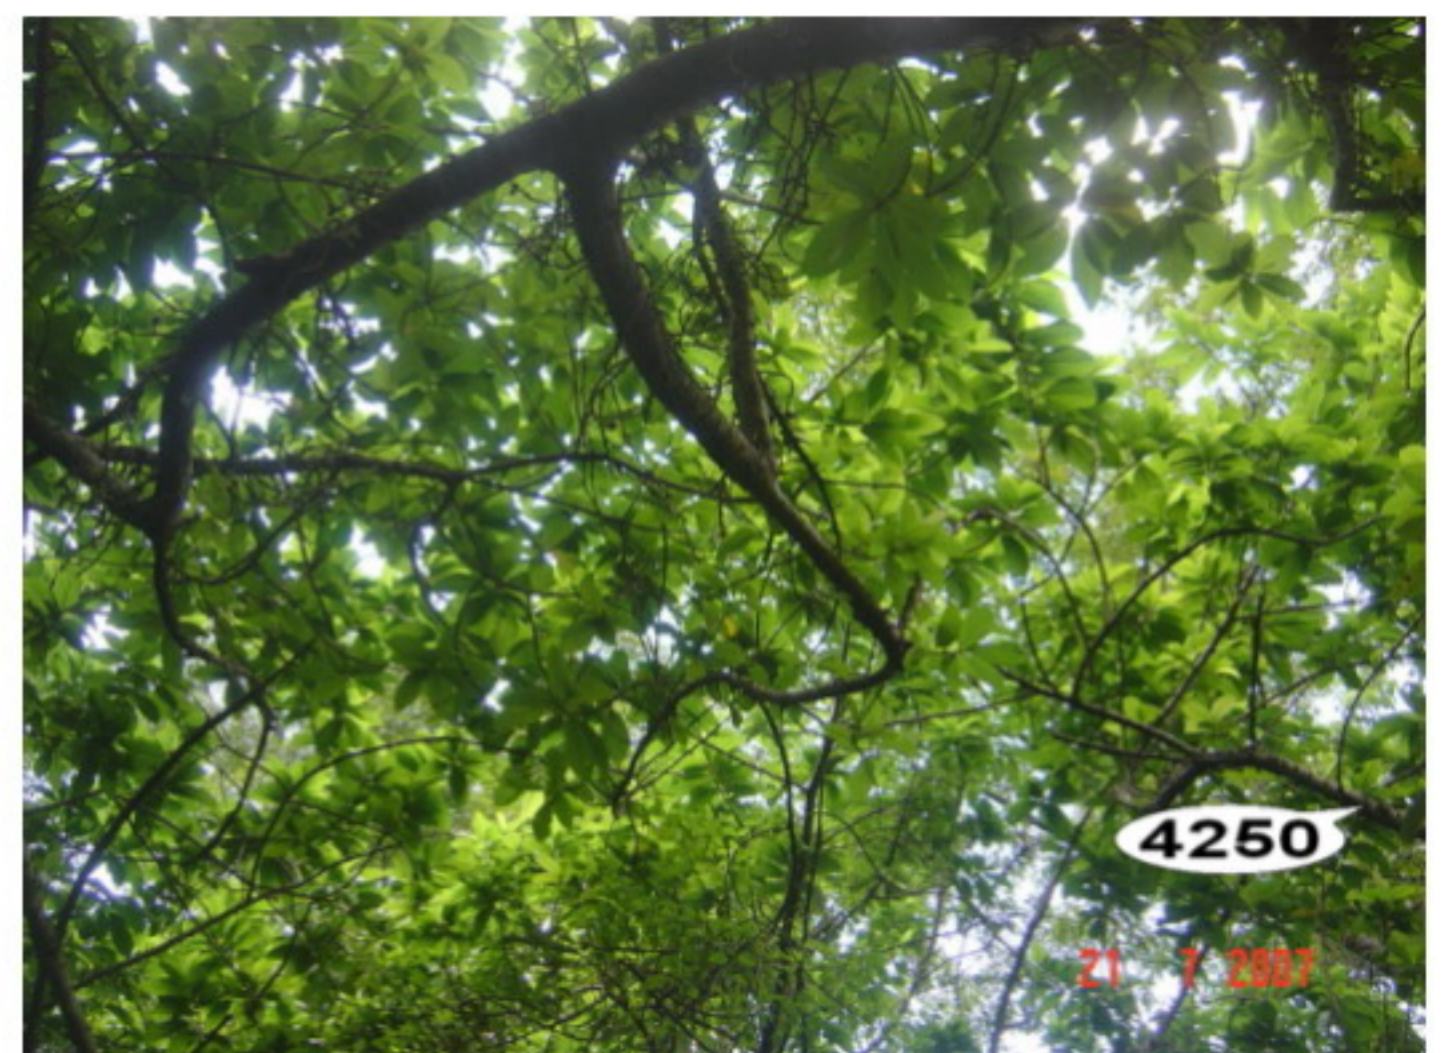
Tree 4249

Poor form which lead to low amenity value. Besides, the tree is unbalance. It may need heavy pruning after transplantation that will affect its transplantation survival rate. Moreover, the operation of the transplantation for poor form tree is also difficult.

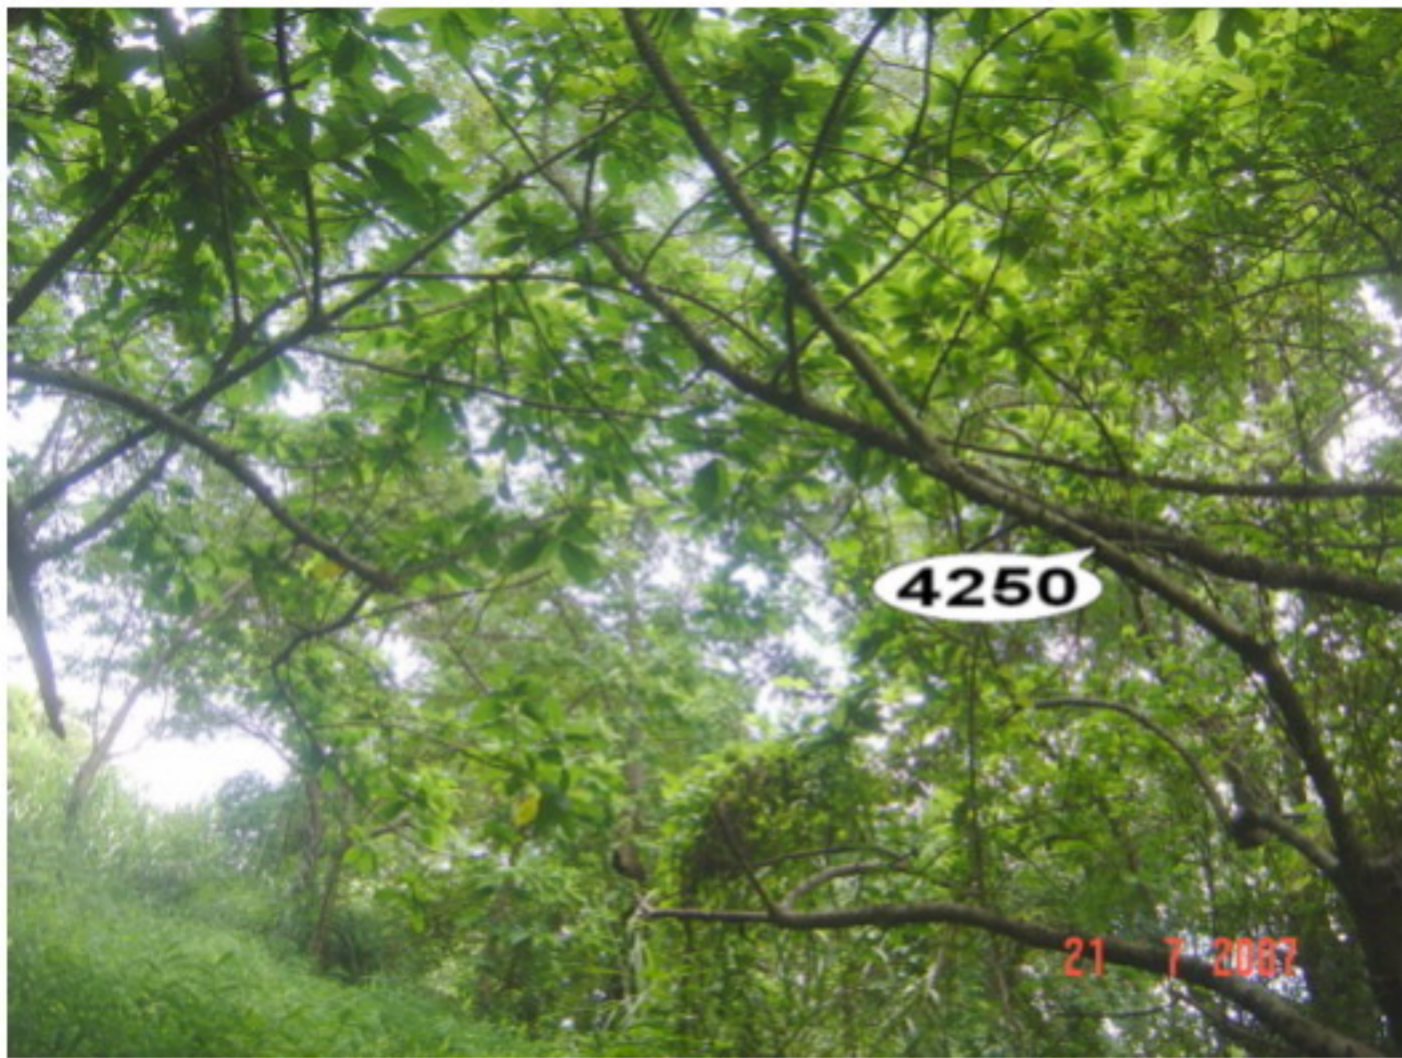
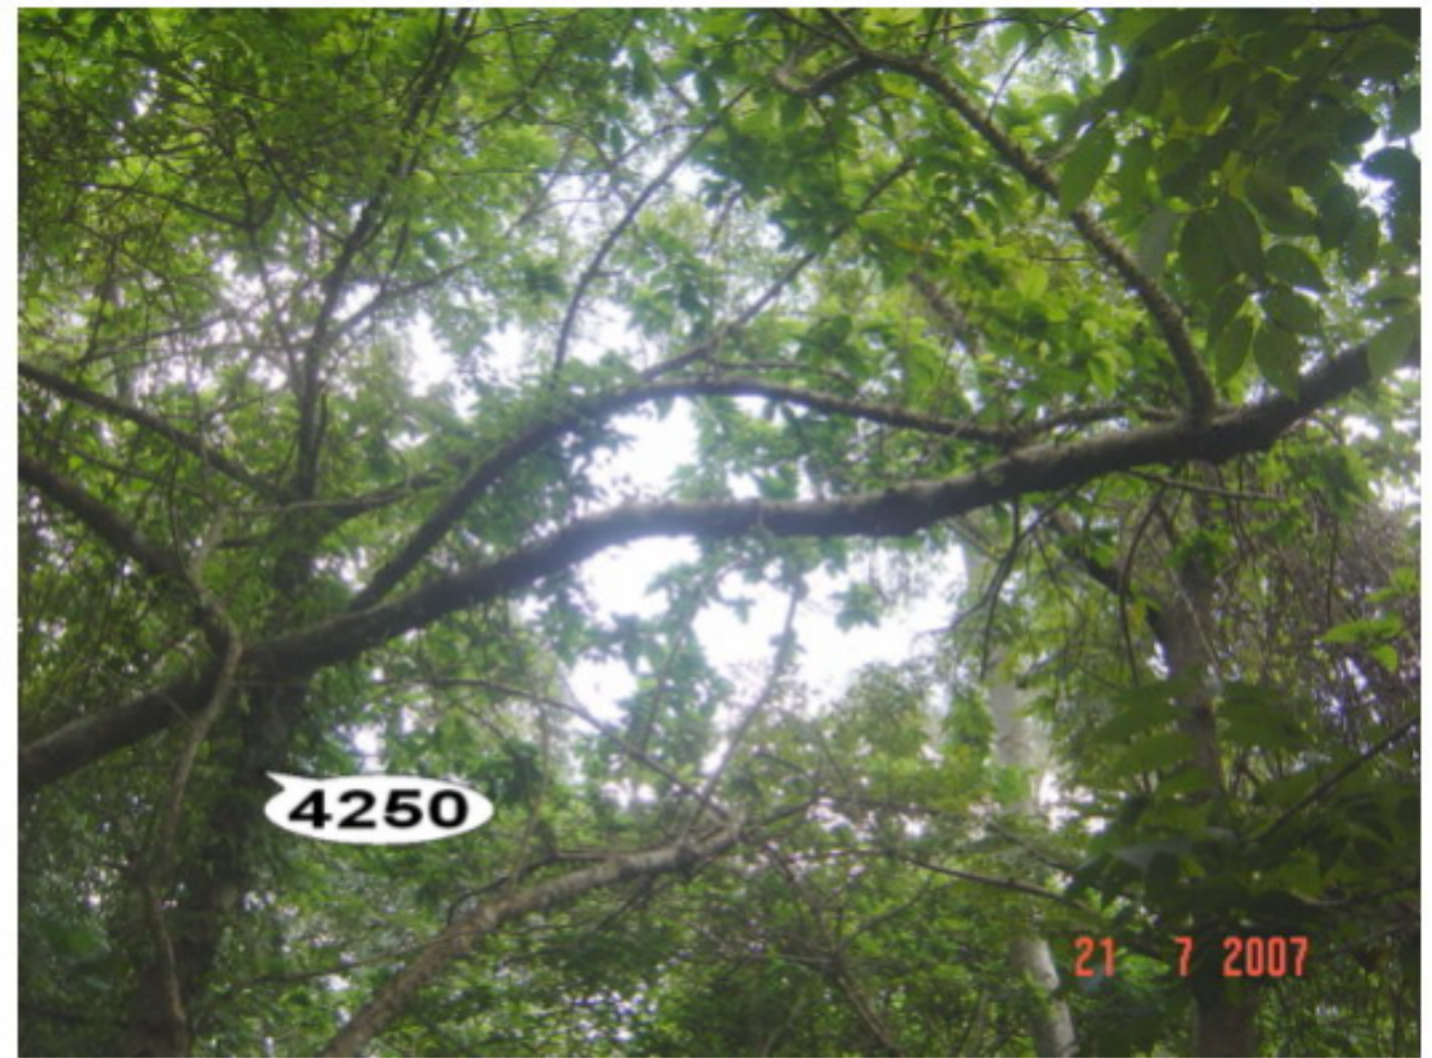
#### Tree 4250

Poor form which lead to low amenity value. Besides, the tree is unbalance. It may need heavy pruning after transplantation that will affect its transplantation survival rate. Moreover, the operation of the transplention for poor form tree is also difficult.
