# Provision of Cremators at Wo Hop Shek Crematorium

Tree Survey Report

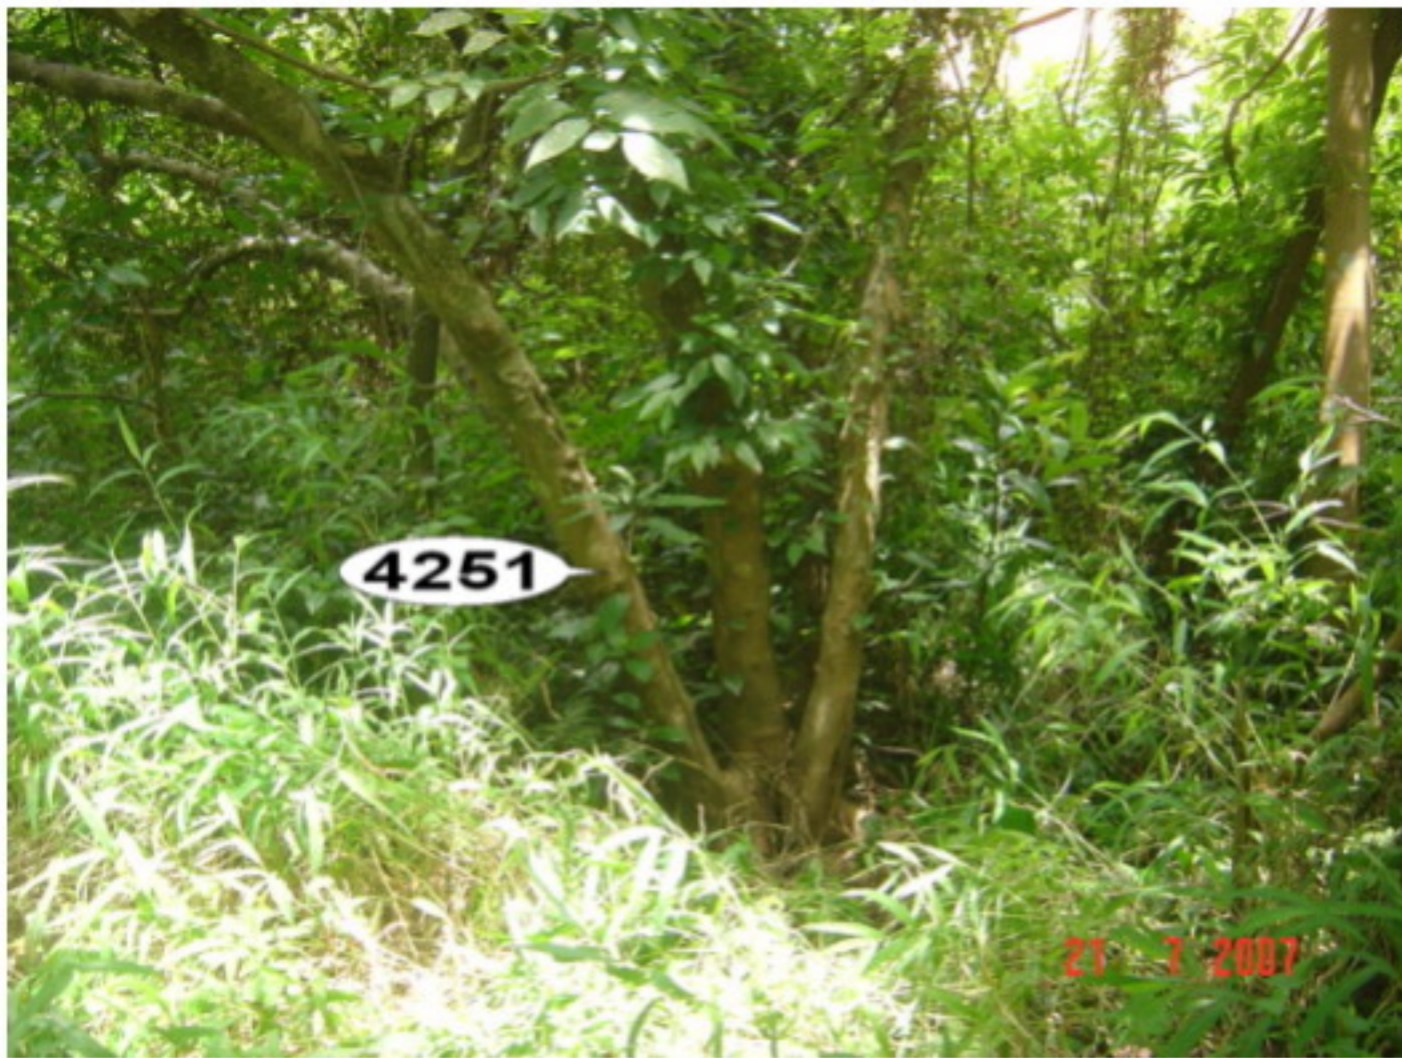
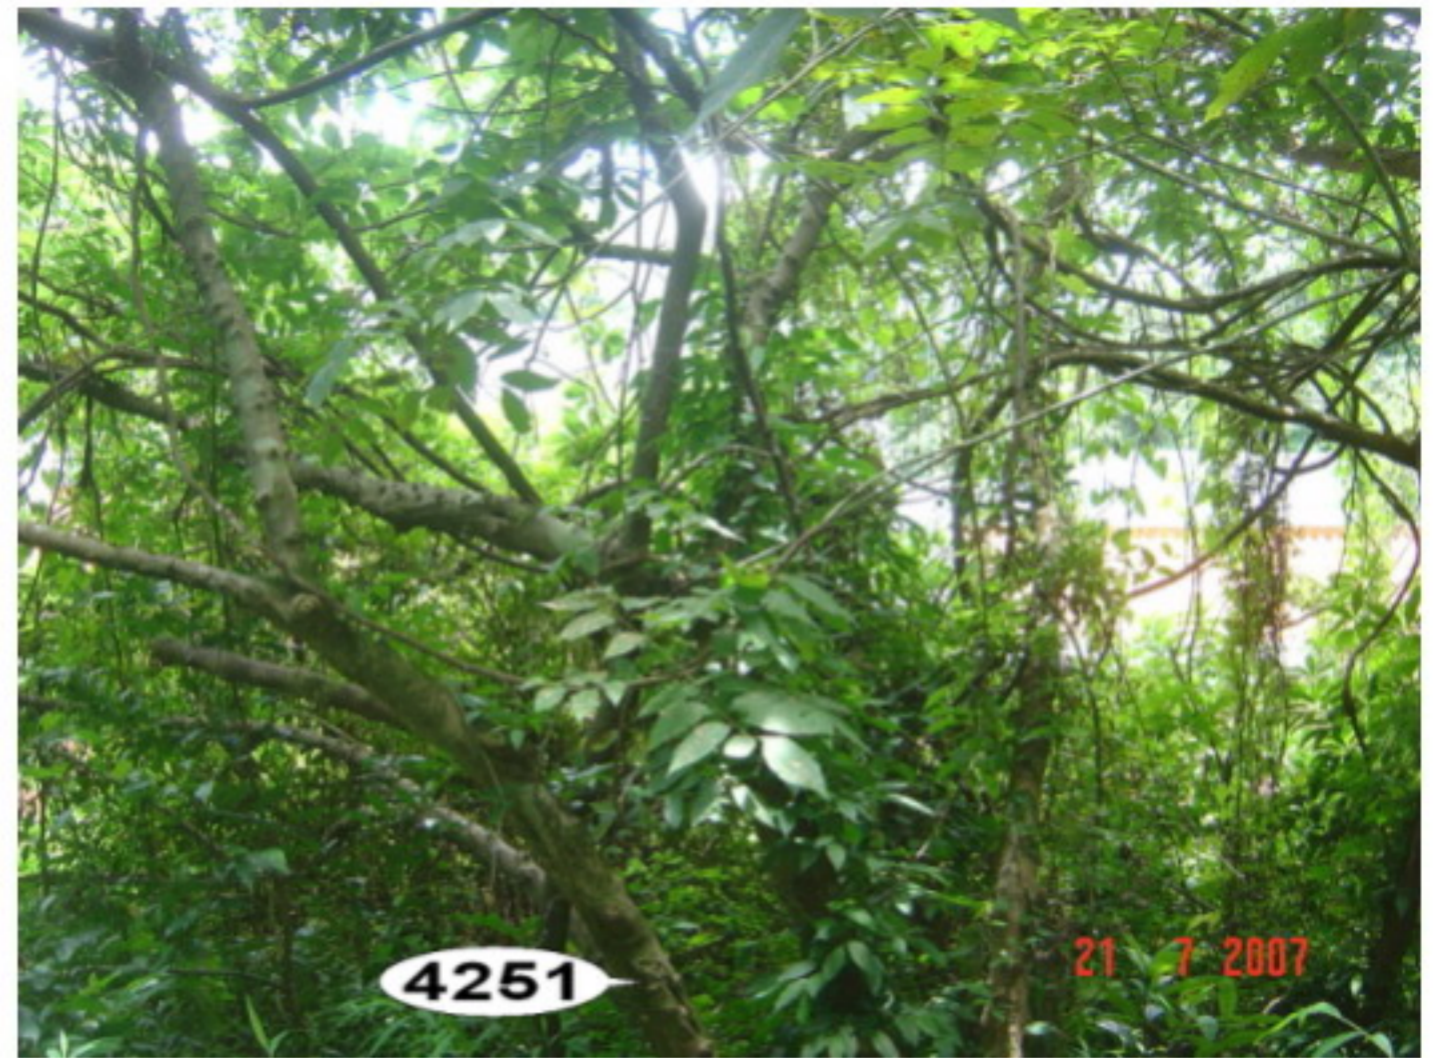
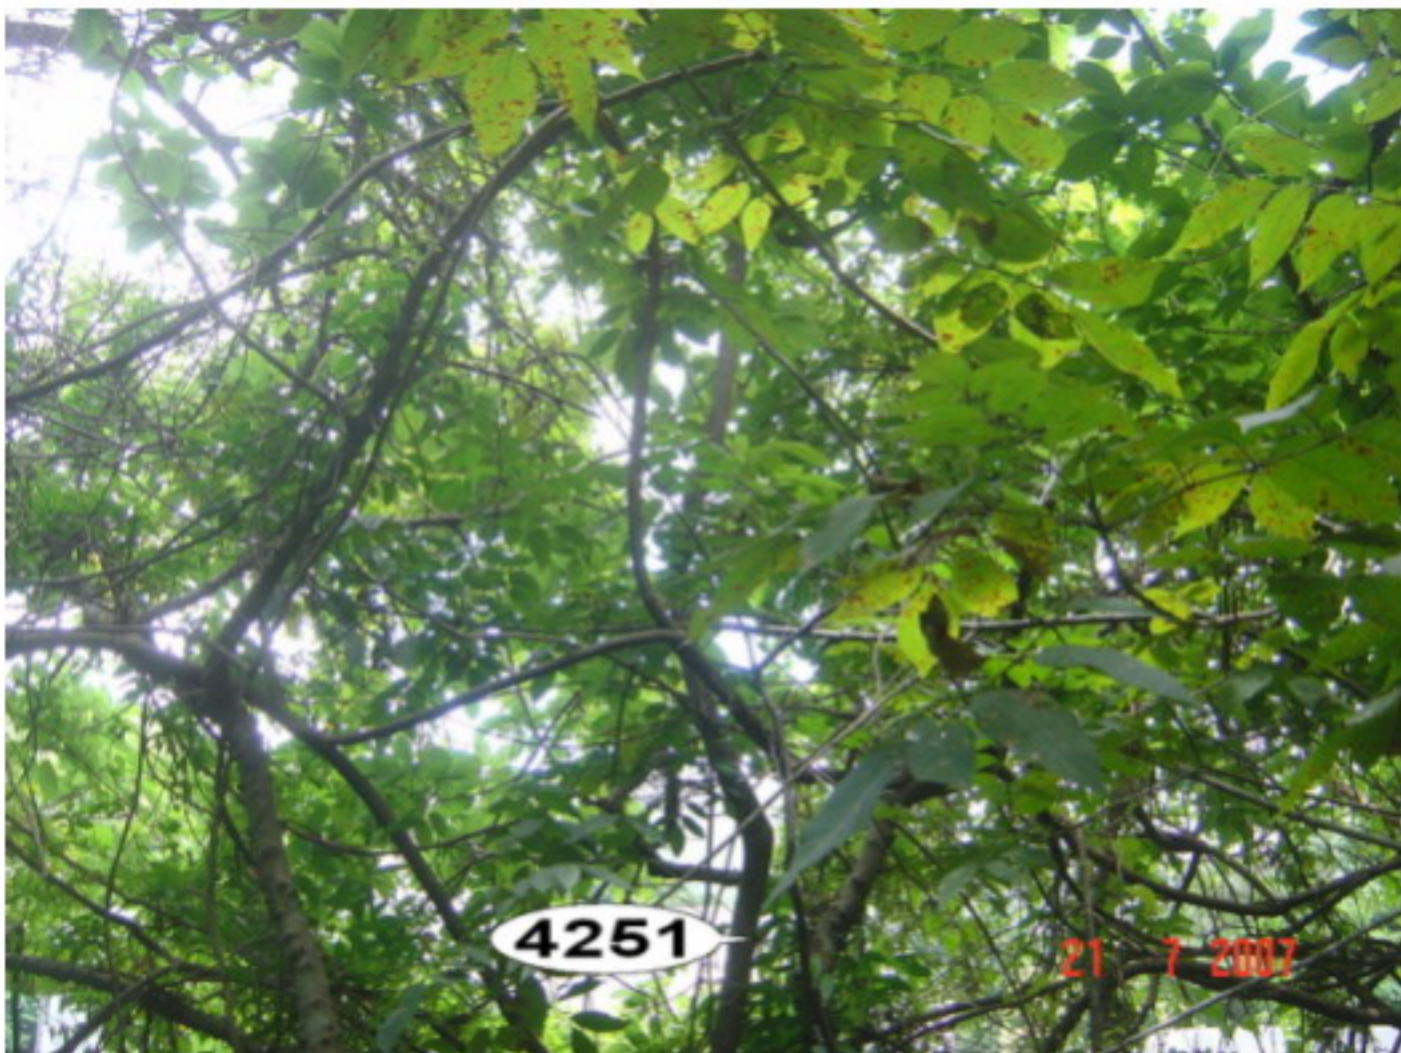
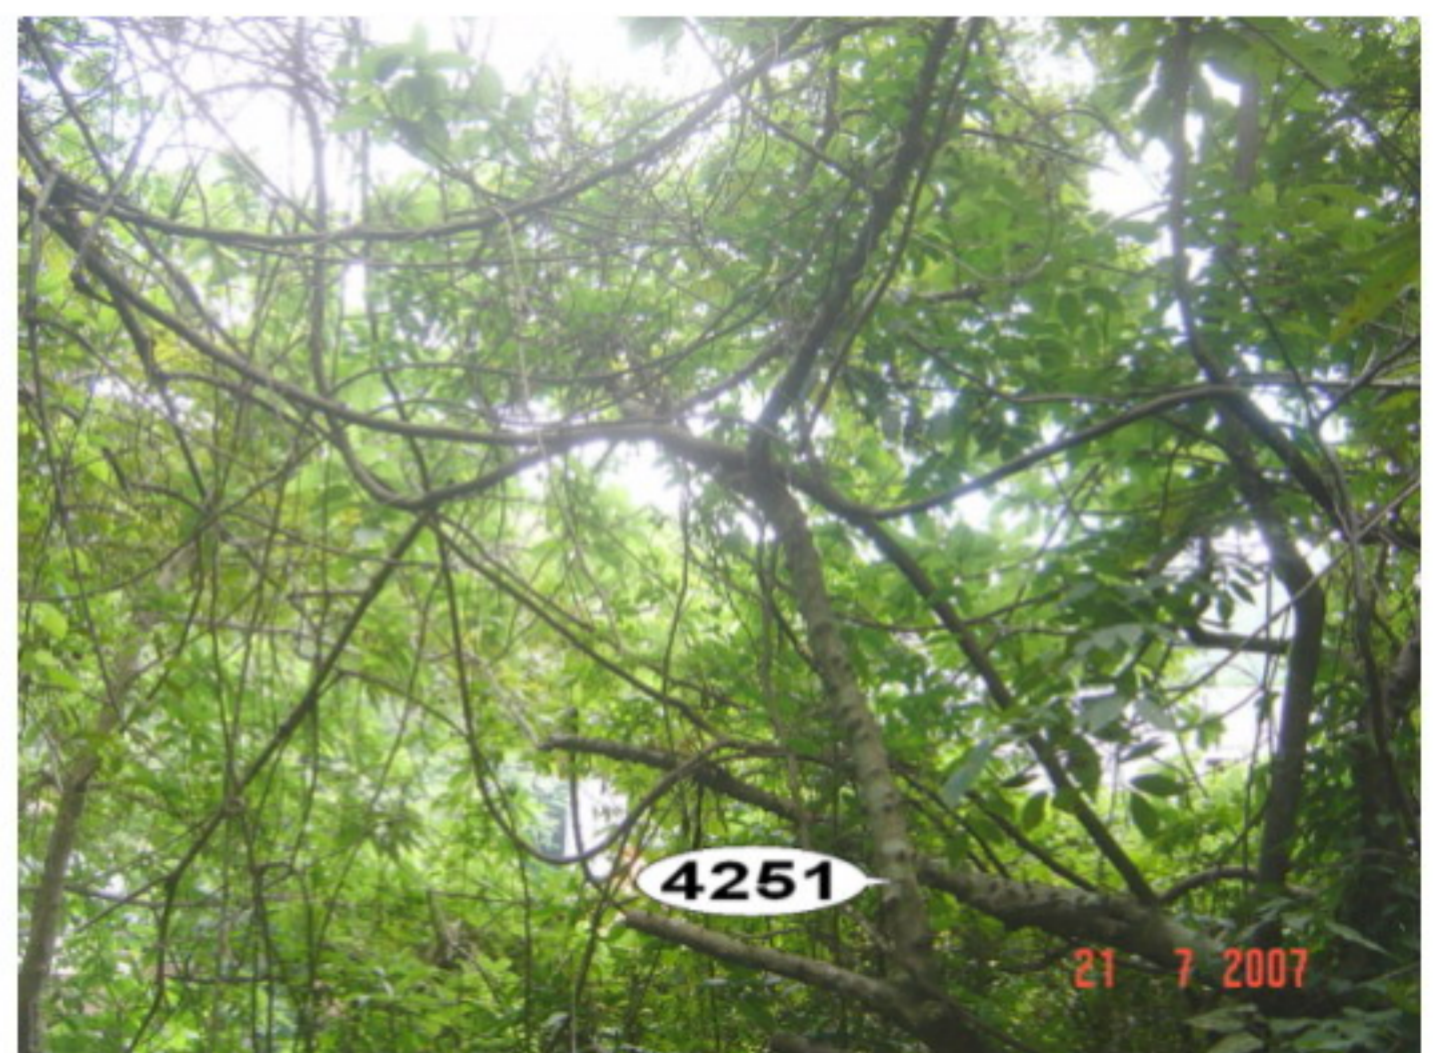
Tree 4250

Poor form which lead to low amenity value. Besides, the tree is unbalance. It may need heavy pruning after transplantation that will affect its transplantation survival rate. Moreover, the operation of the transplantation for poor form tree is also difficult.

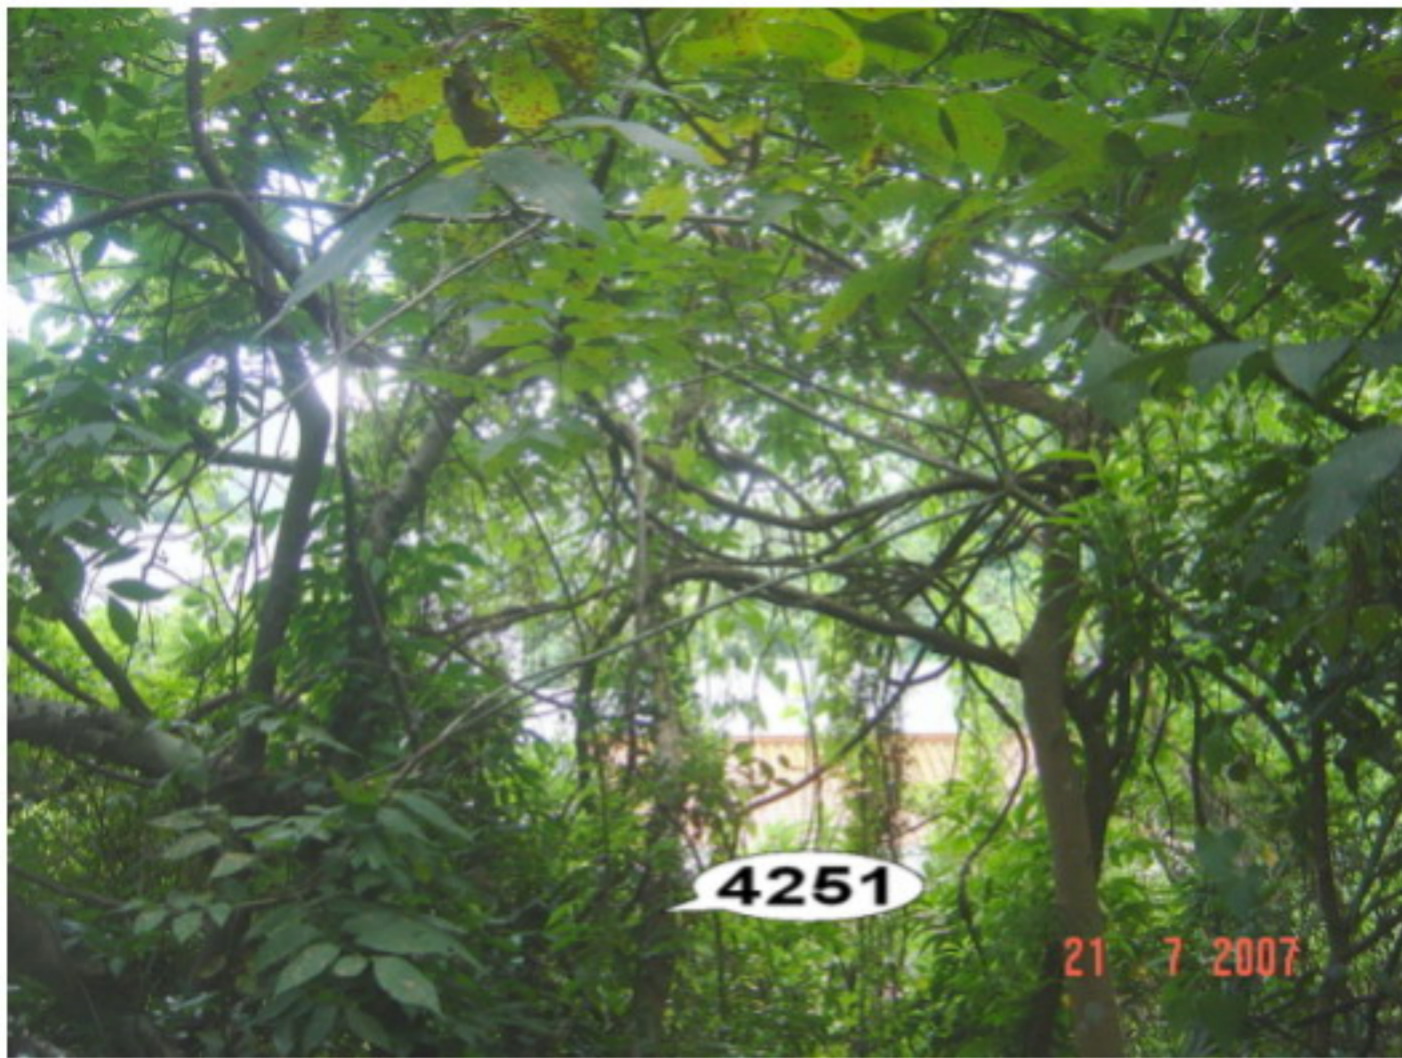
#### Tree 4251

Poor form which lead to low amenity value. Besides, the tree is unbalance. It may need heavy pruning after transplantaion that will affect its transplantaion survival rate. Moreover, the operation of the transplantaion for poor form tree is also difficult.

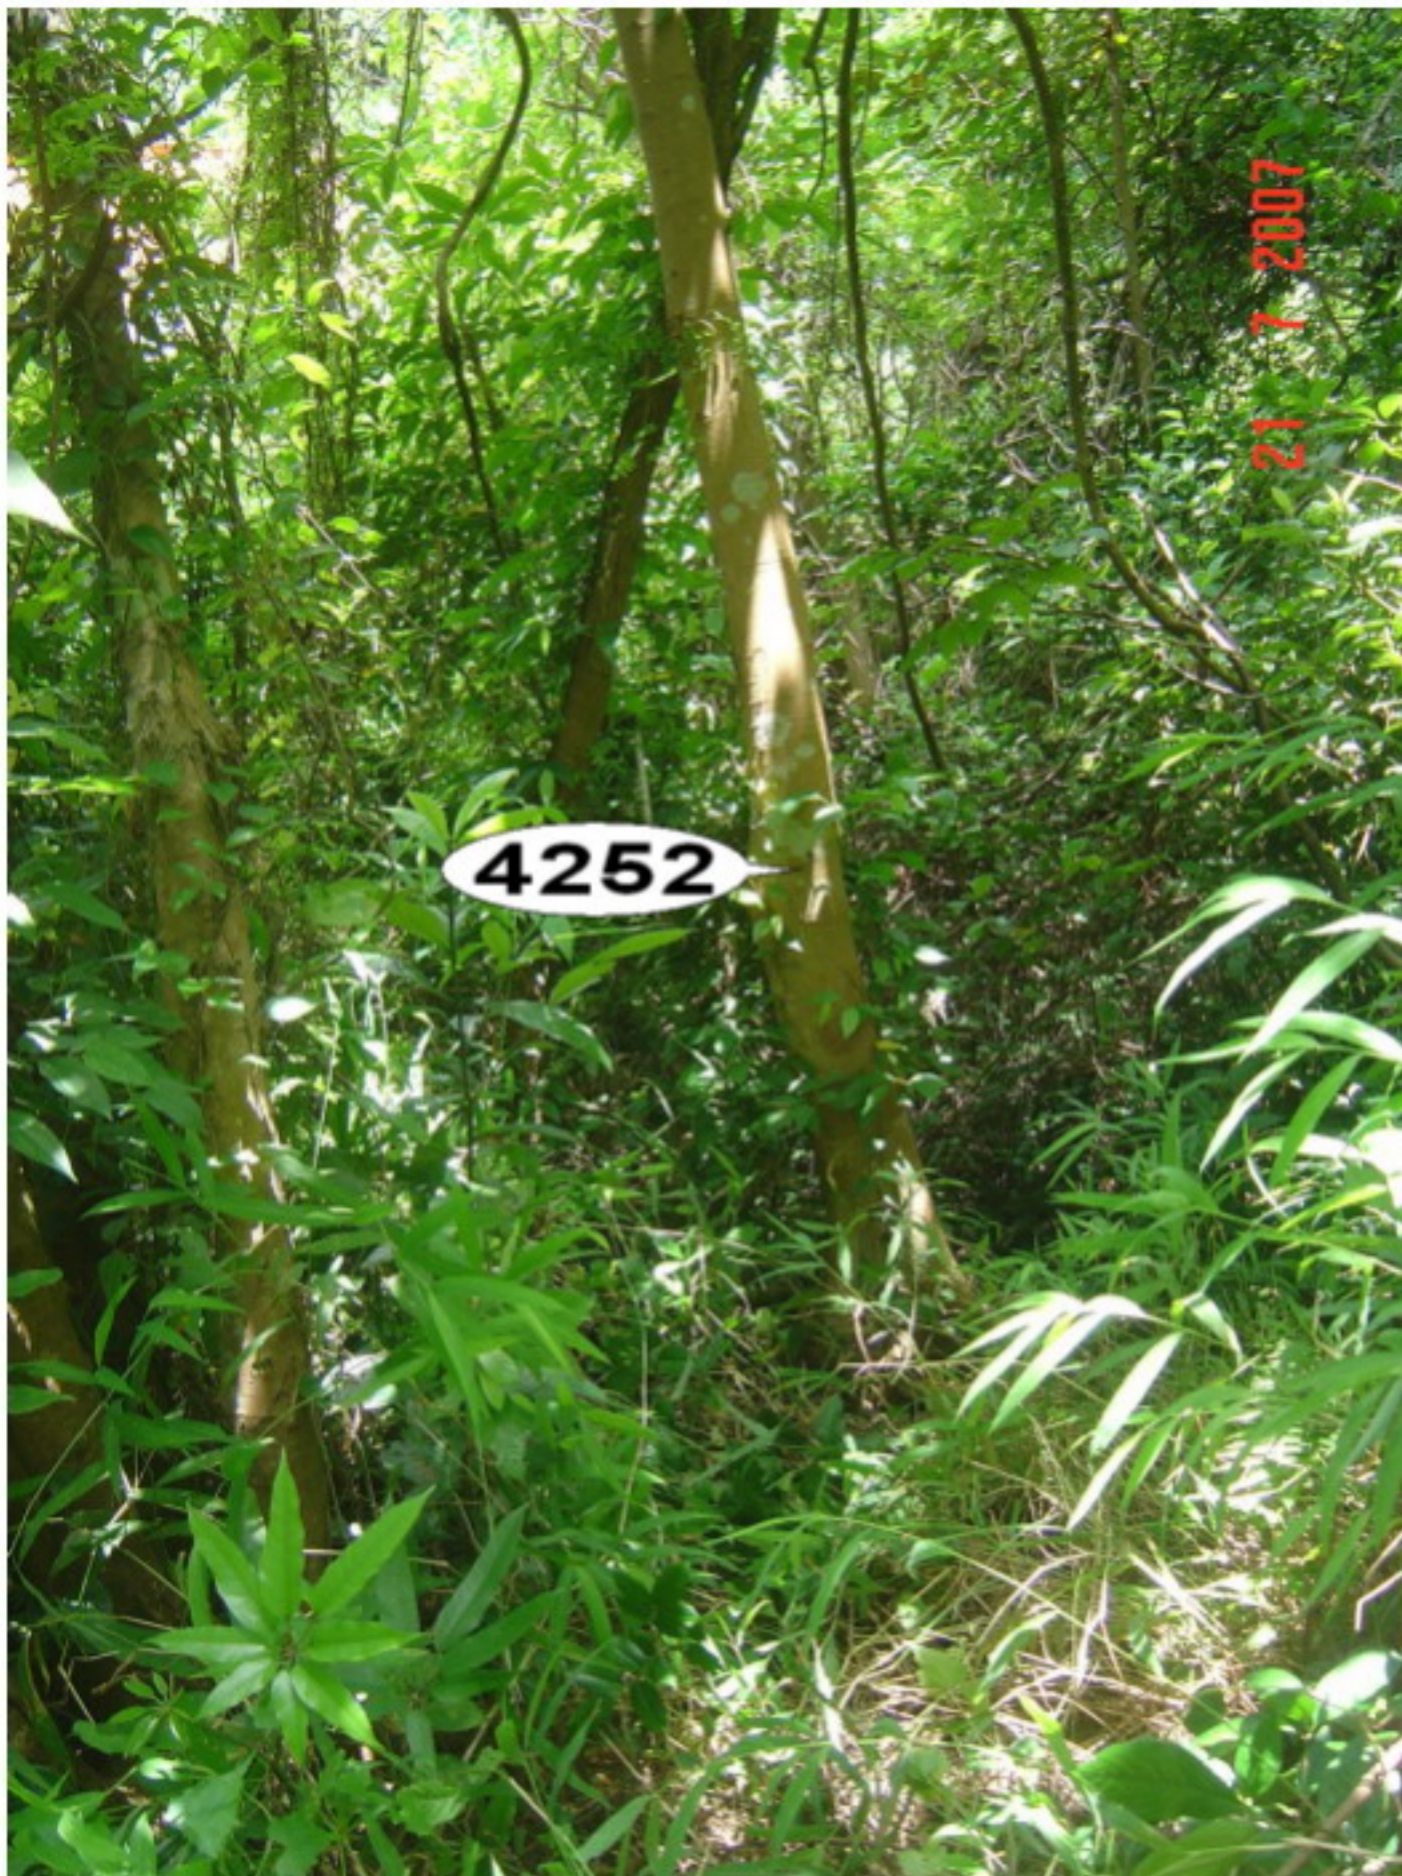
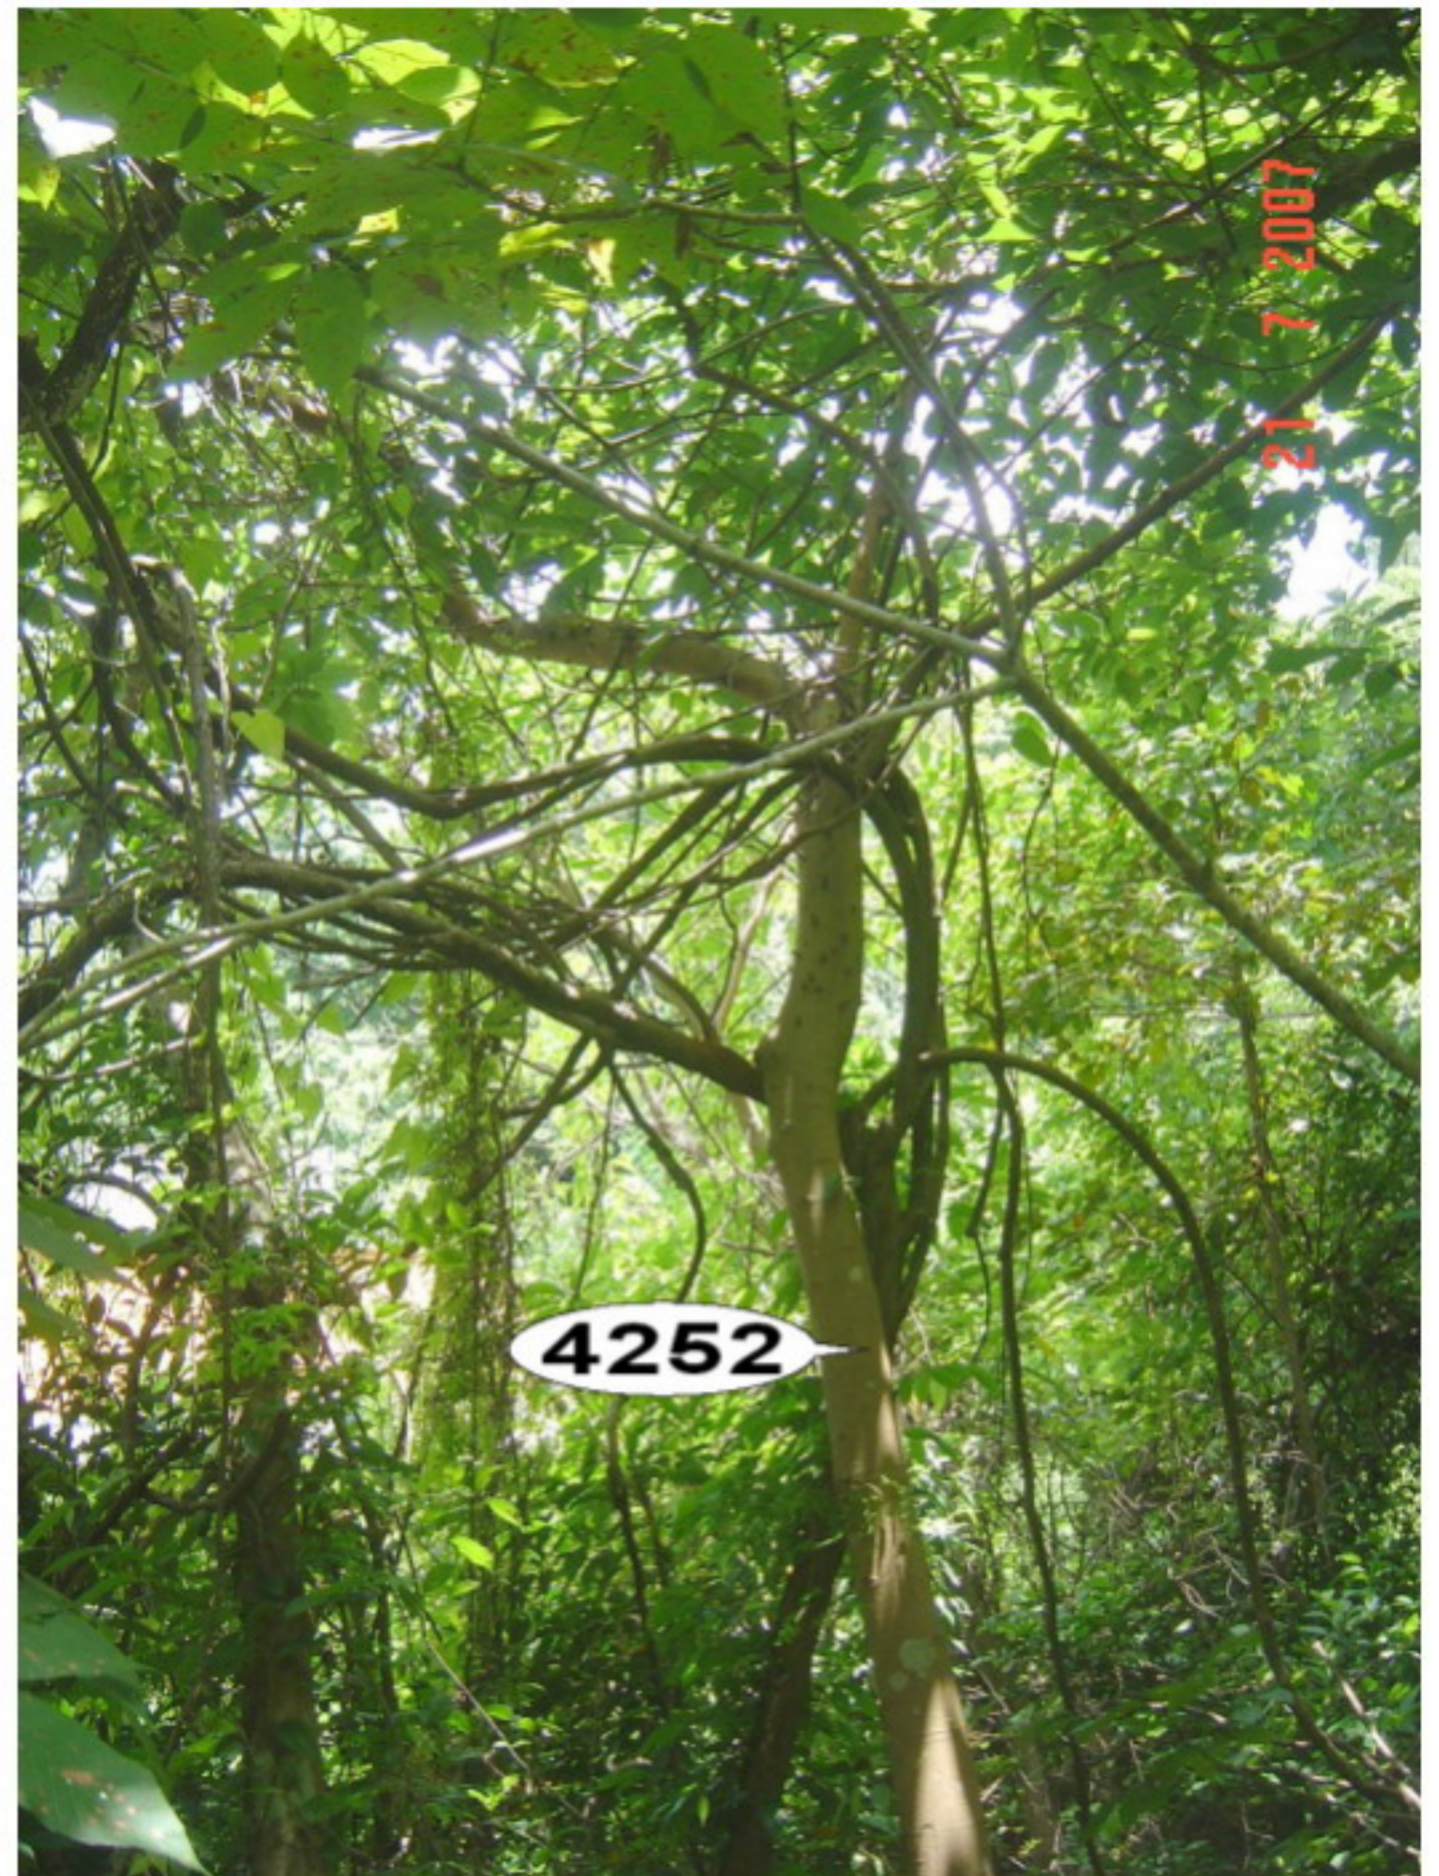
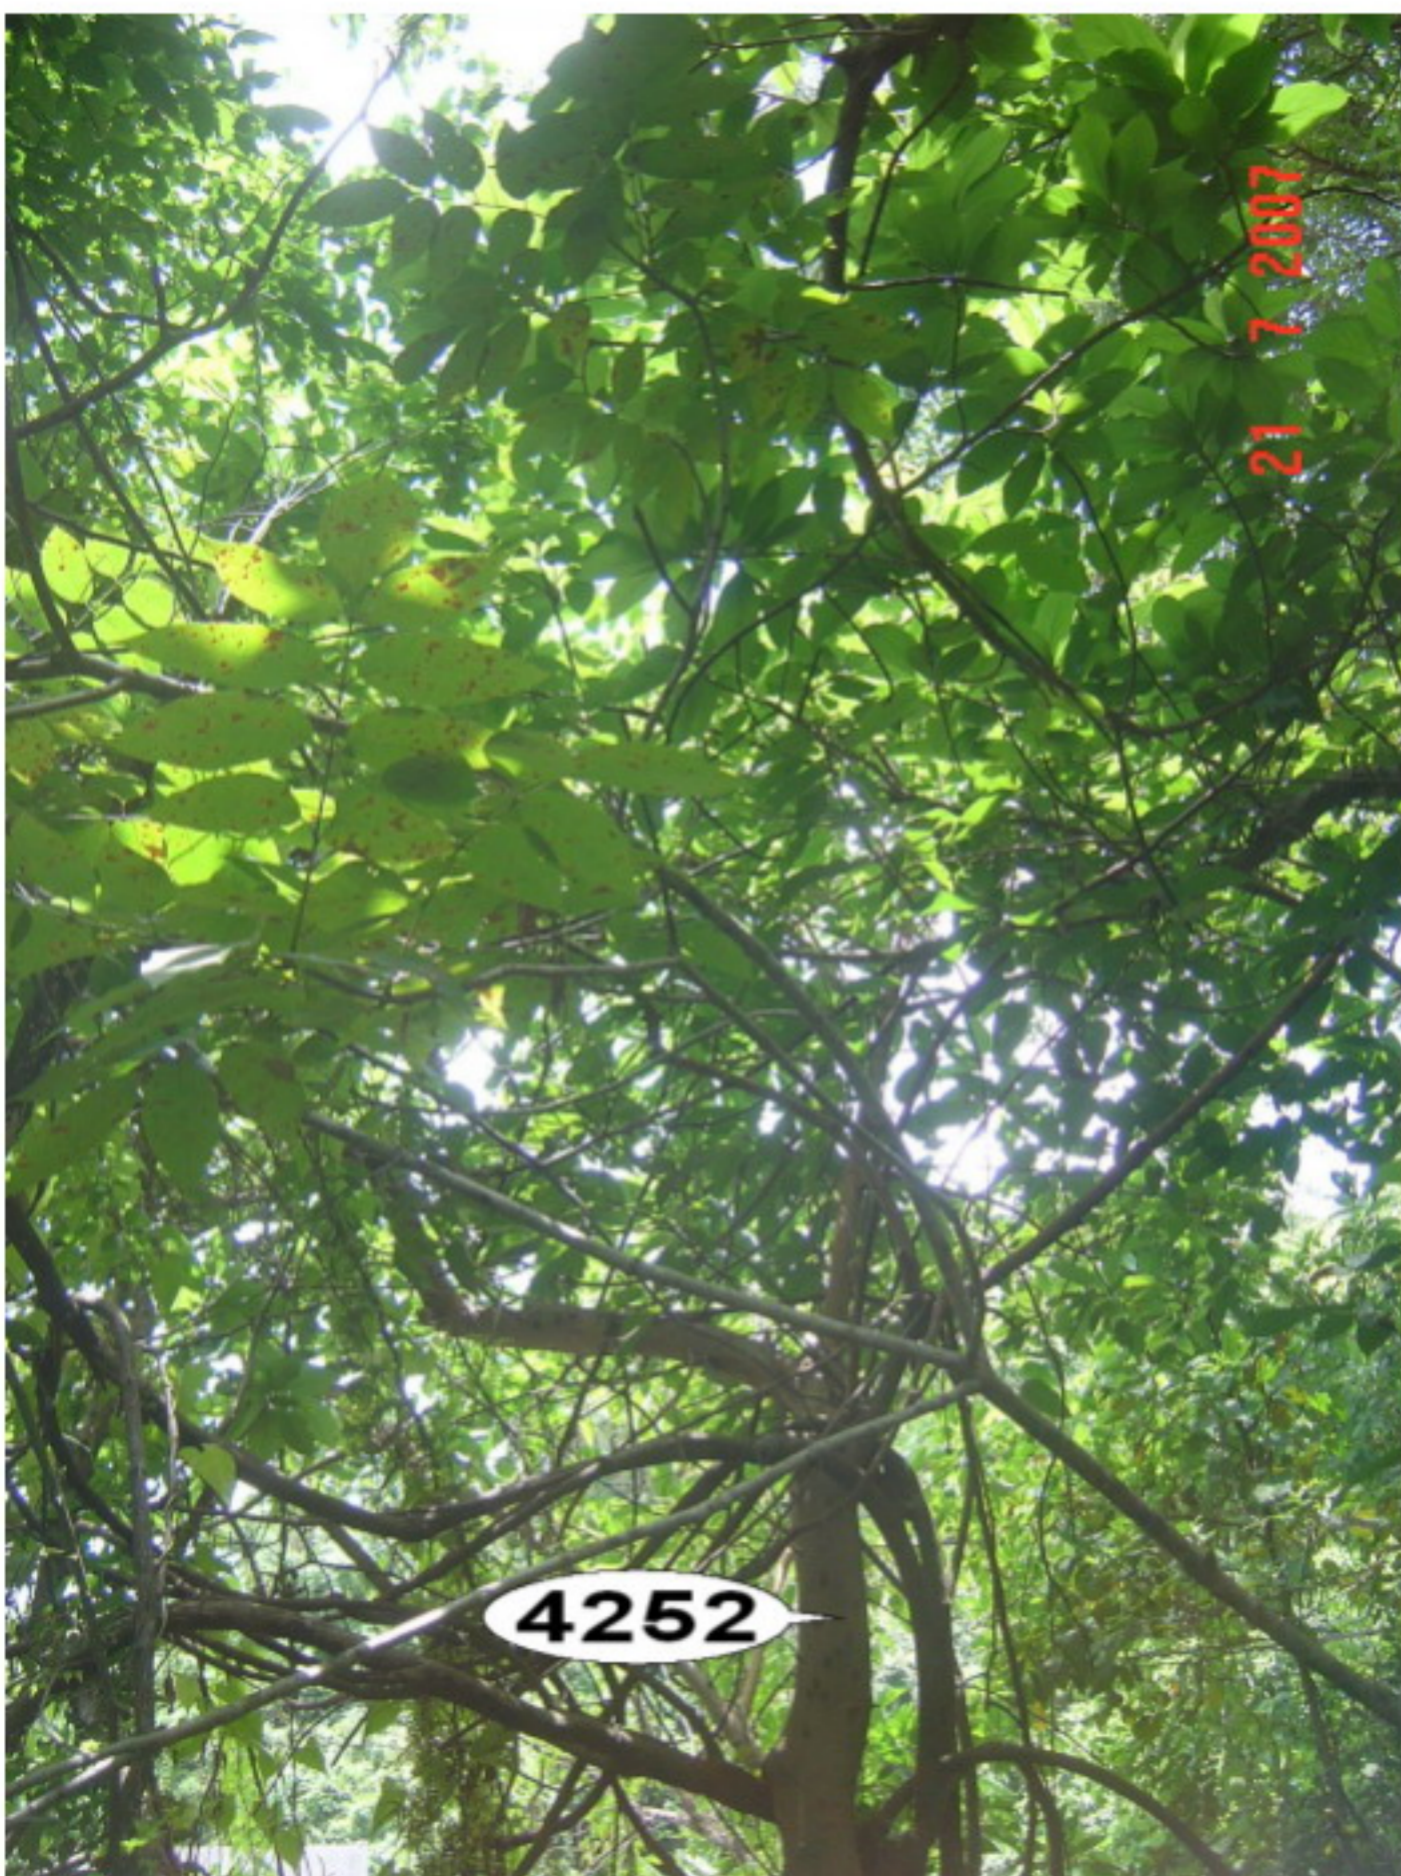
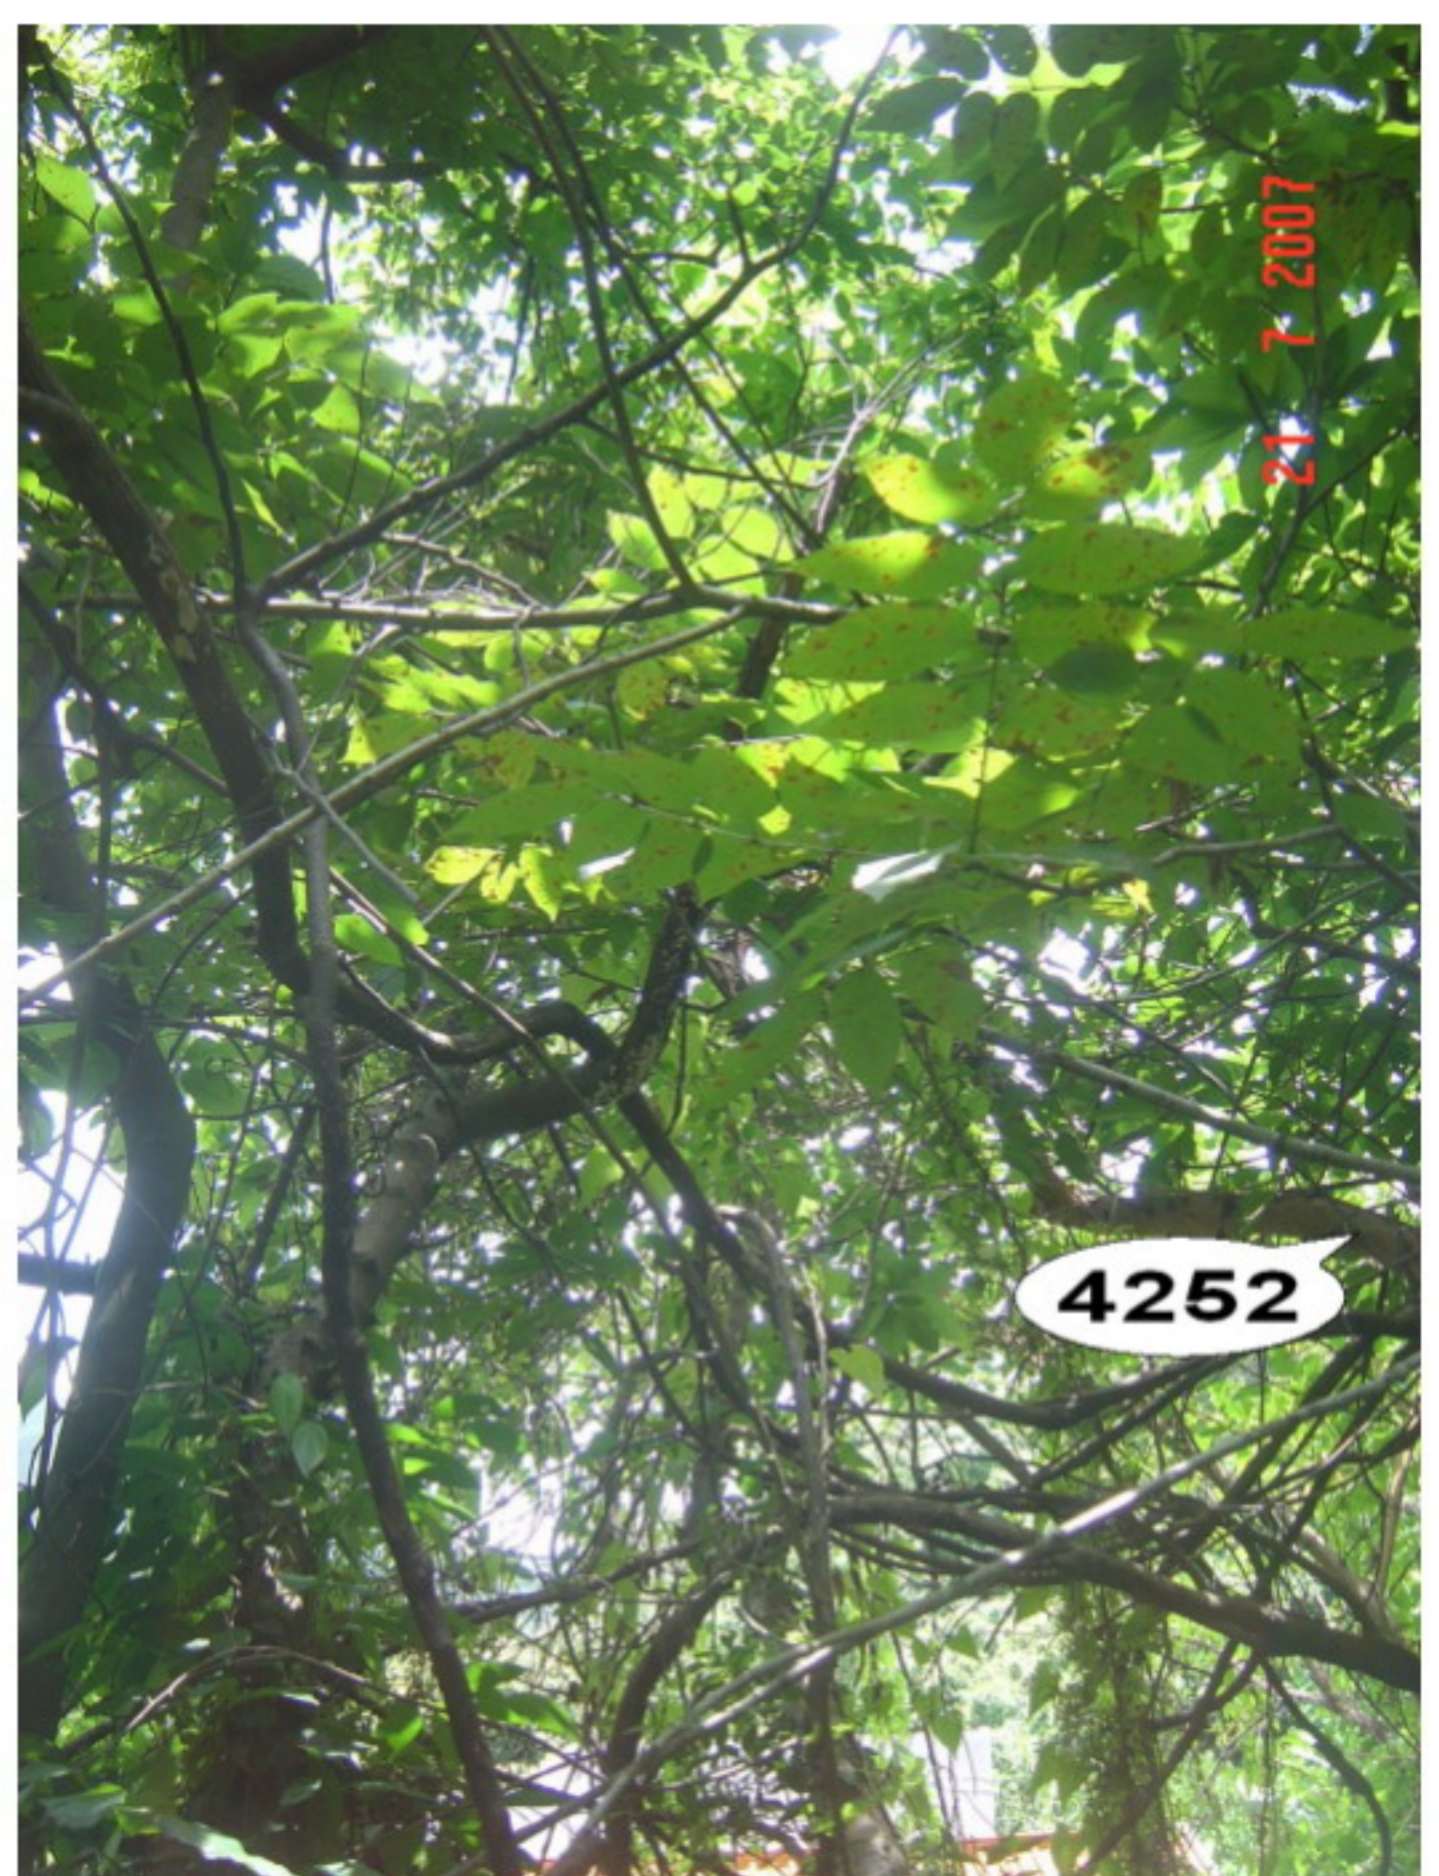
Tree 4251

Poor form which lead to low amenity value. Besides, the tree is unbalance. It may need heavy pruning after transplantation that will affect its transplantation survival rate. Moreover, the operation of the transplantation for poor form tree is also difficult.

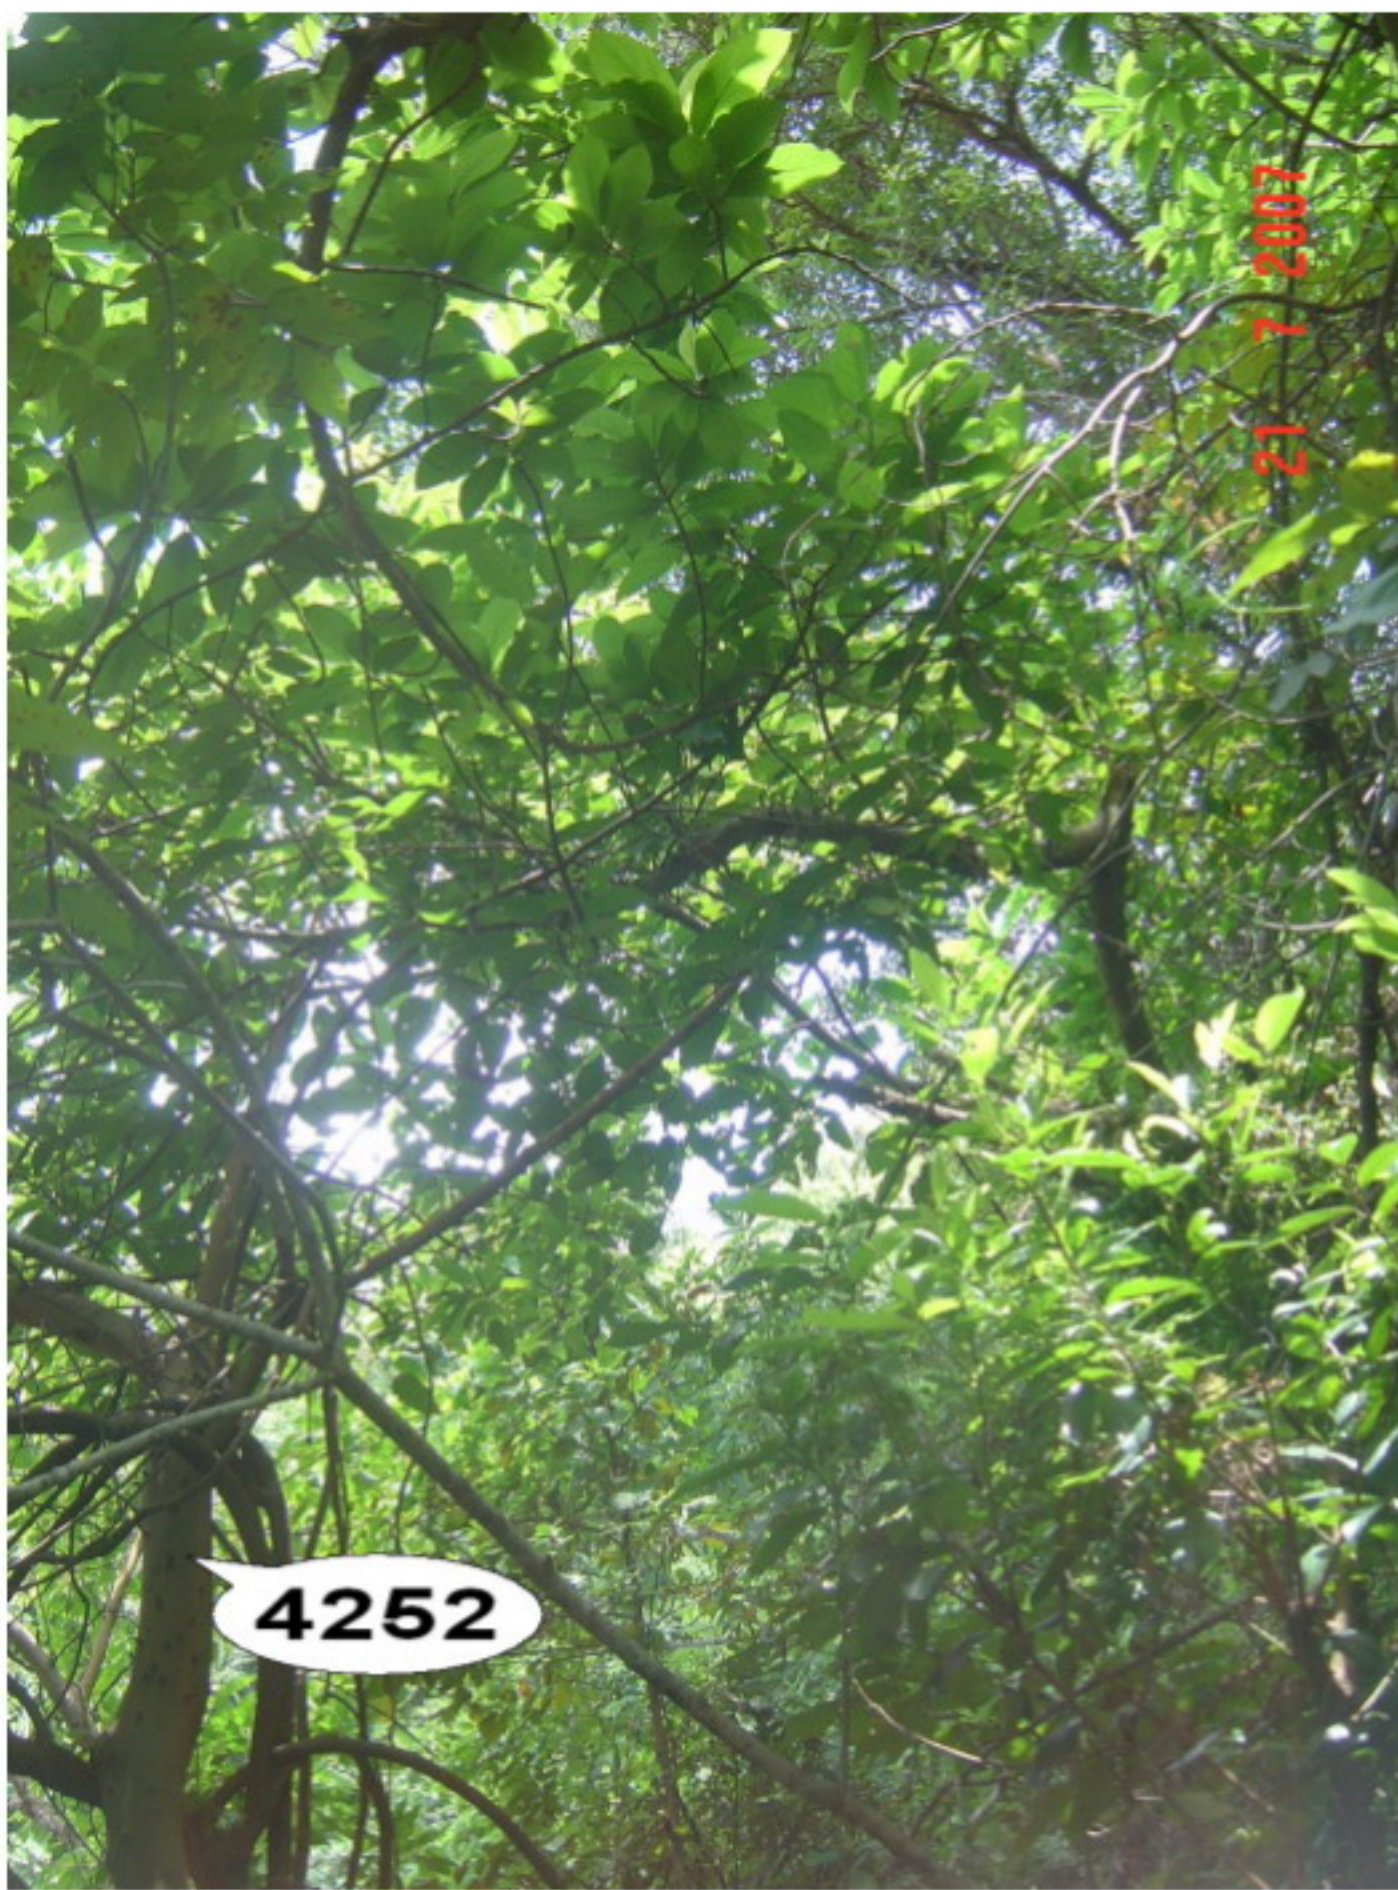
Tree 4252

Poor form which lead to low amenity value. Besides, the tree is unbalance. It may need heavy pruning after transplantation that will affect its transplantation survival rate. Moreover, the operation of the transplantation for poor form tree is also difficult.
