# Provision of Cremators at Wo Hop Shek Crematorium

Tree Survey Report

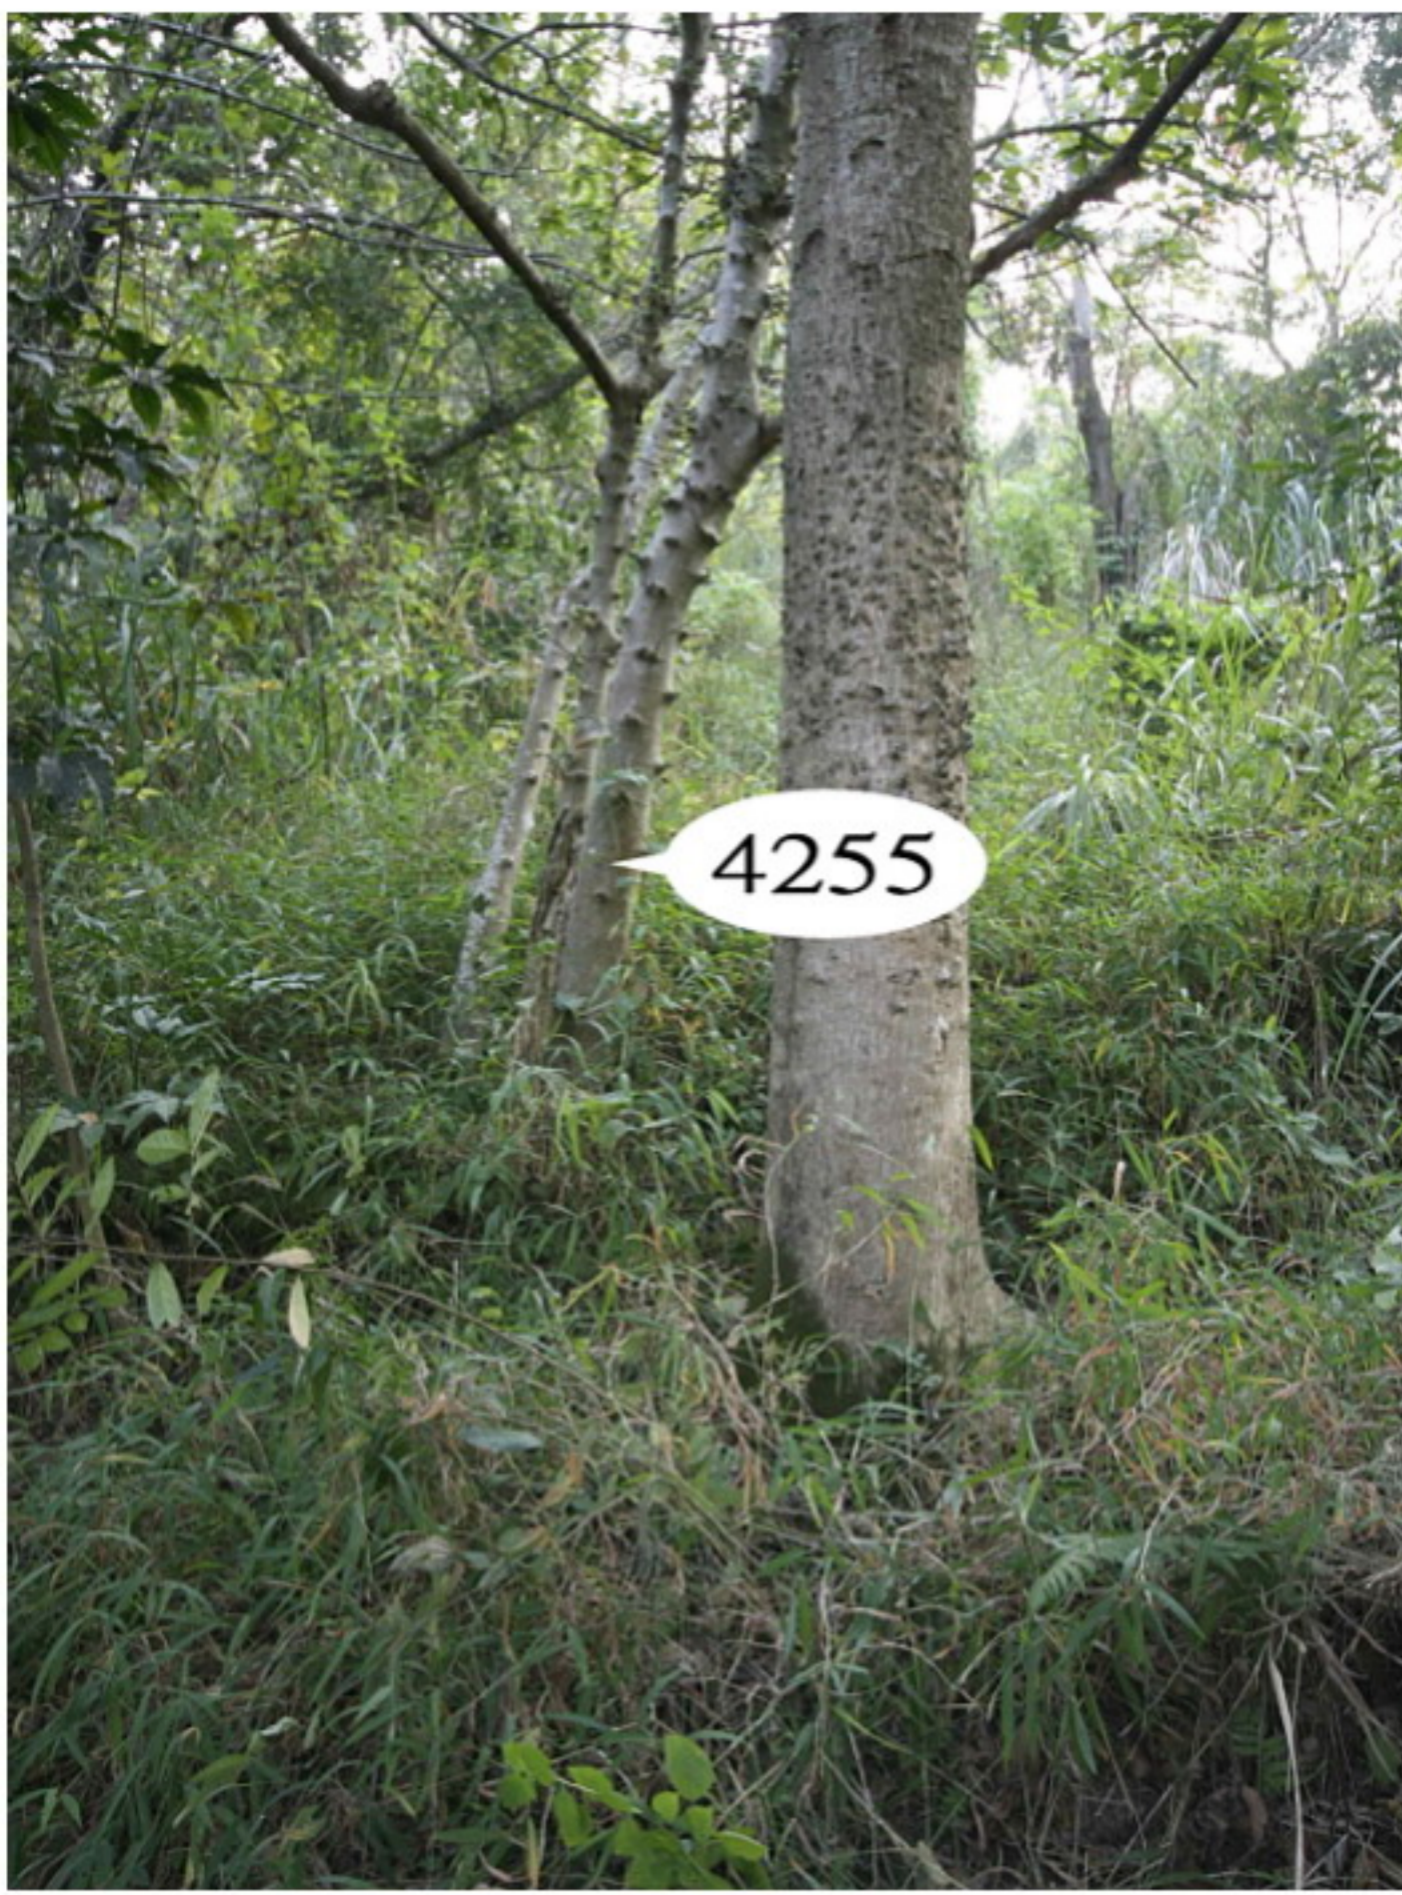
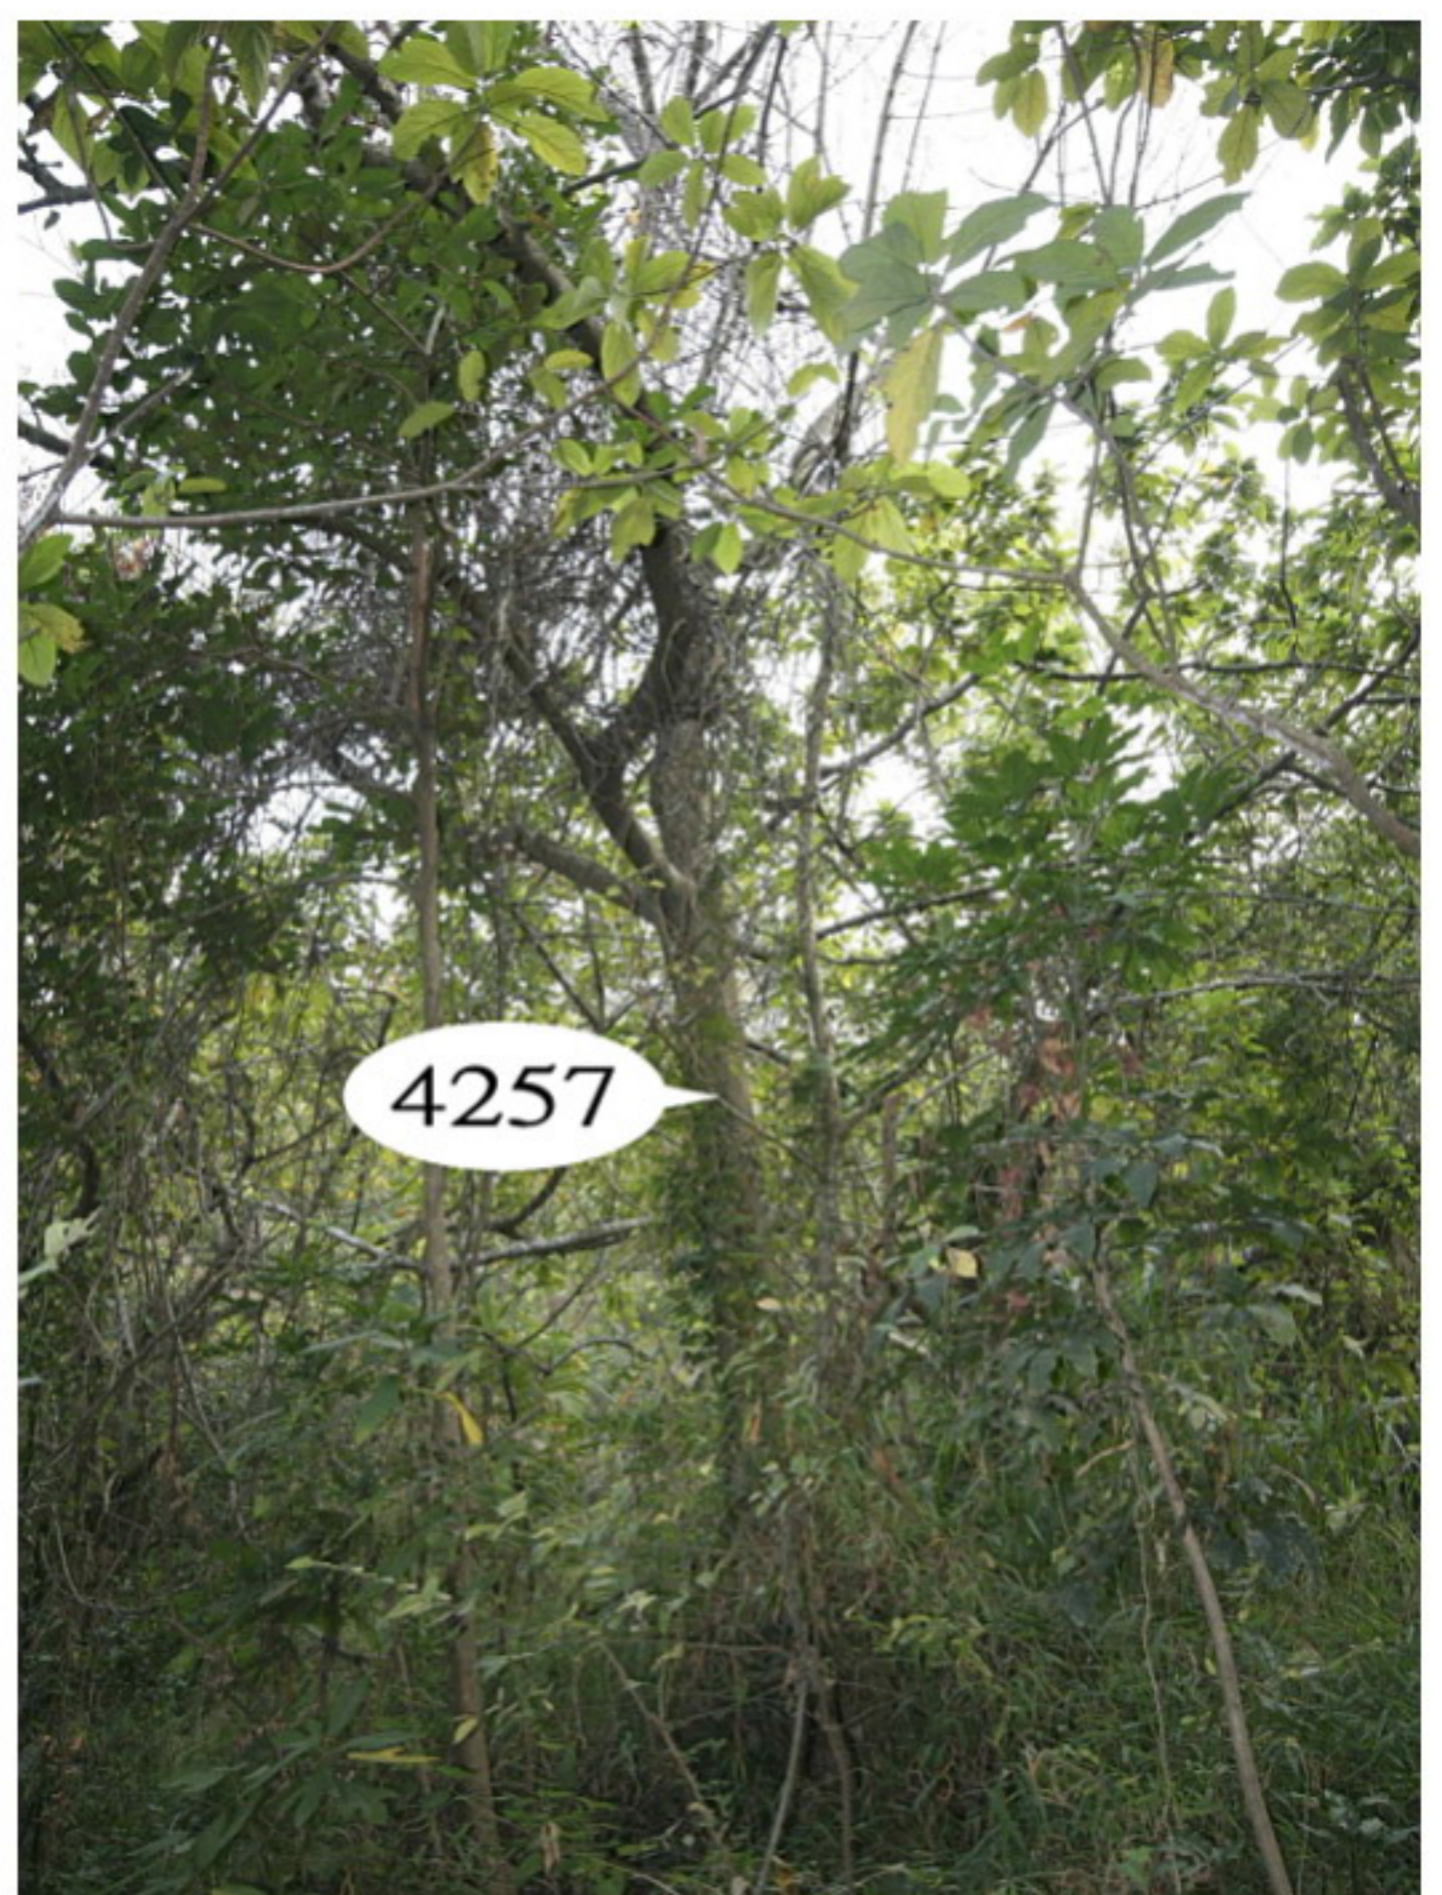
Tree 4252

Poor form which lead to low amenity value. Besides, the tree is unbalance. It may need heavy pruning after transplantation that will affect its transplantation survival rate. Moreover, the operation of the transplation for poor form tree is also difficult.

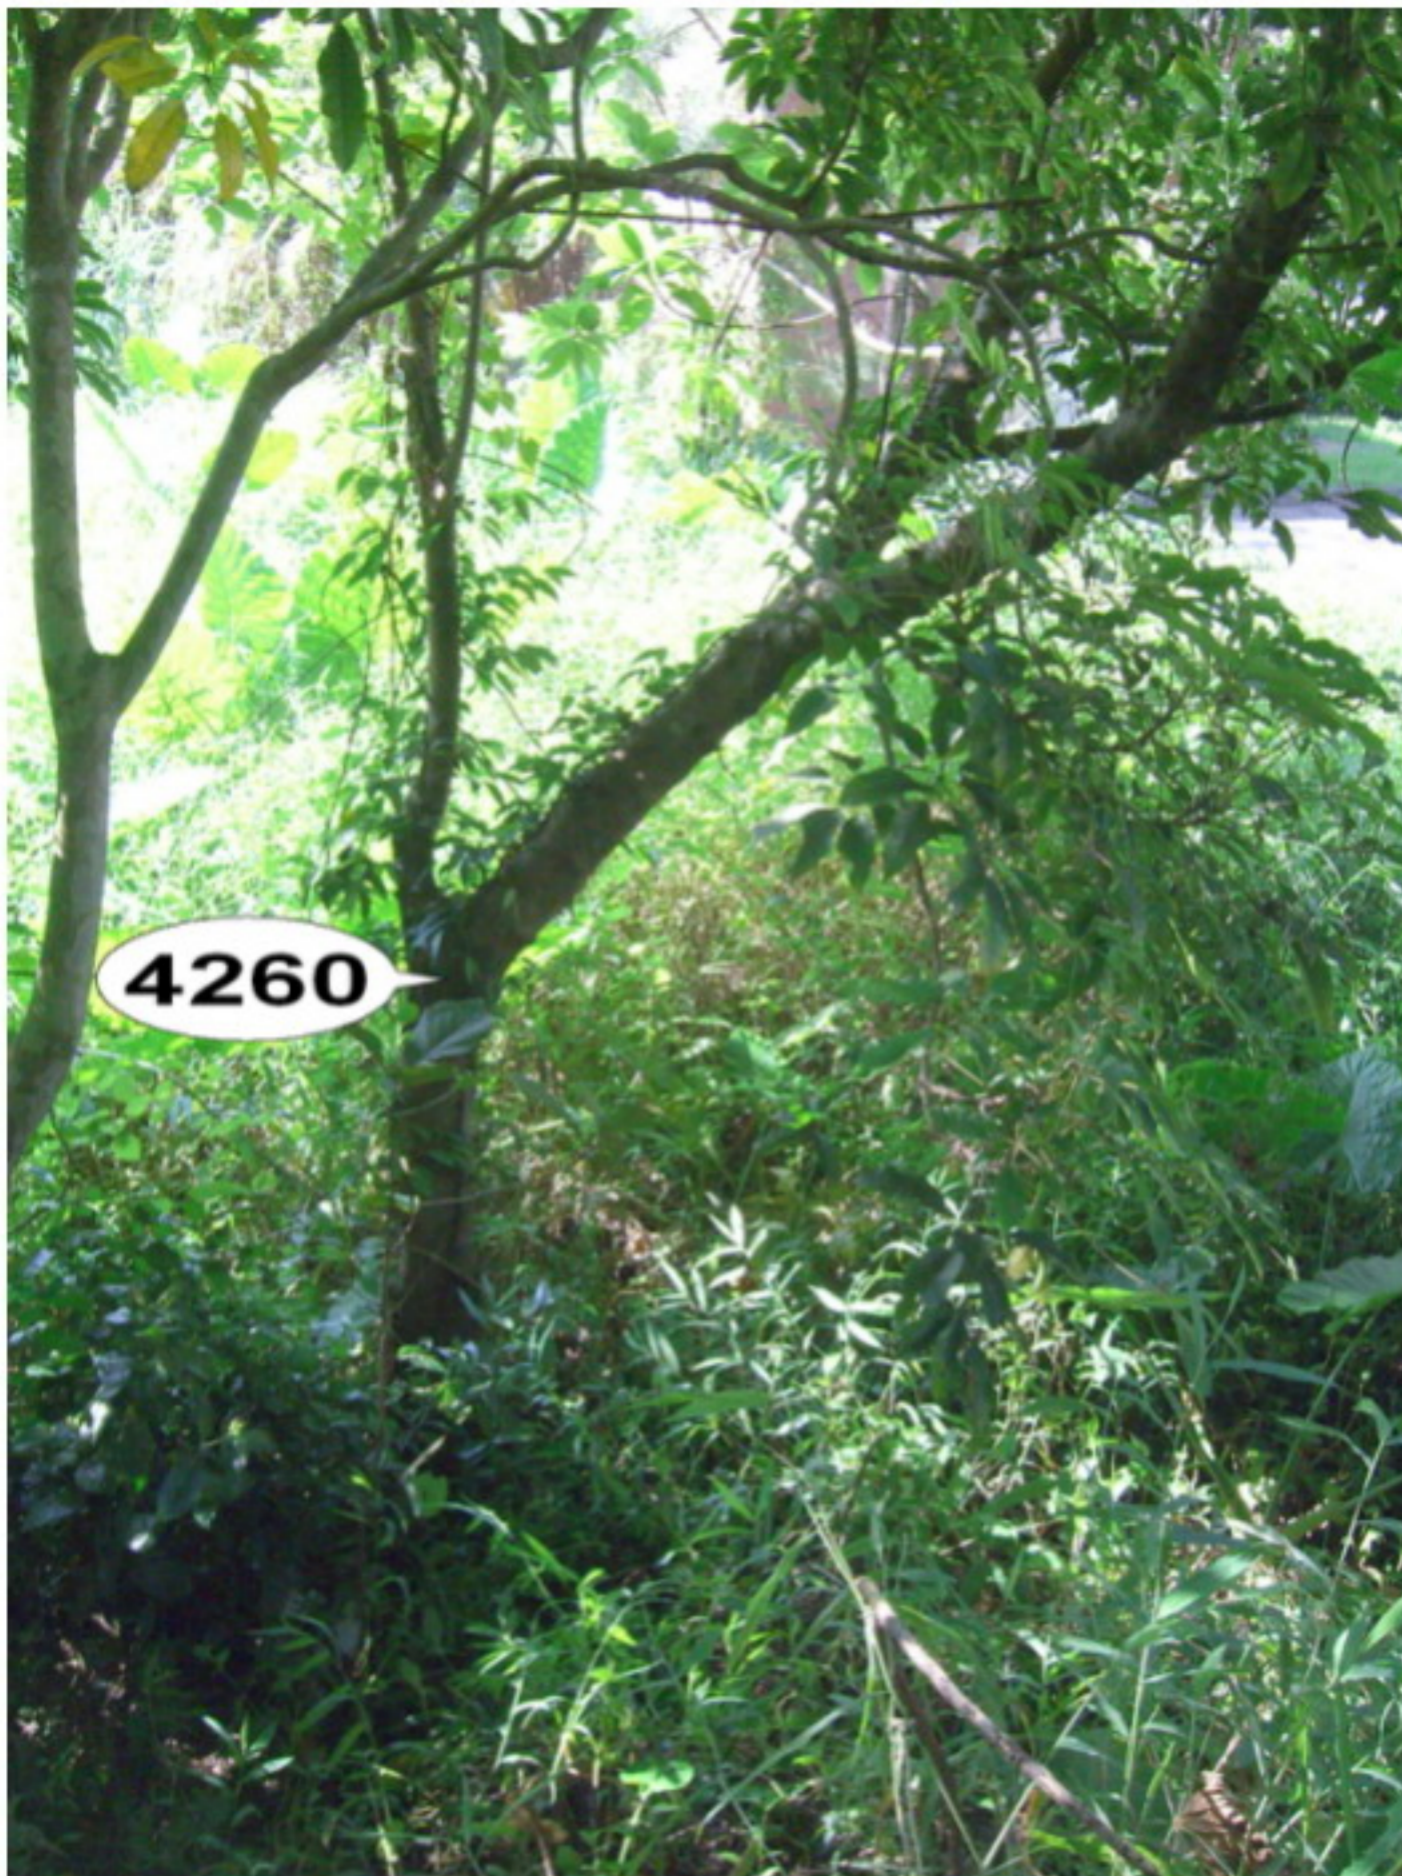
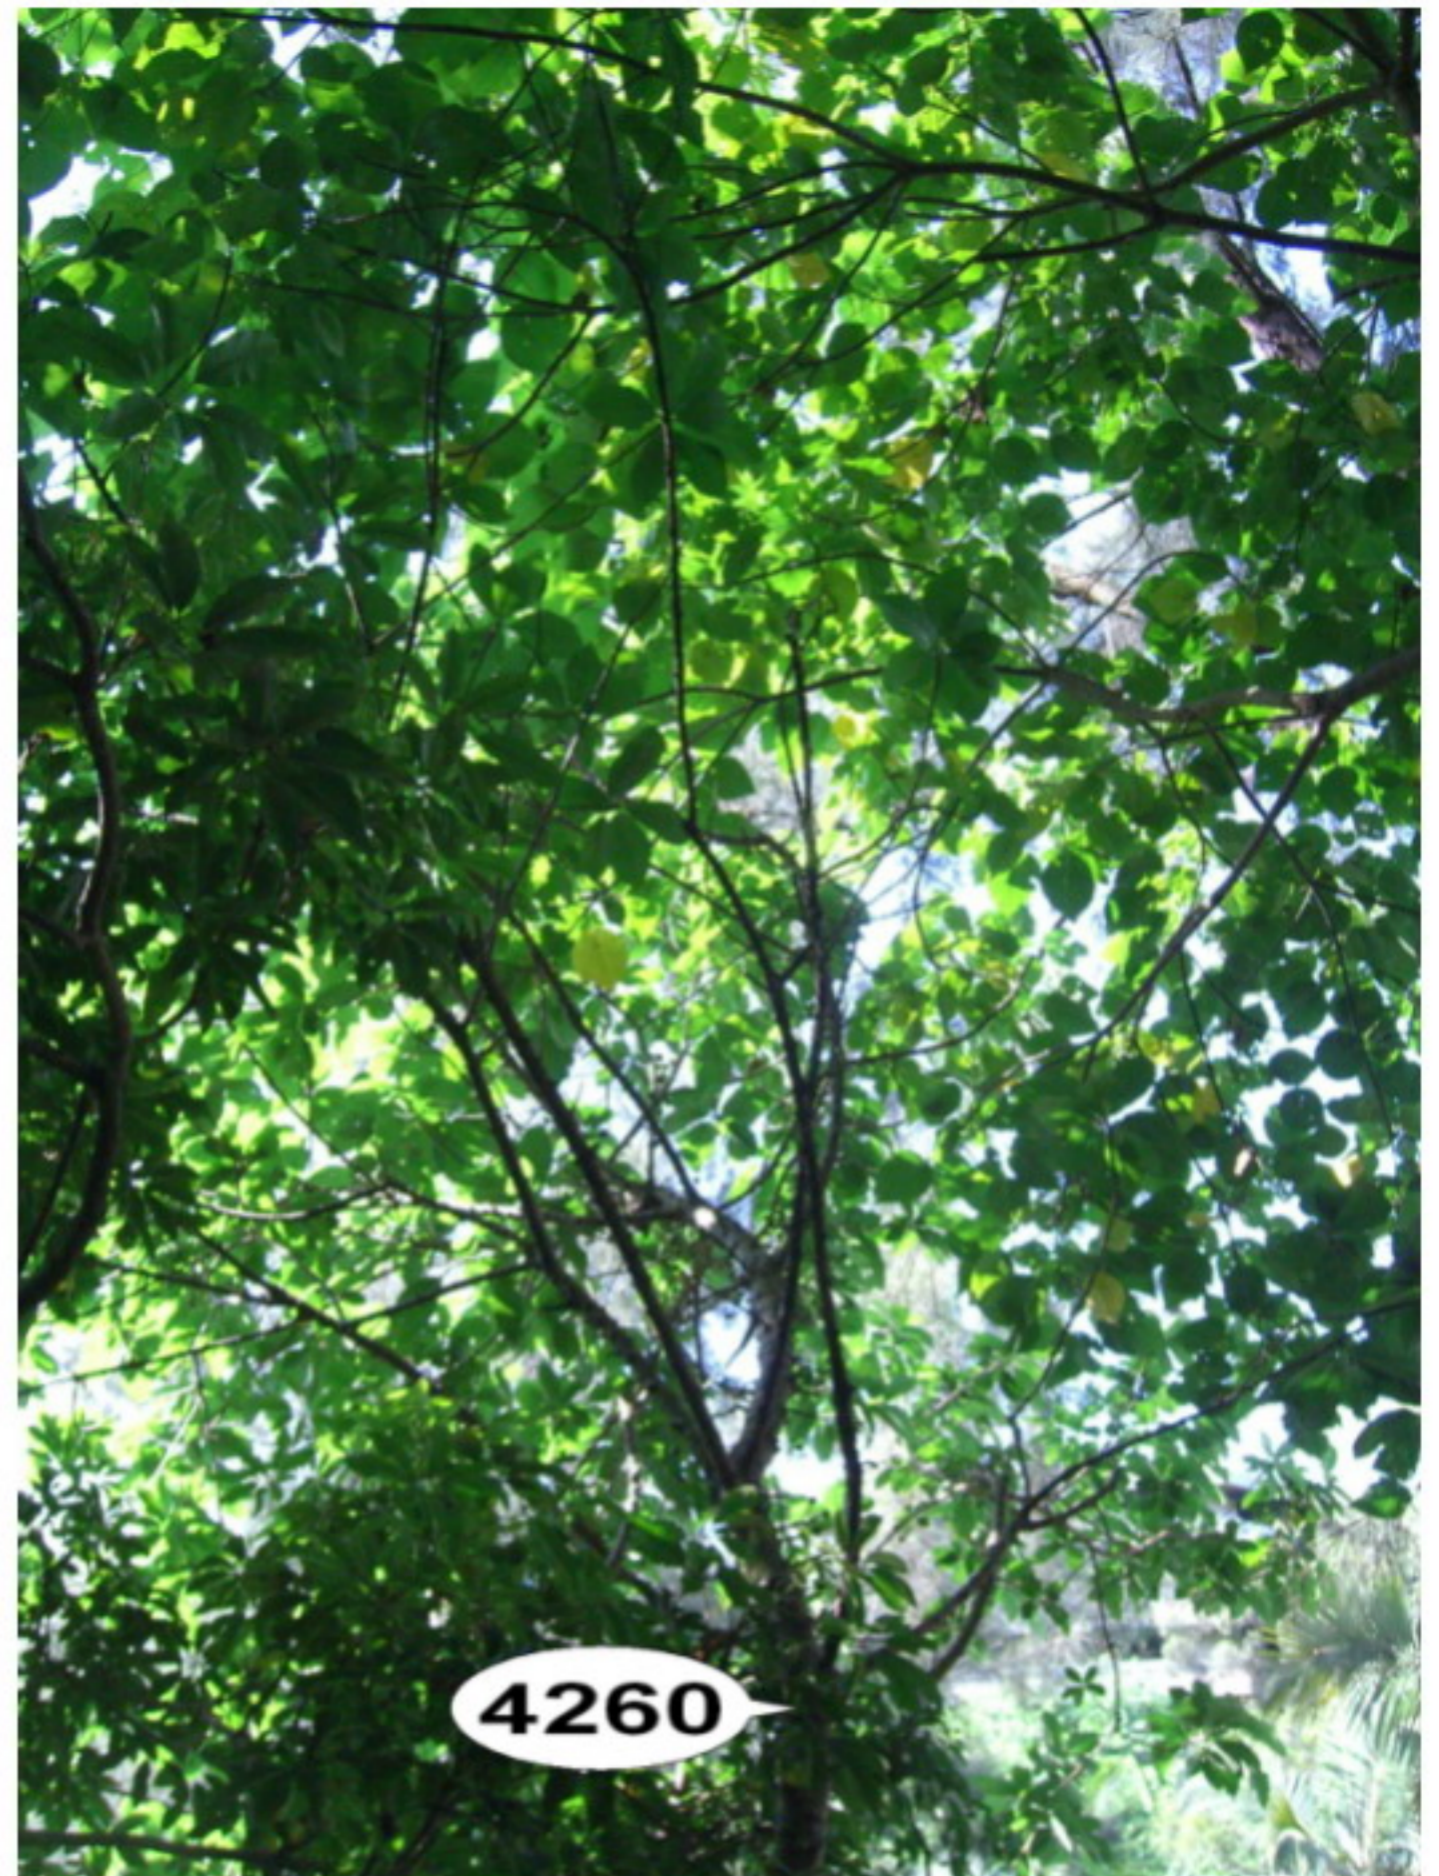
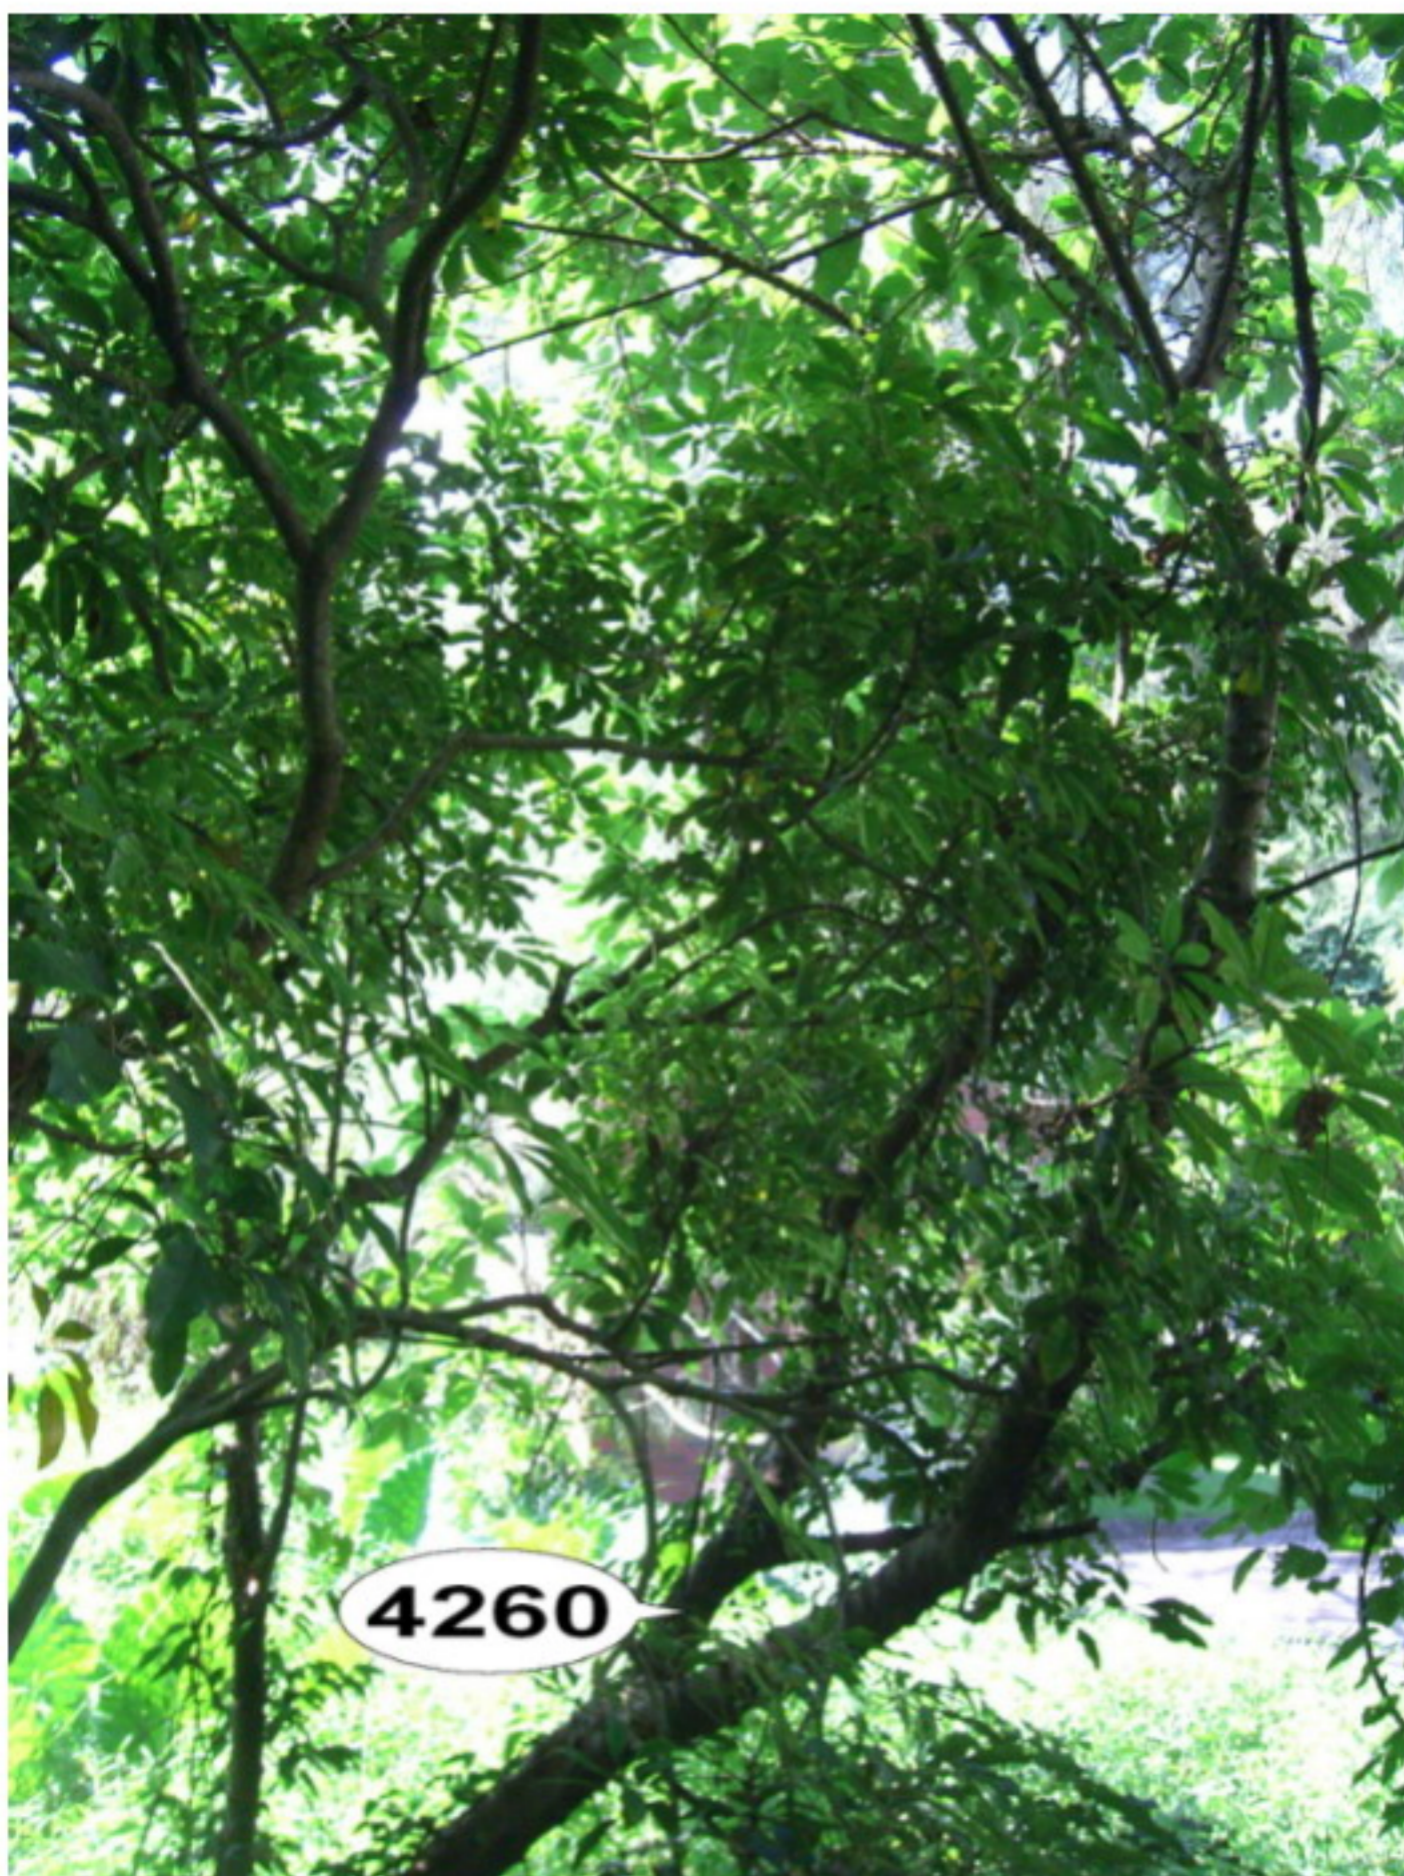
Tree 4255 and 4257  
Dear Tree
