# Provision of Cremators at Wo Hop Shek Crematorium

Tree Survey Report

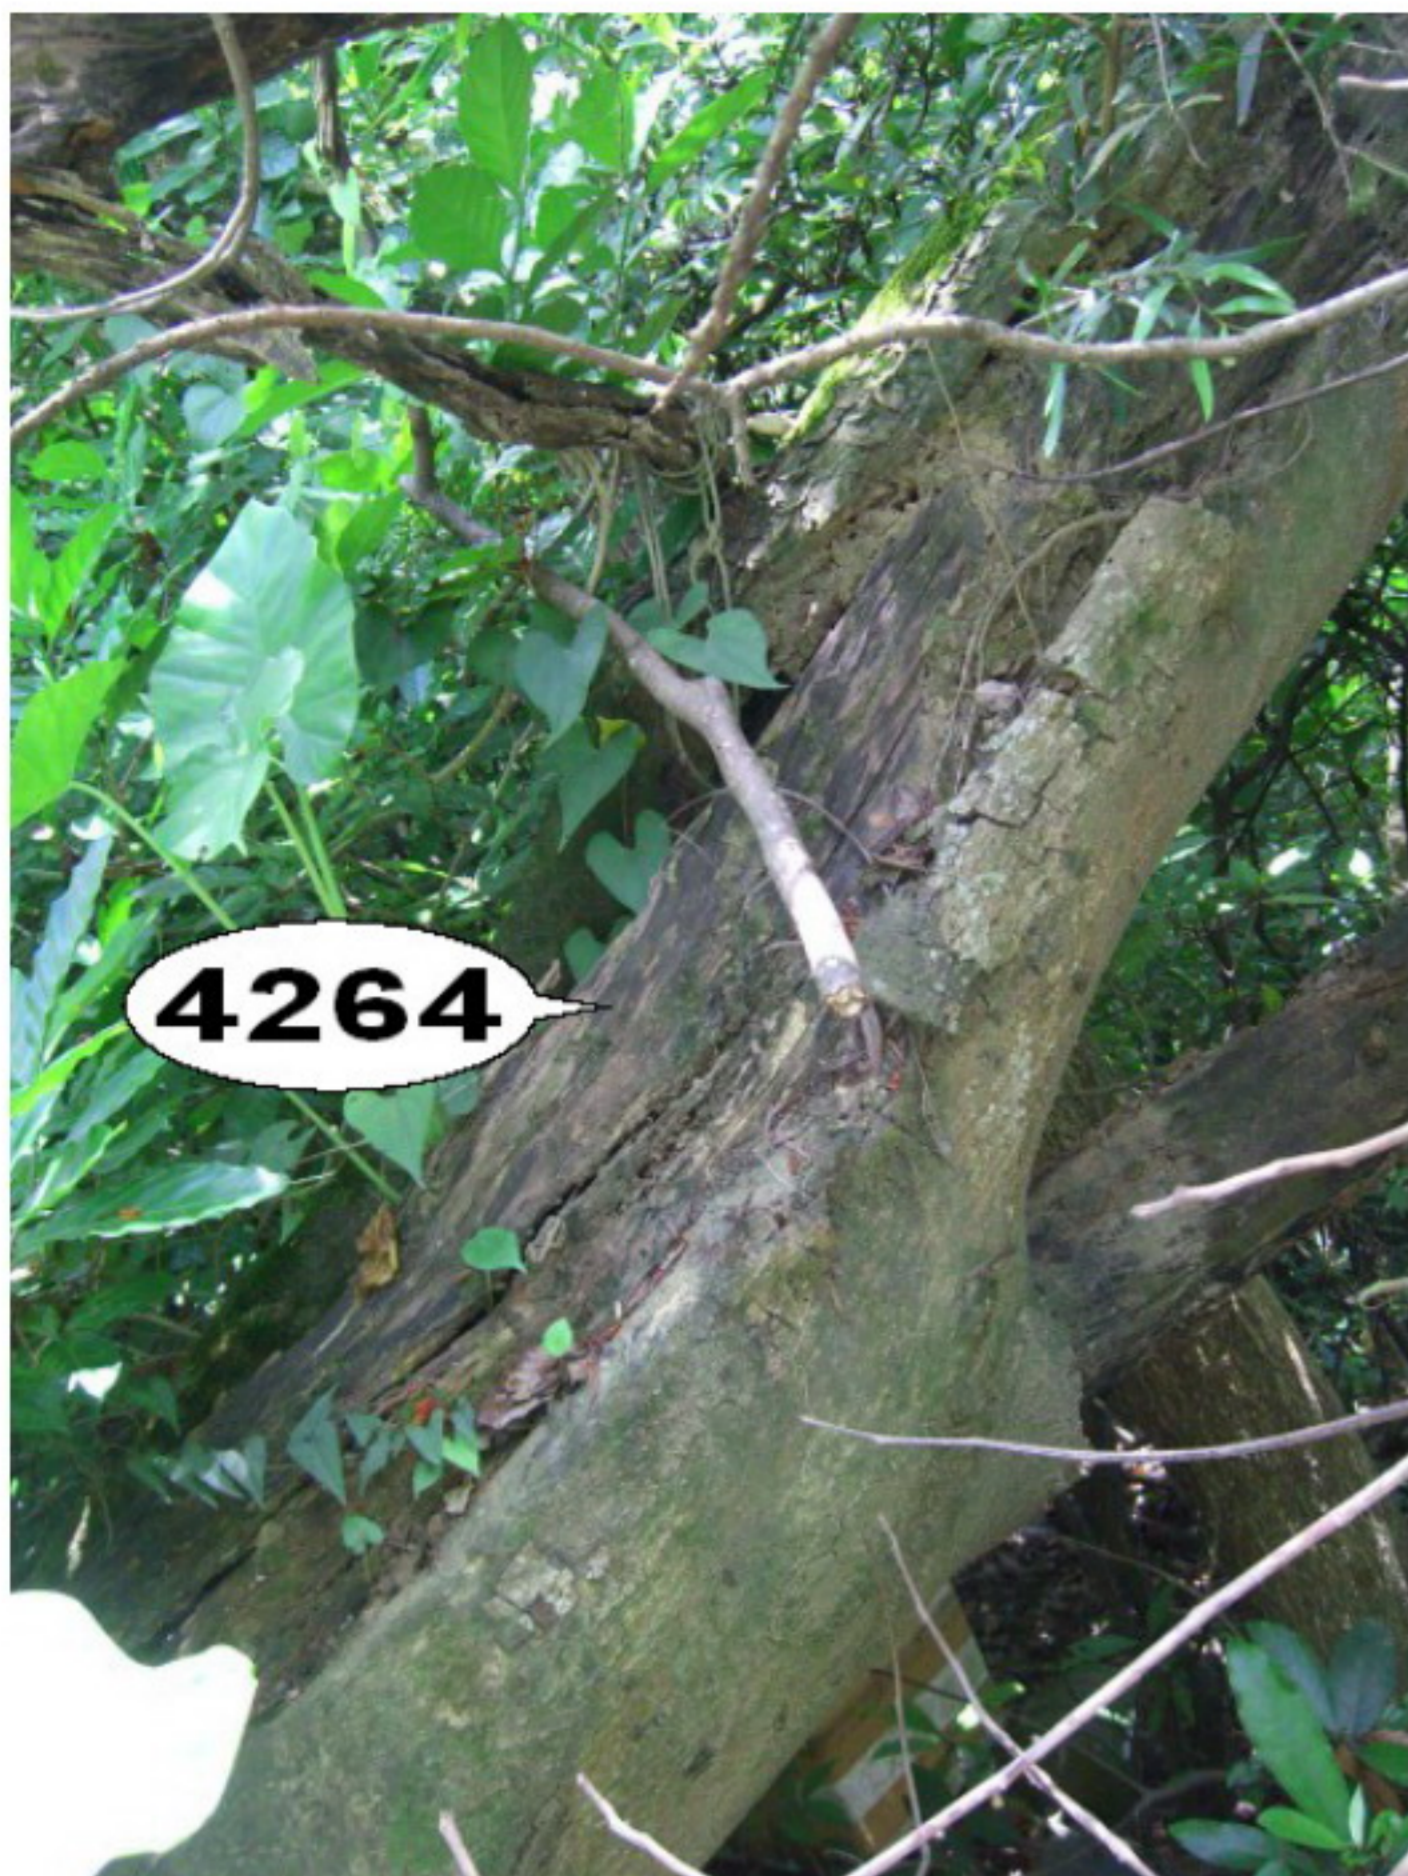
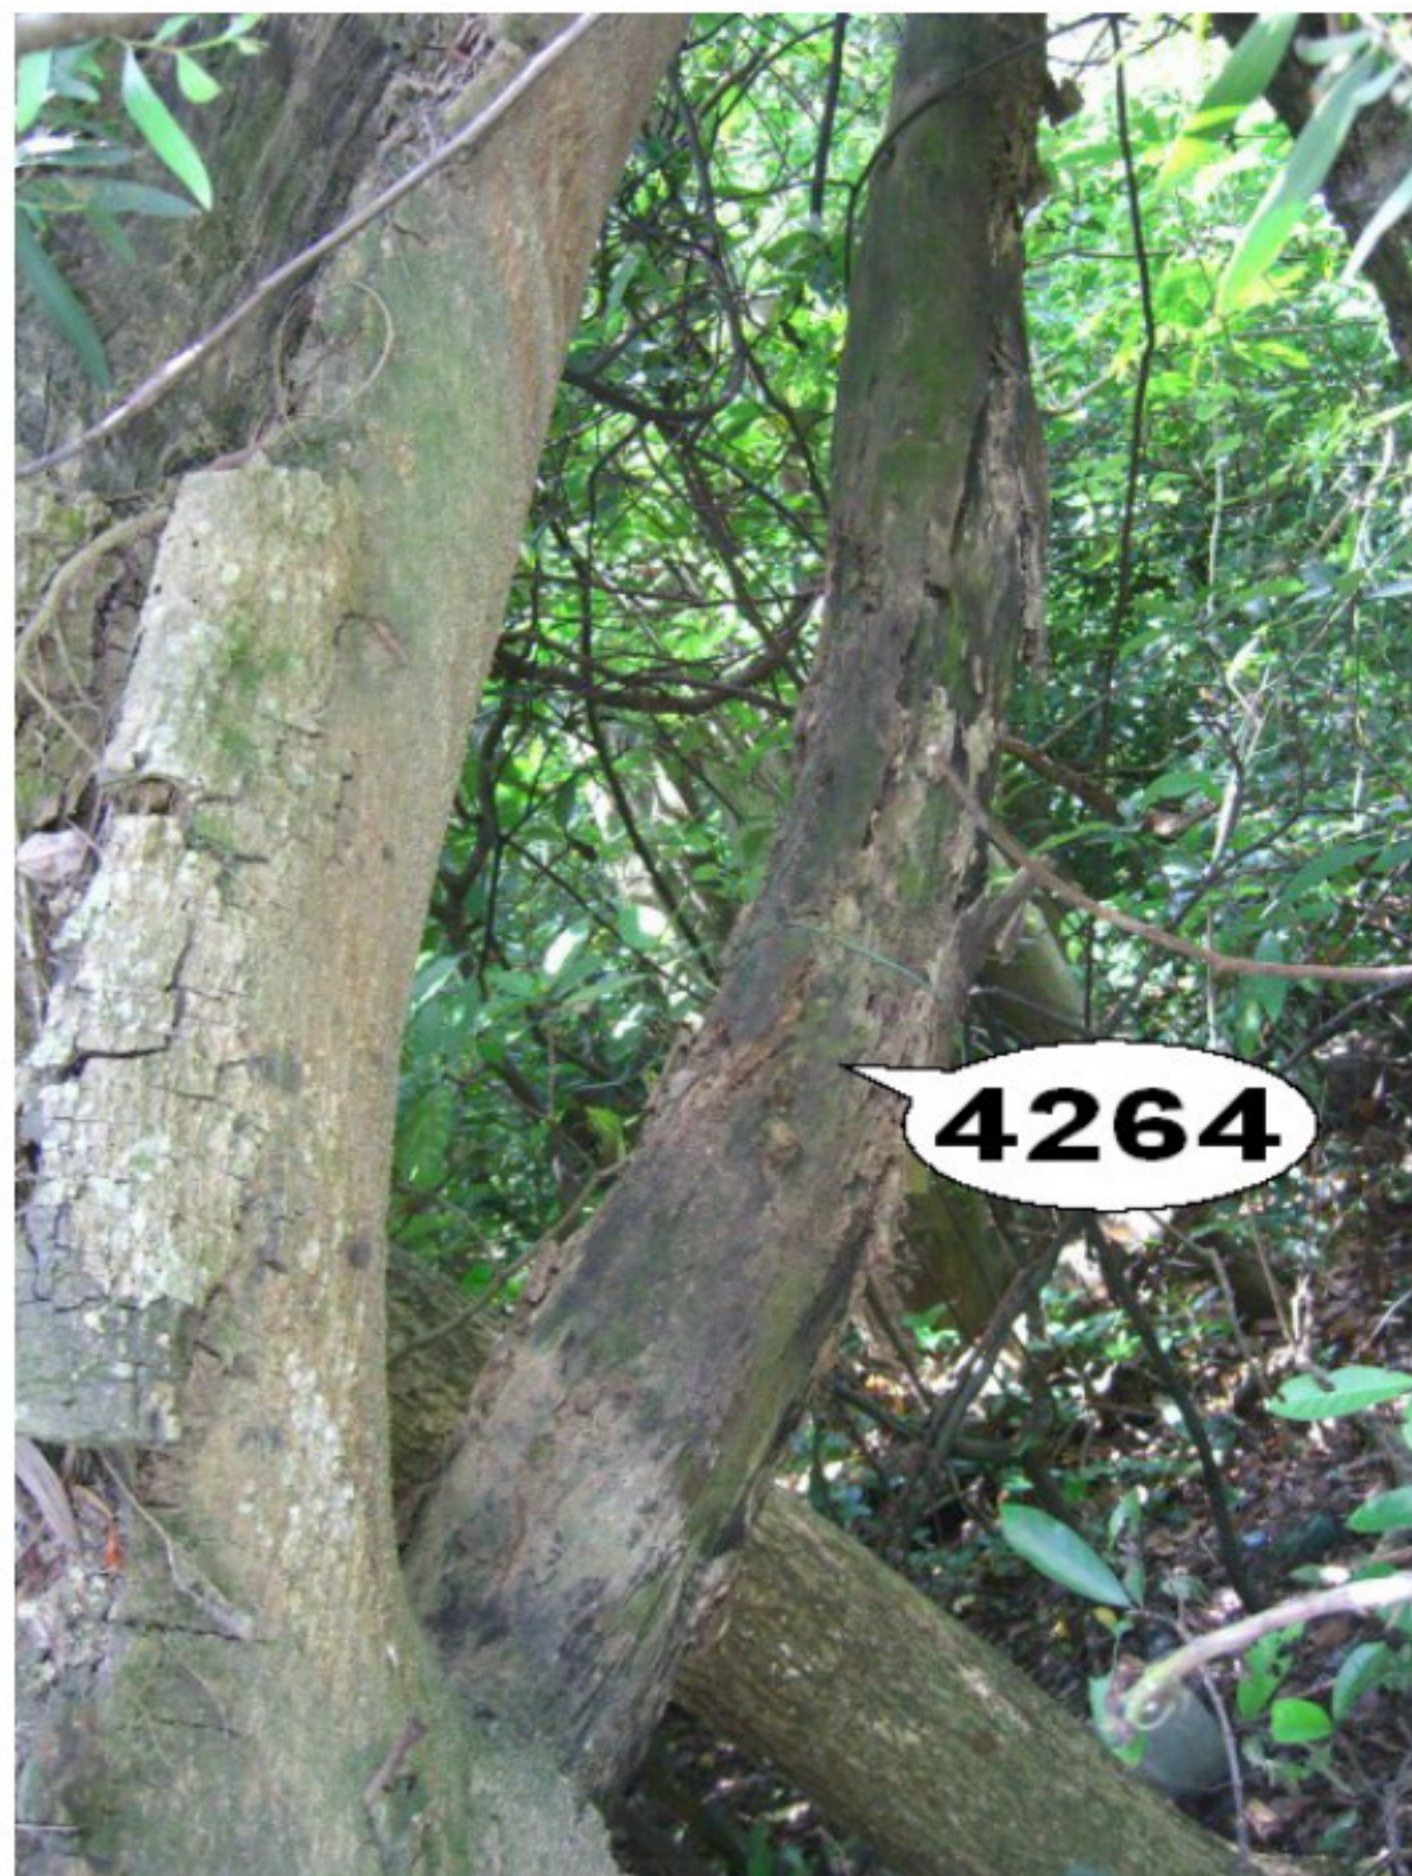
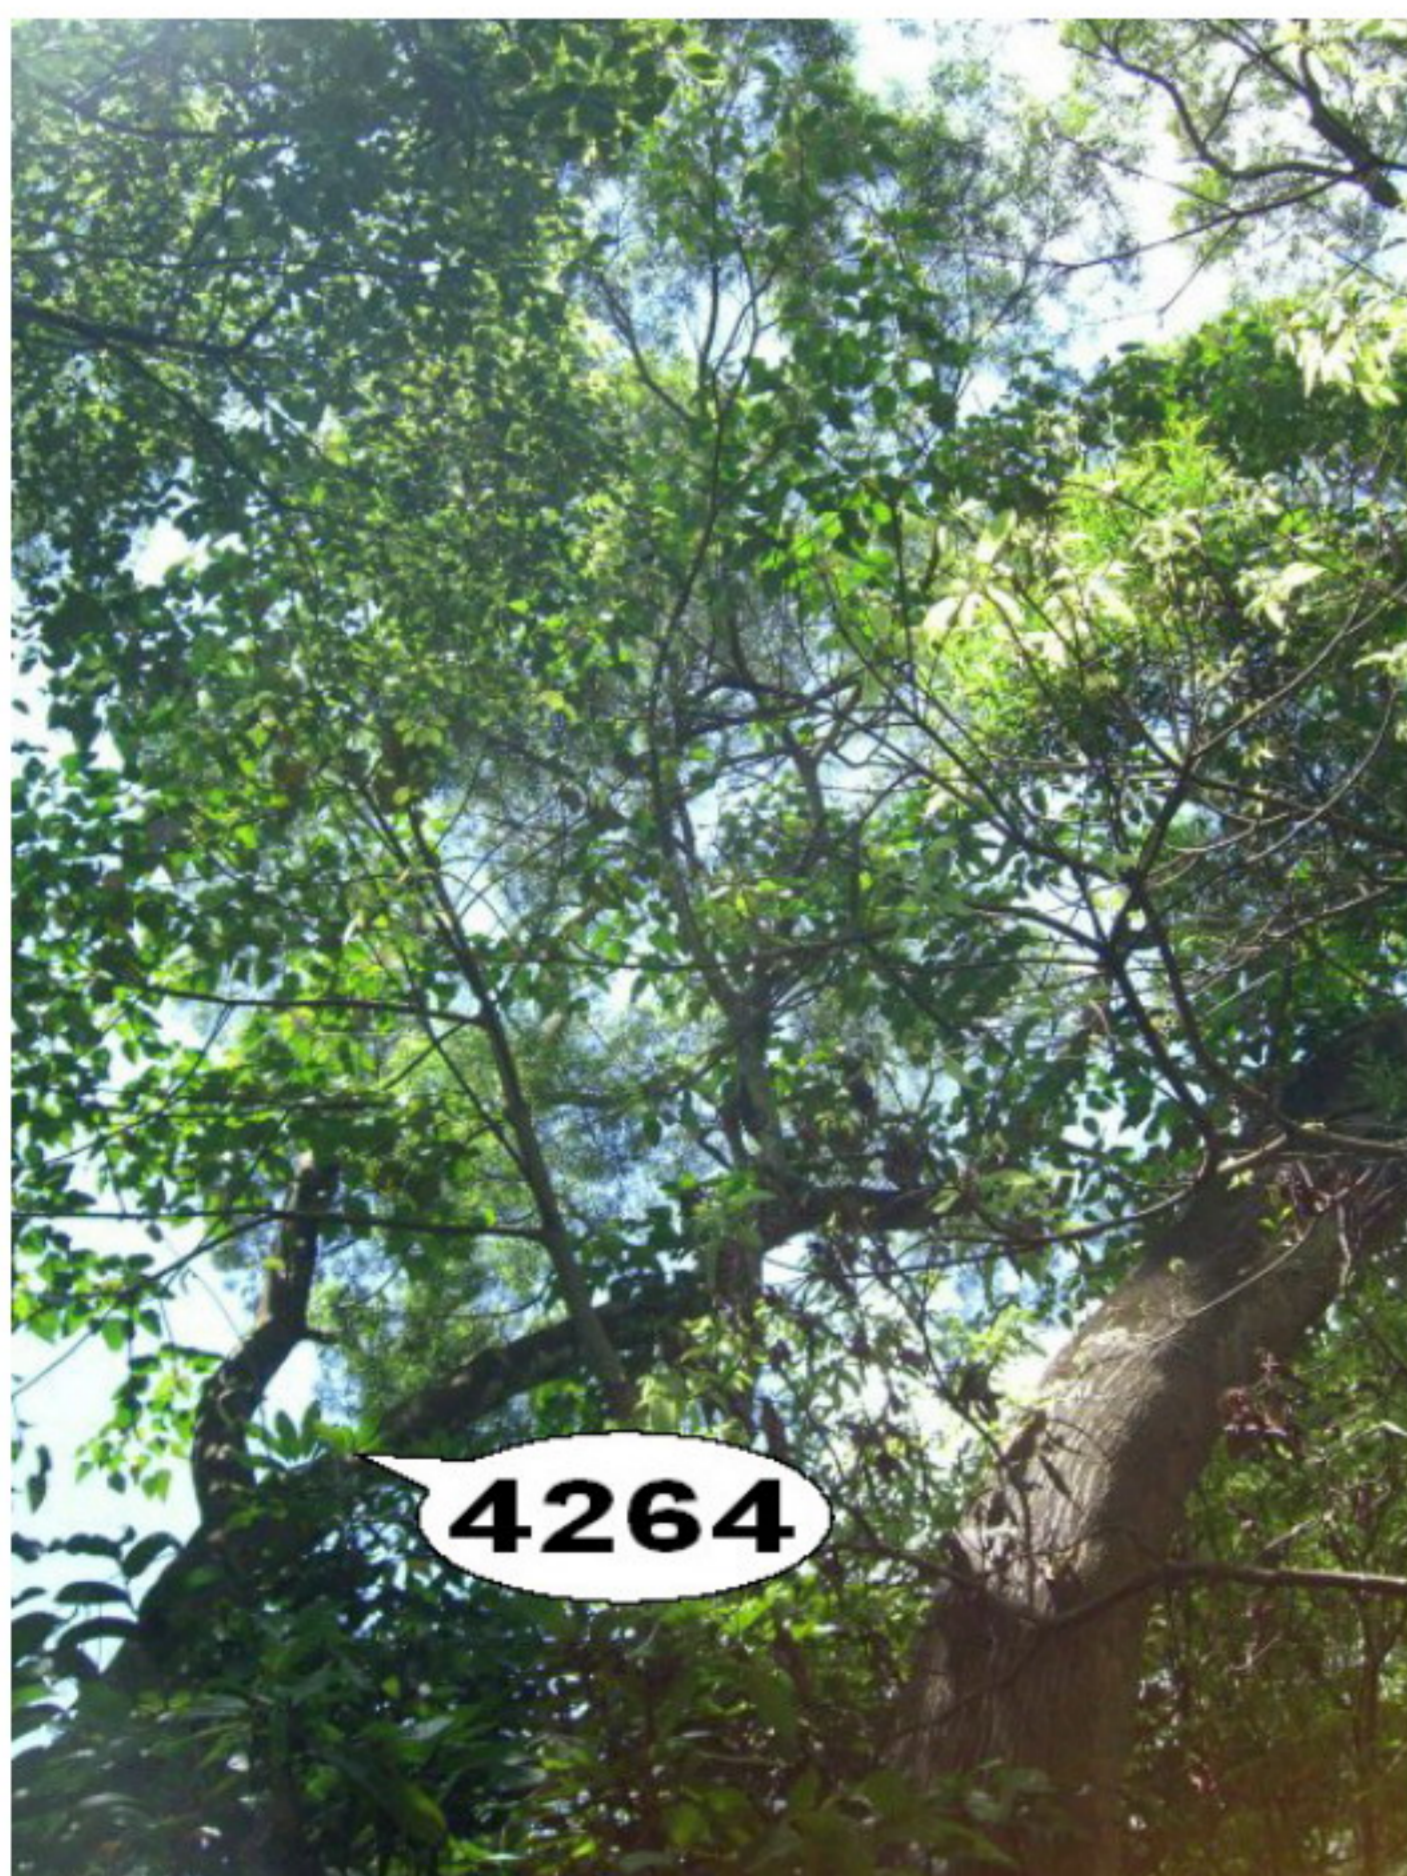
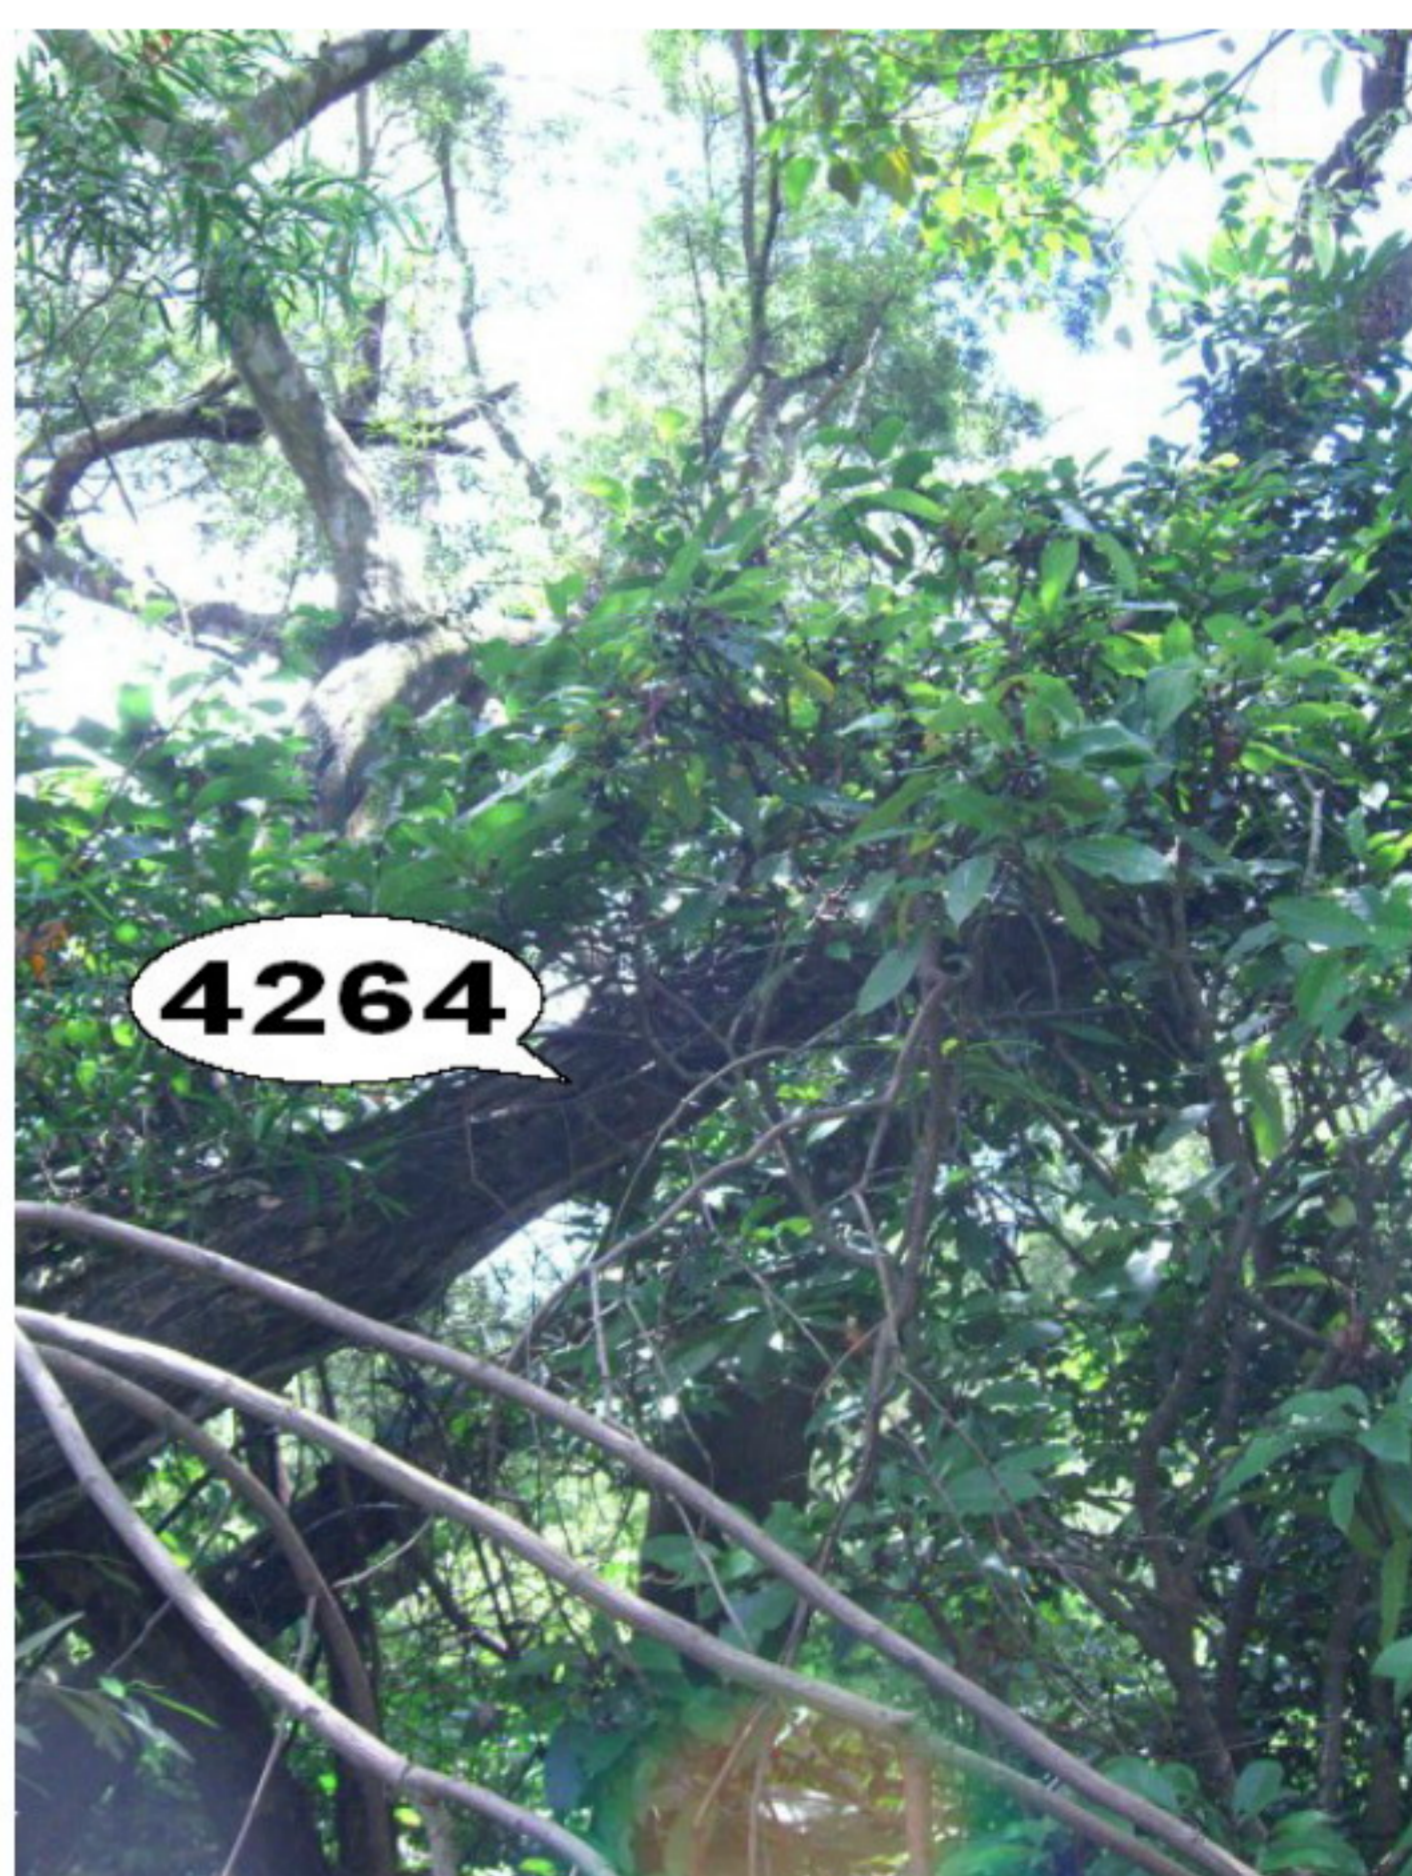
Tree 4263  
Poor health will lead to low transplantation survival rate.

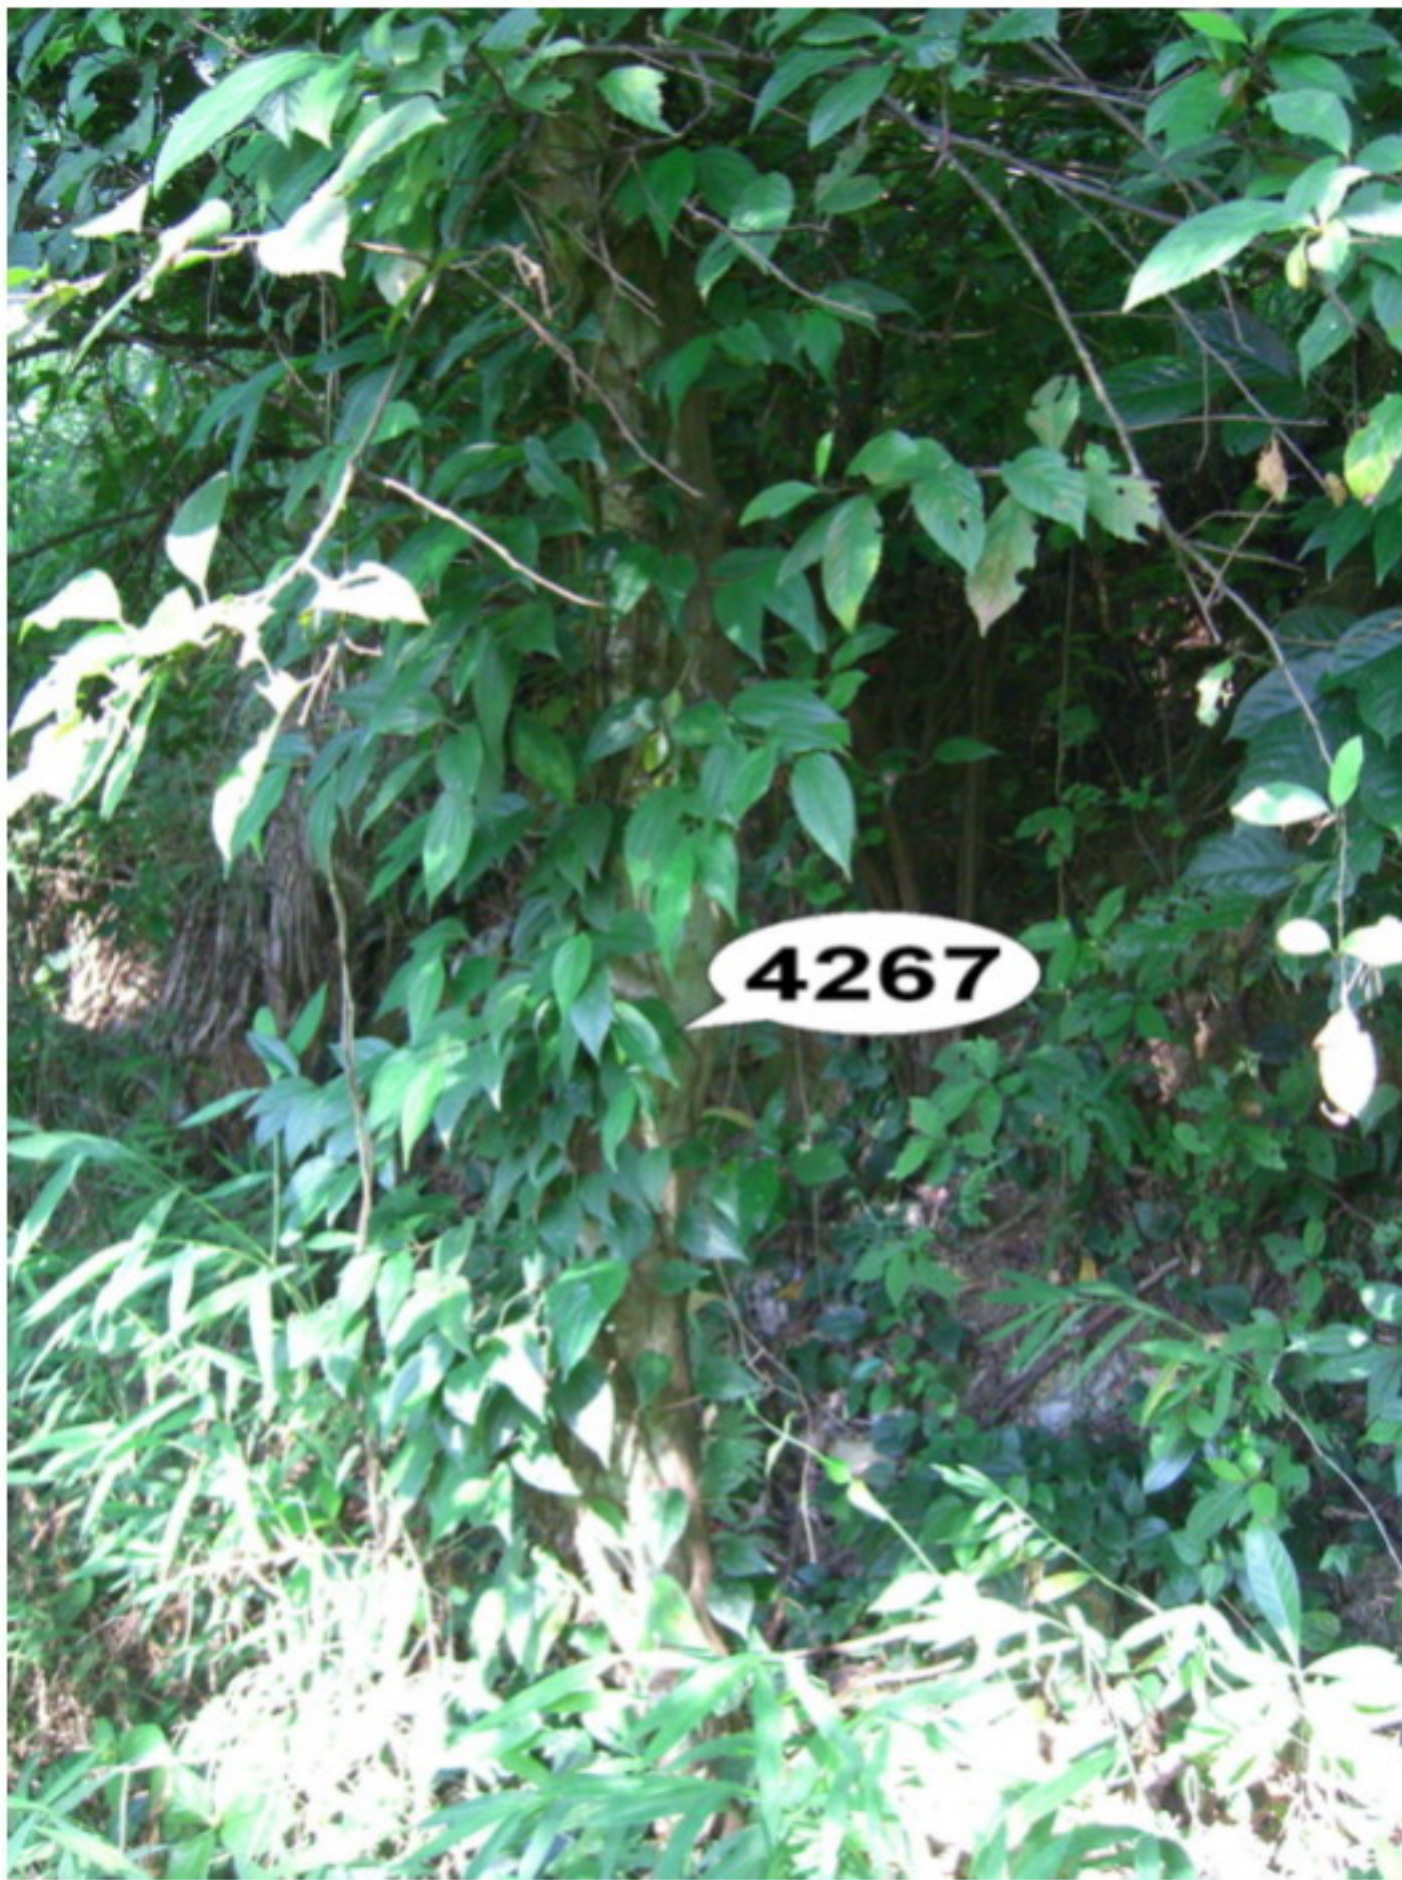
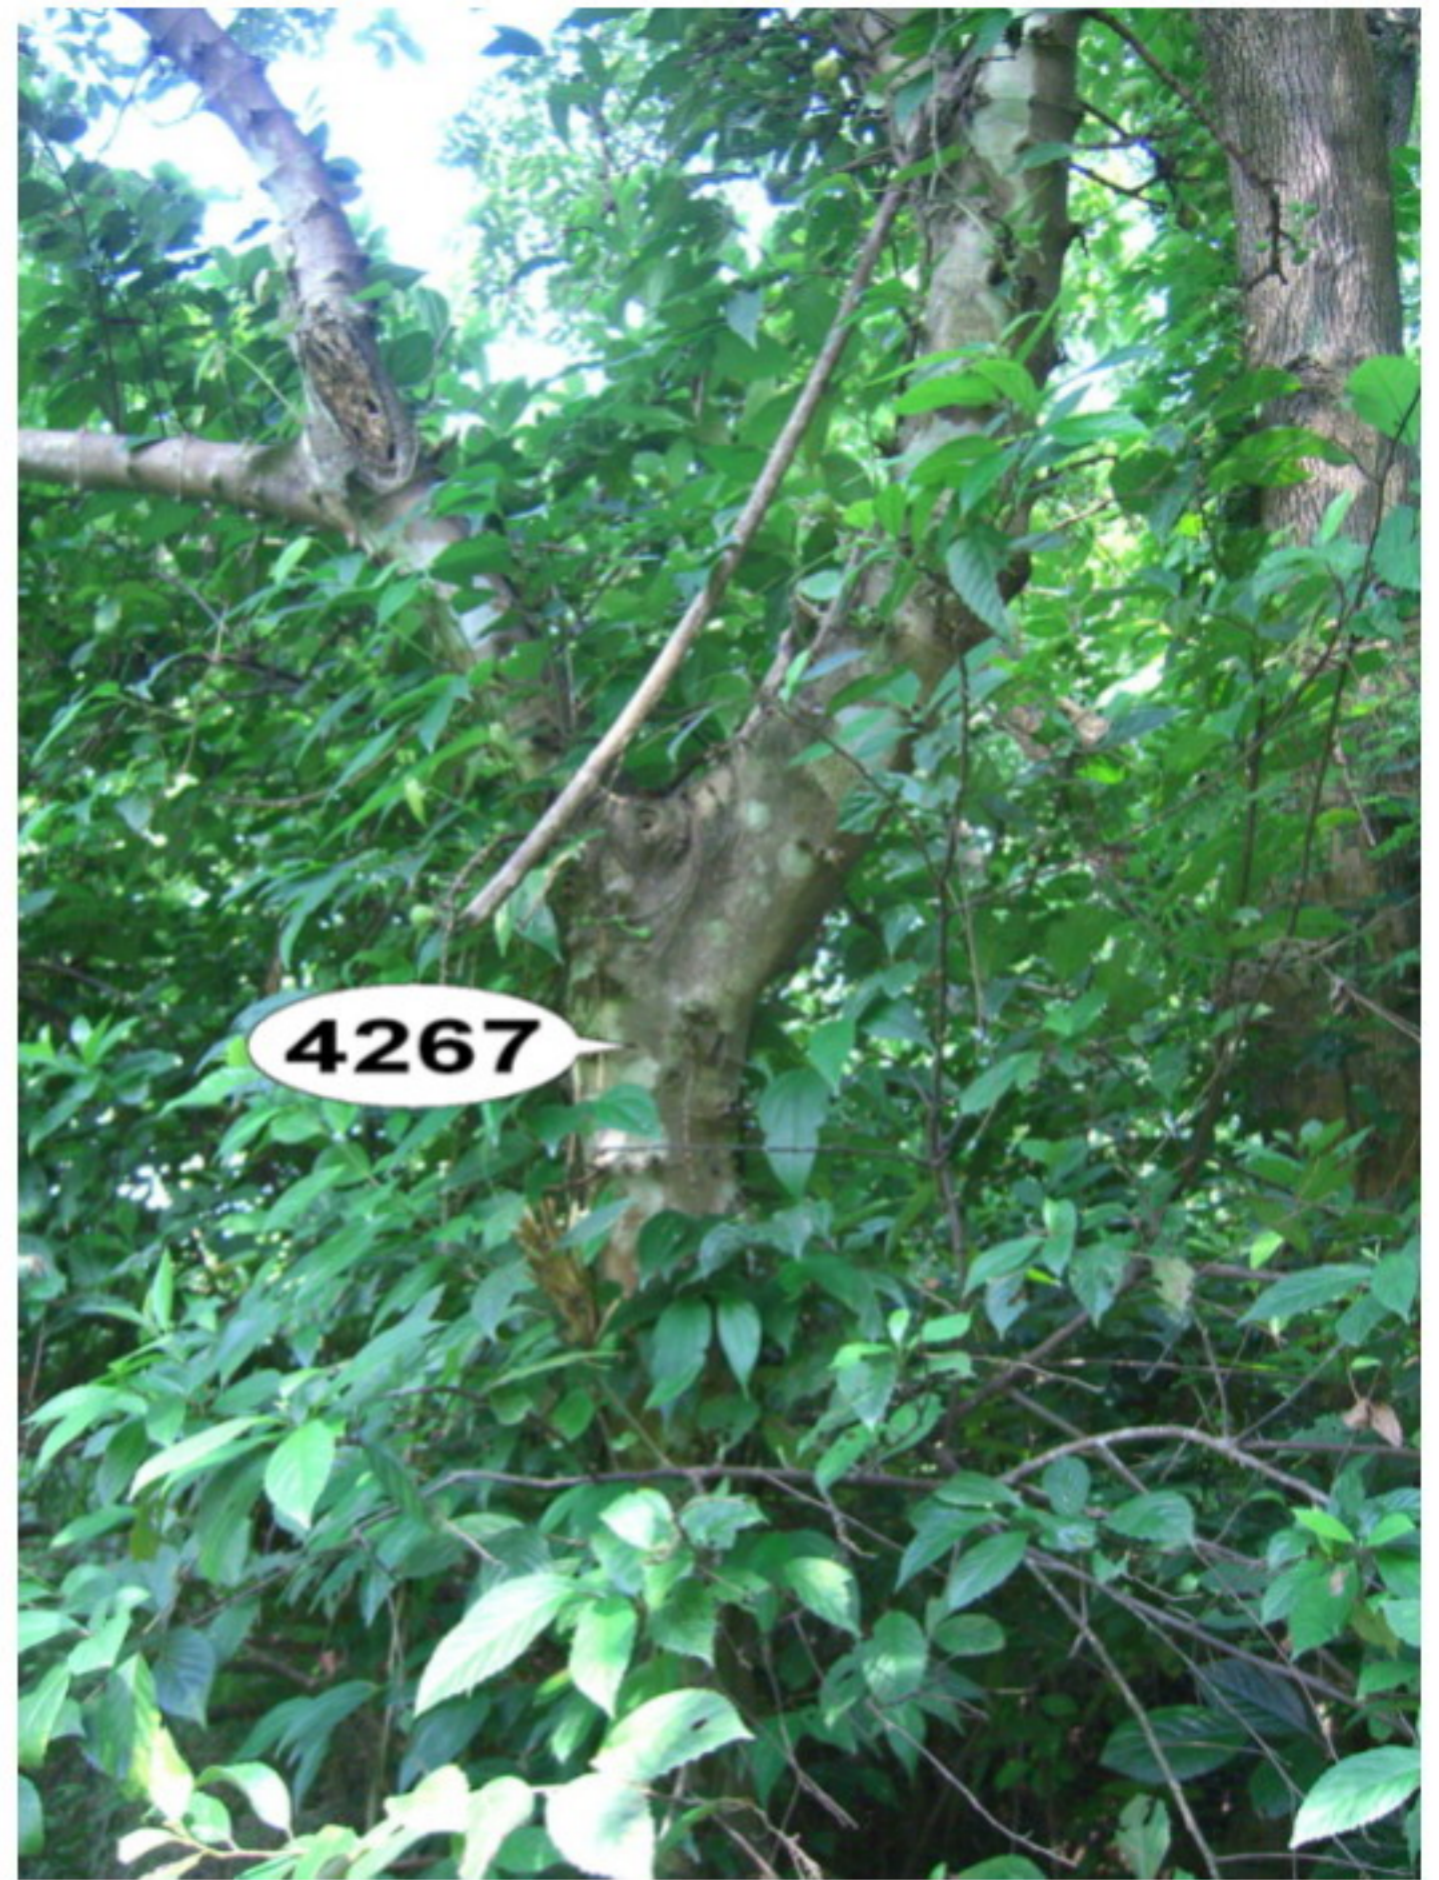
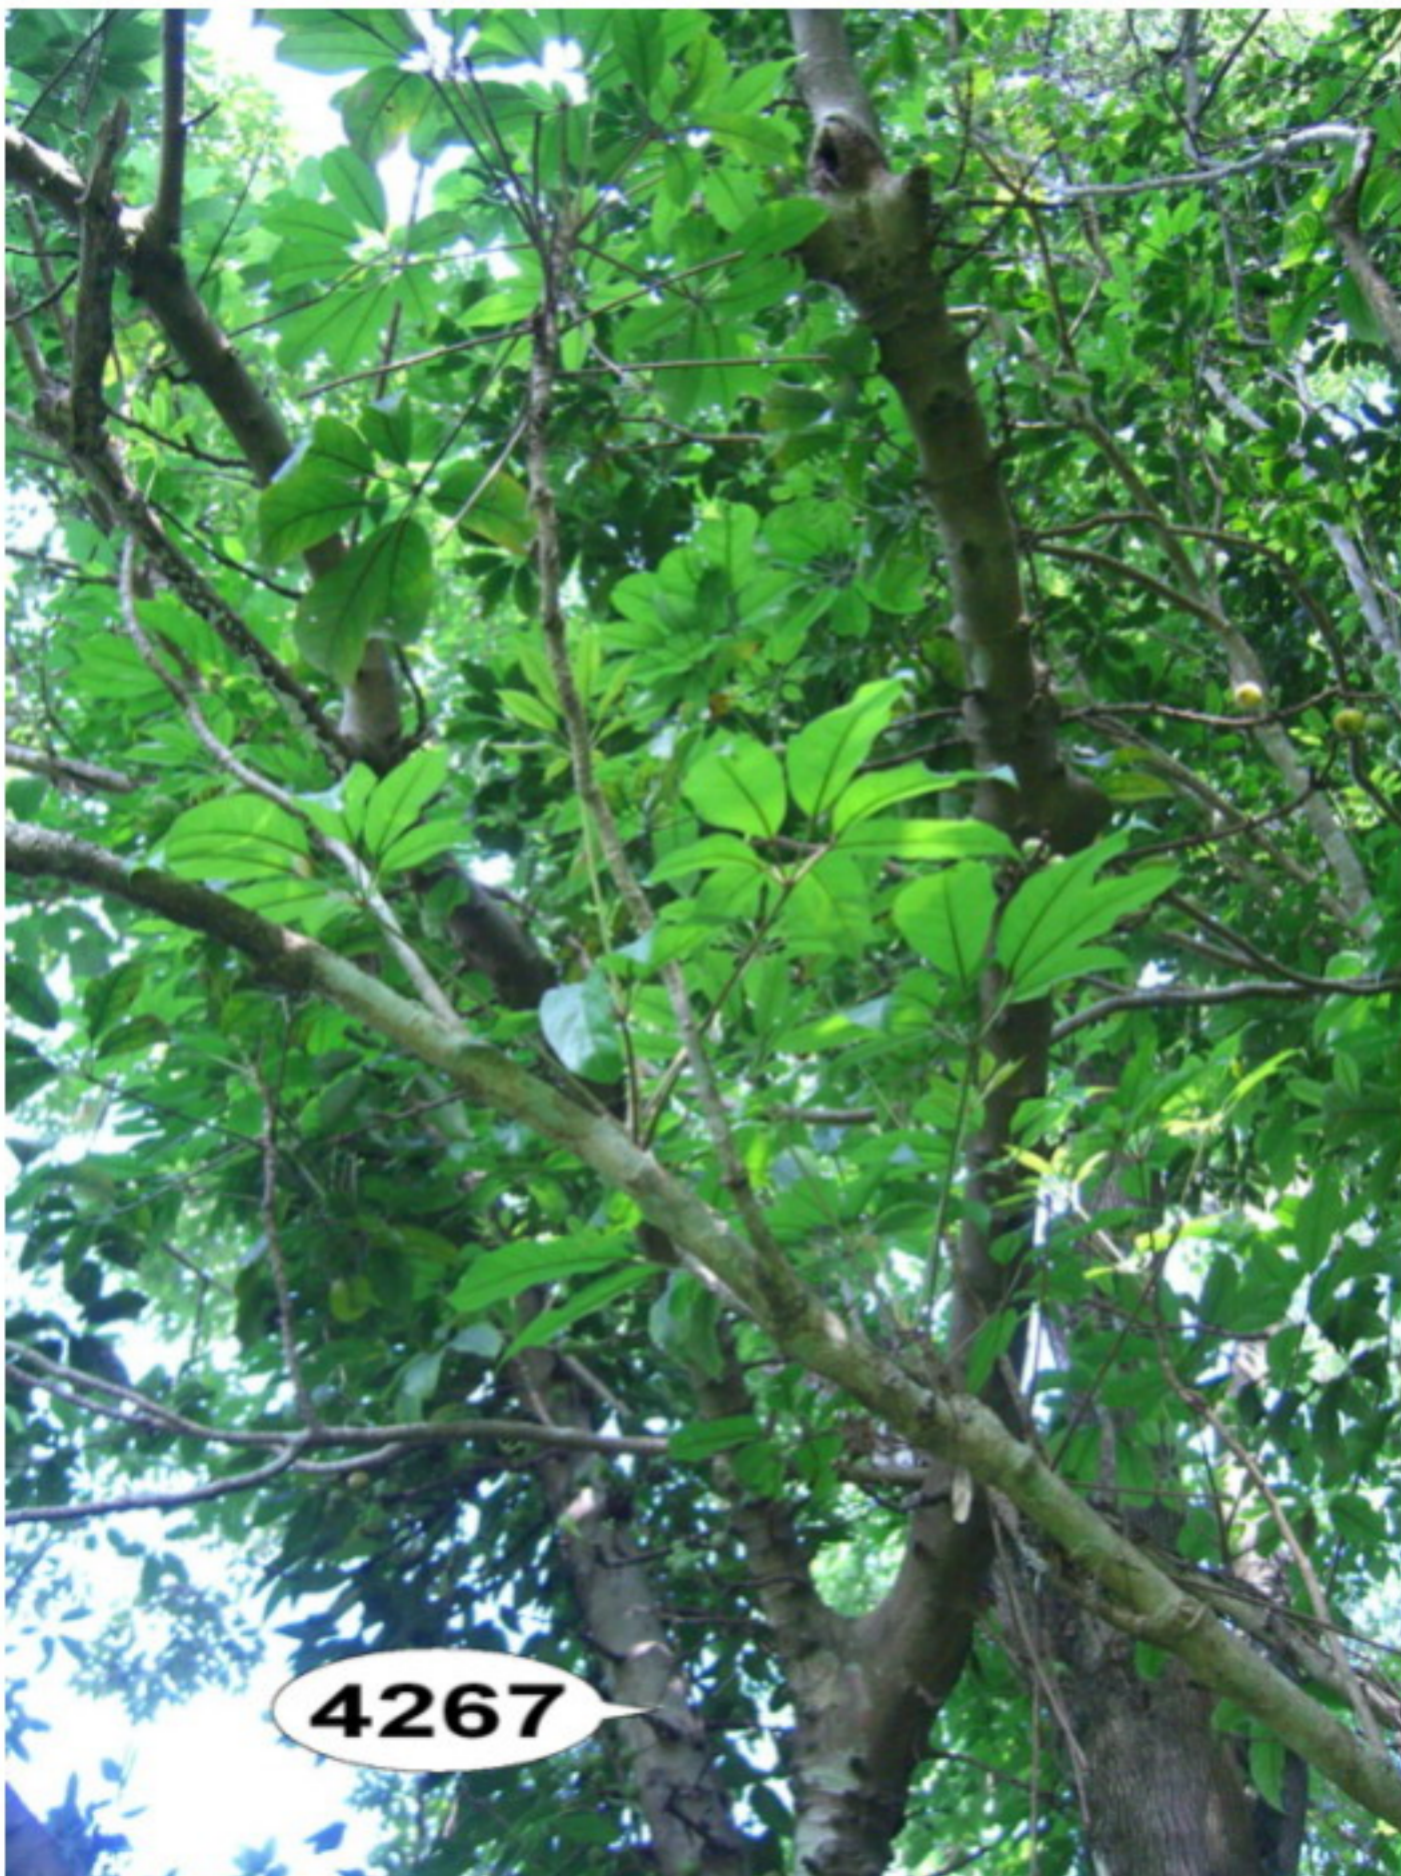
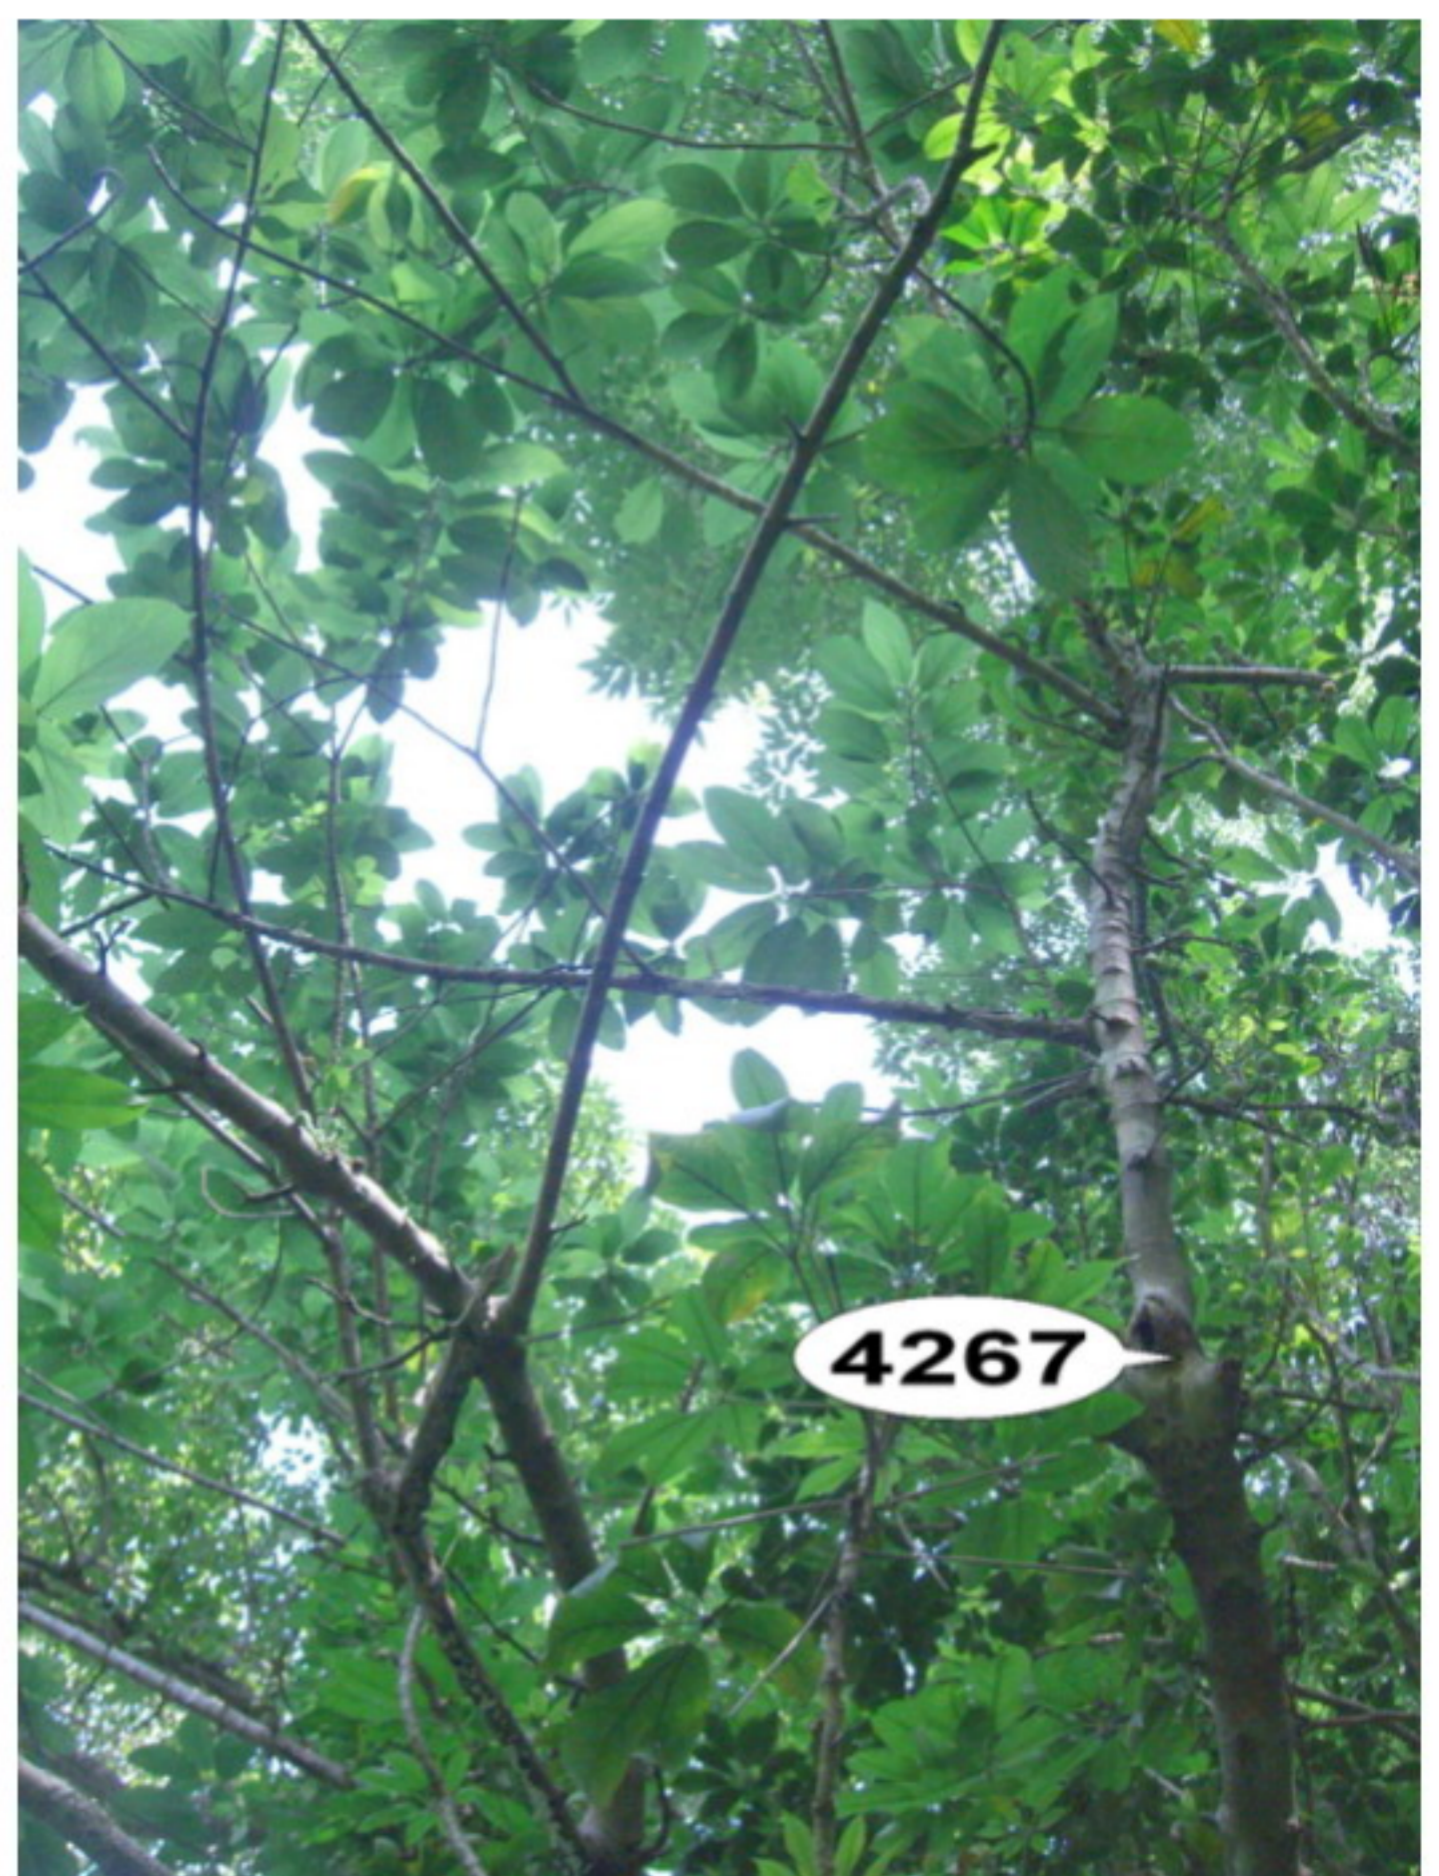
Tree 4266

Poor health lead to low transplantation survival rate. Termites attack was found on tree trunk.
