# Provision of Cremators at Wo Hop Shek Crematorium

Tree Survey Report

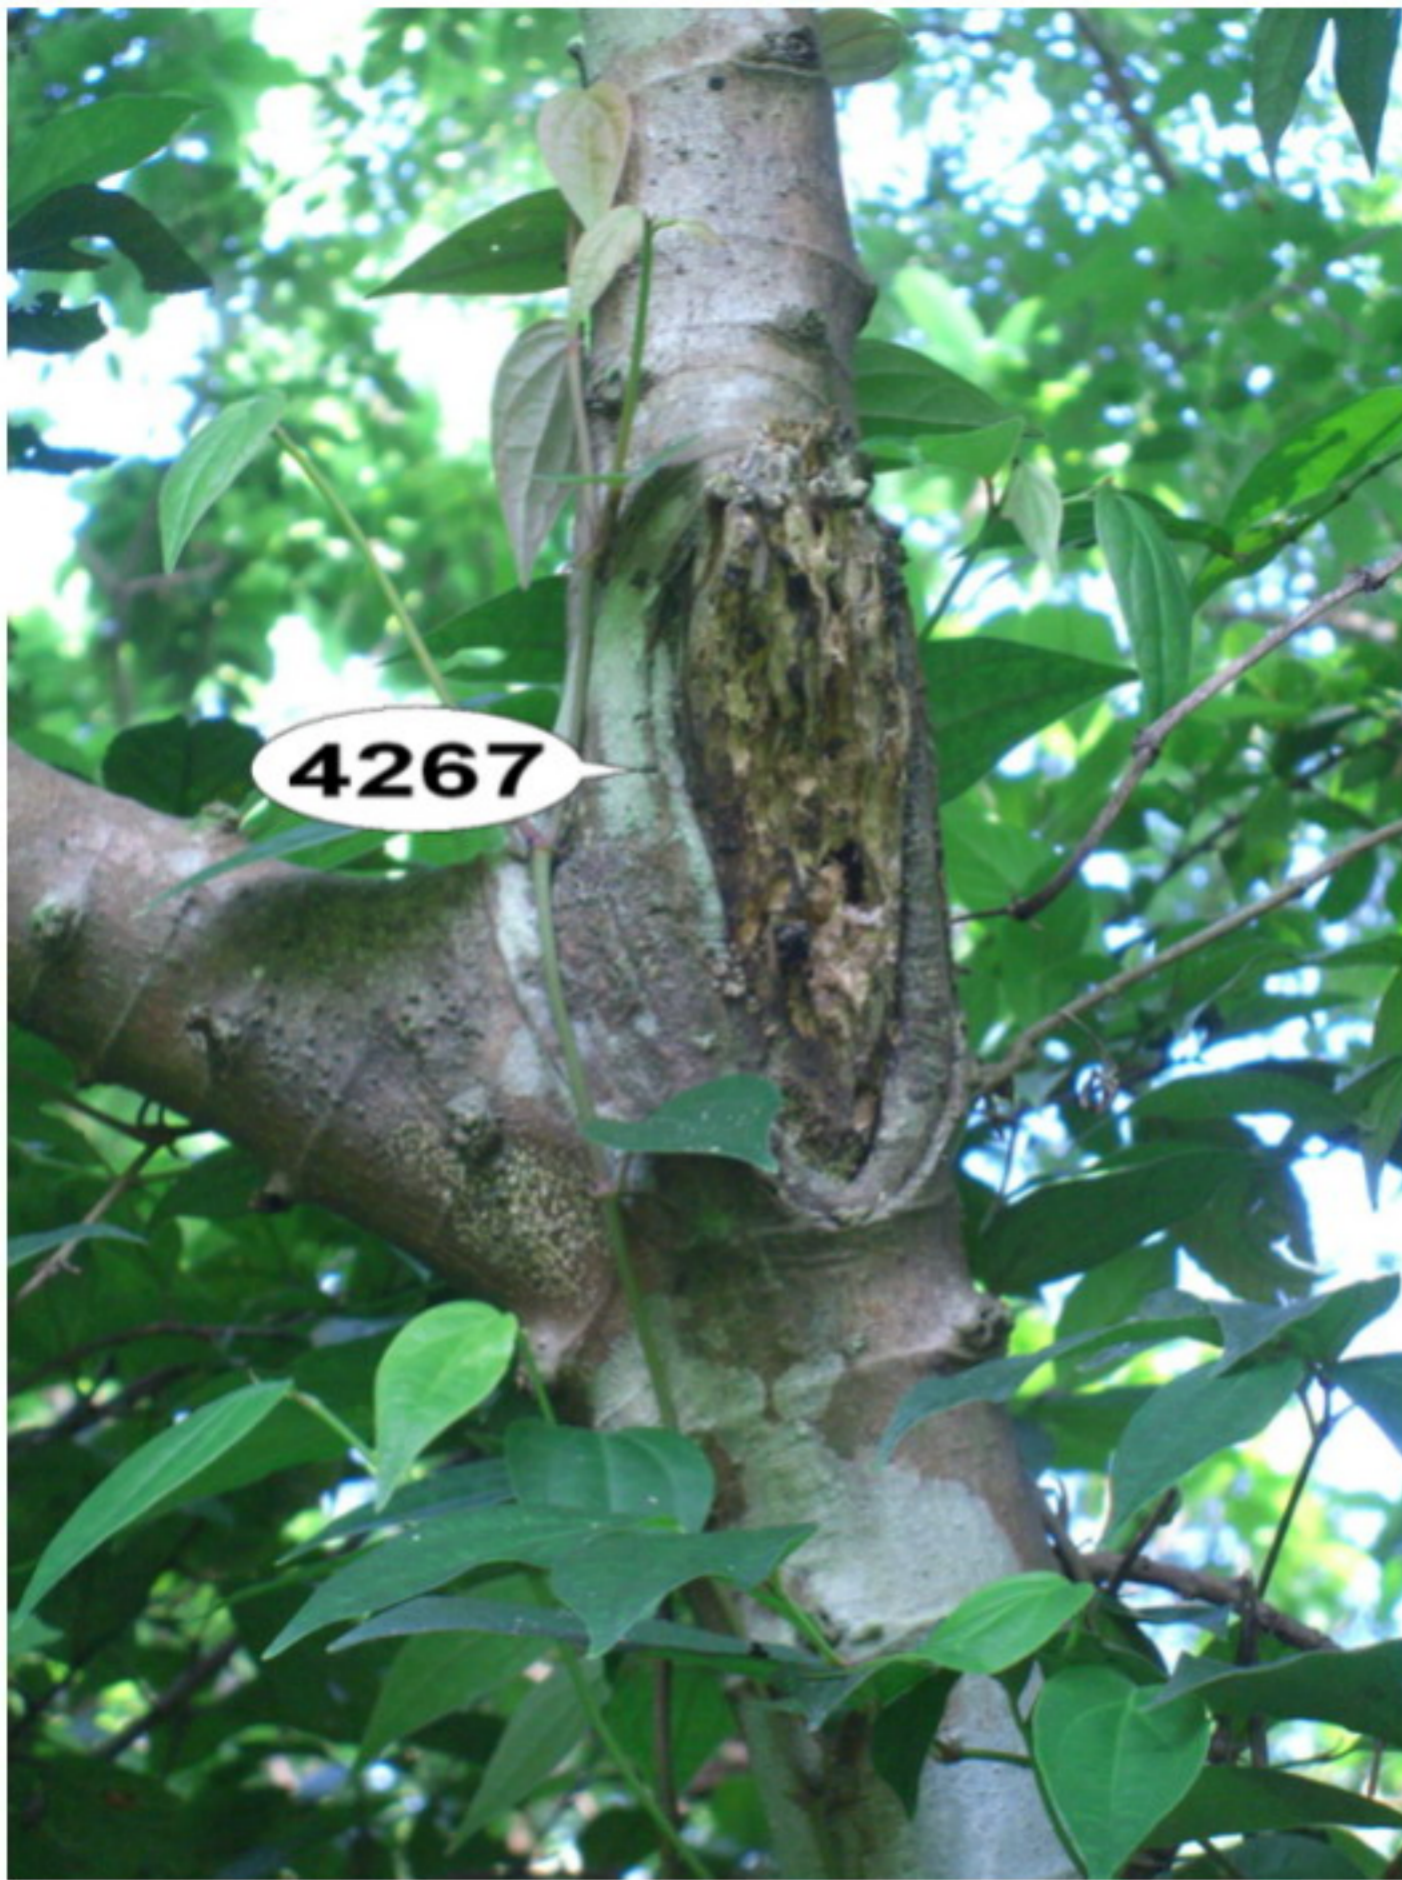
Tree 4267

Poor health will lead to low transplantation survival rate. Poor form which also lead to low amenity value. Besides, the tree is unbalance. It may need heavy pruning after transplantation that will affect its transplantation survival rate. Moreover, the operation of the transplantation for poor form tree is also difficult.

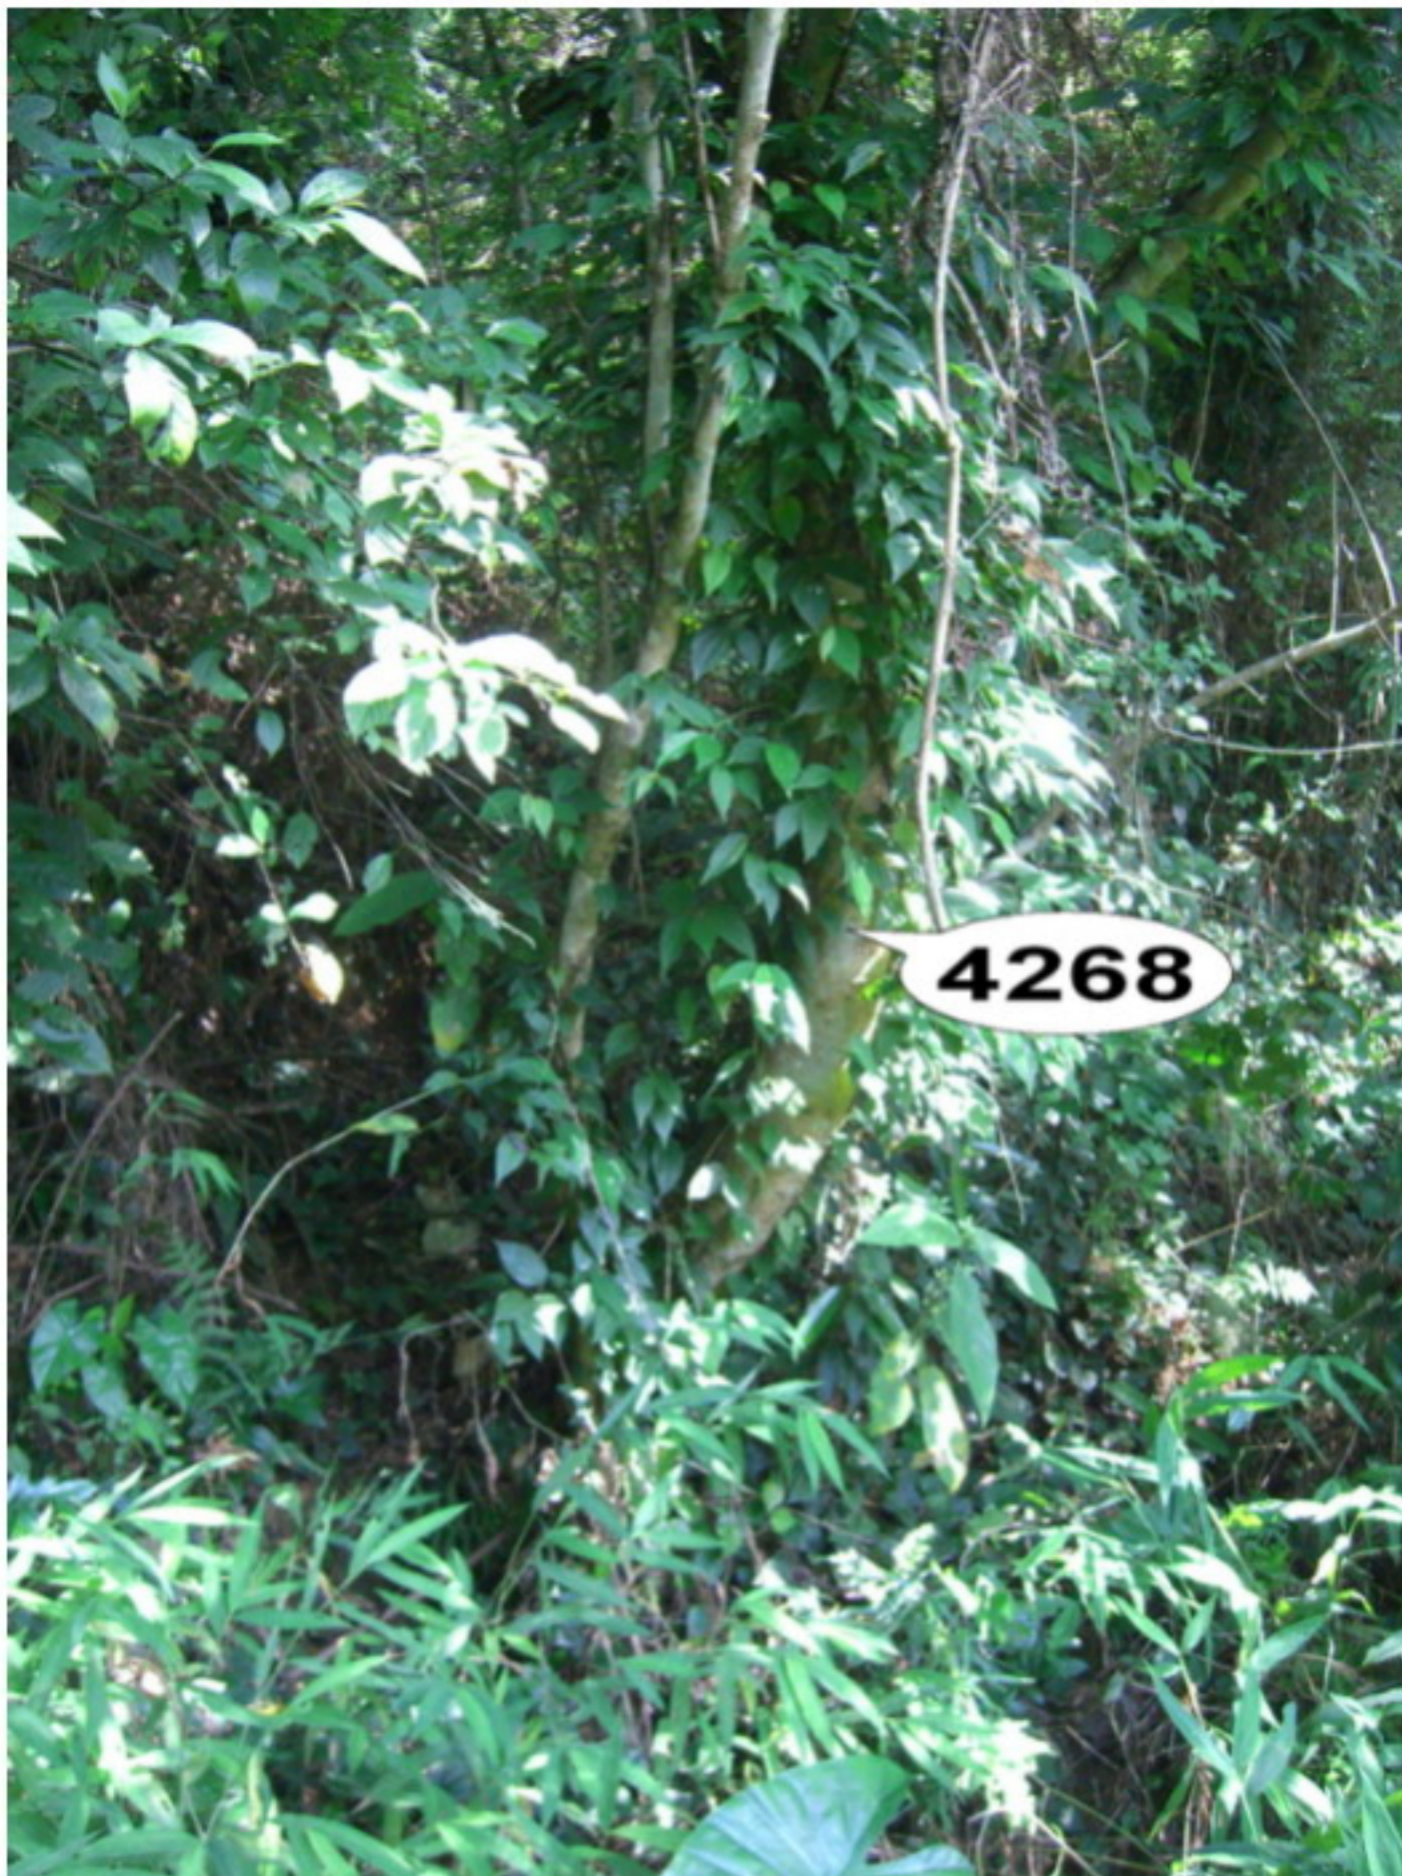
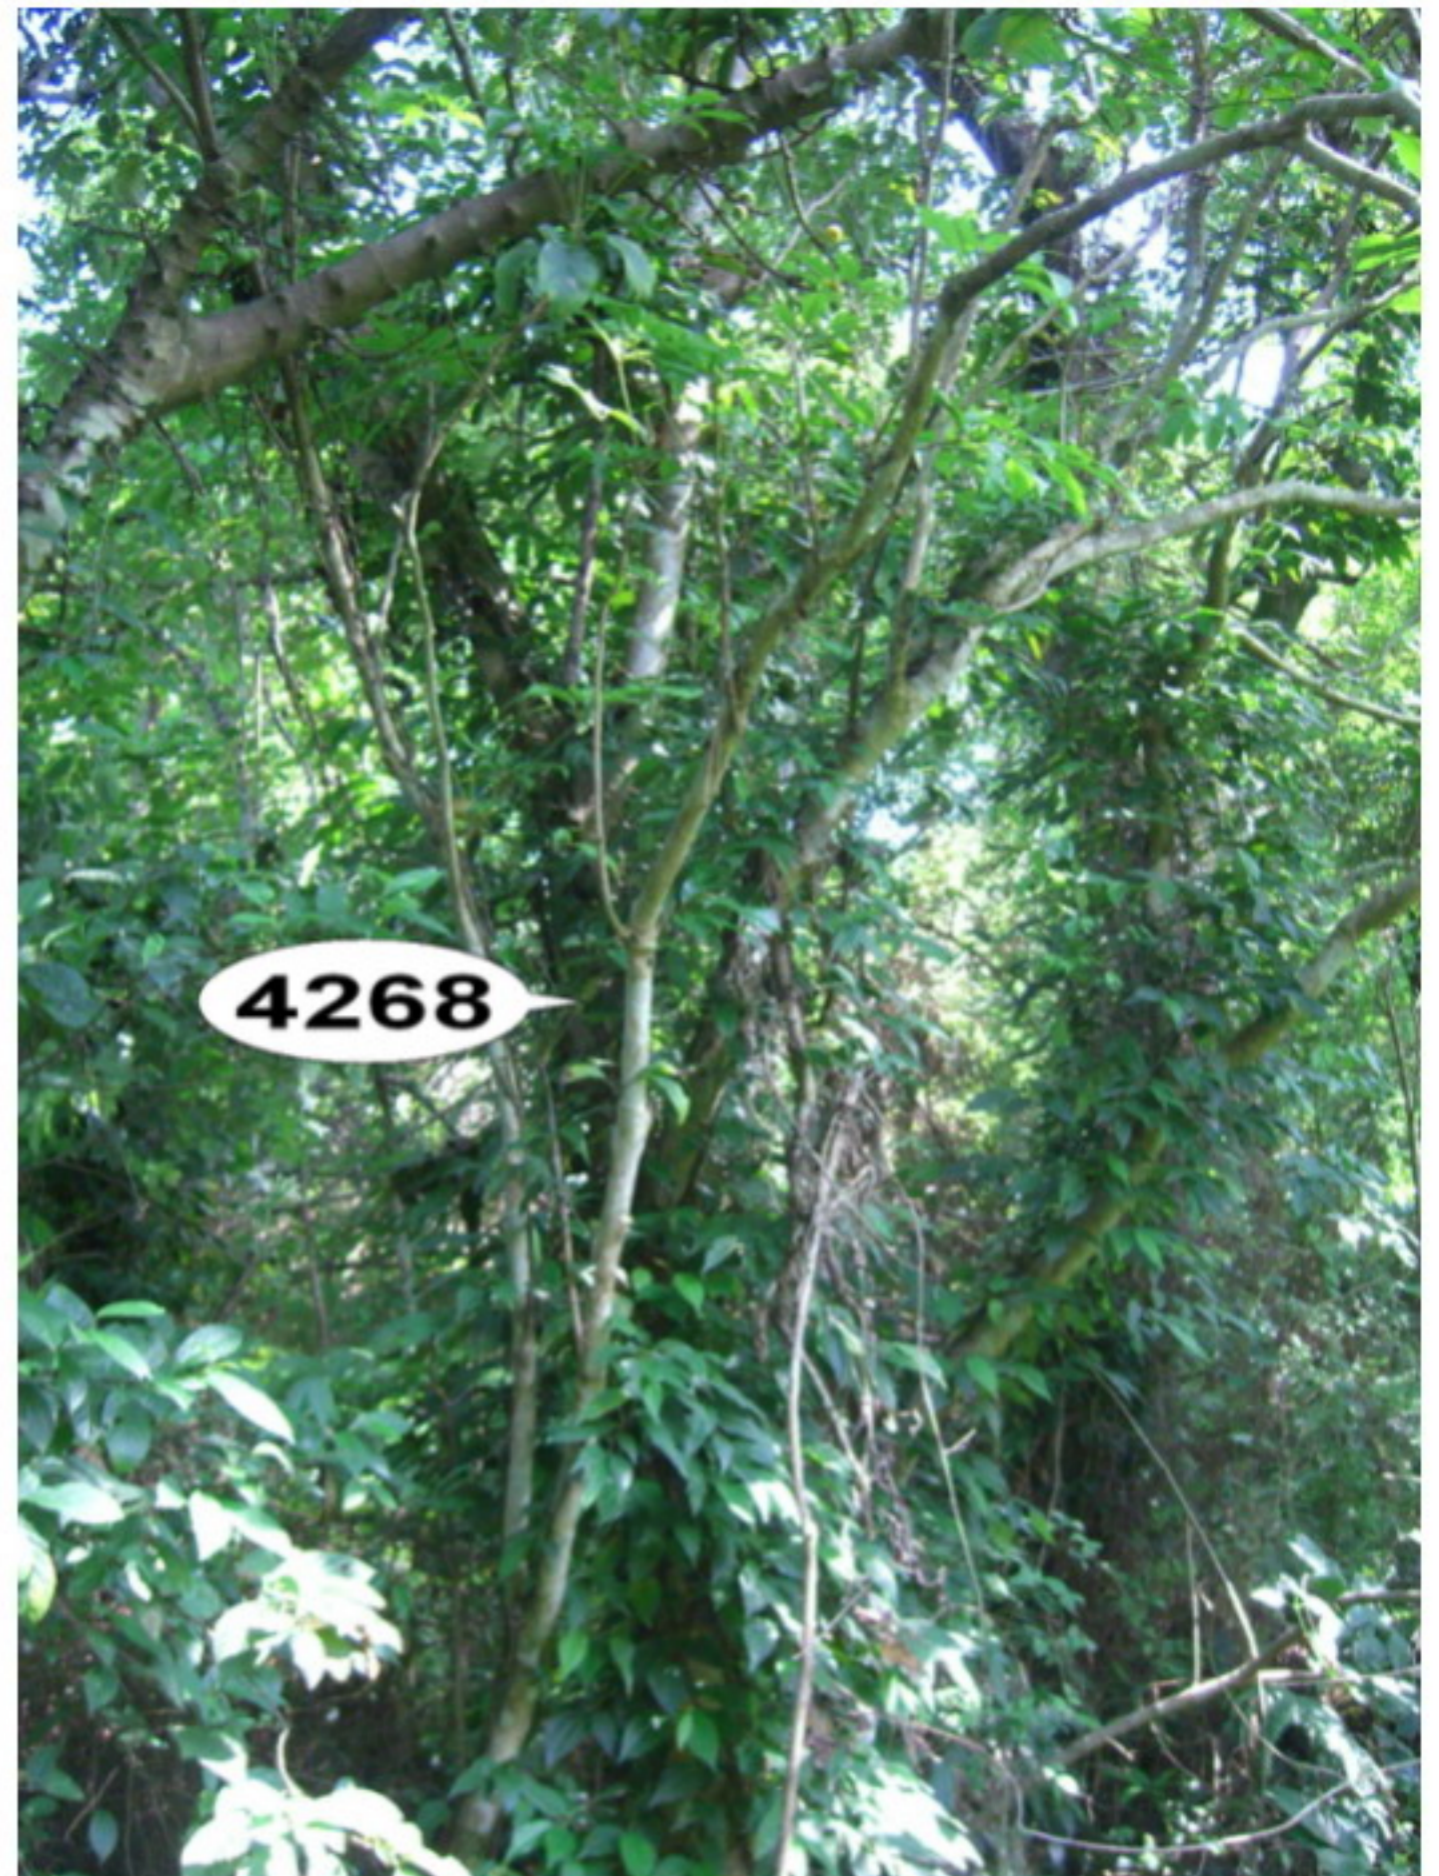
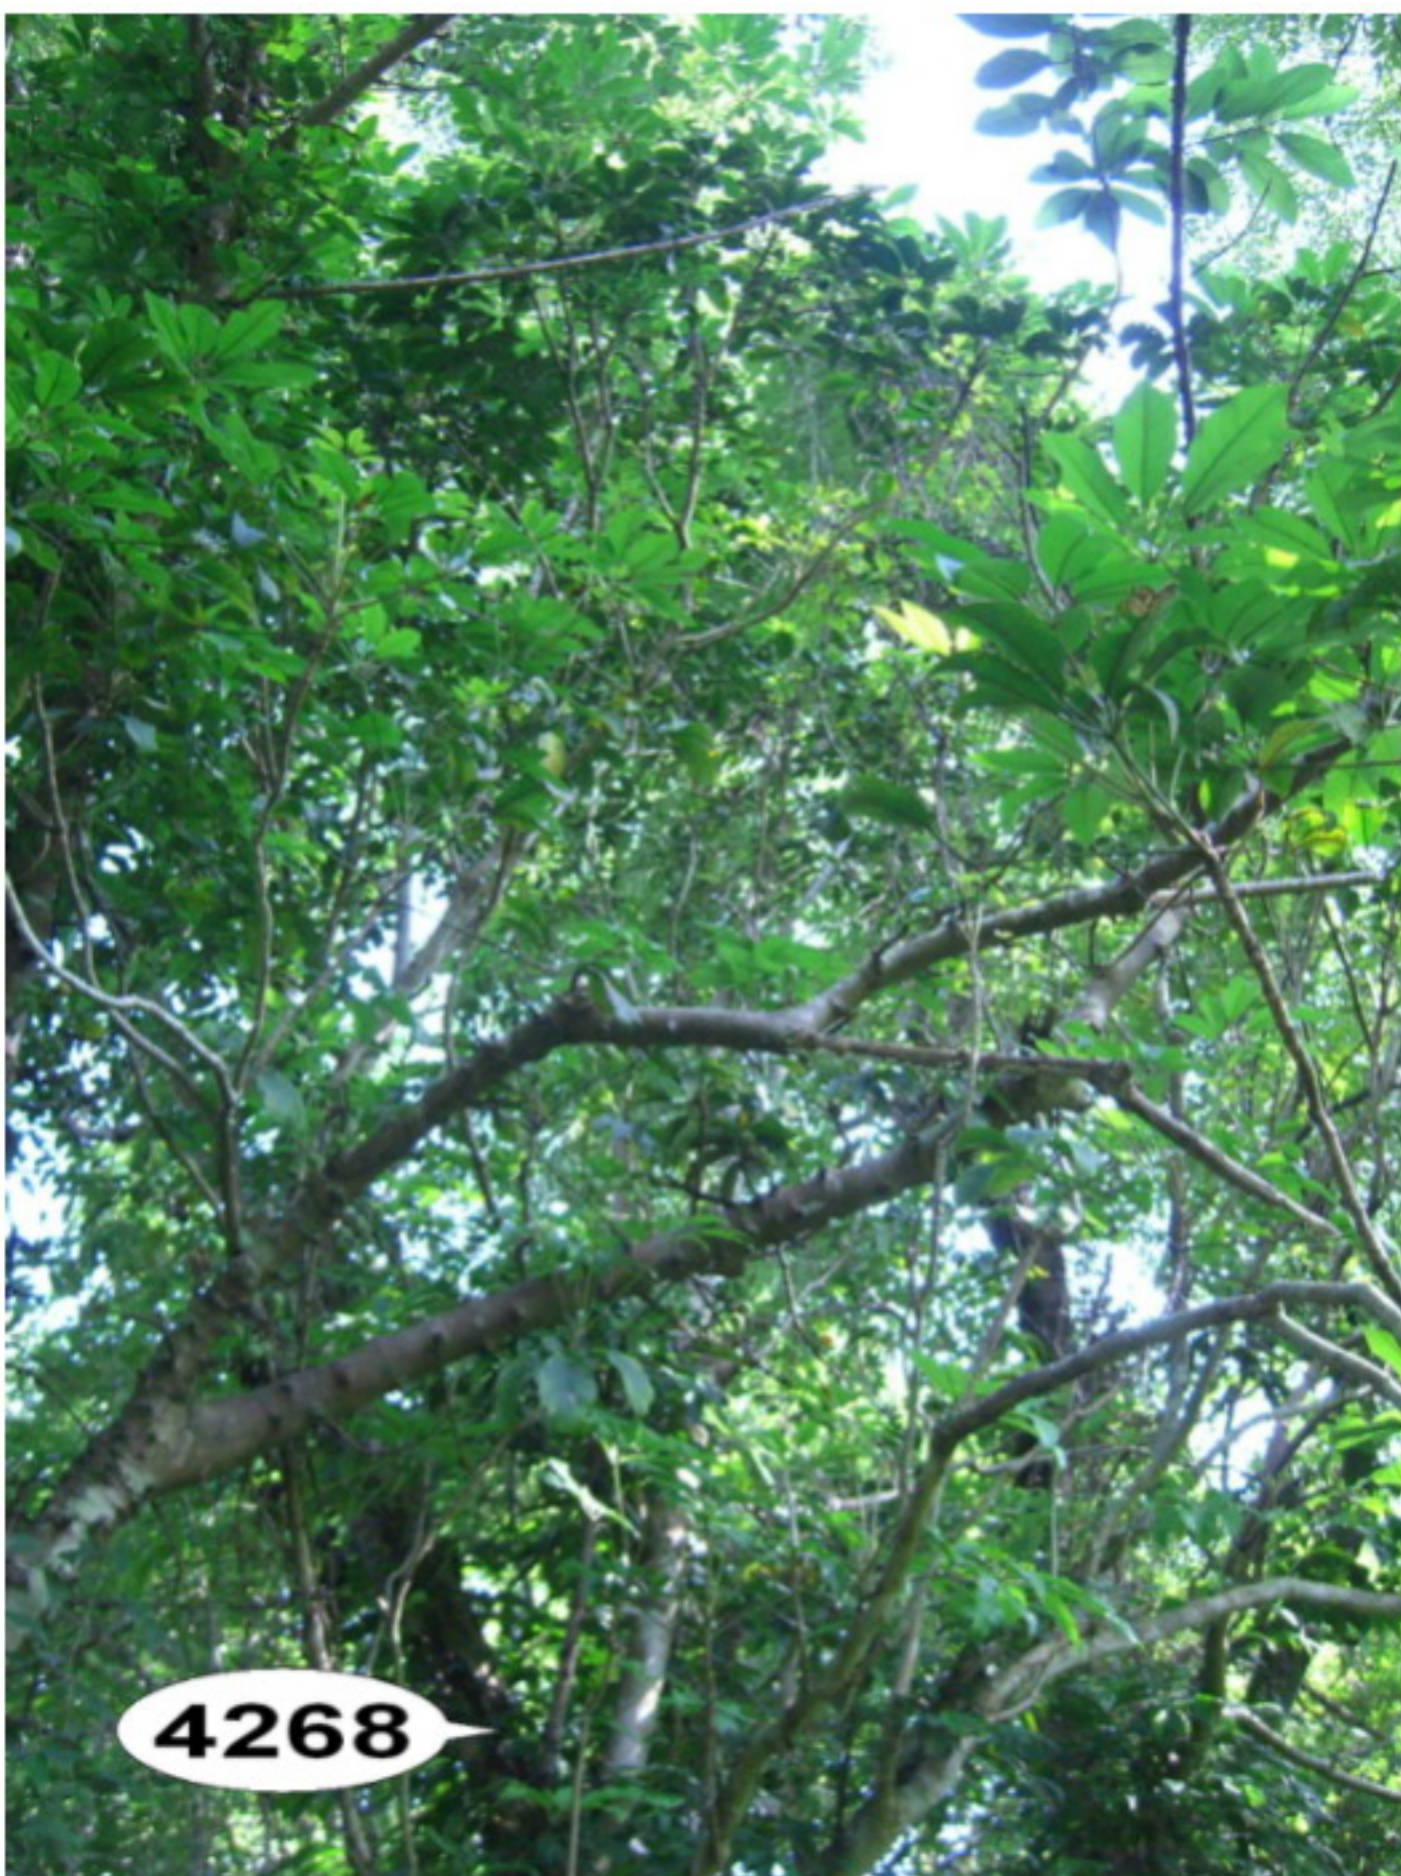
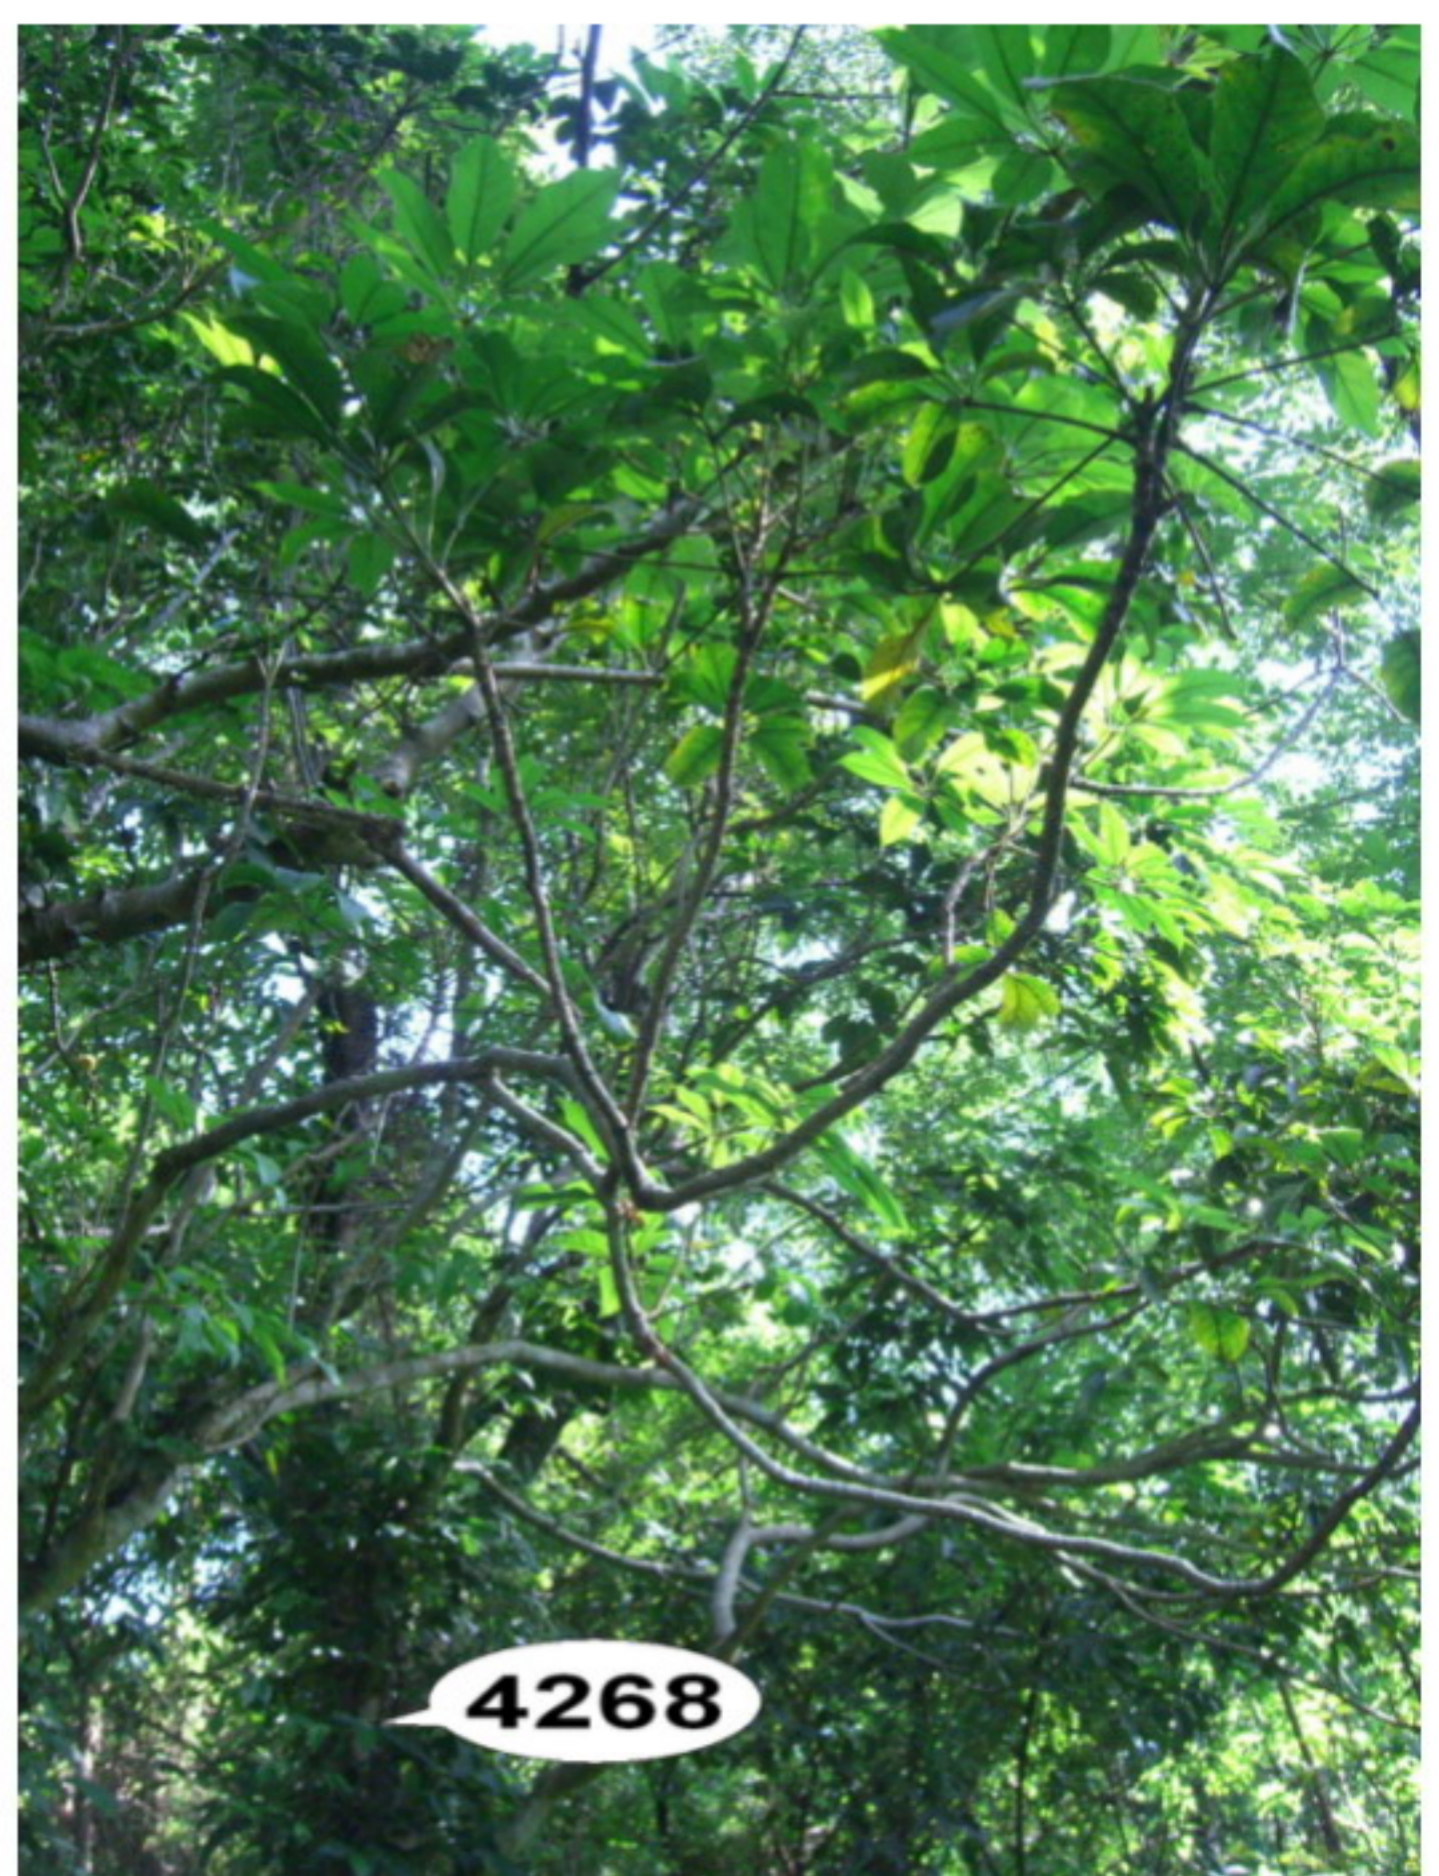
#### Tree 4267

Poor health will lead to low transplantation survival rate. Poor form which also lead to low amenity value. Besides, the tree is unbalance. It may need heavy pruning after transplantation that will affect its transplantation survival rate. Moreover, the operation of the transplation for poor form tree is also difficult.

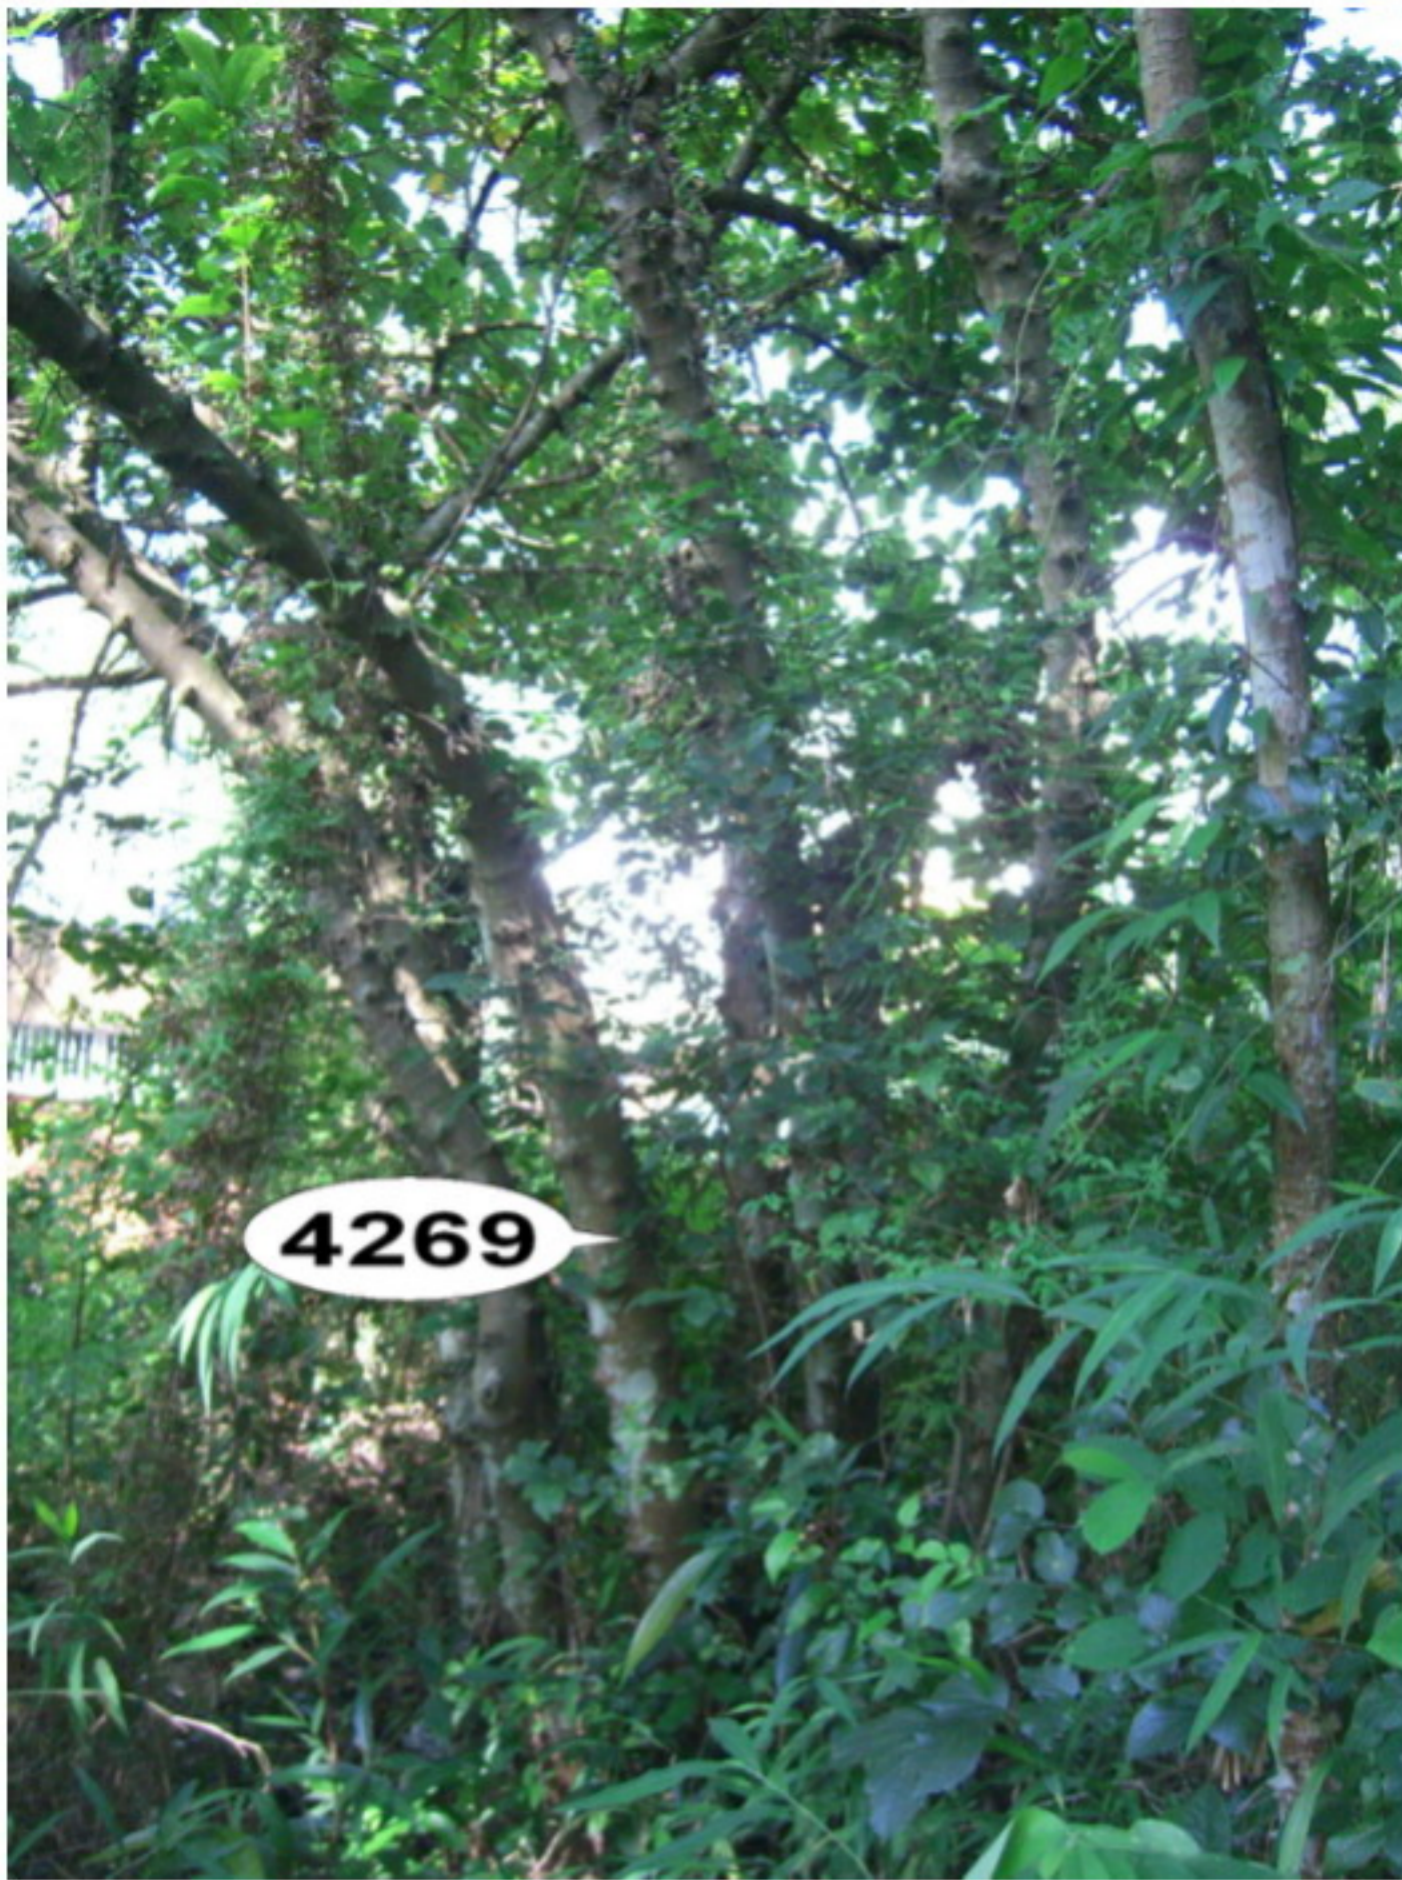
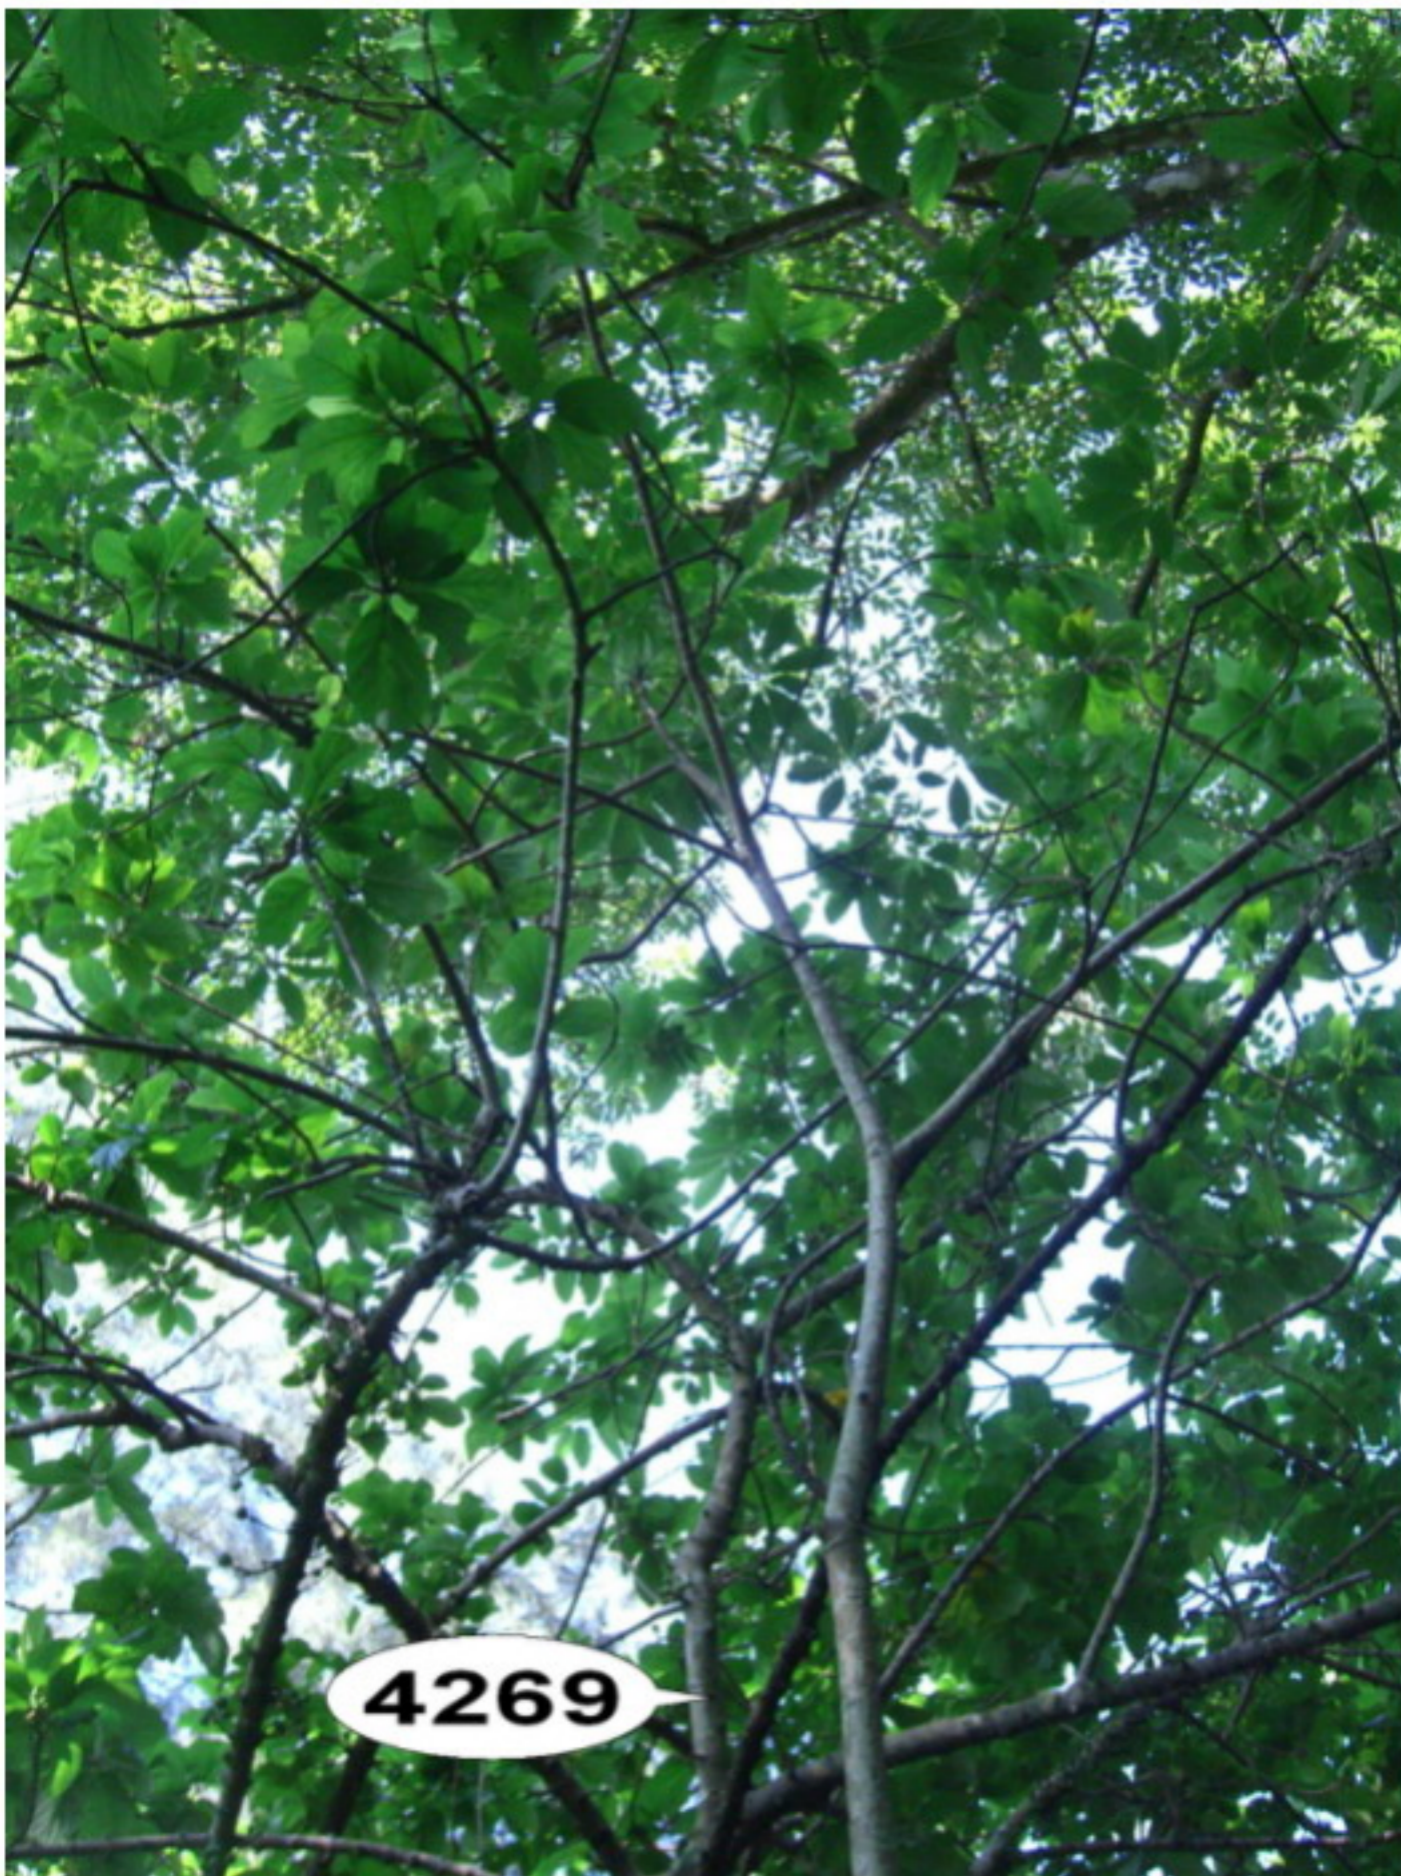
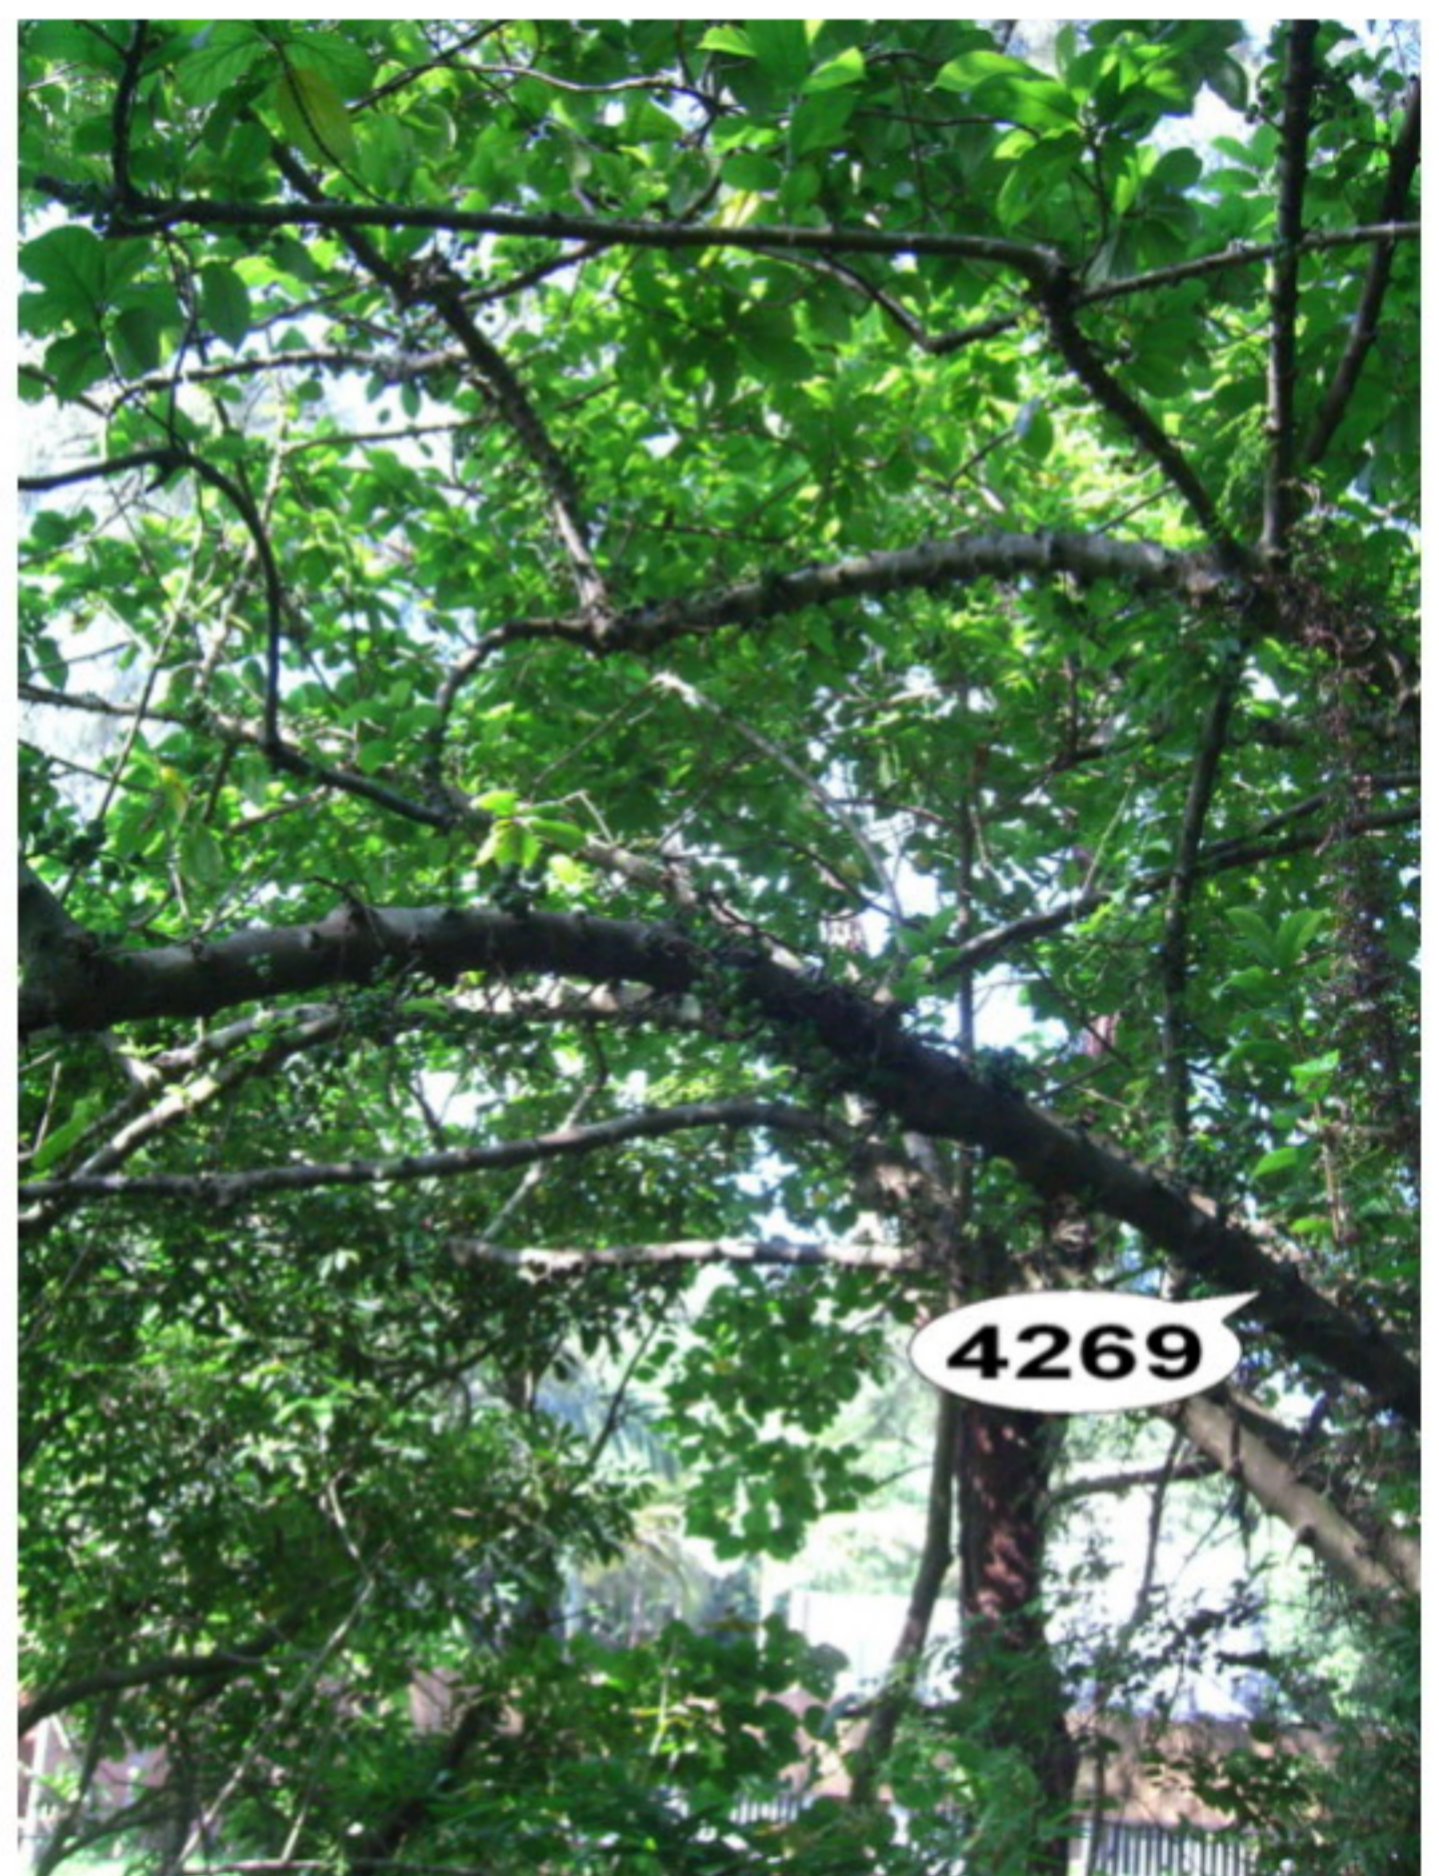
Tree 4268

Poor health will lead to low transplantation survival rate. Poor form which also lead to low amenity value. Besides, the tree is unbalance. It may need heavy pruning after transplantation that will affect its transplantation survival rate. Moreover, the operation of the transplantation for poor form tree is also difficult.
